KINCOPPAL - ROSE BAY

SCHOOL OF THE SACRED HEART

CONSERVATION MANAGEMENT PLAN

Final Report - August 2020

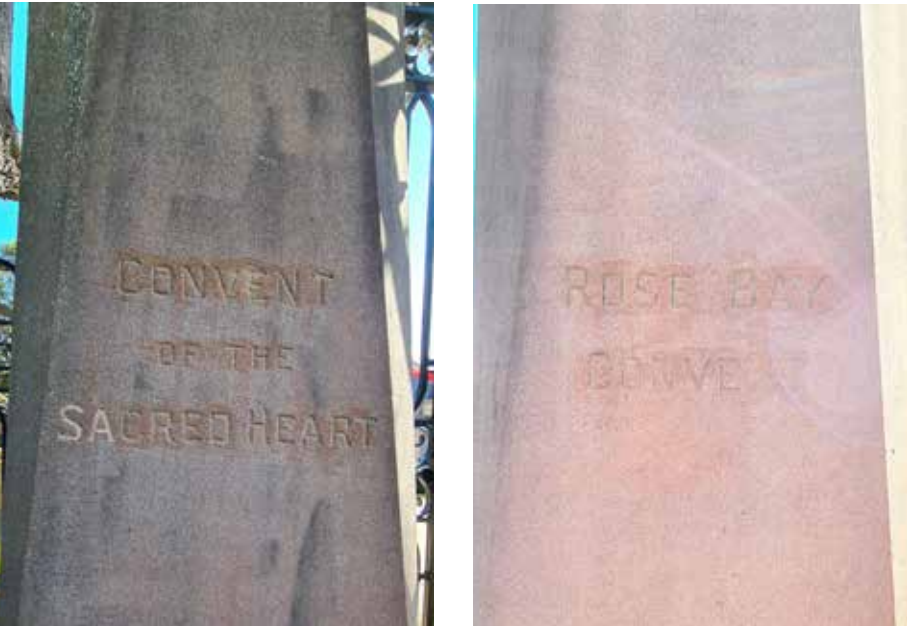
Figure 2.244: Sandstone pillars with carved lettering to the Jubilee Gates.

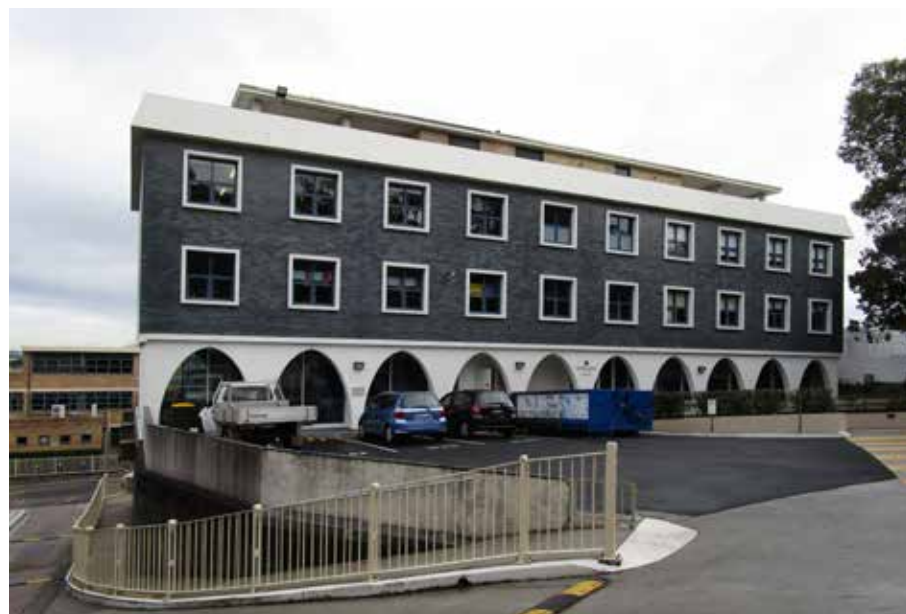
Figure 2.245: The eastern elevation of Barat Burn with its distinct rendered catenary arch colonade as seen from Vaucluse Road.

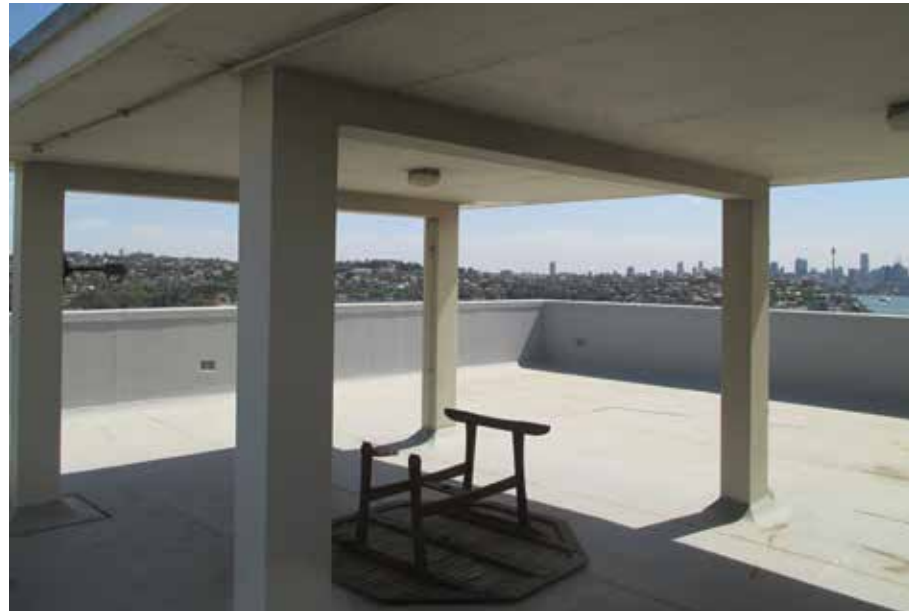
Figure 2.250: View south west over the harbour towards Rose Bay from the roof terrace at Barat Burn. Note the steel and concrete cantilevered flat roof.

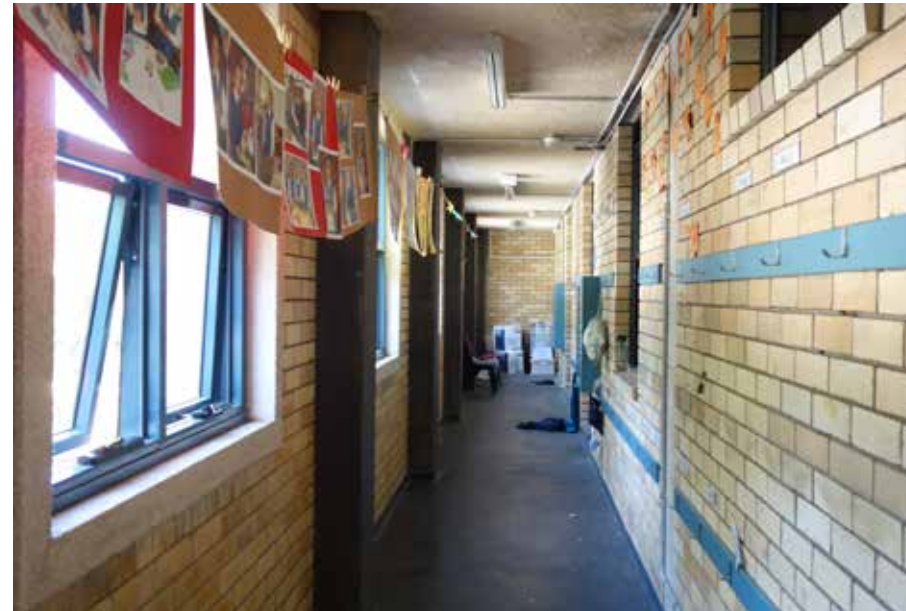
Figure 2.253: Former open balcony on the eastern side, with classrooms to the right. Note the modern aluminium awning windows to the former openings.

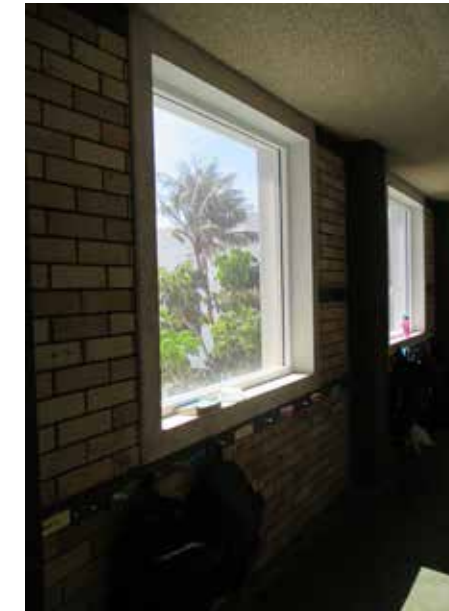
Figure 2.256: The former open balcony on the western side has been enclosed by a single pane of glass. Note the original exposed aggregate window surrounds.

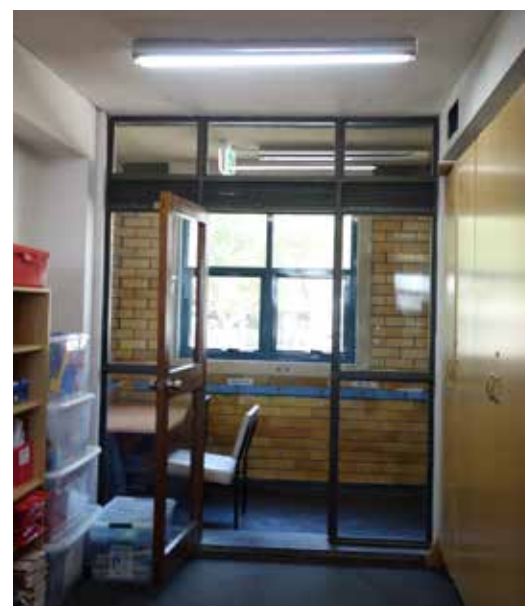
Figure 2.255: Steel framed door to balcony, showing the flooring finishes and terrazzo door threshold at Barat Burn.

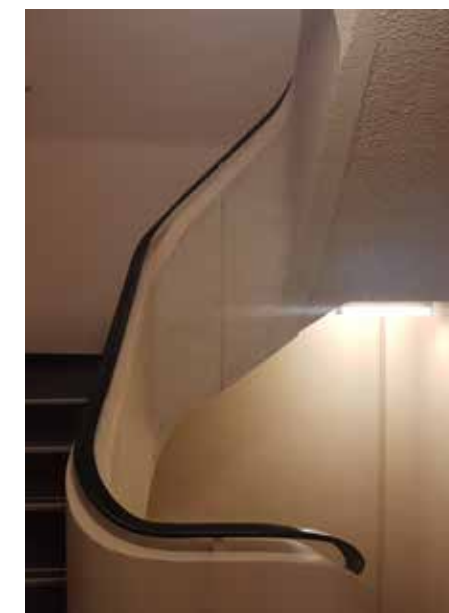
Figure 2.258: View of the white, unpolished terrazzo balustrade of the feature central staircase at Barat Burn

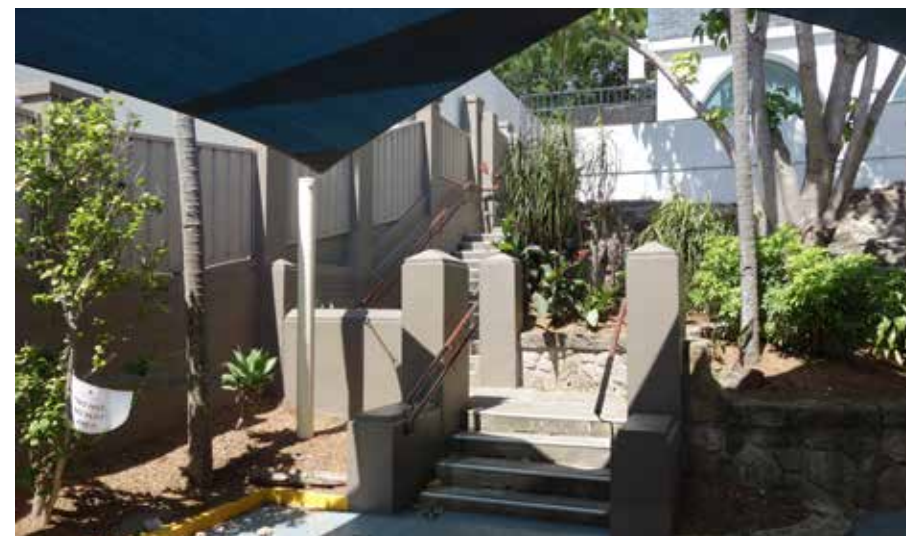
Figure 2.264: Rendered masonry pillars / walls and steps from the former Melocco villa at the eastern end of the playground.

To the north of the Junior school is a small toilet block, similarly with orange face brick walls and concrete flat roof. The surrounding courtyard / play ground is asphalted and the northern half is covered by a series of shade structures. The northern boundary wall of this courtyard features the remains of a Melocco era marble scroll below which hangs a painted ceramic tablet of the Madonna and Child. A set of steps and rendered masonry pillars / walls at the north-eastern corner of the playground also date from the Melocco residence.

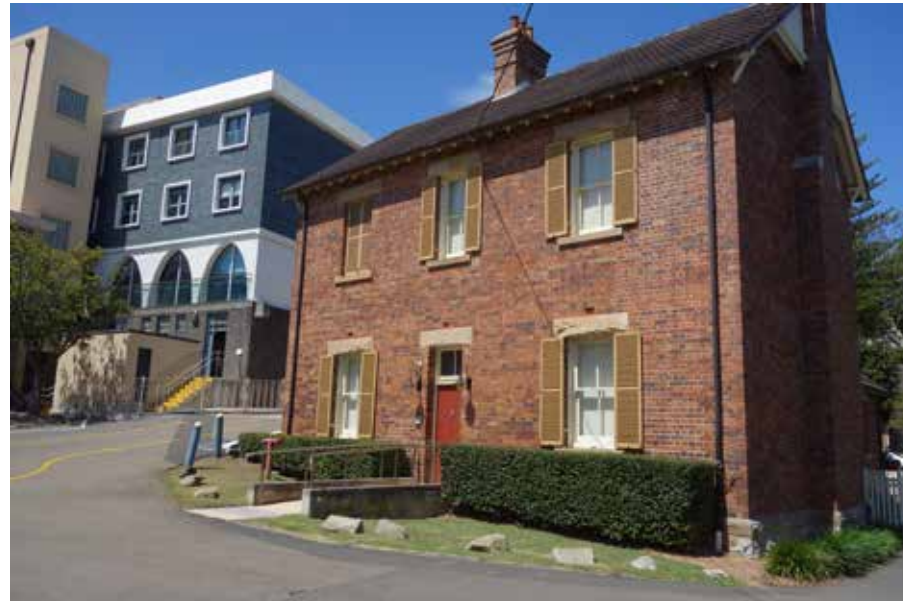
Figure 2.267: The western elevation of the Villa, with Barat Burn in the background.

The building has rock faced stone ashlar foundations, four-pane double hung timber windows, with rock faced stone lintel and smooth finished stone sill. The north and south elevations include terracotta vents at ceiling and roof level. Modern downpipes discharge rainwater away from the building into the ground. The upper storey windows to the north and all windows to the west have timber shutters. The western facade of the Villa presents as the main elevation, around a central door, and symmetrically placed windows on either side. A secondary external access to the first floor is provided via a steel stair on the north side.

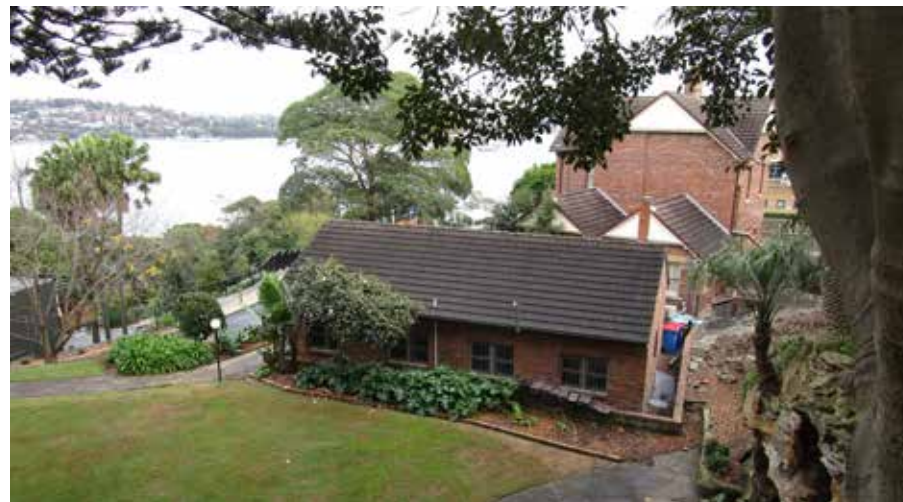
Figure 2.269: View of the Workshop and Garage as seen from the Grotto, with the Villa in the background.

Located to the rear (east) of the Villa, this building was constructed 1965-66 as a new garage and workshop to a design by architects Hennessy and Hennessy. It is a free standing single storied gabled brick building with tiled roof and timber windows. It faces onto the open lawn area in front of the grotto to the east.

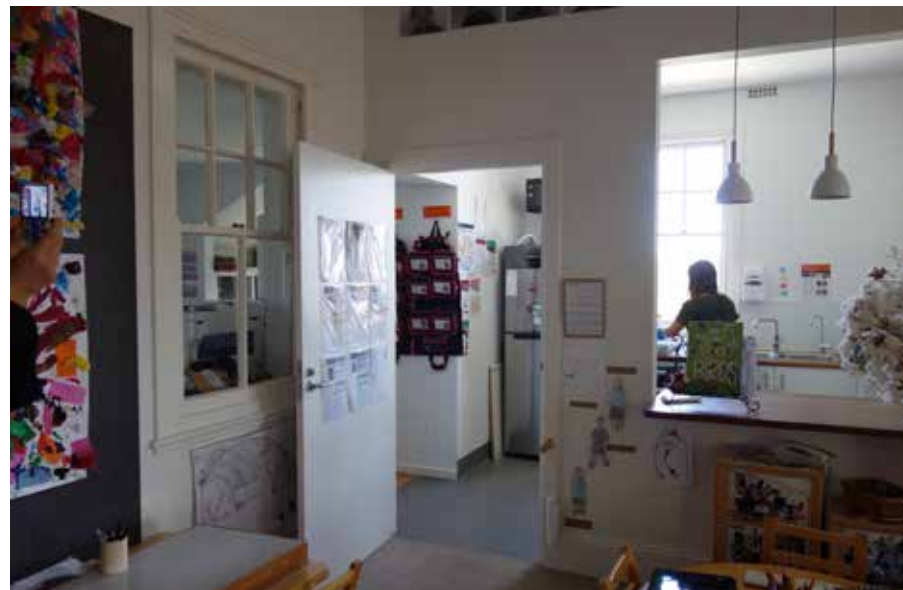
Figure 2.275: Remnant, formerly external, timber sash window.

Internally, the building has been heavily modified and opened up, although its earliest form remains legible in the painted brick walls (original face brick) and internal sash windows. There remains evidence of a former corner fireplace, and original joinery which includes skirtings and architraves. Ceilings appear to have been replaced with new plasterboard, and new floor finishes of carpet and vinyl have been installed.

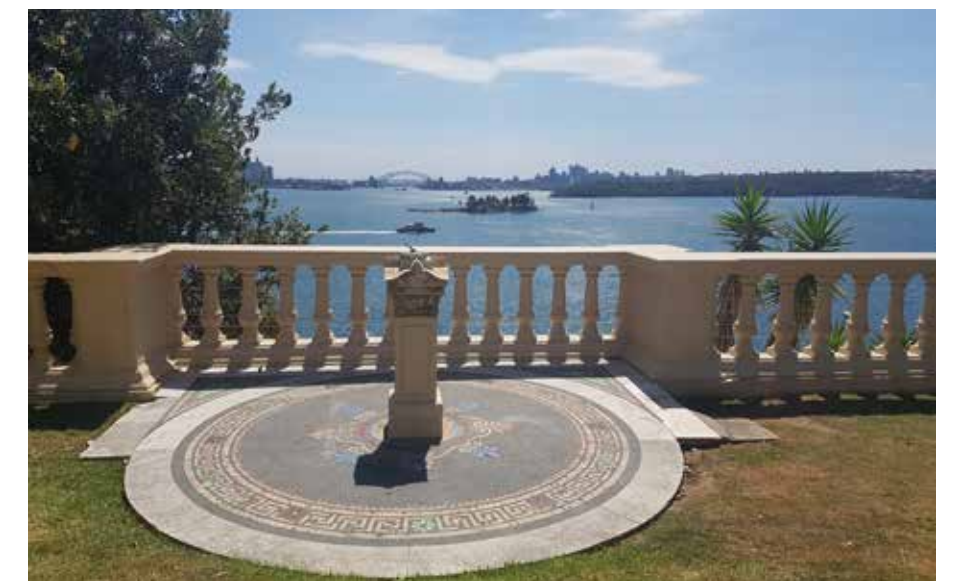
Figure 2.277: The sundial and mosaic paving and Italianate style fence with expansive harbour views behind.

The Sundial Lawn is an open grassed terrace at the western end of the Barat Burn Junior School. The terrace is the only visual reminder of Melocco's c1929 Italianate Villa that once stood here, and was used as the first Junior School from 1952. It is set down approximately 1.5m below the level of the courtyard and lower floor level of the Joigny Centre and is accessed via a set of steps at the western end of the Joigny Centre. Original elements include the stone retaining wall and steps at the southwestern corner, leading to Sophie's Cottage playground, the Italianate style fence on the north and west boundaries, as well as the central sundial with mosaic paving. The sundial itself is comprised of a rendered masonry pillar with ornate marble capital, topped with the bronze sundial. To the south and east, the terrace is bound by a rendered retaining wall and breeze block wall respectively.

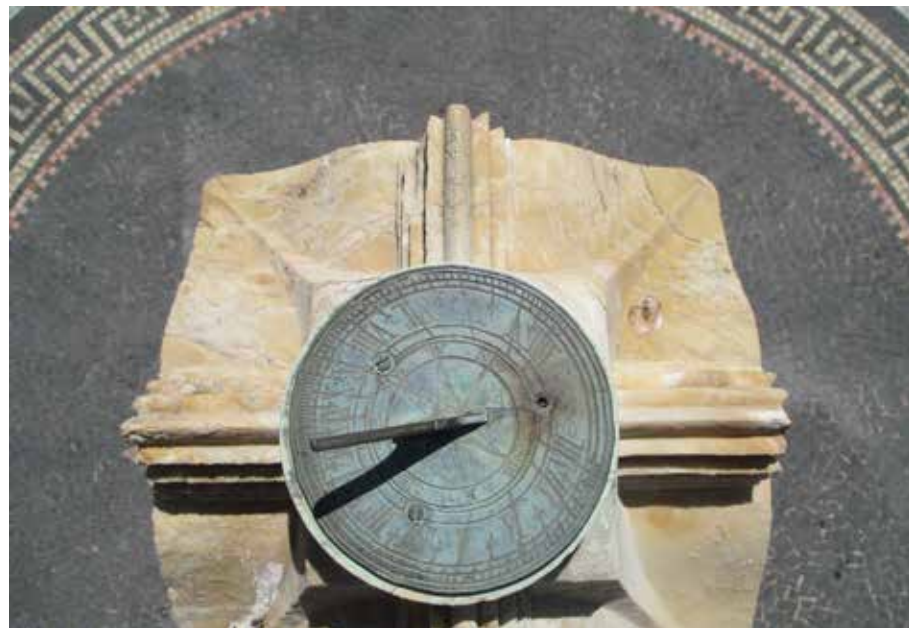
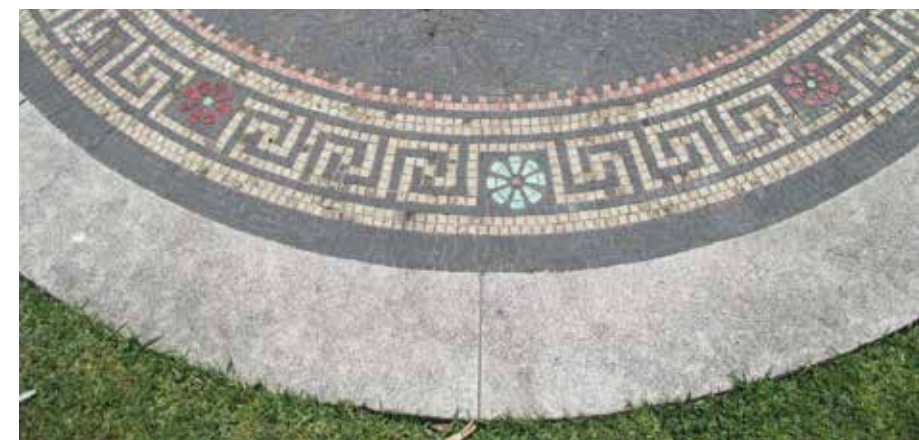
Figure 2.280: Detail of sundial and surrounding mosaic paving on the Sundial Lawn, a remnant of the former Melocco Villa "The Poplars".

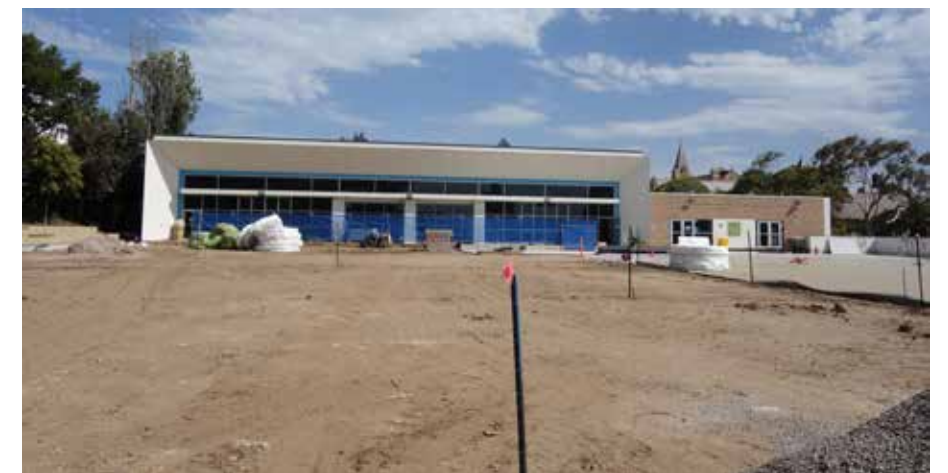
Figure 2.283: The northern elevation of the Maureen Tudehope Centre, looking over the Playing Fields under redevelopment in 2019.

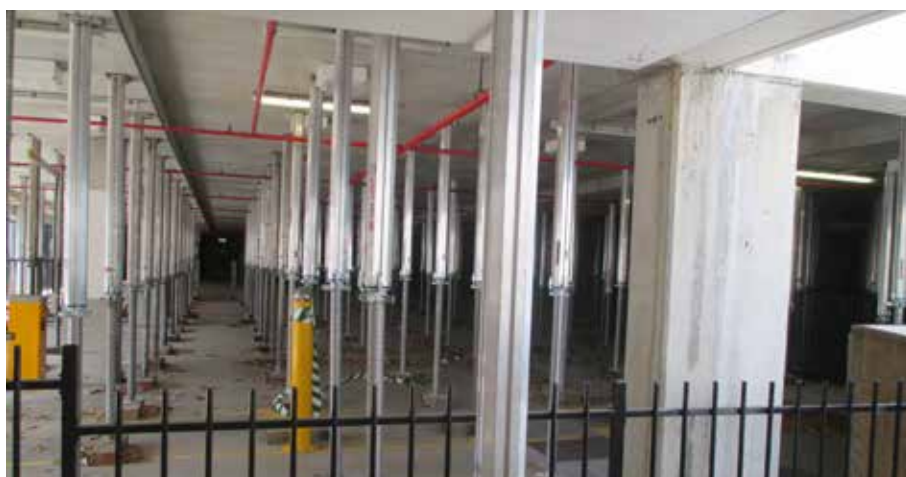
Figure 2.286: Underground carpark of the MTC under the Playing Fields, undergoing stabilisation works in 2019.

The existing playing fields are located on the northern side above the carpark constructed for the Maureen Tudehope Centre. As such, there is little in the way of original fabric due to the broad scale excavation required for the carpark. The embankment along the eastern side of the playing fields would appear to remain largely untouched, and the remains of timber picket fences at the northern end would appear to be late nineteenth / early twentieth century. The fence line along New South Head Road is a timber post and rail fence, and likely dates from the nineteenth century.

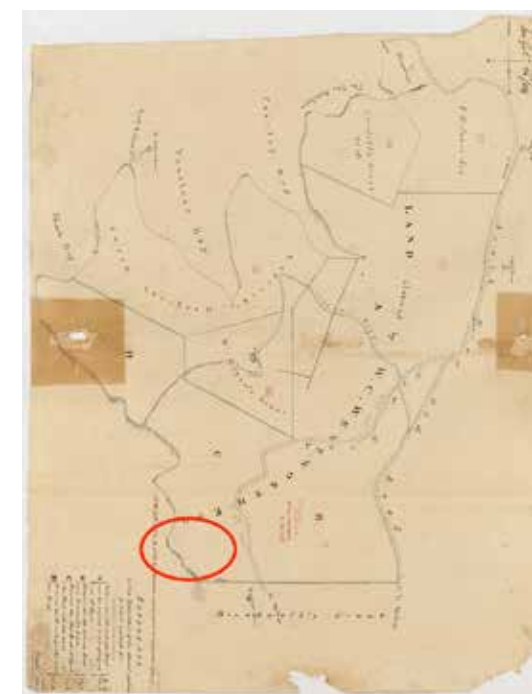
Figure A.1: Sketch survey prepared in 1836 by the government surveyor responding to Wentworth's claim on 370 acres. The survey showed the old and new roads to South Head, Laycock's, Cardell's and McGlynn's grants, with Vacluse House being within McGlynn's 40 acres. Image reorientated for reproduction.. Source: State Archives NSW (SG's Sketch book 3 folio 35) Archives NSW (SG's Sketch book 3 folio 35)

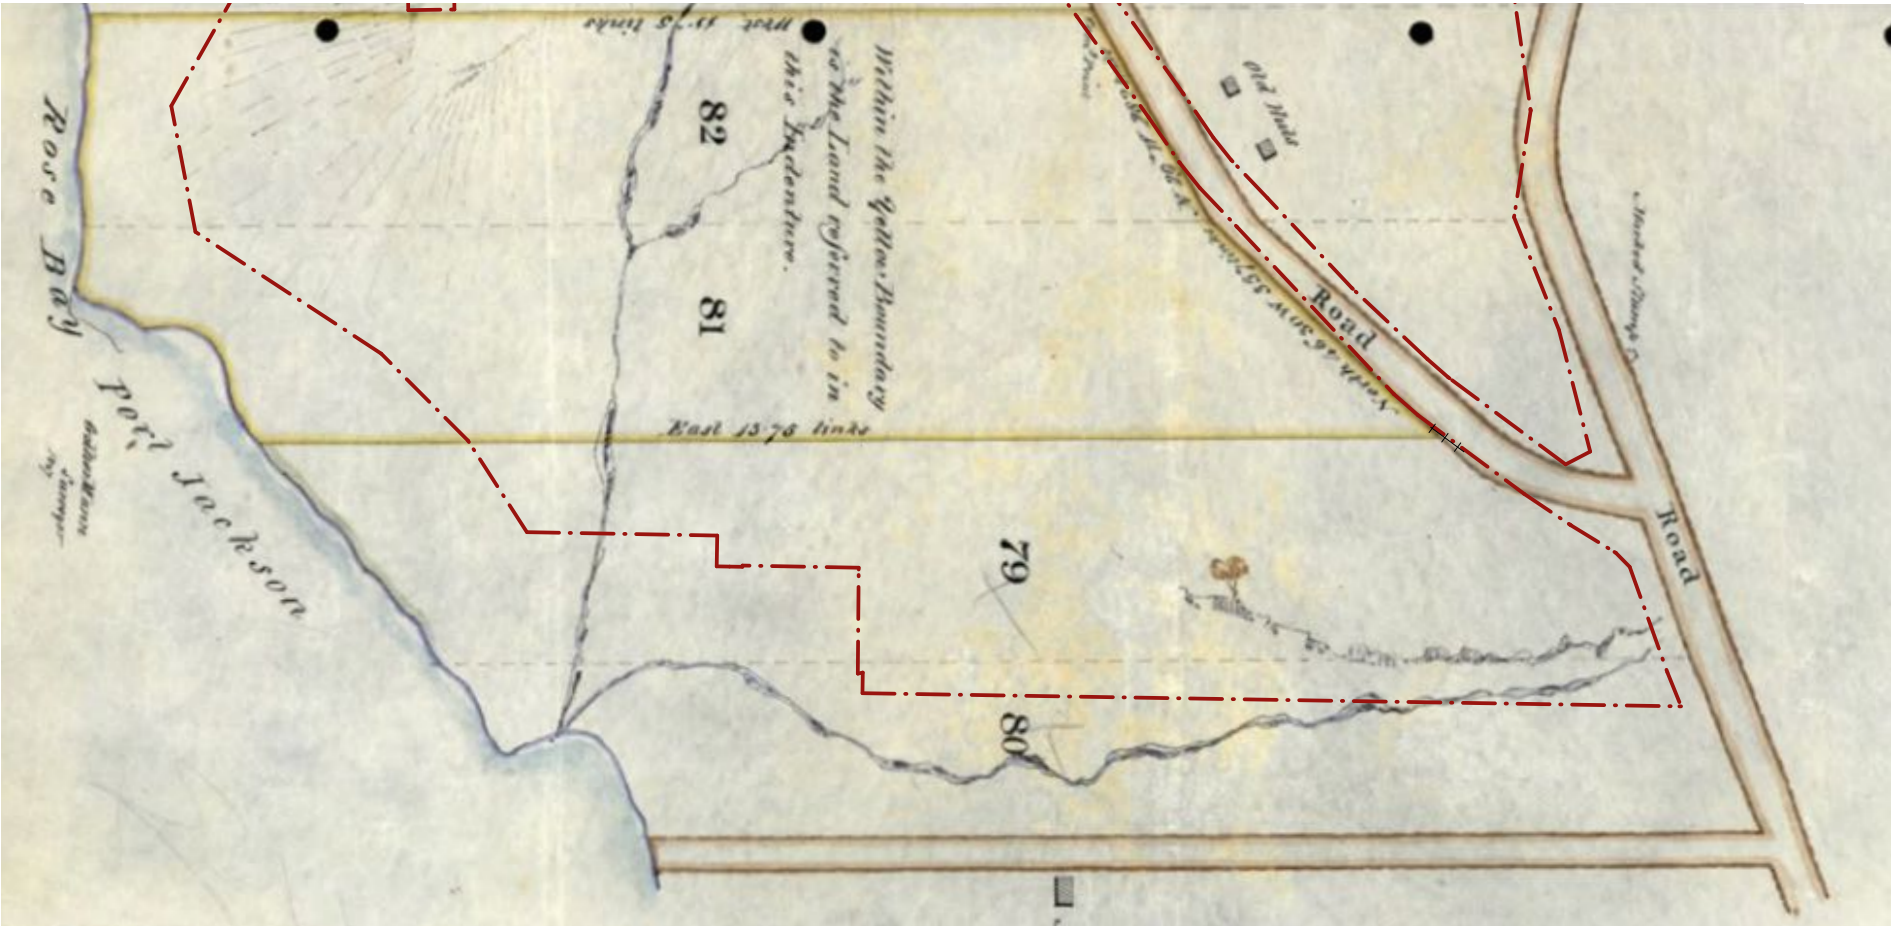
Figure A.3: This detailed survey drawing made in 1847 contains more topographical detail and includes built improvements. The drawing probably was an accurate tracing of the Bemi original of 1838. The survey recorded 'old huts' of the Wentworth era standing within the present day KRB playing fields. Image reorientated for reproduction. Source: NSW Land Registry Services (Bk 13 No. 662)

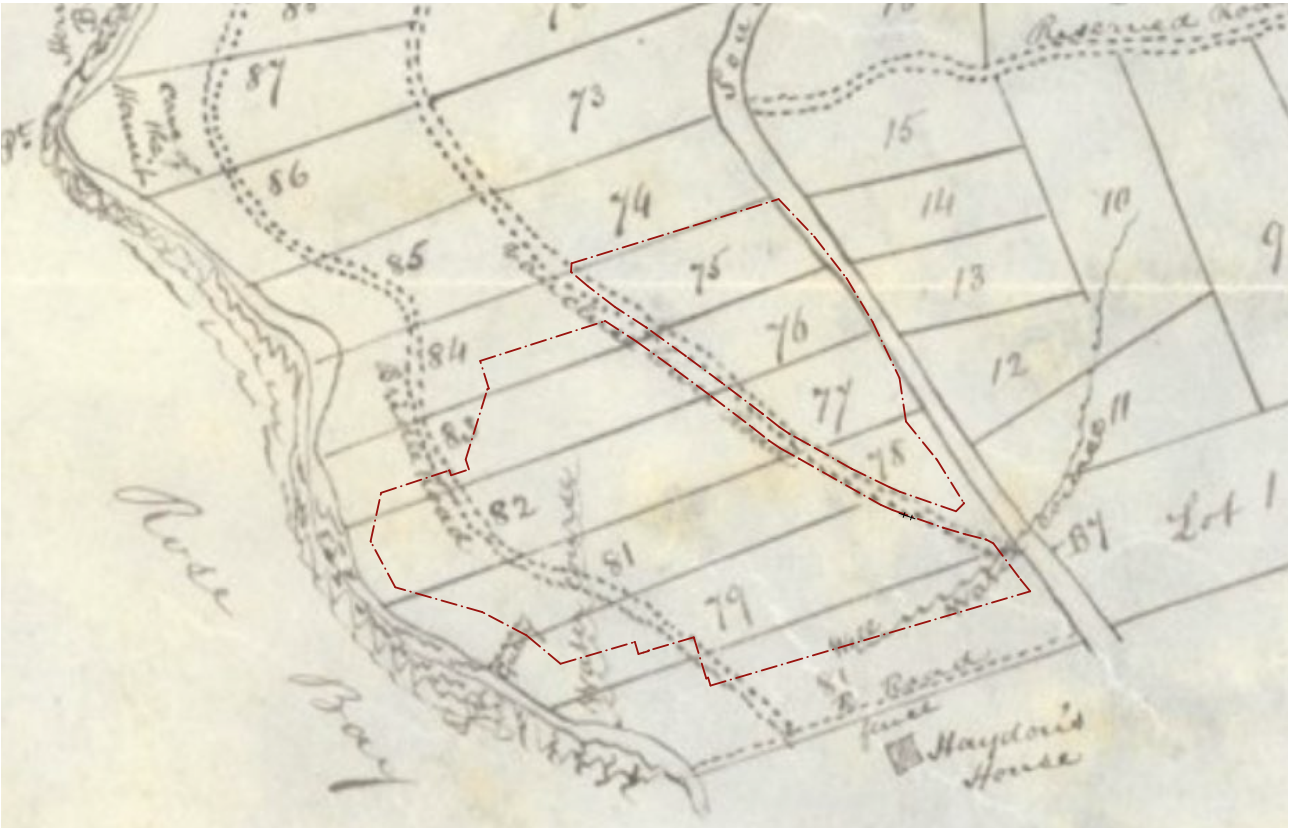
Figure A.4: Detail from a tracing of the Vaucluse Estate subdivision plan included with a deed of conveyance made to Thorne in 1850 and with notations concerning topographic features. Source: NSW Land Registry Services (Book 19 No. 812)

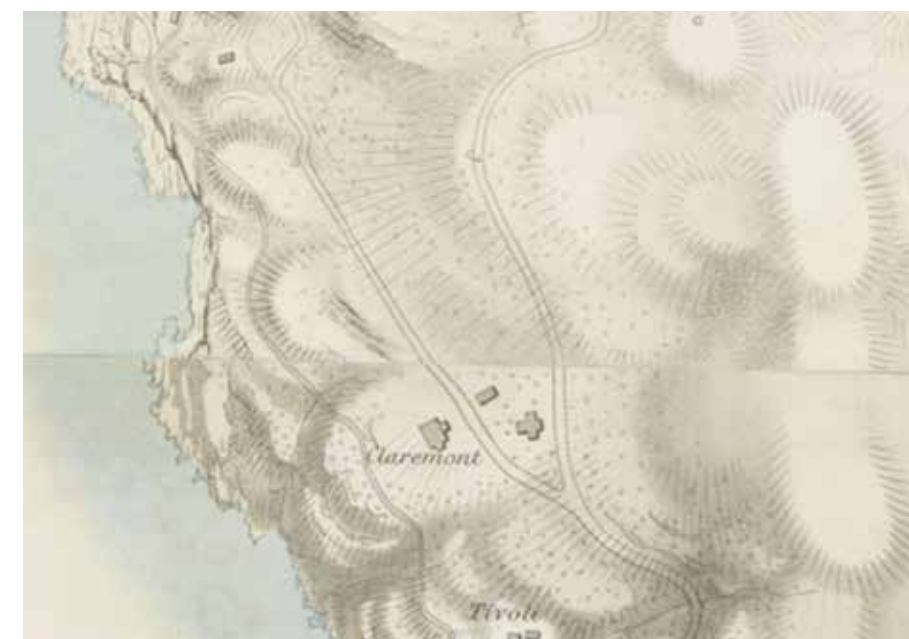
Figure A.9: Detail from TL Mitchell's 'Trigonometrical survey of Port Jackson' published in London in 1853. Depicted was Thorne's Claremont with its gate lodge and another structure to the north of it. Source: State Library of NSW (Z/ M4 811.15/1853/1)

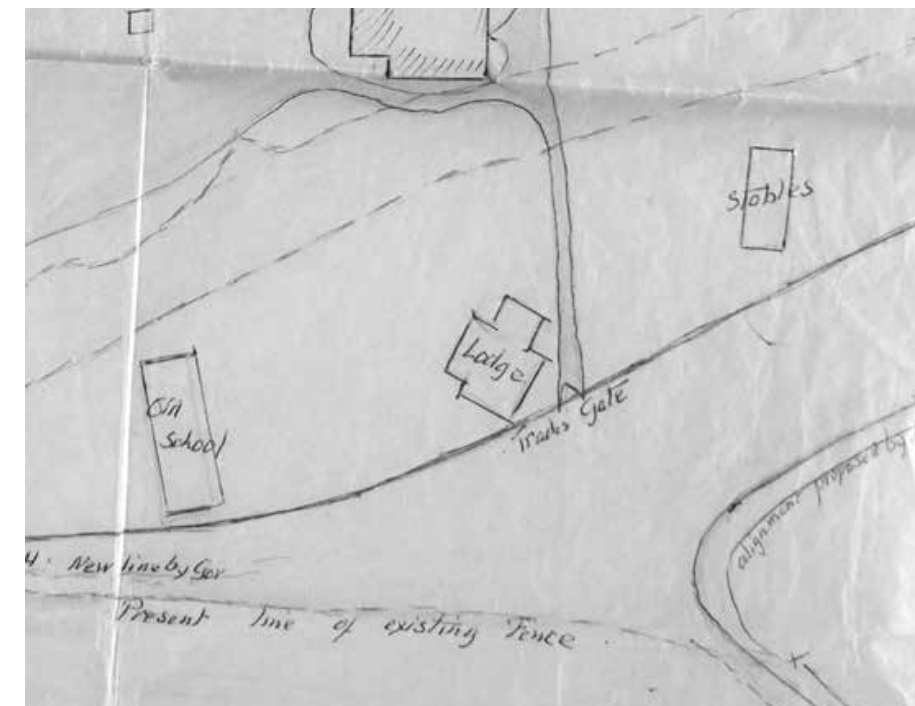
Figure A.17: Detail from a rough survey prepared by architect J Horbury Hunt. The drawing has been annotated and dated February 1903, but more probably dates from 1887. It recorded the location of structures surviving from the Thorne era (pre 1879). It recorded the lodge, later known as Claremont Cottage (demolished in 1991), and the stables (the 'old school' was a later, 1885 development). The lodge (as gardener's cottage) and stables were noted in the 1879 sale notice. Source: Provincial Archives of the Society of the Sacred Heart

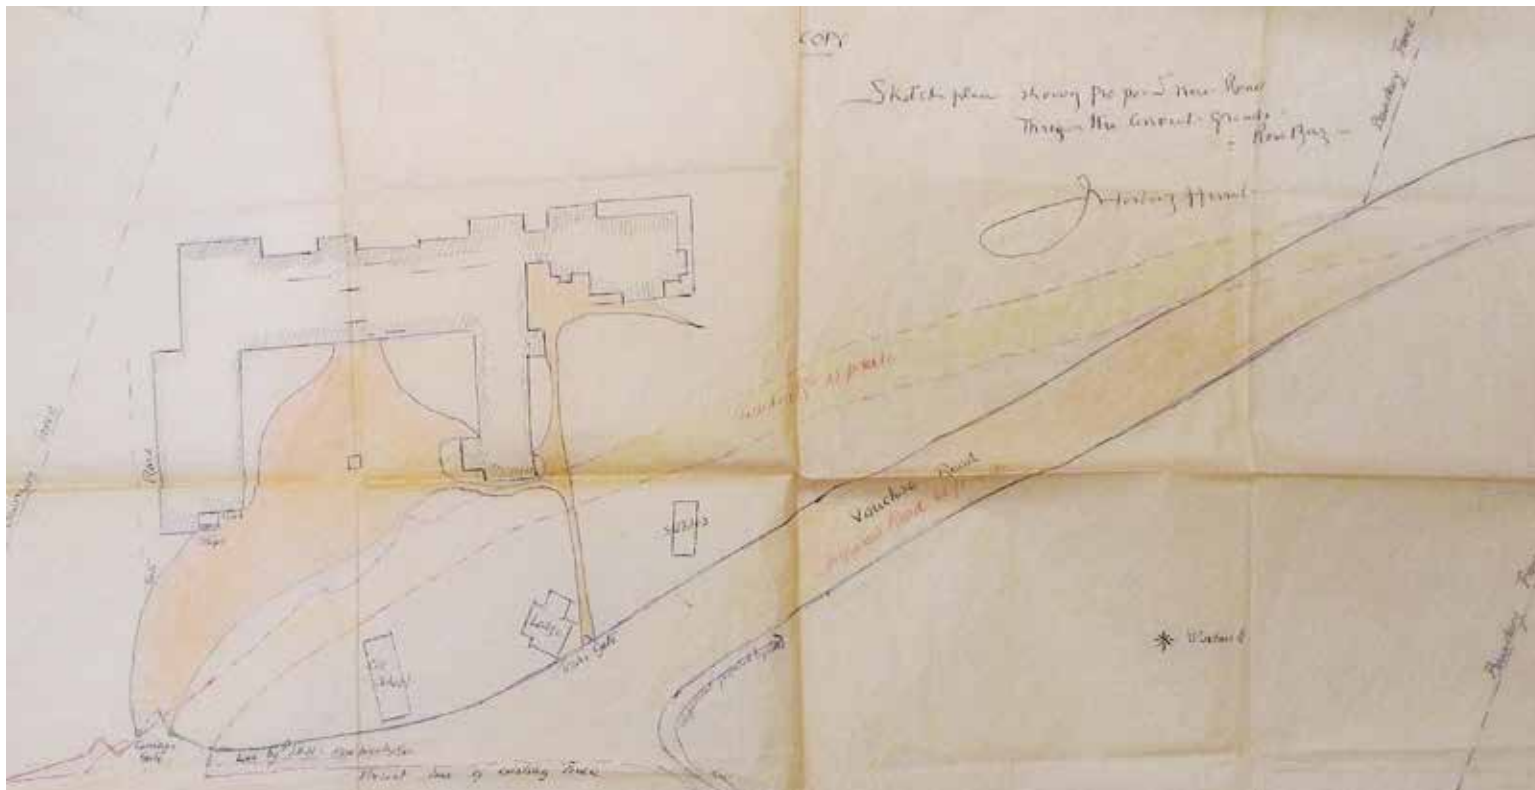
Figure A.20: Detail from a rough survey prepared by architect J Horbury Hunt in 1902, which recorded the location of structures surviving from the Thorne era (pre 1879). It recorded the lodge, later known as Claremont Cottage (demolished in 1991), the stables, and a windmill sited over the well. The lodge (as gardener's cottage) stables, and well were noted in the 1879 sale notice.
Source: Provincial Archives of the Society of the Sacred Heart

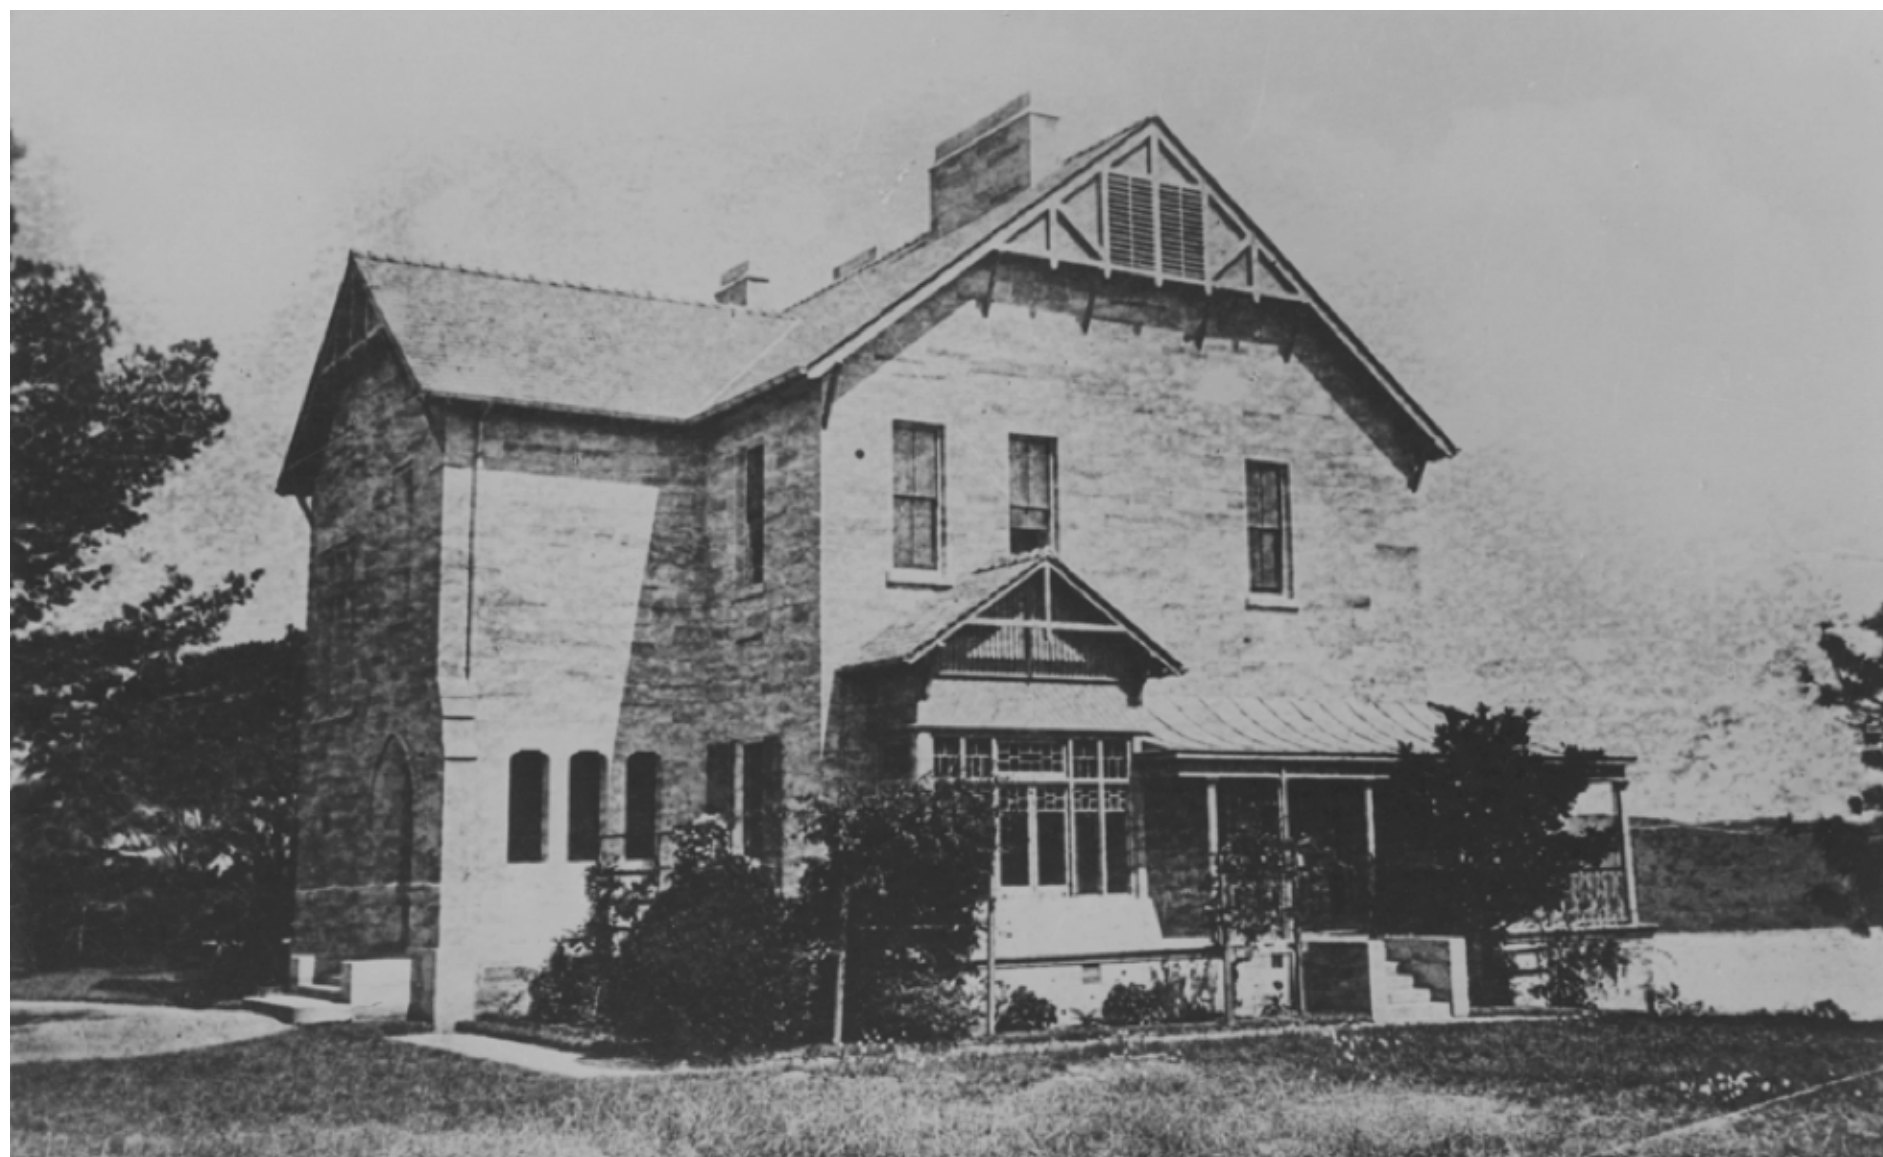
Figure A.23: Claremont, the house designed in 1881 by John Horbury Hunt for Henry Arding Thomas. North and east elevations, with north lawn, and gravel carriage drive. The verandah structure, stone flagged margin path, and steps to the entry porch clearly were part of Thorne's Claremont. Source: Provincial Archives of the Society of the Sacred Heart

Thomas rebuilt Claremont, probably in 1881, engaging architect John Horbury Hunt to document the alterations and additions. The circumstances behind Thomas' engagement of Hunt have not been reported, but possibly came about owing to Hunt's residence at Double Bay (the demolished Cranbrook Cottage from 1876), and Thomas' known association with the Armidale (Anglican) Diocese and building of St Peter's Cathedral from 1870 (designed by Hunt) for it was said 'probably he did more towards the erection of Armidale Cathedral than anyone identified with it'.³⁴

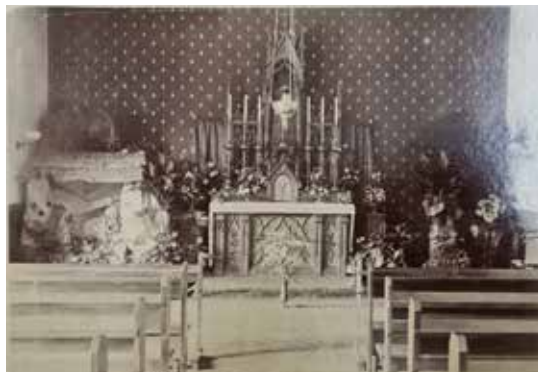
Figure A.30: Interior of the third chapel in 1894. Note the painted dado and decorative cross pattern behind the Mother Vercruysse altar. Source: Provincial Archives of the Society of the Sacred Heart (Album 20, Item 31)

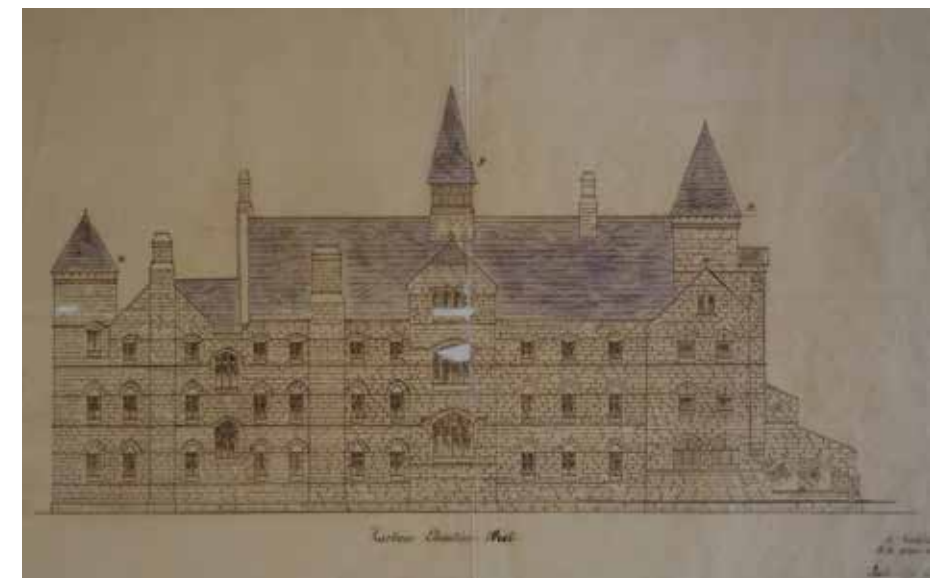
Figure A.33: This undated drawing of the harbour front elevation by Hunt seems to be of the June 1884 proposal sent to Paris for construction approval. French chateau like in its presentation, the building was intended to be free standing of Claremont. Source: Provincial Archives of the Society of the Sacred Heart

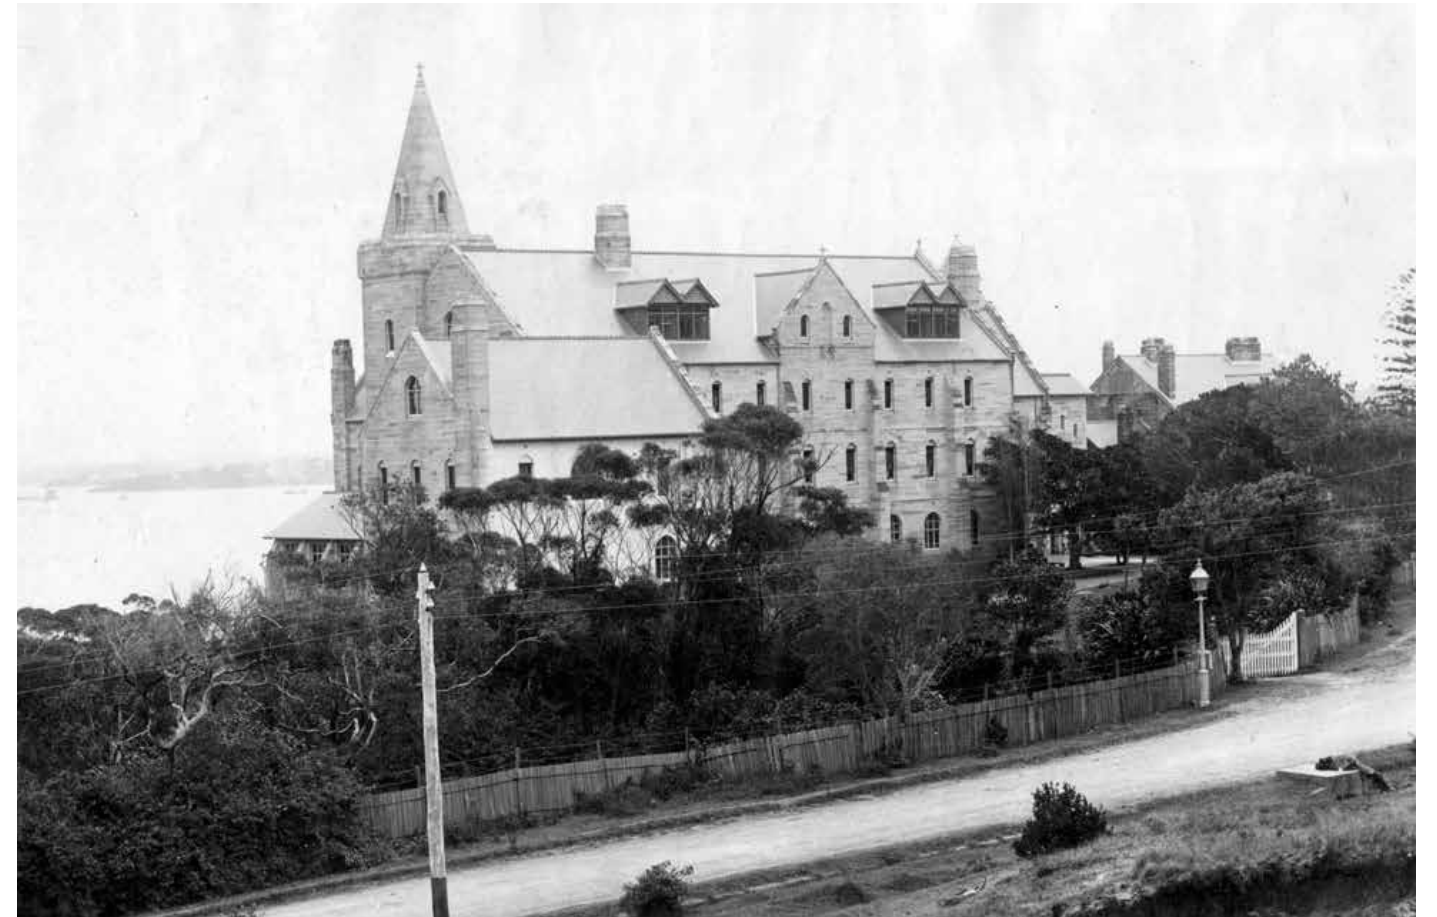
Figure A.46: The west and south wings on completion in 1888. This photograph recorded the east elevation. Provision was made in the uncompleted stone coursing for future additions for the chapel, and to the south wing. Source: Provincial Archives of the Society of the Sacred Heart (Album 11, Item 47)

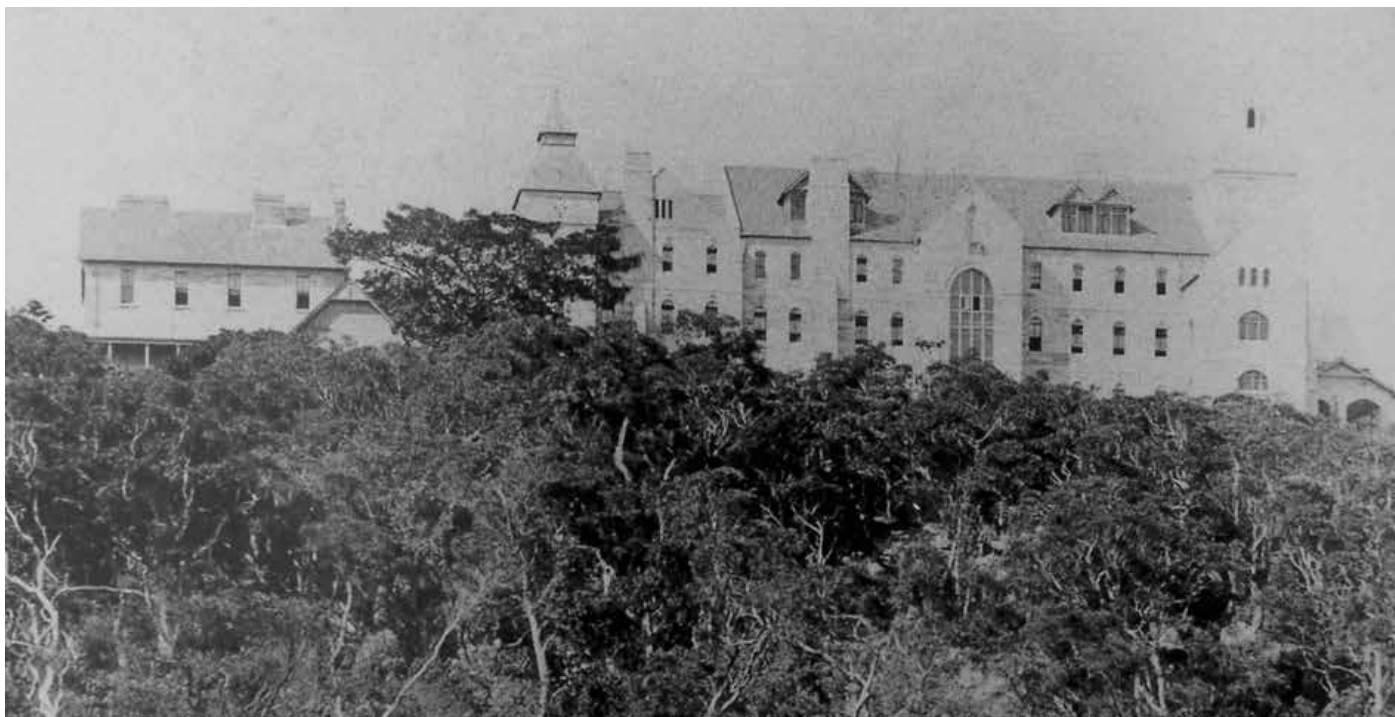
Figure A.47: The east and south elevations of the building completed in 1888. Not dated. Source: Kincoppal–Rose Bay School of the Sacred Heart Archives

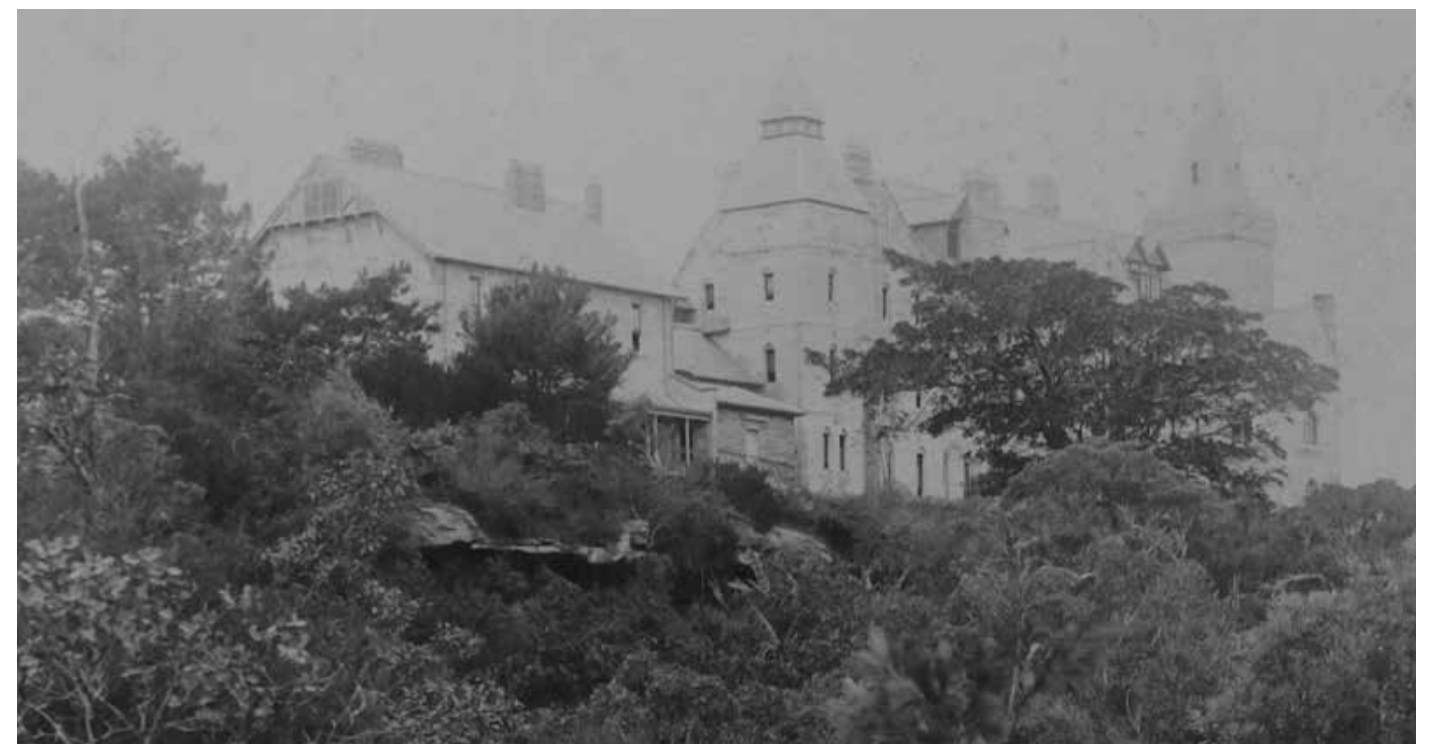
Figure A.48: The west elevation of the building, probably on completion in 1888. This view shows the temporary chapel. Source: Provincial Archives of the Society of the Sacred Heart

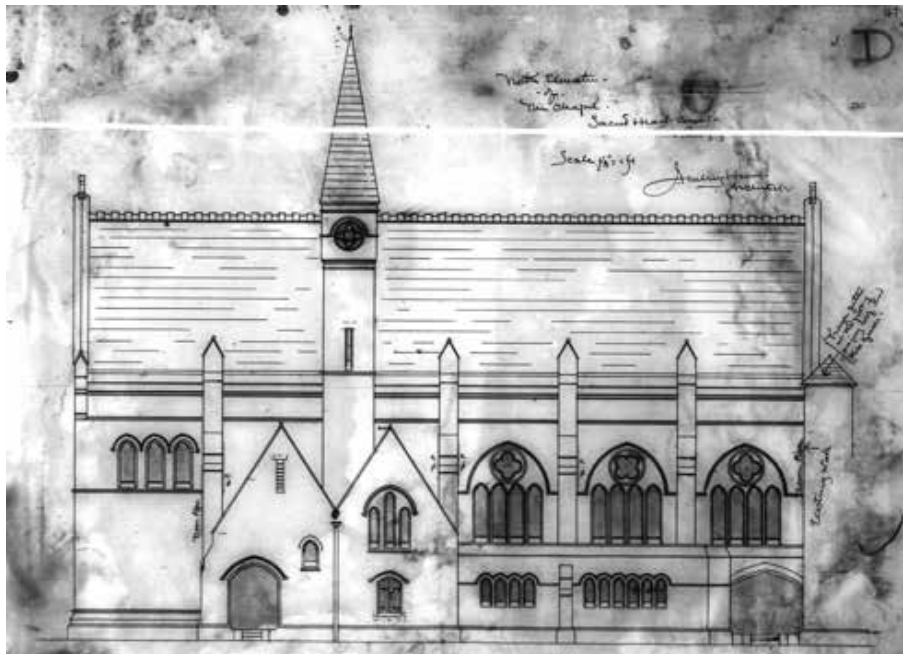
Figure A.69: Elevation drawing dated February 1897.
Source: State Library of NSW (PXD 573 f.166)

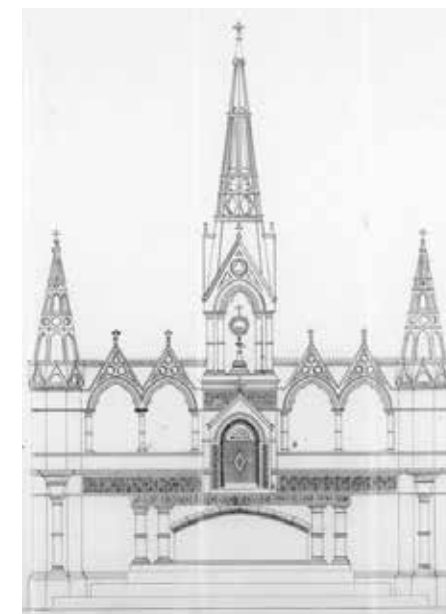
Figure 6.75: Undated elevation drawing of the High Altar by Hunt. This drawing probably was prepared in May 1898. Source: State Library of NSW (FM1/2578)
