KINCOPPAL - ROSE BAY

SCHOOL OF THE SACRED HEART

CONSERVATION MANAGEMENT PLAN

Final Report - August 2020

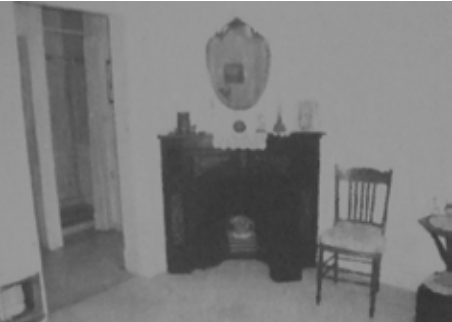
Figure A.88: Original fireplace and surround restored in 2007. Source: Heritage Impact Statement prepared by Kubanyi Architects, August 2007

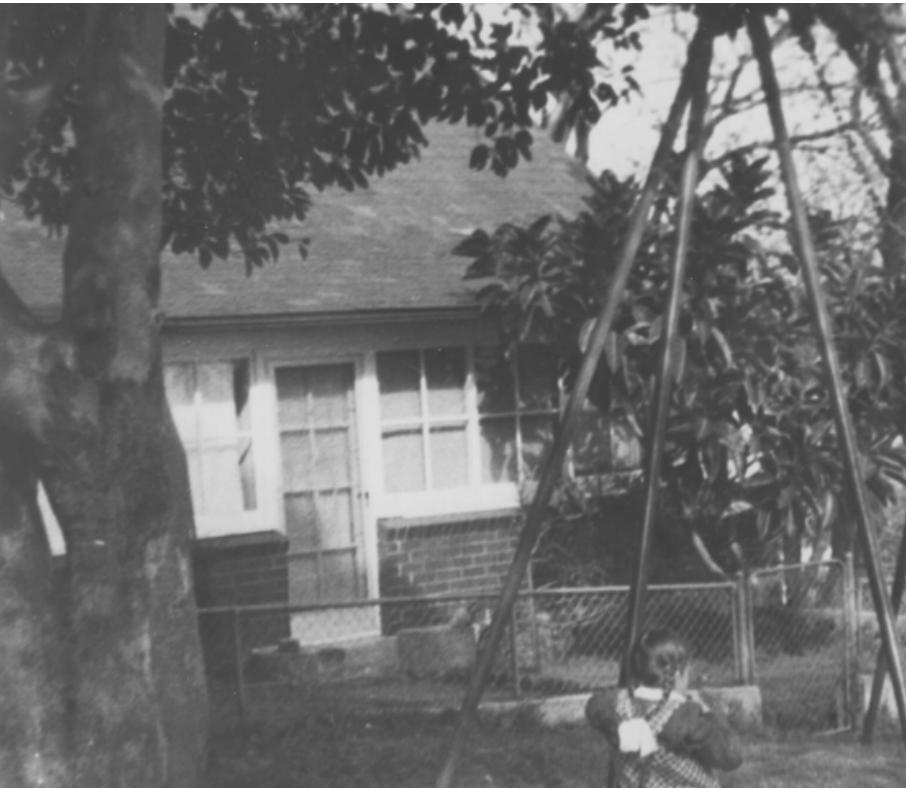
Figure 6.93: The gardener's cottage photographed in 1962 with the verandah addition of 1935. Source: Kincoppal–Rose Bay School of the Sacred Heart Archives

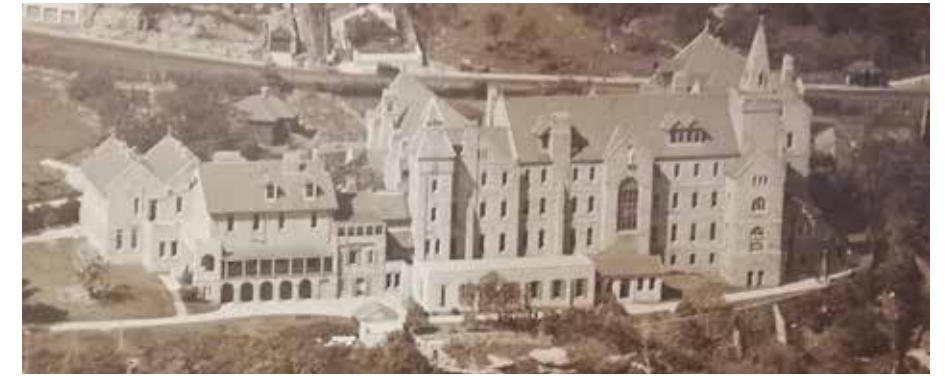
Figure A.94: Western elevation of Convent and School in the early 1920's. Note: the 1917 and 1928 Novitiate. The window shutters to the Refectory were installed in 1930 to safeguard against theft. The building to the right of the refectory possibly was the kitchen. Source: Provincial Archives of the Society of the Sacred Heart (Album 11 Item 57)

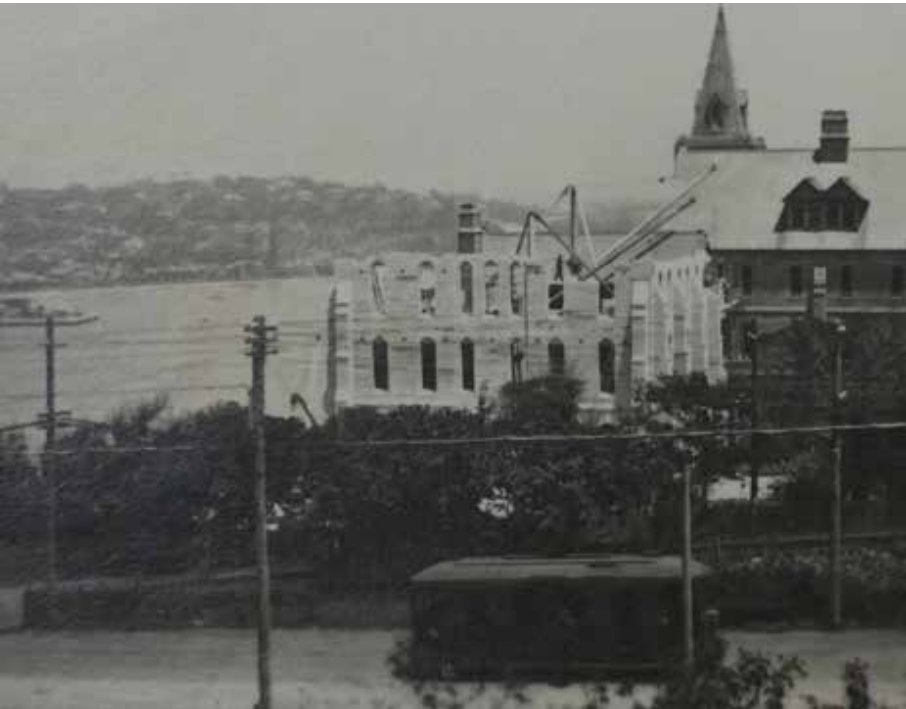
Figure A.100: The south wing under construction, not dated, about 1920/21. Source: Provincial Archives of the Society of the Sacred Heart

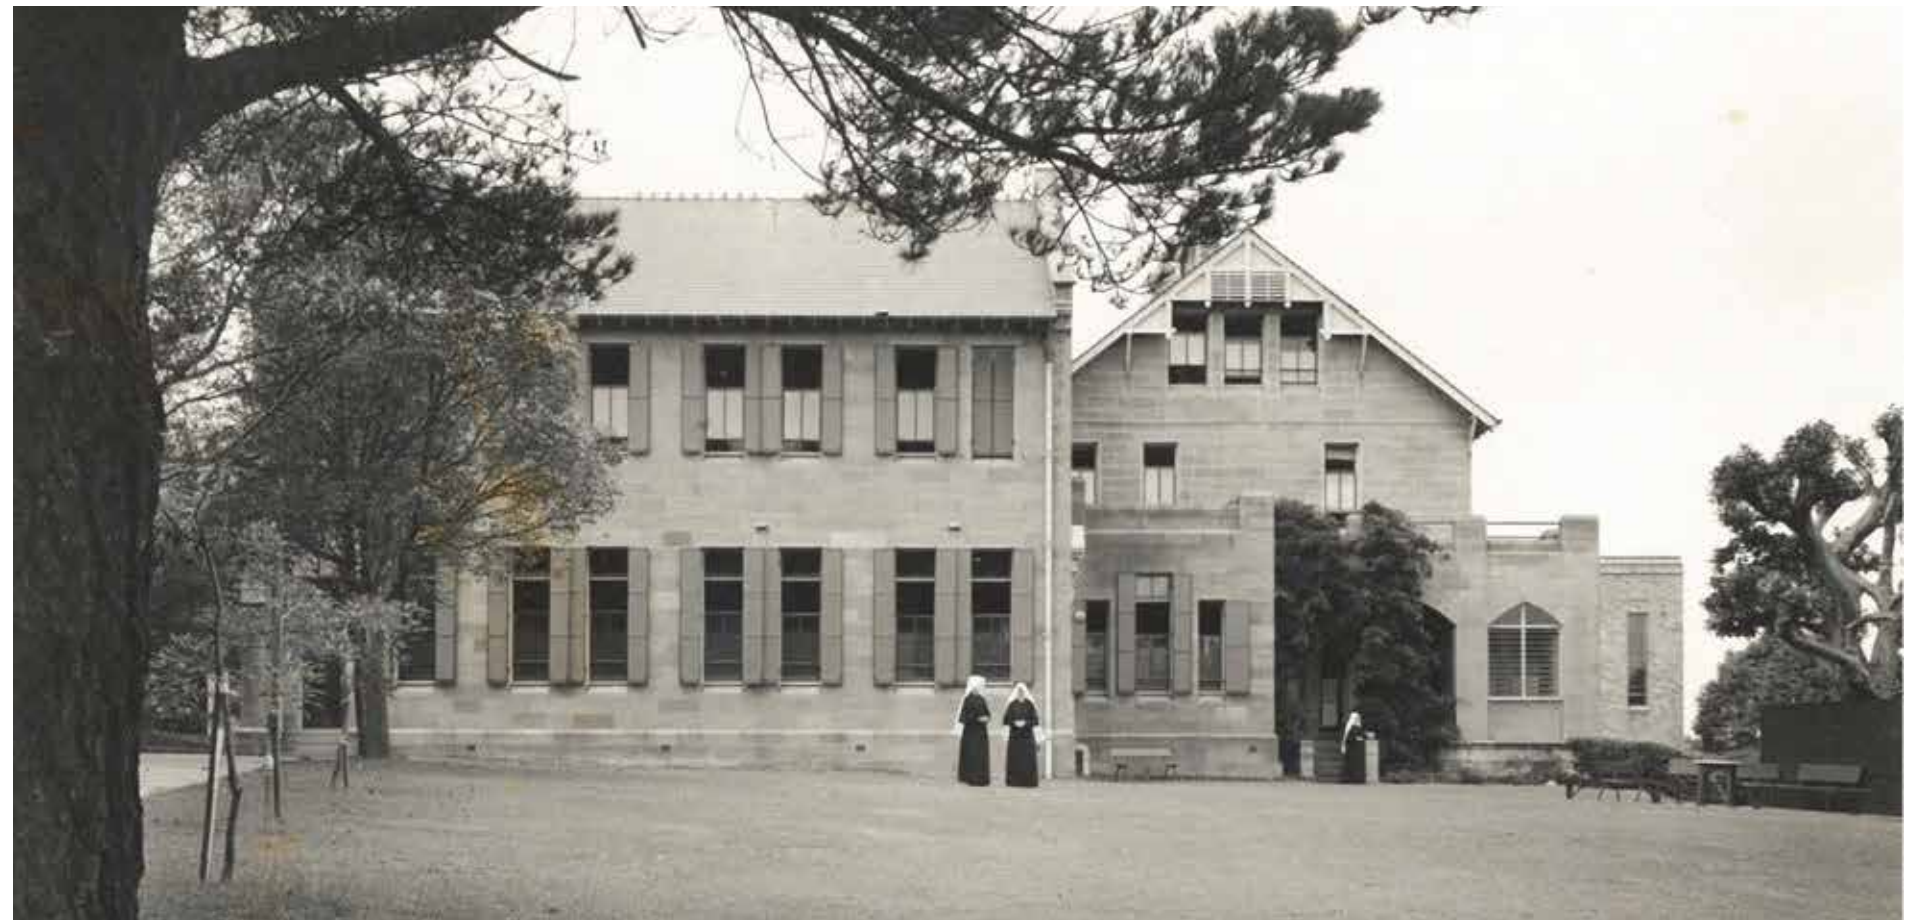
Figure A.104: The Noviceship wing designed by architects Hennessy and Hennessy in 1927, built by W O'Donoghue, and completed in early 1928. The lawn to the north of this wing was levelled and turfed also in 1928 (E 5/1928). The window shutters were fitted in 1931 owing to the summer heat. (E8/1931). Not dated, late 1930s? Source: Kincoppal-Rose Bay School of the Sacred Heart Archives

Attached to Claremont on its northern elevation, the two storey wing was built in sandstone, and the pair of roof gables covered in Welsh slates. The stone used was sourced from buildings being demolished in the city, carefully selected for colour likeness to match the stone quarried on site and used in the neighbouring buildings, and the surface redressed. On the ground floor were the novices' community room, and their classroom and study. On the first floor were two dormitories for the novices, and another three small bedrooms and the bathrooms. On the north elevation an open or colonnaded verandah was built in stone connecting with Claremont.²⁰³

The use of this building changed in the late 1960s when it ceased to house novices, and was converted to classrooms in about 1971.²⁰⁴

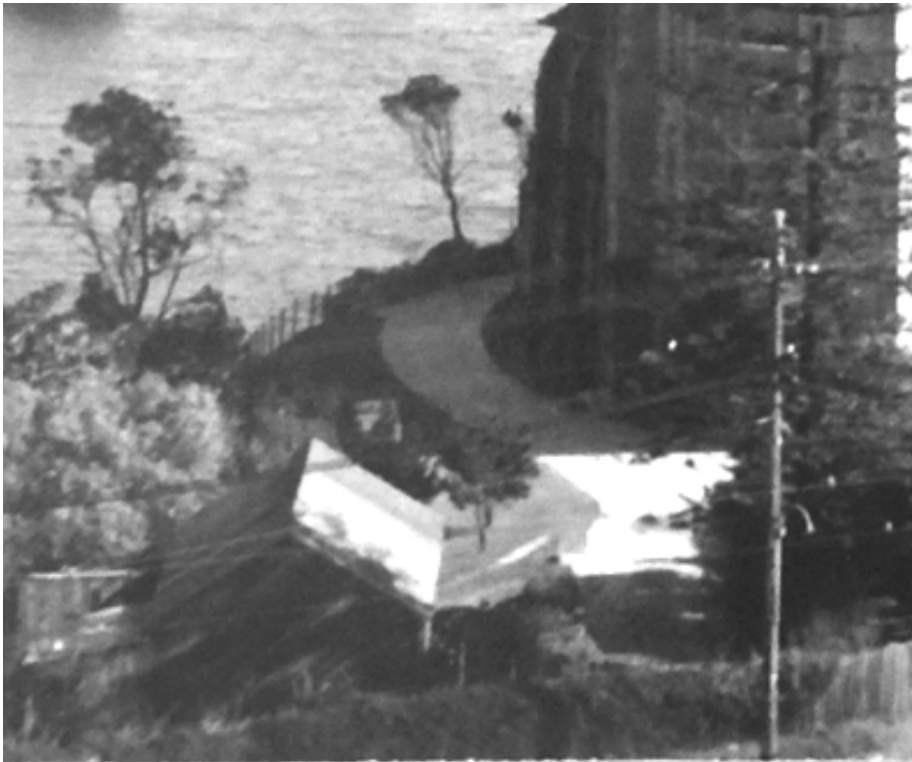
Figure A.108: The conservatory or bush house recorded in this photograph of 1932. Source: Provincial Archives of the Society of the Sacred Heart (Album 7 Item 15)

Located at the south-east corner of the property near the entrance gate was a conservatory or bush house. The date of this structure has not been determined, but was standing by 1894,²⁰⁷ and was probably another of Mr Knott's construction works. In 1910 it was completely repaired, with the roof of tea tree branches then being replaced by narrow timber laths.²⁰⁸ In 1932 the structure was moved owing to the new alignment of New South Head Road.²⁰⁹

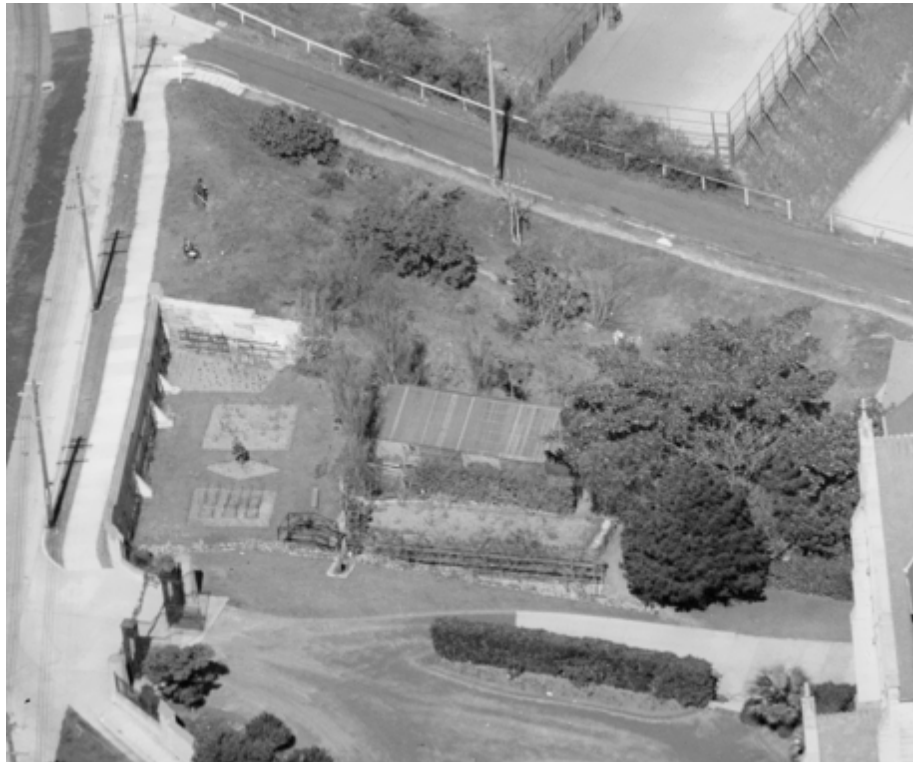
Figure A.109: This aerial photograph dates from about 1940, showing the relocated conservatory or bush house. Source: State Library of NSW (c112330016)

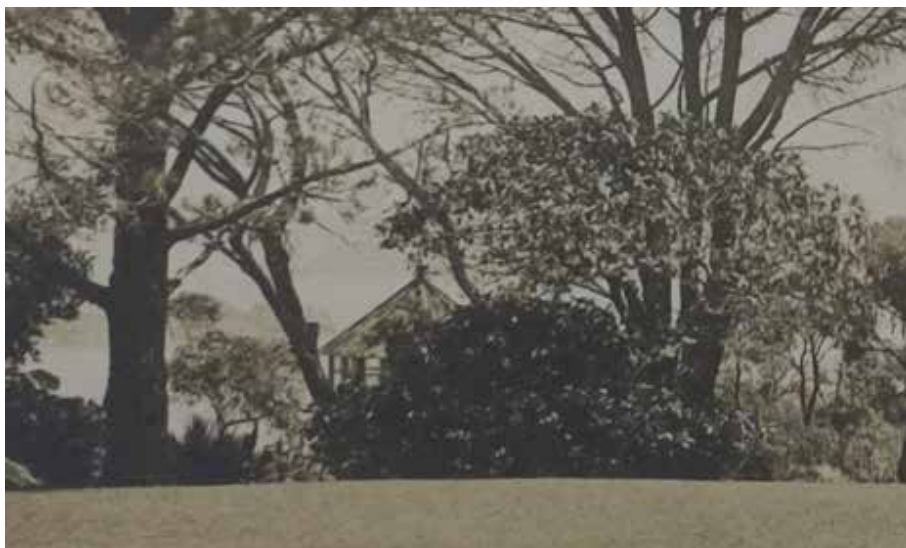
Figure A.113: The timber summer house, built in 1920. Not dated, early 1920s. Source: Provincial Archives of the Society of the Sacred Heart

The north garden had been established in the days of Thorne's Claremont, and continued to be used by the sisters, novices and pupils. In 1931 on the advice of an arborist several of the trees in the north lawn were cut back, inclusive of large fig trees under which the sisters sat at times of rest;²¹⁰ in 1920 a timber summer house for recreational use by the sisters had been built by the live-in carpenter Knott.²¹¹

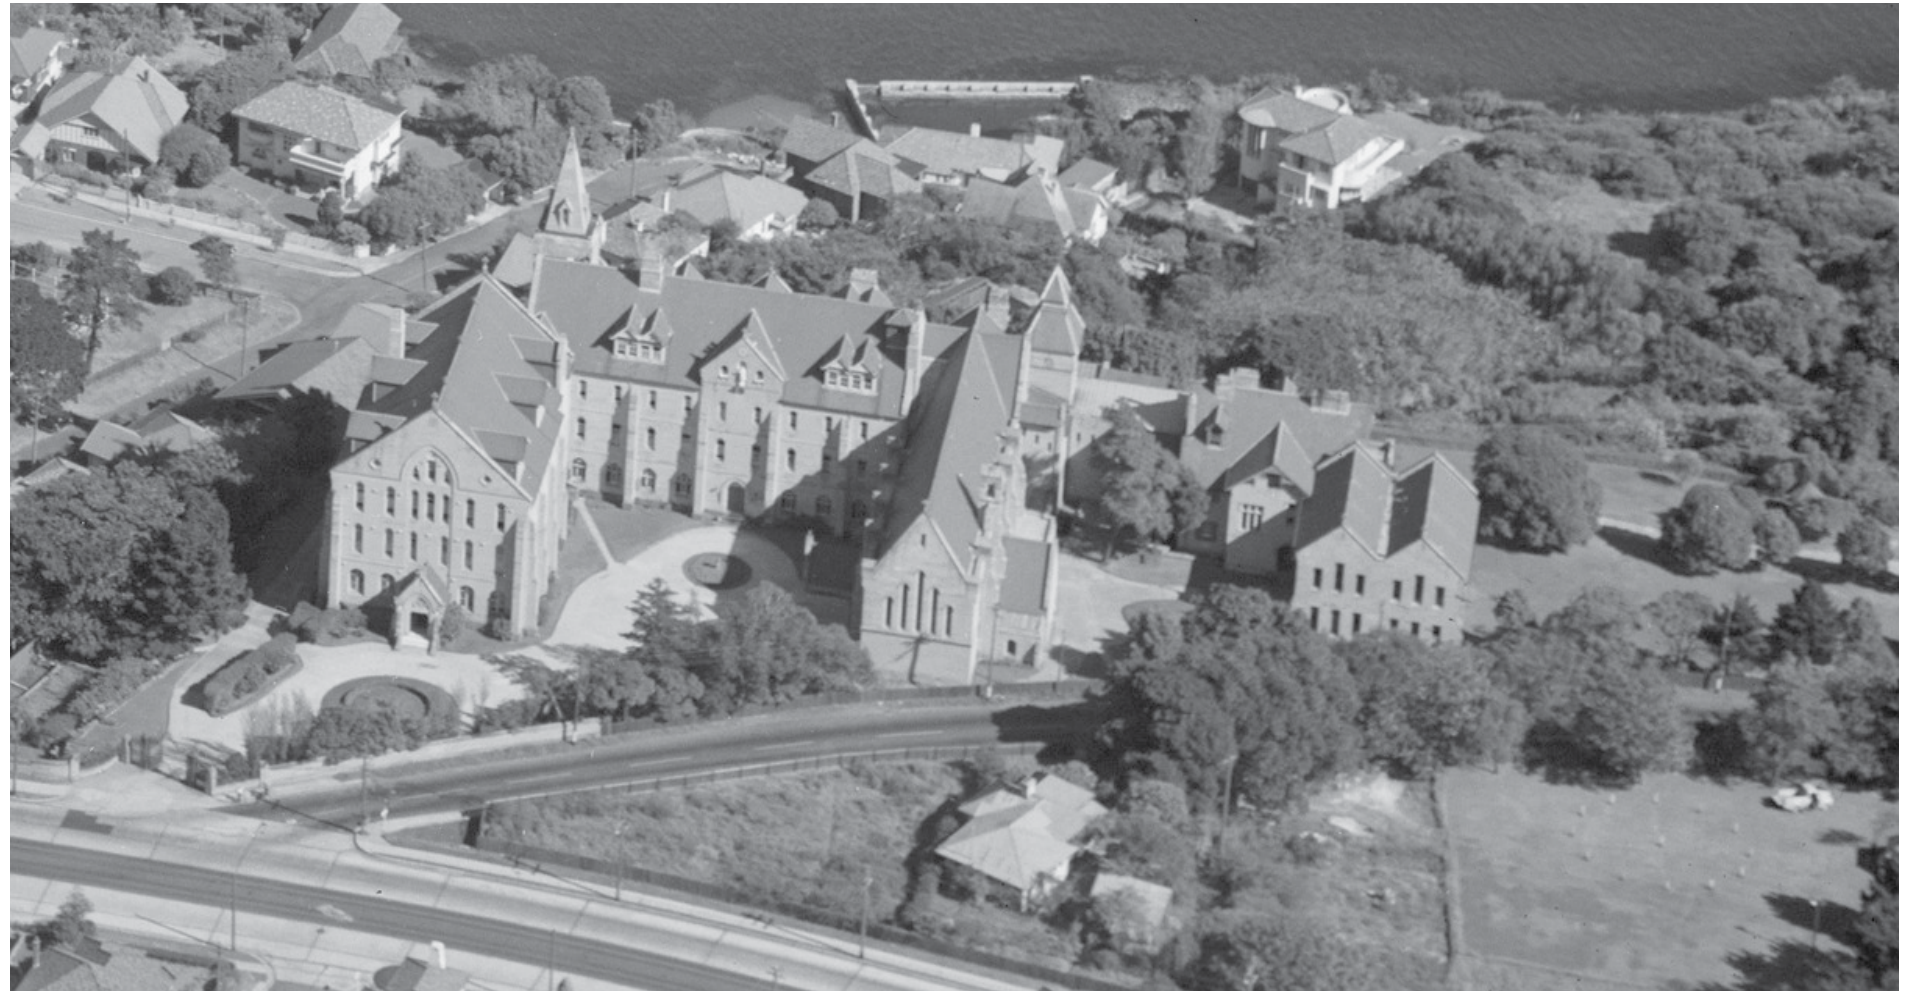
Figure A.115: This aerial photograph dates from about 1940. It records the formal garden beds set within the concrete drives laid from the late 1920s. Source: State Library of NSW (C111820011)

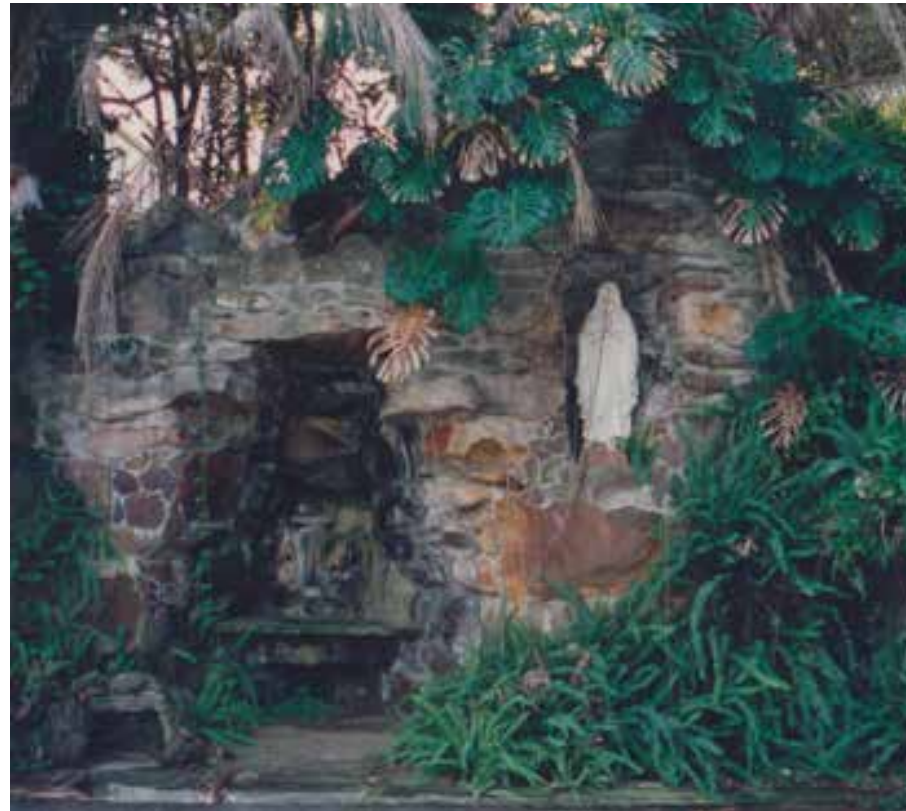
Figure A.130: The condition of Our Lady of Lourdes Grotto in 1992. Source: Kincoppal–Rose Bay School of the Sacred Heart Archives

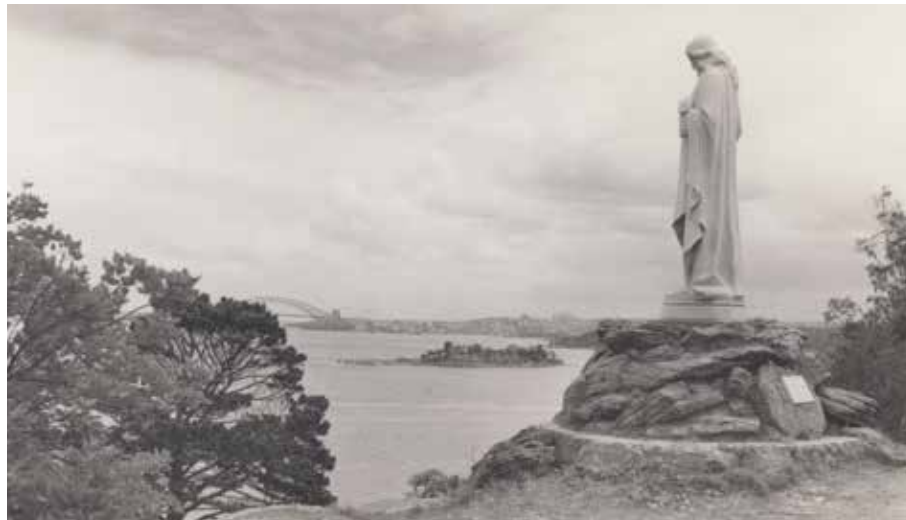
Figure A.132: Statue of the Sacred Heart erected in 1932. The rock base was built up by John Crozzoli. Source: Kincoppal–Rose Bay School of the Sacred Heart Archives

In early 1932 Crozzoli built up the rock base and pedestal for the seating of the large statue of the Sacred Heart and rearranging the grounds around it. The 10 feet high statue was a jubilee year gift from the pupils and the other convents of the Sacred Heart, and specifically sited to overlook the harbour.²⁶³ The sisters considered this work done by Crozzoli as 'truly wonderful and (he the) most artistic workman'.²⁶⁴ A little later, gardener Hayes turfed the ground round the Sacred Heart.²⁶⁵

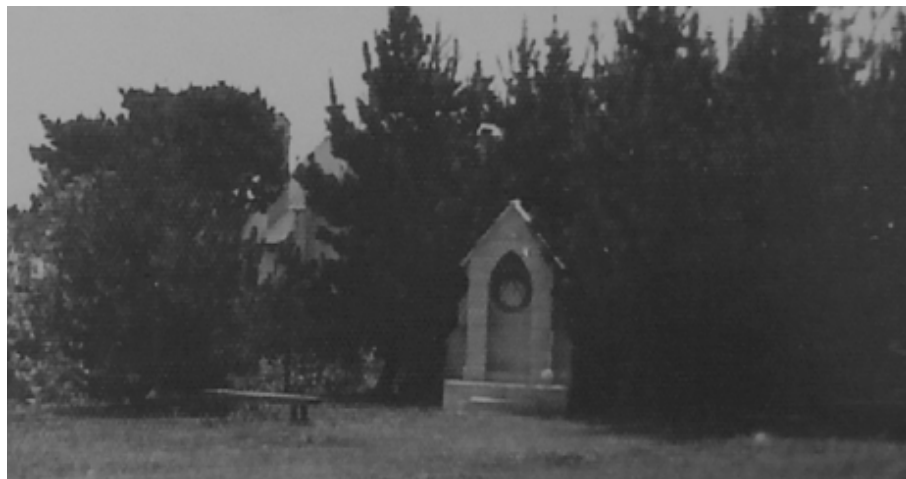
Figure A.134: Shrine of St Anne made by John Crozzoli in 1932. Source: Provincial Archives of the Society of the Sacred Heart (Album 7 Item 21)

The Shrine of St Anne was made by Crozzoli also in 1932. The copy of a sculpture by Luca Della Robbia (1399-1482) being given by Peter Melocco.²⁶⁶

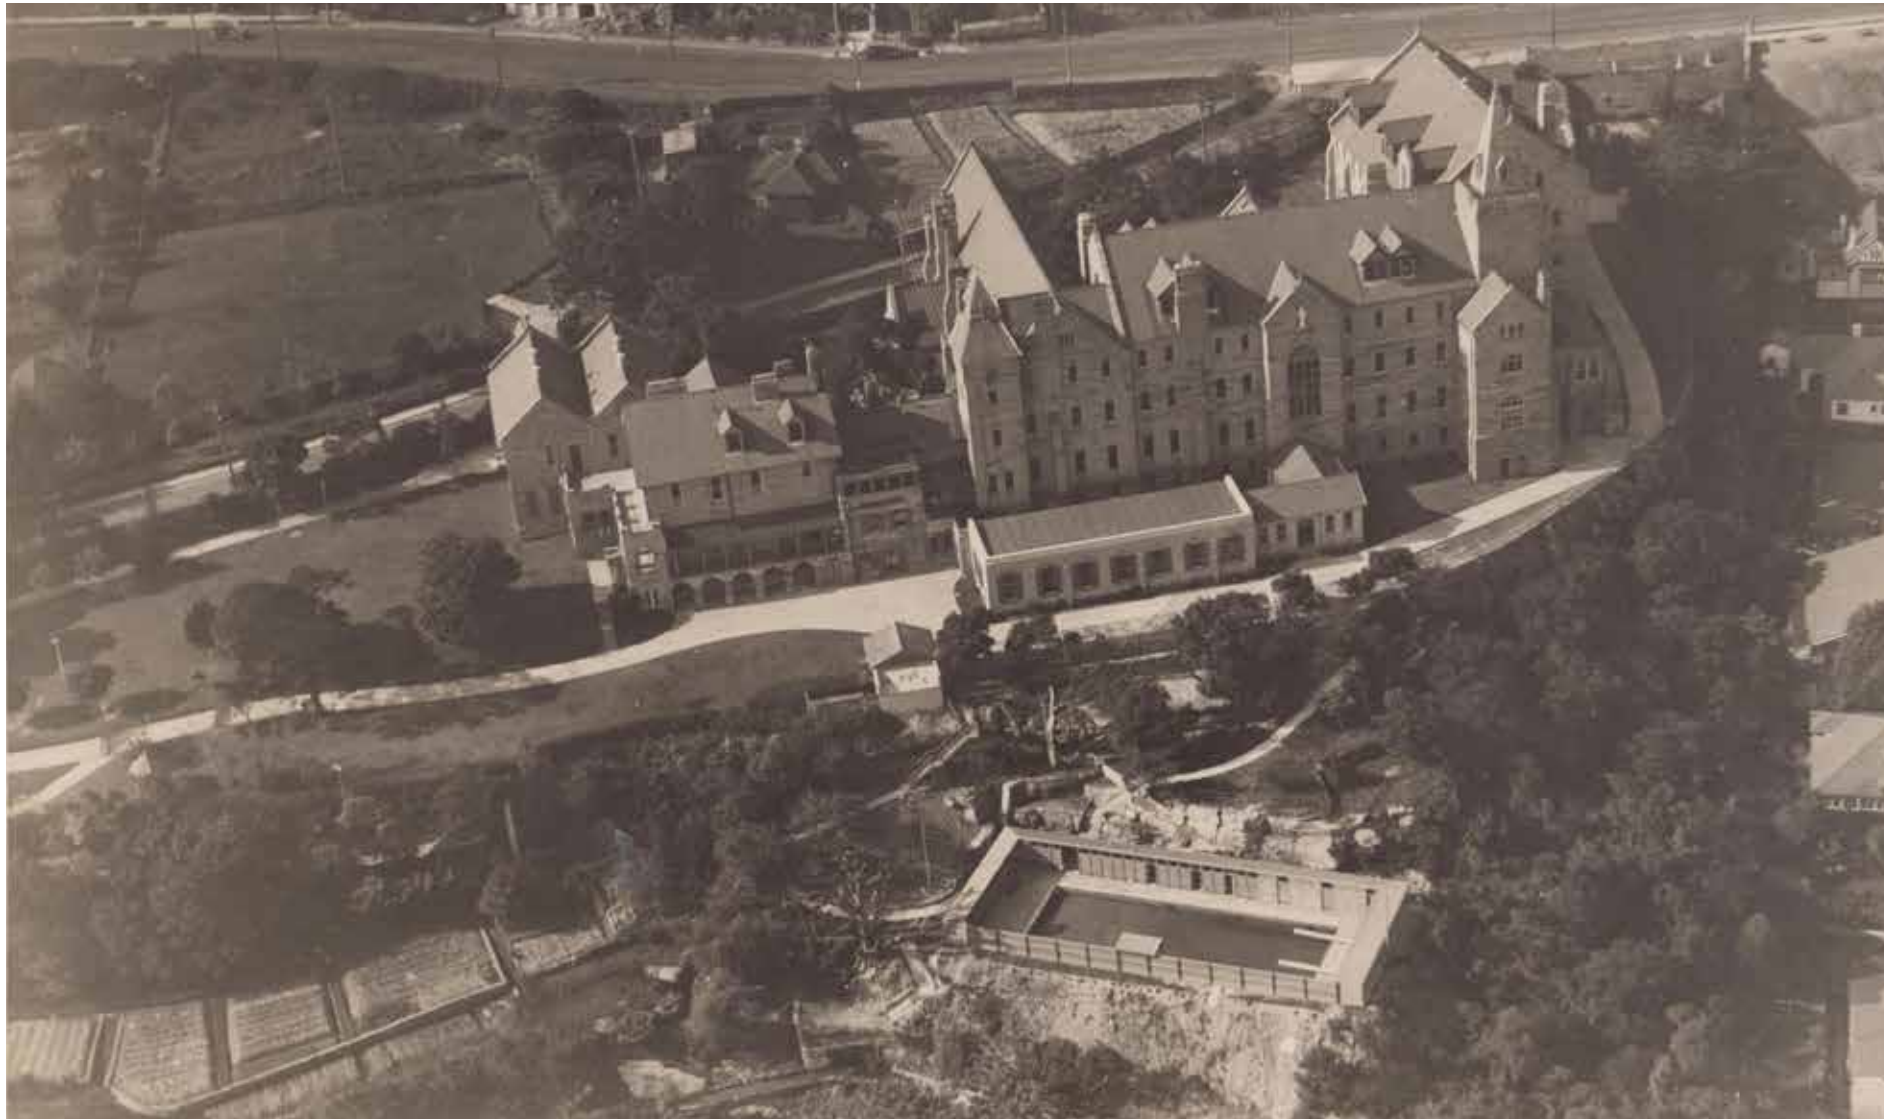
Figure A.137: The newly completed pool in 1935. Source: Kincoppal–Rose Bay School of the Sacred Heart Archives

Planning for this pool commenced in May 1934 with permission to proceed with it being received from Paris. At that time Sir Mark Sheldon expressed an interest in the project, and the builders Stuart Brothers Limited were engaged to prepare the plans and undertake construction.²⁶⁹ A little later Lady Blanche Mary Sheldon offered to pay the full cost of the pool, which was put at 2980 pounds (completion cost was 3500 pounds).²⁷⁰

The pool used salt sea water pumped from an inlet situated on the foreshore. The use of salt water proved problematic in later years as it quickly corroding the pump and inlet pipes.²⁷⁴ Gaining the necessary permission to install the water line across the public reserve delayed progress, with construction commencing in September 1934.²⁷⁵

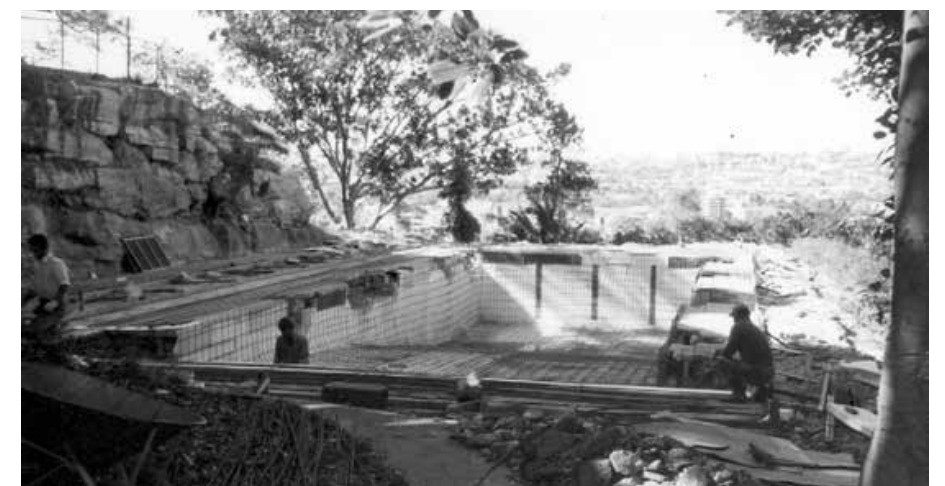
Figure A.140: The pool undergoing rebuilding in the early 1980s. Source: Kincoppal–Rose Bay School of the Sacred Heart Archives

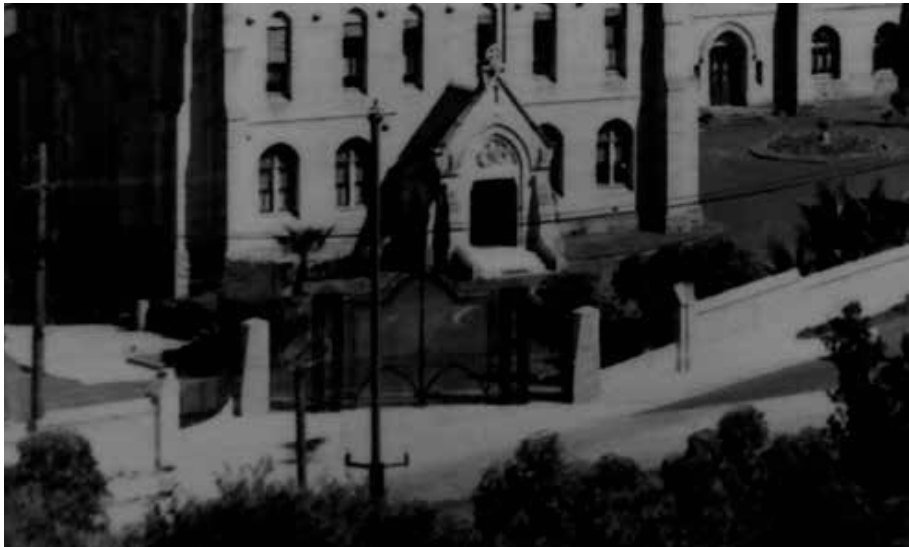
Figure A.142: The entry and gates after 1933. Source: Provincial Archives of the Society of the Sacred Heart (Album 7, Item 12)

The Jubilee Gates were installed in 1933.²⁸³ The wrought iron gates and stone pillars to the new drive entrance were gifted by former pupils to mark the jubilee year of the Society at Rose Bay.²⁸⁴ The design by J Richards (no other details found) was selected by committee under Lady Sheldon. The dimensions of the gates are 32 feet wide and 15 feet high. Electric lights were set in the head of the two wrought iron newels.²⁸⁵

By 1961 the iron work of the gates had corroded badly, and consideration then was given to making new gates. Fortunately, architects Hennessy and Hennessy were consulted, and they advised retention and repair. The gates were dismantled and repaired at the workshop of NSW Ornamental Steel Company, and were back in position at Rose Bay by September 1961.²⁸⁶

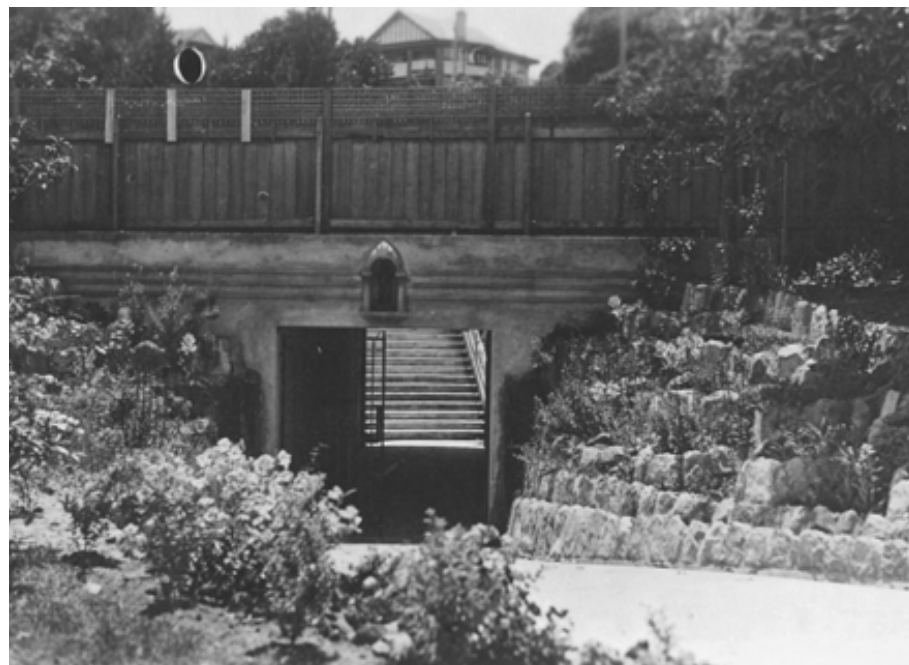
Figure A.146: The recently completed subway in about 1934. Built by Welch Bros, designed by architects Hennessy and Hennessy, and landscaped by Crozzoli and Hayes. Source: Provincial Archives of the Society of the Sacred Heart (Album 7 Item 17)

Sir Mark Sheldon suggested in 1932 that a subway under Vaucluse Road be built and paid for by the government,²⁸⁷ presumably as a charitable exercise to employ men at this time of economic depression. Sir Sheldon engaged in negotiations with the minister responsible, and with the chief engineer of the Main Roads Board.²⁸⁸ The outcome was the Society engaging architects Hennessy and Hennessy to prepare the plans for the tunnel, and let the construction contract in the usual way, and for the government to pay for this by the compensation for land lost in the resumption.²⁸⁹ The amount of compensation was settled at 1000 pounds, and the winning tender was awarded to Welch Bros for the construction cost of 996 pounds.²⁹⁰ Works on the subway and the entrances were completed in March 1933,²⁹¹ and the compensation money was received in August.²⁹²

As part of this work the front drive was altered and concreted, and the high boundary wall to Vaucluse Road was built in stone as far as funds permitted.²⁹³ The hard landscaping of the entrances to the subway with the rockeries was undertaken by the aforementioned Crozzoli and Hayes in 1933.²⁹⁴

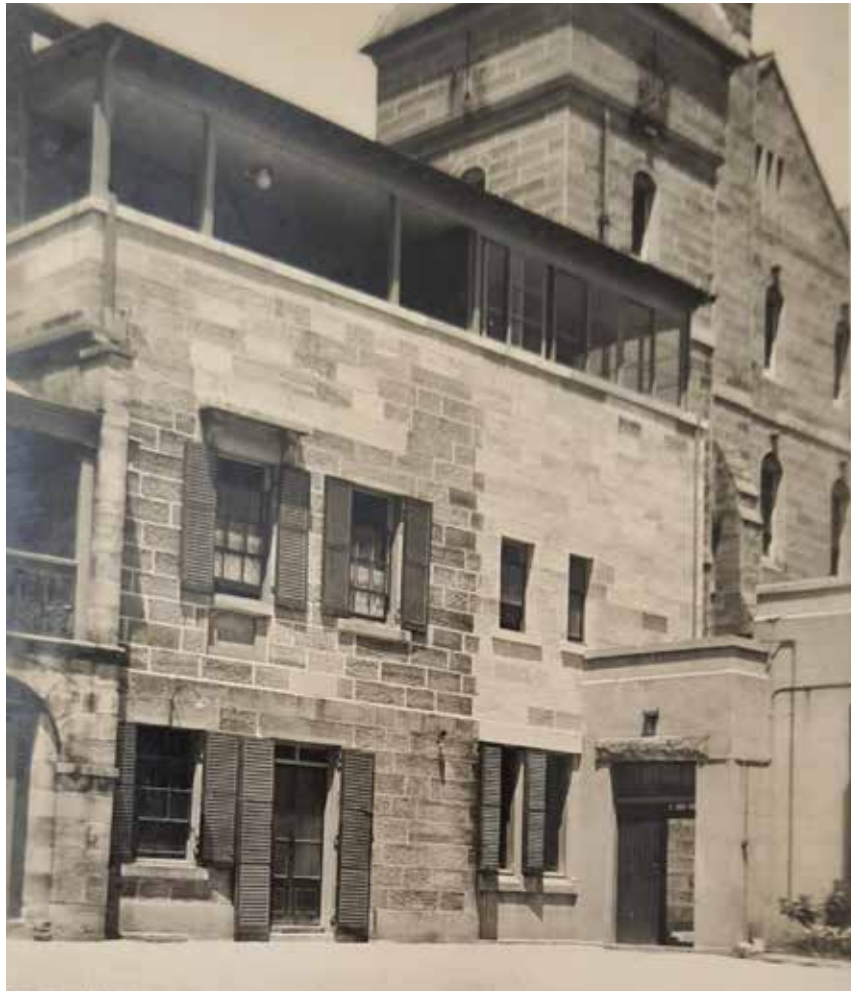
Figure A.152: Level 3 link between Claremont and the Main School Building prior to the construction of the War Memorial Wing. Source: Provincial Archives of the Society of the Sacred Heart (Album 58, Item 98)

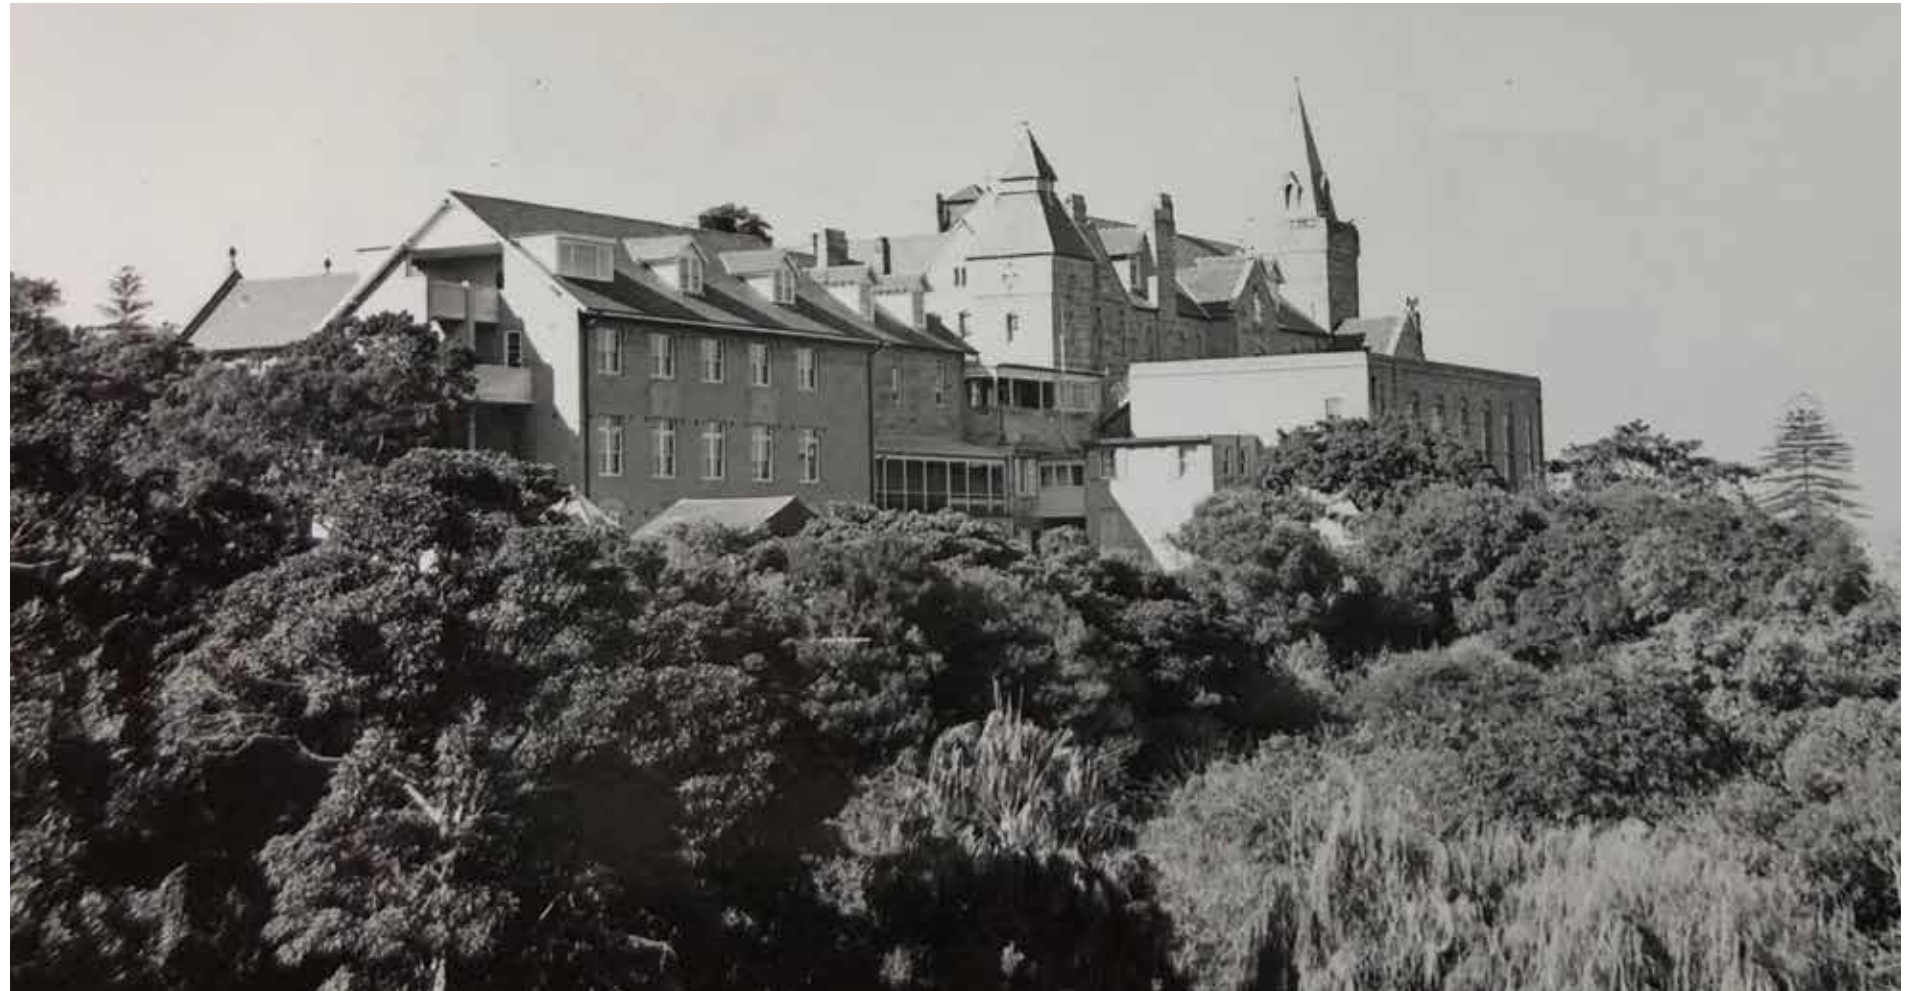
Figure A.153: Western elevation of Kincoppal-Rose Bay in 1976, showing the War Memorial Wing completed in 1956 on the centre right. Title of Photograph: Rose Bay bush near the beach, 1976. Source: Provincial Archives of the Society of the Sacred Heart (Album 28, Item 52 [981/DI-56])

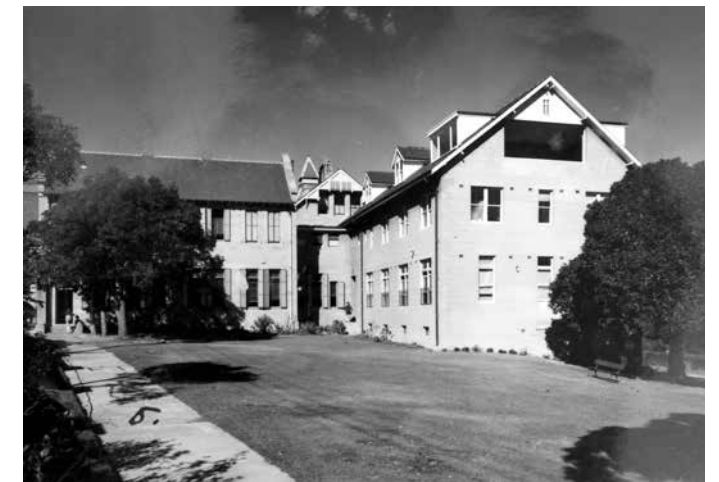
Figure A.164: North and east elevations of the 1958 wing of the Novitiate, and its setting within the north lawn. Not dated (1958). Source: Provincial Archives of the Society of the Sacred Heart

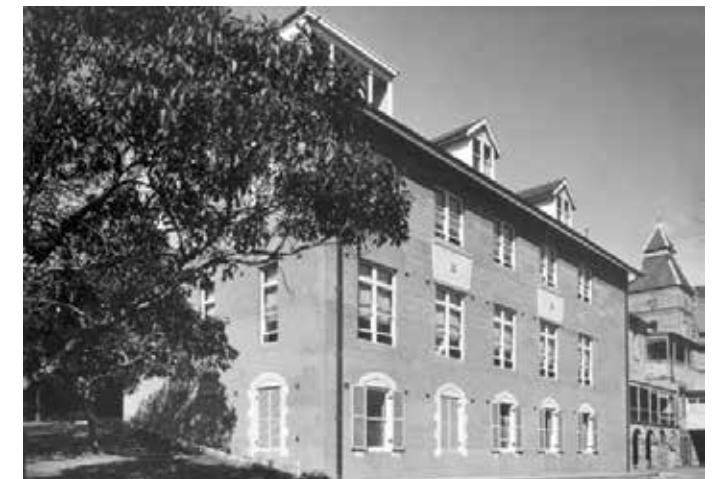
Figure A.165: The east elevation of the 1958 wing of the Novitiate. Not dated (1958). Source: Kincoppal - Rose Bay School of the Sacred Heart Archives

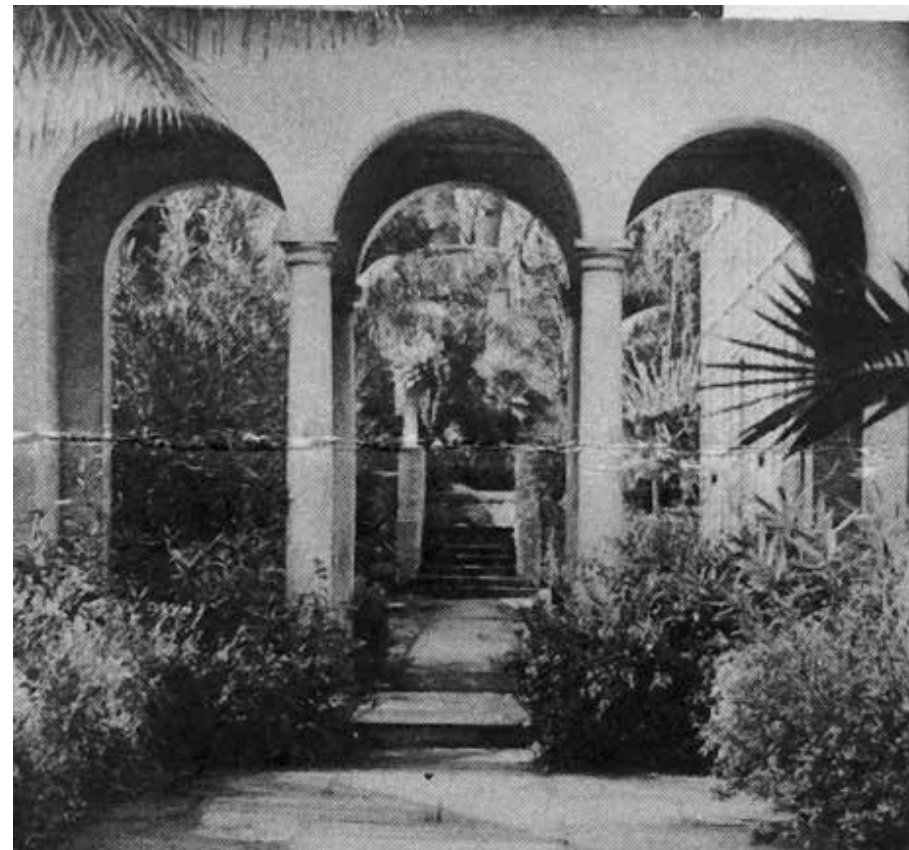
Figure A.170: Part of the arcaded garden setting of the Melocco house, prior to demolition in 1964. The prevailing colonnade motif evidently was incorporated into the design of the new Barat Burn Junior School. Source: Open Gate, 12/1964

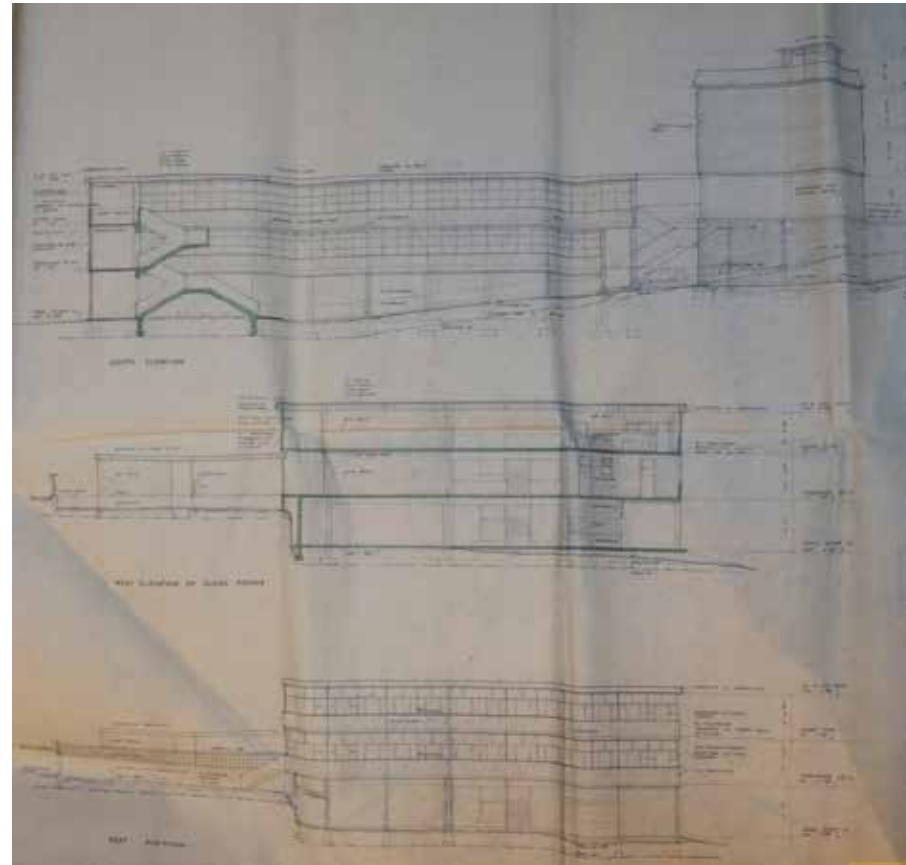
Figure A.175: Elevations and section of the school component of the Barat-Burn development. Source: Woollahra Municipal Council (BA 79/1965)

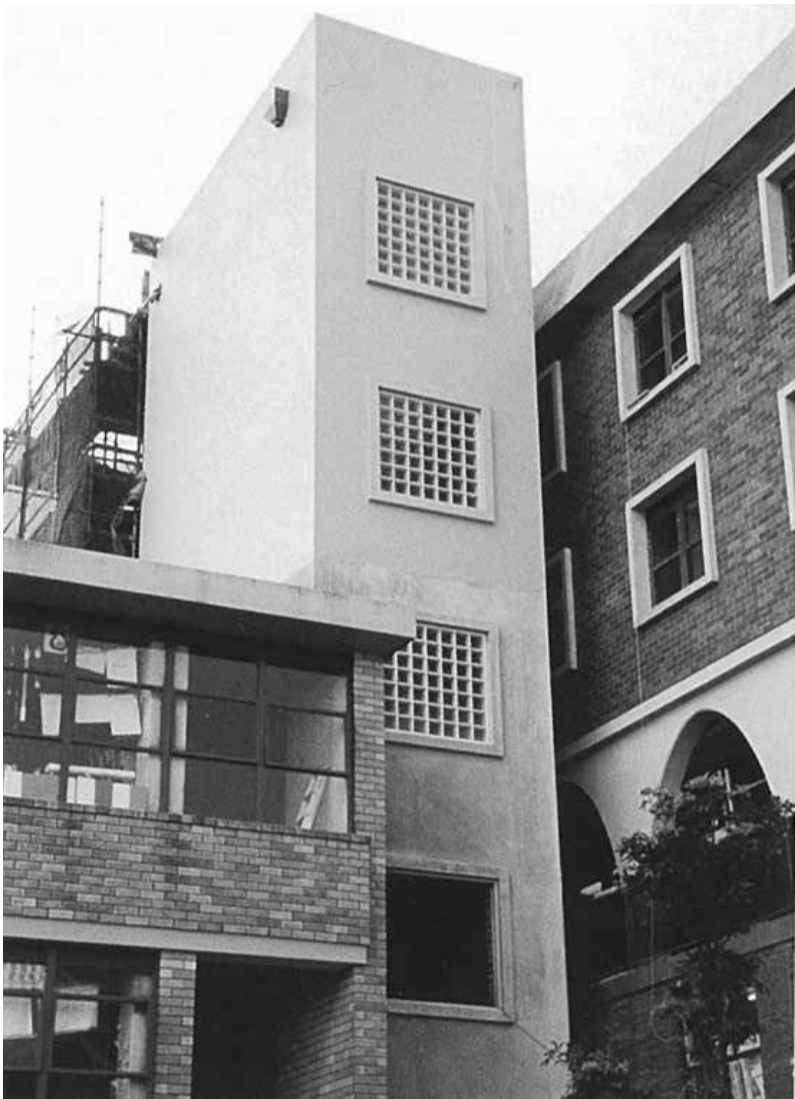
Figure A.178: The new external stair well completed in 2000. Source: Open Gate, January, 2000

In 2000 Level 5 was refurbished, and a new library, and new external stair well were built. This was an outcome, the first stage, of the site masterplan developed in 1993. The refurbishment was continued into the north wing. The undercroft was refurbished also to provide a multipurpose space for the Junior School.³²⁵

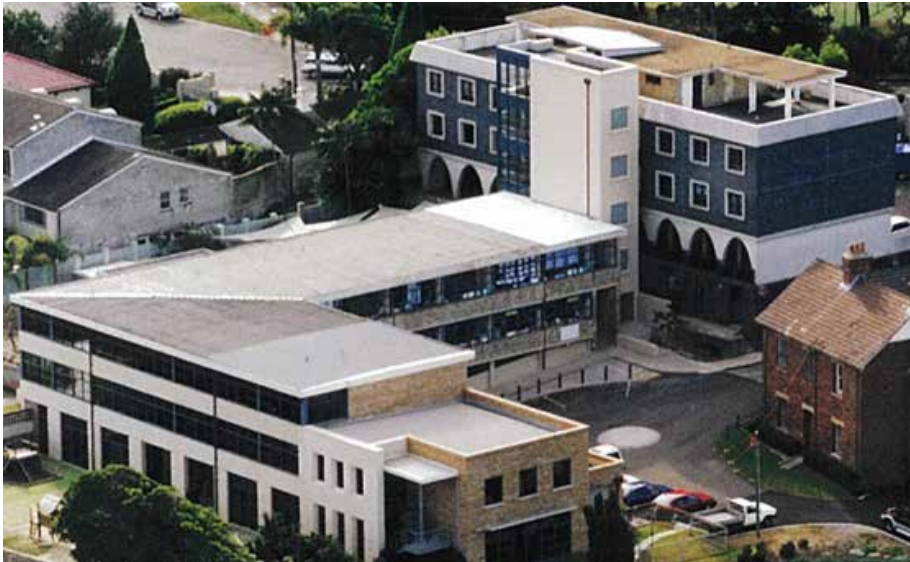
Figure A.183: The remodeled Barat Burn Junior School in 2000. Source: Open Gate, February, 2000

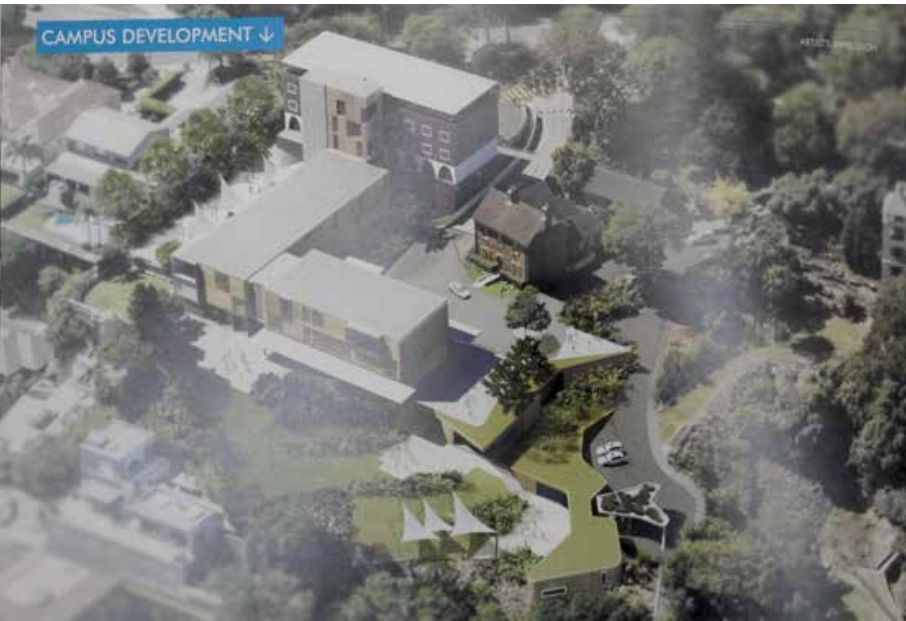
Figure A.186: The BVN Donovan Hill master plan of 2013 for the future development of the Junior School precinct. Source: Open Gate, July 2014

In 2013 the master plan developed by architects BVN Donovan Hill for the Junior School was released.
