KINCOPPAL - ROSE BAY

SCHOOL OF THE SACRED HEART

CONSERVATION MANAGEMENT PLAN

Final Report - August 2020

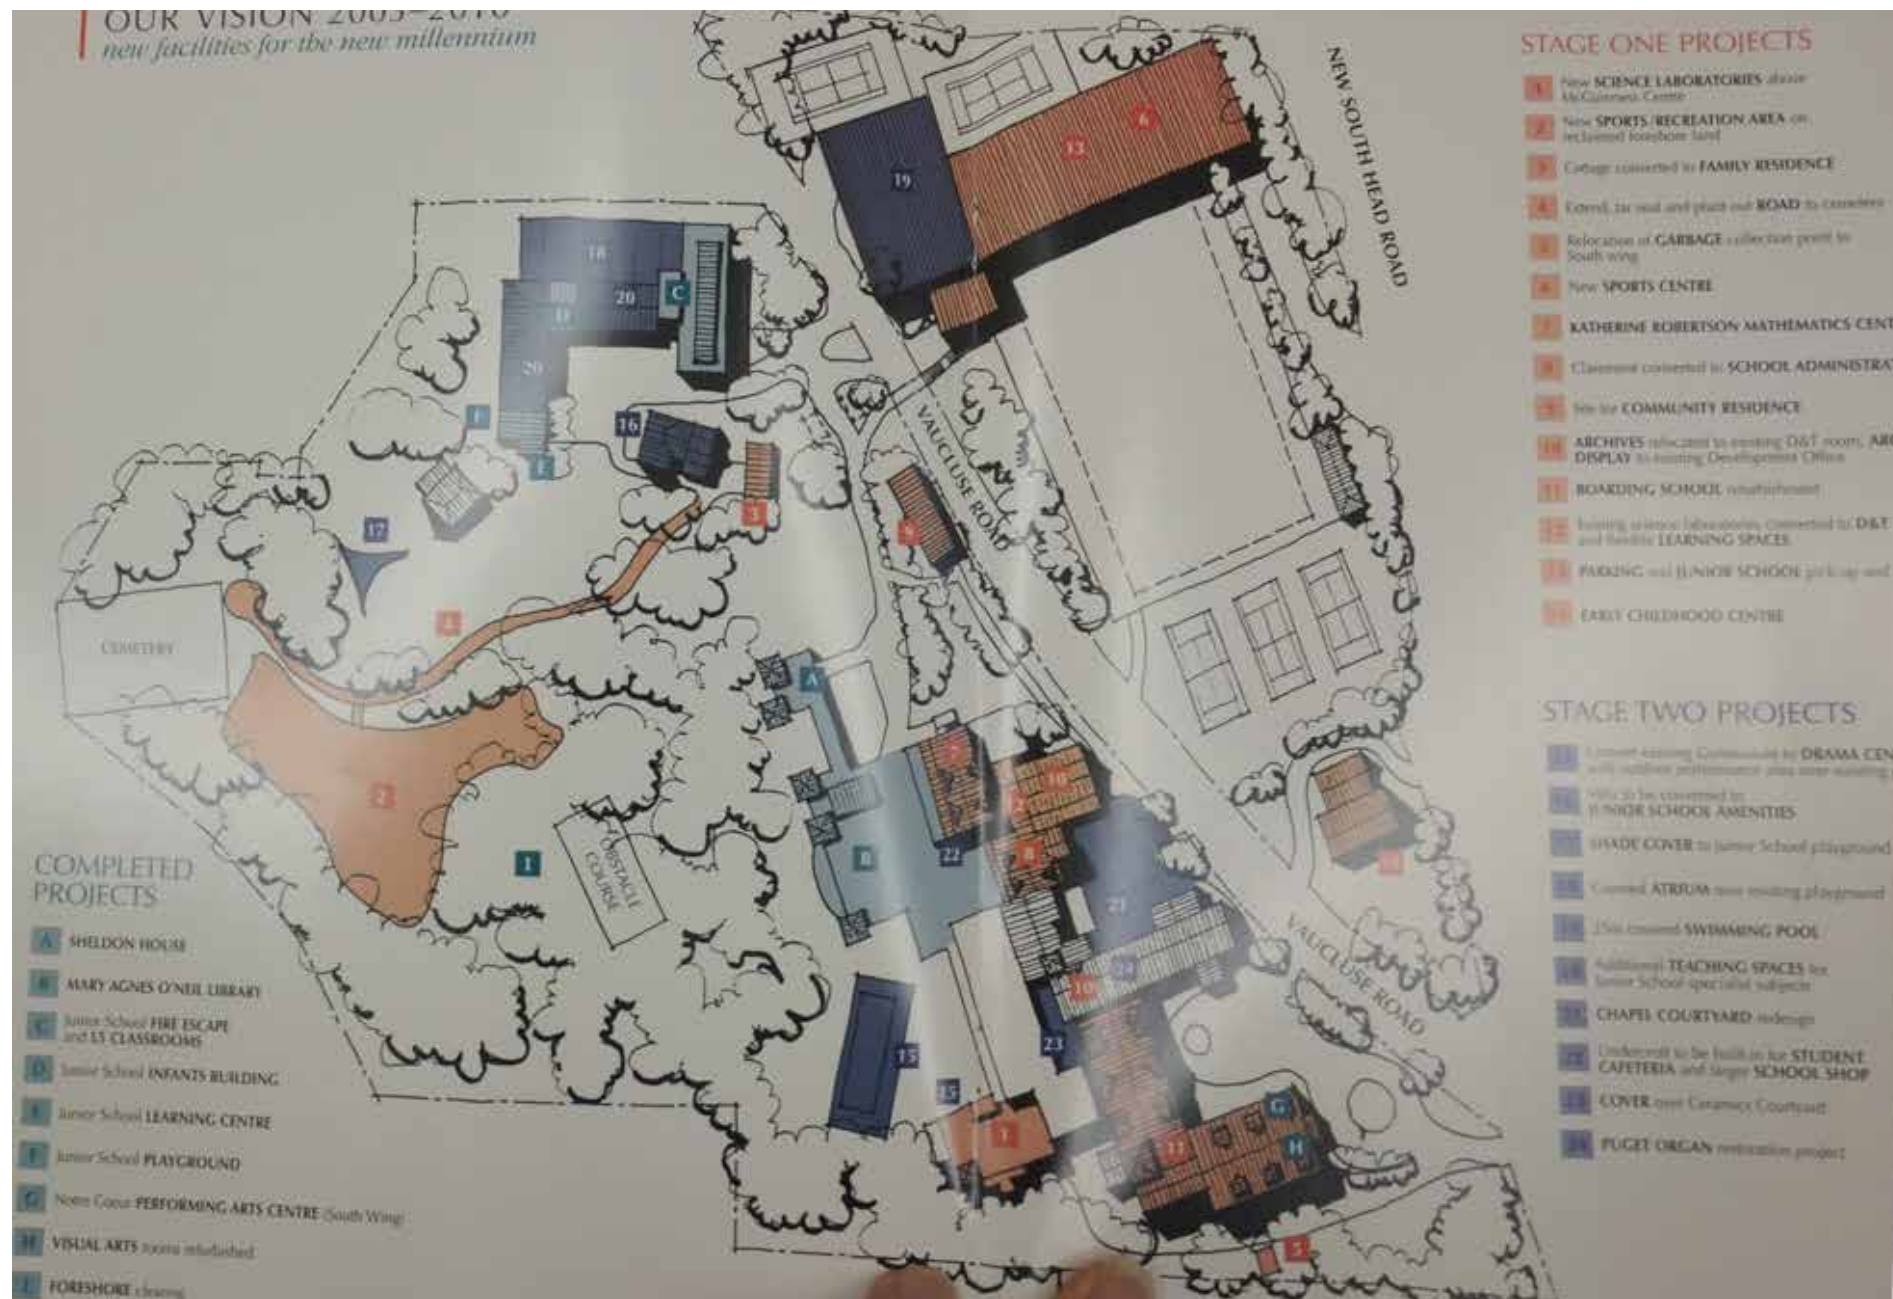
Figure A.187: The master plan released in 2003. Source: Open Gate, March, 2004

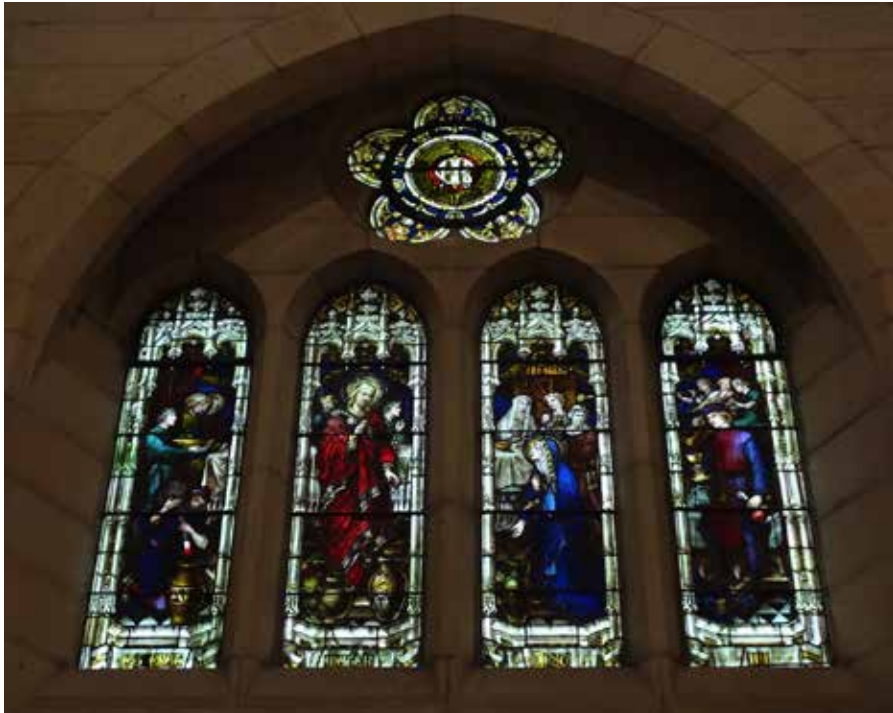
5. Et Erat (text) (hopper)	6. Mater (text)	7. Jesu (text)	8. Ibi (text) (hopper)
Translation: And the mother of Jesus was there. Set depicts the wedding at Cana. Christ’s first miracle took place at a wedding where Jesus changed six jugs filled with water into wine.			
9. Cinquefoil - Ave Maria Gratia Plena (text) Translation: Hail Mary, full of grace. Depicts Christogram IHS in centre. (pivot)			
Provenance: Donated by Lady Sheldon (Blanche Dalton). Title: Marriage feast of Cana. Windows date post 1920. A c1920 postcard shows leaded windows with diamond patterned glass.

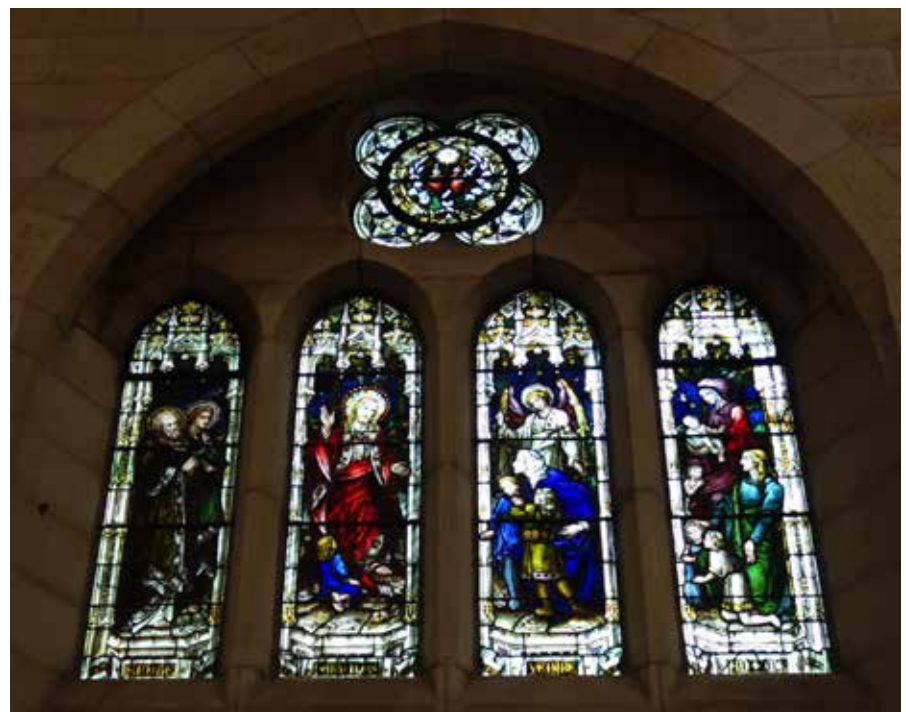
North Elevation – Main Chapel

10. Sinite (text) 11. Parvulos (text) 12. Venire (text) 13. Ad Me (text) (hopper) (hopper) Translation: Let the children come to me. Set depicts Christ standing on stone step with child to his feet (centre left), angel and man with two children (centre right), four children and two women (right); two clerics stand on the side (left). 14. Quatrefoil - Depicts the Crest of the Sacred Heart in the centre. A symbol of the Sacred Heart of Jesus (left) and the Immaculate Heart of Mary (pierced by a sword on right), depicted in the Alliance of the Hearts of Jesus and Mary. (pivot)

Provenance: Donated by the Rose Bay Association in memory of Elizabeth O’Gorman Hughes. [Mrs Gorman Hughes [sic] – first president of the Rose Bay Association; “asked the Pope to send the nuns to Sydney” – establishing the convent – “Lizzie Hughes”, Mr. and Mrs. John Hughes daughter at the age of eight spoke to the Pope at an audience in Rome, where the Pope asked if there was anything she would like to take with her to that faraway Australia. She said, that she would like the Pope to send out to Australia the nuns of the Sacred Heart, who had taught her at the Parisian convent she attended. Source: The Sun, 15th May 1932, p.21] Title: Jesus blessing children. Windows date post 1920. A c1920 postcard shows leaded windows with diamond patterned glass.

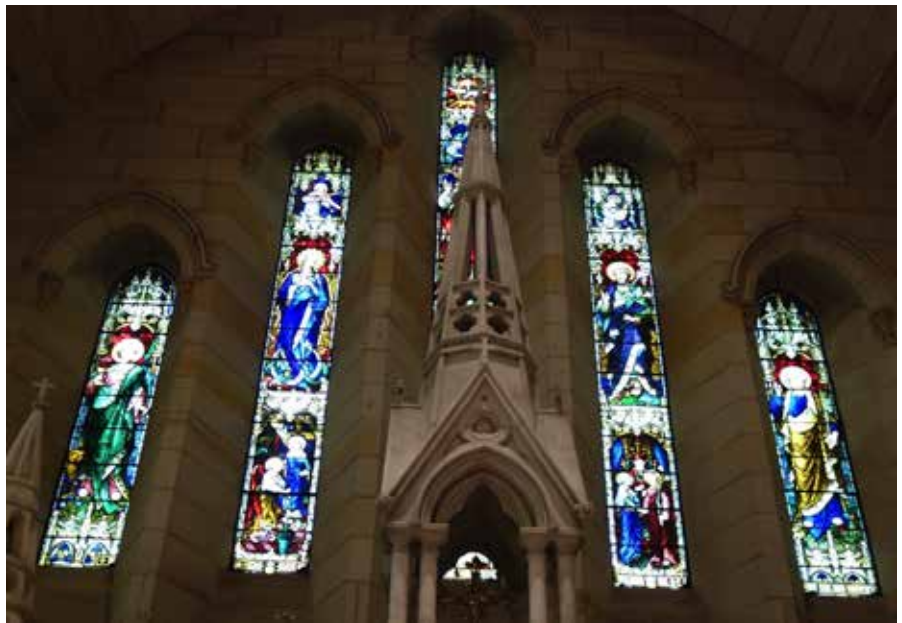
East Elevation – Main Chapel

30. In (text)	31. Memoriam (text)	32. Febronie Vercruysse (text)	33. Religio SCJ (text)	34. OBIT XXIX Juni MDCCCXCV (text)
	Translation: Memory		Translation: Religious of the Sacred Heart of Jesus	Translation: Died 29 June 1895
Depicts St John.	Depicts Mary.	Depicts Jesus and the Sacred Heart; Jesus at the table, holding a loaf of bread.	Depicts Joseph [?]; marriage of Mary and Joseph [?].	Depicts St Peter.

Provenance: Donated by Alumnae at school 1882-1895, their memorial to R. M. Vercruysse

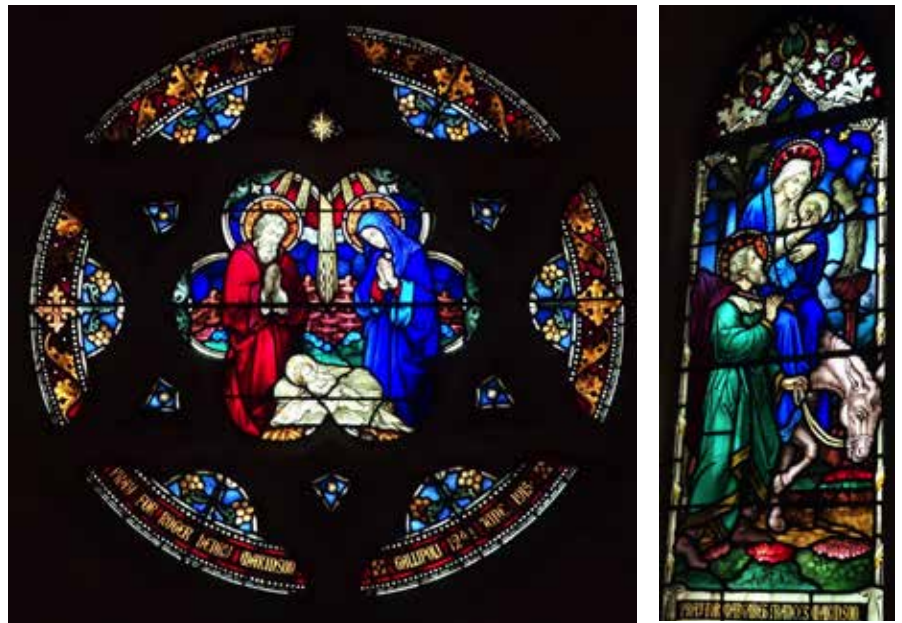
South Elevation - Stranger's Chapel

35. Pray For Roger Henry Makinson – Gallipoli 12th June 1915 (text) [b 19 January 1883 d 12 June 1915]	36. Pray For Margaret Frances Makinson (text)
	[M F Christina – wife of Henry Massey Makinson, mother of Roger Henry and Rose Bay Convent alumnae - d 1927]
Depicts Nativity of Jesus Christ.	(hopper) Depicts Mary with Baby Jesus on horse, traveling with Joseph.

Provenance: Given to the chapel by Margaret Frances Makinson, whose son fought in Gallipoli. Title: The Star of David.	Provenance: Mr Makinson in memory of his Mother and brother killed at Gallipoli. Title: Flight into Egypt
---	--

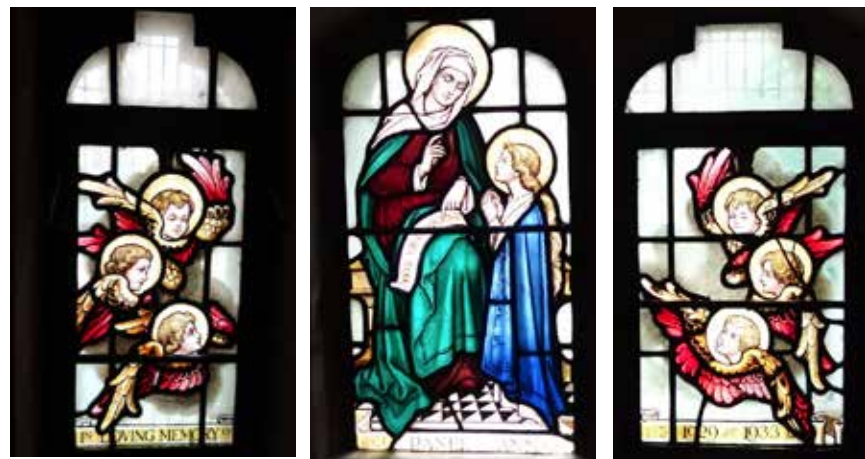
South Elevation – Side Passage

37. In Loving Memory Of (text)
38. Rane Ann (text)
Sash text: Ecce Virgo Conciptet
Translation: A virgin shall conceive.
39. 1929 - 1933 (text)

Provenance: Donated by Mrs R. Flynn (Ranee Adams) in memory of daughter, Anne.
Title: Small window of St Anne.

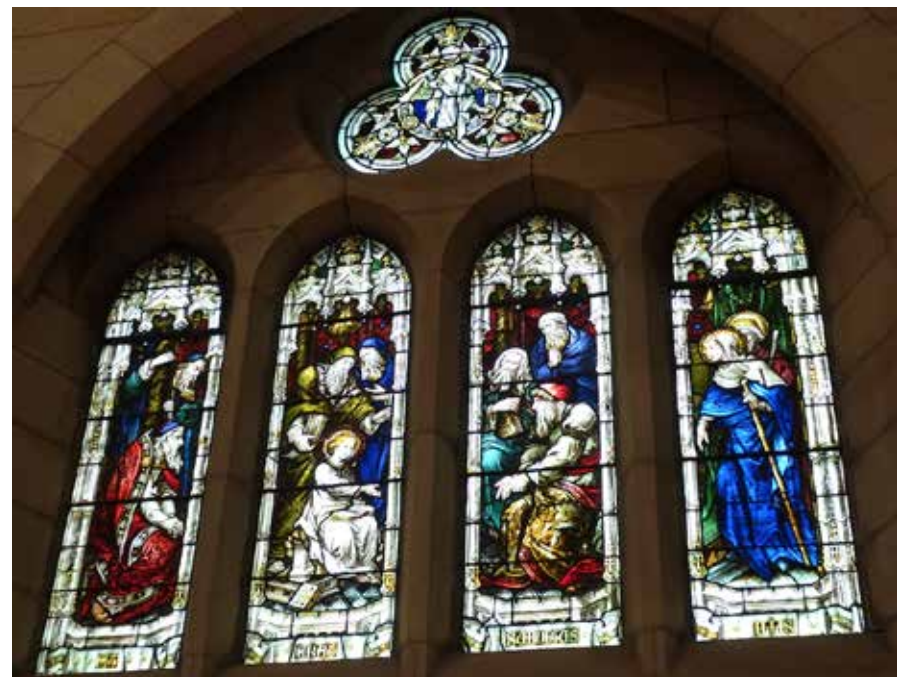
South Elevation – Main Chapel

40. Et (text)
41. Erat (text)
42. Subditus (text)
43. Illis (text)
(hopper)
Translation: He was subject to them. / He was obedient to them.
Depicts the Child Jesus.
Depicts Mary and Joseph.

44. Trefoil - Depicts Angel and three crowns.

Provenance: Donated by the sons of the Hon. John Meagher in memory of Mother Mary Meagher
Windows date post 1920. A c1920 postcard shows leaded windows with diamond patterned glass.
Title: The Finding in the Temple. [Depicts story of Jesus, who was lost and then found in a temple.]

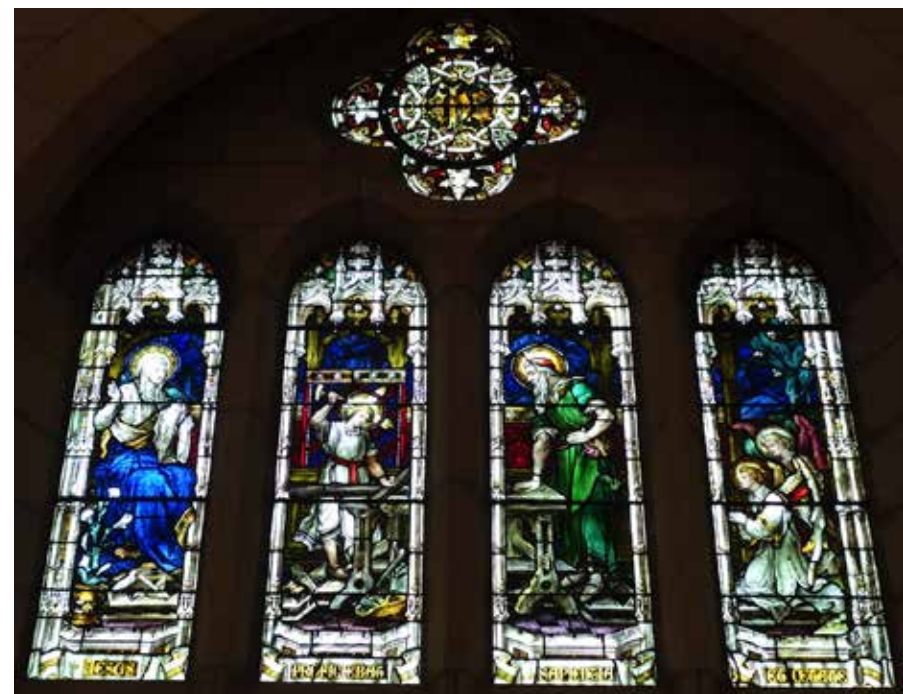
South Elevation – Main Chapel

45. Jesus (text)
46. Proficiebat (text)
47. Sapientia (text)
48. Et Aetate (text)
(hopper)
Translation: Jesus advanced in wisdom and age.
Mary depicted as doing craft.
Young Jesus depicted as working with tools (making a cross).
Joseph looking over the work of Jesus, supervising and teaching.
Two angles in prayer looking over the scene

49. Quatrefoil - Christogram IHS in centre.
(pivot)

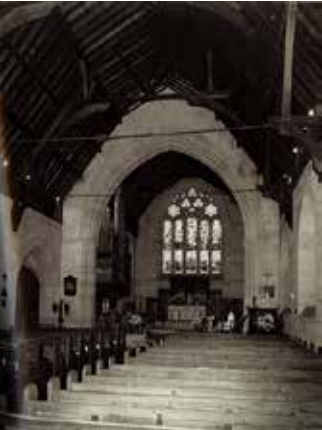
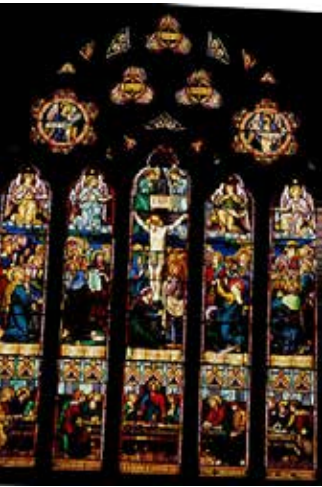
Description (RNE): <i>Large conventional Gothic Revival stone Church of four bays and chancel (fifth bay) and narthex with western front added in 1938. Walls of rugged quarry faced sandstone with dressed window surrounds. Feature of the interior is the chancel arch, a beautiful sweep of stone supported on carved corbels which extend out as buttresses. Pipe organ installed in 1888. Several fine Victorian stained glass windows.</i>

Comment: All Saints Anglican Church in Hunters Hill is comparable with the chapel at Kincoppal-Rose Bay in terms of scale and architectural finesse. The timber truss ceiling is a distinctive feature and contrasts to the solid sandstone walls. The highly decorative stained glass windows and pointed arch sandstone detailing are similarly comparable stylistically. The church is free standing on a suburban block, surrounded by private residences to the north. In terms of siting and prominence it is much less dominant in the surrounding landscape than other examples of Hunt's work.

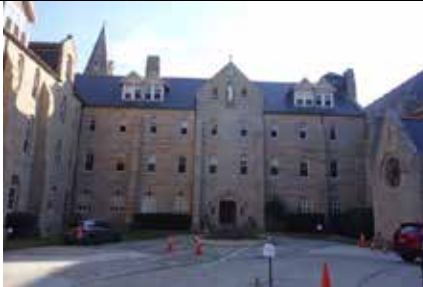
Building / Space: Landscape Area – Main Entry Forecourt (L1) Significance: Exceptional		
Element	Description	Image
Concrete driveway on main entry forecourt	c1970s/1980s concrete panel driveway and turning circle around central circular garden bed on main entry forecourt, providing access to main entrance. Used for car and bus parking during the day. Similar shape but widened compared to previous gravel driveway and less landscaped. Graded to drain towards central circular turning circle.

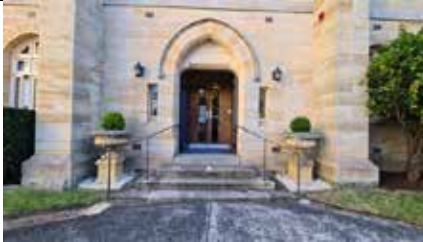
Entrance to Main School Building	Central entrance to Main School Building via the entry forecourt. Entrance has a chamfered pointed arch opening with decorative stone mounding above, terminating in carved floral motifs. Set of pyramidal stone steps with a simple curved steel handrail leading up to the recessed (modern) timber and glass panelled door.

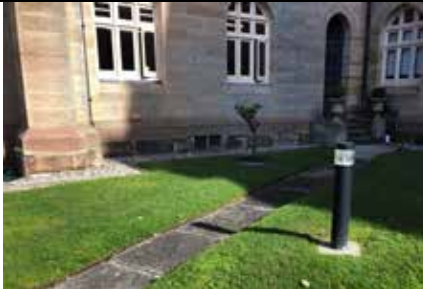
Sandstone Steps to South Wing – Side Entrance, concrete footpath, gravel drain	Early / original steps to 1888 part of South Wing. Alignment of path from at least 1940. Brick drainage channels and concrete paving of concrete footpath modern c1970s / 1980s when entry forecourt was formalised as concrete drive. Gravel drain surrounding the base of the Main School Building, South Wing and Chapel.

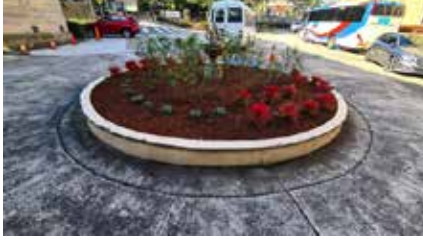
Landscaping	Landscaped open lawns to forecourt and low hedge and shrub planting adjacent the buildings is early.	
Brick drainage	c1970s/1980s open brick drainage channels between landscaped and lawned areas and concrete paved driveway. Earlier single row brick edging between concrete driveway and lawn to Chapel, curving towards entry.

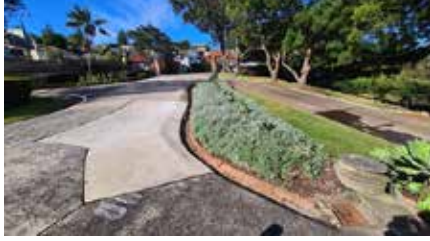
Garden bed between main entry forecourt and southern driveway	c1930s informal garden bed with open brick drain, separating upper and lower concrete driveways. Planted bed along forecourt level and lawned area along lower drive, separated by low random rubble retaining wall. Orientation and alignment remains unchanged, style of planting has changed over the time with low hedges and shrubs in c1940s.

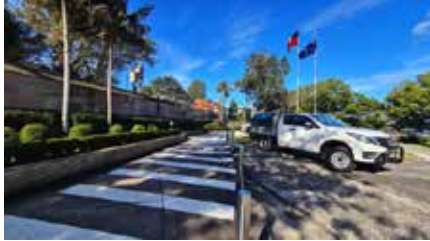
Sandstone boundary wall, low sandstone retaining wall, garden beds	1933 sandstone ashlar boundary wall (picked finish), with triangular capping and a low plinth course installed with the Jubilee Gates. Modern low sandstone retaining wall to garden bed with open brick drain. Concrete drive, modern steel bollards with chain and zebra crossing linework identify pedestrian path

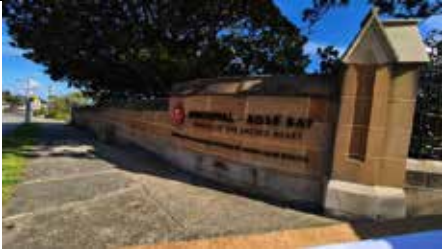
Building / Space: Landscape Area – Former Conservatory Site (L12) Significance: High / Moderate		
Element	Description	Image
Sandstone boundary wall (east)	Extending from the Jubilee Gates, this sandstone boundary wall forms the eastern edge of the former conservatory site and dates from 1933. Sandstone ashlar wall (picked finish) with triangular capping and low plinth course. (High significance) Installed with the Jubilee Gates. Modern signage. Concrete retaining wall below street level on the former conservatory side.

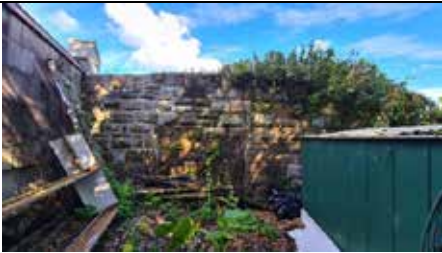
Southern boundary wall	Rock faced random rubble sandstone wall to southern boundary (High significance), c1920s continues in brick, concrete block and chain wire mesh fence further downhill.

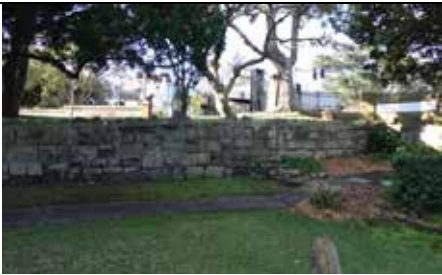
Sandstone retaining walls and stairs	Sandstone block retaining wall delineating "Courtyard" space and lower terrace. c1930s sandstone retaining walls with rugged cut stone edge, (some stones in top course missing) providing access to the former conservatory site level and low random rubble retaining wall with straight edge to second, lower level. Some stones have deep pick marks and evidence of 'dog' holes, possibly from 1880s construction.

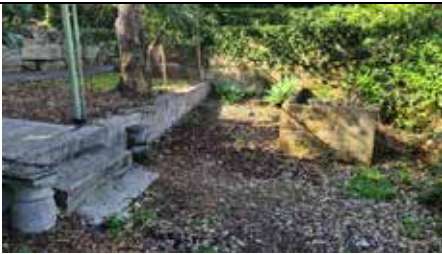
Concrete block boundary retaining wall and former brick structure	Remnant square brick structure adjacent concrete retaining wall. (post 1940?)

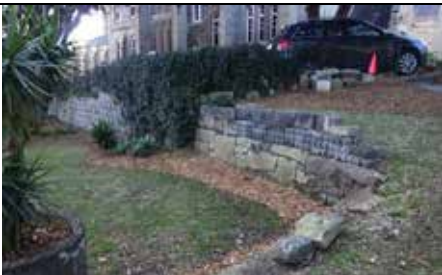
Concrete block retaining wall	Continuation of low sandstone retaining wall between second and third terrace (north south) but in an east-west direction and with rising level change to concrete driveway above. One course at eastern end replaced by concrete block and changes to full concrete block retaining wall half way. Wall topped with modern aluminium fence and hedging to paved parking area above.

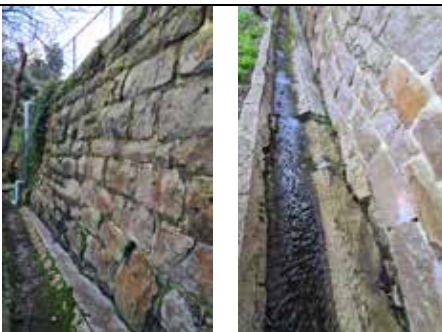
Horbury Hunt sandstone retaining wall and stone culvert;	Rock faced sandstone ashlar retaining wall, in parts buttressed and former hoisting ('dog') holes visible to some stone blocks. Forms part of the 'plateau' the school buildings were constructed on. Appears repointed at south-eastern end. Stone culvert for site drainage at base of Hunt retaining wall, following the topography.

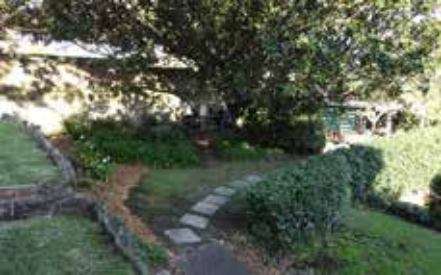
Building / Space: Landscape Area – Former Conservatory Site (L12) Significance: High / Moderate		
Element	Description	Image
"Courtyard" and Landscaping - planting	Area between sandstone boundary wall to New South Head Road and next terrace down. Low hedge to west, central concrete paved path and informal garden bed with low shrub planting to west. Planting and layout post 1940. Predominantly modern hedging and mulched informal garden beds with some low ground cover, one mature Magnolia grandiflora along eastern boundary remaining (post 1940). Structures: modern timber lattice awning / pergola and modern Colorbond garden shed.

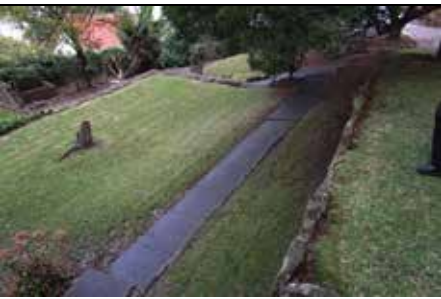
Landscaping – general	Former formal garden beds and conservatory site, now mix of informal garden beds and open lawned terraces. East-west concrete pathway on the first terrace along the length of the c1930s sandstone retaining wall.

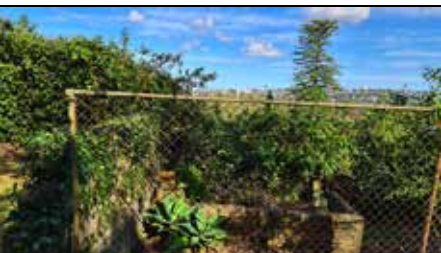
Metal fences	Modern aluminium fence on top of concrete retaining wall to paved parking area. c1930s pipe and chain link wire mesh fence to southern boundary, on top of Hunt retaining wall and on lower terrace adjacent the remnant brick structure.

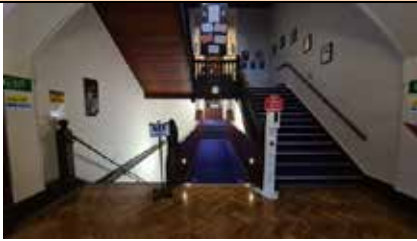
Building / Space: Senior School Main Building (S1) – Level 2 Significance: Exceptional		
Element	Description	Image
Room No:	Room Name: Main Stair	
Floor	Marble tile on Level 1, herringbone parquet on Level 2 foyer space, blue carpet with gold quatrefoil pattern and modern non-slip nosing on treads and landings.

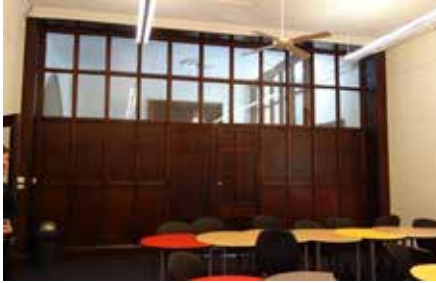
Room No:	Room Name: GLA1	
Floor	Dark, functional carpet (Original timber floors may remain under)

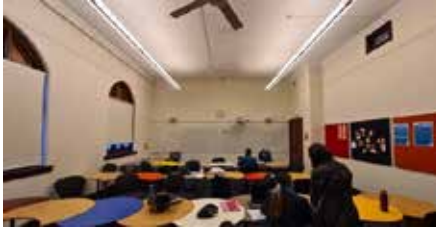
Ceiling	Lath and plaster with original / early ceiling rose, surface mounted electrical in cable channels, two ceiling fans and suspended fluorescent light fitting. Early cornice to masonry walls.

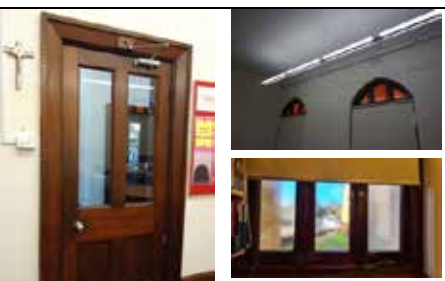
Room No: S2-11	Room Name: GLA2	
Floor	Dark functional carpet (Original timber floors may remain under).

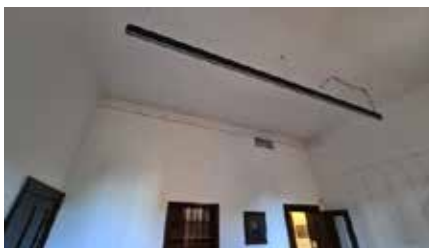
Building / Space: Senior School Main Building (S1) – Level 2 Significance: Exceptional		
Element	Description	Image
Room No: S2-10	Room Name: Meeting Room 2	
Floor	Carpet over original timber floors.

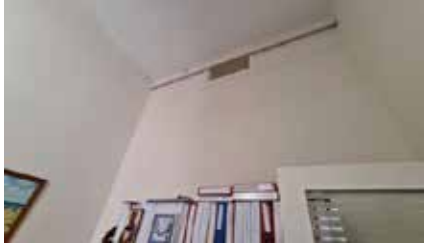
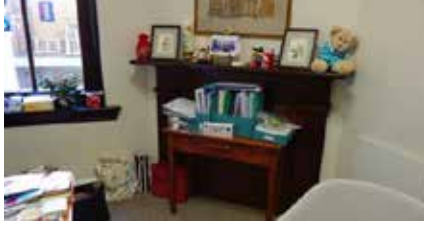
Room No: S2-26 / G21	Room Name: Deputy Principal / St Gabriel	
General	Originally one space, currently divided into two offices by modern plasterboard partition with large glazed panel. Dado to all original walls.

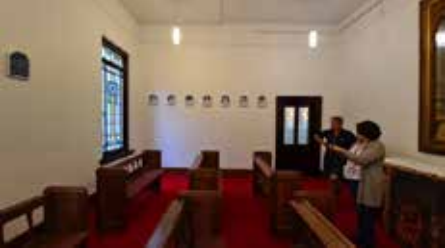
Building / Space: Senior School Main Building (S1) – Level 2 Significance: Exceptional		
Element	Description	Image
Room No: S2-28	Room Name: Staff Offices 2 / Chapel of Mater Admirabilis	
General	Recently altered to accommodate the Chapel of Mater Admirabilis by removal of plasterboard office partitions and new fitout.

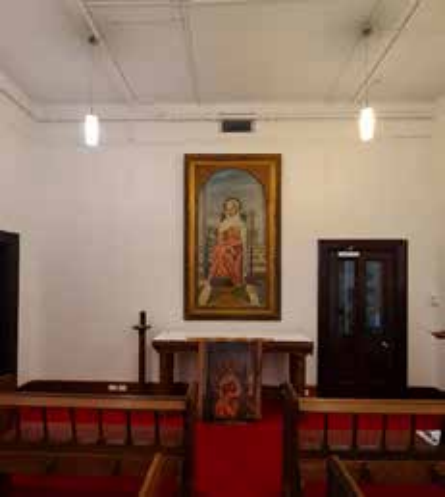
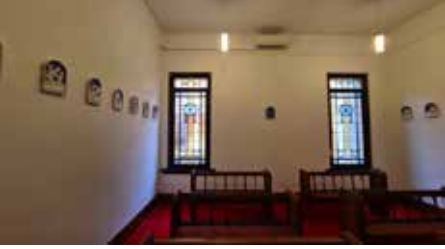
Floor	Red carpet (Original timber floors may remain under).	
Walls	<p><u>North</u> – Wall is solid plaster over stone with 4-panel cedar door, upper glazed panels, modern door hardware, exposed pipework, dado, Stations of the Cross.</p> <p><u>East</u> – Wall is solid plaster over stone (wall opposite Chapel) with 4-panel cedar door, upper glazed panels, modern door hardware, exposed pipework and high level vent / high light, dado running through northern plasterboard wall, painting of the Mater Admirabilis and timber altar against this wall, furniture layout in space facing this elevation.</p> <p><u>South</u> – Wall is plasterboard, no dado, Stations of the Cross.</p> <p><u>West</u> – Wall is solid plaster over stone with two original stained glass windows, air-conditioning unit outlet through plasterboard south wall, dado, memorial tablet.</p>

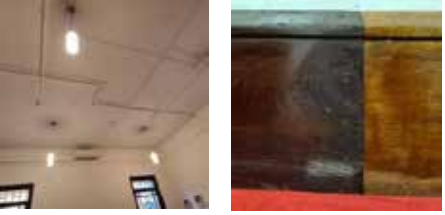
Ceiling	Ceiling is plasterboard over lath and plaster, evidence of former partition wall remains, no cornice, modern pendant lighting, exposed service channels.

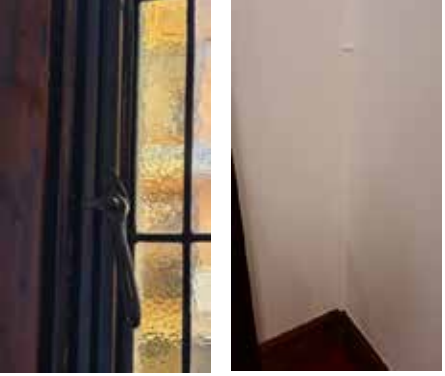
Skirting	High, simple profile non-original and early cedar skirting, electrical services run behind new skirting and surface mounted outlets.

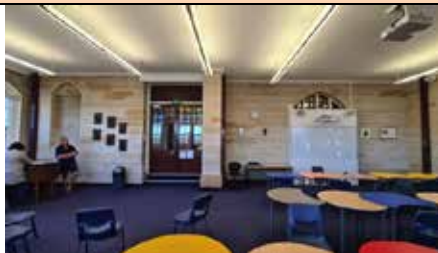
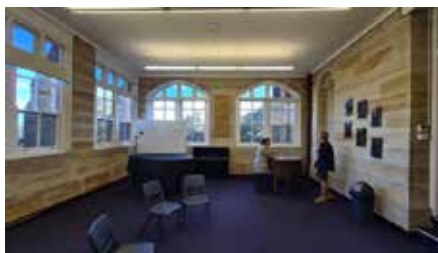
Building / Space: Senior School Main Building (S1) – Level 2		
Significance: Exceptional		
Element	Description	Image
Room No: S2-07	Room Name: GLA3 / 'Verandah and Balcony'	
Floor	Dark functional carpet (Original timber floors may remain under).

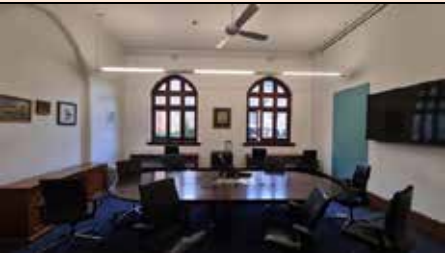
Building / Space: Senior School Main Building (S1) – Level 2 Significance: Exceptional		
Element	Description	Image
	<p>South – Wall is solid plaster over stone (wall to hallway) with plasterboard blind arch and later cedar double doors.</p> <p>West – Wall is solid plaster over stone with two plasterboard blind arches.</p>

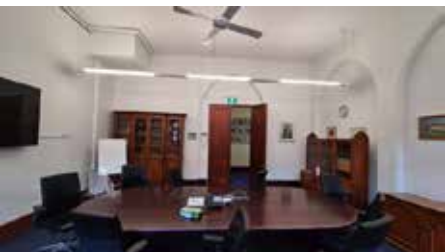
Ceiling	Suspended fluorescent lighting and ceiling fans with surface mounted cable channels on suspected lath and plaster ceiling.

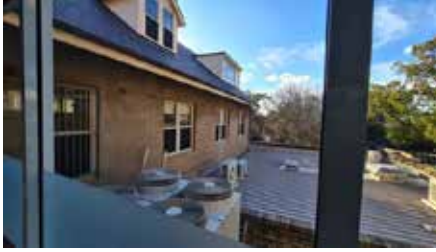
Building / Space: Science Block (S6) / 1959 Noviceship Wing Additions – Level 3 Significance: Moderate		
Element	Description	Image
Exterior		
General	<p>Three storey (plus attic) rendered masonry building (picked to resemble sandstone).</p> <p>Original elevations subsumed by 1976 Science Block to east and west up to Level 2 inclusive and 1976 fire stair to north (up to attic level).</p> <p>Original cedar double hung sash windows (painted externally) extant at Level 3.</p>	 
East Elevation	<p>Extant picked render finish and terracotta vents, four original timber sash windows.</p> <p>No access to roof of Science Block and services and plant located on this elevation.</p>

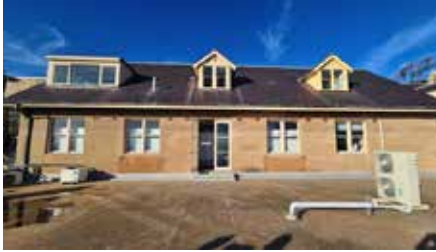
West Elevation	<p>Extant picked render finish and terracotta vents, four original timber sash windows (painted) and centred glazed double door and steps, providing access to concrete roof of Science Block (waterproof membrane), services and plant located on this roof. Slate roof, copper downpipes.</p> <p>Evidence of former structure and alteration in render under two windows adjacent door.</p>

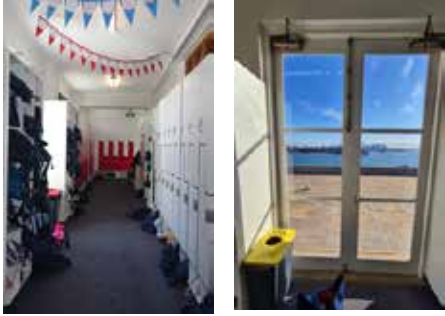
Building / Space: Science Block (S6) / 1959 Noviceship Wing Additions – Level 3 Significance: Moderate		
Element	Description	Image
Room No:	Room Name: Hallway	
Floor	Concrete floor with dark blue and light striped carpet tile over.

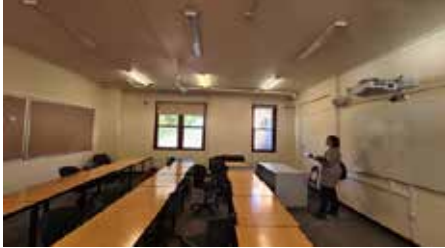
Walls	External – masonry, internal – plasterboard partitions;	
Ceiling	Ceiling is plasterboard ceiling with simple coved cornice, exposed services and modern fluorescent tube lighting.	
Joinery	All doors modern, flush with vision panel; double timber and glazed door to Science Block roof; simple low timber skirting.	
Finishes	Light modern colour scheme.	
Room No: S3-39	Room Name: GLA1	
Floor	Concrete floor with carpet over.

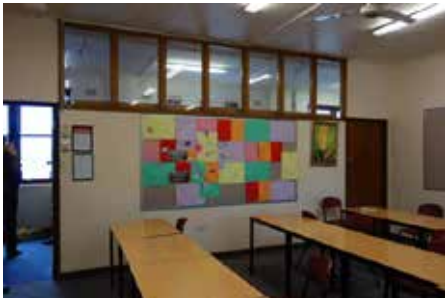
Ceiling	Plasterboard with simple coved cornice, surface mounted fluorescent tube lighting and ceiling fans.	
Skirting	Low timber skirting to all walls.	
Services	Surface mounted electrical services, services riser and bulkhead to east.	
Furniture	Modern classroom fitout.

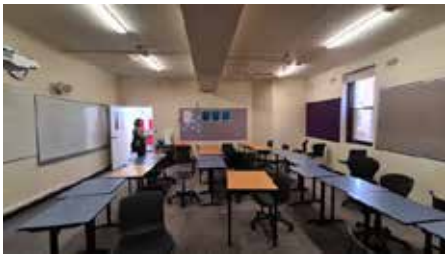
Services	Services bulkhead through centre.

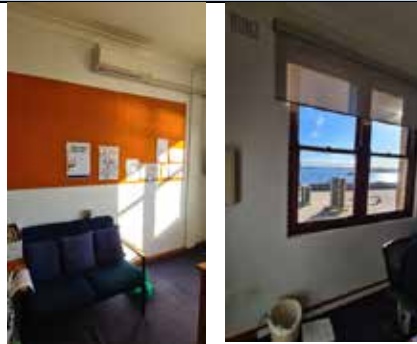
Building / Space: Science Block (S6) / 1959 Noviceship Wing Additions – Level 3 Significance: Moderate		
Element	Description	Image
Room No: S3-37	Room Name: Amenities / Female Toilet	
General	Walls are masonry walls with lightweight modern bathroom fitout, grey floor tile over concrete, three timber sash windows with obscured glass east.	No image
Room No: S3-38	Room Name: YR 8 Co-ord.	
Floor	Dark blue carpet on floor with low, simple profile timber skirting with additional surface mounted services in cable channels.

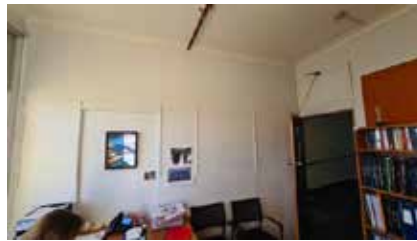
Walls	Walls are modern plasterboard partitions with services riser and air-conditioning unit.	
Ceiling	Plasterboard ceiling with simple coved cornice and exposed pipework.	
Doors	Flush, painted timber frame door with vision panel and large highlight over (blockout film applied), no architrave.	
Windows	Timber frame, double hung cedar sash window with later brass window hardware and blockout roller blinds.

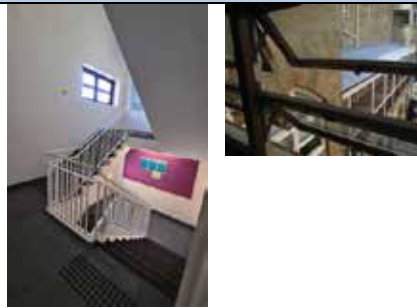
Room No:	Room Name: Store (not accessed)	
Not accessed.		
Room No:	Room Name: Egress Stair 1	
General	Concrete and steel fire stair at south-western corner of the building, in place of former colonnade constructed as part of the 1928 Noviceship Wing.

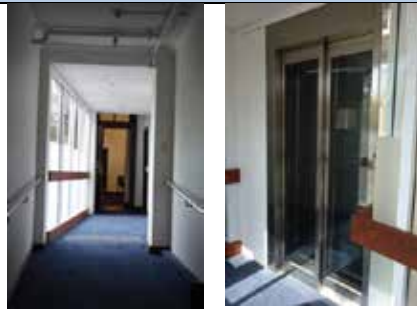
Walls	Walls are masonry with painted skirting and concrete floor. Stair with fixed non slip nosing and steel handrail.	
Joinery	1959 Timber framed awning windows.	
Room No:	Room Name: Connecting Hallway from Noviceship Wing / 1970s Walkway	
General	1970s glazed walkway and lift access to Level 3 of the 1959 Noviceship Wing Additions from Ground Floor Reception (Level 2). Lift c2010.

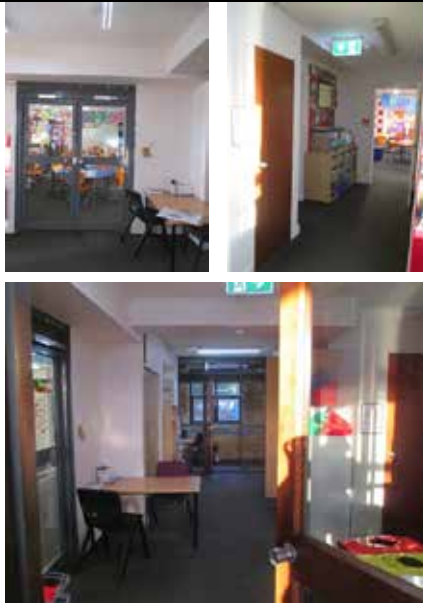
Building / Space: Junior School / Joigny – Barat Burn, Barat Burn East Wing (J1)		
Significance: High / Moderate		
Element	Description	Image
Level 4 in this table is Level 1 on architectural plans.		
Room No: B4-5	Room Name: Level 4 Foyer	
Floor	Modern carpet laid on floor, originally vinyl in foyer, which may survive under.

Walls	<p>North – Masonry wall in location of original construction, location of access and openings are modern.</p> <p>East – elevation of foyer area is defined by alumidised aluminium frame glazing with 2-panel timber and glass door to eastern balcony and original terrazzo threshold.</p> <p>South – masonry walls of the central stair to the east and bathrooms to the west. Formerly connected to a further long hallway to bedrooms during convent use. Flush timber door to main stair.</p>	
Ceiling	Plasterboard ceiling with exhaust duct behind and services riser on this wall. Fluorescent tube lighting on vermiculite ceiling throughout foyer area.

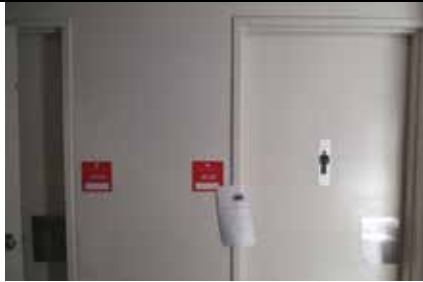
Doors	Modern aluminium frame glazed door to B4-2 in foyer, design similar to original alumidised aluminium doors to classrooms off balconies.	
Furniture	Hallway / foyer has modern built-ins and is dressed with modern storage solutions and furniture.	
Room No:	Room Name: Level 4 Toilets	
General	Modern bathroom fitout in the location of original bathrooms for the dormitory and convent use.

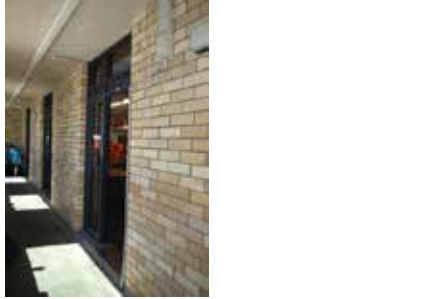
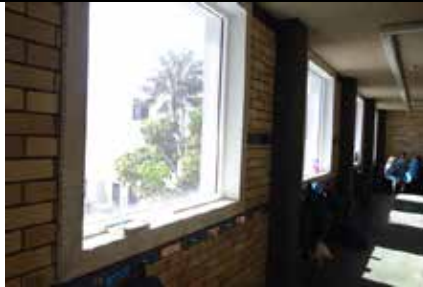
Room No:	Room Name: Level 4 Western Balcony	
General	Former external balcony to dormitory.

Structure	Equally spaced concrete encased steel columns along western elevation between window openings.	
Floor	Concrete floor.	
Walls	Orange face brick walls.	
Ceiling	Vermiculite ceiling.	
Doors	3 original aluminium door sets with glazed high and side lights and later 2-panel timber and glass doors and terrazzo threshold.

Windows	External façade has large openings with marble terrazzo surrounds, infilled with fixed aluminium windows. Aluminium window in southern bay of internal core.

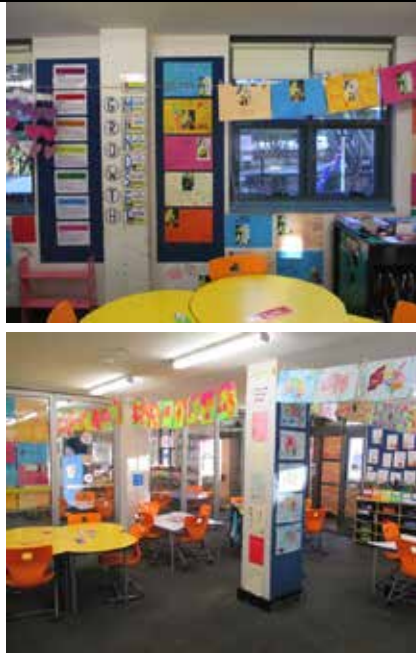
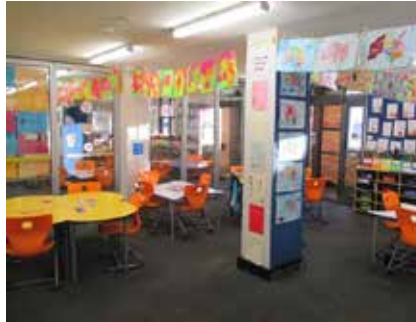
Building / Space: Junior School / Joigny – Barat Burn, Barat Burn East Wing (J1)		
Significance: High / Moderate		
Element	Description	Image
Room No: B4-1	Room Name: Level 4 Classroom	
Floor	Carpet over concrete slab. Formerly this space was used for dormitory and convent use and is noted to have had parquetry flooring, which may survive under the carpet.

Structure	Concrete encased steel columns through centre of space.	
Walls	Rendered masonry walls with ducted skirtings (original). Operable aluminium frame and glass panel partition with adjacent classroom (B4-2).	
Ceiling	Plasterboard ceiling with surface mounted fluorescent lighting.	
Doors	Two original aluminium door sets with side and highlights and timber and glass doors (west side).	
Windows	Later aluminium awning windows with timber sill within original openings to external walls (east side).

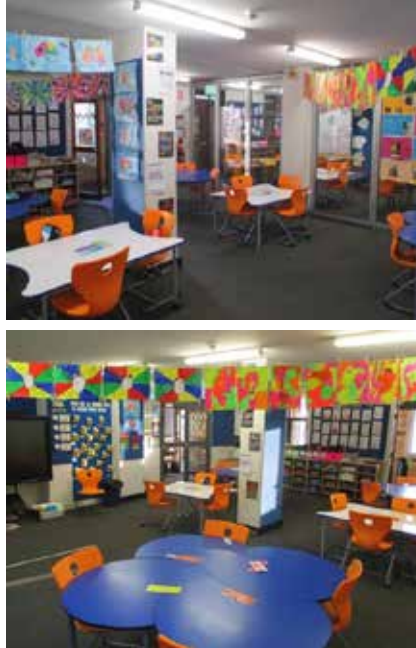
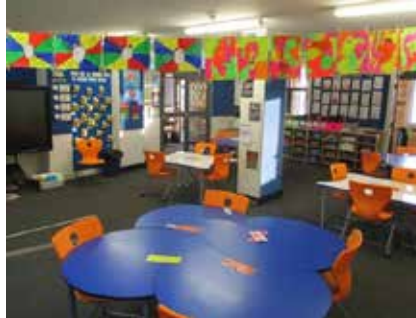
Furniture	Modern classroom fitout.	
Room No: B4-2	Room Name: Level 4 Classroom

Floor	Carpet over concrete slab. Formerly this space was used for dormitory and convent use and is noted to have had parquetry flooring, which may survive under the carpet.

Structure	Concrete encased steel columns through centre of space.	
Walls	Rendered masonry walls with ducted skirtings (original). Operable aluminium frame and glass panel partition with adjacent classroom (B4-1).	
Ceiling	Plasterboard ceiling with surface mounted fluorescent lighting.	
Doors	One original aluminium door set with side and highlights and timber and glass door, and one original 4-panel aluminium window (west side).	
Windows	Later aluminium awning windows with timber sill within original openings to external walls (east side). Original 2-panel timber and glass door to south east corner, accessing the eastern balcony.

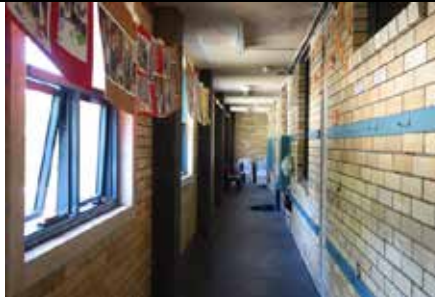
Building / Space: Junior School / Joigny – Barat Burn, Barat Burn East Wing (J1)		
Significance: High / Moderate		
Element	Description	Image
Room No:	Room Name: Level 4 Eastern Balcony	
General	Formerly external eastern balcony to dormitory.`

Structure	Equally spaced concrete encased steel columns along western elevation between window openings.	
Floor	Concrete floor.	
Walls	Orange face brick walls.	
Ceiling	Vermiculite ceiling.	
Doors	Doors are alumidised aluminium frame with 2-panel timber and glazed doors and terrazzo threshold. Window is aluminium sash. Original timber and glass door with highlight over accesses spaces B4-2 and B4-1 to the north.

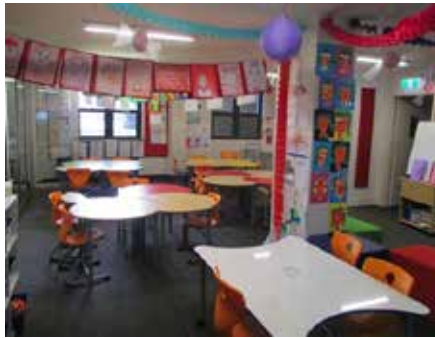
Structure	Concrete encased steel columns equally spaced north to south through space.	
Walls	<u>North</u> – Modern plasterboard wall with kitchenette / wet area in place of former bathroom and shower facilities. <u>East</u> – Rendered masonry wall to eastern balcony with one sash window and original alumidised aluminium door frame with side and high lights and 2-panel timber and glass door and terrazzo threshold. <u>South</u> – Classrooms as for B4-1 and B4-2.

Ceiling	Plasterboard ceiling with surface mounted fluorescent lighting.	
Doors	Flush timber door with vision panel to foyer adjacent main stair and rendered masonry wall to south of staircase. Operable aluminium frame glass partition between B4-3 and B4-4.

Windows	All four windows original alumidised aluminium frame sash windows with later flyscreens and original window hardware to all 4 windows on western elevation.	
Furniture	Modern classroom furniture throughout.

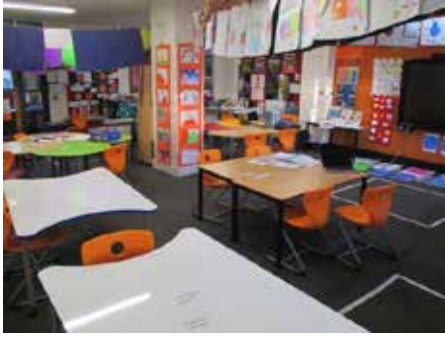
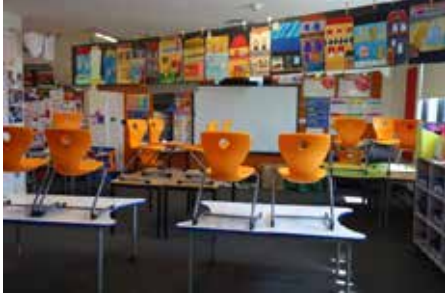
Building / Space: Junior School / Joigny – Barat Burn, Barat Burn East Wing (J1) Significance: High / Moderate		
Element	Description	Image
Room No: B4-4	Room Name: Level 4 Classroom	
General	All finishes as for B4-3 above.

Walls	<p>East – Rendered masonry wall with two original alumidised aluminium frame doors with side light and high light, 2-panel timber and glass door.</p> <p>South – Rendered masonry wall to south of building (external wall), no openings.</p> <p>West – As for B4-3 above, two original windows.</p>

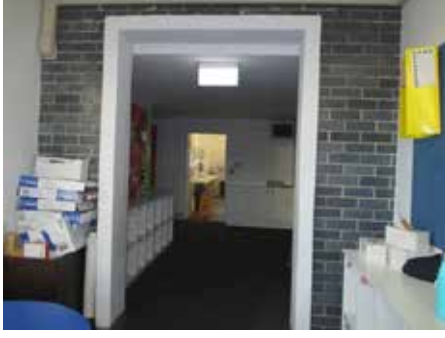
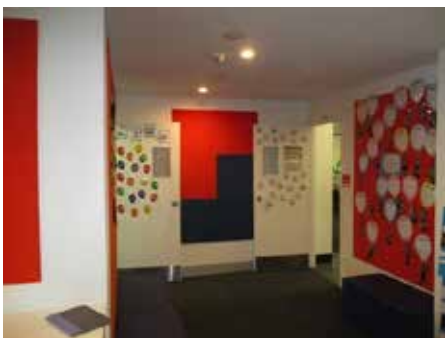
Level 5 in this table is Level 2 on architectural plans.		
Room No: B5-5	Room Name: Level 5 Foyer	
General	<p>The Level 5 foyer space (as seen from 2000s secondary circulation core) centrally connects all spaces on this level.</p> <p>Main stair and bathrooms to centre east and two classrooms to either north and south. Secondary circulation core to western façade on the exterior with altered window to accommodate new opening.</p> <p>Space has plasterboard ceiling and modern carpet throughout (formerly vinyl which may remain under).</p> <p>Secondary circulation core to west of building was constructed in 2000 and original ceramic glazed brickwork of the exterior of the building can be seen on the western façade.</p>

Walls	<p>North – Masonry wall with flush doors with vision panel to either side, giving access to B5-2 and B5-3.</p> <p>South – Plasterboard wall in changed configuration to originally constructed, modern light decorative scheme. Part of western elevation in this photograph shows window with view blocked by 2000s secondary circulation core.</p> <p>West – Rendered masonry wall (external wall) with new opening in location of former window to 2000s secondary circulation core.</p>

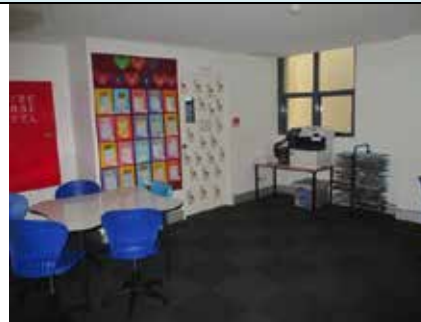
Building / Space: Junior School / Joigny – Barat Burn, Barat Burn East Wing (J1)		
Significance: High / Moderate		
Element	Description	Image
Other	Plasterboard encased distribution board cabinet located adjacent main stair.

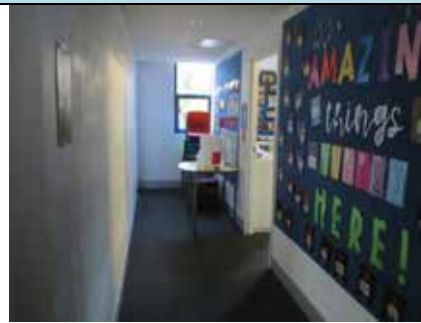
Furniture	Modern storage solutions and classroom furniture.	
Room No: B5-6	Room Name: Level 5 Hallway (Old Boarder Mistress Flat)	
General	Formerly part of the Old Boarder Mistress' Flat, now narrow corridor with masonry wall to main stair to north and new plasterboard wall to classrooms B5-1 and B5-4 to south. Original window halved by modern plasterboard wall.

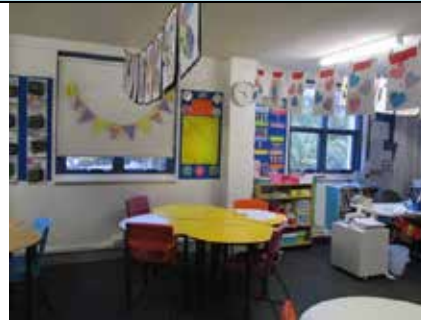
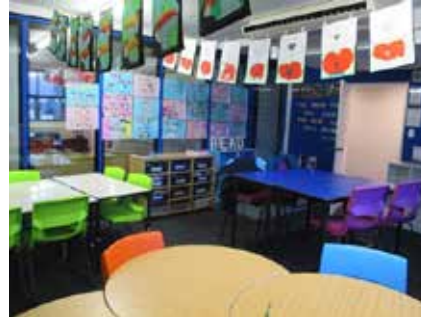
Room No: B5-7	Room Name: Level 5	
General	Modern bathroom fitout, masonry walls and plasterboard ceilings.	No image
Room No: B5-8	Room Name: Level 5 Toilets & Shower – J5-04	
General	Modern bathroom fitout, masonry walls and plasterboard ceilings. Tiles to floor and opaque film to original window.	No image
Room No: B5-1	Room Name: Level 5 Classroom – J5-01

Floor	Carpet throughout (original parquetry may remain under).

Walls	<u>North</u> – Modern plasterboard wall with flush door with vision panel. <u>East</u> – Masonry wall (external wall) with modern aluminium awning windows. <u>South</u> – Rendered masonry wall (external wall) with no openings. <u>West</u> – Operable aluminium and glass partition between bathrooms.	
Ceiling	Vermiculite ceiling and ducted skirting to all walls. Surface mounted fluorescent lighting throughout.

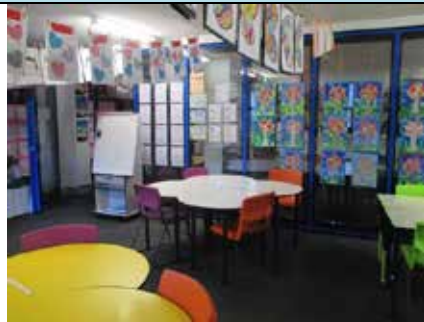
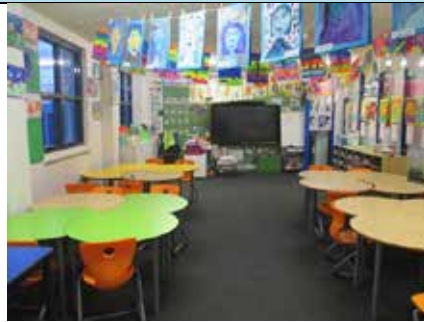
Building / Space: Junior School / Joigny – Barat Burn, Barat Burn East Wing (J1)		
Significance: High / Moderate		
Element	Description	Image
Room No: B5-4	Room Name: Level 5 Classroom – J5-02	
Floor	Carpet throughout (original parquetry may remain under).

Walls	<u>North</u> – As for B5-1, modern plasterboard wall with single flush door and vision panel. <u>East</u> – Operable aluminium and glass partition between concrete encased steel columns at centre of space. <u>South</u> – As for B5-1. <u>West</u> – Rendered masonry wall (external wall) with modern aluminium windows.	
Ceiling	Vermiculite ceiling and ducted skirting to all walls. Surface mounted fluorescent lighting throughout.	
Furniture & Finishes	Modern classroom furniture throughout. Modern light colour scheme.	
Room No: B5-2	Room Name: Level 5 Classroom – J5-05	
Floor	Carpet throughout (original parquetry may remain under).
