KINCOPPAL - ROSE BAY

SCHOOL OF THE SACRED HEART

CONSERVATION MANAGEMENT PLAN

Final Report - August 2020

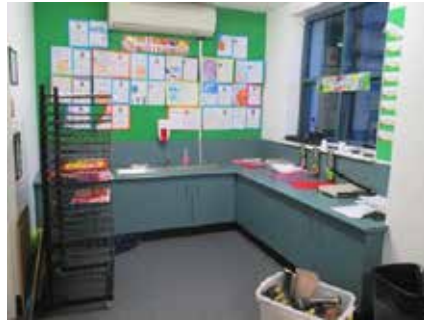
Walls	<u>North</u> – Masonry wall (external wall) with no openings. <u>East</u> – operable aluminium and glass partition between concrete encased steel columns at centre of space. <u>South</u> – Masonry wall with modern kitchenette / wet area fitout and vinyl flooring off main classroom area. Air-conditioning unit surface mounted on this elevation. <u>West</u> – Rendered masonry wall with modern aluminium windows and concrete encased steel columns between.

Ceiling	Vermiculite ceiling and ducted skirting to all walls. Surface mounted fluorescent lighting throughout.	
Furniture & Finishes	Modern classroom furniture throughout. Modern light colour scheme.

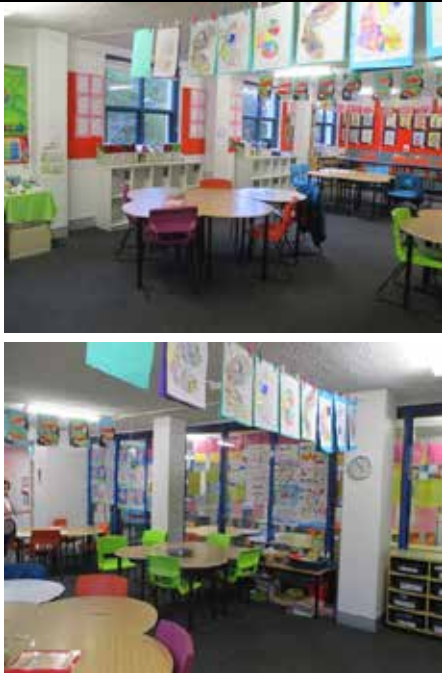
Building / Space: Junior School / Joigny – Barat Burn, Barat Burn East Wing (J1) Significance: High / Moderate		
Element	Description	Image
Room No: B5-3	Room Name: Level 5 Classroom – J5-06	
Floor	Carpet throughout (original parquetry may remain under).

Walls	<p>North – As for B5-2 (adjacent classroom).</p> <p>East – Rendered masonry wall with modern aluminium windows and concrete encased steel columns between.</p> <p>South – As for B5-2 (adjacent classroom), including wet area but in line configuration.</p> <p>West – Operable aluminium and glass partition between concrete encased steel columns at centre of space, dividing B5-2 and B5-3.</p>	
Ceiling	Vermiculite ceiling and ducted skirting to all walls. Surface mounted fluorescent lighting throughout.	
Furniture & Finishes	Modern classroom furniture throughout. Modern light colour scheme.	
Level 6 in this table is Level 3 on architectural plans.

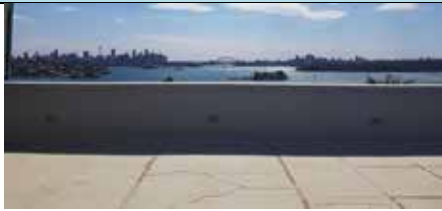
Room No:	Room Name: Level 6 – Roof Terrace External	
Floor and parapet wall	<p>Precast reinforced concrete parapet with exposed aggregate render to outside and cement render internally.</p> <p>Concrete floor on roof terrace.</p>

Walls	Light coloured face brick structure, set back from parapet wall, air-conditioning units placed along this elevation.

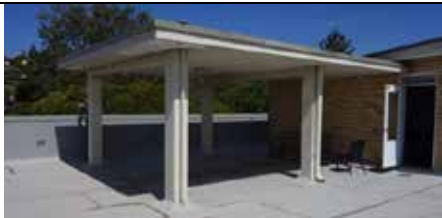
Flat Roof and structural columns	Reinforced concrete flat roof slab, supported on square posts, where cantilevered. Open to the roof terrace.

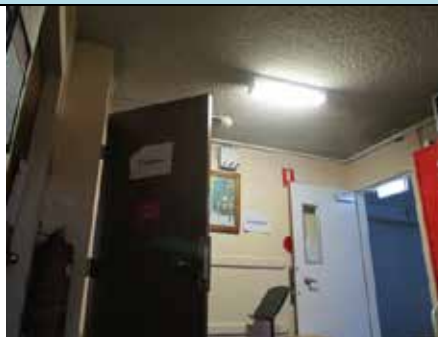
Building / Space: Junior School / Joigny – Barat Burn, Barat Burn East Wing (J1)		
Significance: High / Moderate		
Element	Description	Image
Room No:	Room Name: Level 6 – Hallway – Roof Level	
General	Level 6 hallway / foyer at the top of the main stair in central structure on roof terrace, providing access between former roof chapel (north) and bathroom / kitchen spaces (south).

Floor	Carpet over concrete floor.	
Walls	Rendered masonry walls.	
Ceiling	Vermiculite ceiling with surface mounted fluorescent lighting and services.	
Doors	Doors are flush with vision panel to chapel.	
Other	Small wall-mounted brass plaque on timber panel for former chapel located adjacent chapel door.	
Room No:	Room Name: Level 6 – Gap Accommodation / Chapel	
General	Floor: Modern carpet, original parquetry may remain under.

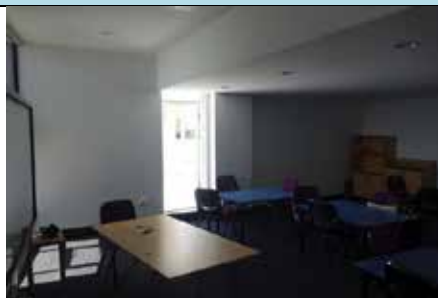
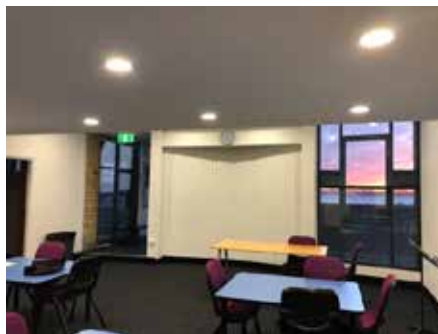
Walls	<p><u>North</u> – Rendered masonry wall (external wall) with later glazed door to roof terrace.</p> <p><u>East</u> – Rendered masonry wall (external wall) with original aluminium awning window with fixed window over and under.</p> <p><u>South</u> – Rendered masonry wall to main stair.</p> <p><u>West</u> – Timber boarded western elevation of former chapel with the wall positioned at a wide angle to meet in the centre. Marble terrazzo finish to exterior.</p>

Ceiling	Plasterboard ceiling with recessed lighting. Higher ceiling due to skillion roof against flat roof of the remaining brick structure.

Joinery	Original full height aluminium frame window with surrounding fixed panels to north of timber boarded wall. Original window hardware to all windows in this space.

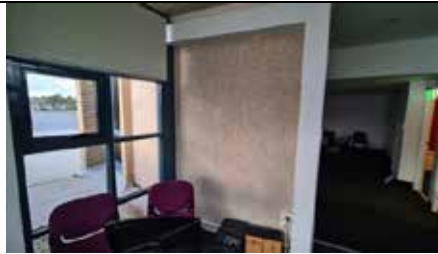
Other	<p>Later opening for 2000s secondary circulation core to south.</p> <p>Marble terrazzo finish to exterior of timber boarded wall as seen from external secondary circulation core. Northern half of marble chip terrazzo finish exposed on roof terrace.</p>

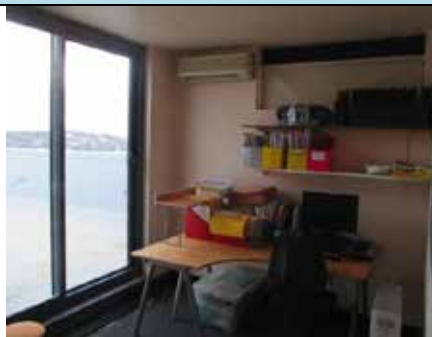
Building / Space: Junior School / Joigny – Barat Burn, Barat Burn East Wing (J1)		
Significance: High / Moderate		
Element	Description	Image
Room No: B6-2	Room Name: Level 6 – WC1 / Kitchen (now office)	
General	Former bathroom space for GAP accommodation, now office.

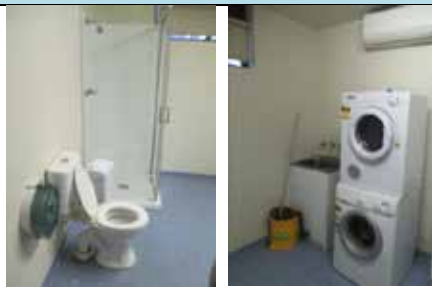
Floor	Carpet over concrete floor.	
Walls	Masonry walls to exterior and modern plasterboard wall to south.	
Ceiling	Concrete ceiling.	
Doors & Windows	Flush timber door to hallway. Original high level window and aluminium frame, glazed sliding door to southern roof terrace with terrazzo threshold.	
Services	Air-conditioning unit installed on western elevation.	
Room No: B6-1	Room Name: Level 6 – WC / Bathroom	
Floor	Rendered masonry walls to exterior.

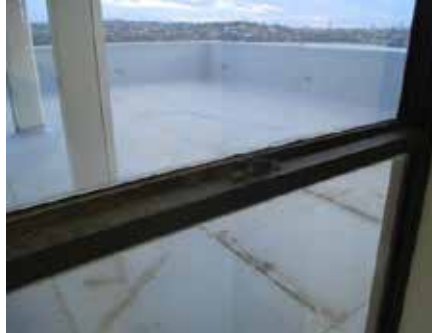
Walls	Vinyl floor.	
Ceiling	Concrete ceiling.

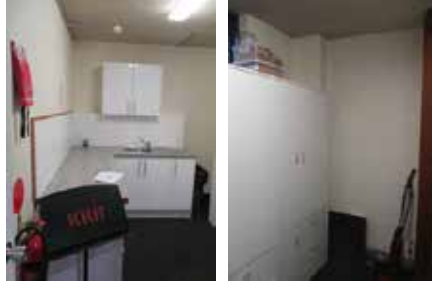
Furniture & Finishes	Modern bathroom and laundry fitout.	
Room No:	Room Name: Level 6 – Kitchen	
General	Carpet on floor.

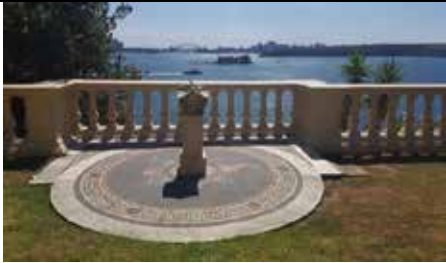
Boundary wall balustrade	c1929 Italianate style rendered fence above a sandstone rubble retaining wall to the adjacent property. Recent tensioned wire infill to balustrade

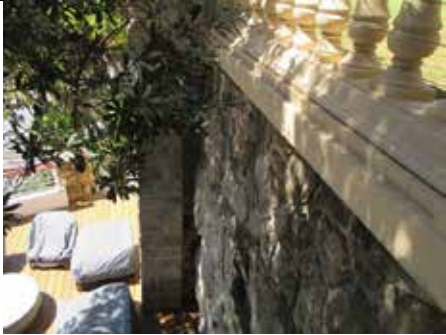
Sandstone retaining wall to Sundial Terrace	c1929 sandstone random rubble retaining wall to adjacent property, topped with rendered Italianate style balustrade.

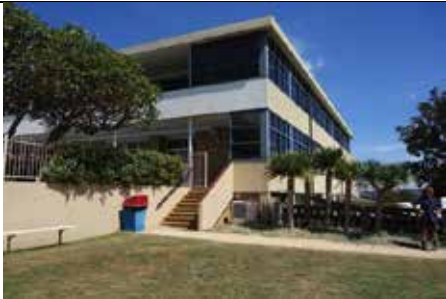
Paths and landscaping	Gravel path with timber edging and informal garden bed planted with low ground covering and five palms along southern side. Remainder of terrace is open lawn.

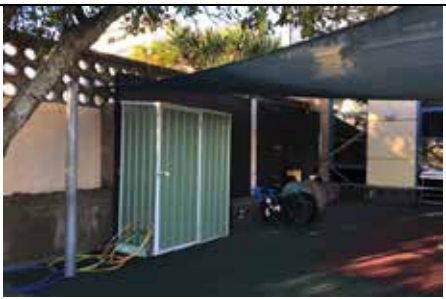
Concrete retaining wall, steps to upper terrace	Concrete steps on brick base from Sundial Lawn to Level 1 of Junior School West Wing Modern concrete retaining wall with modern metal fence to upper level Junior School Outdoor Play Area from Sundial Lawn.

Furniture	Modern benches placed along eastern side.	
Southern boundary	Concrete base retaining wall on sandstone bedrock, with concrete breezeblock and brick balustrade.

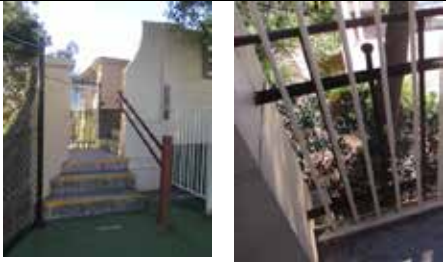
Steps to Sundial Lawn / Terrace, Fence Area 2 & Gate	Concrete steps with rendered balustrade from Sophie's Cottage Outdoor Play Area to Sundial Lawn with simple modern steel handrail. Remnant original/early iron fence panel of Melocco villa on western side of landing. Remnant of former Melocco Villa)

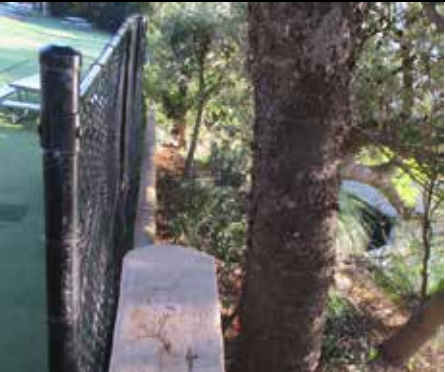
Building / Space: Landscape Area – Sundial Terrace / Sundial Lawn (L8)		
Significance: Moderate		
Element	Description	Image
Boundary wall to southwest of Sundial Terrace	Scalloped rendered masonry wall, remnant of former Melocco Villa, extending to the southwest.

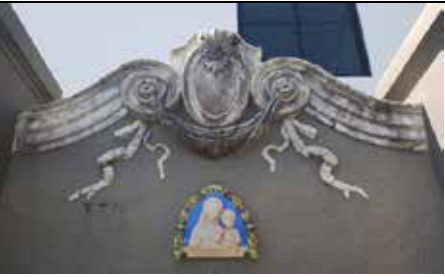
Boundary wall to northwest of Barat Burn	Remnant of former Melocco Villa boundary fence (c1929) to the northwest of Barat Burn.

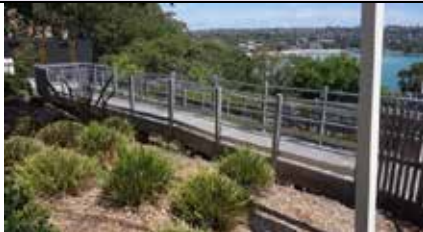
Building / Space: Junior School / Joigny – Barat Burn, Sophie's Cottage (J3) - Externally Significance: High / Low		
Element	Description	Image
Timber Access Ramp	Modern timber and steel access ramp with timber posts, security wire and timber slatted panels linking Sophie's Cottage with the Joigny Centre. Recently re-landscaped with low shrubs and mulched garden beds.

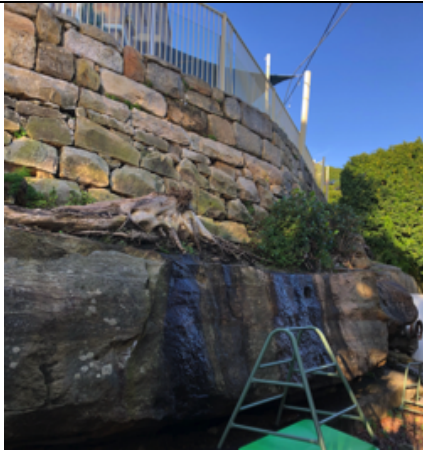
Sandstone retaining wall & stairs to Barat Burn	Random rubble sandstone retaining wall on cut bedrock with some worked and reused stones with picked finish. Modern aluminium fence with glass panels to Joigny level playground.

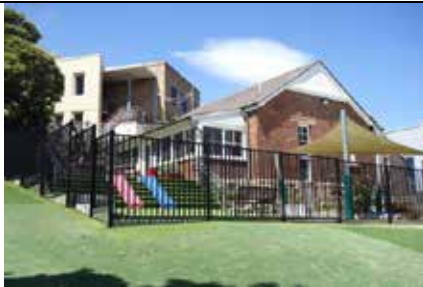
Junior School Outdoor Play Area 1	Junior School play area immediately surrounding Sophie's Cottage to the west with modern, with high aluminium fence. Ground has Astroturf applied throughout. Two sets of modern timber stairs from Sophie's cottage to surrounds. Modern canvas shade structure with steel posts.

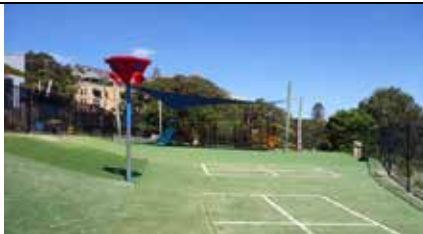
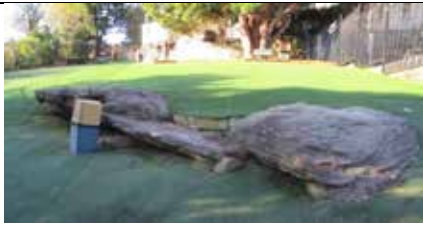
Junior School Outdoor Play Area 2	Large open play area stretching along the south-western elevation of Sophie's Cottage from the internal road to Sundial Terrace/Lawn at Barat Burn. Area is Astroturfed throughout and fenced with modern chain-wire mesh fence. Play area includes modern canvas shade structure with massive steel posts over modern play equipment. Exposed sandstone outcrop at centre.

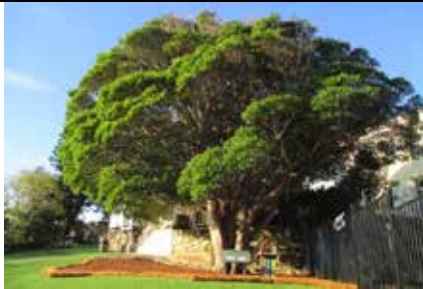
Landscape - Planting	Mature Lophostemon confertus (Moderate significance)

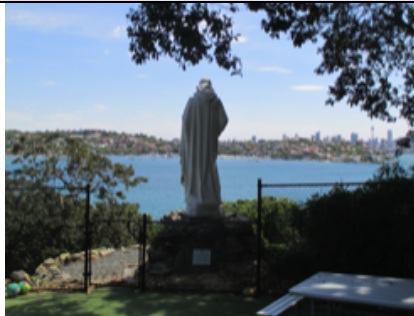
Building / Space: Junior School / Joigny – Barat Burn, Sophie's Cottage (J3) - Externally Significance: High / Low		
Element	Description	Image
Statue of the Sacred Heart and steep embankment (in vicinity)	1932 Statue of the Sacred Heart (High significance), located to the west of Play Area 2, formed in white marble on a rubble stone base, approximately 3 metres in height.

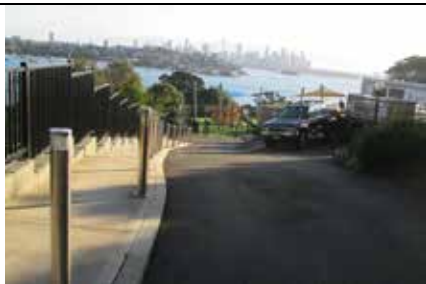
Internal Sealed Road	Recent sealed road and concrete footpath from the Junior School and Villa, extending past Sophie's Cottage and providing access to the modern Staff Accommodation. Modern steel bollards with integrated lighting.
