Fort Street Public School Conservation Management Plan

SSD 10340

Prepared by Curio Projects

Conservation Management Plan

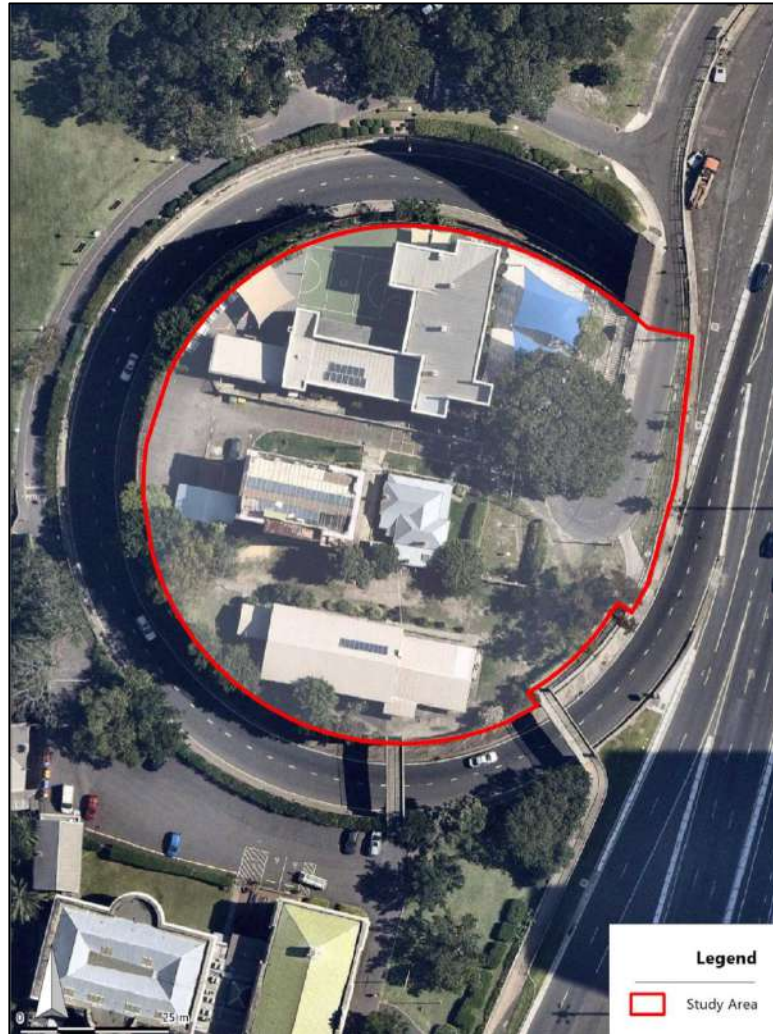
Figure 1.1: General FSPS Study area Location. (Source: Curio 2019)

The Fort Street Public School (FSPS) site (the study area) is located on Observatory Hill, at Upper Fort Street, Millers Point, and is generally defined by the circular cut of the Cahill Expressway on ramp (Figure 1.1). The study area is located to the south of the Sydney Observatory, between the Bradfield Highway in the east, and residential development along Kent Street to the west (Figure 1.1).

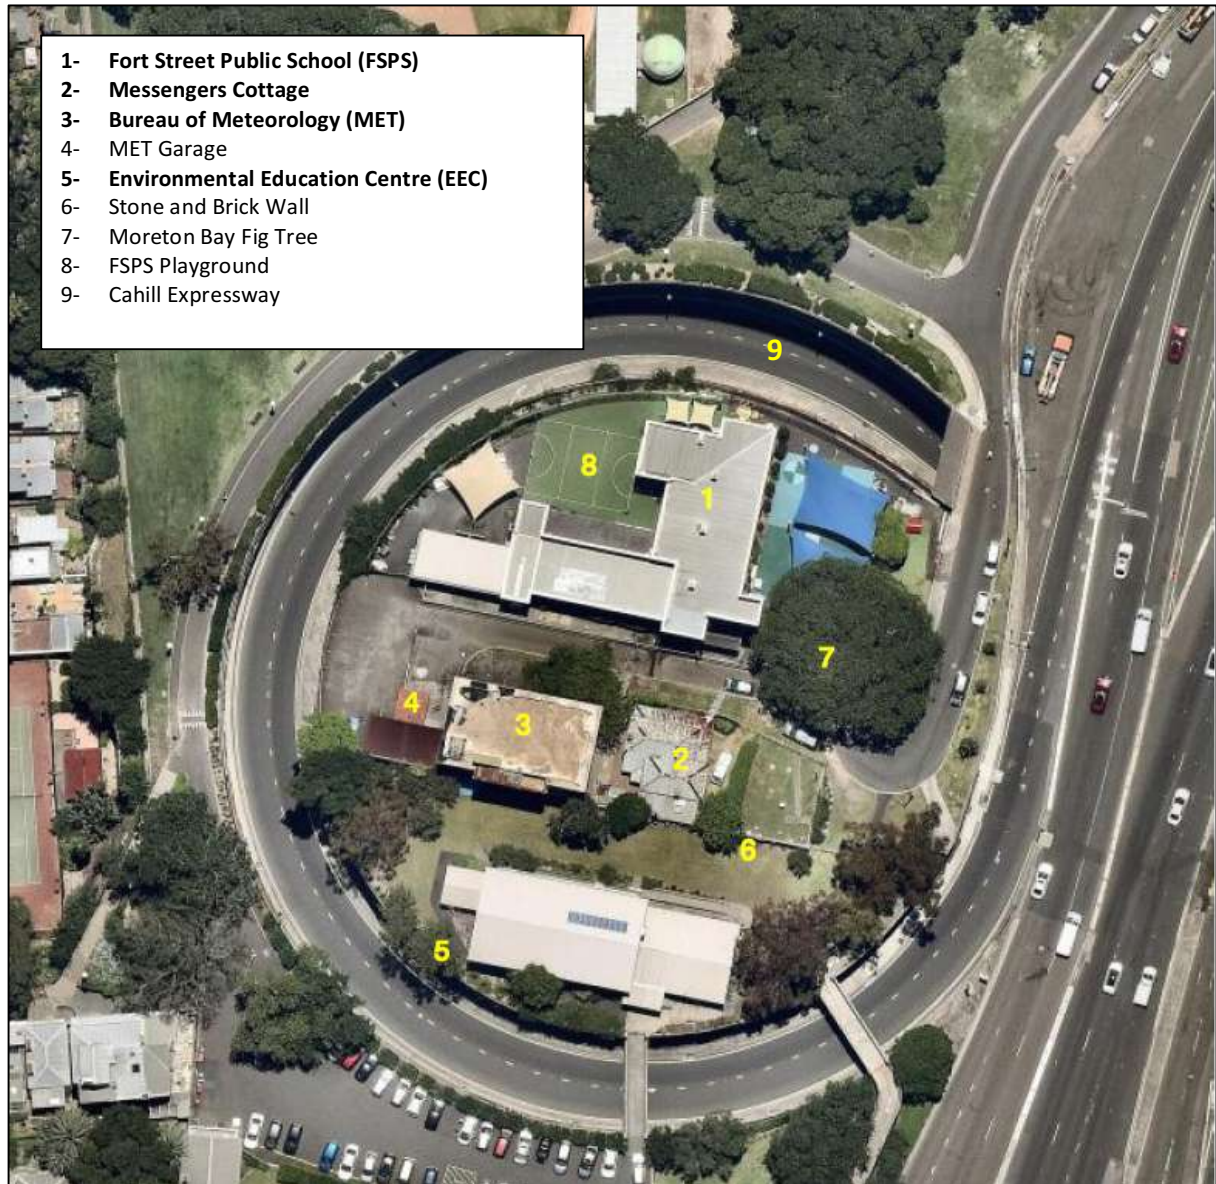
Figure 1.2: FSPS Site Plan (Source: TKD 2016, Fig. 36)

At the time of writing (March 2020), the FSPS site consisted of four main buildings (Figure 1.2): The Fort Street School; The Messengers Cottage; The Bureau of Meteorology building (MET Building), and the Environmental Educational Centre (EEC) building. Of these four structures, only the EEC building is not heritage listed.

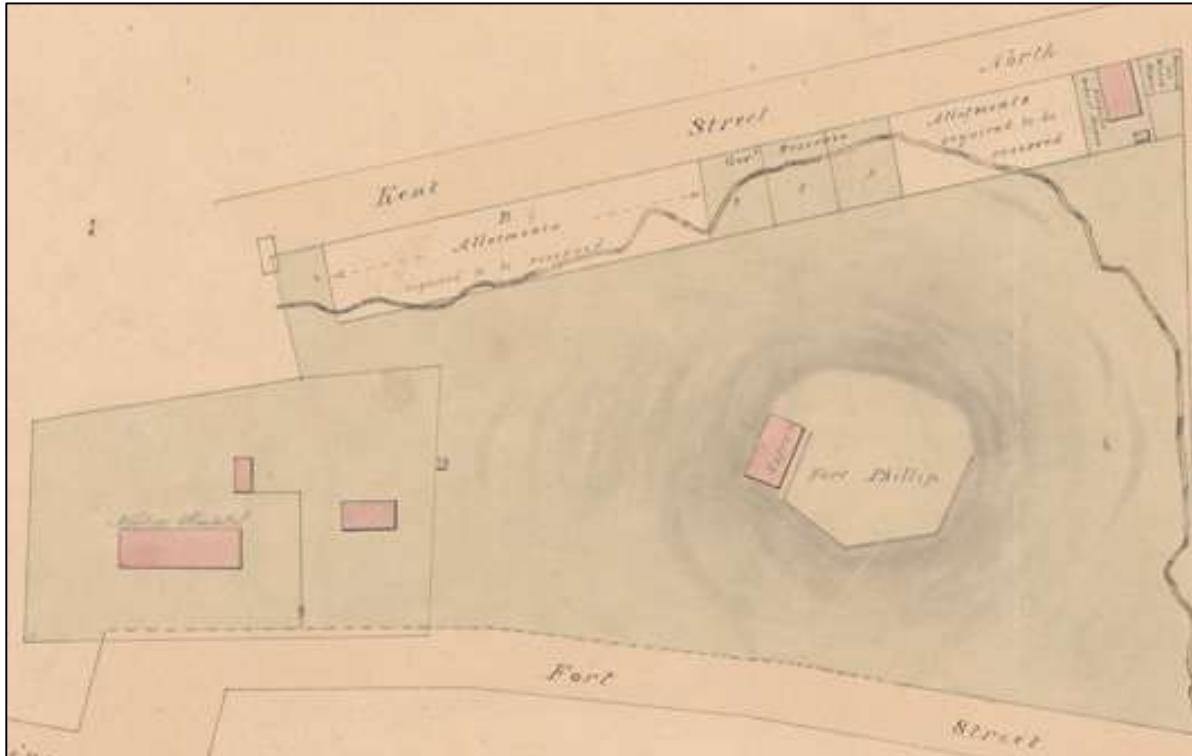
Figure 2.7: 1836 Plan of Military Hospital. Main hospital and two outbuildings surrounded by perimeter fence or wall. Detail of perimeter/boundary is not specified and north boundary appears to be slightly splayed (Source: NSW State Archives and Records, Digital ID: NRS13886[X755]_a110_000118)

There remains some uncertainty through the historical records as to when the boundary wall was first constructed (and hence what date the extant wall within the site dates to). A plan of the compound in 1836 shows the main hospital and its two main out-buildings, all of which appear to be surrounded by a perimeter fence or wall- however, the drawing does not detail the wall, and the depiction of the northern boundary appears to be slightly splayed (Figure 2.7). An annotated drawing from the Surveyors Sketch Books dated 1854 notes that the northern boundary was fenced, the remainder of the site (including the extension to Princes Street) being walled. A 1856 plan of the site depicts the boundary line as a single faint line not double as stone wall as for other clearly depicted walls in the plan. A 1864 photograph of the site appears to depict the boundary as a wall, indicating that the boundary was constructed first as a wall sometime in the early 1860s.

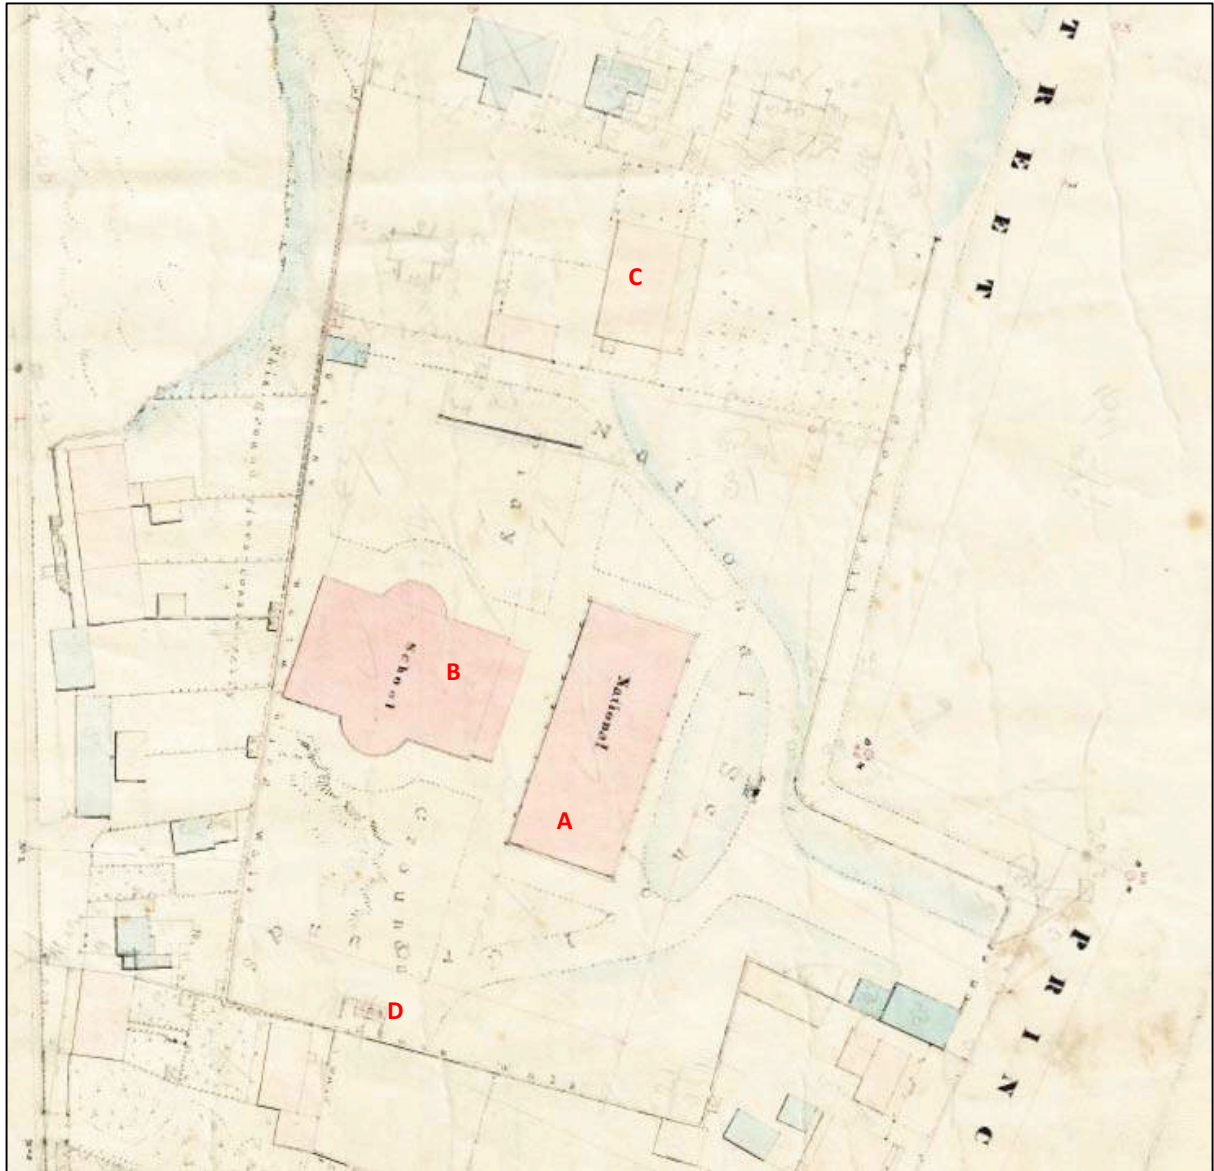
Figure 2.10: Portion of a survey prepared by H Chauncy and dated 7 October 7 1856 showing development across the National School site, which included the modified Military Hospital (A), Henry Robertson's recently completed classroom block (B), the former doctor's residence (C) and privies (D). (Source: Historical Atlas of Sydney - City Detail Sheets, 1855 – Sheet_01.)

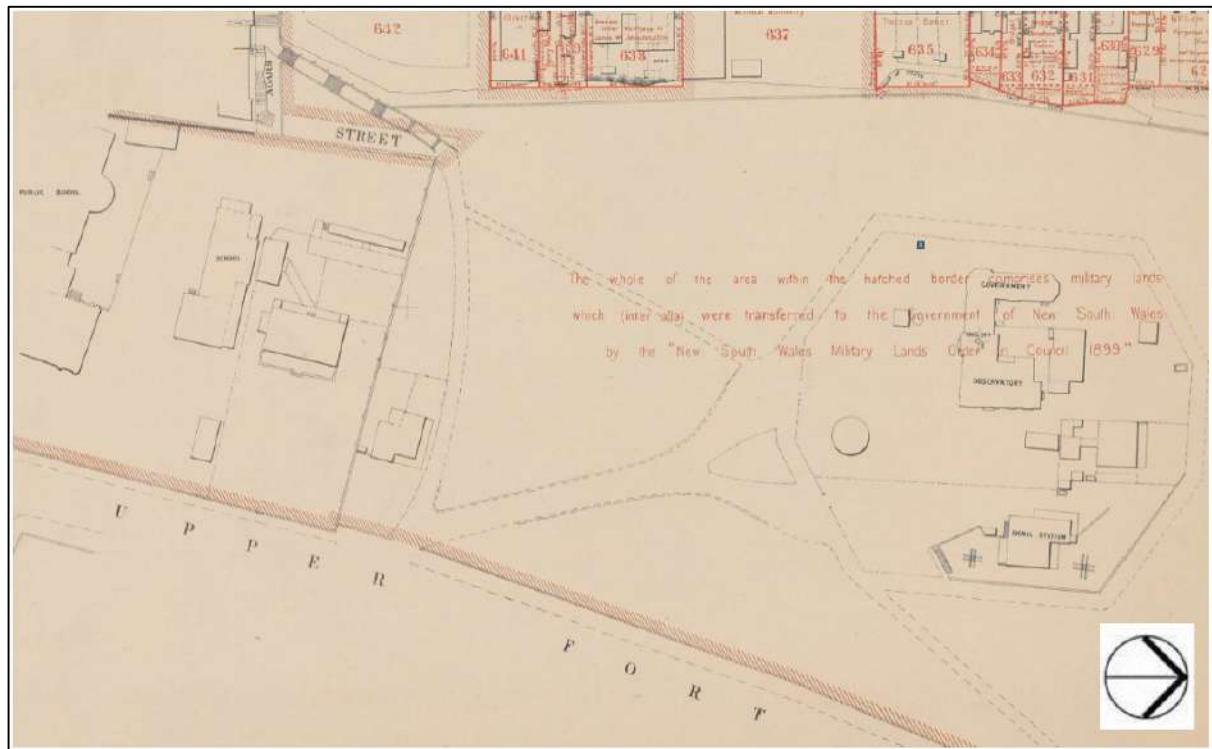
Figure 2.14: Layout of the northern section of the School and its relationship with Sydney Observatory and parklands in 1900. The wide hatched border shows the extent of military lands transferred to the Government of NSW in 1899. (Source: Historical Atlas of Sydney – The Rocks and Foreshore Resumptions, Plan S.)

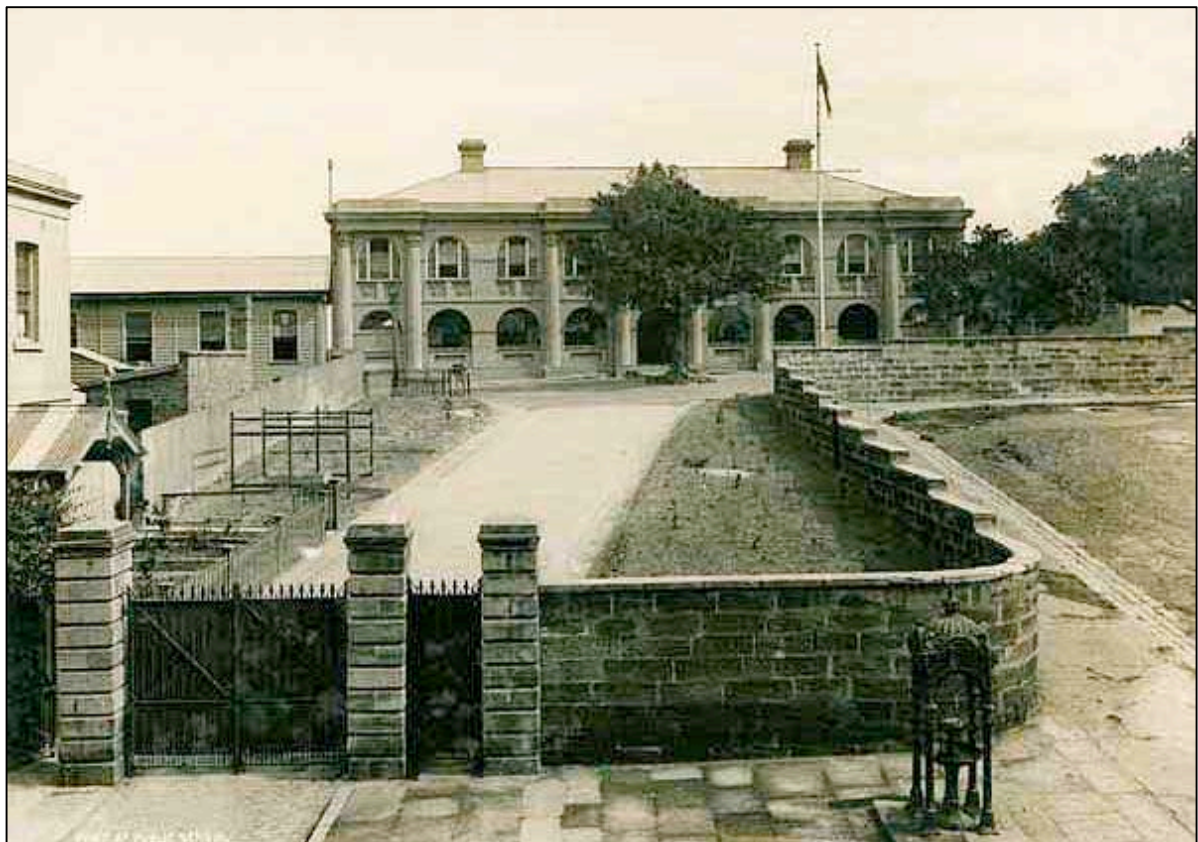
Figure 2.16: View of Fort Street School, circa 1900, showing the gates on Princes Street and the wall extending along Essex Street and Upper Fort Street. (Source: State Records digital ID 4481_a026_000240.jpg)

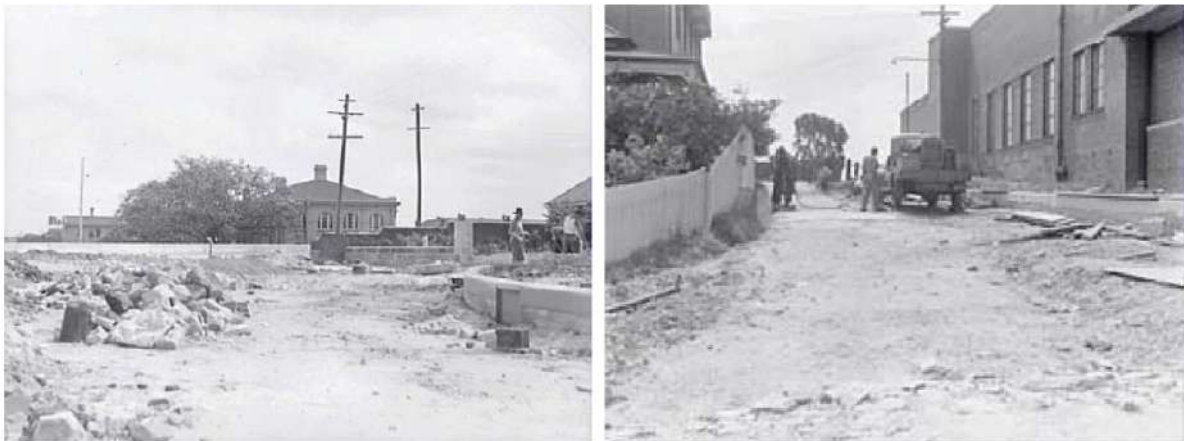
Figure 2.26: Photographs taken in 1941 showing construction of roadworks and fencing in the vicinity of the Public School. (Source: City of Sydney Archives SRC13421 and SRC13420.)

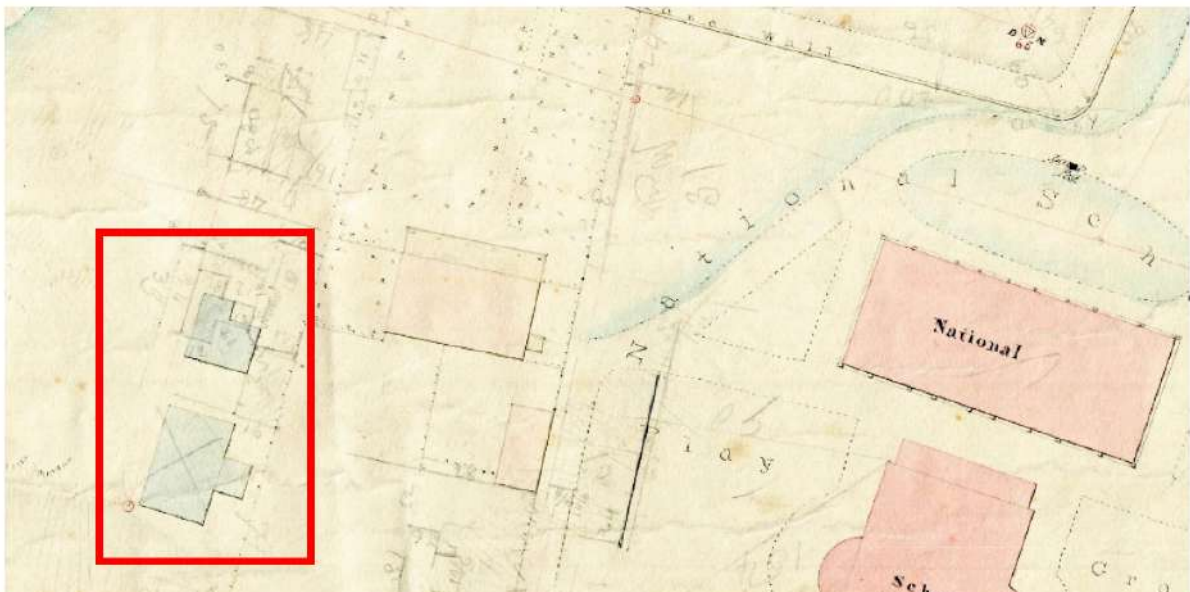
Figure 2.38: Cottages on the site of the Bureau of Meteorology Building, depicted on a circa 1855 survey of Observatory Hill. The footprint of the Messenger's Cottage roughed in above the cottages. (Source: TKD 2016: Fig 35).

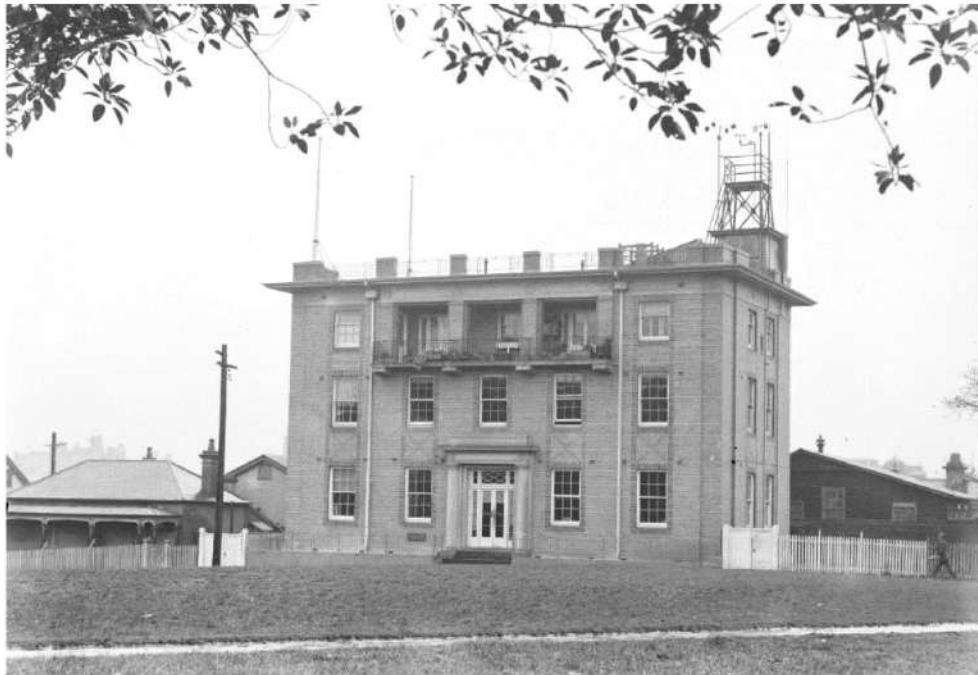
Figure 2.39: Bureau of Meteorology, photographed circa 1932. The recessed balcony of the residential apartment appears to have also served as a drying area. The building directly addressed Observatory Hill Park. (Source: TKD 2016: Fig 36).

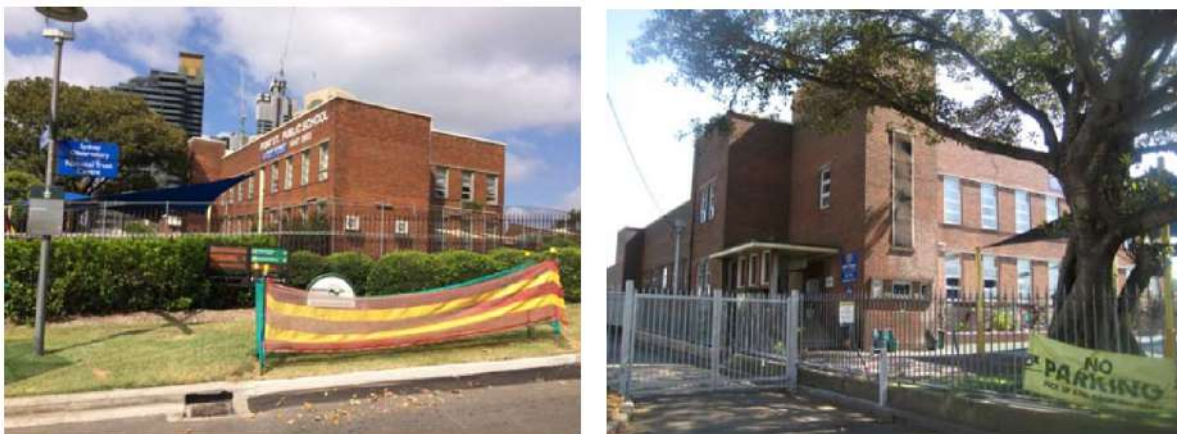
Figure 3.2: Fort Street Public School viewed from the north east (left) and from the south east (right). The main entry to the building is located at the base of the tower, which contains the main stair, and can be distinguished by its projecting roof slab. (Source: TKD 2016: Fig 45)

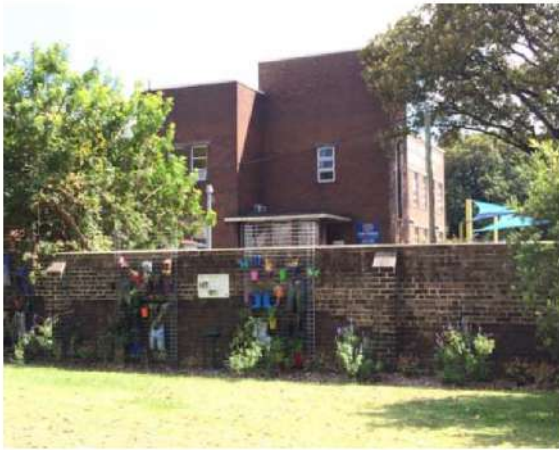
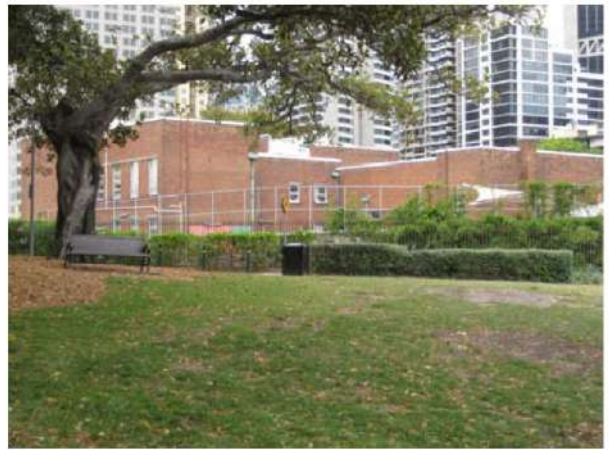
Figure 3.3: The tower at the eastern end of Fort Street Public School viewed from the grounds of the EEC, which occupies the gymnasium that was built in the early 1950s (left); the School viewed from the west on Observatory Hill (right). (Source: TKD 2016: Fig 46)

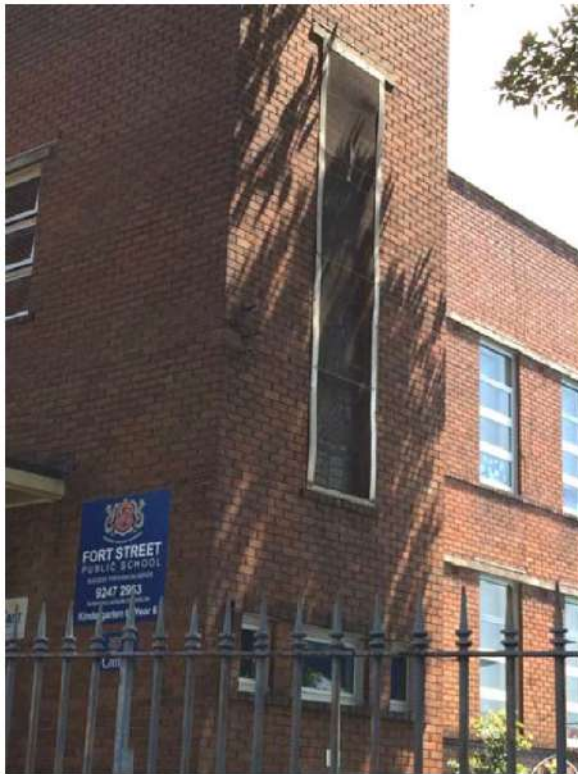
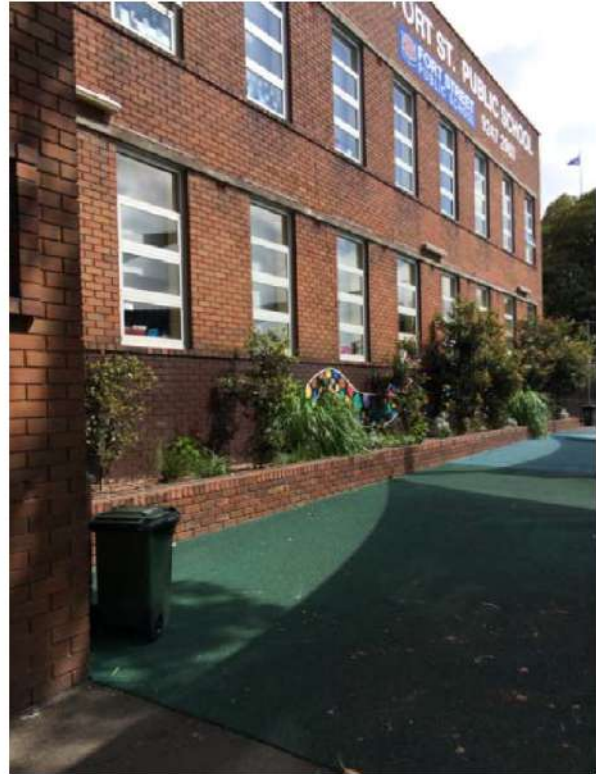
Figure 3.4: Mesh has been placed over the slender window opening to the stair to protect the stained glass window installation (left); the original brick planter at the base of the building's east elevation is still in place (right). (Source: TKD 2016: Fig 47)

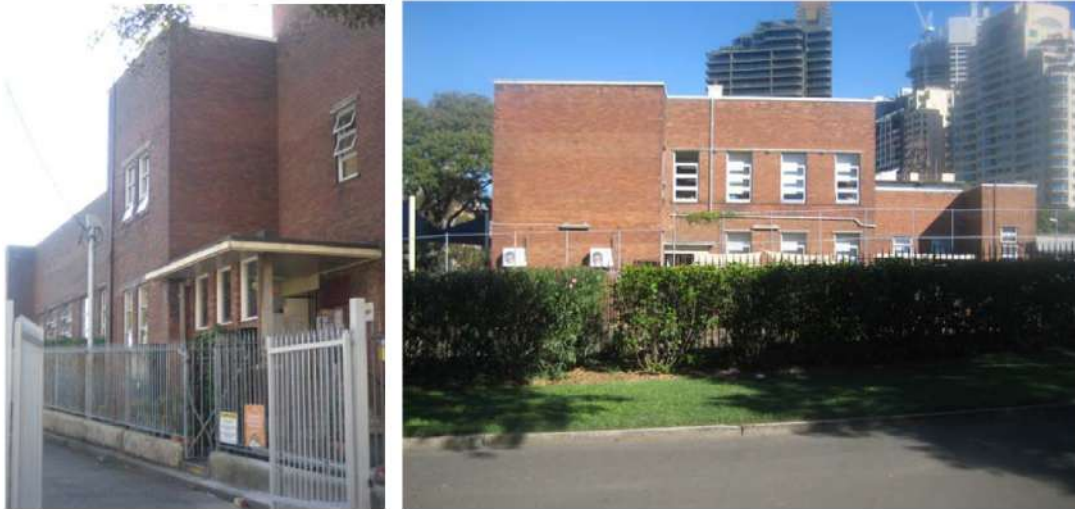
Figure 3.5: Porch at the main entry to the Public School (left); north elevation of the Public School viewed from Observatory Park (right). (Source: TKD 2016: Fig 48)

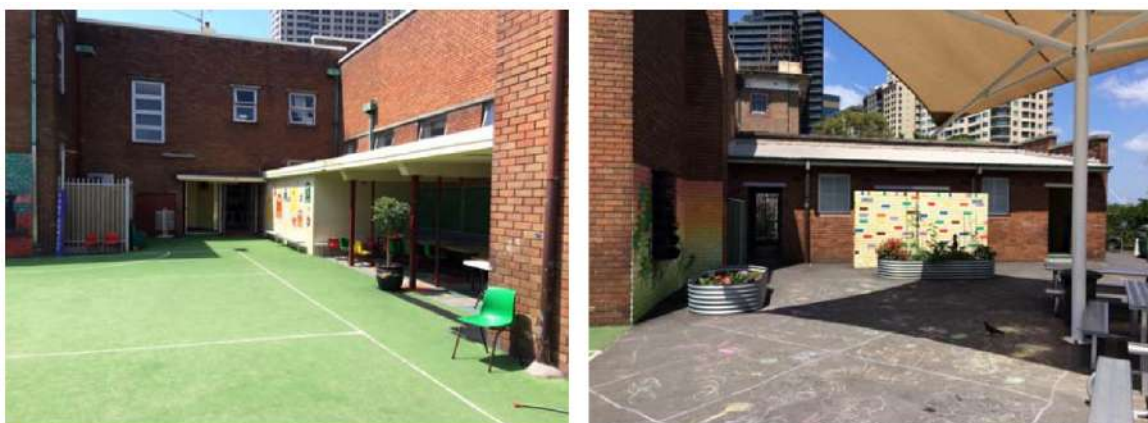
Figure 3.7: A wide reinforced concrete canopy, which is part of the original building structure and was intended as the children's weather shelter, extends along the northern side of the assembly hall. A store room has been constructed under part of it, and is highlighted by its brightly coloured painted finish (left). A similar paint scheme has been applied to part of the exterior of the children's toilet block (right) (Source: TKD 2016: Fig 50)

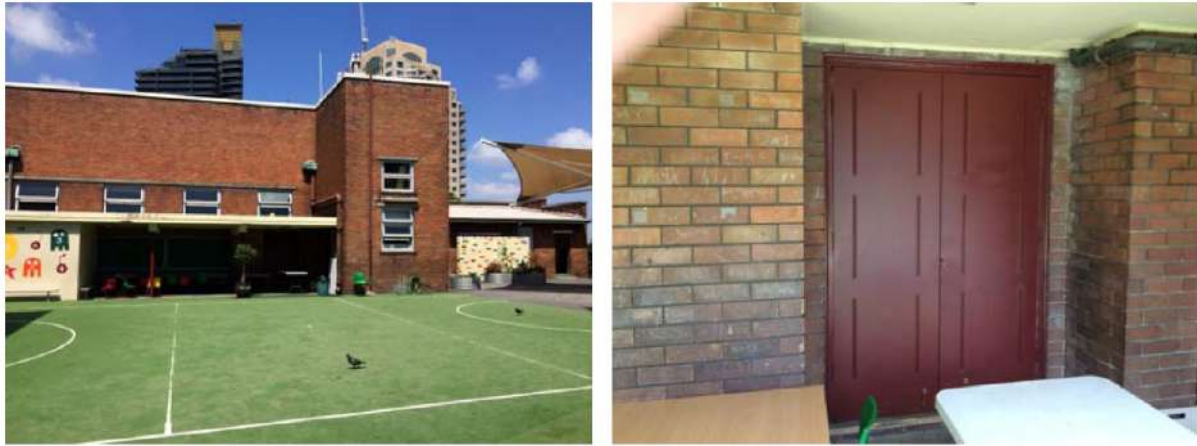
Figure 3.8: Northern side of the wing containing the assembly hall. The stage is contained in the projecting section at its western end, beyond which can be seen the low structure containing the children's toilets (left). These original doors (right) are located at the western end of the hall near the stage. (Source: TKD 2016: Fig 51)

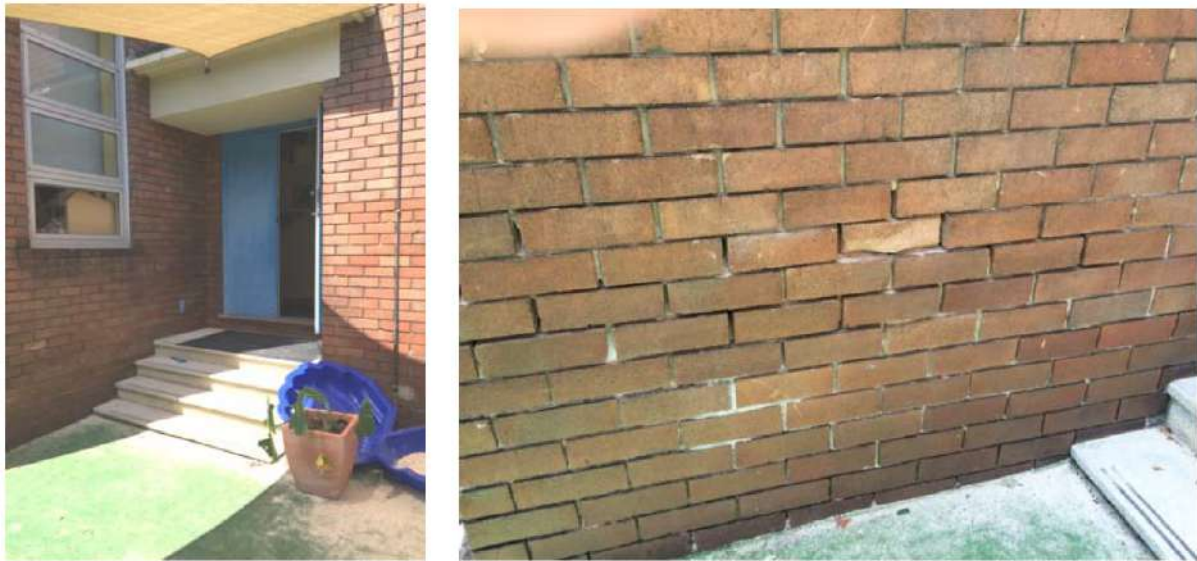
Figure 3.10: Doorway and porch at the northern end of the corridor in the classroom wing (left). Brickwork joints are deteriorating and a number of bricks are fretting in the northern section of the building (right). (Source: TKD 2016: Fig 53)

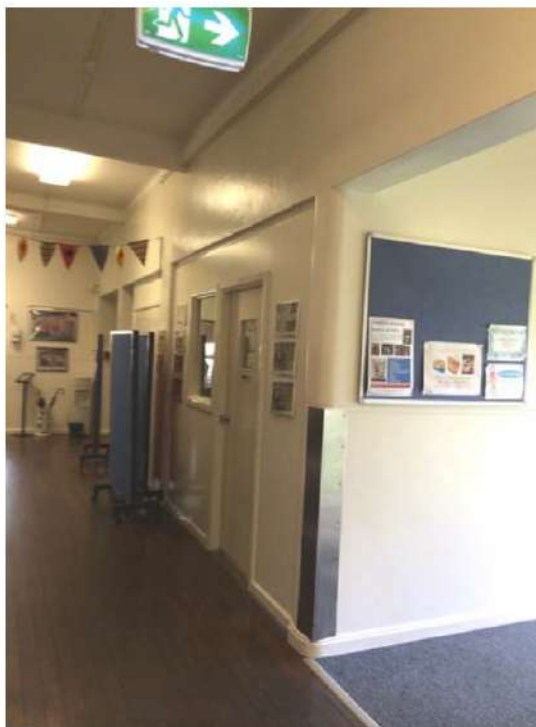
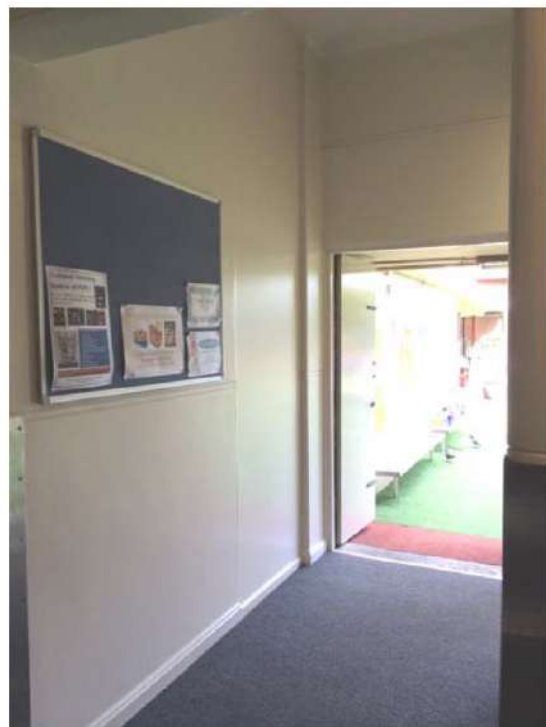
Figure 3.12: Ground floor corridor looking towards the hall. The section of wall containing the small window and door has infilled an opening that served the ground floor hat room (left); short passage from the corridor to the playground (right). (Source TKD 2016: Fig 55).

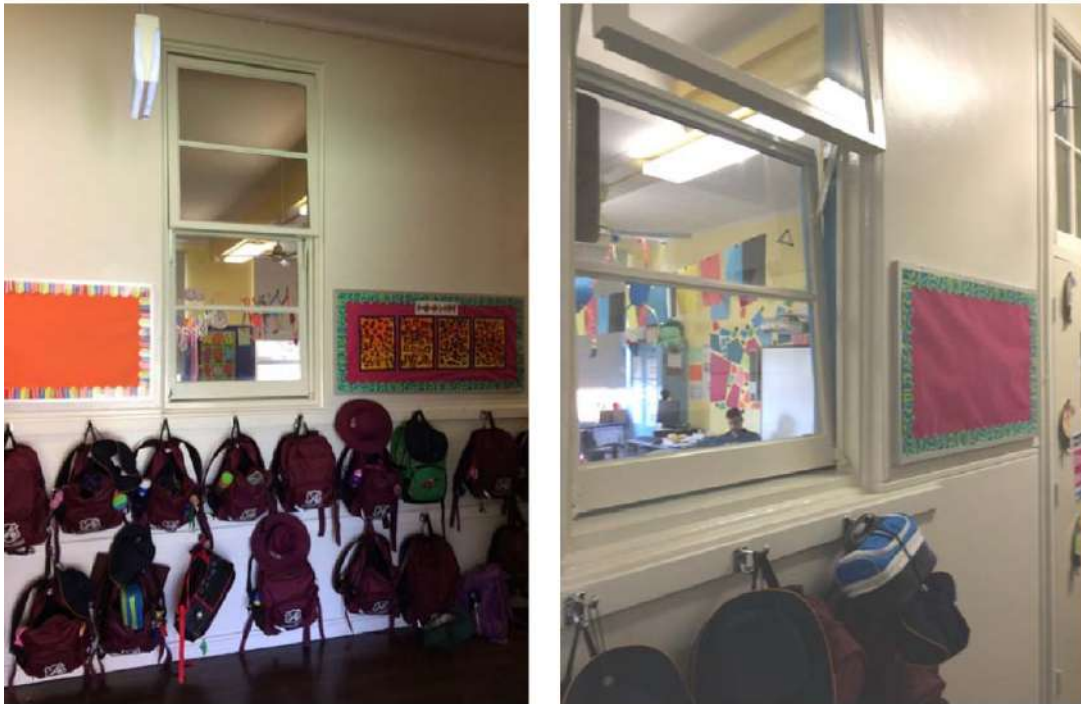
Figure 3.13: Eastern wall of the ground floor corridor, which is punctuated by what appear to be original windows providing light and air to classrooms (left); details of window joinery (right). (Source TKD 2016: Fig 56).

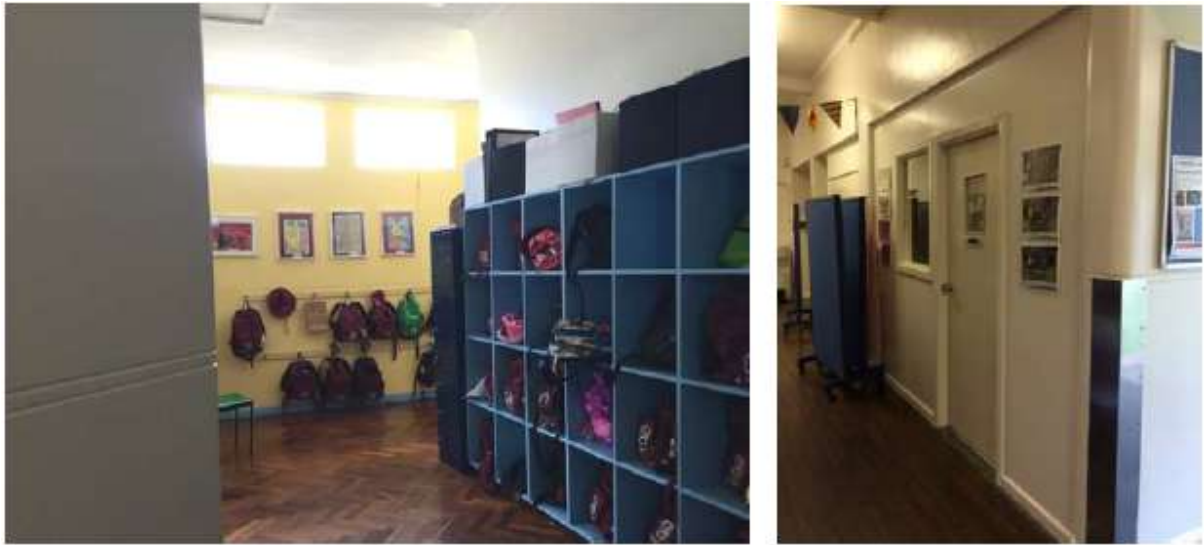
Figure 3.18: Receptacles and hanging space for the use of children in the first floor hall (left); modifications to the first floor hat room and store (right). (Source: TKD 2016: Fig 61)

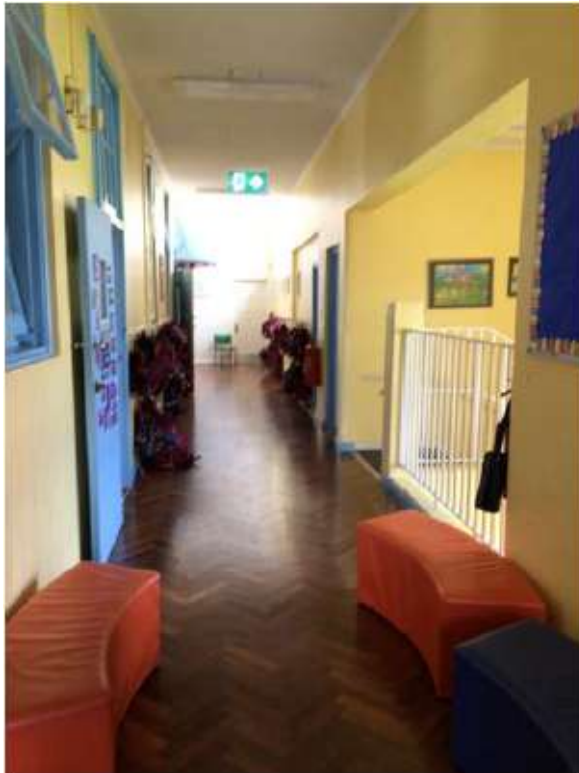
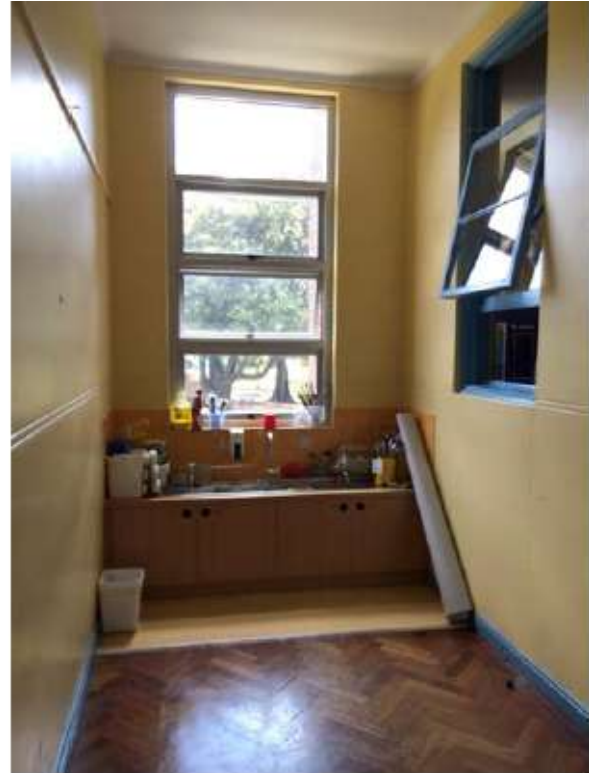
Figure 3.20: The corridor on the first floor has parquet flooring and opens into the secondary stair (left). A sink and cupboard has been installed at its northern end. (right). Comparison with original plans indicates that this has replaced an earlier joinery unit (Source: TKD 2016: Fig 63)

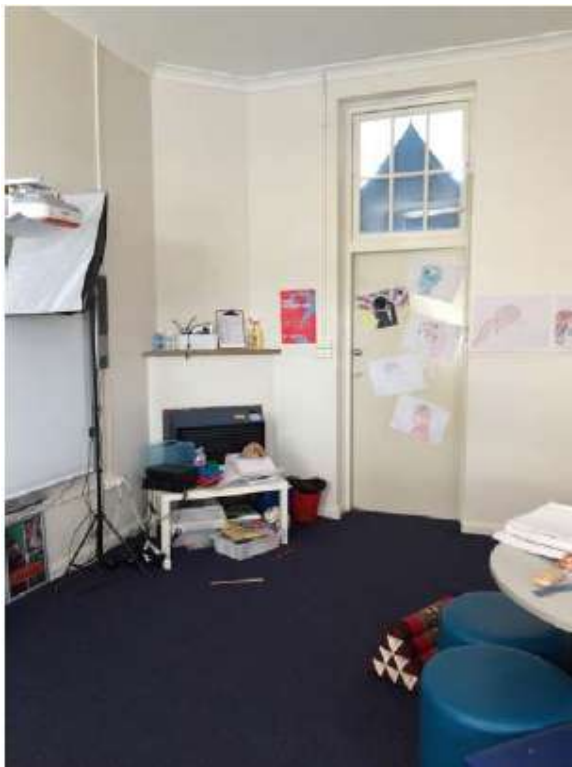
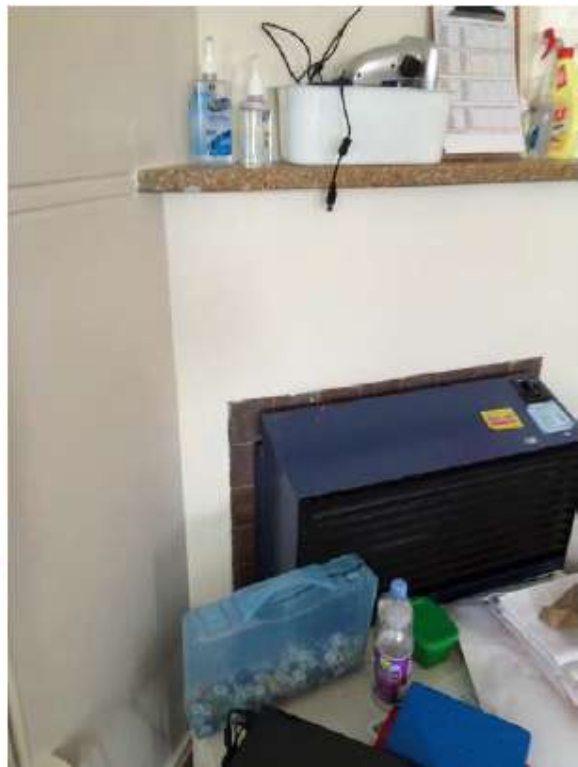
Figure 3.21: Fireplaces in classrooms on the eastern side of corridors are located in corners near doors. The fireplaces have terrazzo mantels and tiled firebox surrounds. Heaters have been installed in each of them. (Source: TKD 2016: Fig 64)

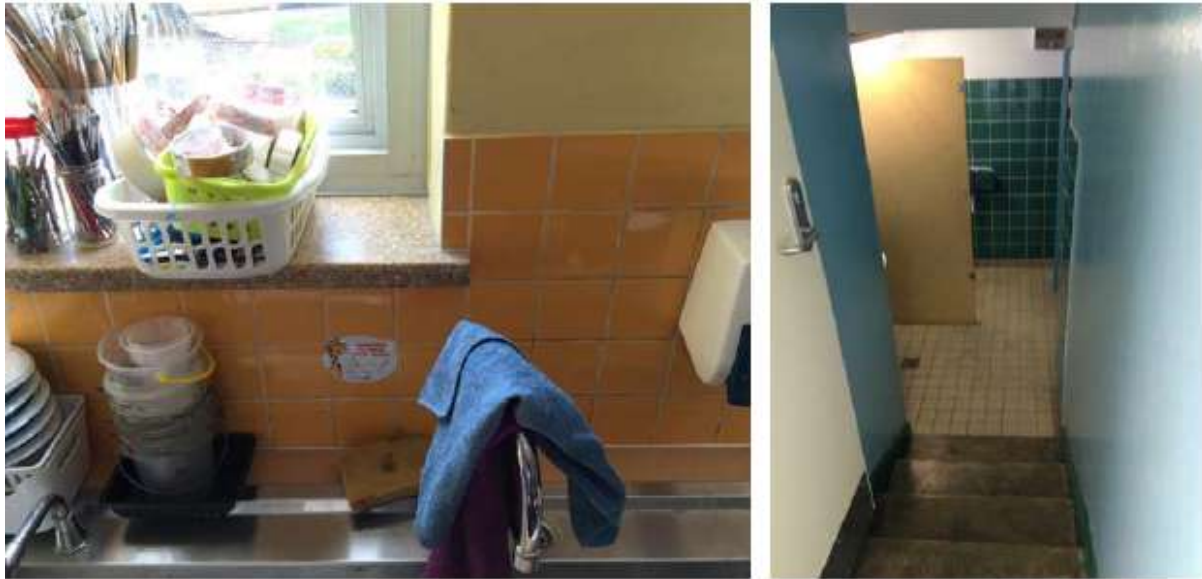
Figure 3.22: Windows in the external walls of classrooms have terrazzo sills (left); a store room in a small basement below the secondary stair has been adapted for use as a lavatory (right). (Source: TKD 2016: Fig 65)

A small basement store on the western side of the eastern wing has been modified to provide lavatory accommodation.

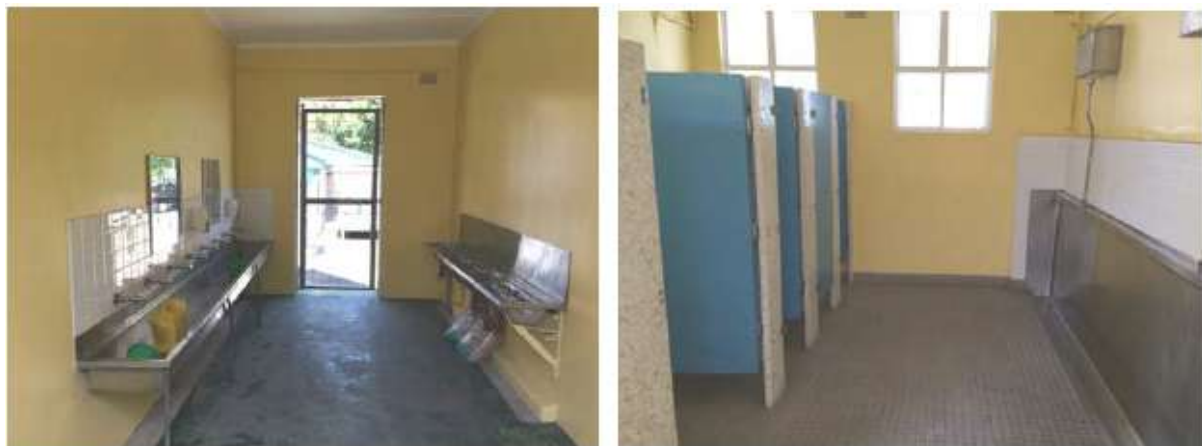
Figure 3.23: The girls' and boys' toilets consist of separate, unconnected rooms containing stainless steel troughs and lavatory fixtures. These photographs show the boy's toilet. Apart from the urinal, both are identical but have distinguishing paint schemes. Stainless steel fittings and ceramic wall tiles are not original. (Source: TKD 2016: Fig 66)

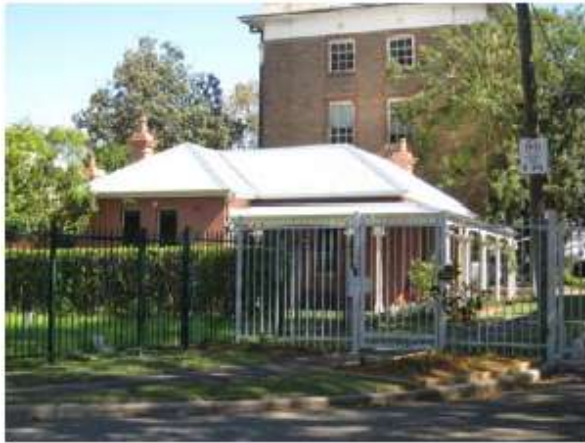
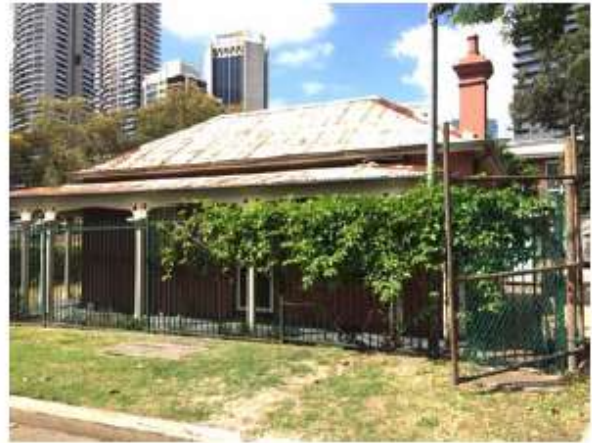
Figure 3.24: The Messenger's Cottage viewed from the east (left) and the north (right). The photograph at left was taken in February 2016, prior to the replacement of the roof covering. Security fencing and gates across Upper Fort Street were installed during the second half of 2016. (Source: TKD 2016: Fig 69)

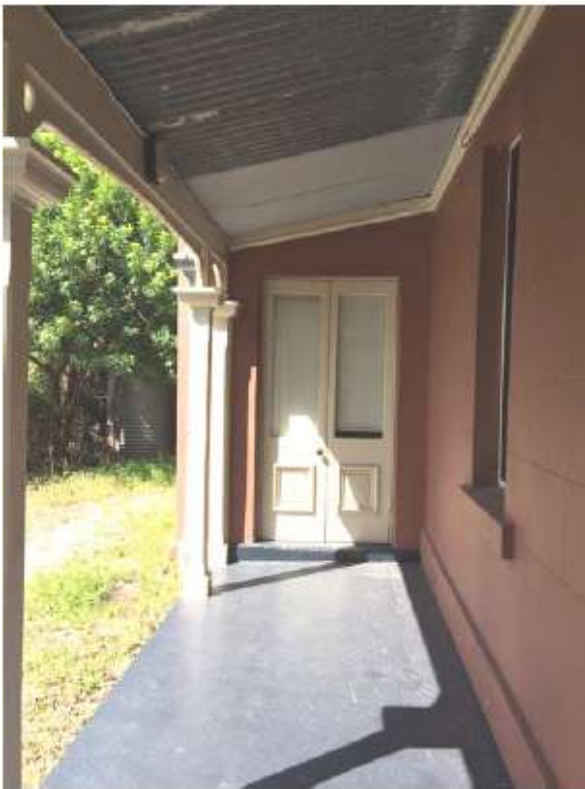
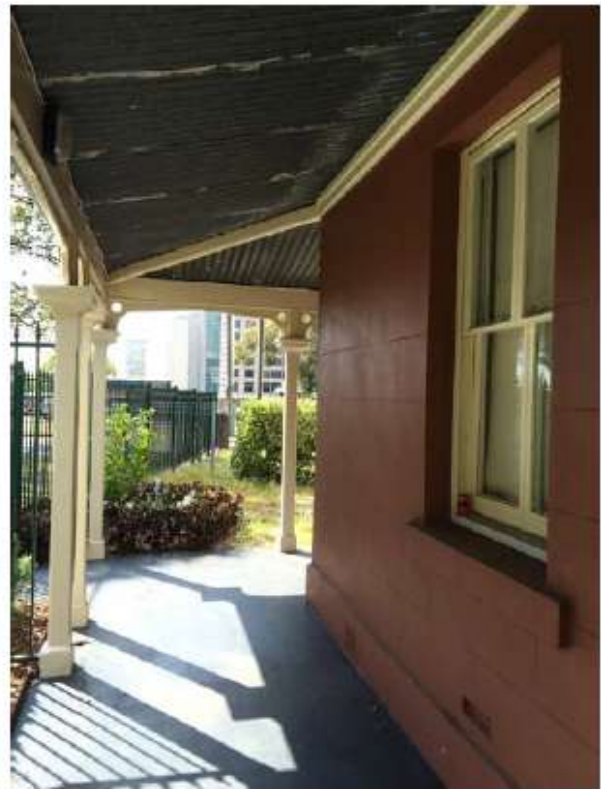
Figure 3.25: Eastern section of the Messenger's Cottage verandah – the French doors are not original but only date to the time that the building was taken over by the National Trust (left); looking east along the northern section of the verandah (right). The inscribed lines in the surface of the cement render imitating ashlar coursing can be seen.

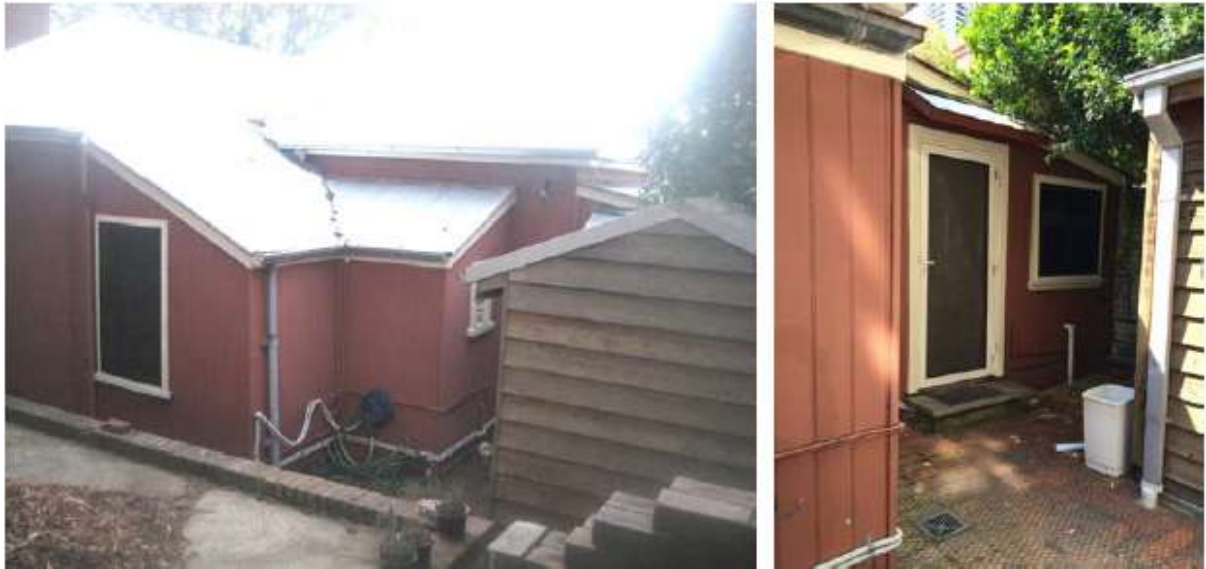
Figure 3.26: Skillion roofed timber weatherboard structures enclosing the bathroom and w.c. at the rear of the Cottage (left); western wall of the skillion roofed section containing the kitchen and Room 4 at the rear of the Cottage (right). The small shed can be seen in both photographs. (Source: TKD 2016: Fig 71)

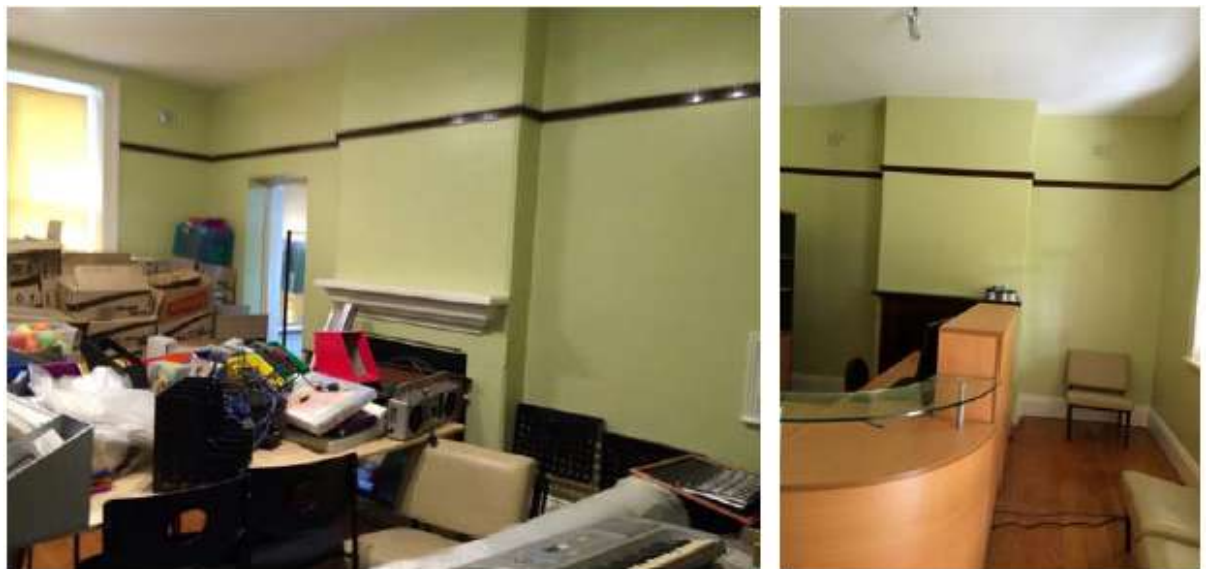
Figure 3.27: Looking to the south east across Room 3, originally added to the Cottage in the 1870s (left); fireplace and chimney breast in Room 1 (right). (Source: TKD 2016: Fig 72)
