Fort Street Public School Conservation Management Plan

SSD 10340

Prepared by Curio Projects

Conservation Management Plan

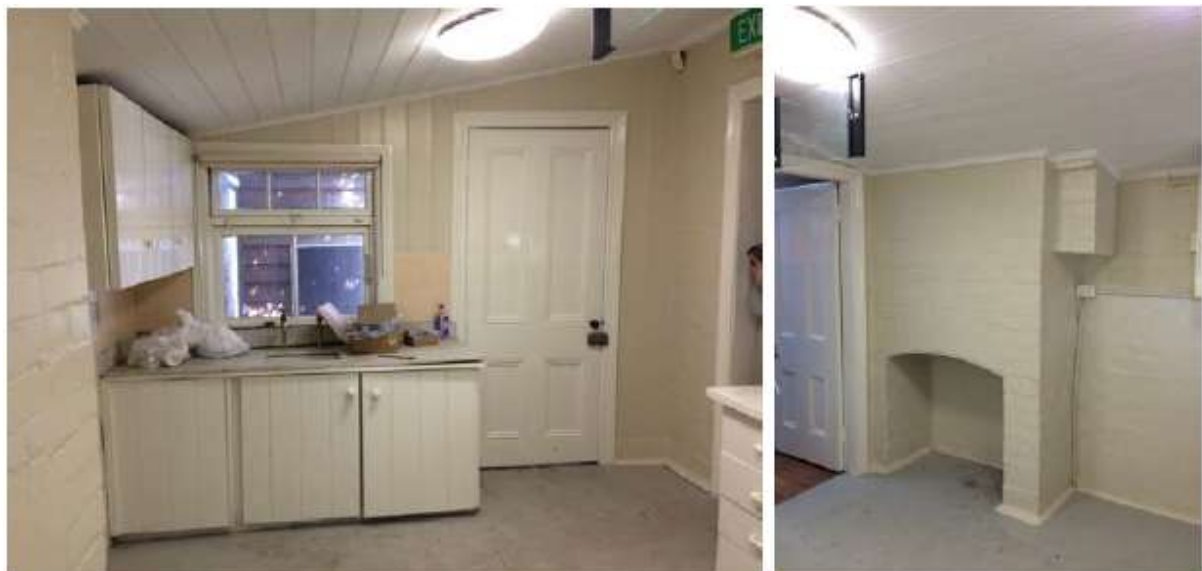
Figure 3.29: Cottage kitchen – recently installed cupboards and fitments (left) and the early fireplace in the south eastern corner of the space (right). (Source: TKD 2016: Fig 74)

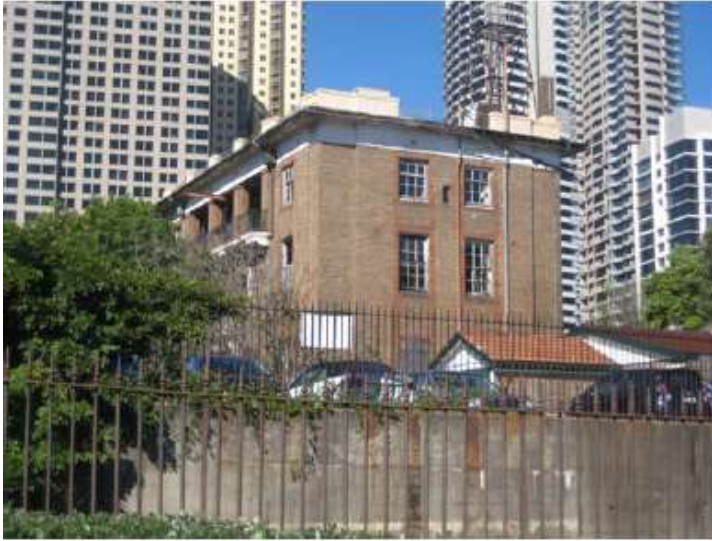
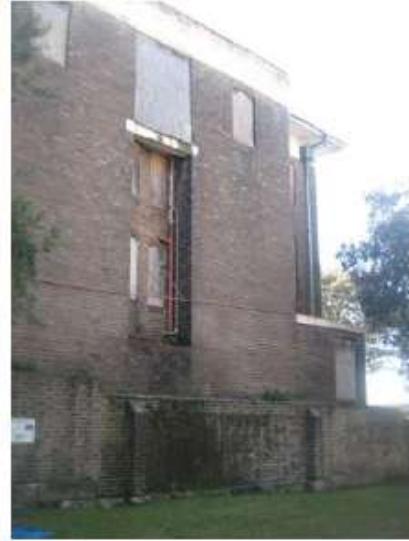
Figure 3.31: Bureau of Meteorology viewed from the west (left); portion of the south elevation, including the recessed light well (right). (Source: TKD 2016: Fig 76)

The eastern and western elevations each contain two bays of windows while the southern elevation incorporates a recessed light well serving lavatories on the first and second floors. There are a limited number of window openings on the ground and first floor levels in this elevation. Windows on this side of the building are boarded up.

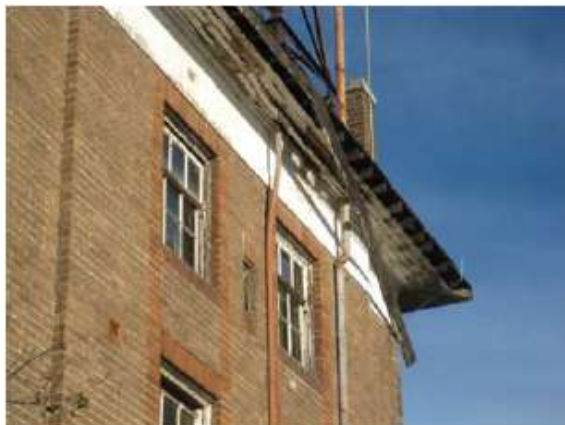
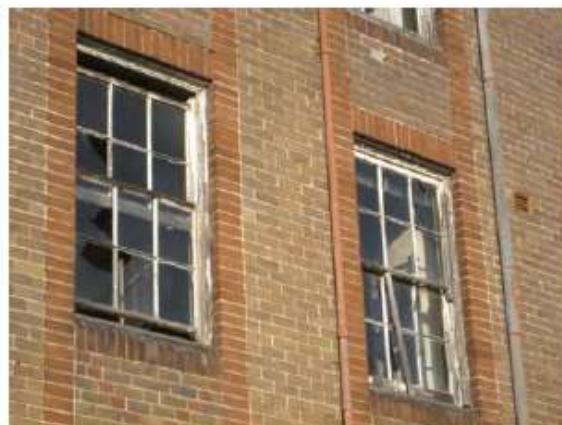
Figure 3.33: Deteriorating eaves fabric (left) and window joinery (right). (Source: TKD 2016: Fig 78)

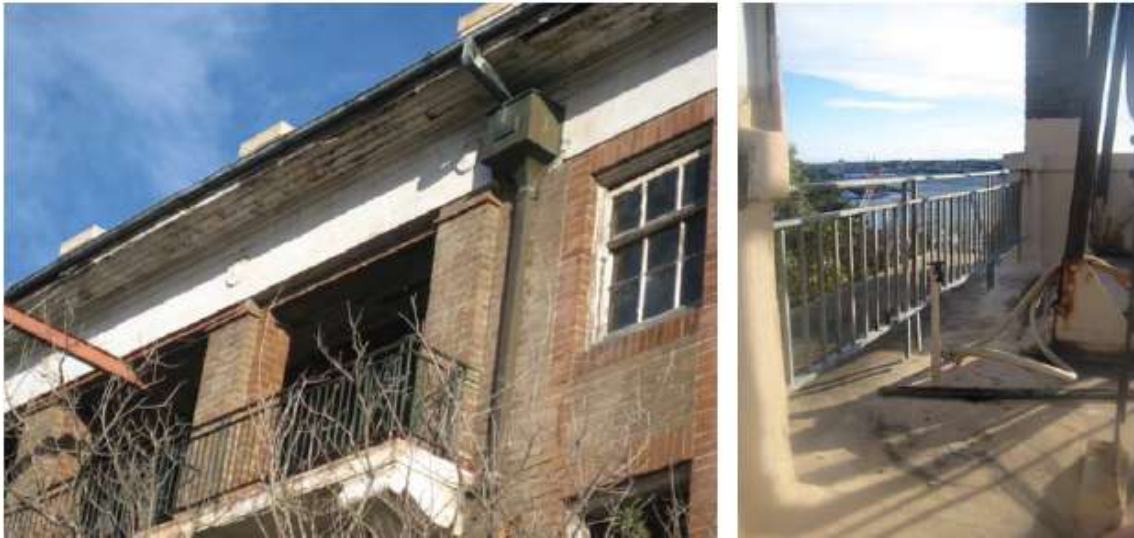
Figure 3.34: Wrought metal balustrade, bracket and piers associated with the 2nd floor loggia. Medallion located above the piers in the frieze (left). Similar balustrading located at roof level (right). (Source: TKD 2016: Fig 79)

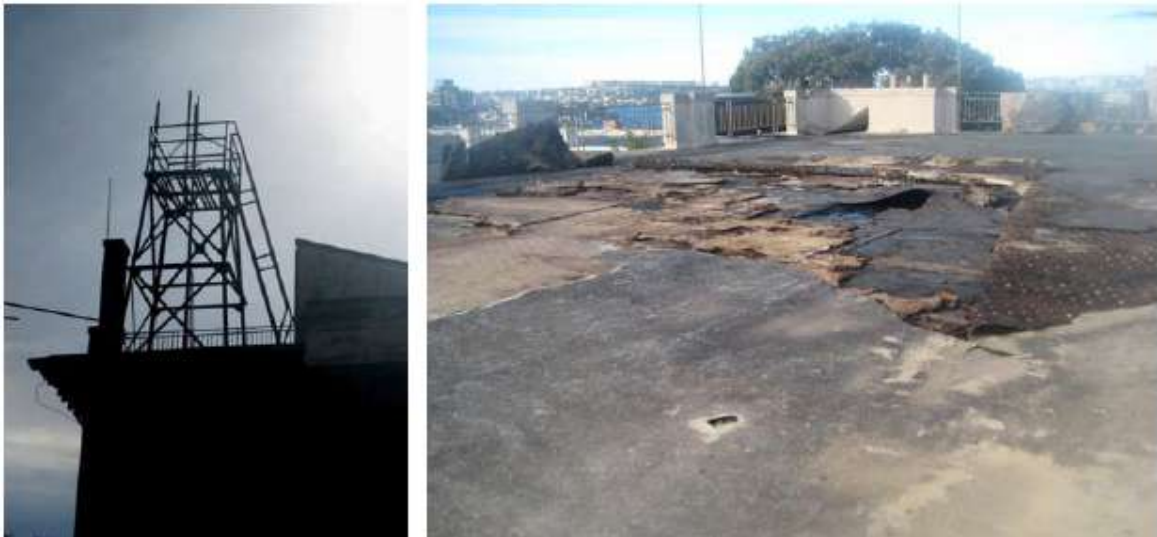
Figure 3.35: Steel-framed tower that was installed to support the wind recording apparatus (left); roof membranes are in very poor condition and are missing in some locations (right). (Source: TKD 2016: Fig 80)

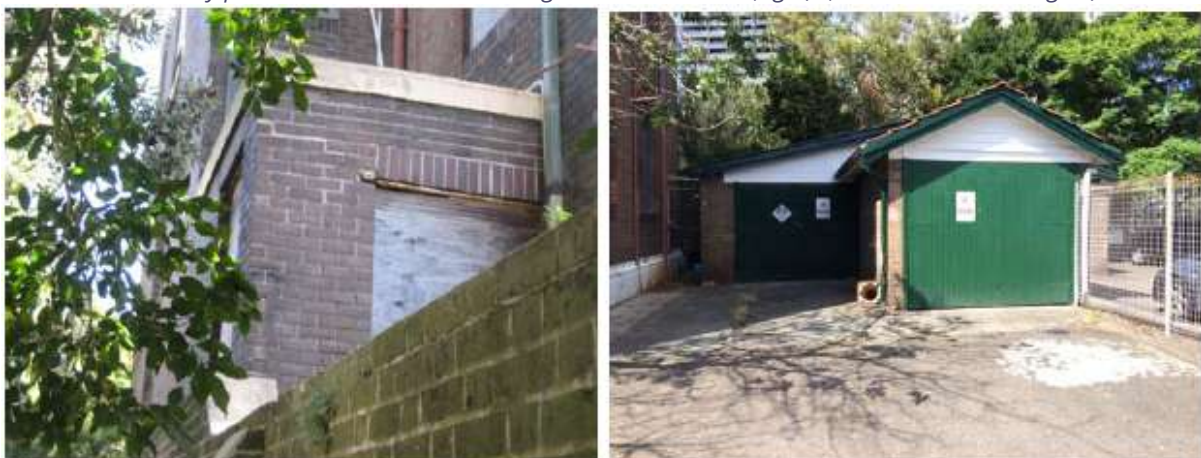
Figure 3.36: Private entry porch to the residential level at the south eastern corner of the building (left); pair of garages to the west of the building (right). (Source: TKD 2016: Fig 81)

A pair of simple gable roofed garages, one of which projects to the north of the second, is located on the western side of the building. It does not appear in early photographs of the building but was evidently in place by 1939.

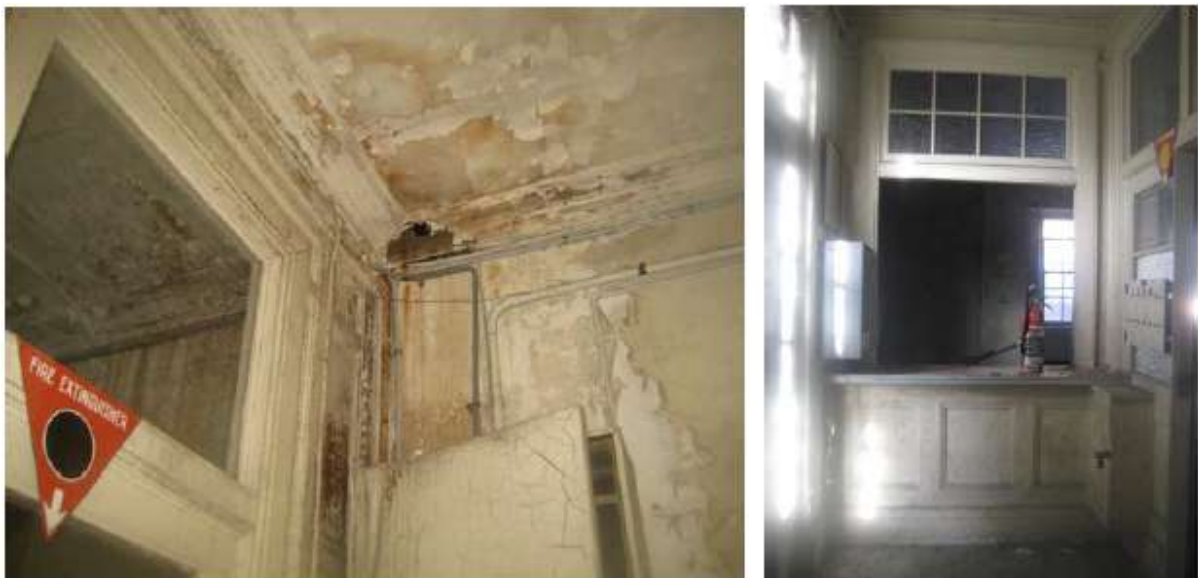
Figure 3.37: Ground floor reception area adjacent to the main entrance. The space has retained a substantial amount of original fabric, including timber joinery items such as the counter and highlight window over it. Decorative plaster cornices are suffering from water damage. (Source: TKD 2016: Fig 82)

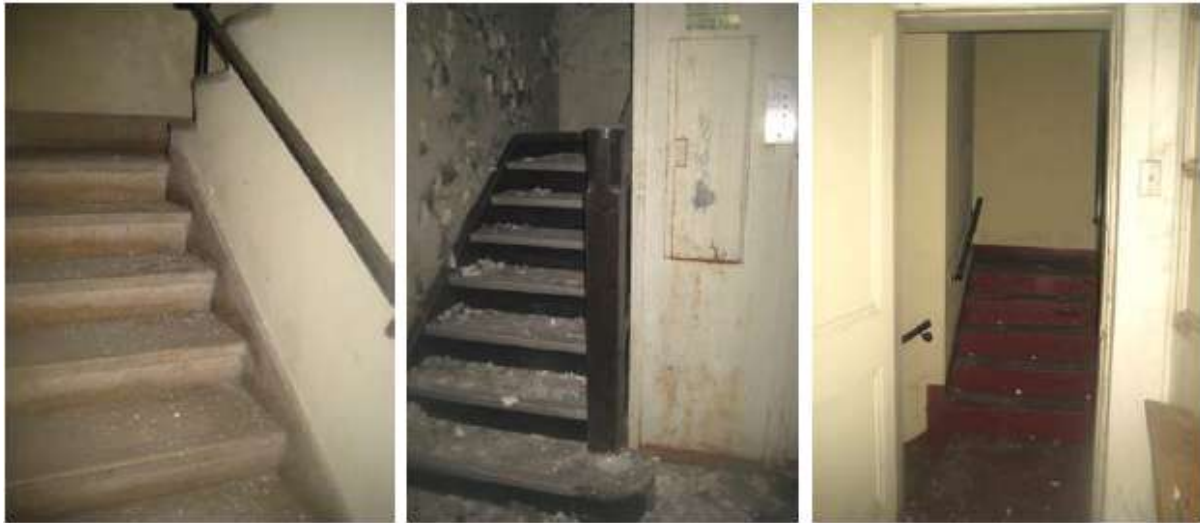
Figure 3.38: Terrazzo stair on the northern side of the building linking the ground and first floors (left), stained and polished timber stair providing access to the residential apartment (centre) and concrete stair connecting all levels of the building, including the roof (right). (Source: TKD 2016: Fig 83)

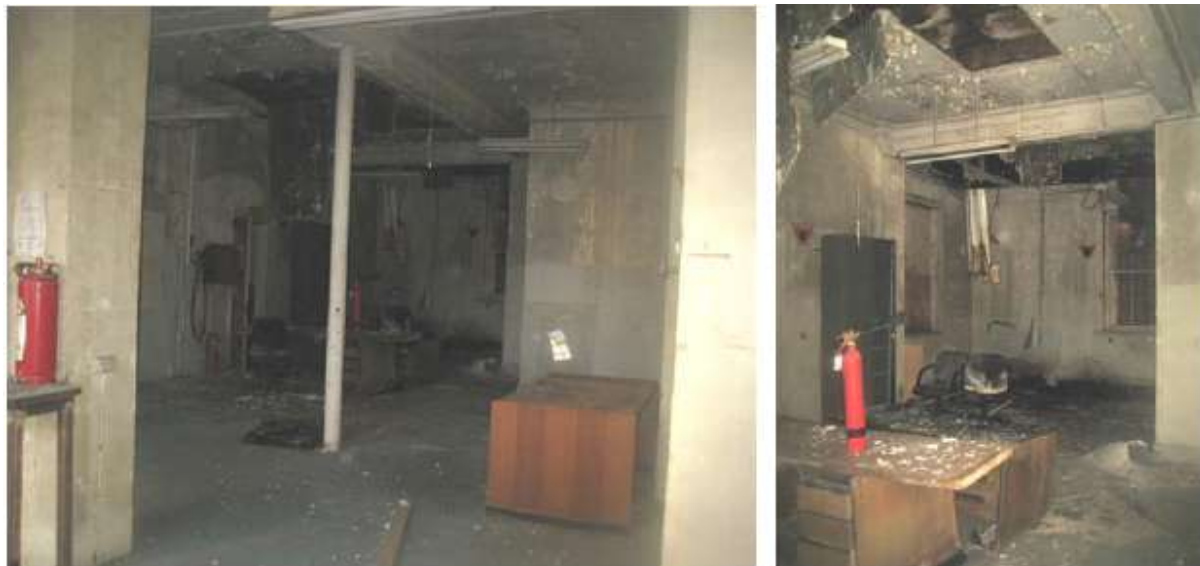
Figure 3.39: Ground floor level, looking to the south west. The tubular steel column is not original. Structural beams have been encased by fibrous plaster linings. (Source: TKD 2016: Fig 84)

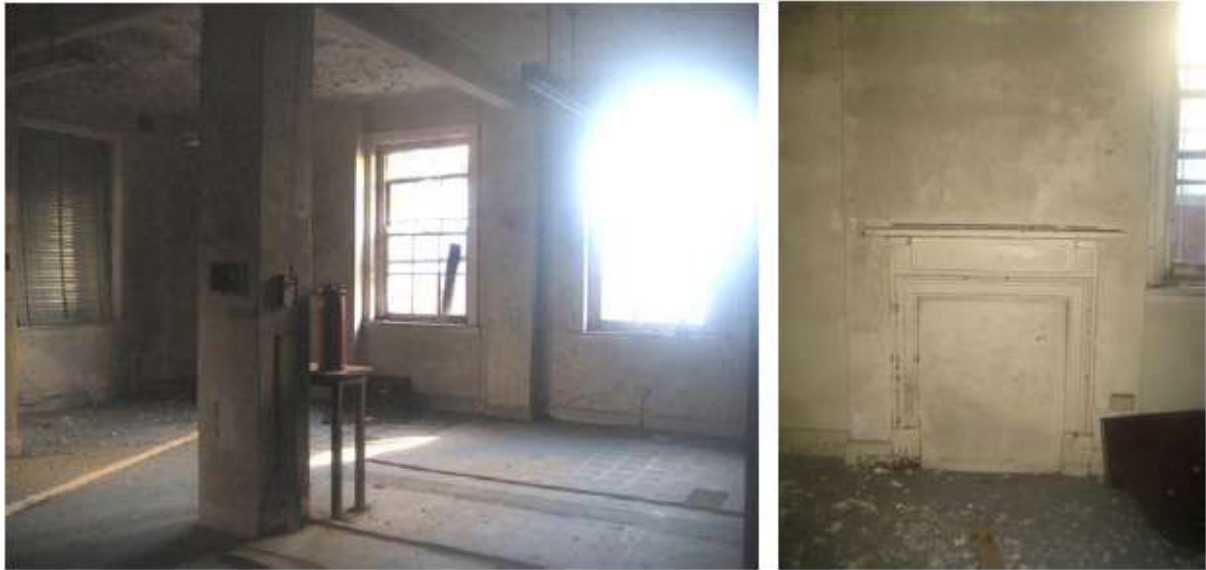
Figure 3.40: North eastern section of the ground floor level (left); intact chimney piece in the south eastern corner of the ground floor (right). (Source: TKD 2016: Fig 85)

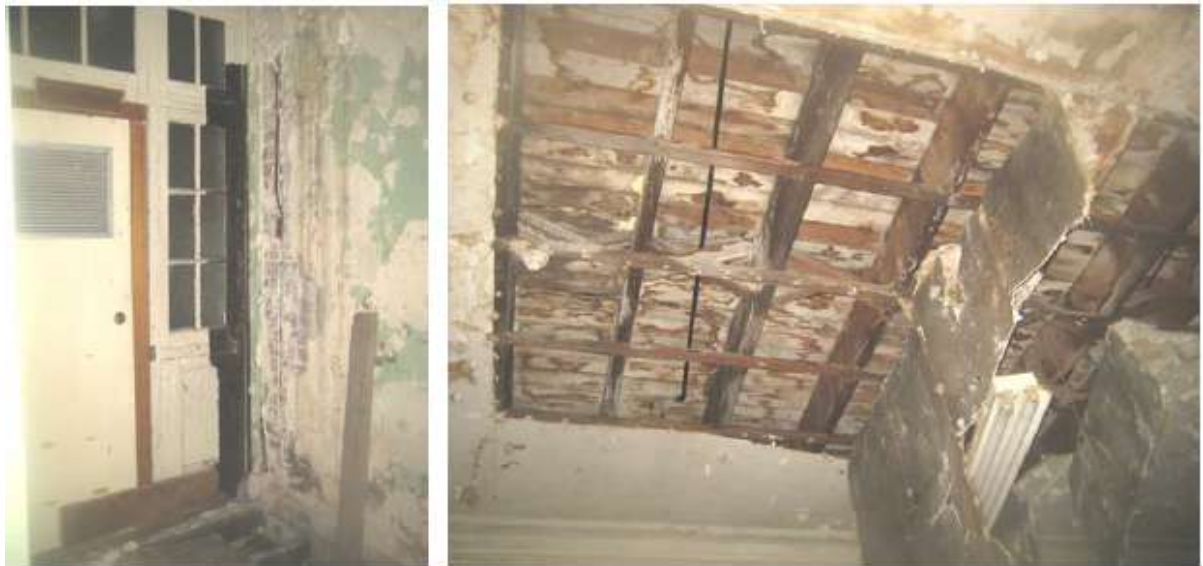
Figure 3.41: A later door has been installed in the private entrance to the building, although original sidelights and highlights remain in place (left). Sections of ceiling lining have come away, exposing the structure of the first floor. (Source: TKD 2016: Fig 86)

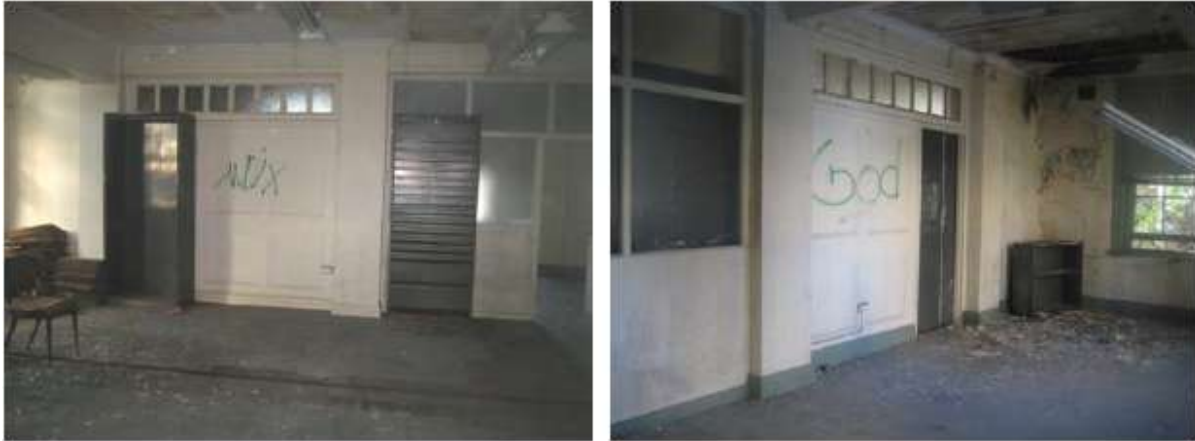
Figure 3.42: General views across the first floor of the building. Ceiling linings are coming away from the floor structure above in places. (Source: TKD 2016: Fig 87)

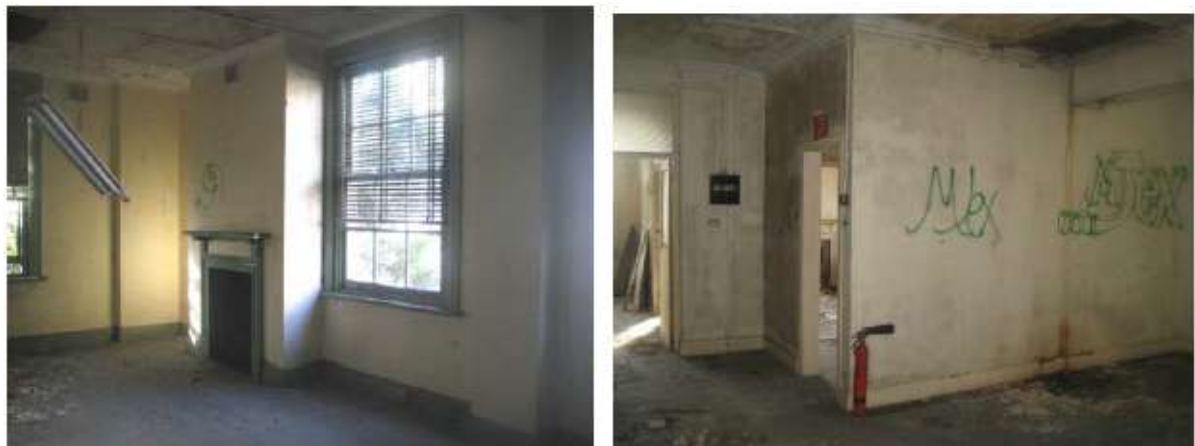
Figure 3.43: North eastern corner of the first floor, which has retained an original fireplace (left); looking towards the stair in the northern section of the building (right). (Source: TKD 2016: Fig 88)

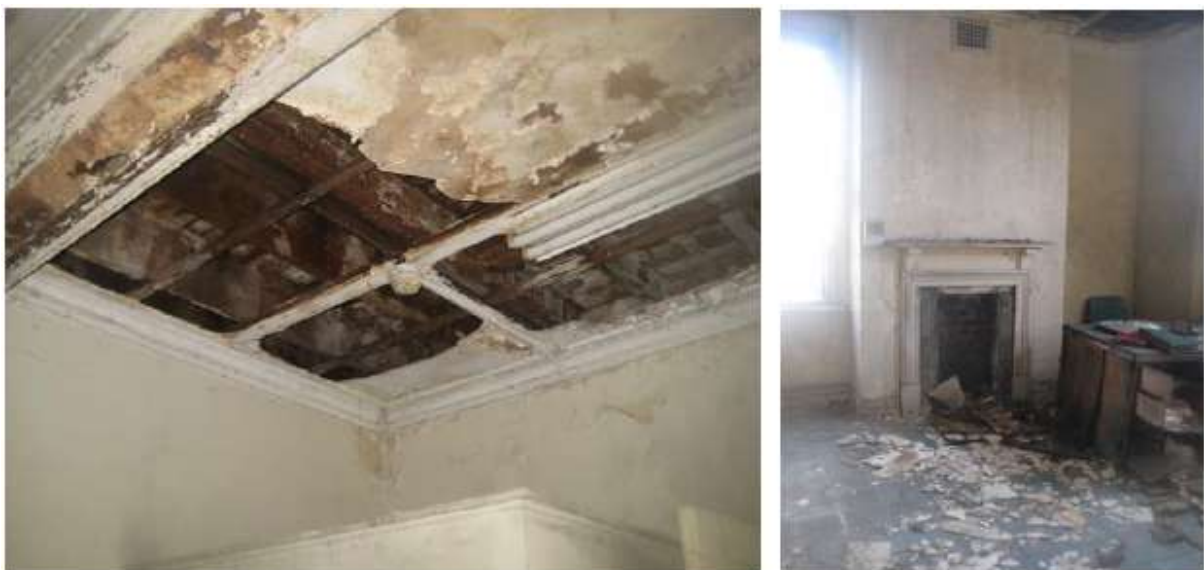
Figure 3.44: Deteriorating ceiling fabric on the first floor (left); fireplace in the north western corner of the first floor (right). (Source: TKD 2016: Fig 89)

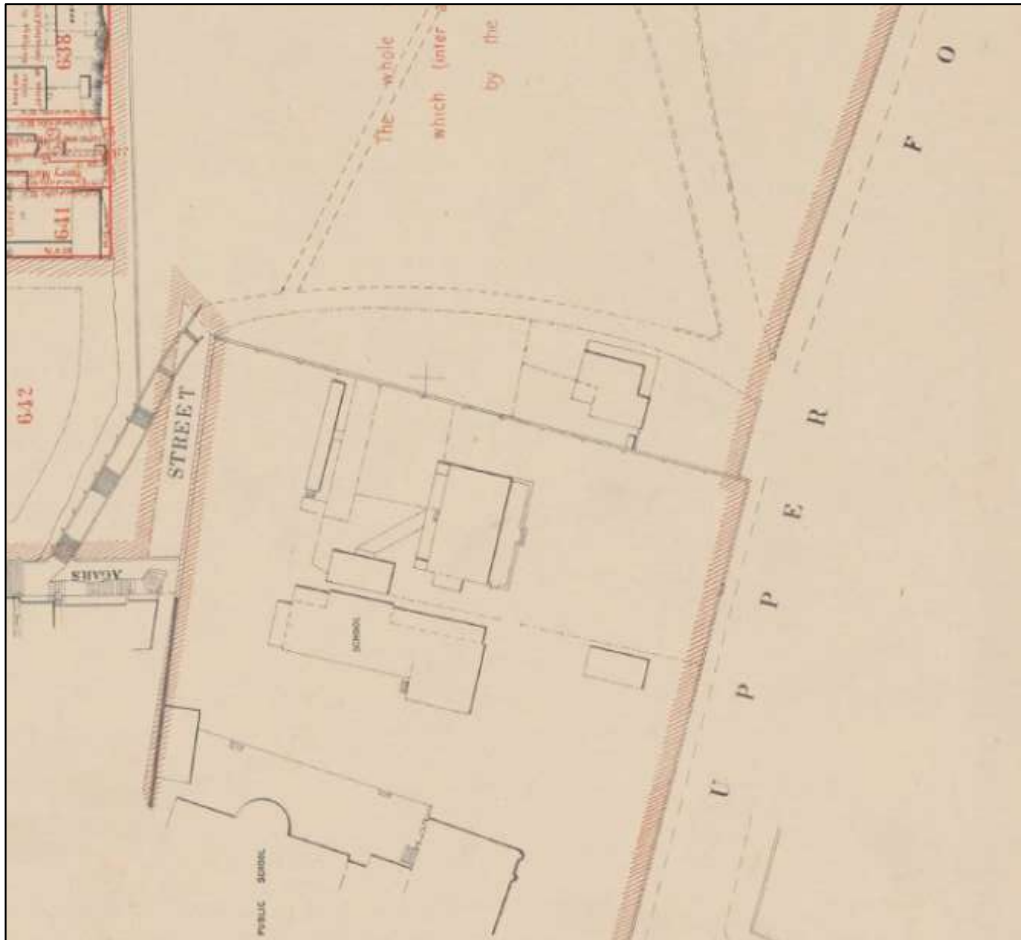
Figure 3.51: Sydney 1900-01 Resumption plan showing northern boundary in its current location as a wall

The brick wall that extends across the boundary between the EEC and land occupied by the Bureau of Meteorology and the Messenger's Cottage is constructed out of sandstock bricks set in a soft mortar over a sandstone foundation. It has been suggested that the wall was part of the Military Hospital compound.⁵⁶ According to one source the likely period in which the wall was constructed was the 1830s and 1840s, based on an analysis of bricks and mortar composition, although the sandstone footings are part of the northern wall to the Military Hospital.⁵⁷ However, what appears to be a timber fence in this location is shown on Sheet 01 of the 1855 City Detail Sheets held at the City of Sydney Archives, on which brick and stone walls are carefully noted and delineated (Figure 3.50). It does show up behind the Messenger's Cottage in the 1864 photograph of Flagstaff Hill (Figure 2.12). Repairs, repointing and reconstruction of damaged sections have been undertaken using the bricks that were available at the time set in a harder mortar. **The 1900-01 resumption plans depicts a wall in its current location (Figure 3.51).**

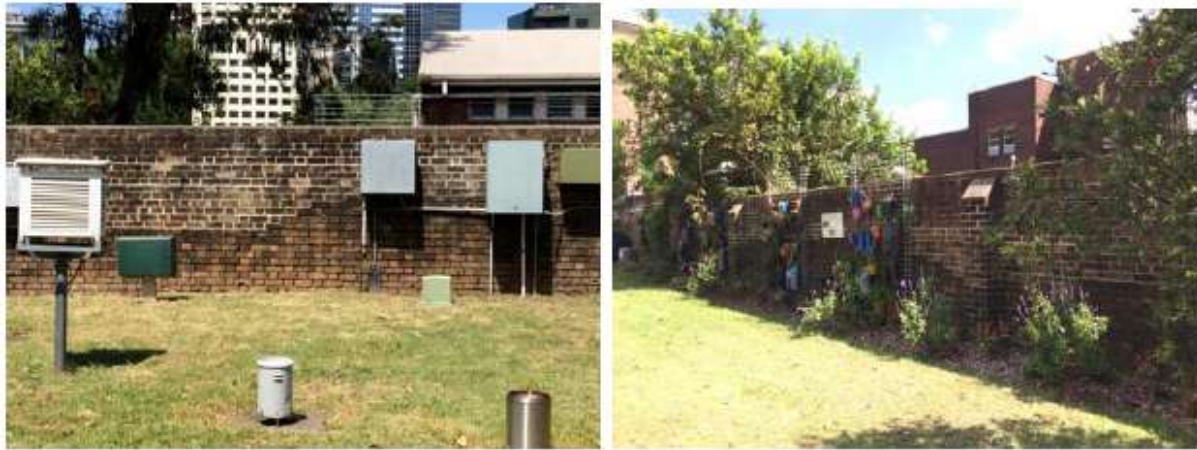
Figure 3.53: Northern section of the wall, to the east of the Messenger's Cottage. Later works associated with the upper sections of the wall are clearly visible (left); southern section of the wall, which is strengthened by brick piers (right). (Source: TKD 2016: Fig 97)

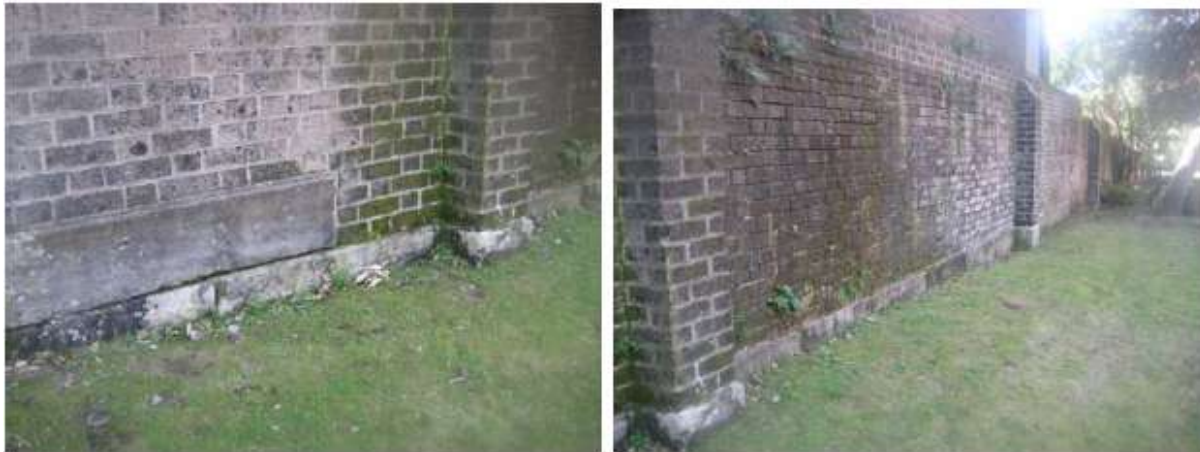
Figure 3.54: The extant brick wall is constructed over stone footings. (Source: TKD 2016: Fig 98)

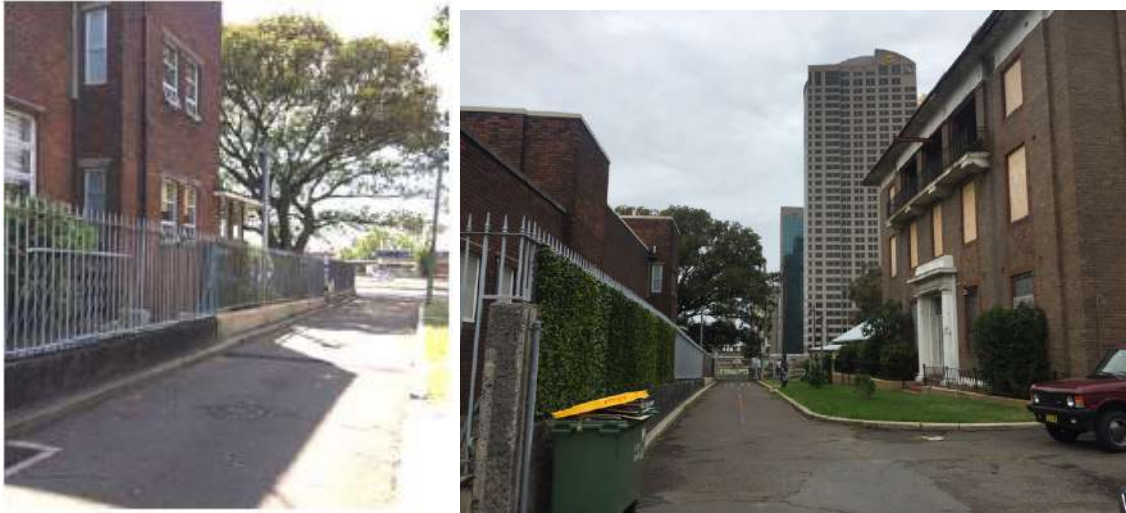
Figure 3.64: The section of Upper Fort Street between Fort Street Public School, and the Messenger's Cottage and Bureau of Meteorology. The school site is bounded by a palisade fence. Originally a simple timber post and rail fence marked the boundary. (Source: TKD 2016: Fig 101 (Left); Curio 2019 (Right))

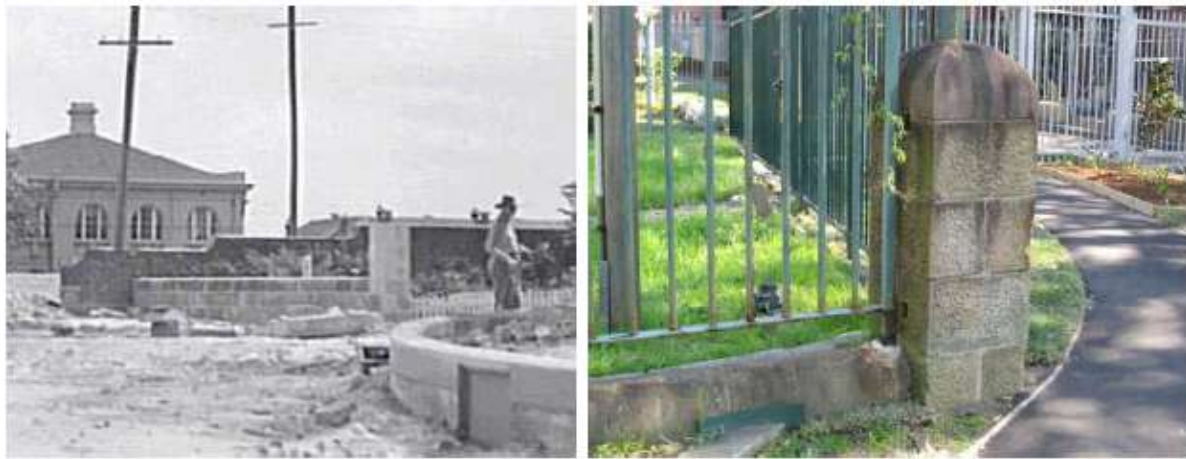
Figure 3.65: This stone pier to the east of the Messenger's Cottage was constructed around 1942, as indicated in the archival photograph at left. Construction took place after the Public School was completed and while the southern section of Upper Fort Street was being formed. (Source: City of Sydney Archive SRC13421; TKD 2016: Fig 102)

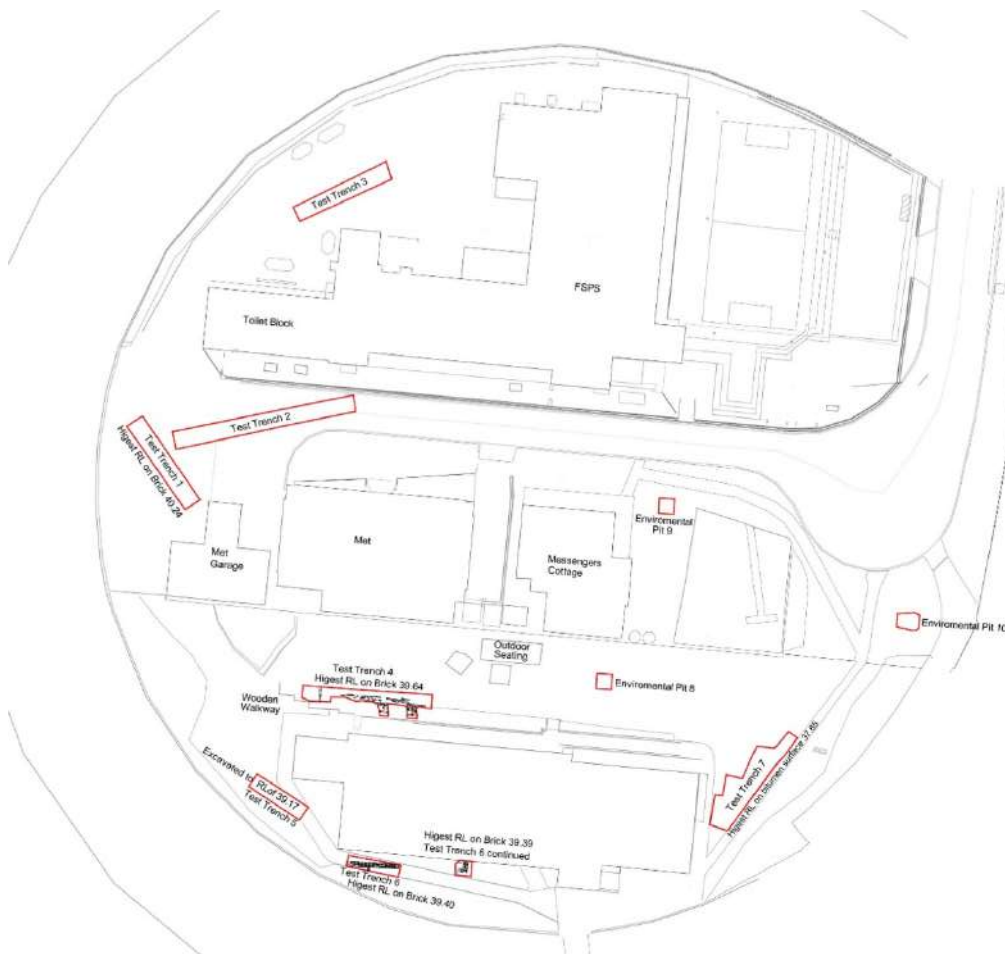
Historical archaeological test excavation was undertaken at the FSPS site in July 2019 (Curio Projects 2019b), in accordance with a Section 60 excavation permit issued by the NSW Heritage Division in May 2019. Seven archaeological test excavation trenches (Test Trench 1-7) were excavated within the FSPS study area, along with a further three pits (Pits 8-10) excavated by environmental scientists under archaeological supervision (Figure 3.69).

The major feature exposed during the test excavation was the brick footings of the former surgeon's house below the EEC building (Test Trenches 4 and 6), confirming the presence of substantial evidence of the surgeon's house brick footings and a suggestion of an attached outbuilding retained within the FSPS site (Figure 3.70 to Figure 3.72). While not encountered during the July 2019 test excavation investigation, the FSPS site retains further un-investigated archaeological potential for occupation deposits and deeper sub-surface features.

Figure 3.69: Historical Archaeological Test Excavation Trenches Location (Source: Curio 2019b, drawn by B. Owens)

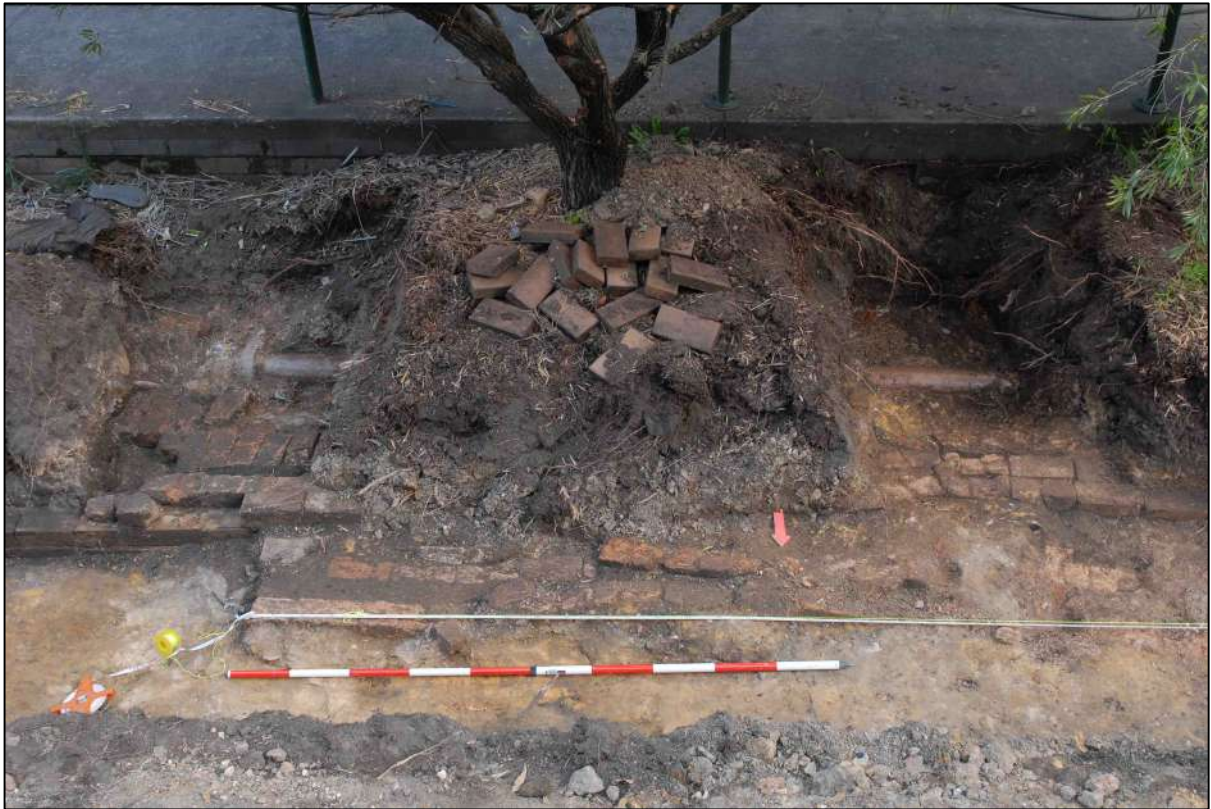
Figure 3.71: Remnant footings of Surgeons Cottage on northern side of EEC (Source: Curio 2019)

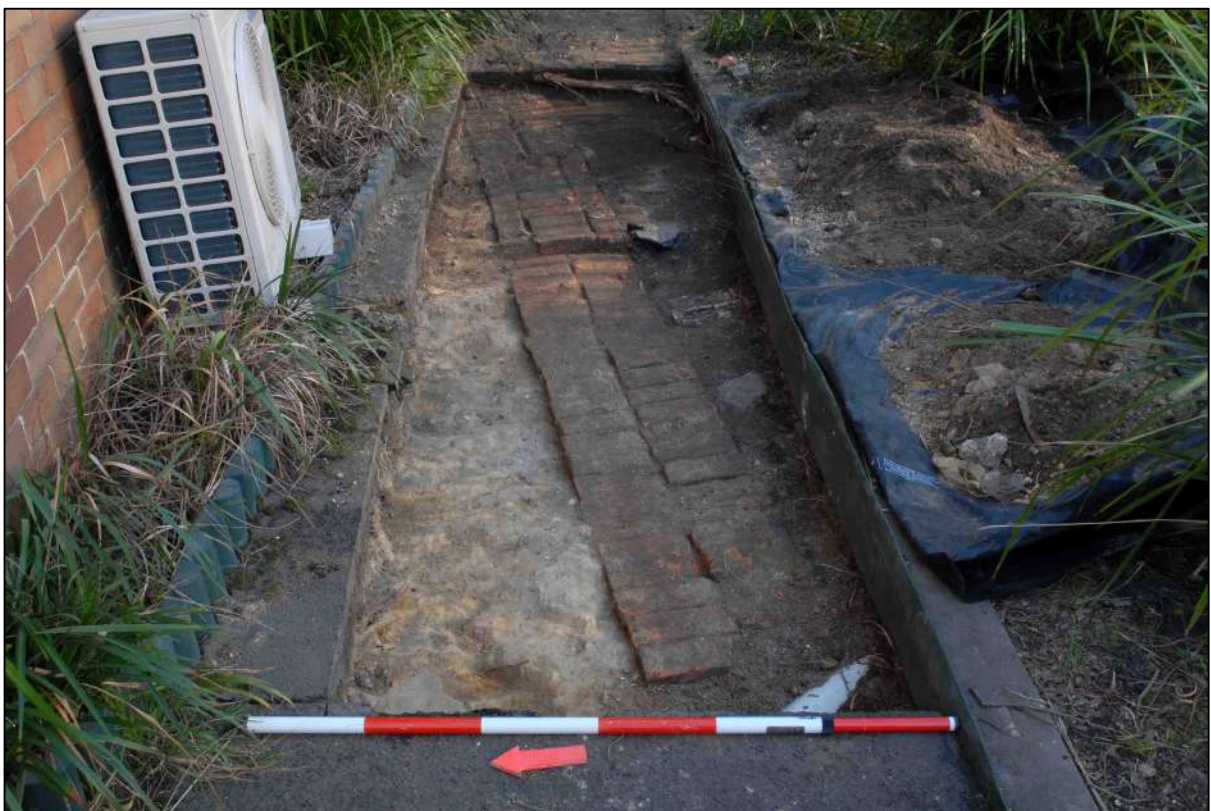
Figure 3.72: Remnant footings of Surgeons Cottage on southern side of EEC (Source: Curio 2019)

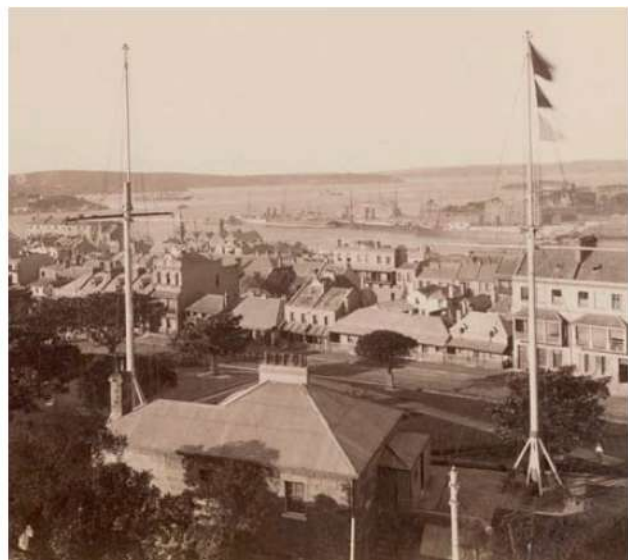
Figure 4.15: The Signal Station viewed from the south, circa 1875 (left) and from the Observatory Tower, circa 1905 (right). By this time it had been re-roofed with corrugated steel. (Source: SLNSW ON 4 Box 60 No 336, digital order no. a2825055 and PXE 711 / 37, digital order no. a116037. TKD 2016, Fig. 132)

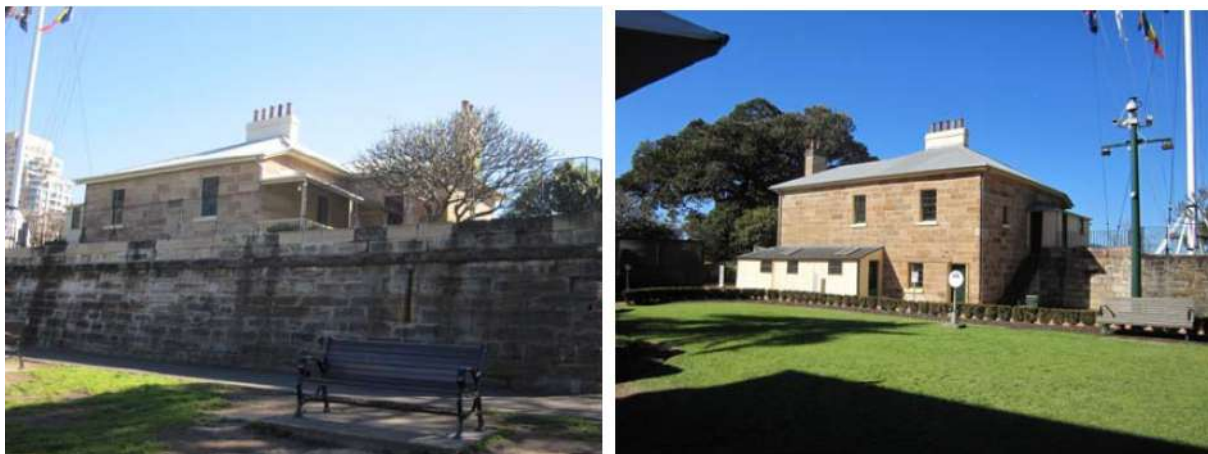
Figure 4.17: The signal master's cottage viewed from the north east (left) and west (right), 2015. (Source: TKD 2016, Fig. 134)

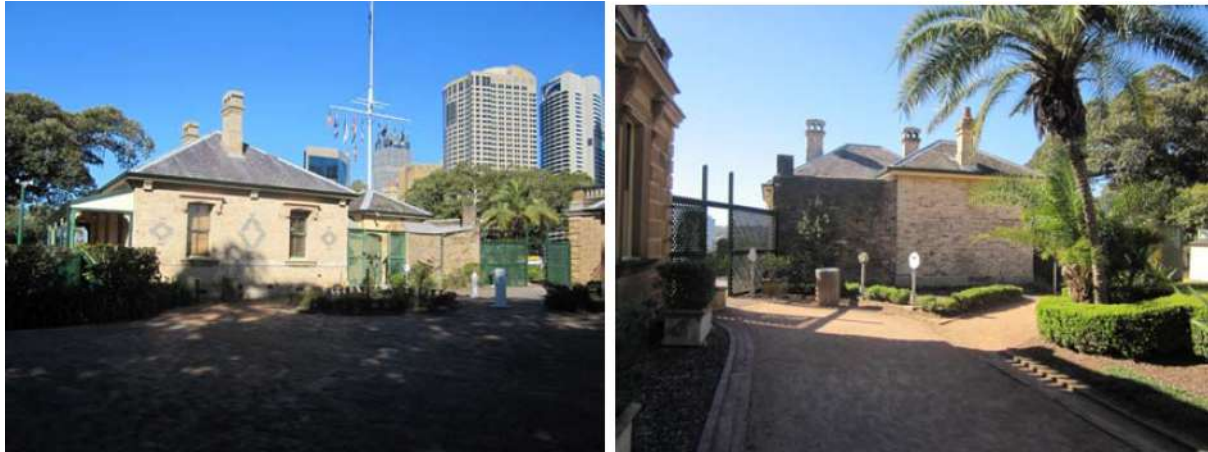
Figure 4.19: The Messenger's Cottage viewed from the west (left) and south (right), 2015 (Source: TKD 2016, Fig. 136)

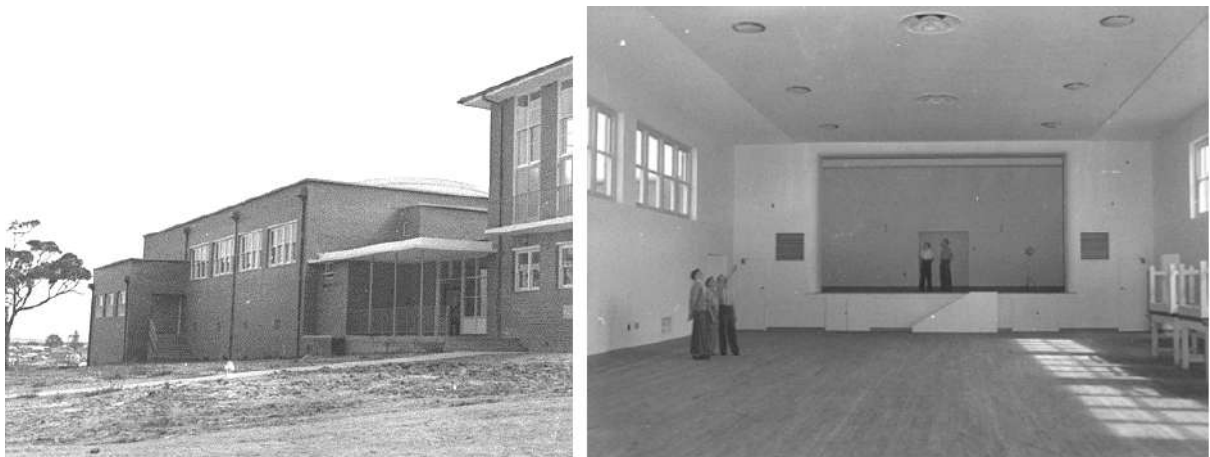
Figure 4.27: Assembly hall and gymnasium combined at the 1953 Belmont High School. The ceiling and placement of windows is similar to the gymnasium at Fort Street Girls' High School. (Source: SLNSW, digital order no's. hood_26887 and hood_26894, Sam Hood photographs. TKD 2016, Fig. 144)

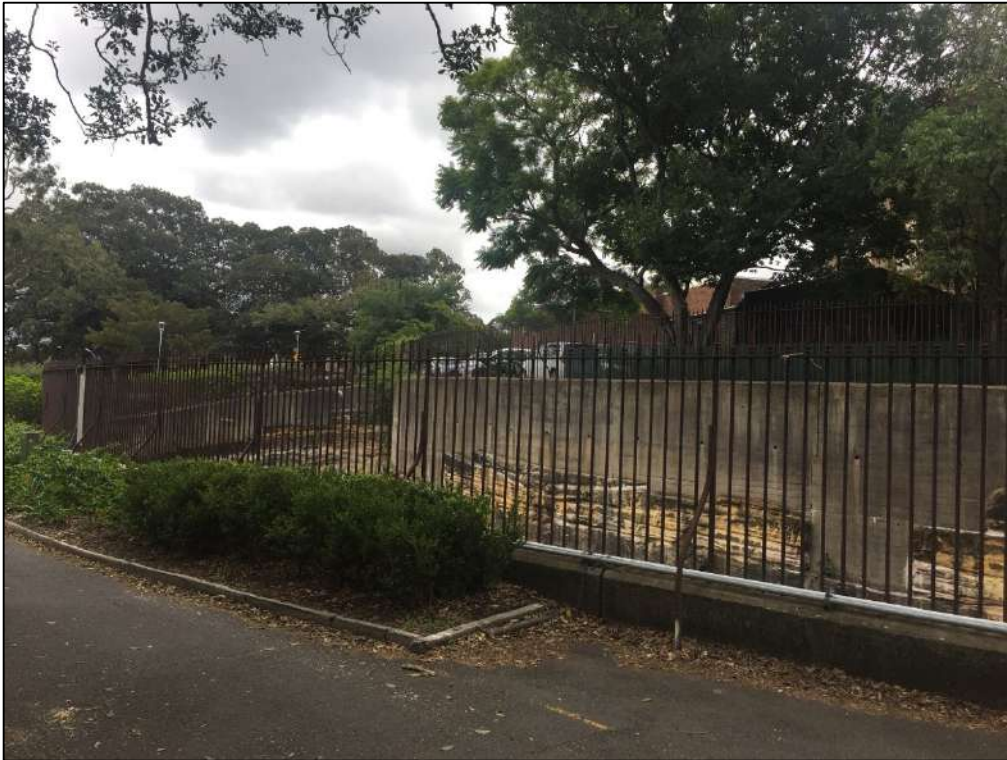
Figure 4.29: Physical element of Cahill Cut disconnecting FSPS site from surrounding Observatory Hill is only readily visible from immediately next to cut- view from National Trust site along northern boundary fence (Source: Curio 2019)

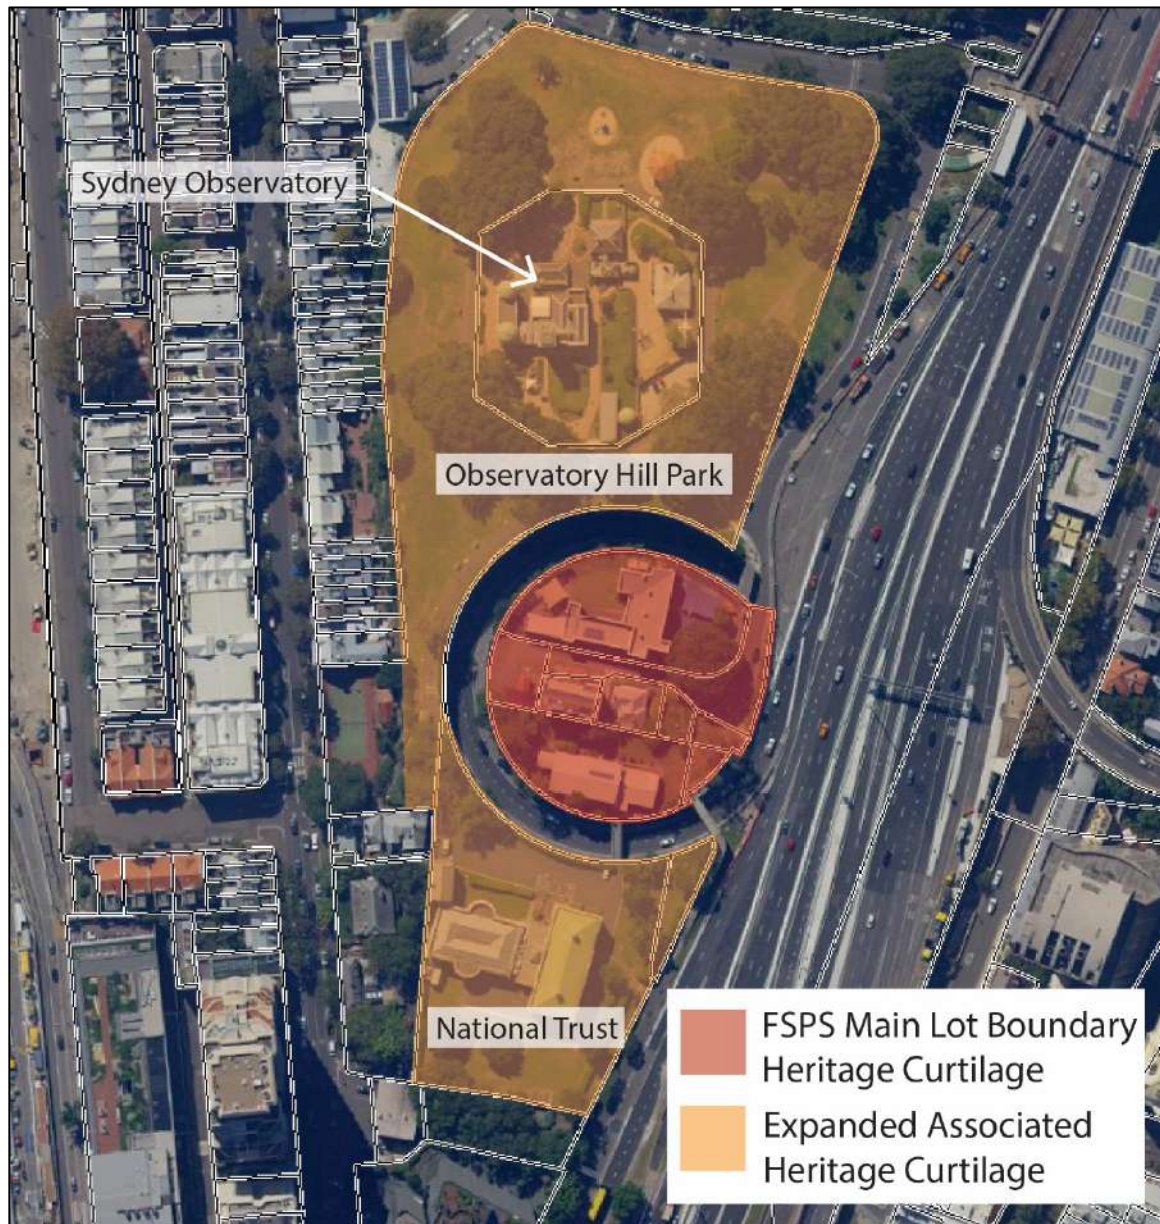
Figure 4.41: Heritage Curtilage for FSPS Site. Main lot boundary vs expanded associated curtilage (Source: Spatial Information Exchange with Curio overlay 2019)

Figure 4.41 Figure 4.41 presents the recommended curtilage for the FSPS Site, both with respect to the immediate lot boundary, as well as the expanded curtilage of heritage and historical significance and association.

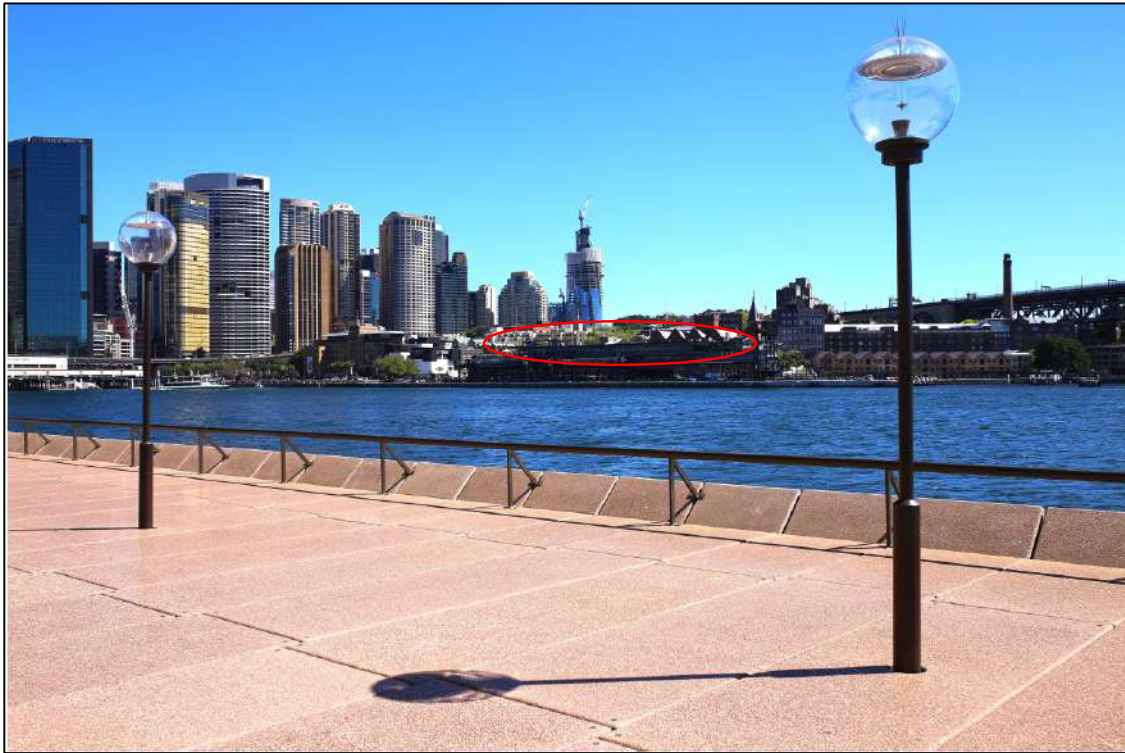
Figure 4.44: View from Sydney Opera House towards FSPS Site (indicated in red). Site not readily visible, view line already dominated by Barangaroo Development (Source: Ethos Urban)

Due to its significance, potential views and vistas between the FSPS site and the Sydney Opera House were considered for this assessment of significant views, however the nature of the landforms and built environment of the area means that no clear viewlines or vistas exist between the two sites (Figure 4.44).

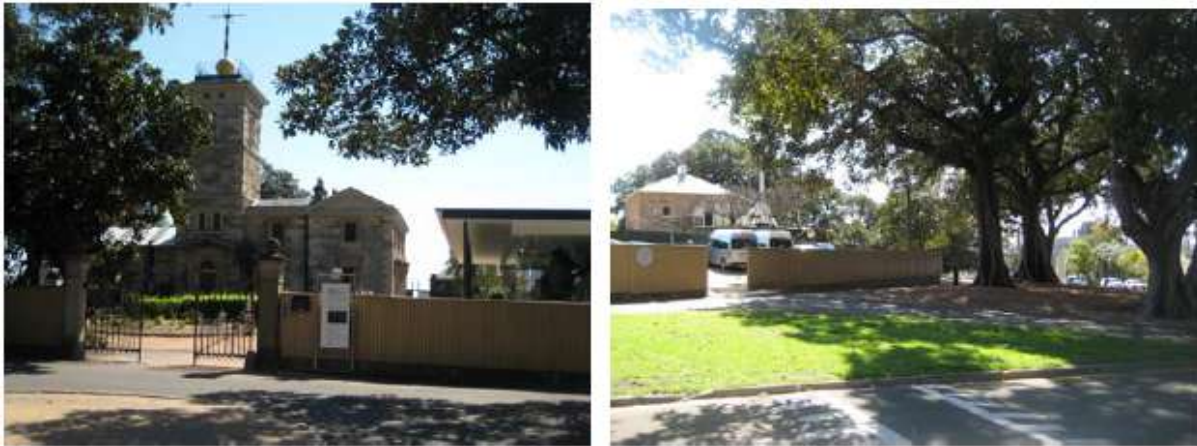
Figure 4.47: View north from northern side of Cahill Cut, to Sydney Observatory. The open space and mature trees in front of the Observatory are an important component of the Public School's setting. (Source: TKD 2016: Fig 113)

The open space and mature trees in the southern extent of Observatory Hill Park to the north of the FSPS site, are also significant in providing landscape context and heritage character of the FSPS site (Figure 4.47). Views from the open space at the southern extent of the Observatory Hill Park, back south across the FSPS site, are also framed by the insistent backdrop of the Central Sydney CBD (Figure 4.48).
