Fort Street Public School Conservation Management Plan

SSD 10340

Prepared by Curio Projects

Conservation Management Plan

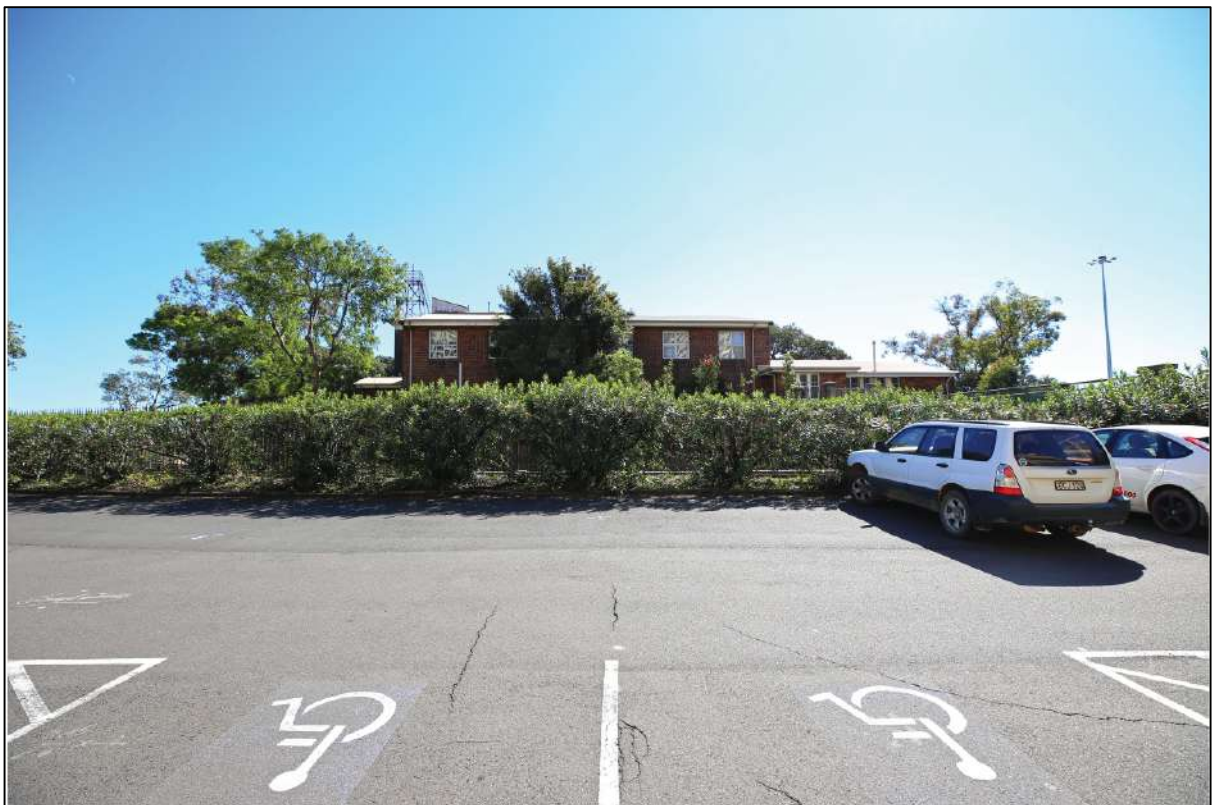
Figure 4.55: View 4: Current view north from National Trust to FSPS Site. View lines to heritage buildings obscured by EEC (Source: Ethos Urban)

As the original Fort Street Public School Building, the former military hospital- now the National Trust Building- is significant in its location and connection to the Fort Street Public School site. However, the visual connection between the FSPS Site and the National Trust building have been significantly impacted over time through the creation of the Cahill Cut (which has effectively created a visual and physical isolation of the site within the circle of the expressway excavation), as well as the slope of the landform. The construction of the EEC building (former Fanny Cohen Gymnasium) in 1949 also served to obstruct views between the National Trust building and the FSPS School/Messenger's Cottage.

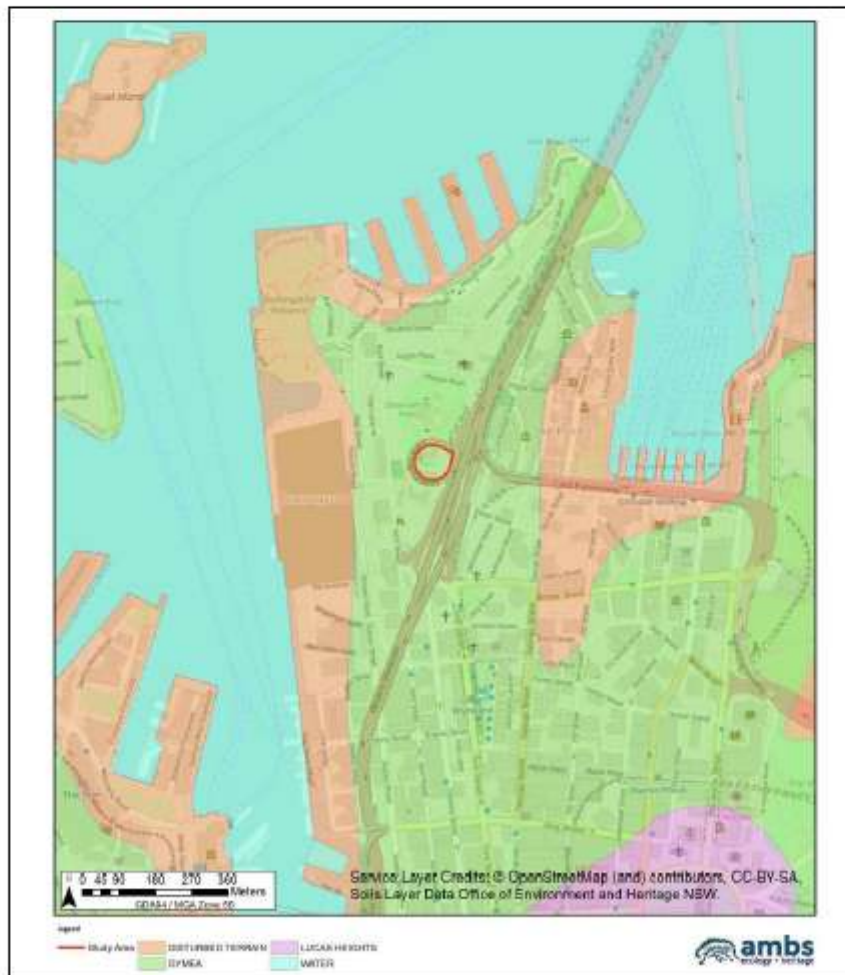
Figure 2.1 Soil landscapes in the vicinity of the study area.

The study area is located within the GyMEA soil landscape, which is characterised by shallow to moderately deep yellow earths and earthy sands on crest landforms, underlain by Hawkesbury sandstone. Sideslope landforms within the soil landscape, such as those immediately surrounding the study area, generally comprise discontinuous siliceous sands and lithosols, with rock outcrops covering up to 25% of the ground surface. Soils within this landscape are prone to severe sheet erosion following removal or damage to stabilising vegetation cover, such as bushfires or land clearing (Chapman & Murphy 1989:64-67).

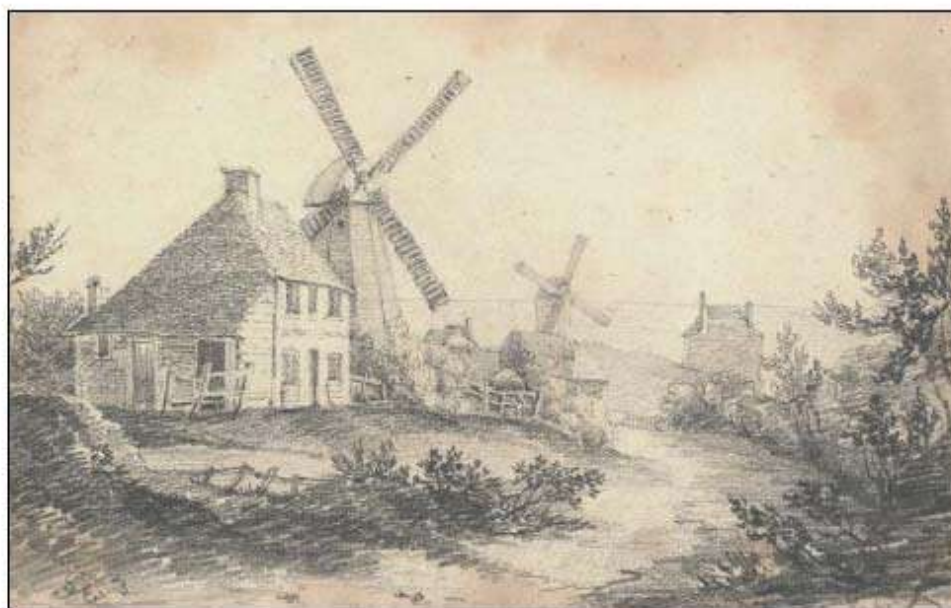
Figure 4.4 Drawing of the Smock windmill and house, Observatory Hill, Sydney, ca. 1850, dated 1876. The octagonal timber construction is clearly visible (<http://nla.gov.au/nla.obj-135207038>).

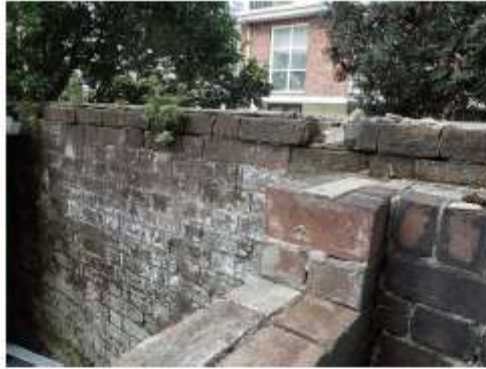
Figure 4.24 Detail view of the east-west brick boundary wall showing areas of damage and the modern wall extending to the north.

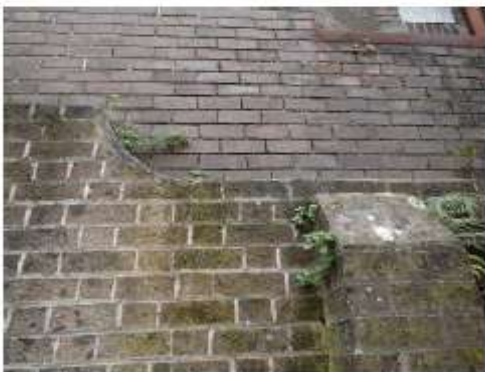
Figure 4.27 Detail view of the brick boundary wall and the Bureau building wall. The bricks are evidently hand-made sandstock bricks set in a soft pre-Portland cement.

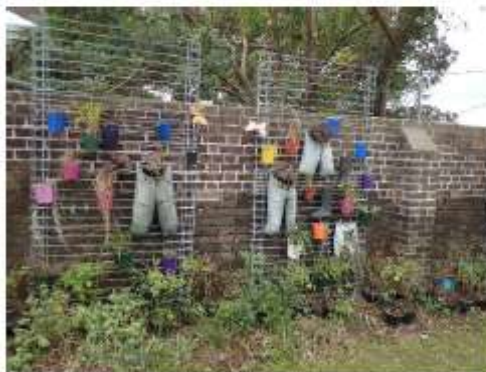
Figure 4.28 Section of the brick boundary wall within the Environmental Education Centre showing evidence of repair and reconstruction using modern bricks and mortar.

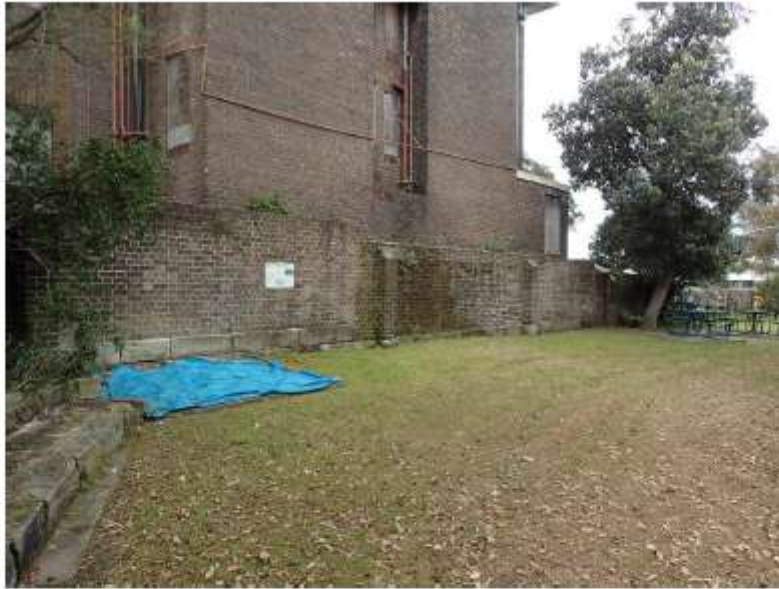
Figure 4.29 View north-east of the rear of the Bureau of Meteorology building and the brick wall. Note the sandstone block foundations.

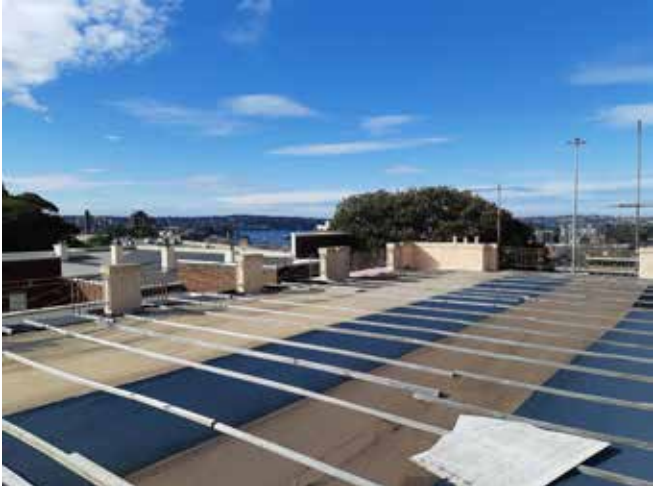
<p>The roof is currently in a very poor state. it has completely perished in some places and a temporary sarlon covering is doing nothing to halt further water ingress.</p> <p>URGENT WORKS: Install a temporary roof to the building that overhangs the parapet and which has temporary downpipes installed.</p> <p>NOTE: Weatherproofing the roof is the major priority. Unless the roof is repaired, additional make-safe works will be of little effect. The building needs to be able to dry-out before the majority of further assessment can be undertaken. Works are to be specified by an experienced heritage architect.</p>

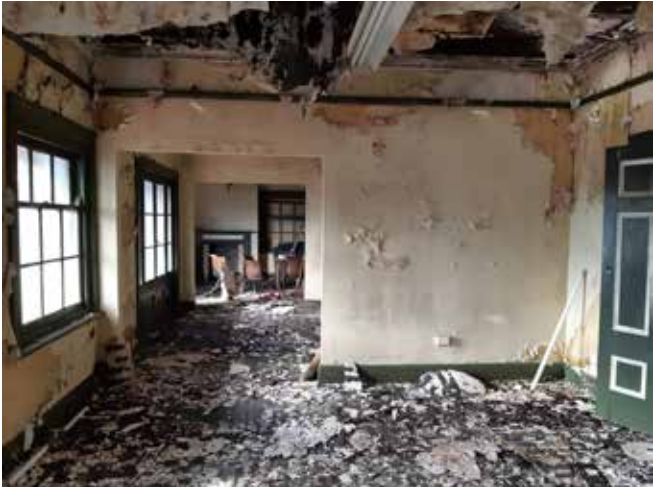
<p>The interior of the building is currently full of broken-down material, much of it related to the ceilings which have collapsed. There is likely to be a number of hazardous materials within the detritus.</p> <p>URGENT WORKS: Undertake a general clean-up of the building using approved contractors, taking care to avoid areas of collapsed floor etc. Scope of Works for clean up to be specified by an experienced heritage architect (to prevent removal/disposal of potentially significant fabric).</p>

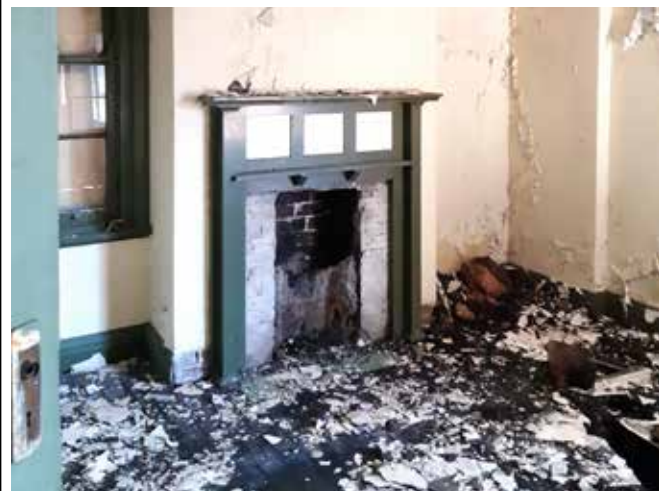
There is a large amount of original fabric within the building, including doors, fireplaces, skirtings etc. Constant water ingress is significantly damaging this fabric which is in otherwise good condition.

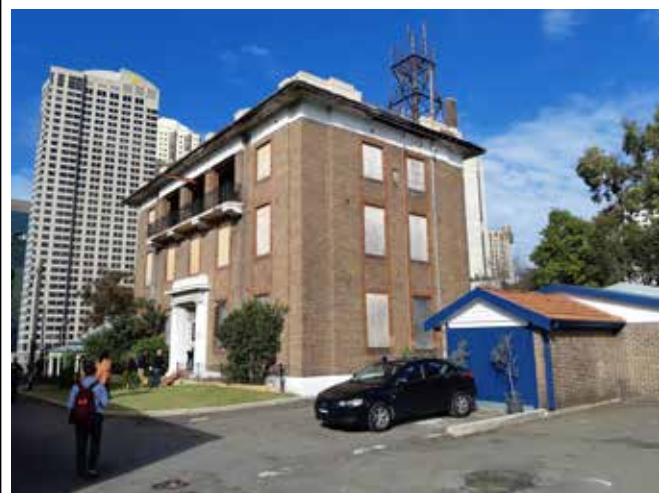
There is a risk of debris falling from the building, including damaged eaves and possibly more major structural members.

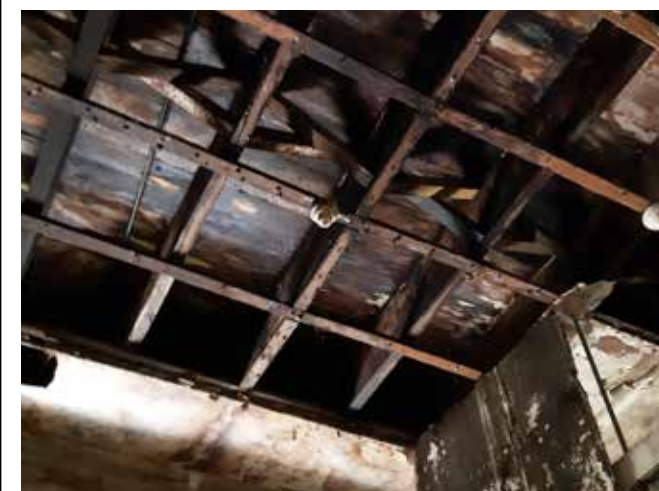
There is a risk of ceiling and floor collapse in certain sections of the building. In some cases the floor is unsafe to walk on or missing completely.

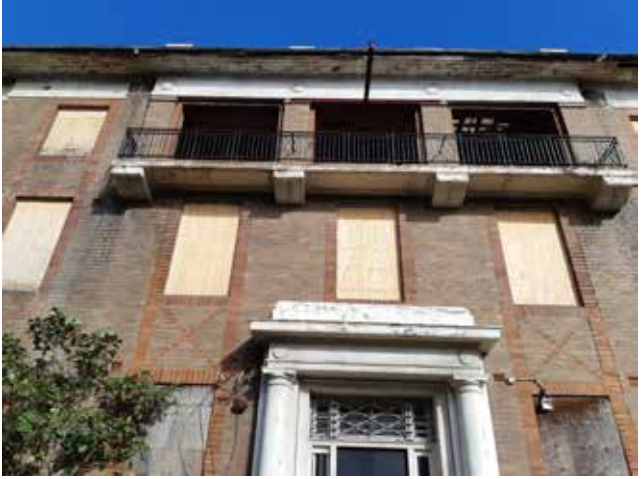
<p>The external brickwork to the building is in various states of repair. The patterned nature of the brickwork is no longer apparent due to the build-up of pollution on the facade.</p> <p>Downpipes and rainwater heads to the building are mostly no longer in place. Only the SE corner has a rainwater head intact.</p> <p>WORKS:</p> <p>Allow for a general clean of the brickwork on all elevations. Allow for approximately 75% repointing of brickwork.</p> <p>Allow for three new custom copper rainwater heads and associated downpipes.</p>

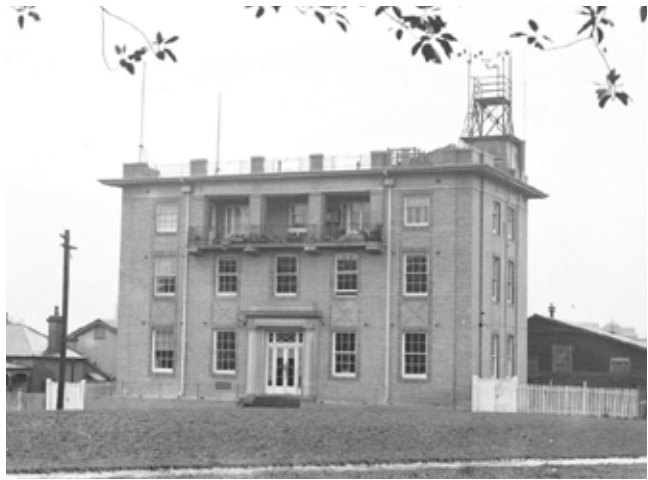
<p>The concrete parapets, door surround and base to the building appear to not have originally been painted. Window and door frames, along with metalwork were painted.</p> <p>WORKS:</p> <p>Allow for historic paint analysis to determine original colour scheme.</p> <p>Allow for complete removal of existing (presumed acrylic) paint from concrete surfaces using approved paint stripping method.</p> <p>Allow to repaint all metalwork following stripping back, repair and application of protective coating.</p> <p>Allow to repaint all timber windows and doors.</p>

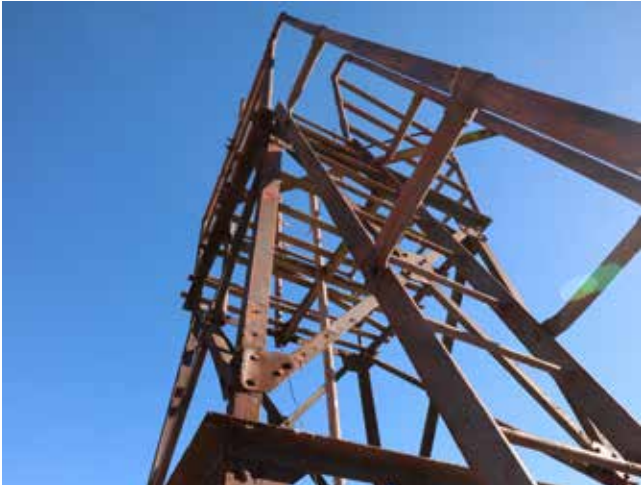
<p>The "wind recording apparatus" to the SW corner of the building is an important element related to the original function of the building.</p> <p>WORKS:</p> <p>Allow for complete restoration of this element. This may involve substantial off-site repair work, sandblasting, repainting, installation of missing elements or new structural members, etc. The two flagpoles (seen in the image above) should also be considered for reinstatement.</p>

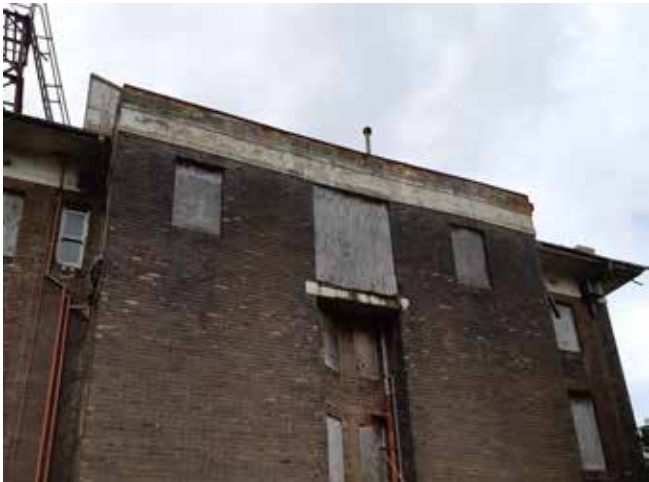
<p>A number of noticeable structural repairs are required on the exterior of the building. Of particular concern is the major cracking to the parapet on the southern elevation.</p> <p>WORKS:</p> <p>Advice of a specialist structural engineer should be sought. Allow for complete dismantling and rebuilding of this section of parapet.</p>

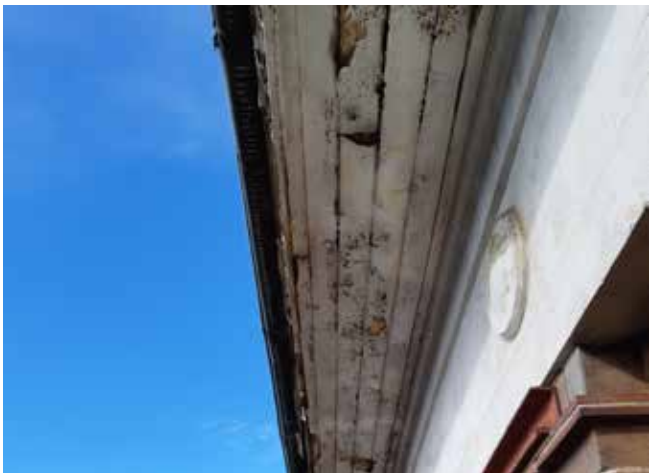
<p>The eaves to the building are in generally poor condition. In some cases they are missing or have completely rotted through. Where they remain in good condition they should be repaired.</p> <p>WORKS:</p> <p>Allow for 100% replacement of eaves using exact matching profile.</p>

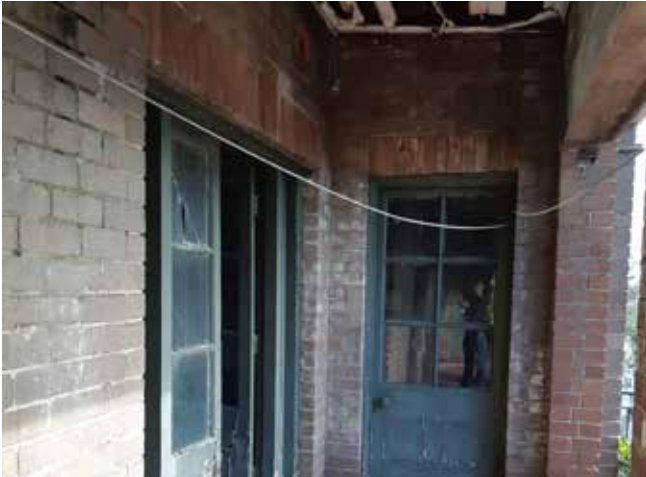
<p>The lining boards to the upper verandah have rotted. External doors and windows are generally in moderate condition.</p> <p>WORKS:</p> <p>Replace the lining boards to the upper verandah.</p> <p>Allow to remove all external doors and windows for repair in a factory. These elements (and their frames) should be sanded back, re-primed and re-painted. New glass should be installed that assists in meeting acoustic requirements. Sash windows should be repaired and made operational. Install appropriate acoustic brush seals to the windows. Original hardware is to be retained and repaired where possible.</p>

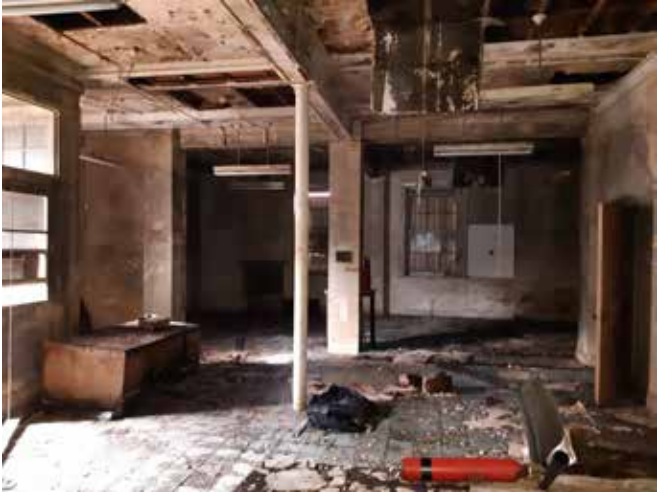
<p>The building interiors need significant repair works.</p> <p>WORKS:</p> <p>Allow for complete reinstatement of all plaster ceilings and cornices to match existing details. Allow for complete reinstatement of all timber floorboards, but retain if possible on the lower floors where there has been less damage. Aim to retain original structure (floor joists etc) where possible, but supplement with new structure where necessary. Allow for upgraded sound and/or fire insulation between floors. Strip paint from all walls, patch and repair as necessary prior to repainting.</p> <p>Remove all existing conduits, wiring etc and re-wire the entire building to meet current standards.</p>

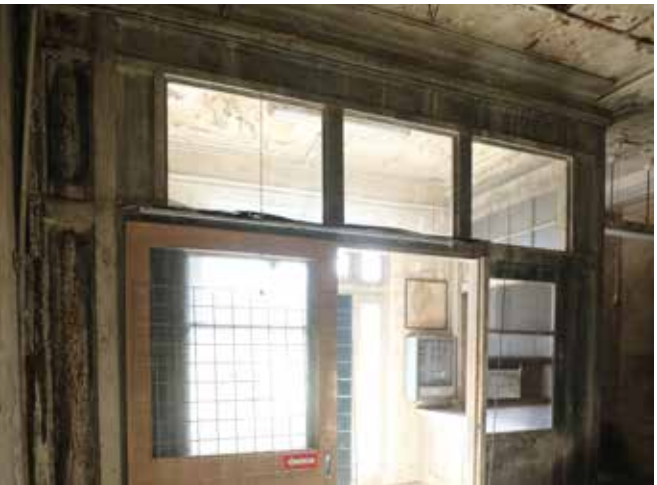
<p>Substantial early joinery remains in the building. it is in generally moderate condition and should be repaired to match. This includes internal doors, the entrance vestibule, fireplaces, skirtingboards, picture rails, and dividing screens.</p> <p>WORKS:</p> <p>Repair all timberwork to the building. Replace elements where missing or damaged (allow 50%). Repaint.</p>

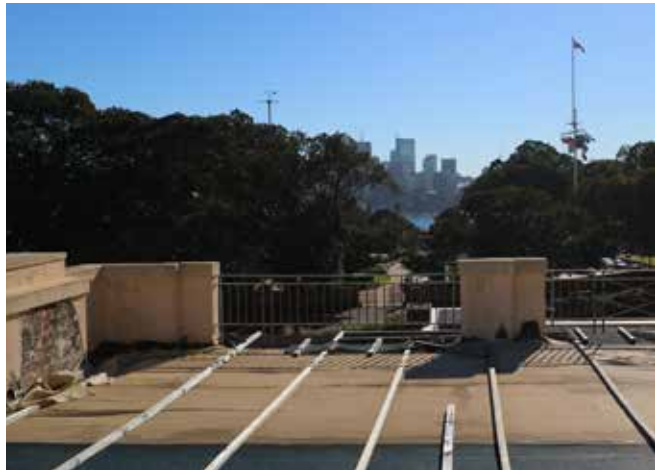
<p>The roof and guttering to the building is missing.</p> <p>WORKS:</p> <p>Repair the existing roof. Exact roof type is to be determined, but this roof is to be trafficable. Existing handrails are to be repaired and repainted, and a new compliant barrier is likely required.</p> <p>Allow for full replacement of the guttering to the building.</p> <p>Allow for full replacement of perimeter membrane above eaves. Allow for new cement topping to all parapets to prevent further water ingress.</p>

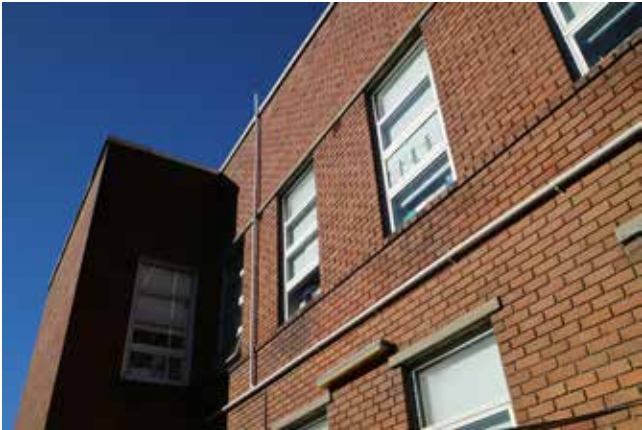
<p>The external brickwork to the building is in generally good condition. Cement string courses and parapet capping are in moderate condition.</p> <p>WORKS:</p> <p>Allow for a general clean of the brickwork and cement elements on all elevations. Allow for approximately 25% repointing of brickwork.</p> <p>Allow for removal of all non-original signage, conduit, lighting, etc and repairs to fabric as necessary. Allow for a new capping element (possibly in folded metal) to the parapet line.</p>

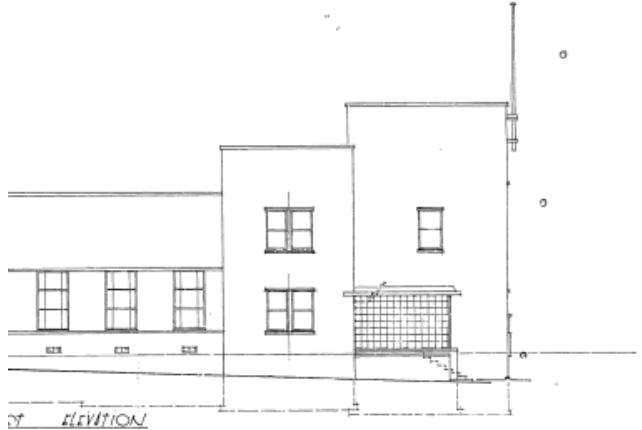
<p>The main entry to the building and the three small windows at the base of the tower have had their glass block windows removed.</p> <p>The flagpole to the main tower has also been removed.</p> <p>WORKS:</p> <p>Allow for reinstatement of the original glass block wall as per the original design.</p> <p>Allow for a new flagpole to the main tower.</p>

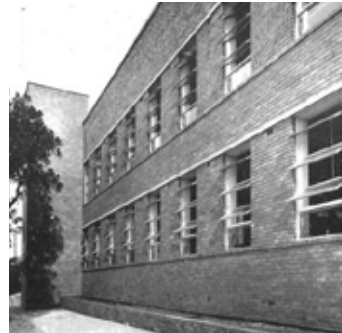
<p>The original steel windows that were an integral part of the design have been replaced. Current windows do not meet acoustic requirements.</p> <p>WORKS:</p> <p>Allow for complete replacement of all external windows. The detail of the new window is to match the original historic steel windows for the building.</p>

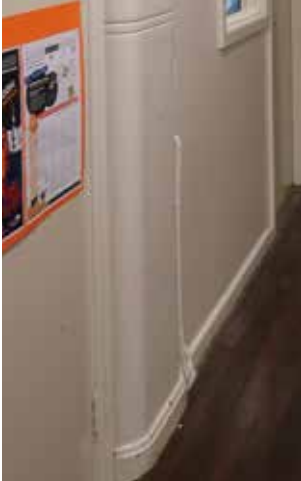
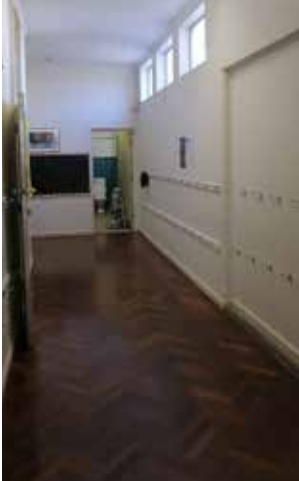
</div>	<p>The significant elements of the building interior should be retained and conserved.</p> <p>WORKS:</p> <p>Allow for a light sanding and repolishing of the original floorboards and parquetry flooring. Repair walls to match existing where any new openings are made or original openings restored. Restore the original curved corner elements to the interior.</p>
<div>

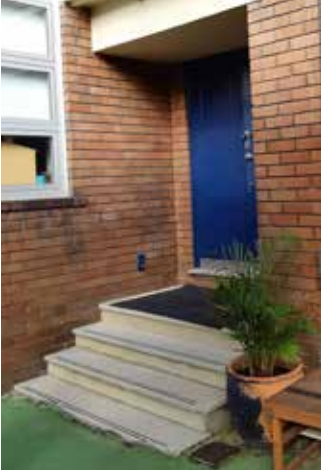
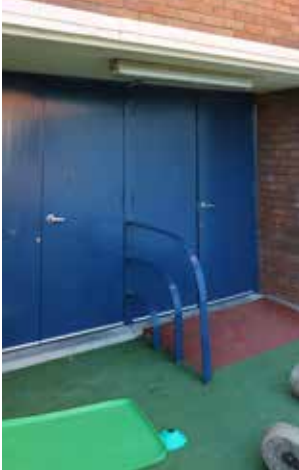
</div>	<p>Original elements to the exterior of the building remain in place and should be conserved. These include the original timber doors, terrazzo steps, and metal handrails.</p> <p>WORKS:</p> <p>Allow for repairs to terrazzo steps.</p>
<div>

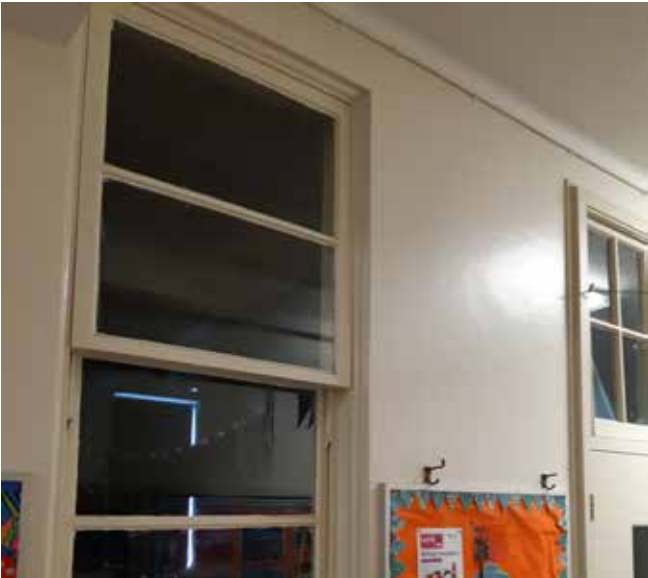
</div>	<p>The internal windows, doors and fanlights are in good condition. They should be retained and conserved wherever possible.</p> <p>WORKS:</p> <p>Minimal repair works required to these elements.</p>

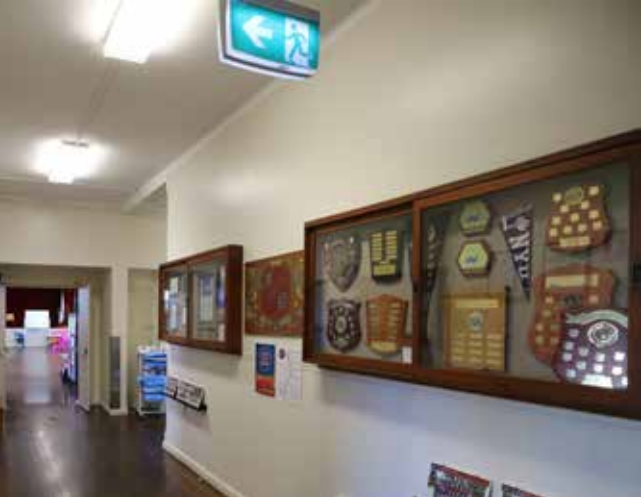
<p>Historic display cabinets, honour boards, etc should be appropriately catalogued and incorporated into the new works. There may be some minor repair works required.</p> <p>WORKS:</p> <p>Allow for the preparation of a moveable heritage management strategy</p>

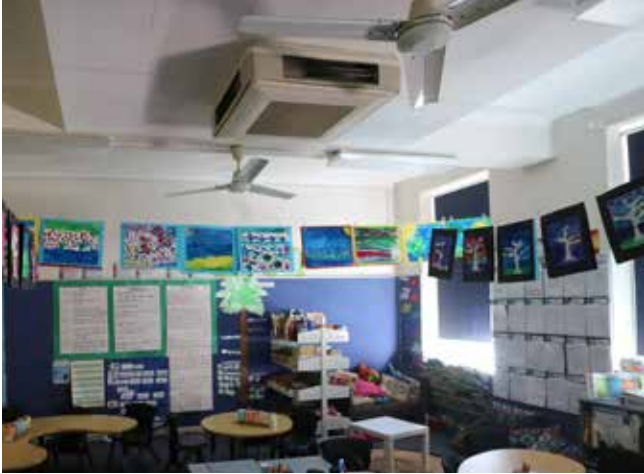
<p>Existing air conditioning units, fans, lights etc are presumed to be upgraded in some way as part of the planned works.</p> <p>WORKS:</p> <p>Allow for repairs to ceilings and walls to match existing surfaces.</p>

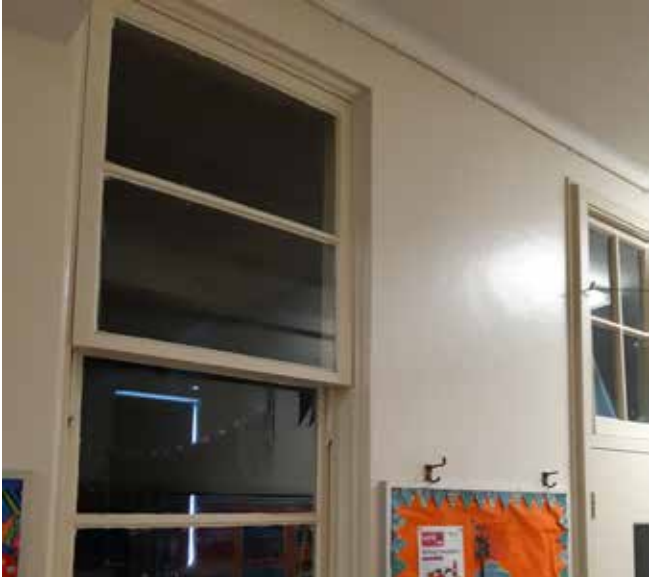
<p>The interior of the building (and selected parts of the exterior such as the doors) may be repainted as part of the works.</p> <p>WORKS:</p> <p>Allow for historic paint scrape analysis to selected original features (timber doors, handrails, internal window frames, skirtings, etc) to assist in preparation of historic colour schedule for appropriate elements.</p>

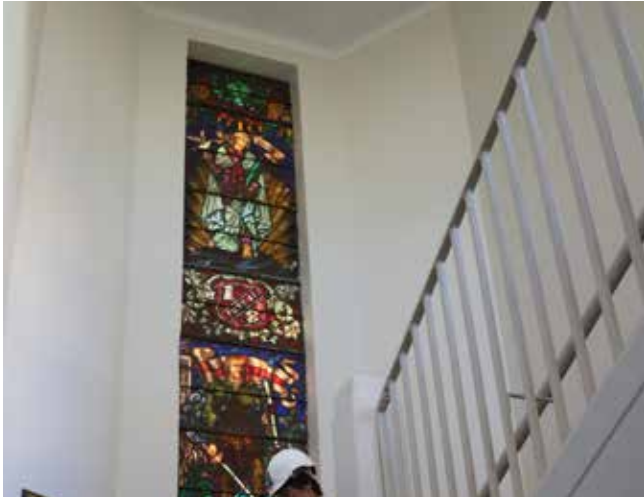
<p>The historic stained glass War Memorial window may require some repair. It would be a positive outcome to remove (or at least upgrade) the external protective grille which is in poor condition</p> <p>WORKS:</p> <p>Allow for the removal or replacement of the security grille to the window. Allow for any necessary cleaning and repairs.</p>

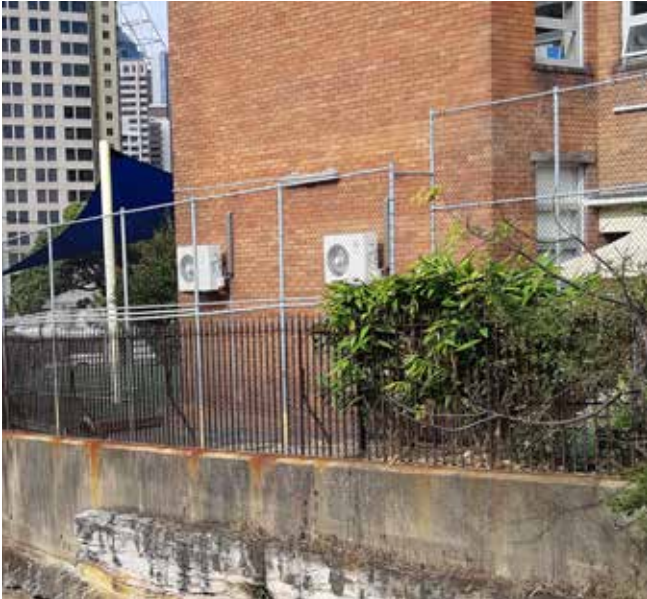
<p>The perimeter palisade fence dates from the time of the Cahill cutting and is in poor condition in some areas. The fencing should be retained and conserved as part of the works. There is some evidence of crevice corrosion (note rusting to concrete base).</p> <p>WORKS:</p> <p>Allow for the removal of existing secondary wire fencing, and of any vegetation.</p> <p>Allow to repair the fence as appropriate.</p> <p>It may be judged necessary to paint the fence. Allow for cleaning and preparation, application of alkyd-based protective primer, and coating with a micaceous iron oxide paint.</p>

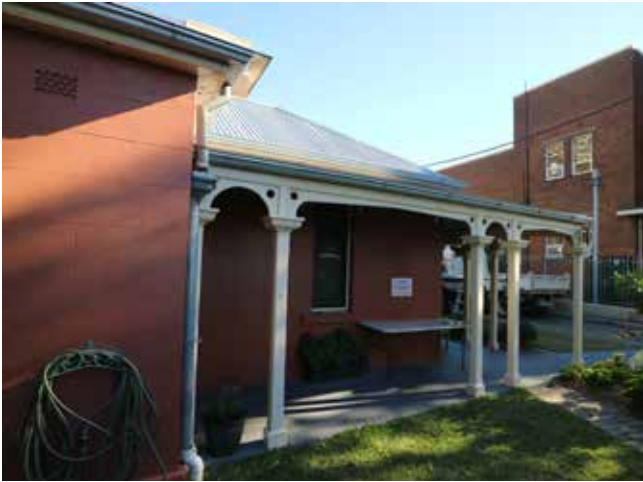
<p>The exterior of the building is in generally good condition.</p> <p>WORKS:</p> <p>Allow for minor repairs only.</p>

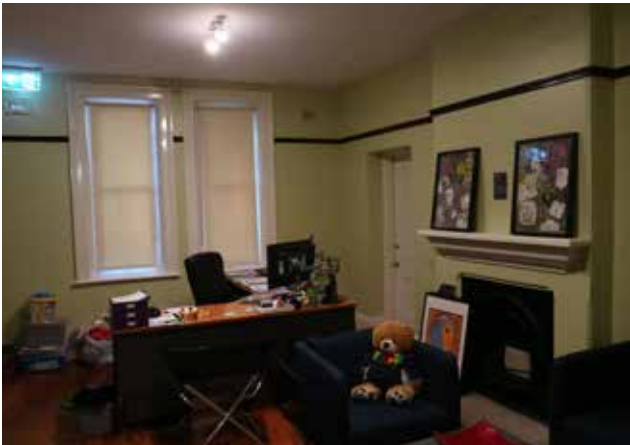
<p>The interior of the cottage is in generally good condition, with a substantial amount of the internal fabric being of new construction but to historically appropriate design.</p> <p>WORKS:</p> <p>Allow for minor repairs only.</p>

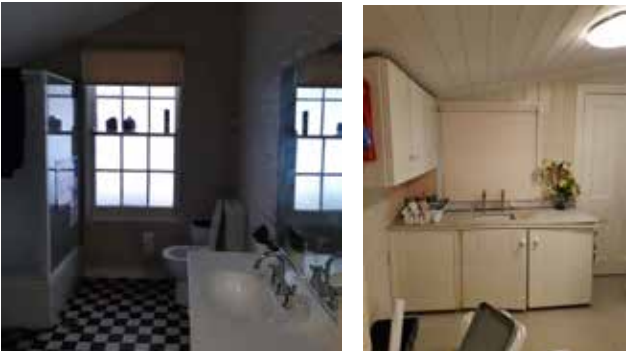
<p>The current bathroom and kitchen are presumed to be modified as part of the works.</p> <p>WORKS:</p> <p>Allow for careful removal and repair any elements as necessary. There may be an opportunity to expose the original external brick wall of the 1862 cottage currently in the bathroom, and this would require appropriate paint stripping.</p>

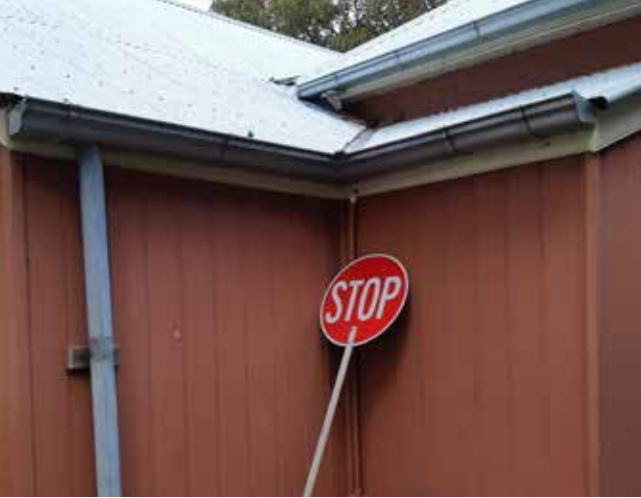
<p>The new roof was installed in 2016. It is in good condition, but there are some loose downpipes and gutter connections.</p> <p>WORKS:</p> <p>Allow for repair to downpipes.</p>

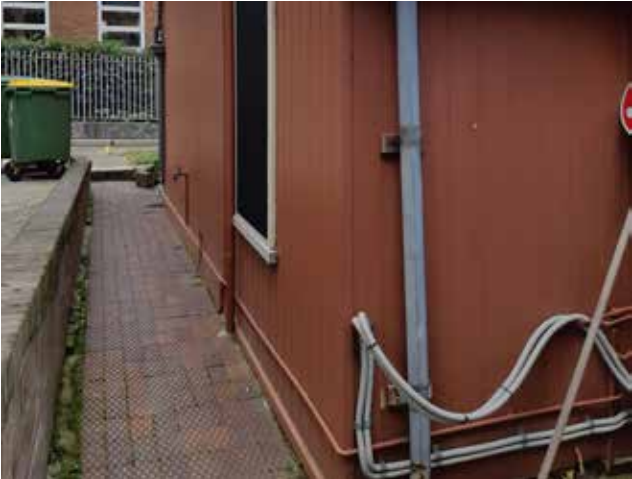
<p>Numerous modern services have been inappropriately installed to the rear of the building.</p> <p>Circulation paths around the building will likely need to be reconfigured.</p> <p>WORKS:</p> <p>Allow for removal/consolitation of necessary cabling. Install cover and paint in to reduce visual impact.</p> <p>Allow for new pathways to the building perimeter. Consider upgrading the modern concrete verandah with sandstone to appropriate detail (it is presumed the building had a stone flagged verandah).</p>
