# FARM DAM INFILLING ENVIRONMENTAL MANAGEMENT PLAN

MARCH 2021

Tweed Valley Hospital Development  
Kingscliff, NSW, 2487

Prepared for Lendlease Building Pty Ltd

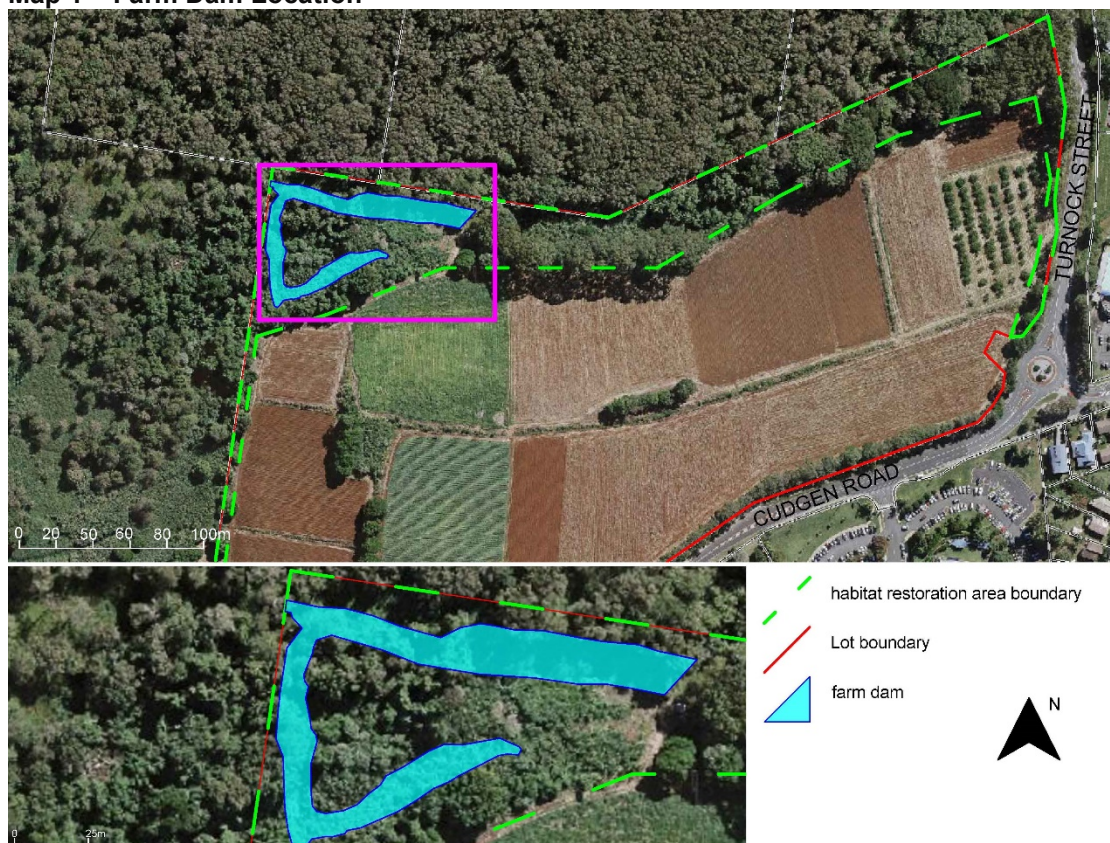
**Map 1 – Farm Dam Location<sup>1</sup>**

A farm dam in the north-western portion of Lot 11 DP1246853, outside the Tweed Valley Hospital construction footprint and inside the habitat restoration area, is scheduled for infilling as part of implementing the Stage 2 Biodiversity Management Plan (BMP, Greencap 2020) of the NSW Health Infrastructure Tweed Valley Hospital (TVH) project. Map 1 illustrates dam location within the Lot and outlines the habitat restoration area.

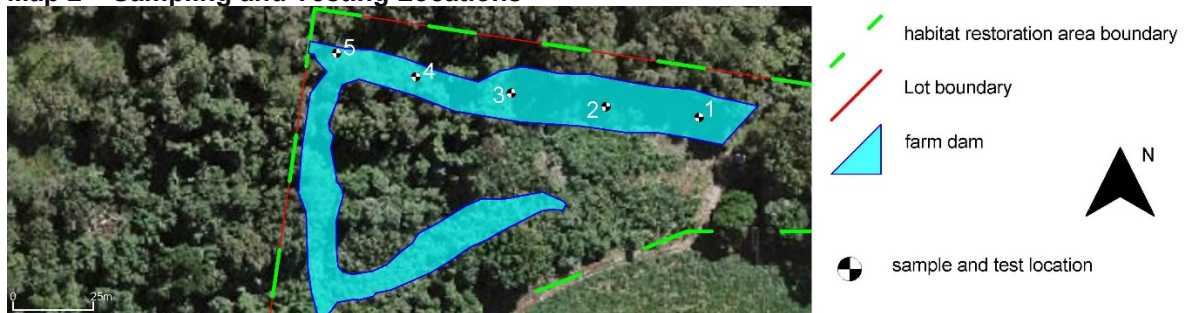
**Map 2 – Sampling and Testing Locations**

The investigation consisted of sampling the base of the dam with a hand auger at three locations and gauging water depth and bathymetry with a depth gauge staff. Three samples were collected and sent to Mazlab laboratory for analysis with the reducible chromium sulfur suite. Field parameters (pH, turbidity, and dissolved oxygen) were measured with a Horiba U-52 water quality monitor within the seasonal flowline and farm dam<sup>3</sup>. Map 2 indicates approximate sampling and testing locations.

*Note: Samples were collected and field parameters were measured in locations 1, 2, and 3. Field parameters were measured in locations 4 and 5 but no samples were collected at these locations.*

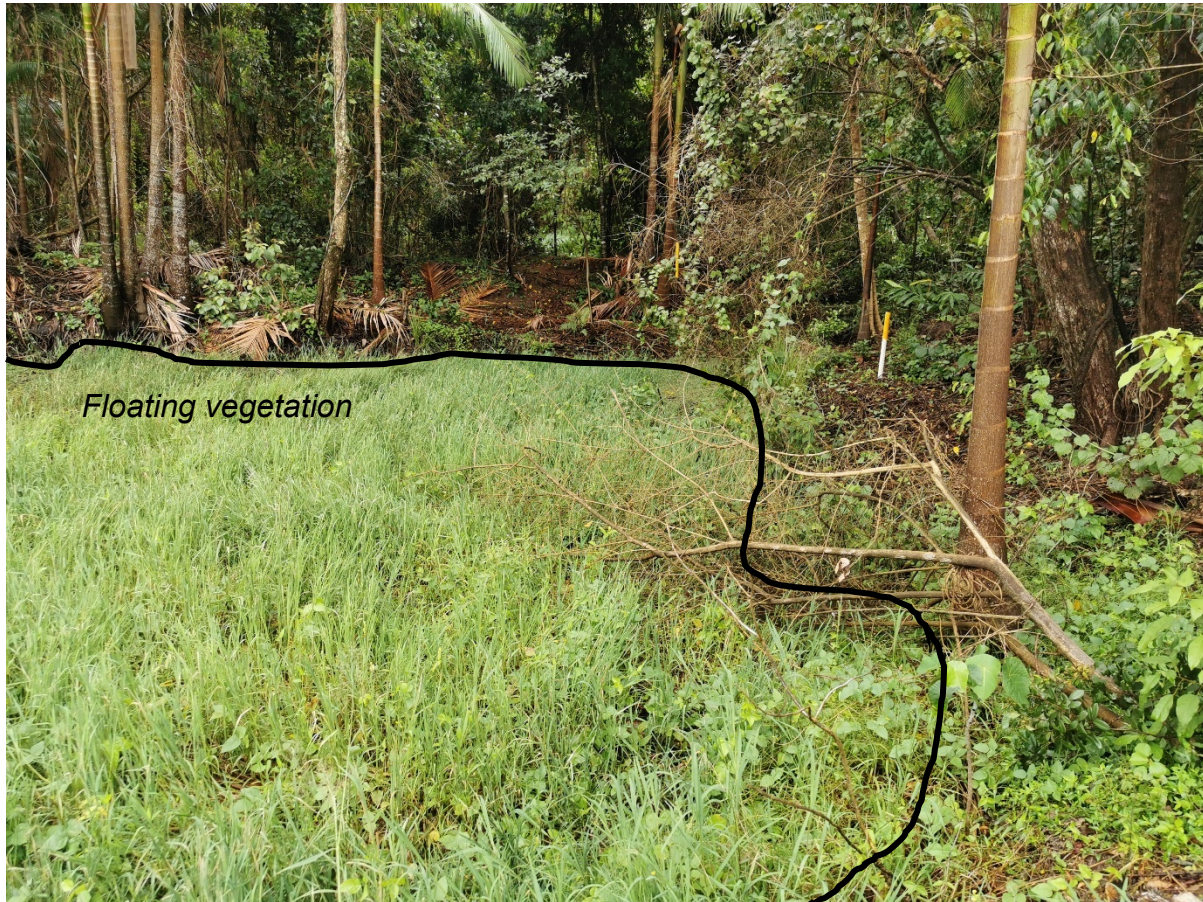
**Image 1 – Floating Mat of Vegetation in the Dam**

The surface of the dam and the seasonal flowline is infested by *Salvinia spp.* (Salvinia). Most of dam contains a thick floating mat of vegetation consisting of *Salvinia spp.* (Salvinia) and invasive pasture grasses such as *Setaria sphacelata* (Setaria) and *Paspalum mandiocanum* (Broad-leaved paspalum). Image 1, taken from the southern bank of the dam facing sampling location 1 outlines the floating mat of vegetation in black.

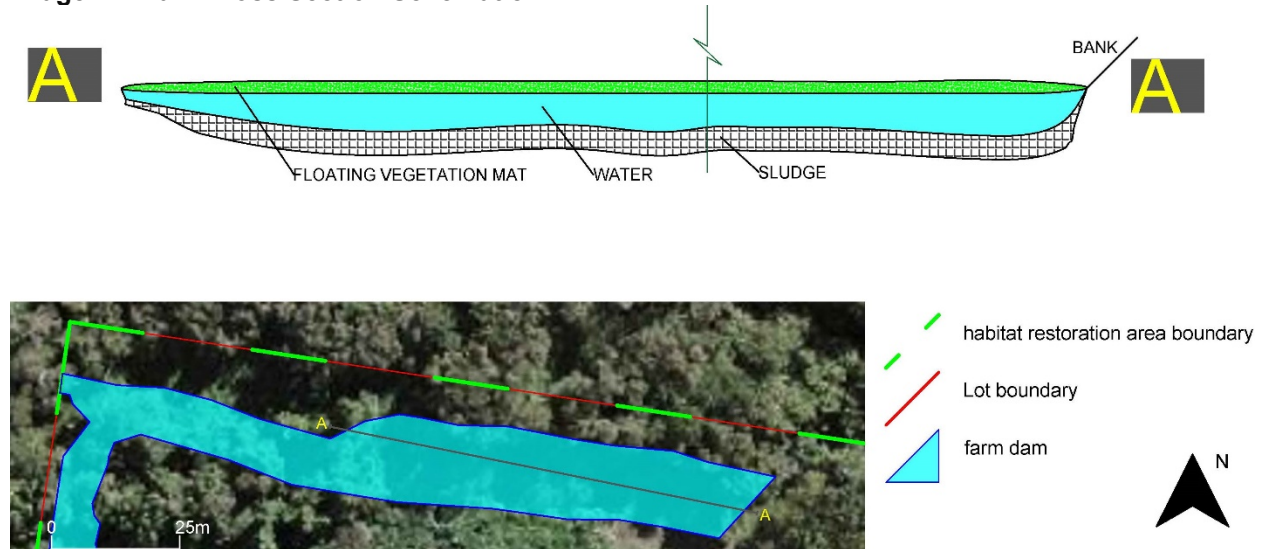
**Image 2 – Dam Cross Section Schematic**

The investigation found that water depth varies. The deepest portion is in the east of the dam and is approximately 2m deep. The shallowest portion is approximately 1.5m deep and is in the west. The dam floor consisted of decomposing vegetation and sludge approximately 1m deep. Image 2 provides a cross section of the dam.

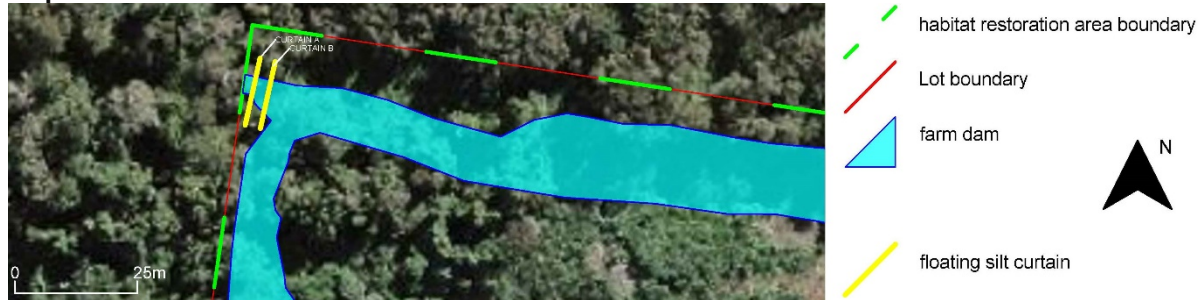
**Map 3 – Sediment Curtain Locations**

Two floating sediment curtains will be placed in the locations indicated in Map 3.

Sediment curtains will be installed in accordance with the International Erosion and Sediment Control Association (IECA) Australia standard drawings FSC-01, FSC-02, and FSC-03, included in Attachment 2. Curtains will be placed at least 10m apart to accommodate cofferdam construction. If deemed necessary by any of the parties listed in Table 1, curtain B can be removed after successful cofferdam installation. Curtain A will remain in place until decommissioning (Step 9).

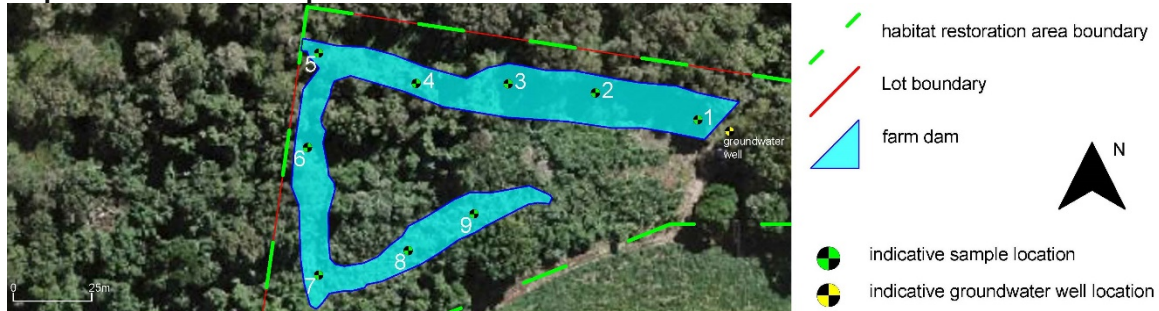
**Map 4 – Additional Sample Locations**

During fyke net deployment, at least four MBO samples will be taken at the approximate locations indicated by Map 4 with at least one sample taken from within the cofferdam alignment. If possible, groundwater depth will be determined from existing investigation results and the groundwater well near the farm dam. Samples will be analysed at a NATA accredited laboratory for acid volatile sulfur and via the reducible chromium sulfur suite. The sample representative of sediment in the cofferdam alignment will be analysed for nutrients and metals in accordance with (Burton 2019).

MBO sample analysis results and groundwater table height will determine MBO management options, as described in Section 6.7.

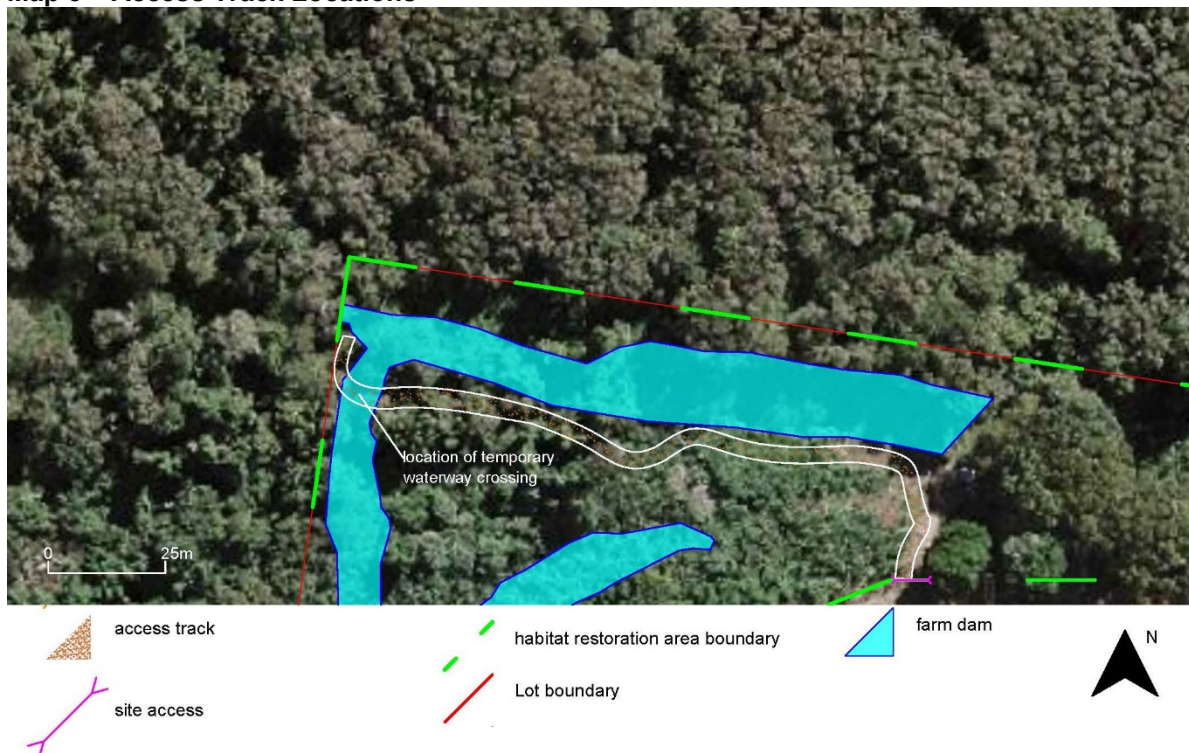
**Map 5 – Access Track Locations**

During fyke net deployment, an access track will be constructed in the approximate location indicated by Map 5. The site visit concluded that VMZ 1.4 is not exhibiting significant native recruitment and the areas in Map 4 are indicative of locations with significant invasive pasture grass infestation. Access track alignment will be approved by the restoration foreman, in accordance with Section 7. A temporary waterway crossing will be constructed in the location indicated in Map 5 in accordance with the general methodology included in Attachment 3.

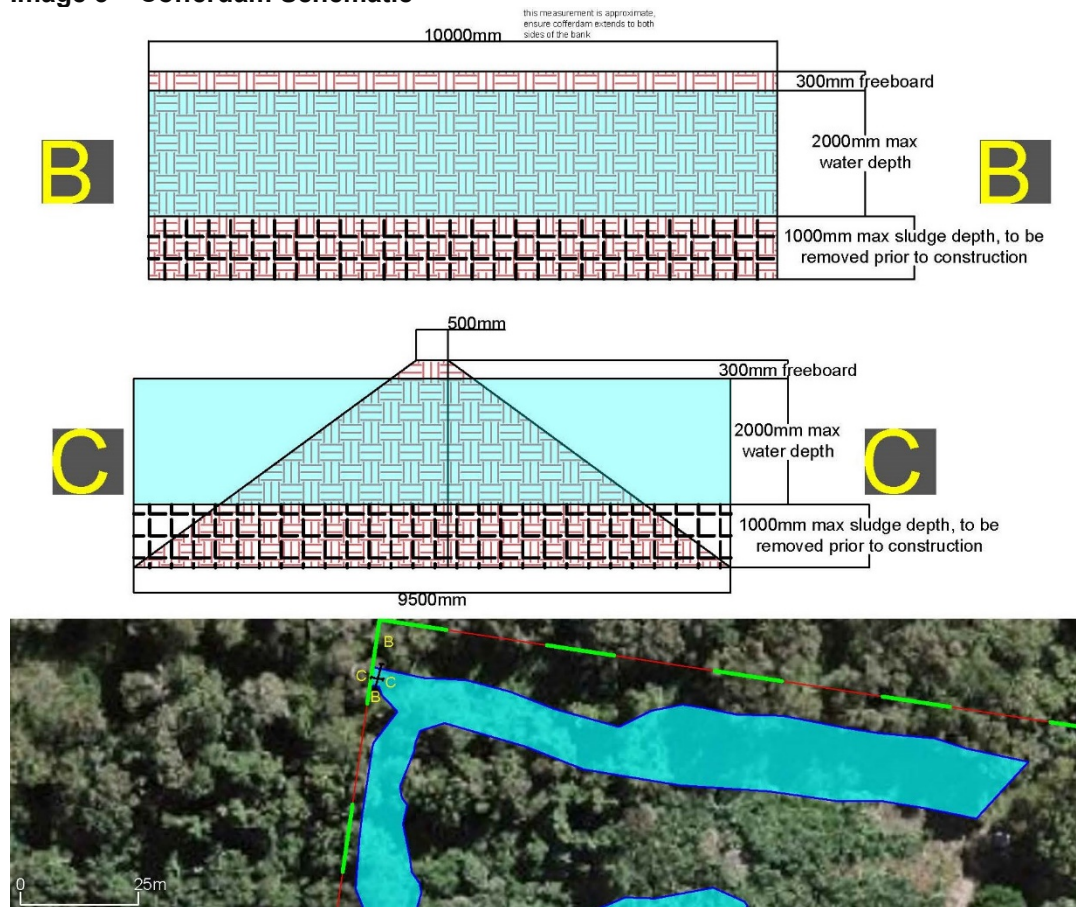
**Image 3 – Cofferdam Schematic**

The cofferdam should be generally constructed in accordance with the schematic in Image 3.

The cofferdam will be constructed under the supervision of Pacific Geotech and amendments to cofferdam construction will be made in accordance with Section 7.

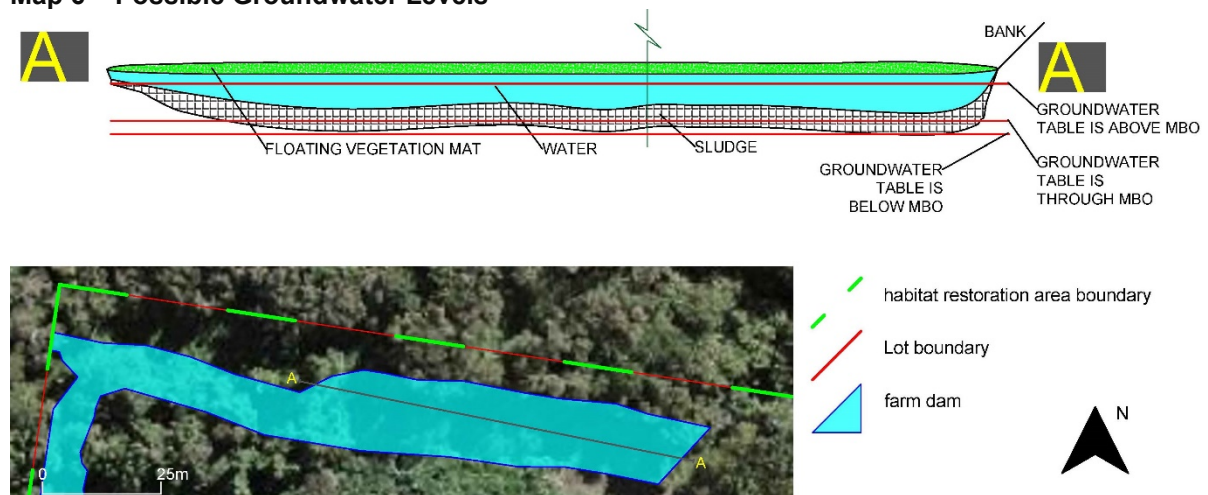
**Map 6 – Possible Groundwater Levels**

Results of additional sampling will classify MBO (see Section for 6.5 for definitions of low, medium, and high risk MBOs) and identify the level of the standing groundwater table. The standing groundwater table may be above the level of MBO, thereby providing an anaerobic environment to the MBO after filling, groundwater may be below the MBO, in which case the MBO will be exposed to some oxygen after filling and may acidify groundwater, or the groundwater may be in the middle of the MBO layer in which case parts of the MBO will be in the groundwater while parts will be above after the dam is filled. Map 6 provides a schematic of possible groundwater levels.

There are two management options depending on the results of the investigation. Option A involves dewatering the dam, placing a layer of aglime on top of the MBO, and proceeding with the infilling operation. Option B involves stopping dewatering before high risk MBO is exposed, placing lime into the water that is covering the MBO and proceeding with the infilling operation. Table 4 outlines what combination of results would lead to management options A or B.

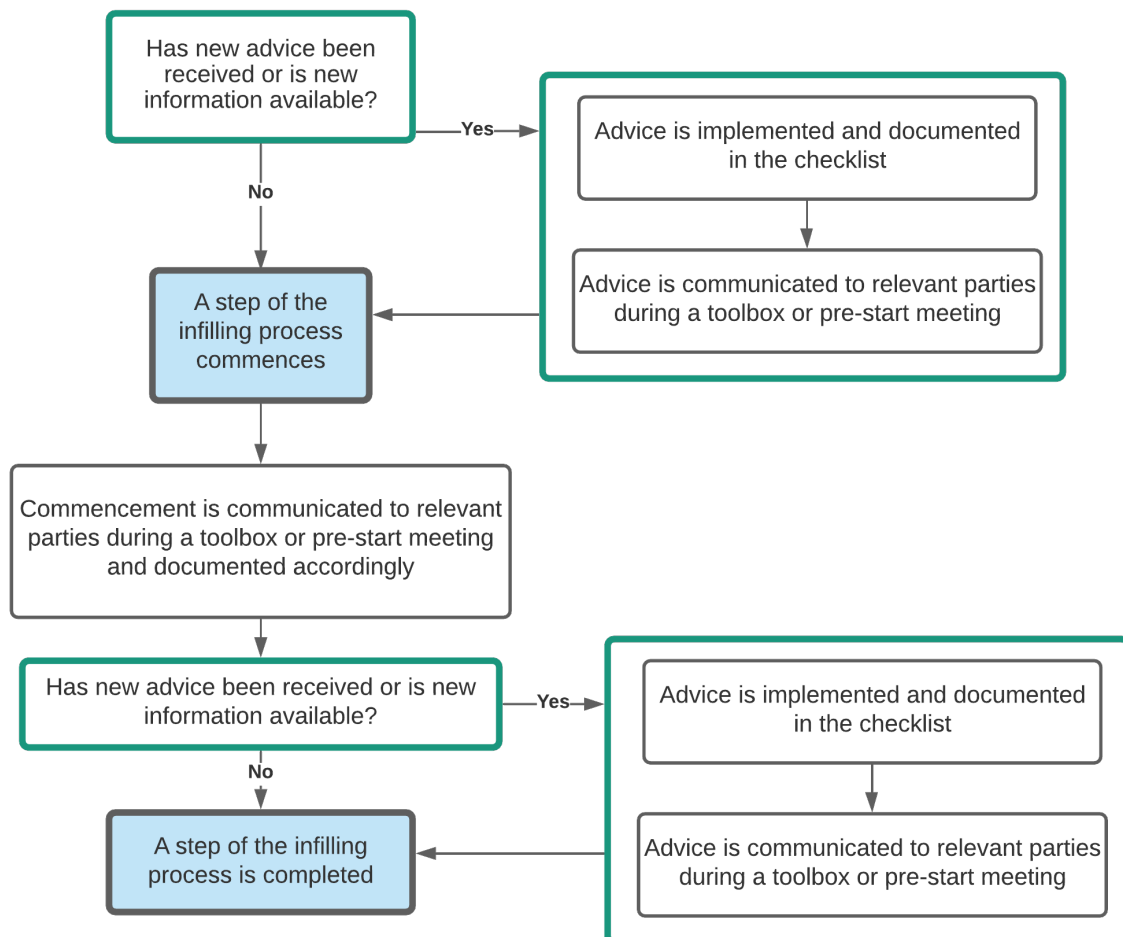
**Flowchart 1 – Managing and documenting advice and information**

The overarching process of managing and documenting advice and information, including additional relevant information outside the immediate scope of the Checklist, is provided in Flowchart 1.

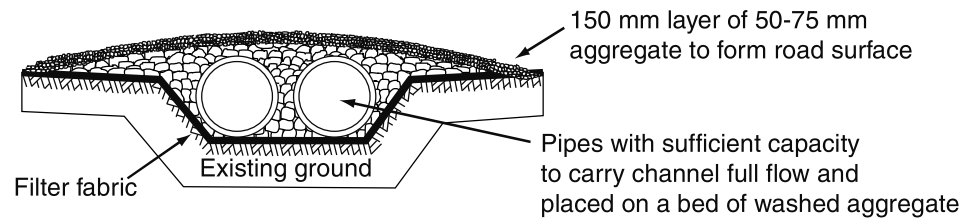
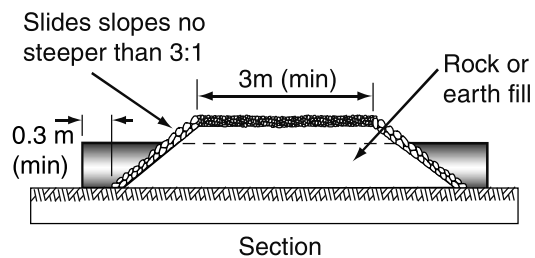
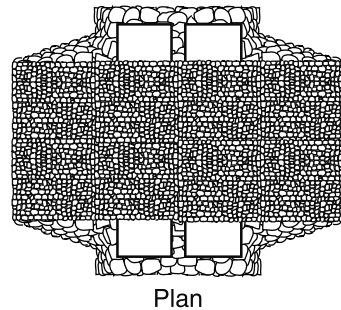
**(a) Preferred arrangement for temporary culvert crossings**

In situations where it is not practicable to allow overflows to initially passing around the culvert on a stable (well vegetated) stream bank, then the center must be set low to allow flow to pass over the culvert along the centreline of the channel

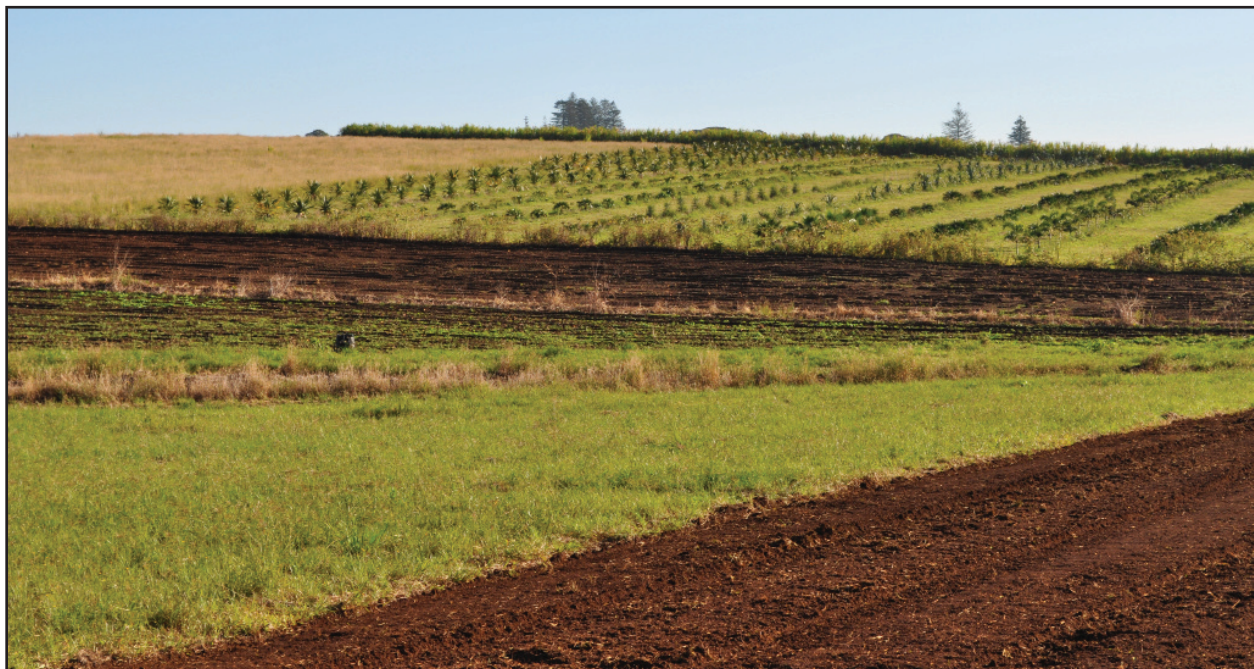
**cu****CUDGEN**

**Landscape**—low undulating hills and rises on Tertiary basalt plateau. Relief is 20–40 m; elevation 30–40 m; slopes 2–10% and steepening to 20% on plateau margins. Completely cleared closed-forest (rainforest).

**Landscape Variant**—**cua**—narrow drainage depression.
