Hans Sydney Pty Ltd
Preliminary Site Investigation

Stage 2
338 Pitt St, Sydney
NSW 2000

19 December 2019
57557/126005 Rev 1
JBS&G

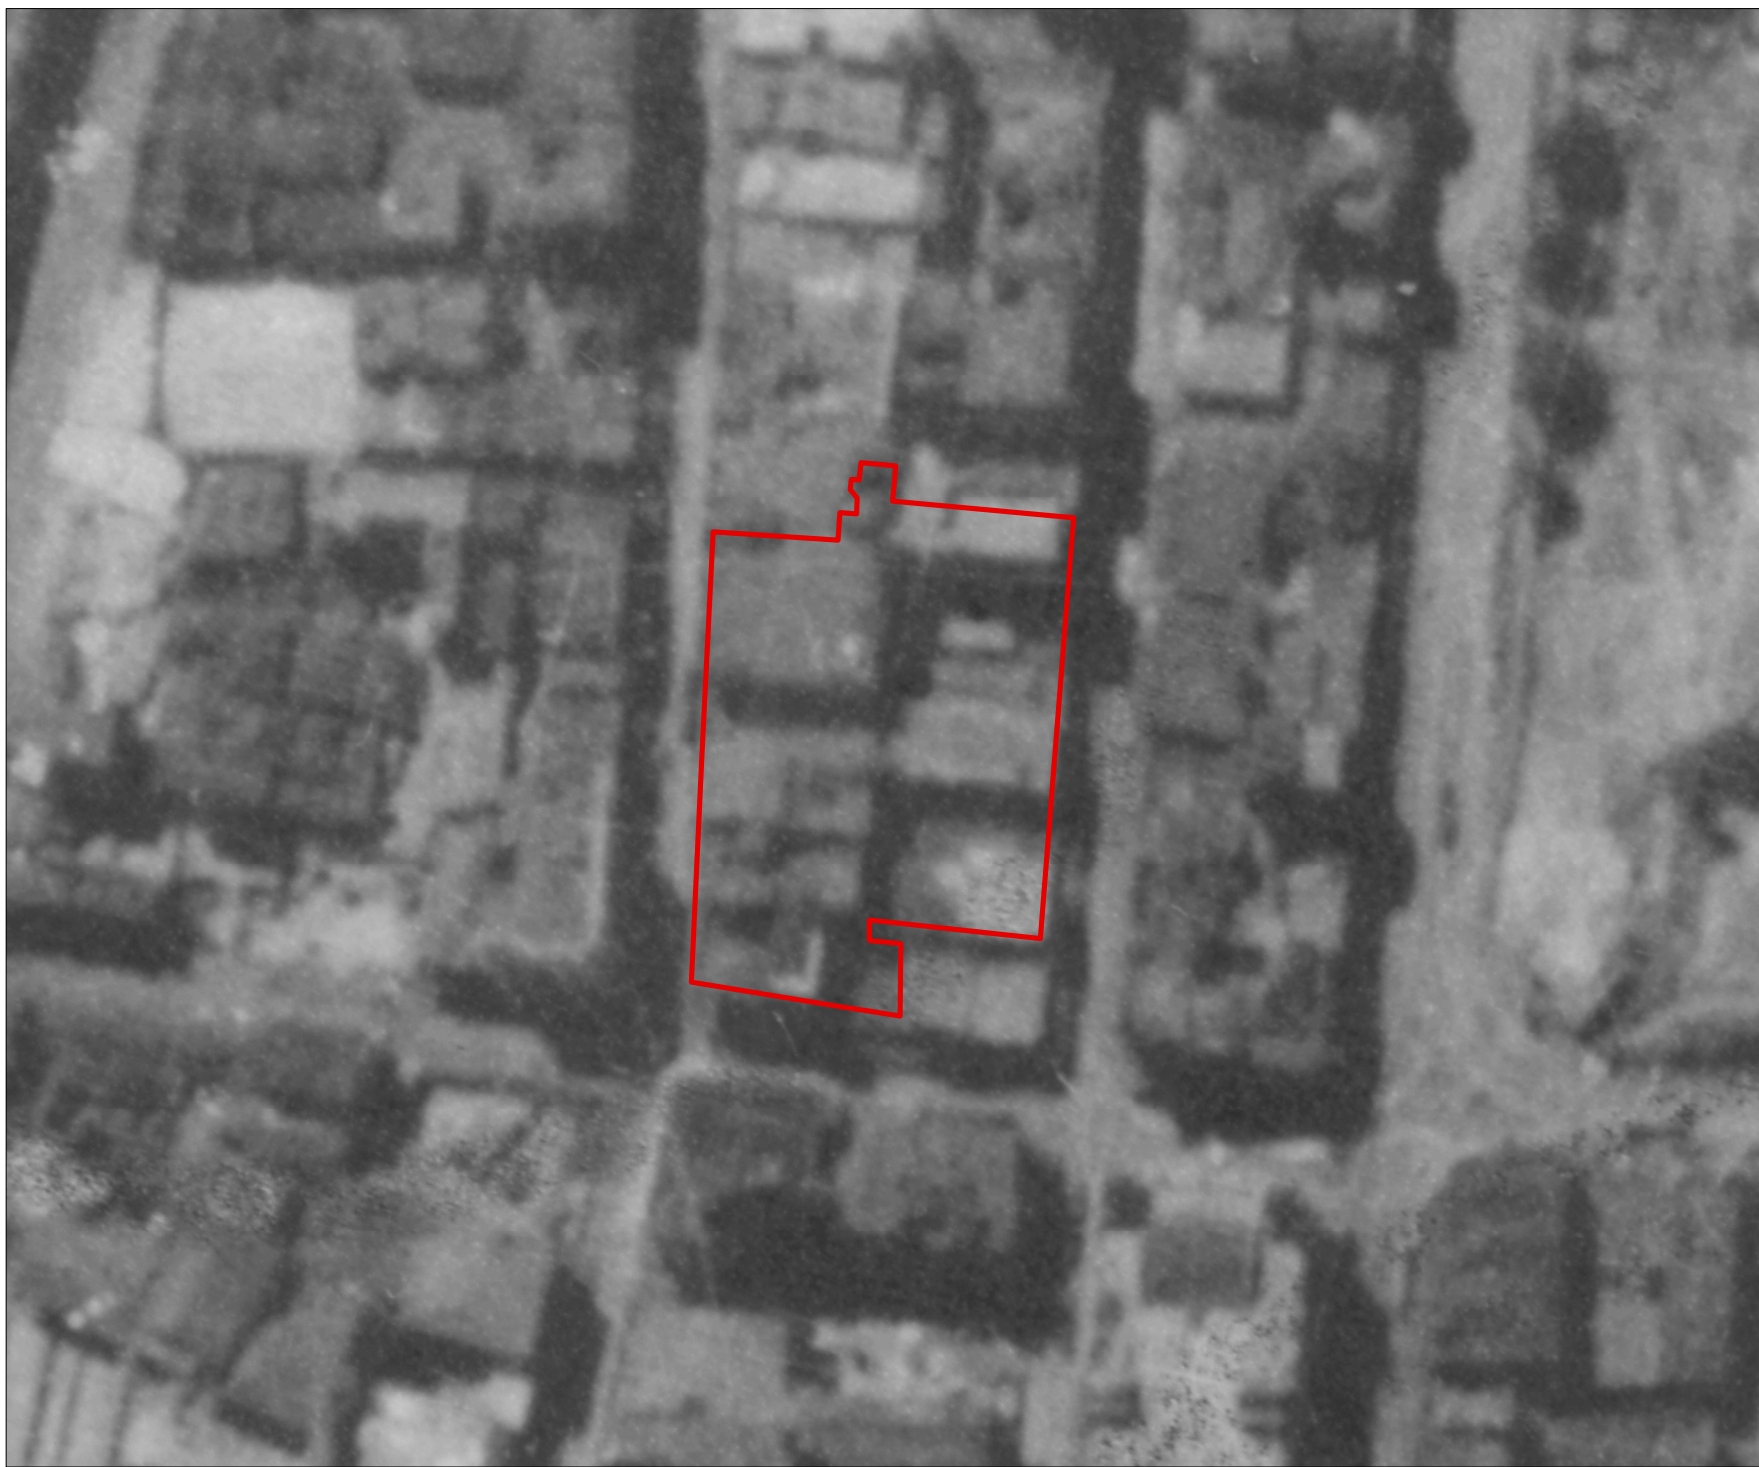
FIGURE 1930

- **1930:** The site appears to be occupied by multistorey buildings. A portion of the north east of the site, adjoining Castlereagh Street, appears to be occupied by two small structures. Other portions of the site may be vacant, however, it is difficult to be certain due to shadows cast by the taller structures at the site.

**HISTORICAL AERIAL
IMAGERY - 1930**

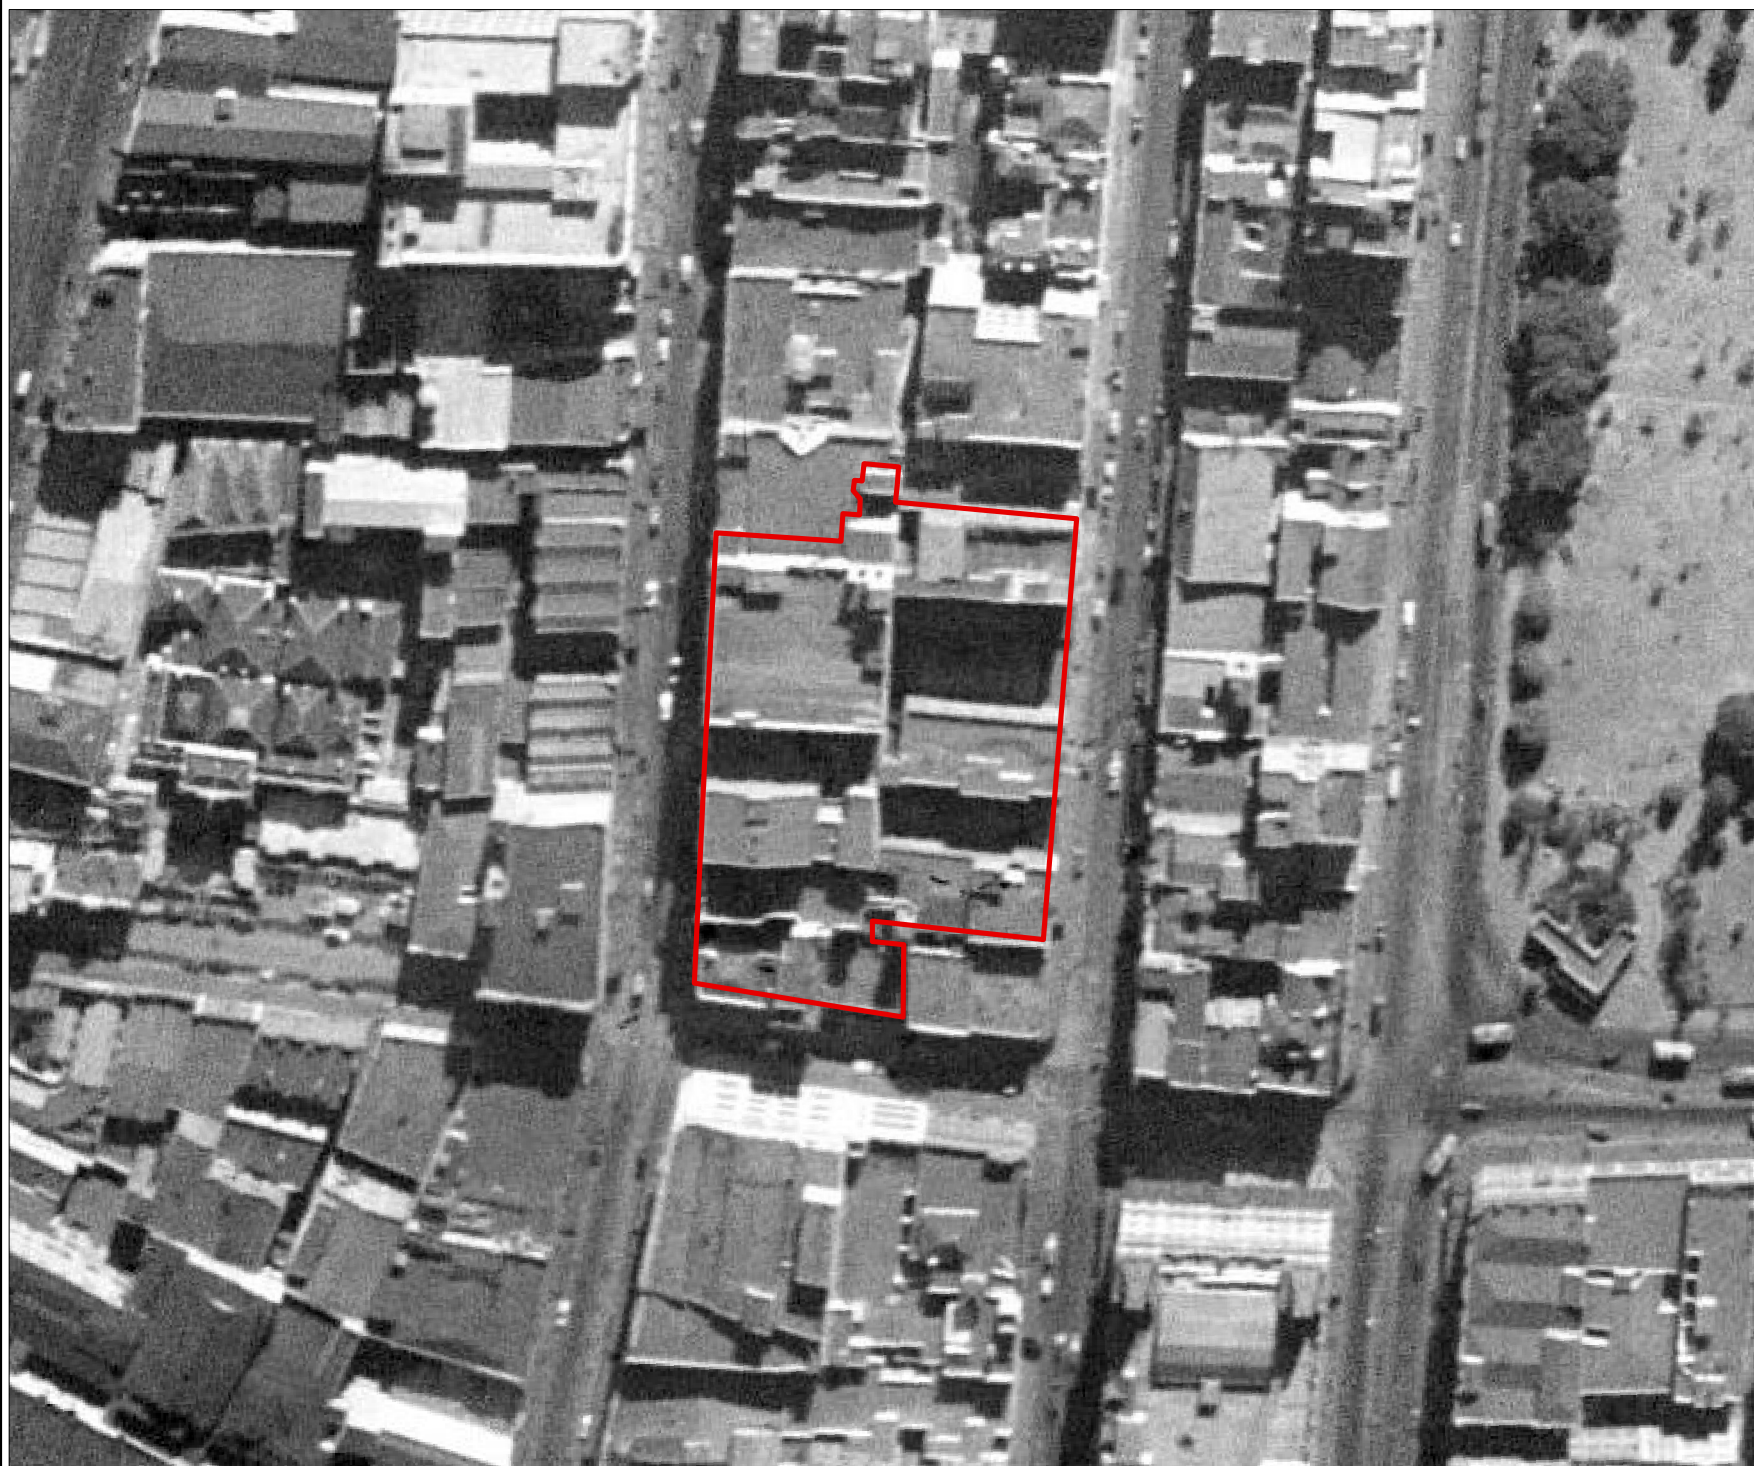
FIGURE 1943

- **1943:** The site appears mostly unchanged from the 1930 imagery with the exception that the smaller structures in the north east of the site are no longer visible.

**HISTORICAL AERIAL
IMAGERY - 1943**

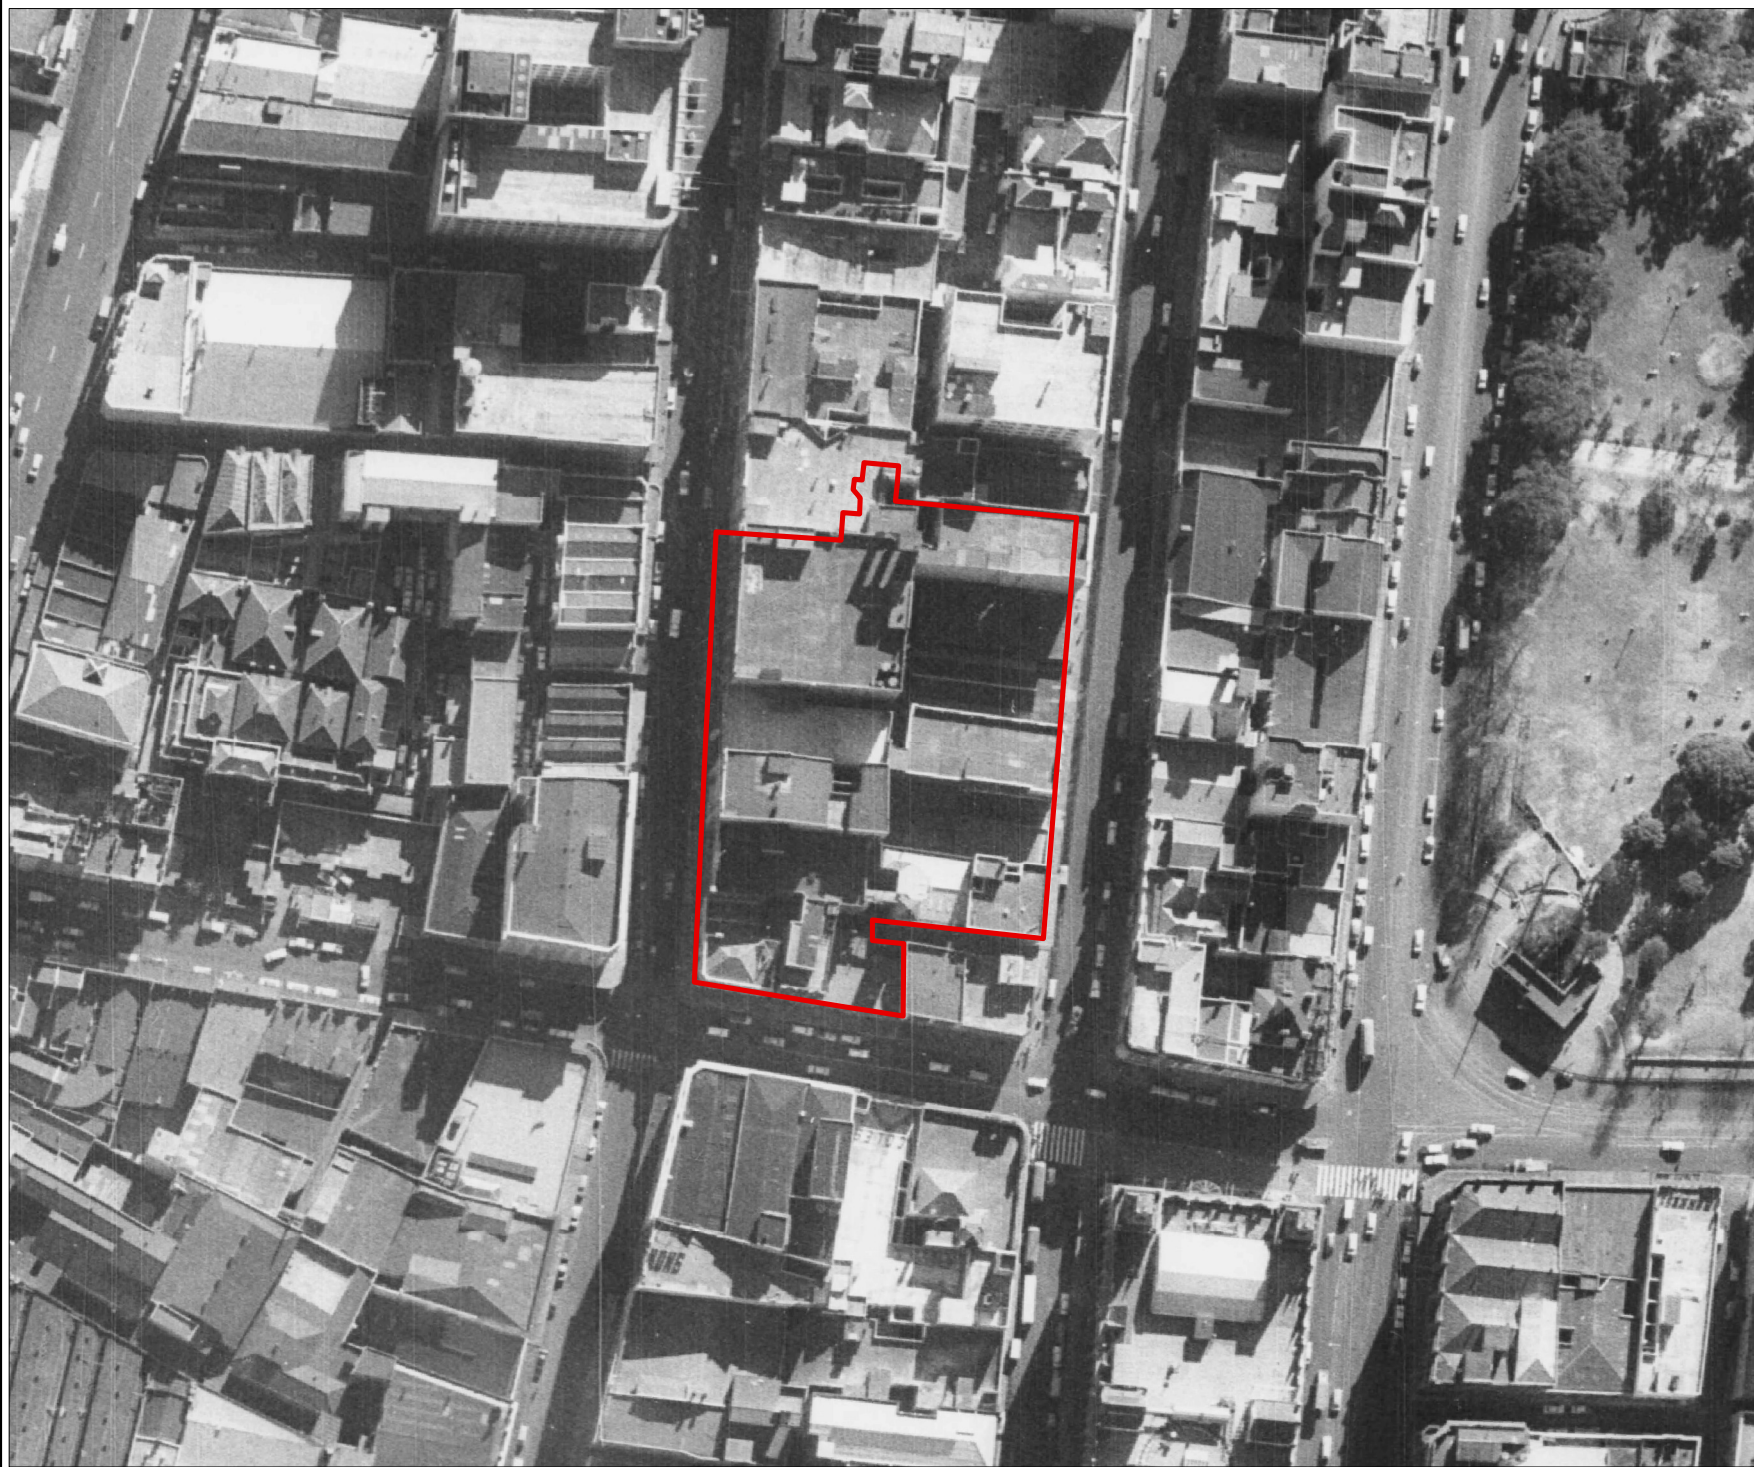
FIGURE 1961

- **1961:** The whole site area is occupied by buildings, including the areas between the larger structures which appeared possibly vacant in the 1930 and 1943 images.

**HISTORICAL AERIAL
IMAGERY - 1961**

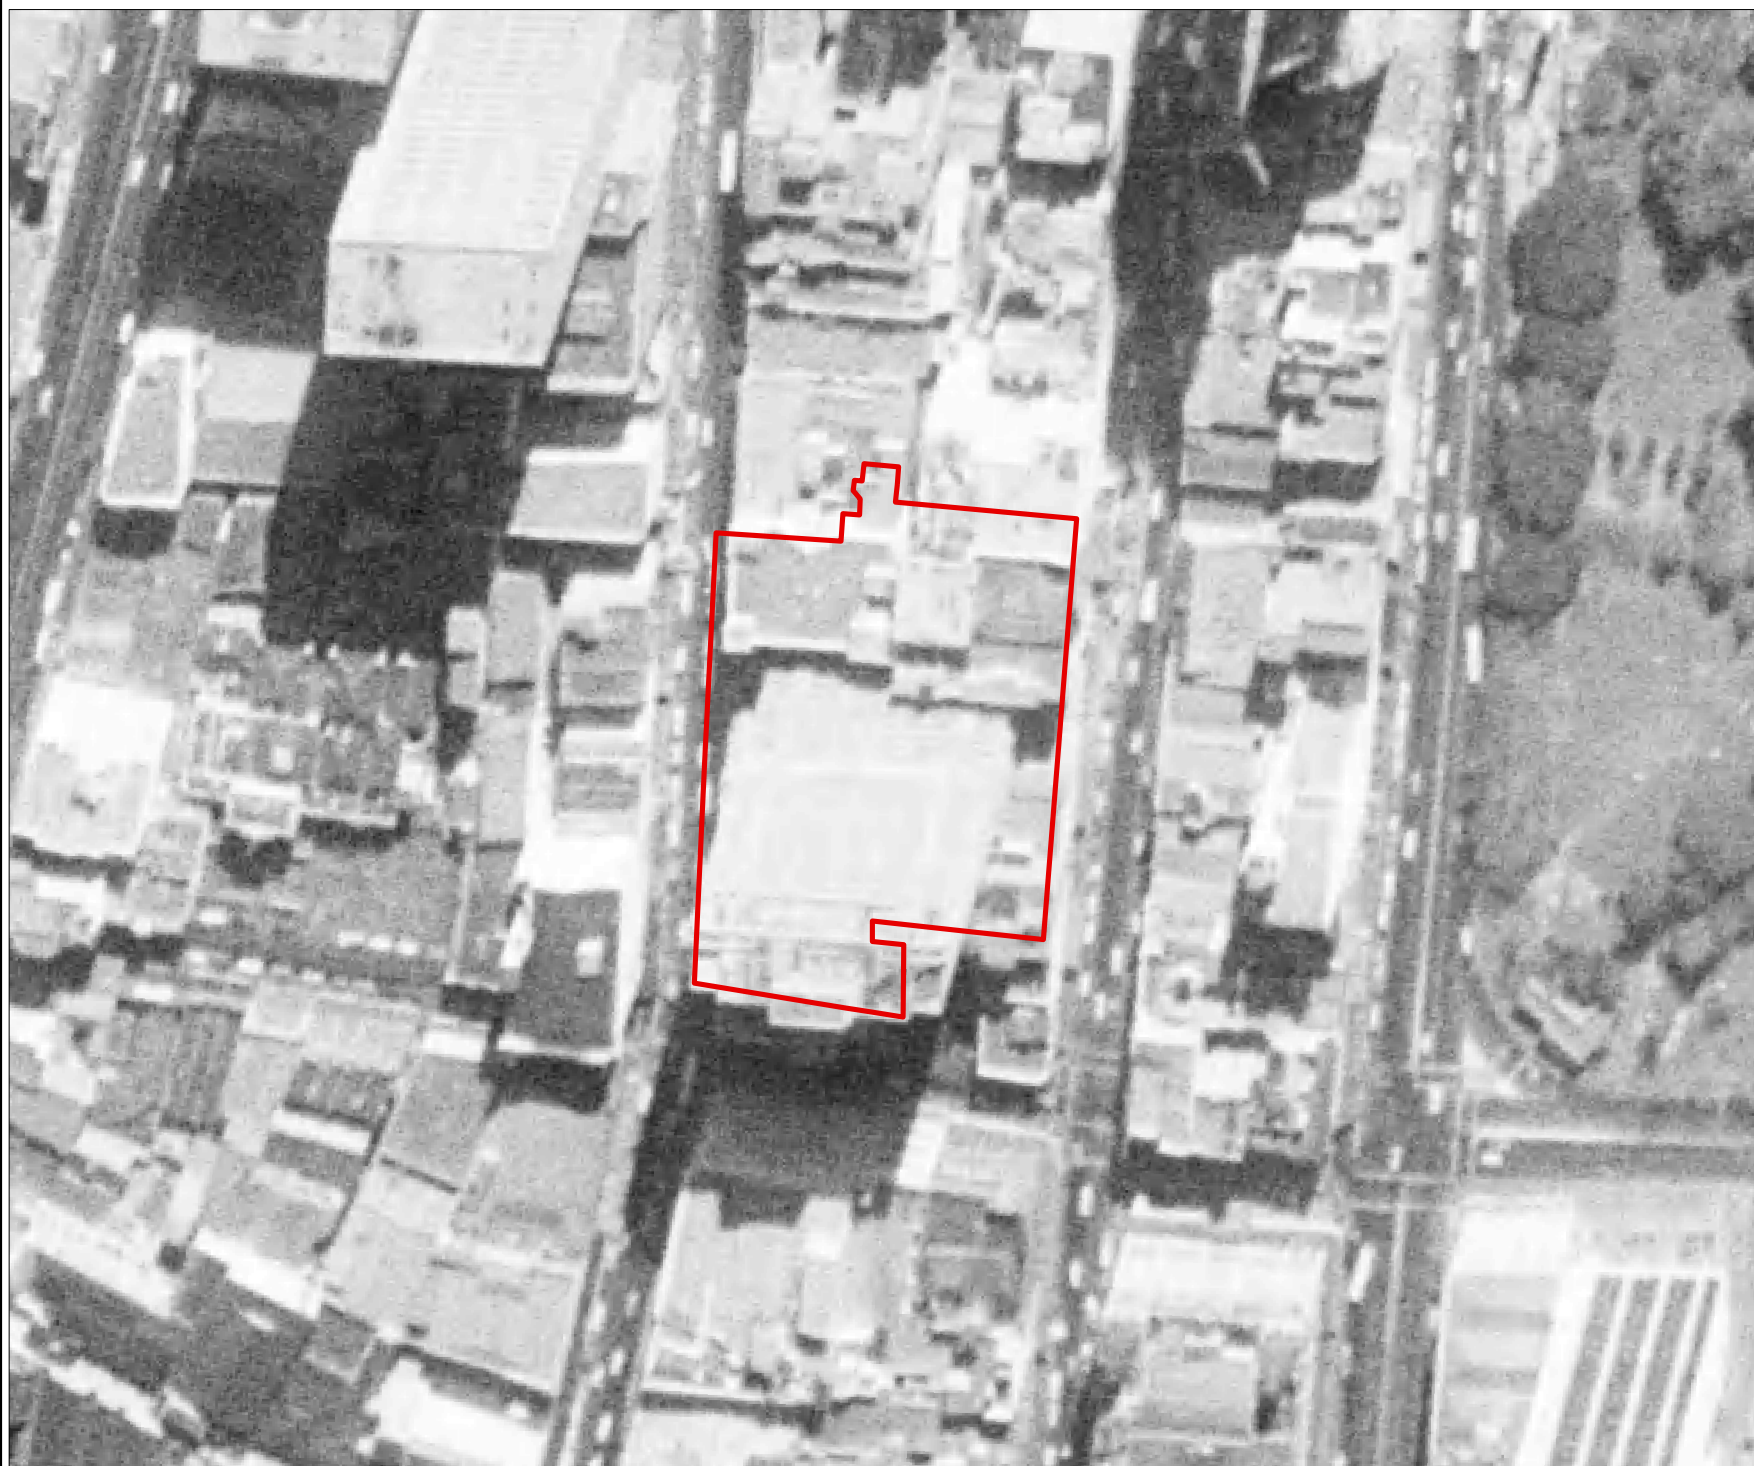
FIGURE 1975

- **1975:** A new multistorey building has been constructed in the northern portion of the site which is significantly taller than the buildings previously in this location, and has an associated courtyard adjoining Castlereagh Street. This building obscures a large portion of the site due to the angle of the aerial photograph.

**HISTORICAL AERIAL
IMAGERY - 1975**

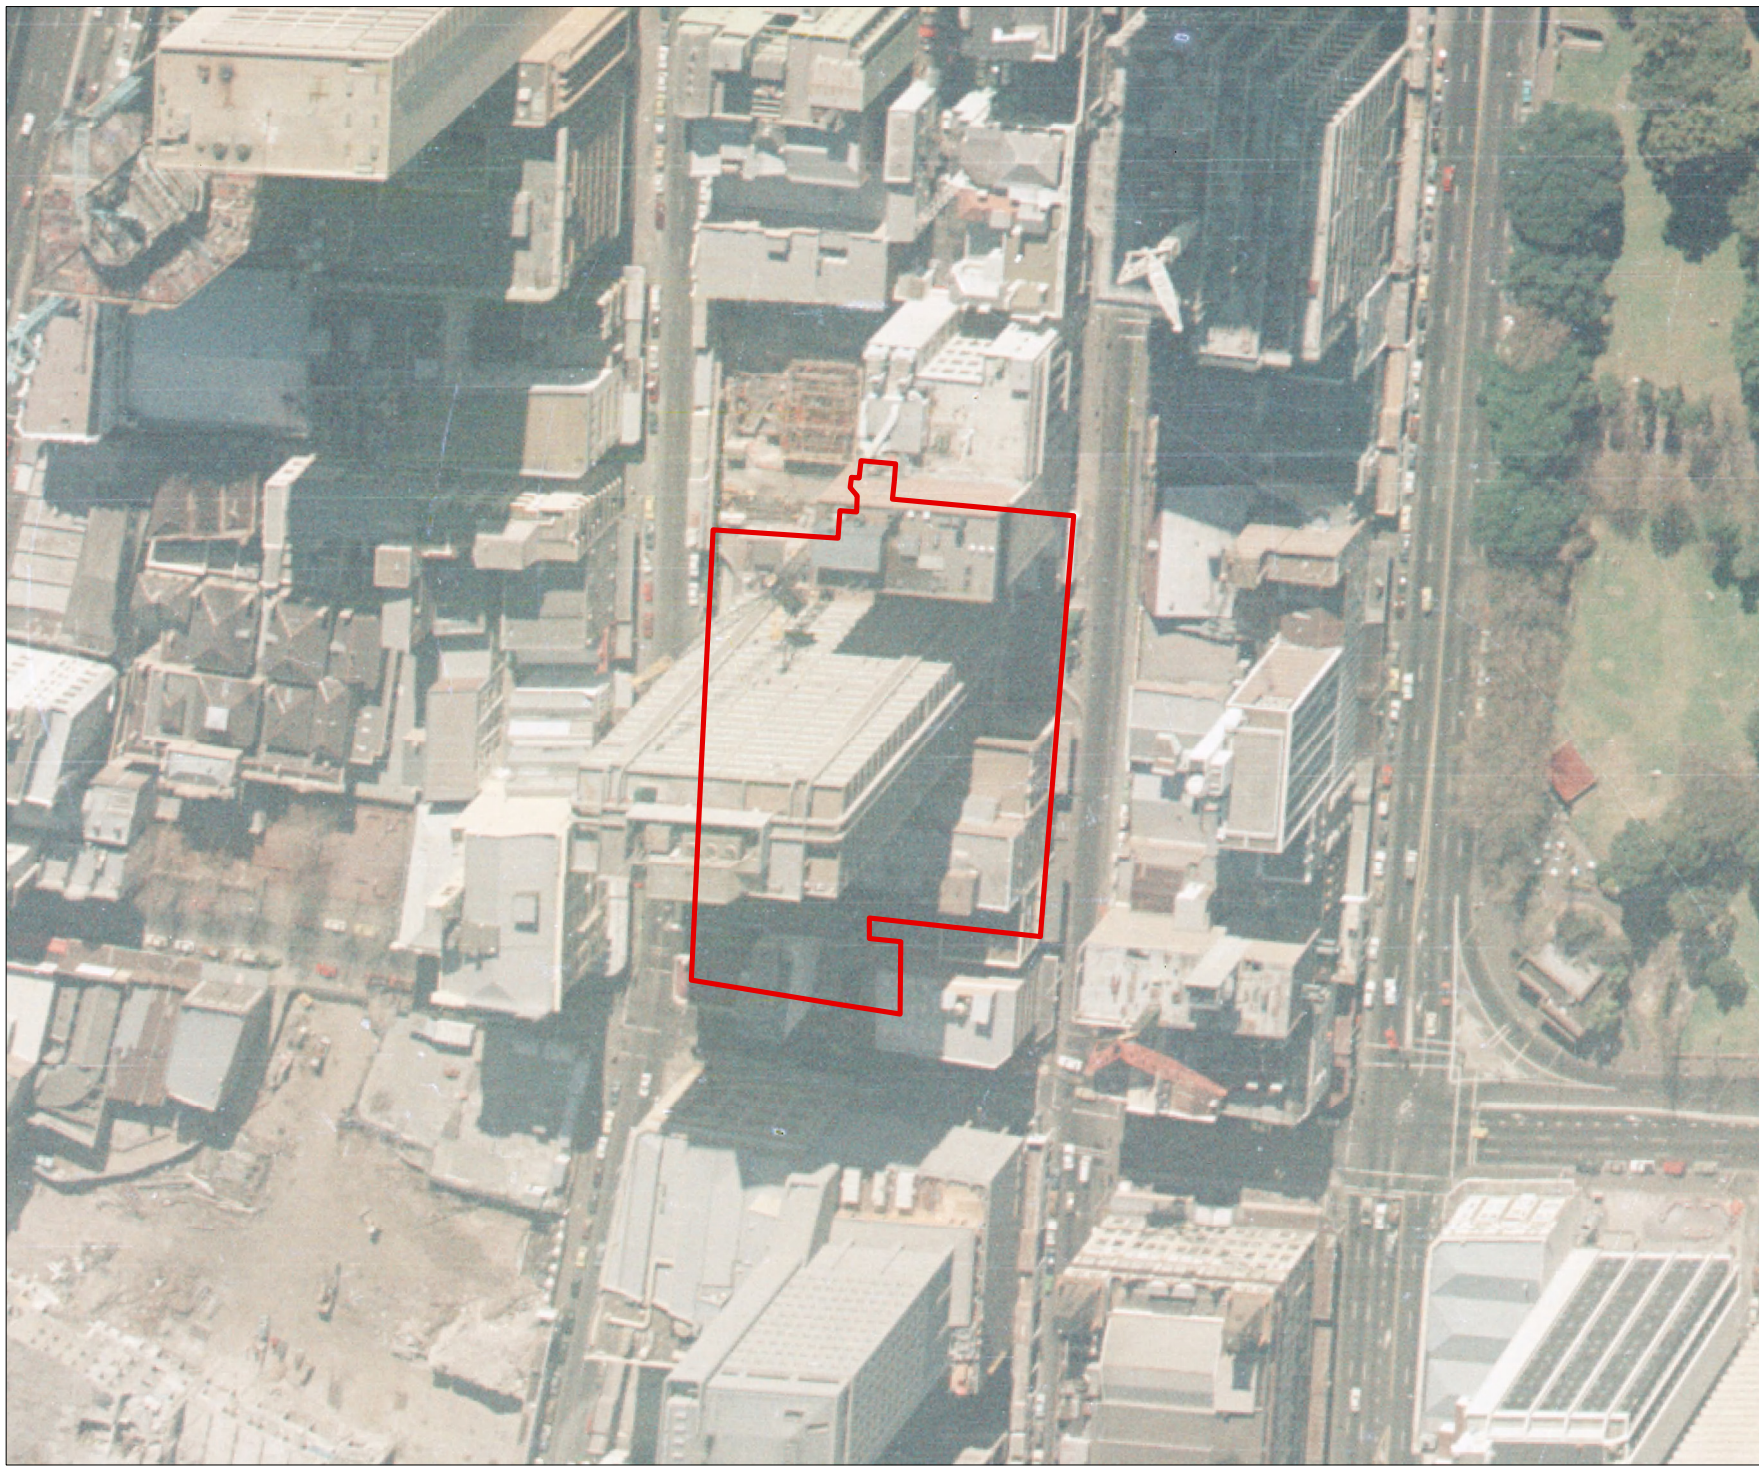
FIGURE 1986

- **1986:** The site appears mostly unchanged from the 1975 imagery.
- **1994:** A new multistorey building is present in the south-west of the site, at the corner of Pitt Street and Liverpool Street.

**HISTORICAL AERIAL
IMAGERY - 1986**

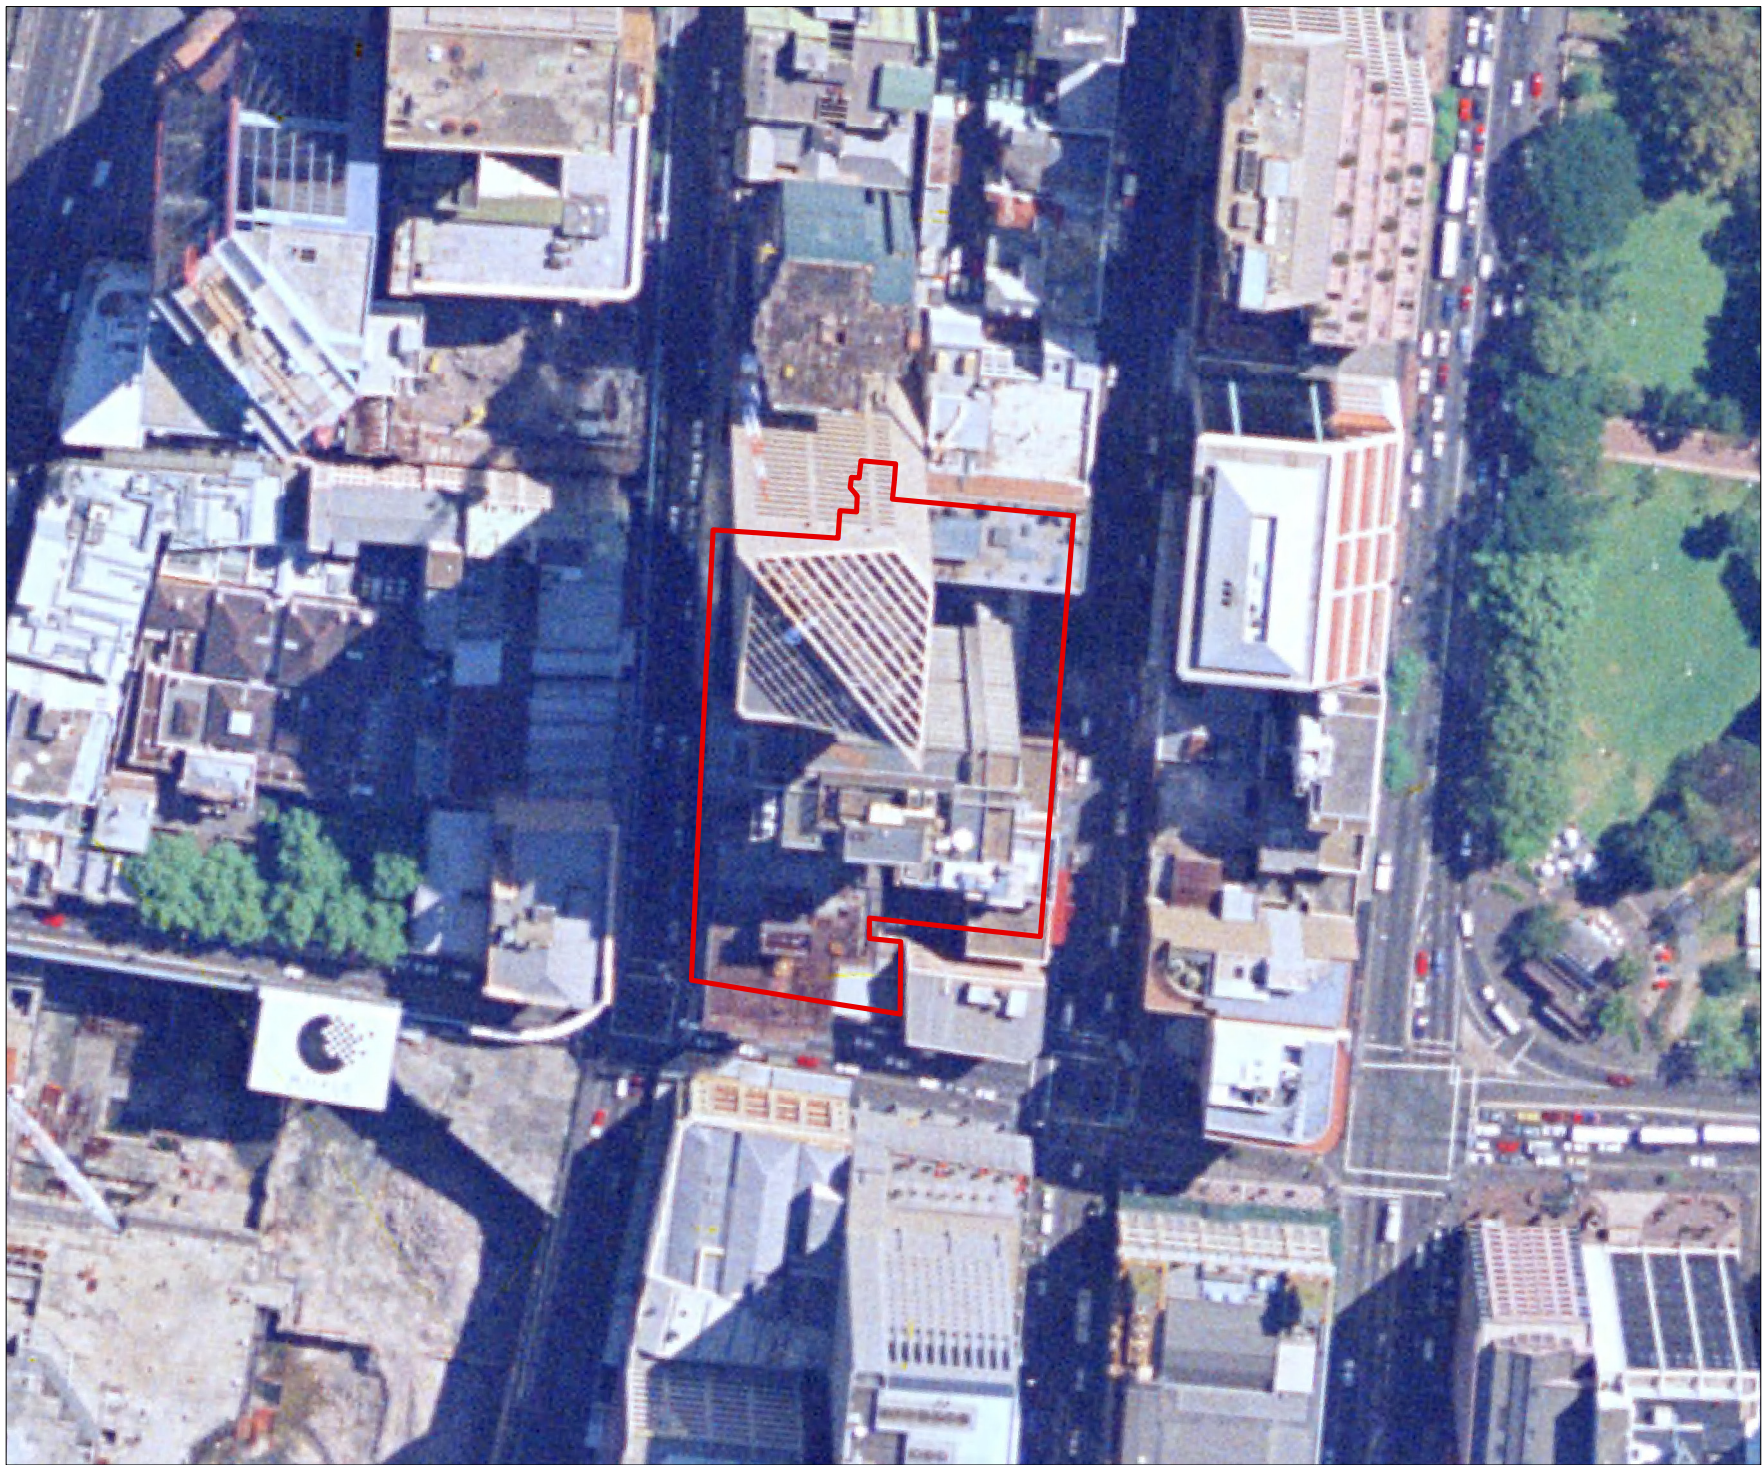
FIGURE 1994

**HISTORICAL AERIAL
IMAGERY - 1994**

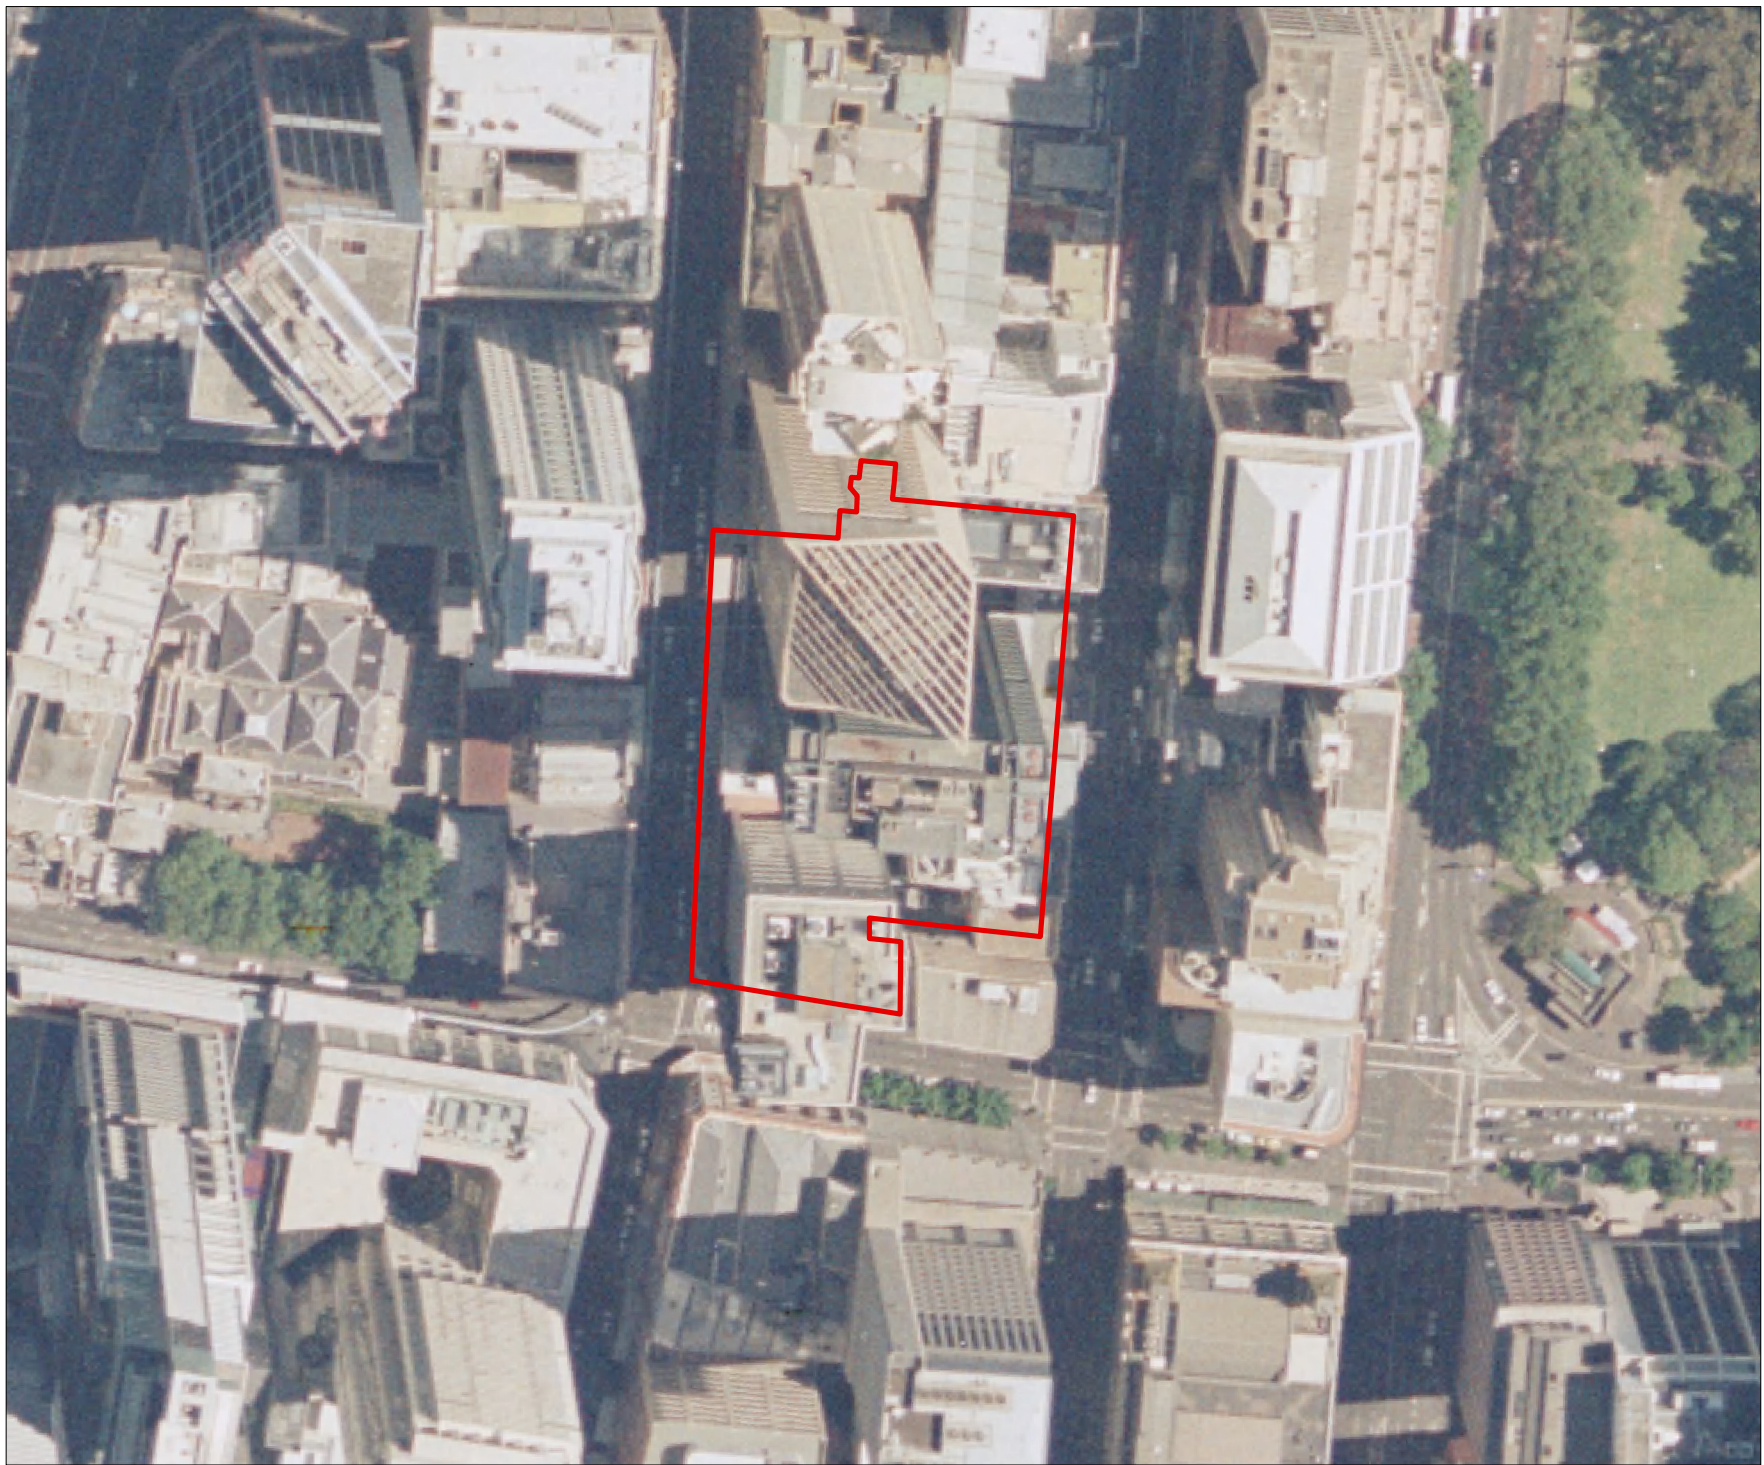
FIGURE 2005

- **2005:** A new multistorey building is present in the south-west of the site, at the corner of Pitt Street and Liverpool Street, replacing the building noted in the 1994 aerial.

**HISTORICAL AERIAL
IMAGERY - 2005**
