**REPORT TO
HEALTH INFRASTRUCTURE**

**ON
REMEDIAL ACTION PLAN (RAP)**

**FOR
PROPOSED NEW MULTI-STOREY CAR PARK**

**AT
LIVERPOOL HOSPITAL, MAIN CAMPUS, ELIZABETH
STREET, LIVERPOOL, NSW**

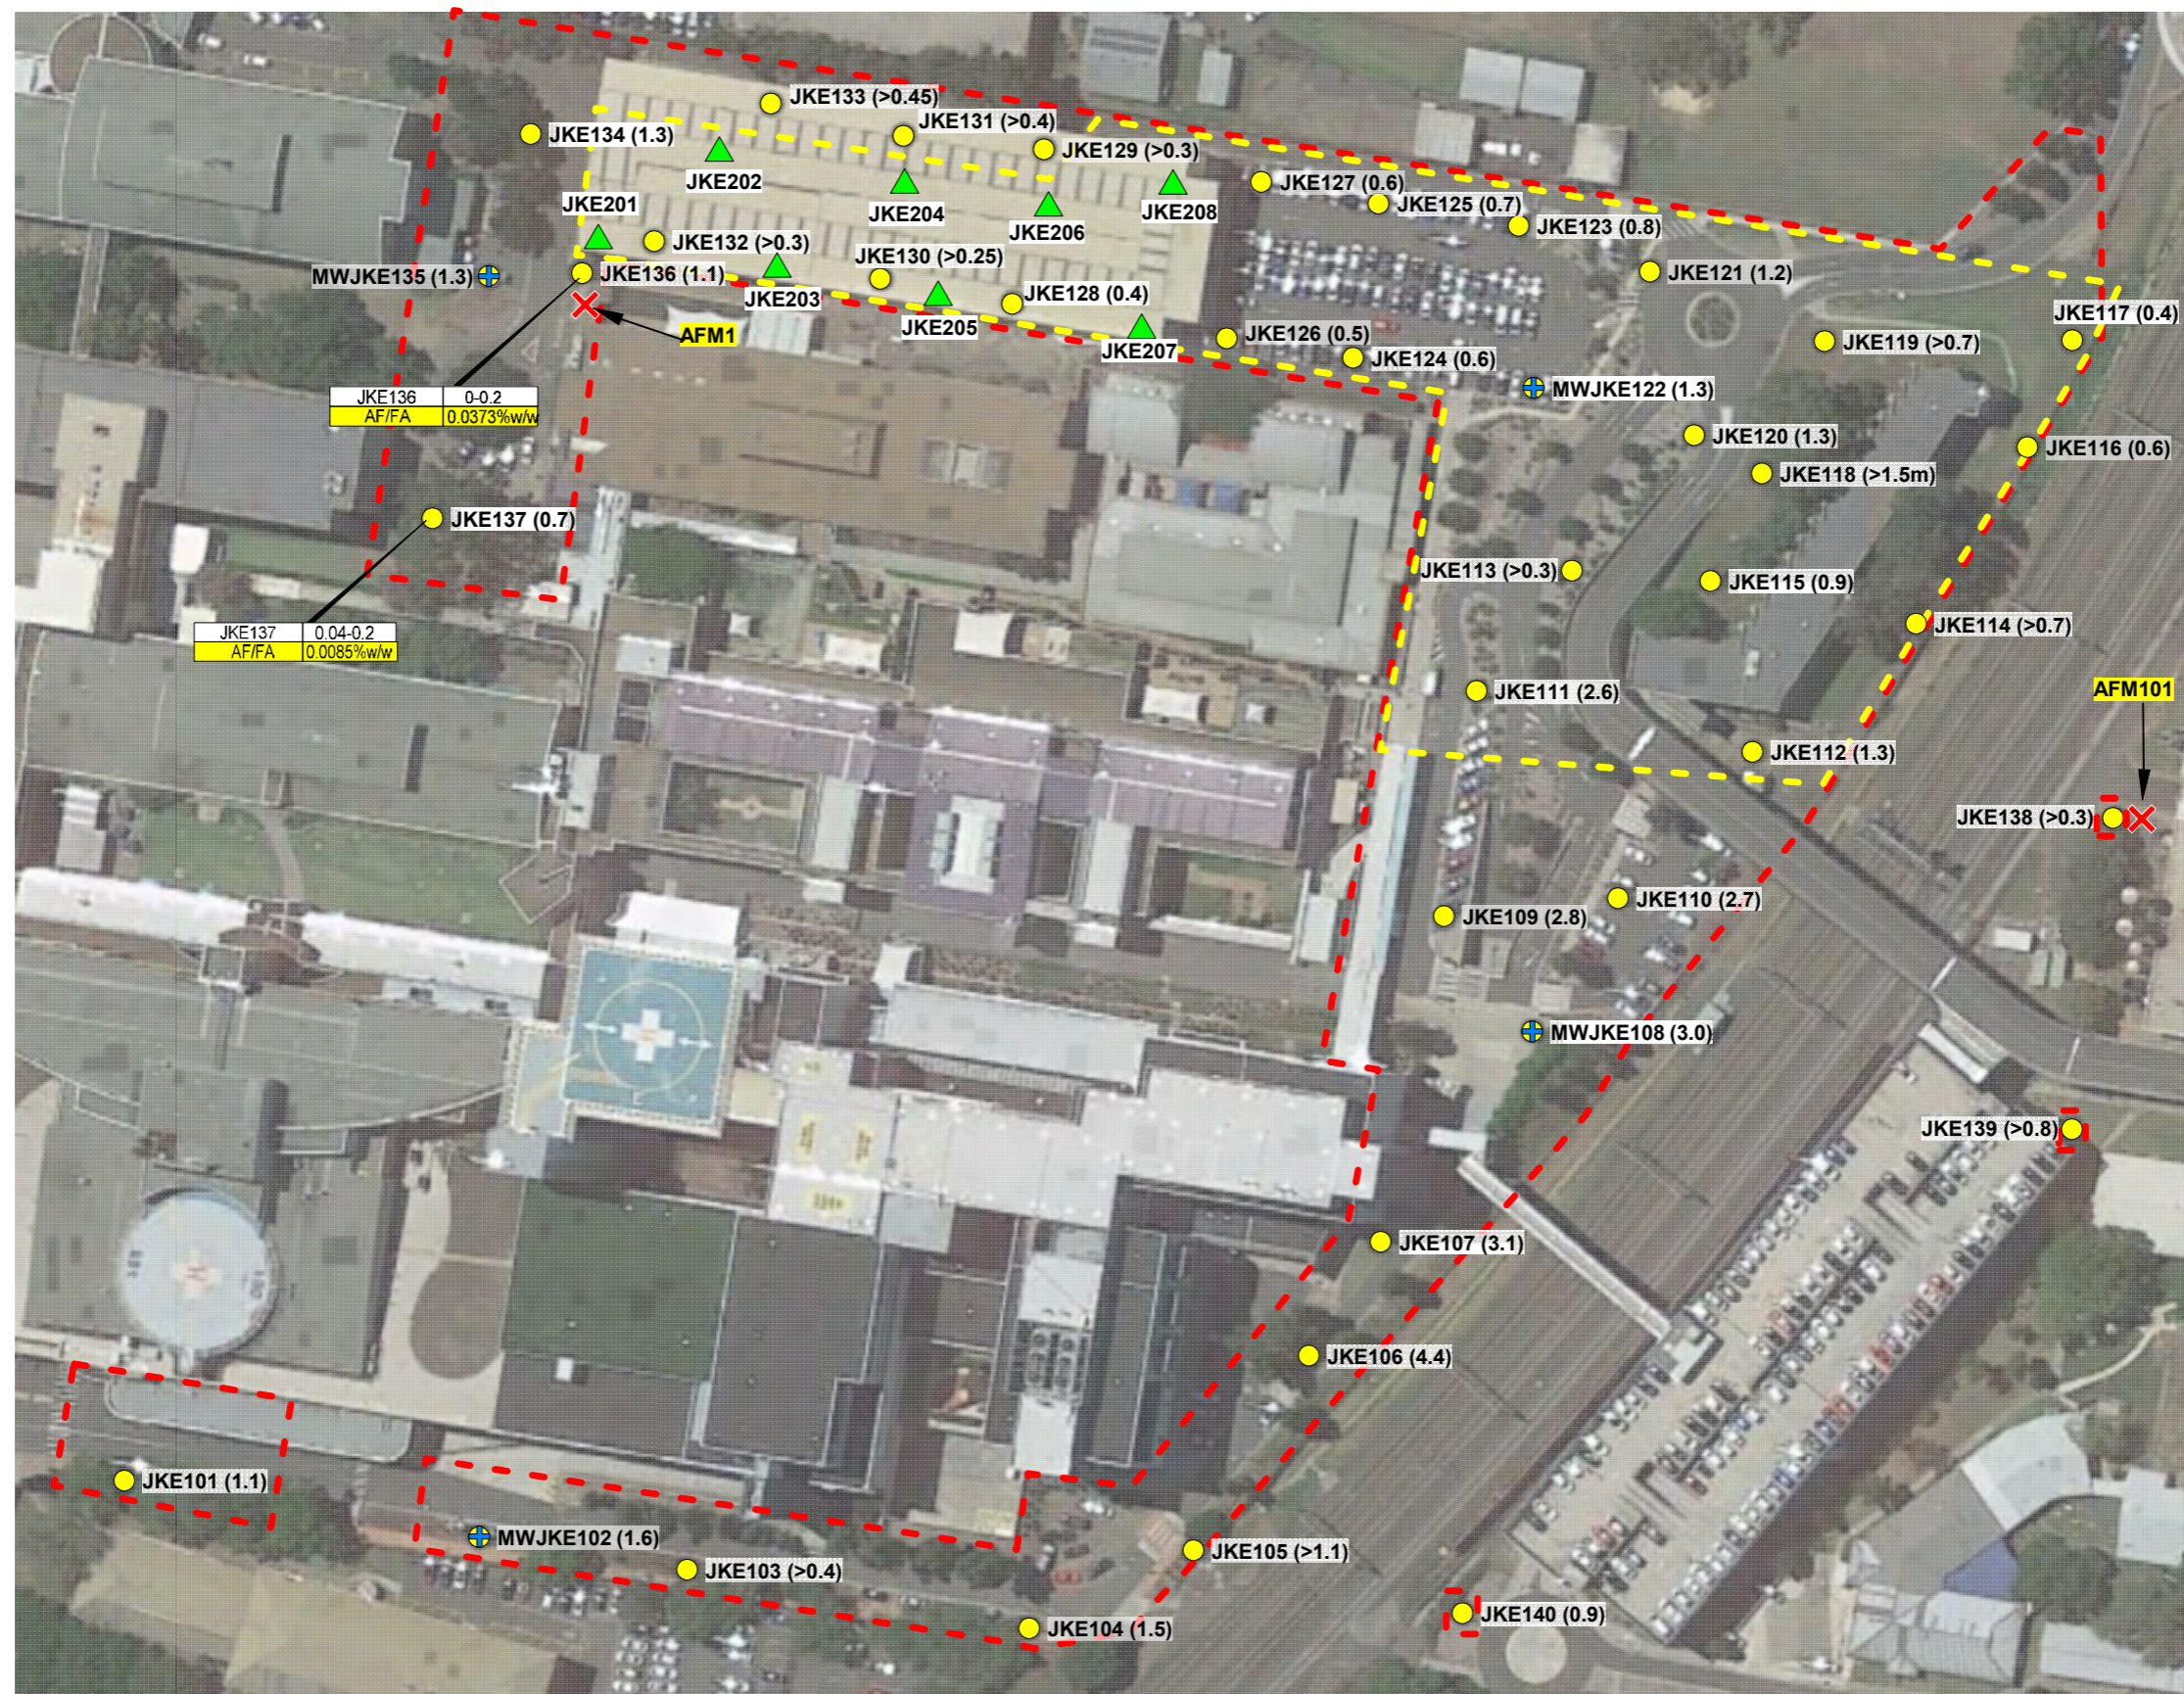
Title: PROPOSED POST-DEMOLITION VALIDATION SAMPLING PLAN	
Location: LIVERPOOL HOSPITAL ELIZABETH STREET, LIVERPOOL, NSW	
Report No: E32465BDrpt6-RAP	Figure No: 2
JK ENVIRONMENTS

| ● JKE (0.1) | JKE STAGE 2 ESA (2019) BOREHOLE LOCATION, NUMBER AND DEPTH OF FILL (m) | ■ | SOIL CONTAMINATION ABOVE SAC FOR HUMAN HEALTH RISK (%W/W) |
| ⊕ MWJKE (0.1) | JKE STAGE 2 ESA (2019) BOREHOLE AND GROUNDWATER MONITORING WELL LOCATION, NUMBER AND DEPTH OF FILL (m) | | |

Johnstaff Projects Pty Ltd on behalf of Health Infrastructure NSW ('the client') commissioned JK Environments (JKE) to prepare a Remediation Action Plan (RAP) for the proposed new multi-storey car park (MSCP) at Liverpool Health + Academic Precinct (Liverpool Hospital), Elizabeth Street, Liverpool, NSW ('the site'). The site location is shown on Figure 1 and the RAP applies to the land within the site boundaries as shown on Figure 2 attached in Appendix A.

Post-demolition validation sampling is required to assess the potential for asbestos in soil data gap in the west section of the site, to further assess the extent of remediation. Other CoPC are to be considered for completeness and for waste classification purposes, given that all boreholes drilled within the existing P2 MSCP footprint area meet refusal within fill. The Post-demolition validation scope of works is outlined in Section 4.

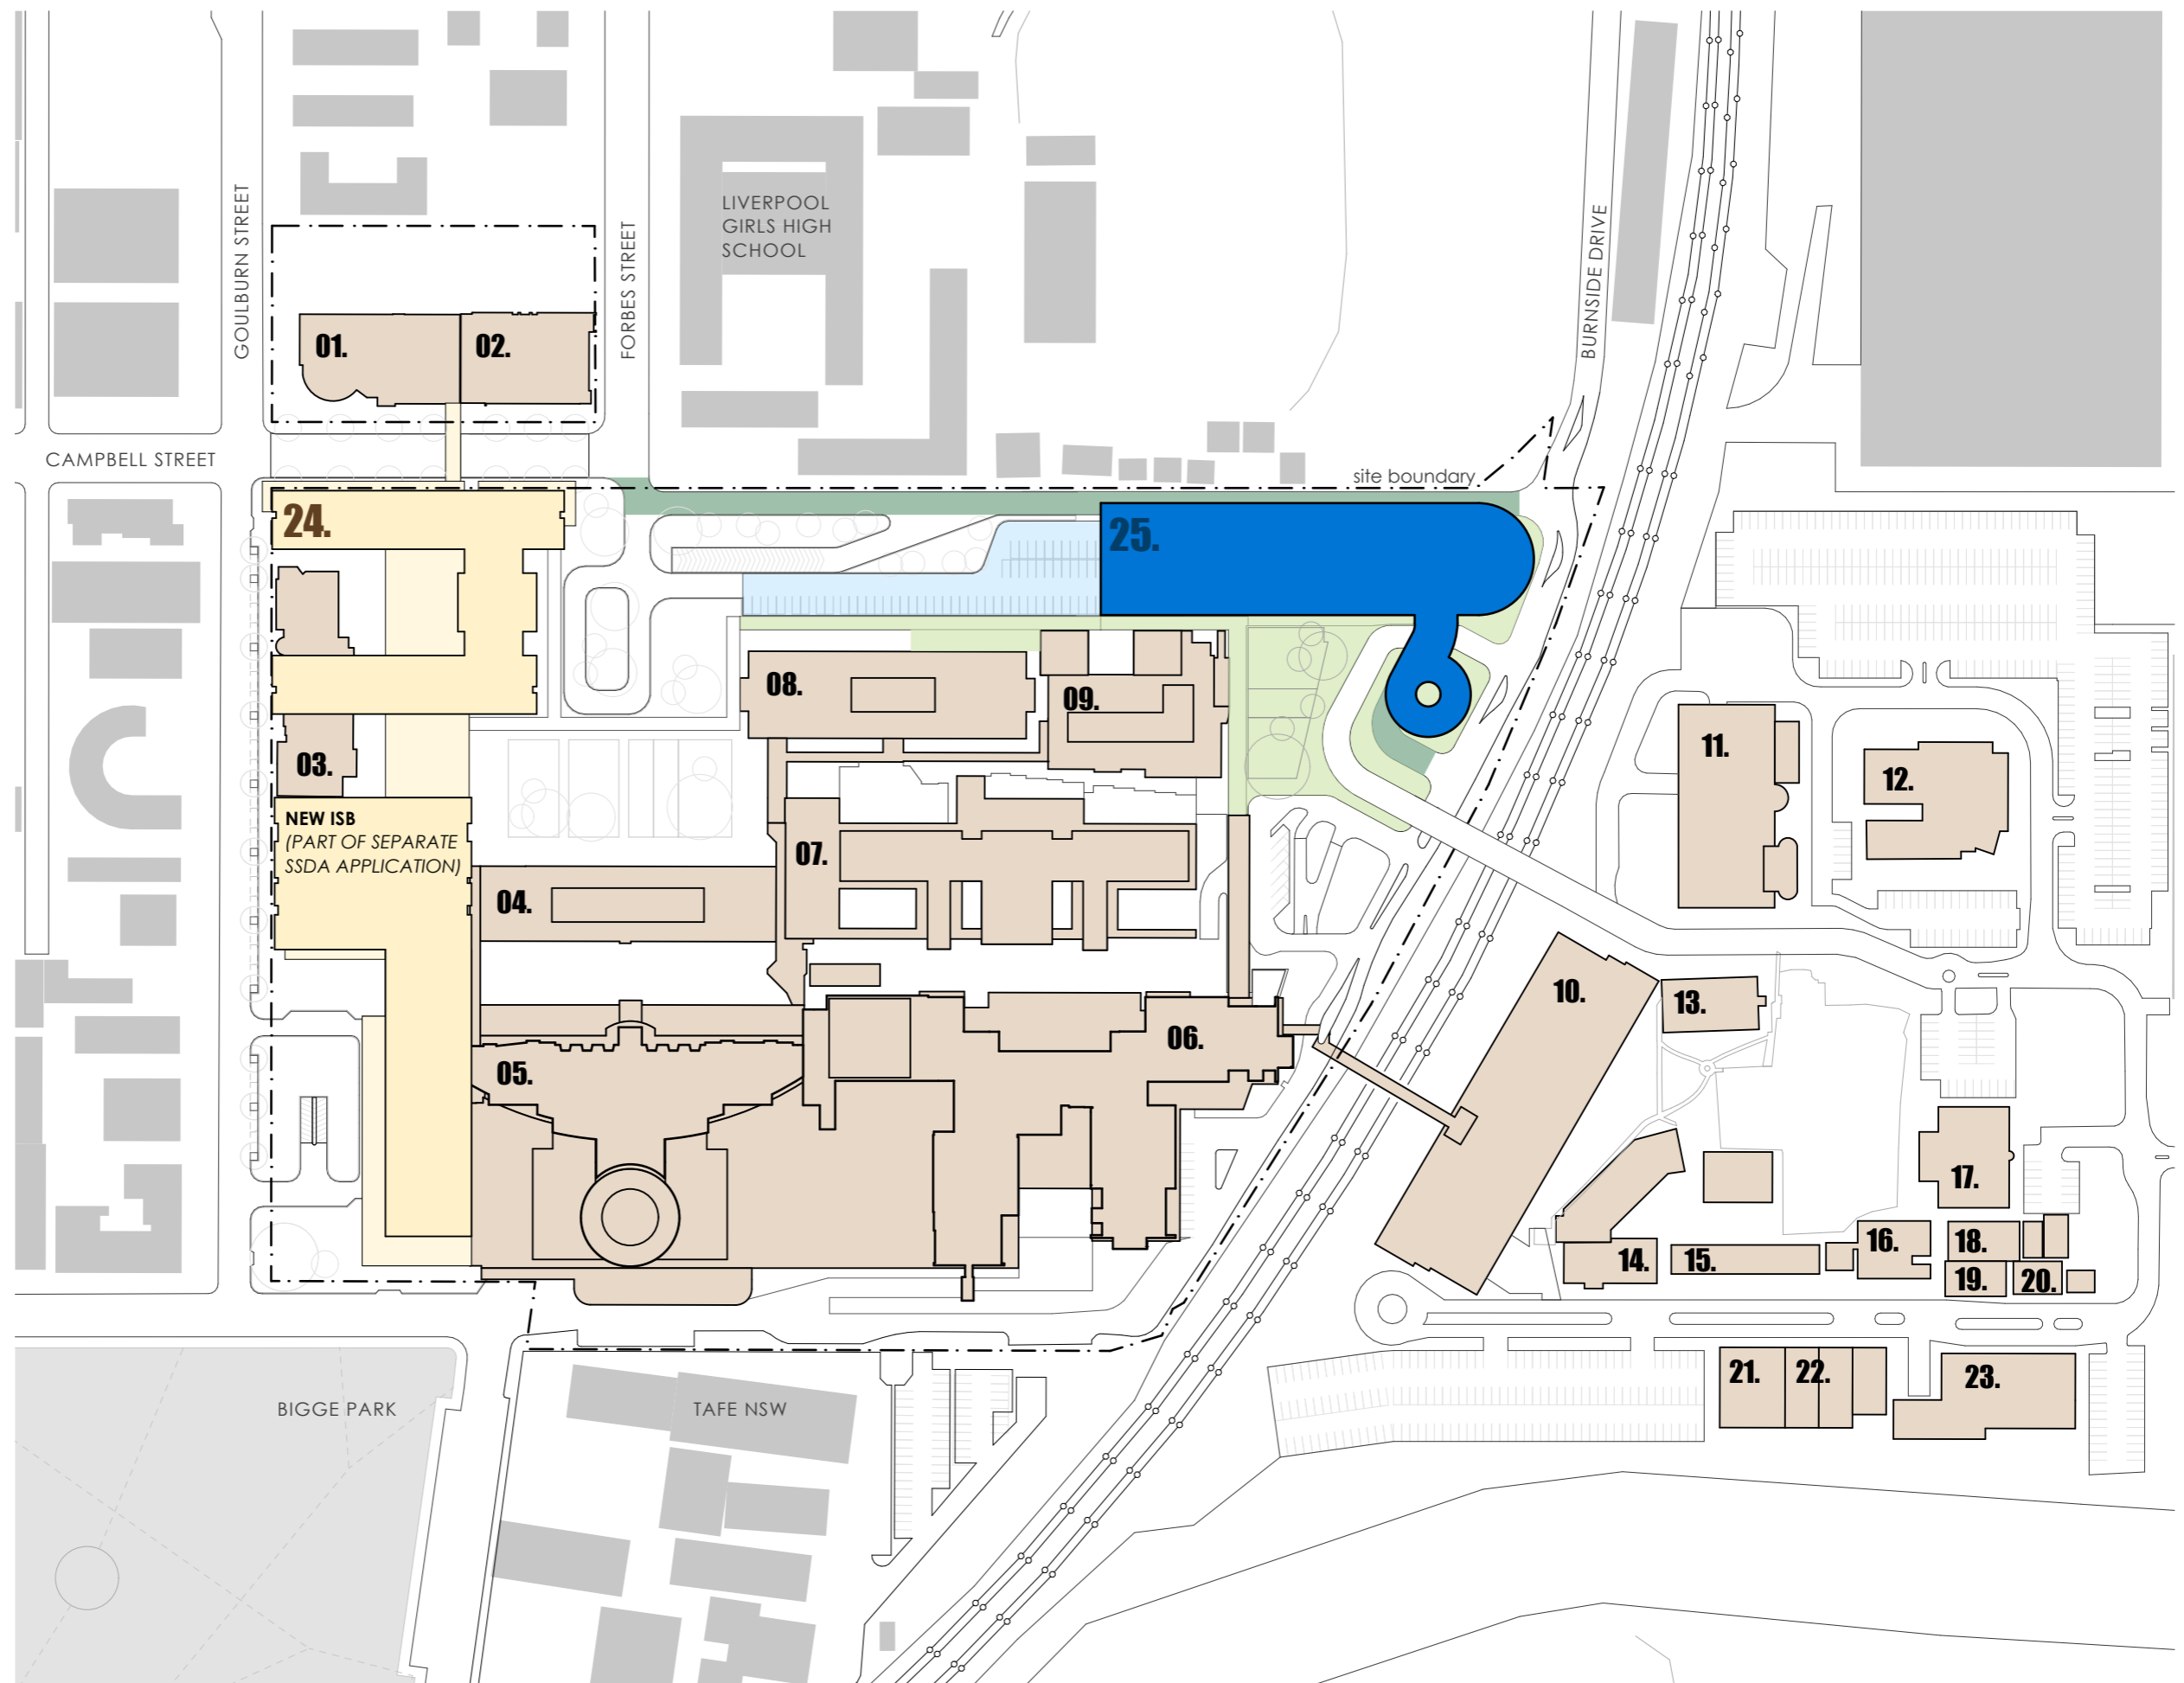
DRAWING	PROJECT NO.	DRAWING NO.	ISSUE
DEMOLITION PLAN	21807	A-SSDA-MSCP-04	05
PRINT DATE	STATUS		
31/01/2020	DRAFT FOR REVIEW

- road demo works
- ▨ buildings to be demolished
- ▭ liverpool campus
- existing buildings

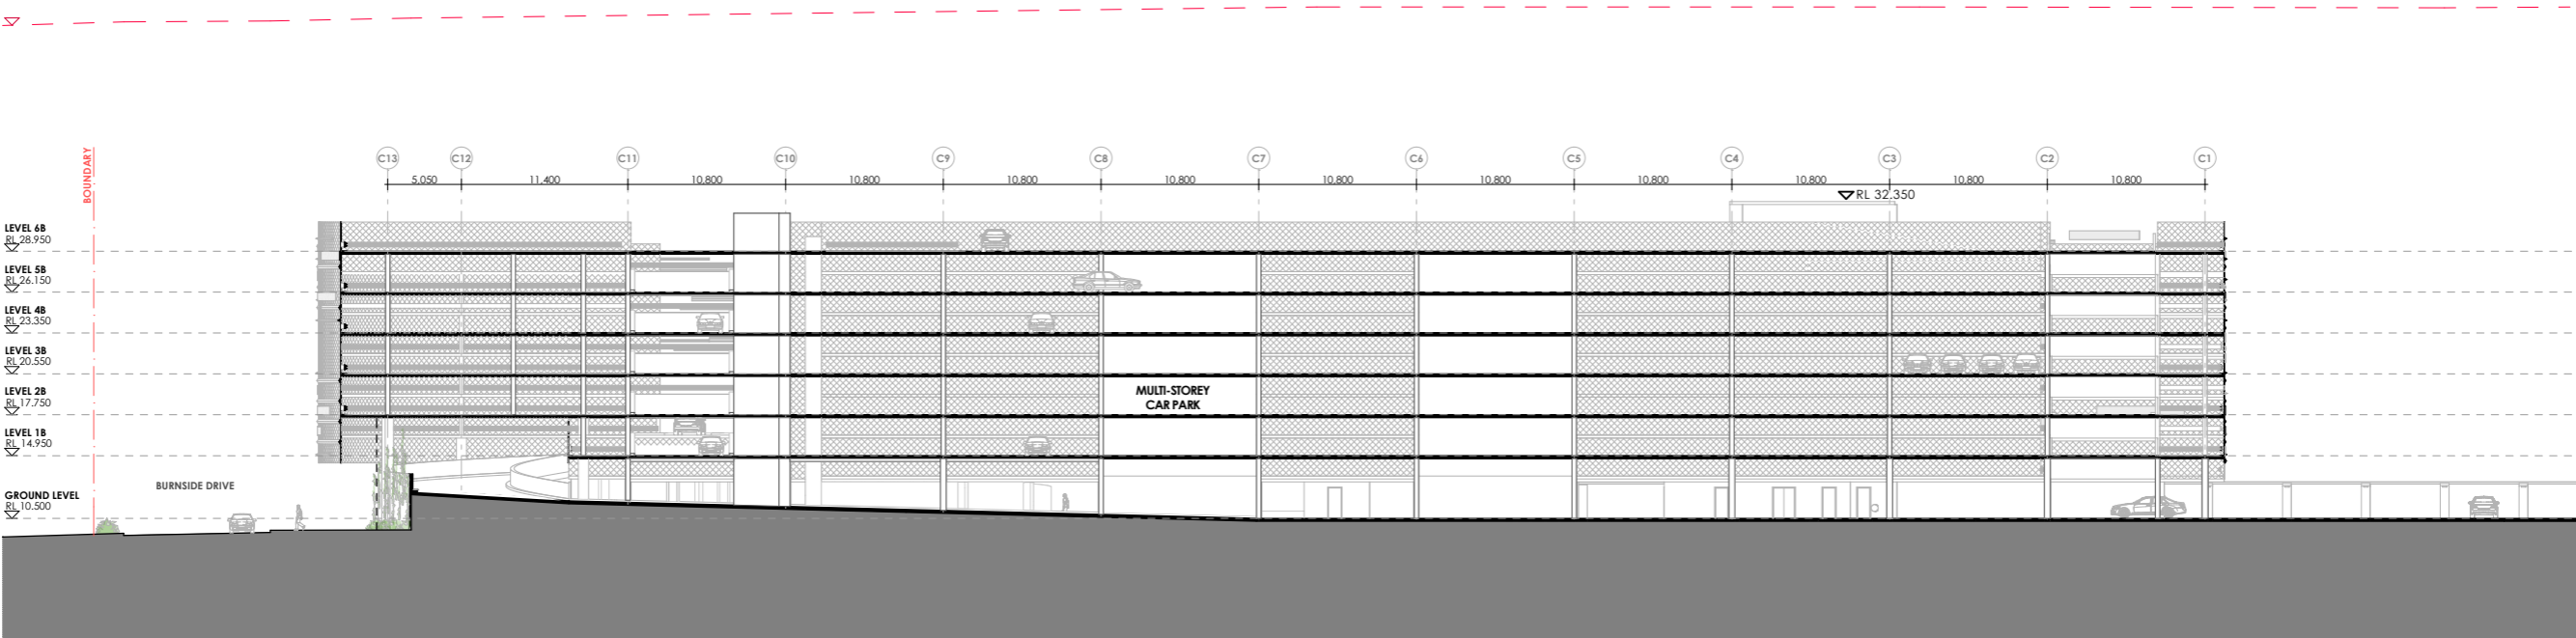
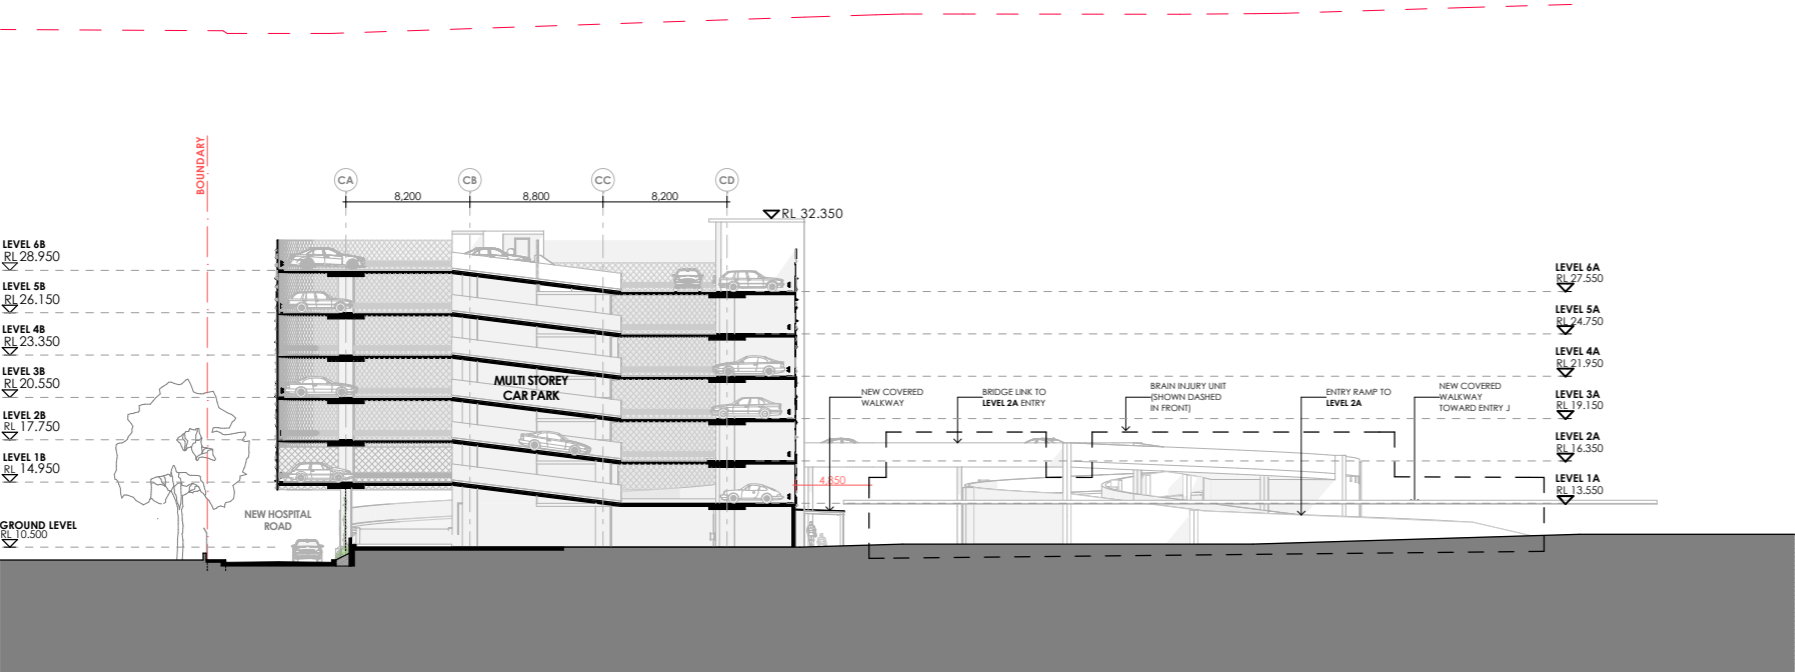
PROJECT NO.
21807
DRAWING NO.
A-SSDA-MSCP-14
ISSUE
05
STATUS
DRAFT FOR REVIEW

LEP HEIGHT CONTROL
35m ABOVE GROUND

SECTION A

SECTION B

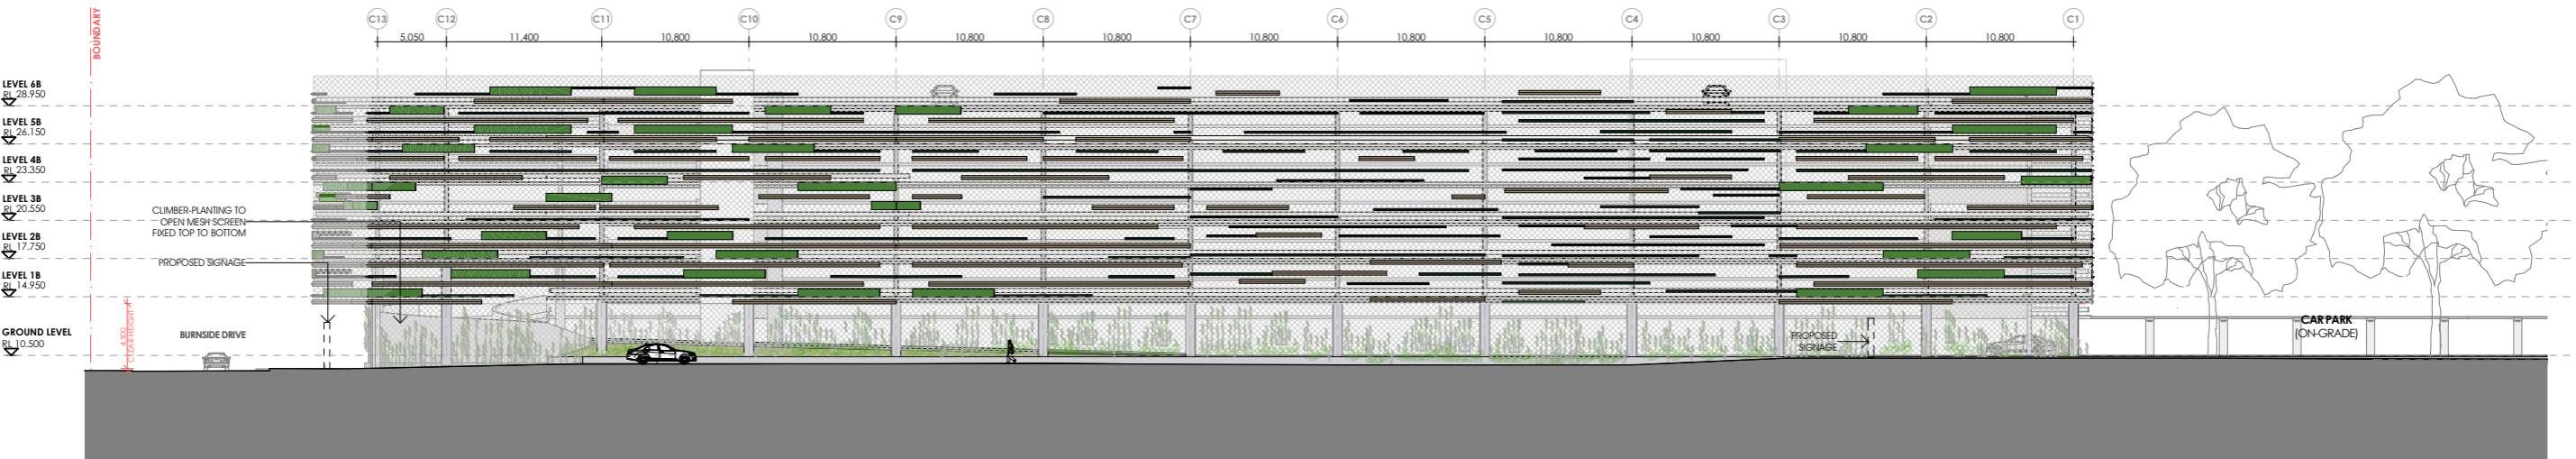
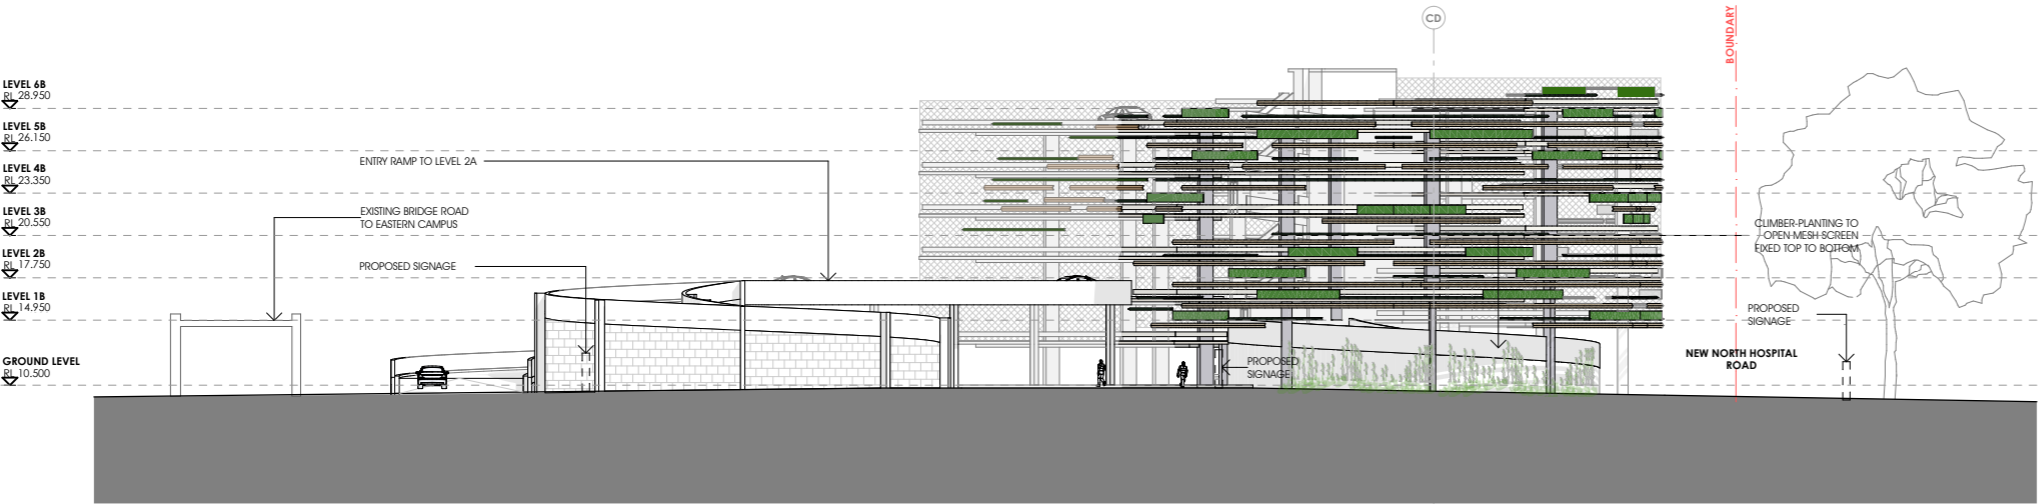
PROJECT NO.
21807
DRAWING NO.
A-SSDA-MSCP-15
ISSUE
05
STATUS
DRAFT FOR REVIEW

LEP HEIGHT CONTROL
35m ABOVE GROUND

NORTH ELEVATION

EAST ELEVATION

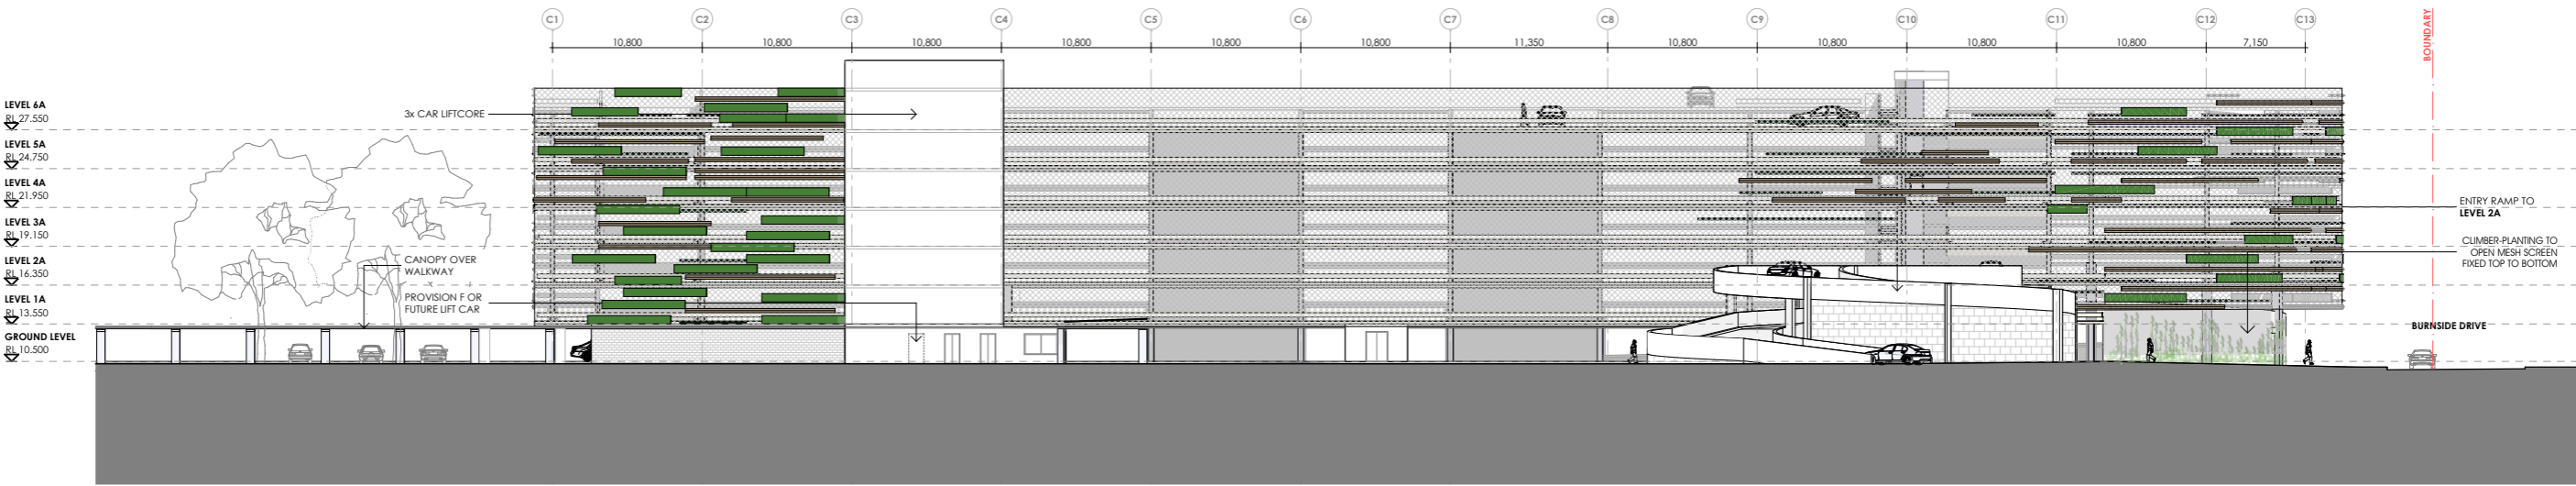
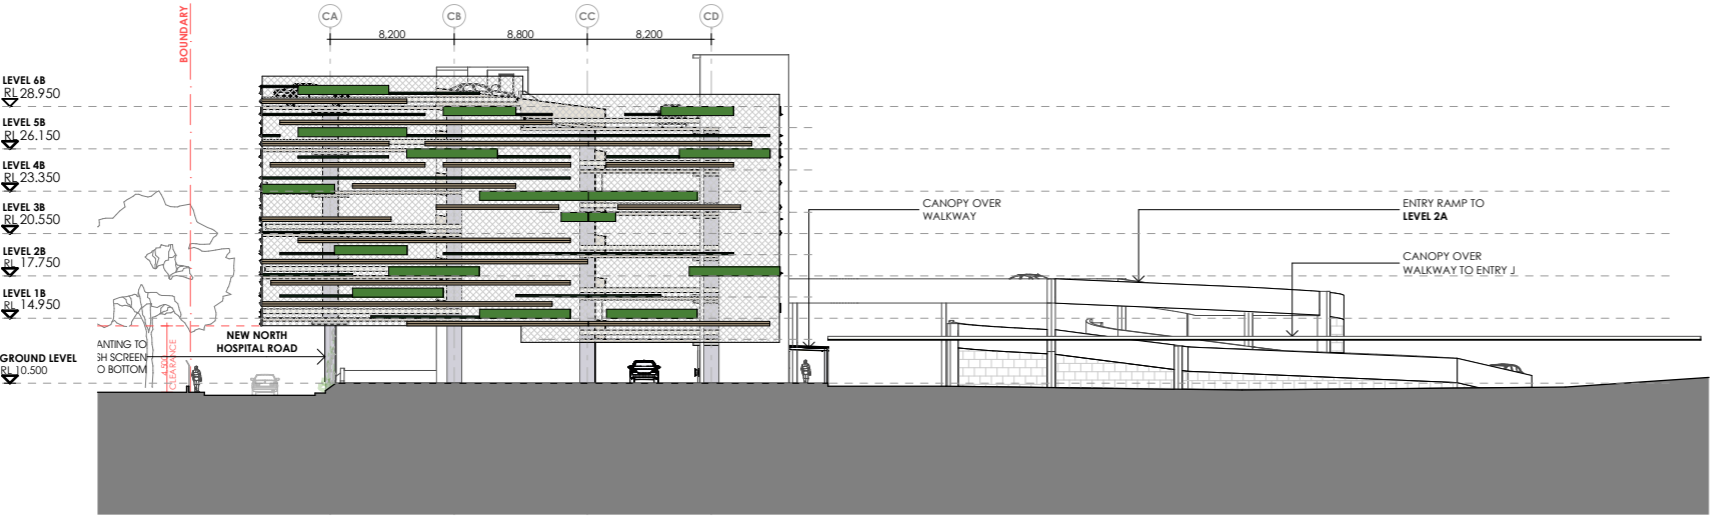
PROJECT NO.
21807
DRAWING NO.
A-SSDA-MSCP-16
ISSUE
05
STATUS
DRAFT FOR REVIEW

LEP HEIGHT CONTROL
35m ABOVE GROUND

SOUTH ELEVATION

WEST ELEVATION

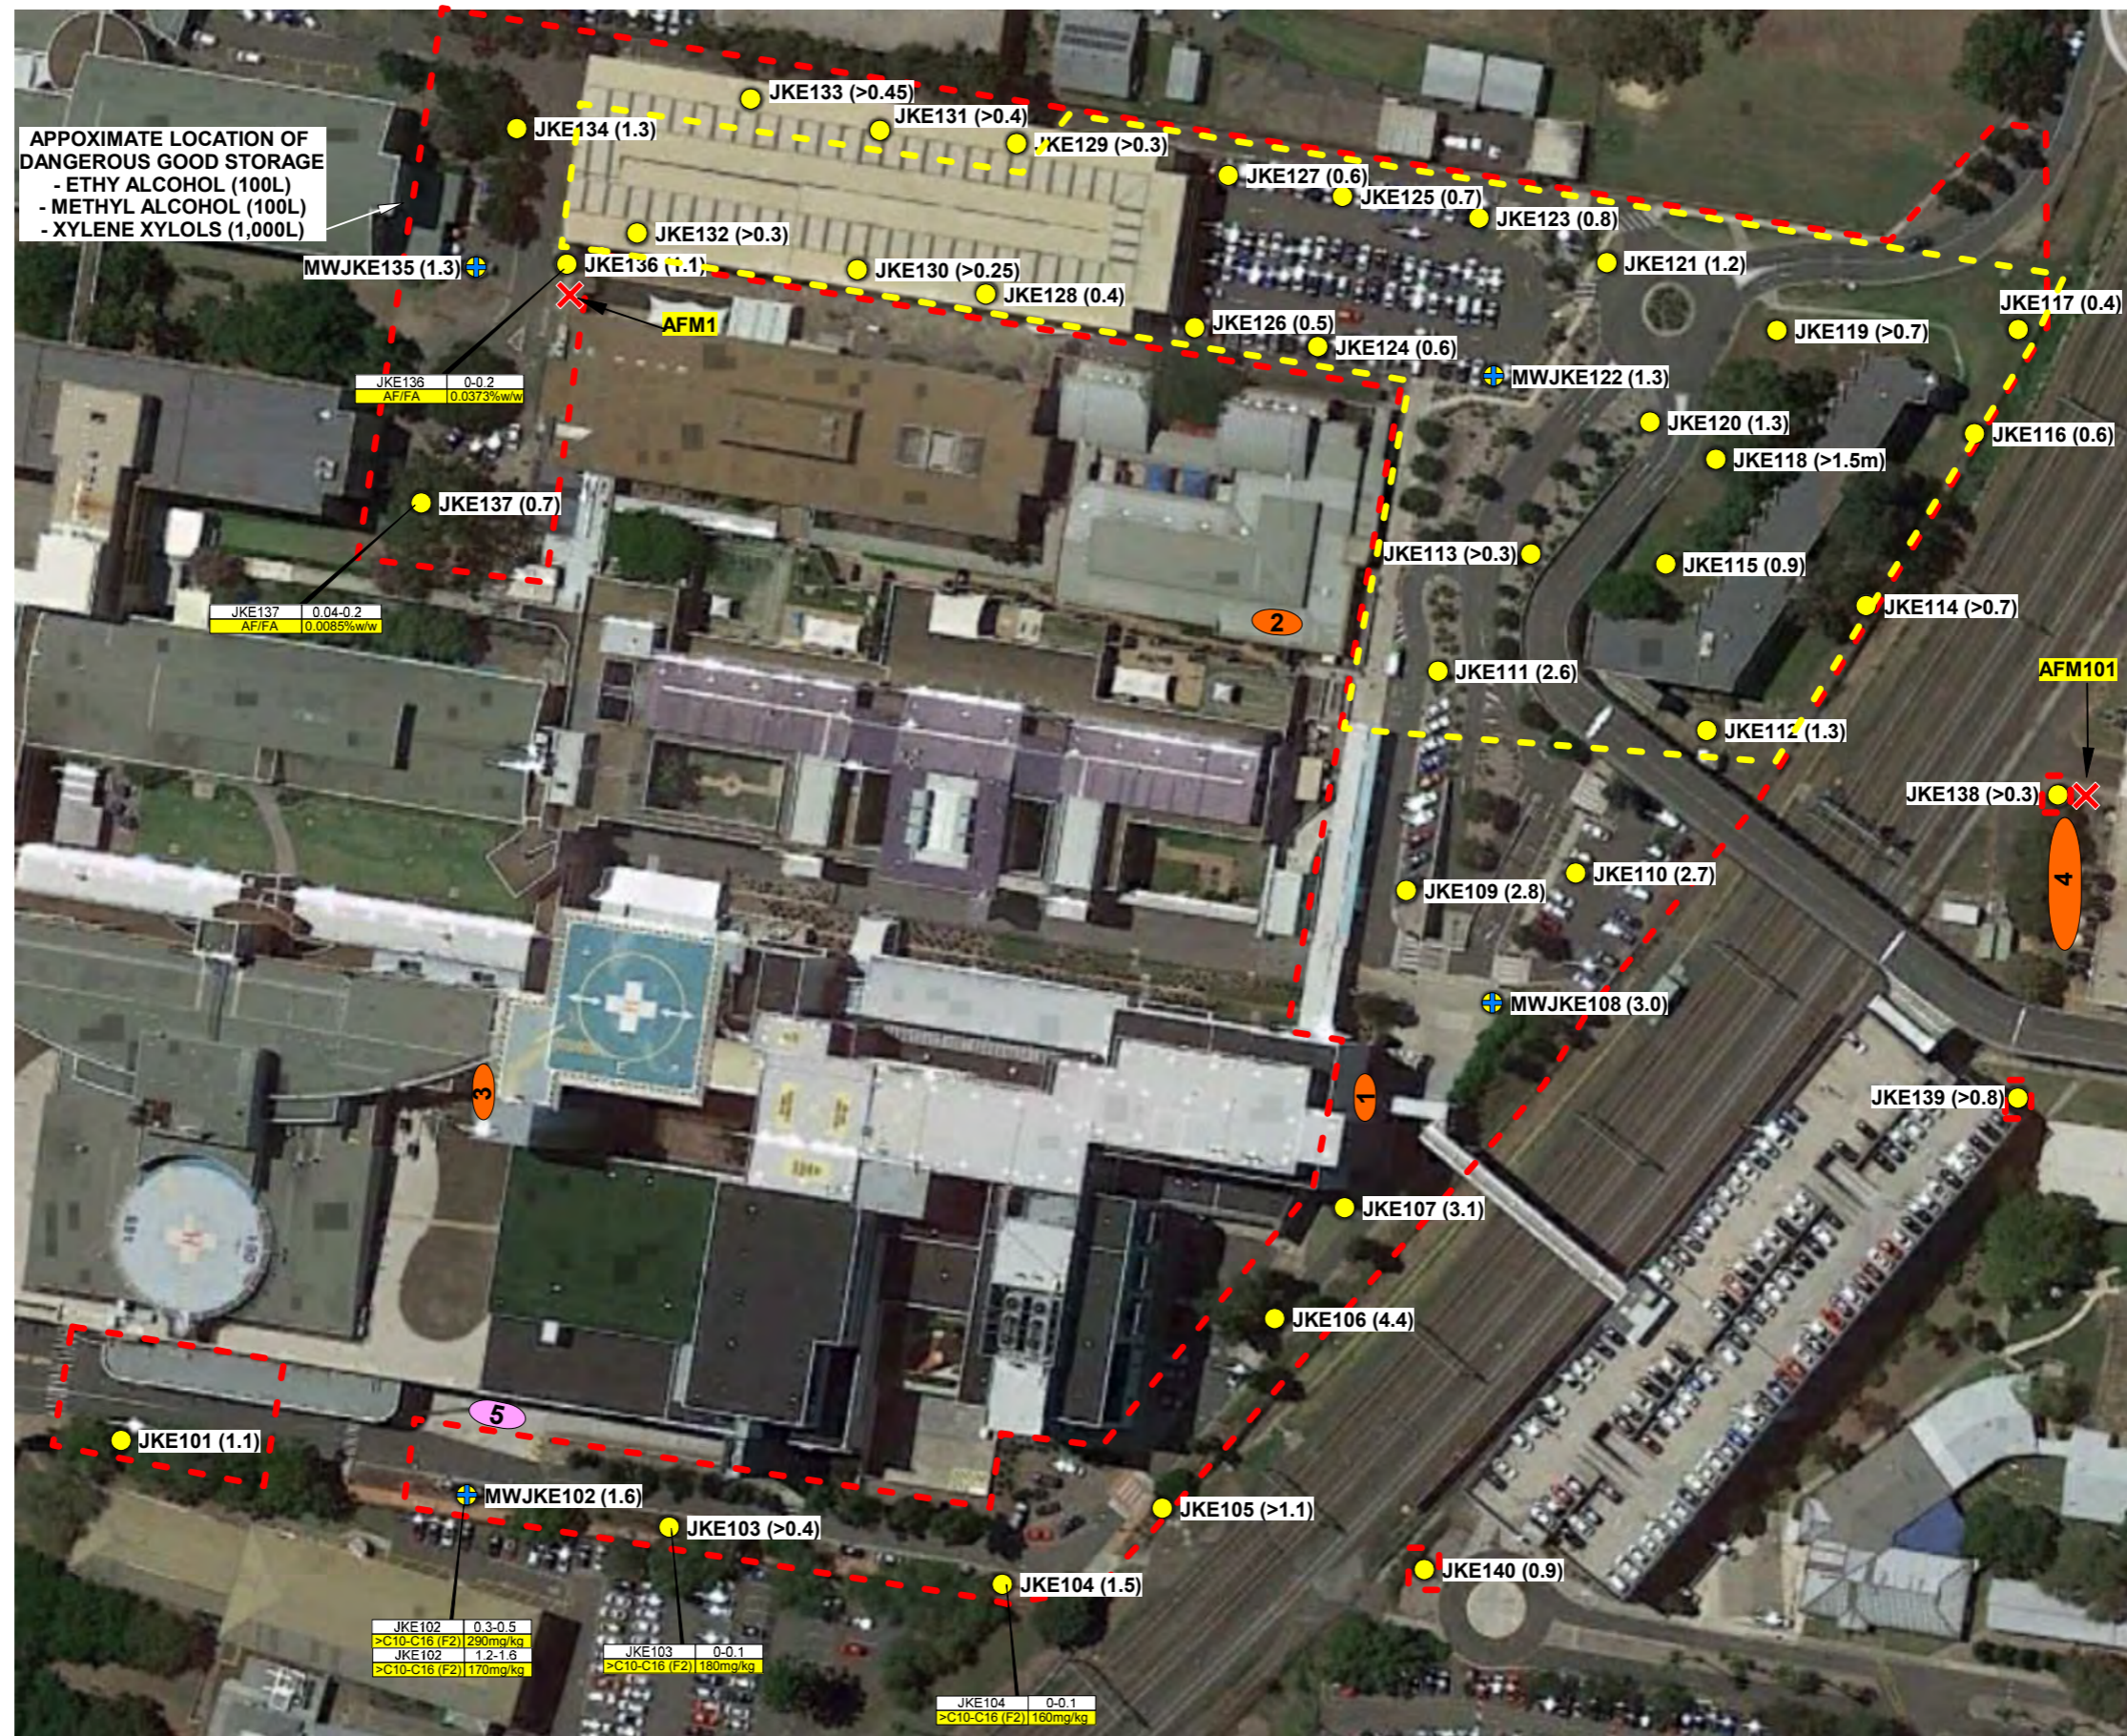
Title: SAMPLING LOCATION PLAN	
Location: LIVERPOOL HOSPITAL ELIZABETH STREET, LIVERPOOL, NSW	
Report No: E32465BDrpt5	Figure No: 2
JK ENVIRONMENTS

- APPROXIMATE SITE BOUNDARY
- APPROXIMATE EXTENT OF MULTI STOREY CARPARK DEVELOPMENT
- JKE (0.1) BOREHOLE LOCATION, NUMBER AND DEPTH OF FILL (m)
- ⊕ MWJKE (0.1) BOREHOLE AND GROUNDWATER MONITORING WELL LOCATION, NUMBER AND DEPTH OF FILL (m)

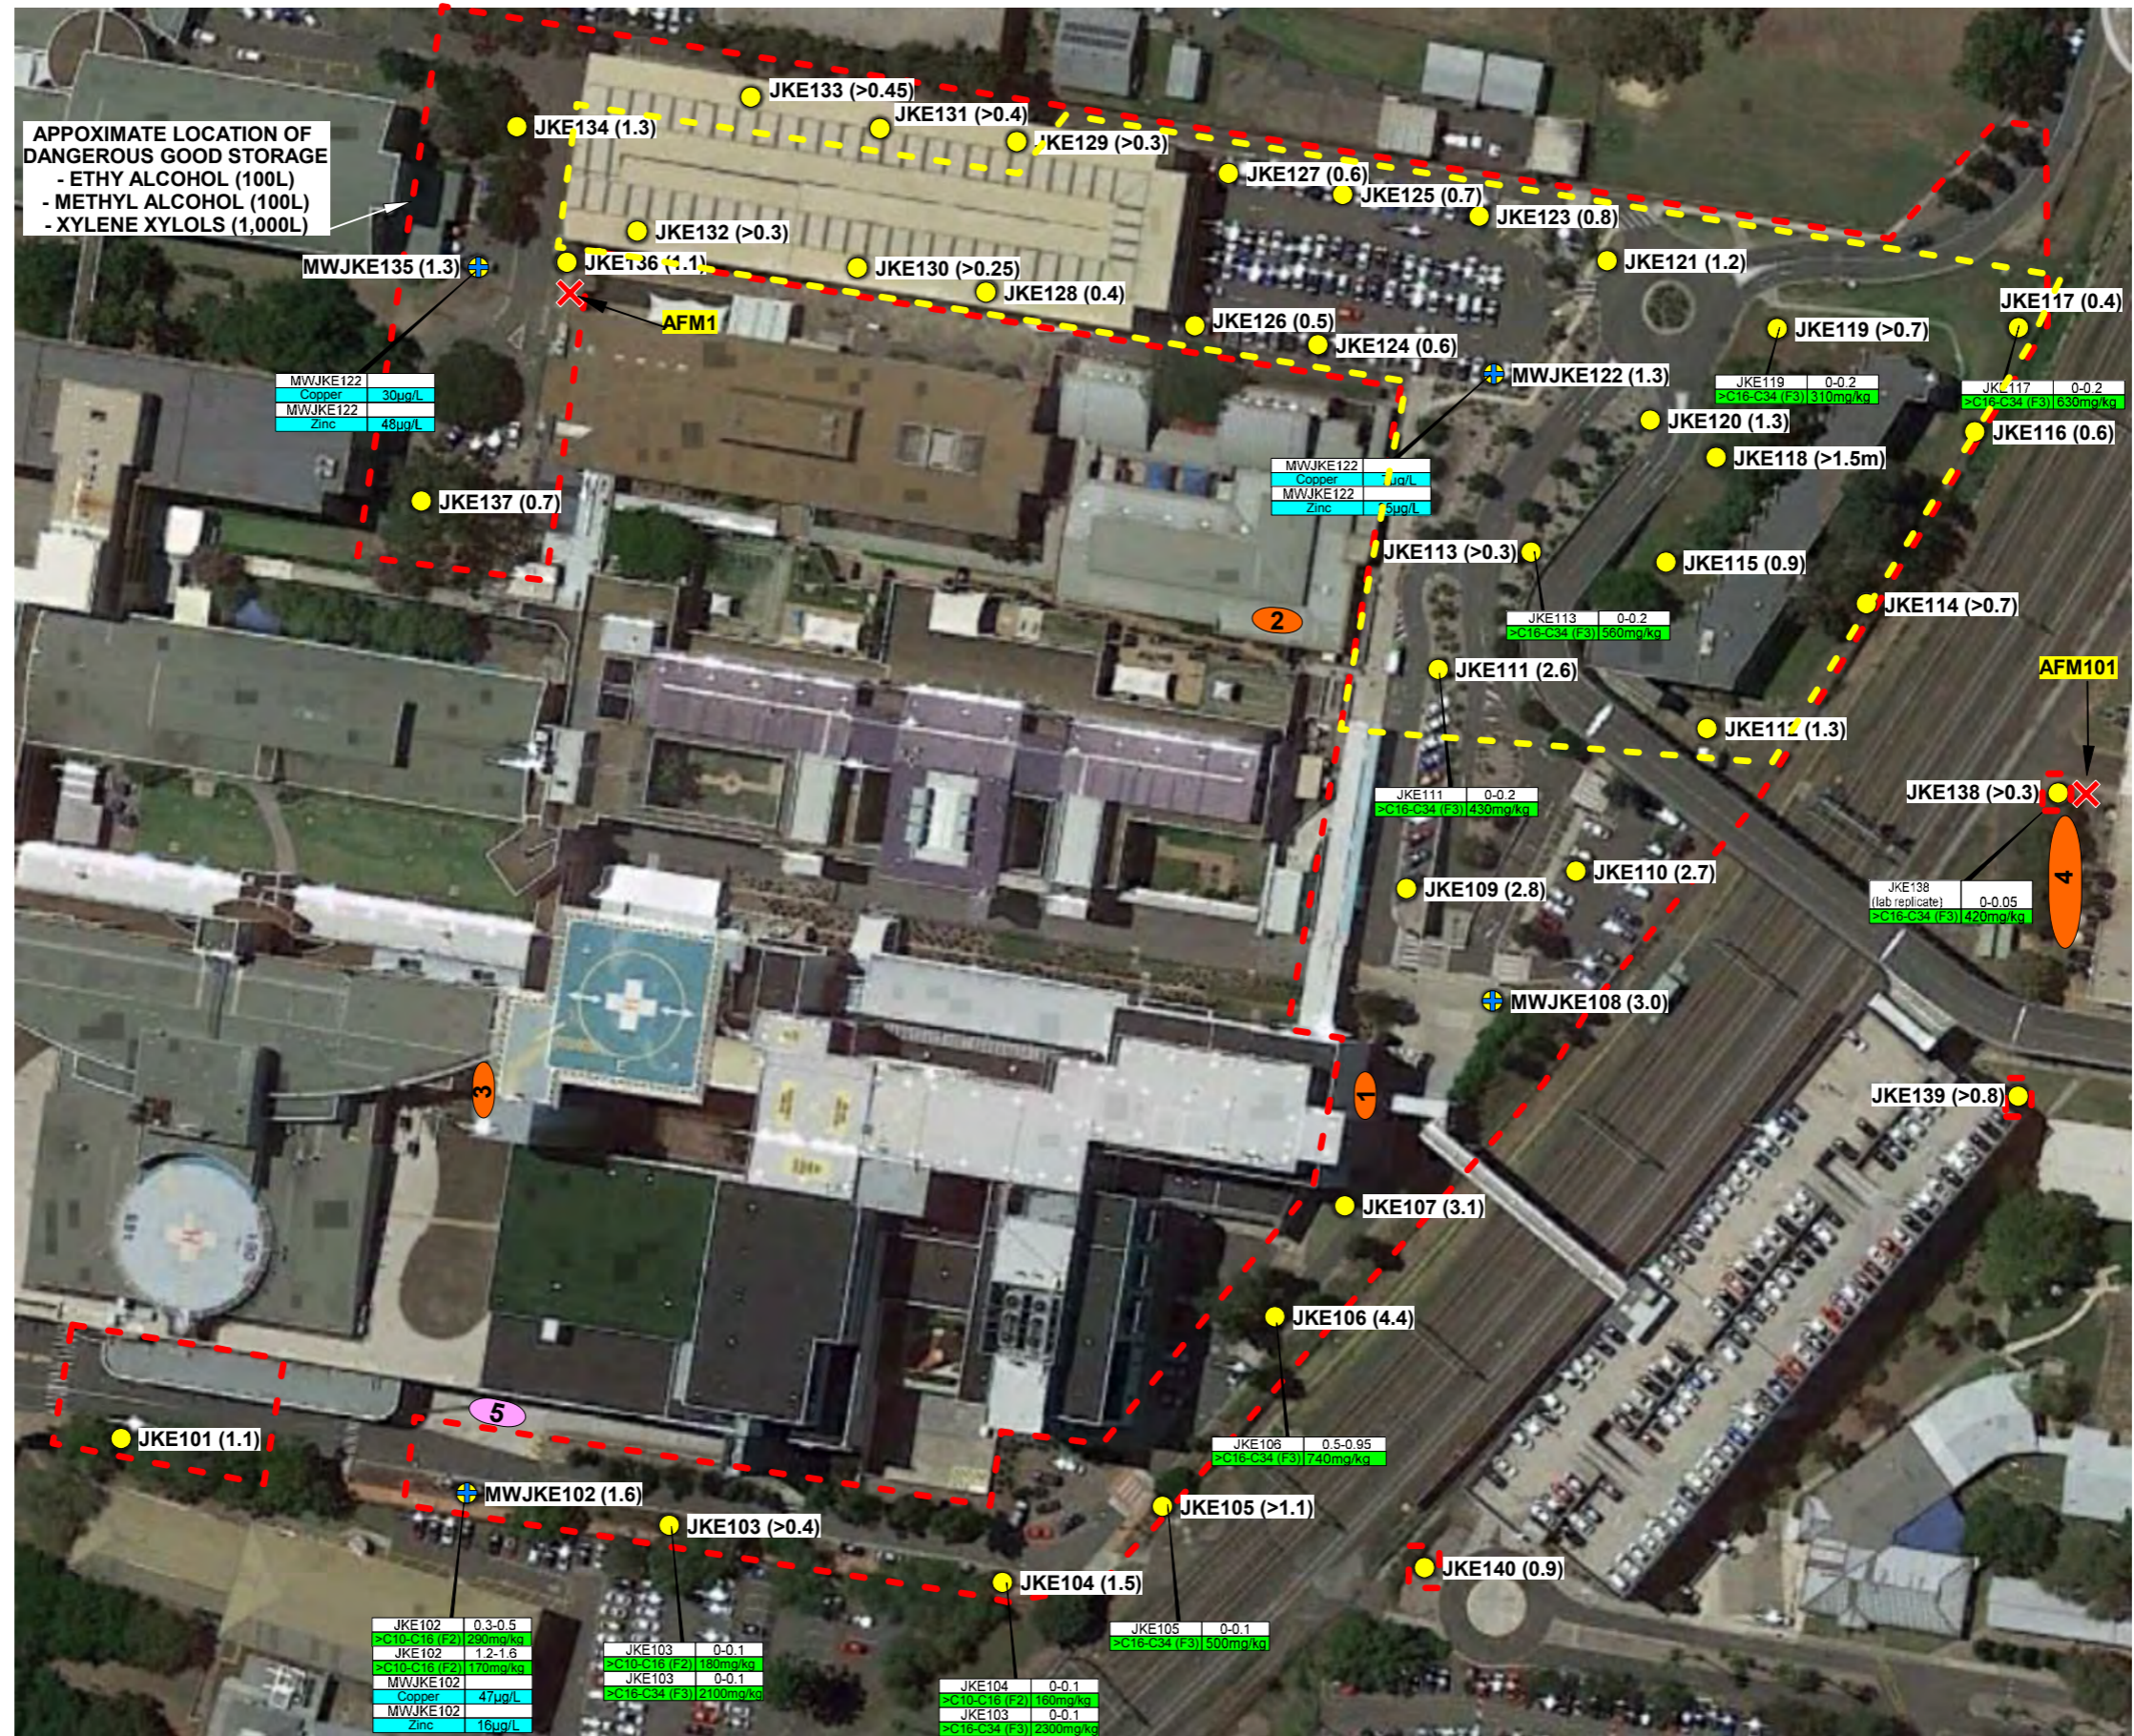
Title: CONTAMINATION DATA PLAN - HUMAN HEALTH	
Location: LIVERPOOL HOSPITAL ELIZABETH STREET, LIVERPOOL, NSW	
Report No: E32465BDrpt5	Figure No: 3
JK ENVIRONMENTS

- APPROXIMATE SITE BOUNDARY
- APPROXIMATE EXTENT OF MULTI STOREY CARPARK DEVELOPMENT
- JKE (0.1) BOREHOLE LOCATION, NUMBER AND DEPTH OF FILL (m)
- MWJKE (0.1) BOREHOLE AND GROUNDWATER MONITORING WELL LOCATION, NUMBER AND DEPTH OF FILL (m)
- AMF ASBESTOS SURFACE FRAGMENT LOCATION
- 1 APPROXIMATE LOCATION OF UNDERGROUND STORAGE TANK, REMOVED IN 2008
- 2 & 3 APPROXIMATE LOCATION OF UNDERGROUND STORAGE TANK, STATUS UNKNOWN
- 4 APPROXIMATE LOCATION OF EXISTING UNDERGROUND STORAGE TANK
- 5 APPROXIMATE LOCATION OF EXISTING ABOVEGROUND STORAGE TANKS, WITHIN A BASEMENT
- SOIL CONTAMINATION ABOVE SAC FOR HUMAN HEALTH RISK (%W/W or mg/kg)

- The calculated Asbestos Fines (AF)/ Fibrous Asbestos (FA) concentrations of 0.0373% w/w (JKE136 (0-0.2m)) and 0.0085% w/w (JKE137 (0.04-0.2m)) were above the SAC of 0.001% w/w. The sampling locations and contamination data are shown in Figure 3 attached in Appendix C and are located immediately to the south-west of the site. AF/FA or ACM were not observed during soil sampling and bulk screening field works. AF/FA materials are considered friable; and
- A surface ACM (sample ref: AMF1) were identified immediately to the south west of the site and in the eastern hospital campus (sample ref: AMF101). The ACM sampling locations are shown in Figure 3 attached in Appendix C. The ACM were unable to be broken by hand and therefore considered non-friable by our field staff.
