**REPORT TO
HEALTH INFRASTRUCTURE**

**ON
REMEDIAL ACTION PLAN (RAP)**

**FOR
PROPOSED NEW MULTI-STOREY CAR PARK**

**AT
LIVERPOOL HOSPITAL, MAIN CAMPUS, ELIZABETH
STREET, LIVERPOOL, NSW**

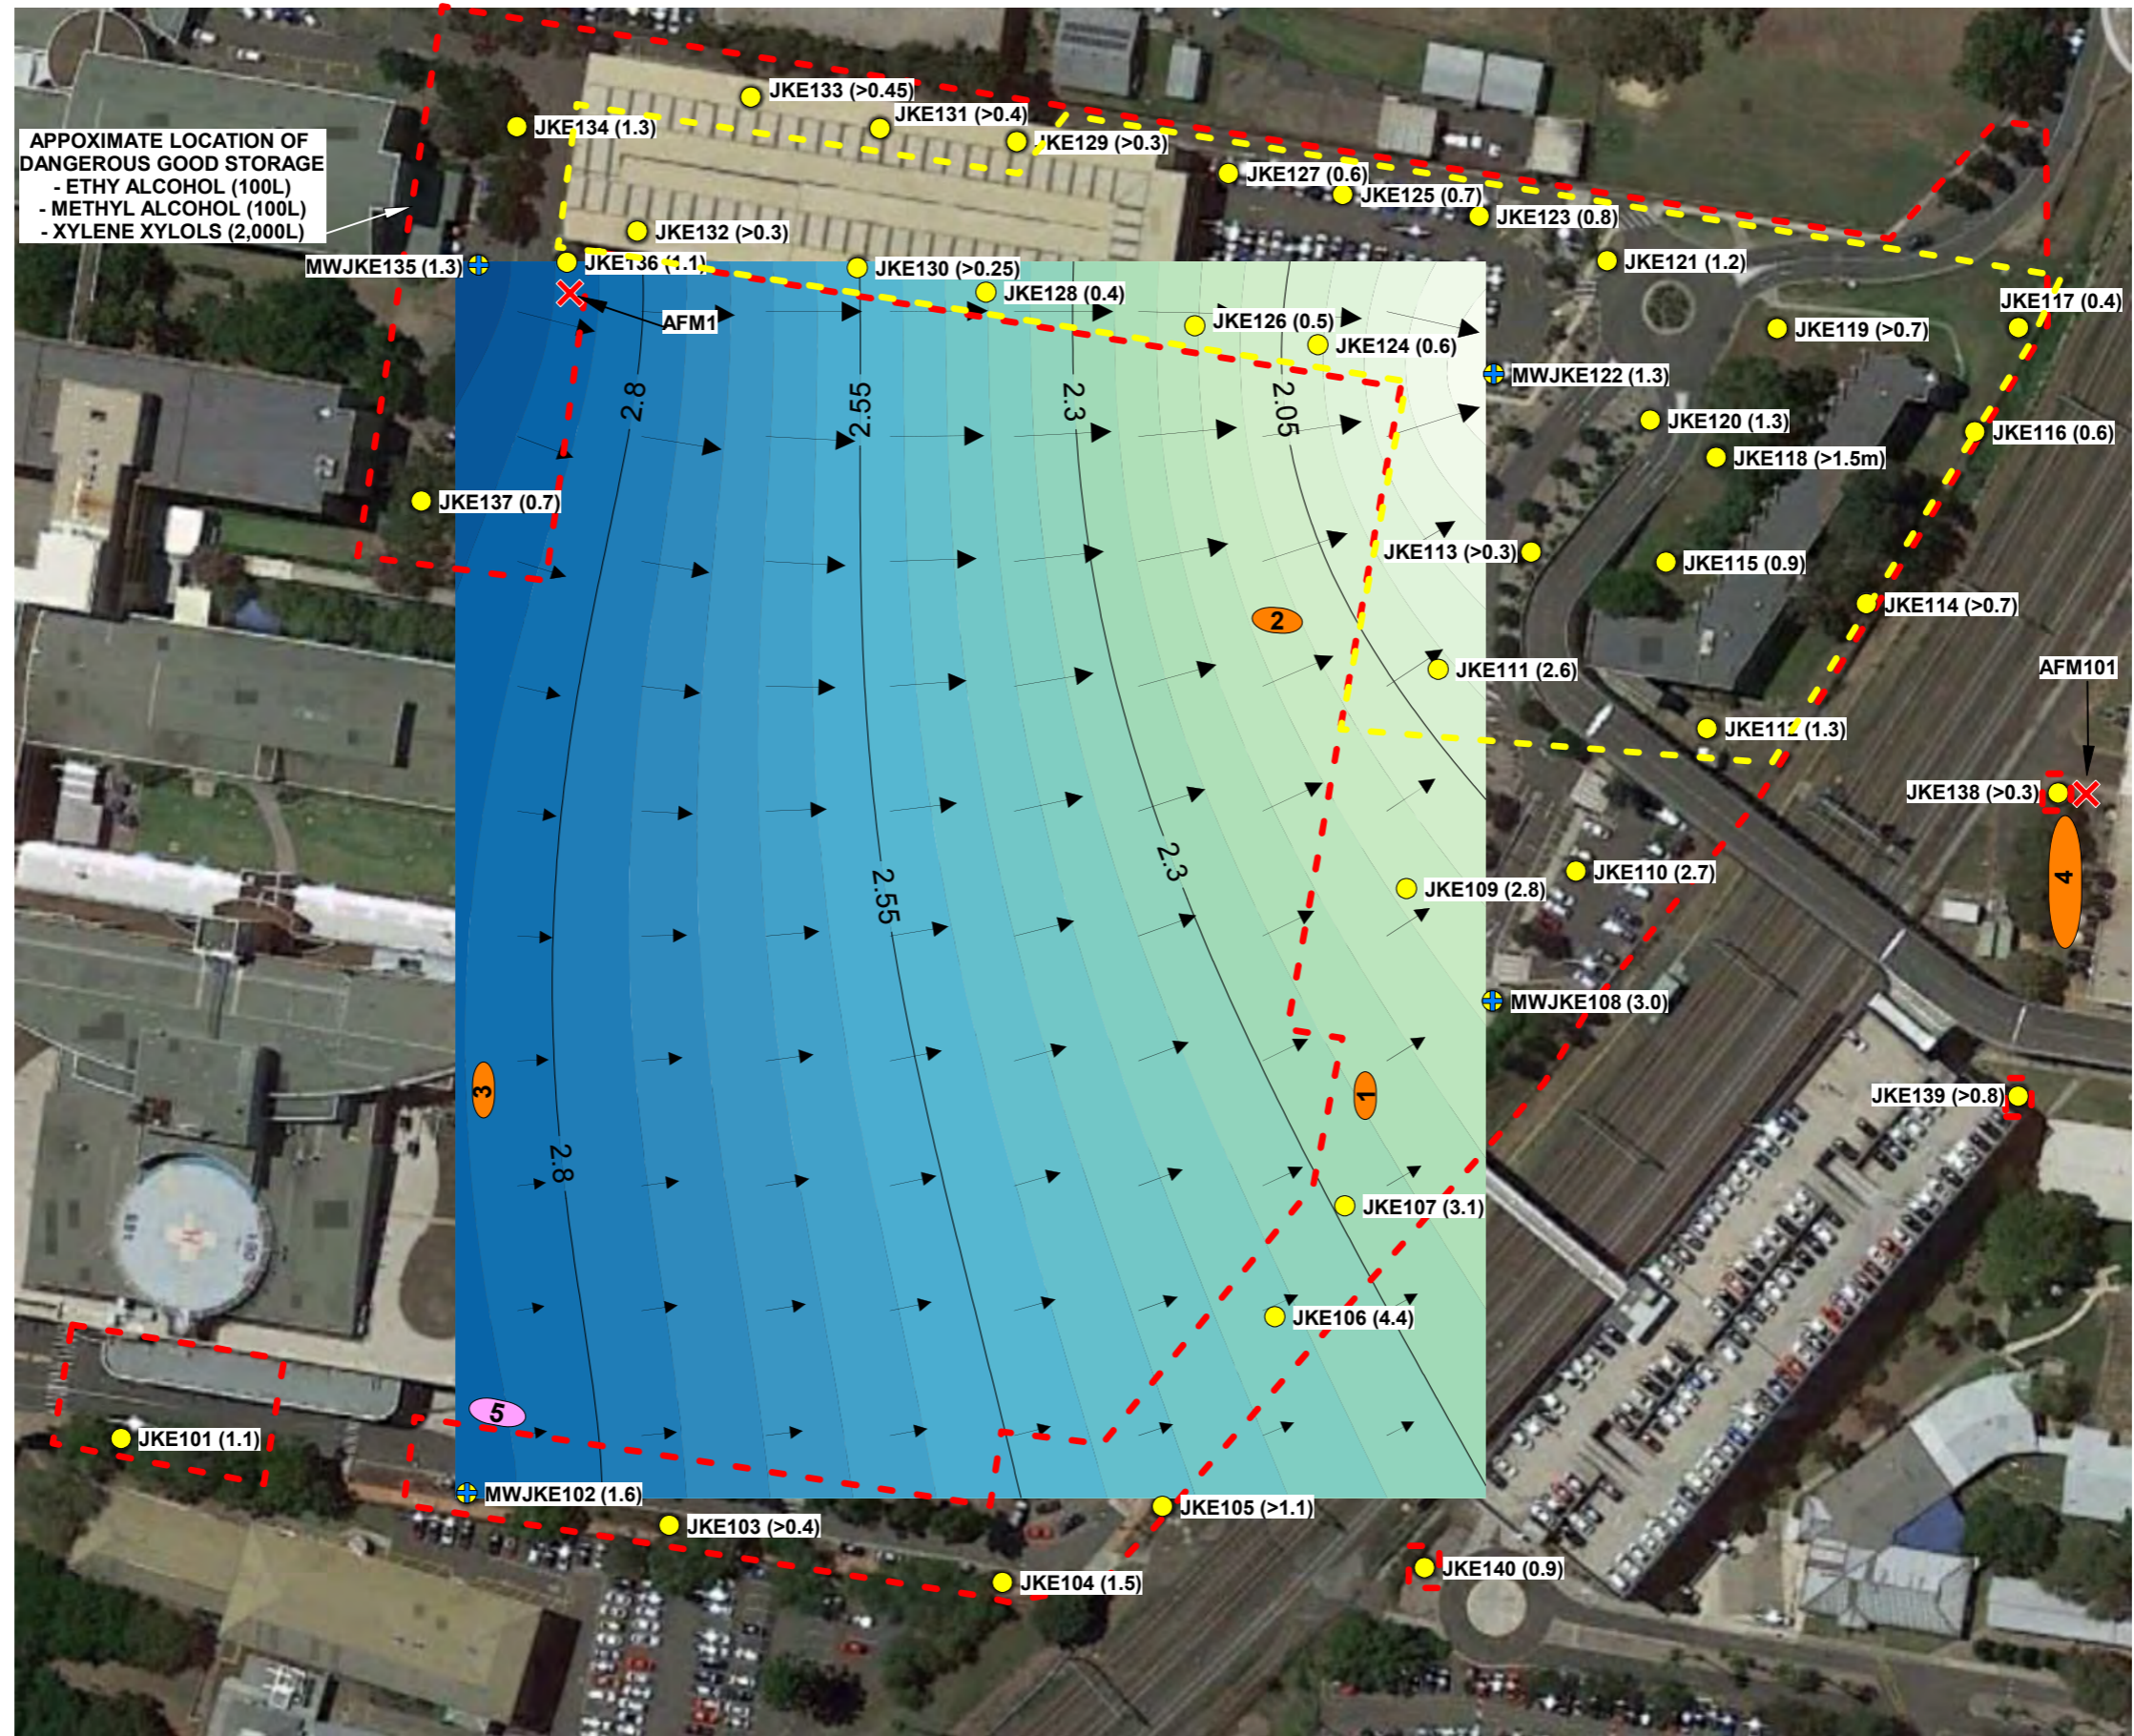
Title: CONTAMINATION DATA PLAN - ECOLOGICAL	
Location: LIVERPOOL HOSPITAL ELIZABETH STREET, LIVERPOOL, NSW	
Report No: E32465BDrpt5	Figure No: 4
JK ENVIRONMENTS

- APPROXIMATE SITE BOUNDARY
- APPROXIMATE EXTENT OF MULTI-STOREY CARPARK DEVELOPMENT
- JKE (0.1) BOREHOLE LOCATION, NUMBER AND DEPTH OF FILL (m)
- MWJKE (0.1) BOREHOLE AND GROUNDWATER MONITORING WELL LOCATION, NUMBER AND DEPTH OF FILL (m)
- ✗ AMF ASBESTOS SURFACE FRAGMENT LOCATION
- 1 APPROXIMATE LOCATION OF UNDERGROUND STORAGE TANK, REMOVED IN 2008
- 2 & 3 APPROXIMATE LOCATION OF UNDERGROUND STORAGE TANK, STATUS UNKNOWN
- 4 APPROXIMATE LOCATION OF EXISTING UNDERGROUND STORAGE TANK
- 5 APPROXIMATE LOCATION OF EXISTING ABOVEGROUND STORAGE TANKS, WITHIN A BASEMENT
- SOIL CONTAMINATION ABOVE SAC FOR ECOLOGICAL RISK (mg/kg)
- GROUNDWATER CONTAMINATION ABOVE SAC FOR ECOLOGICAL RISK (µg/L)

Elevated soil concentrations of TRH (F3) were identified in the fill above the ecological-based Site Assessment Criteria (SAC). The source of TRH is likely associated with the importation of fill to the area. The copper and zinc results of all groundwater samples obtained were greater than the ecological-based SAC. Elevations of heavy metals (particularly copper and zinc) are very common in urban groundwater as a result of leaking water infrastructure and surface run-off. The ecological elevations are shown on Figure 4 attached in Appendix C. Based on the Tier 1 risk assessment, the levels of contamination identified in the soils and groundwater at the site above the ecological-based SAC were assessed to pose a low risk to the receptors and remediation was not proposed due to the ecological elevations.
