## Groundwater Field Sheets

Client:	Johnstaff Projects Pty Ltd	Job No.:	E32837BD
Project:	Proposed Main Works Building	Well No.:	241
Location:	Gourburn Street, Main Campus, Liverpool Hospital, LIVERPOOL, NSW	Depth (m):	11.7

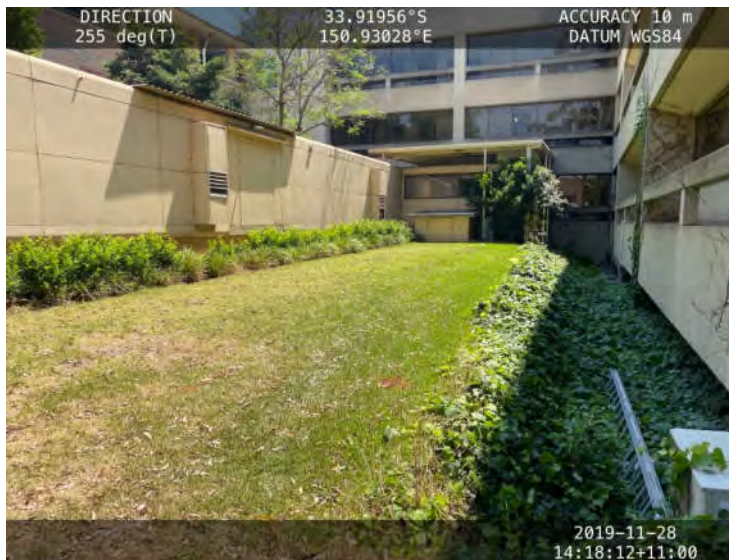
Photograph taken 28  
November 2019 showing the  
grassed and landscaped area  
immediately to the south east  
of the Alex Grimson Building.

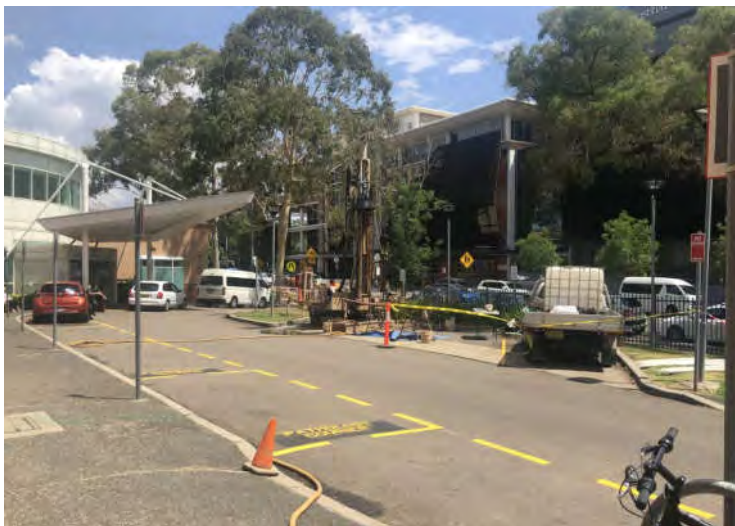
Photograph taken 27  
November 2019 showing the  
north section of the site and  
the sampling location MW1.

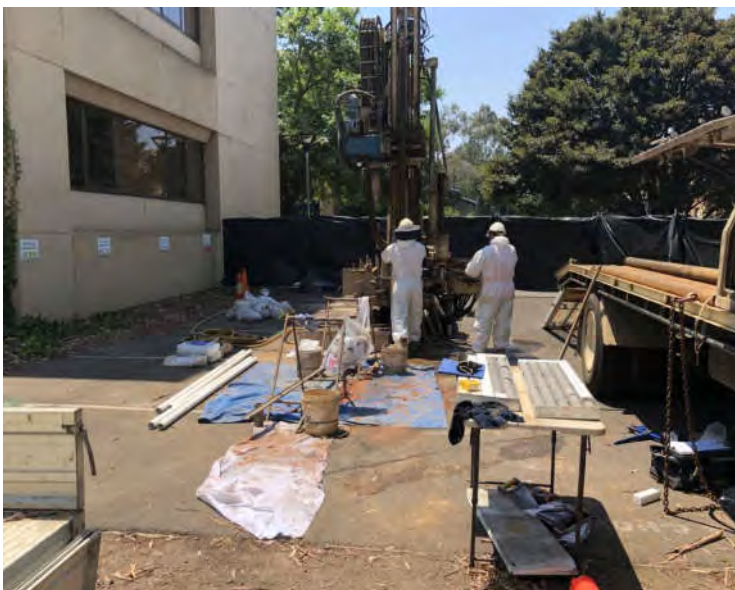
Photograph taken 28  
November 2019 showing the  
central/east section of the  
site and the sampling location  
MW2. Asbestos related  
controls were implemented  
due to the previous detection  
of friable asbestos at the  
nearby sampling location  
JKE137.

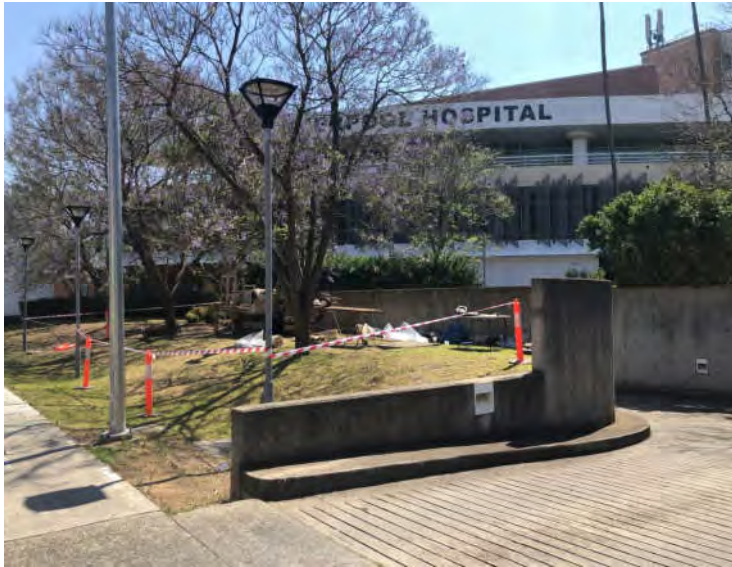
Photograph taken 27  
November 2019 showing the  
south west section of the site  
and the sampling location  
MW3.

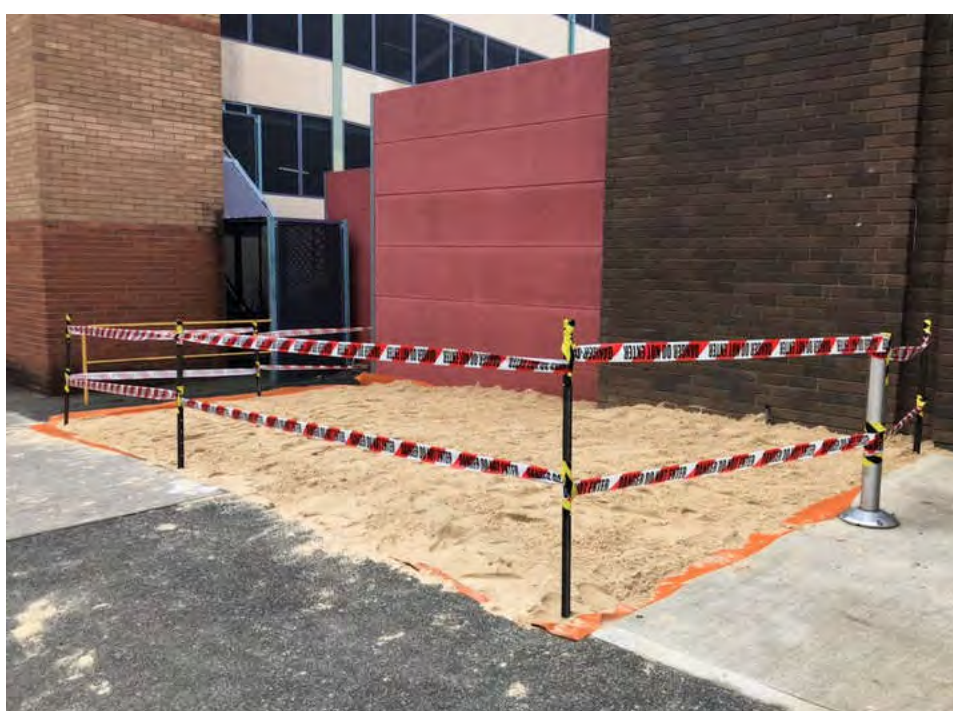
Site Photograph Showing Temporary Capping at JKE136  
Provided by SWSLHD

Note: Photograph provided by SWSLHD, showing the barricading and temporary capping of the formerly exposed soils in the area surrounding sampling location JKE136.
