Geotechnical Investigation

235 Grose Vale Road, North
Richmond, NSW

Prepared for: St John of God Health Care Inc C/- Johnstaff NSW
Pty Ltd

EP1494.002 13 February 2020

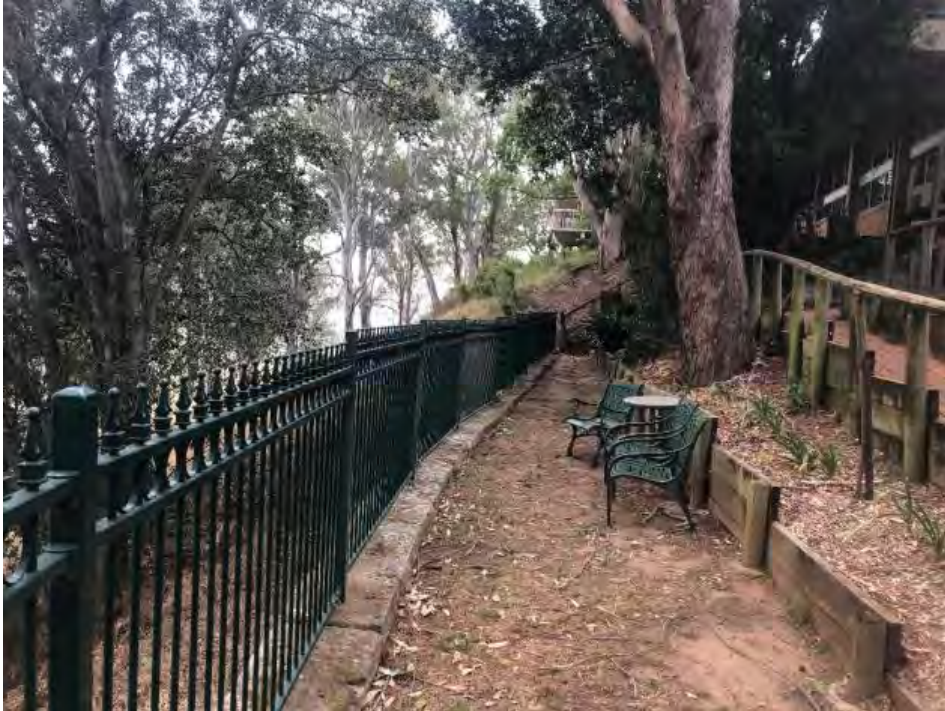
**Plate 1****Description:**

Steep to extreme slopes and retaining wall on the eastern boundary of the Site.

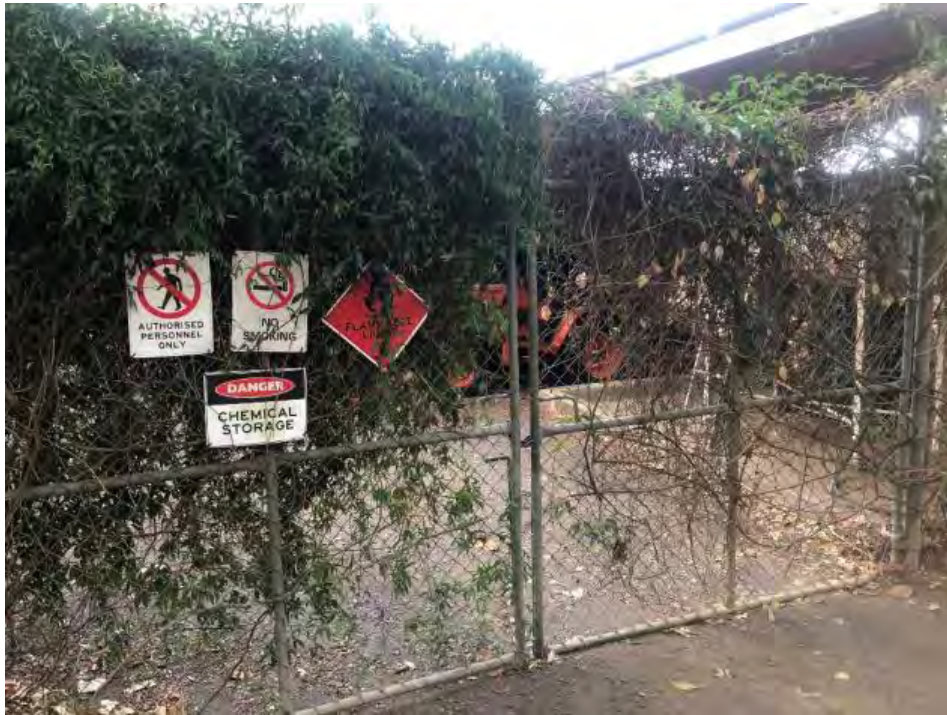
**Plate 5**

Description:
Above ground diesel tank and chemical storage area located adjacent to the maintenance shed.
