Our Ref: PSM4010-003L

**44 CLUNIES ROSS STREET, PROSPECT.
DESKTOP STUDY AND RESULTS OF GEOTECHNICAL INVESTIGATION**

This letter provides the results of desktop study, factual results of site investigation between 8 and 10 January 2020 and interim geotechnical design advice (IGDA) for the proposed industrial development and associated earthworks at Clunies Ross Street, Prospect NSW.

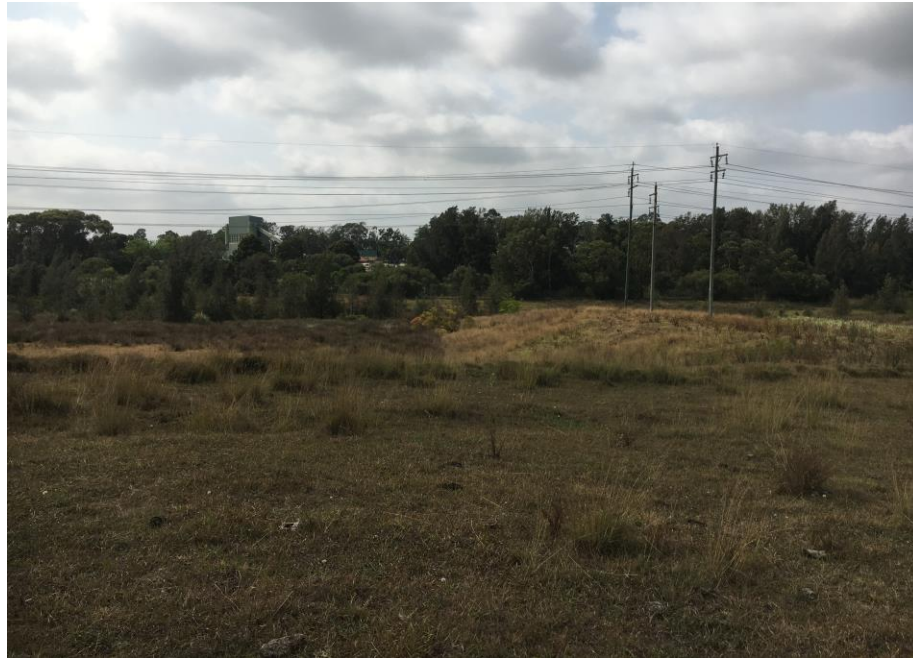
Photo 1: Looking south east from borehole BH12

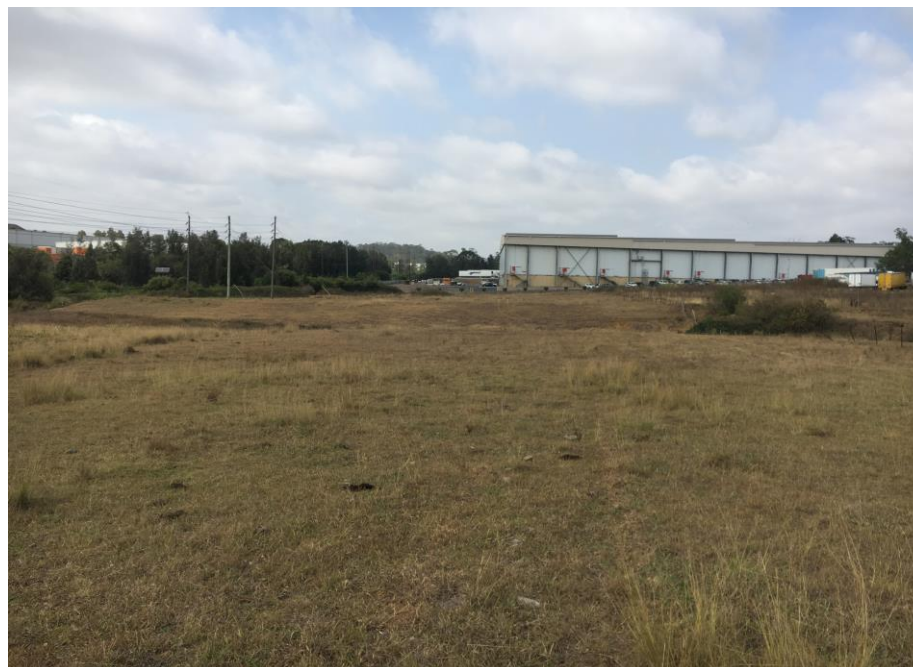
Photo 2: Looking south from borehole BH12

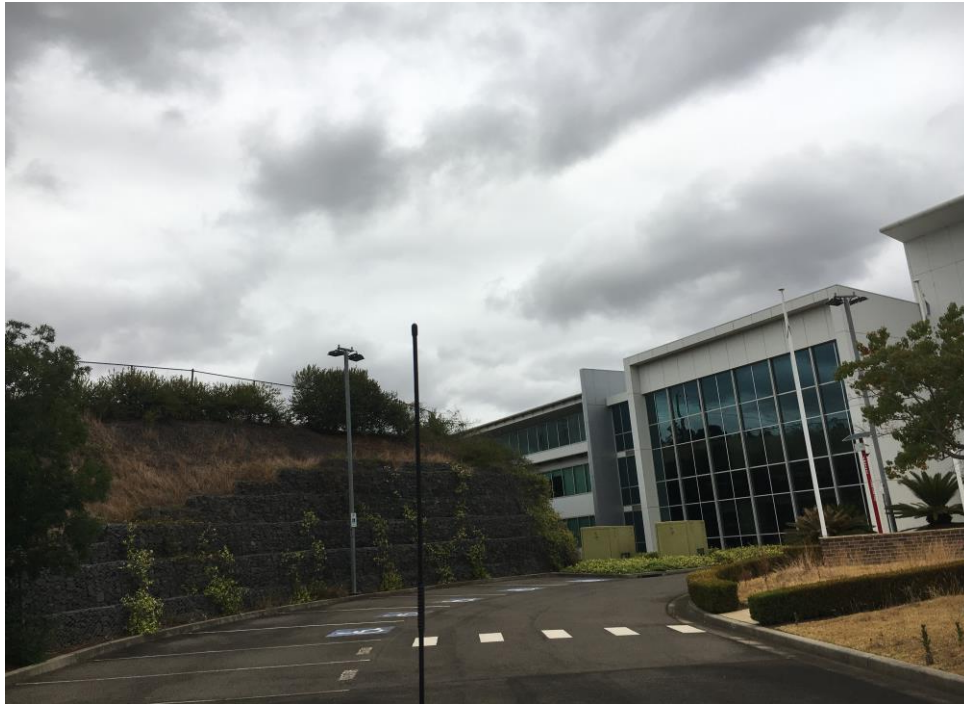
Photo 3: Gabion Wall at Boral House looking south west

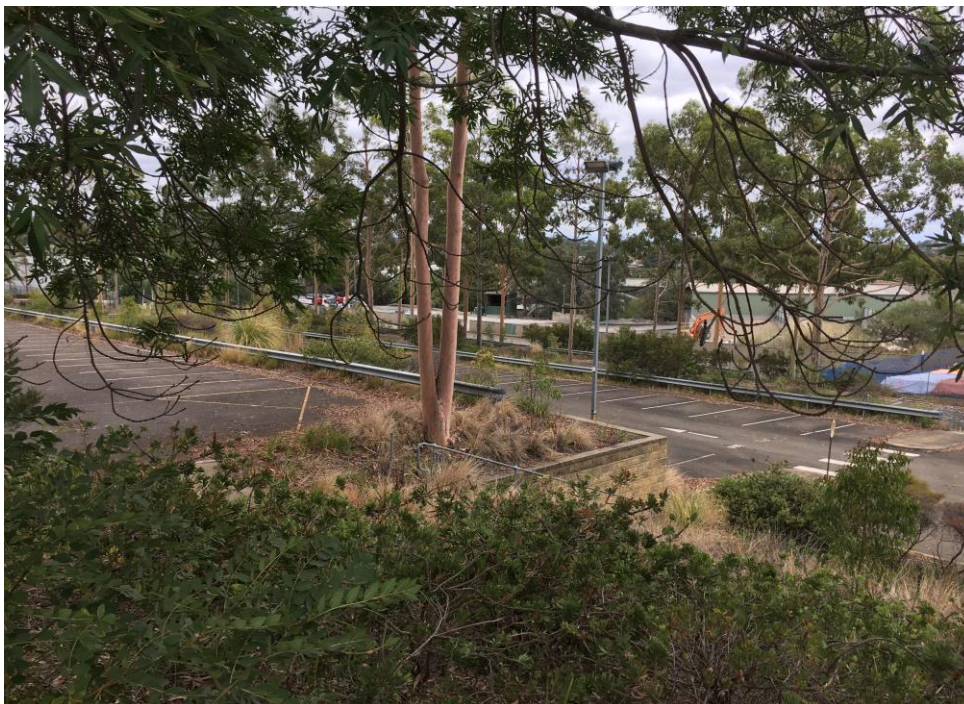
Photo 4: Looking North West across the Boral House car parks

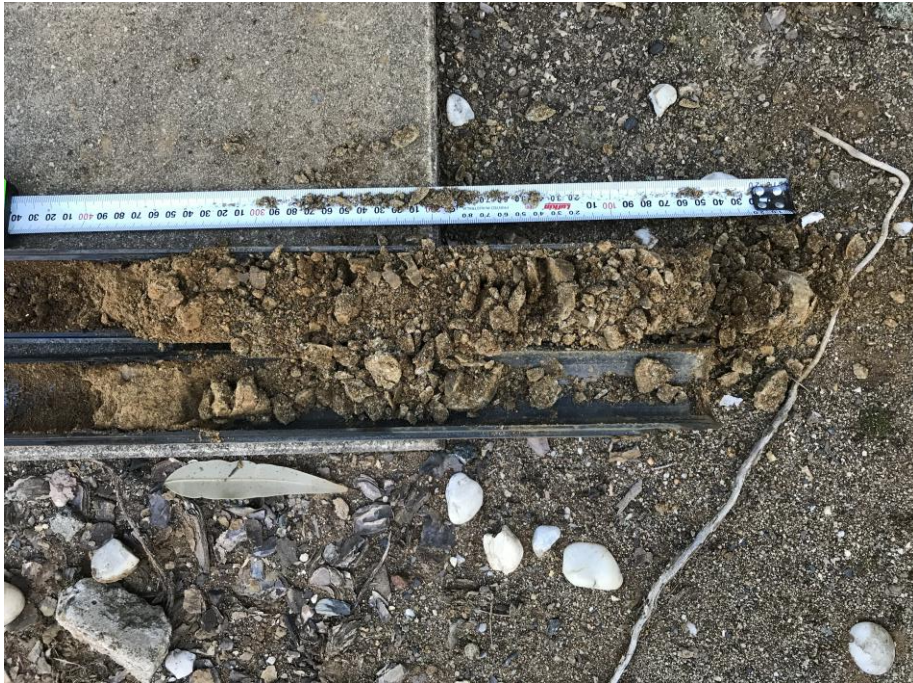
Typical Residual Dolerite (Residual B)

We note that it is difficult to determine fill and natural in-situ material in augered boreholes where the fill is composed of locally excavated natural material. It is possible that some of the SOIL units are fill placed under controlled conditions and therefore the fill may be thicker than interpreted. Typical photos of residual shale and dolerite are presented in Figure 6.

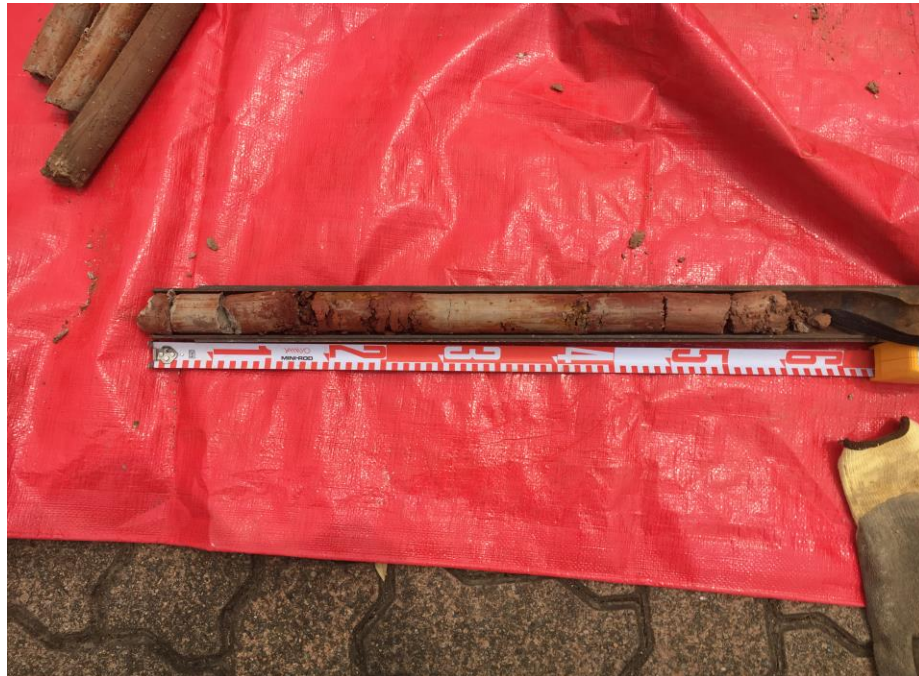
Typical Residual Shale (Residual A)

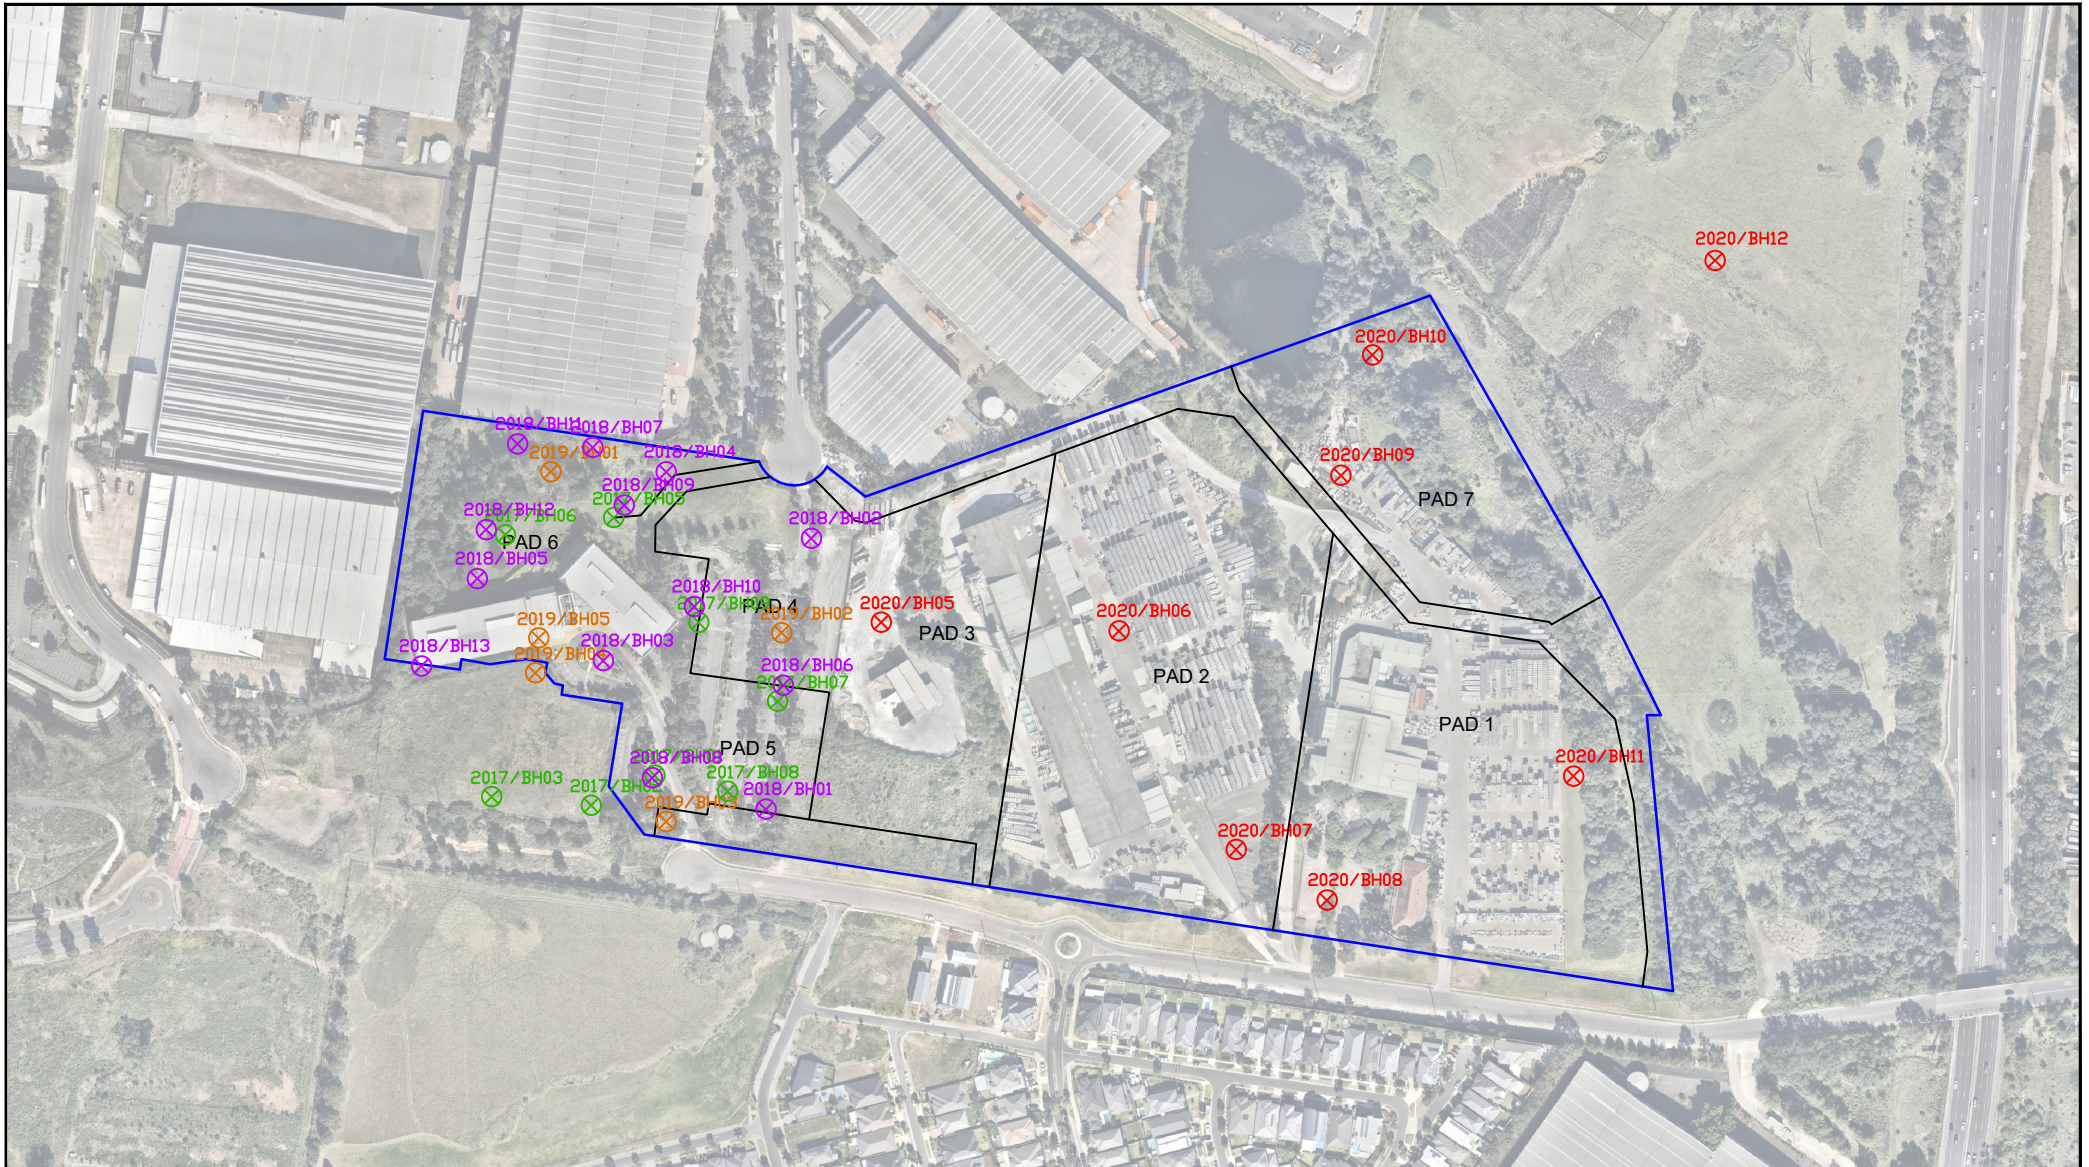
Figure 1 Site Locality Plan

- ⊗ 2020/BH - Boreholes undertaken in 2020
- ⊗ 2019/BH - Boreholes undertaken in 2019
- ⊗ 2018/BH - Boreholes undertaken in 2018
- ⊗ 2017/BH - Boreholes undertaken in 2017
- Approximate boundary of proposed development
- Approximate pad boundaries
