ISPT Pty Ltd
c/o
Aliro Management Pty Ltd

Phase 1 and Phase 2 Environmental Site Assessment

Prospect Logistics Estate
Pemulwuy, NSW

58238/130144 (Rev 0)
JBS&G Australia Pty Ltd

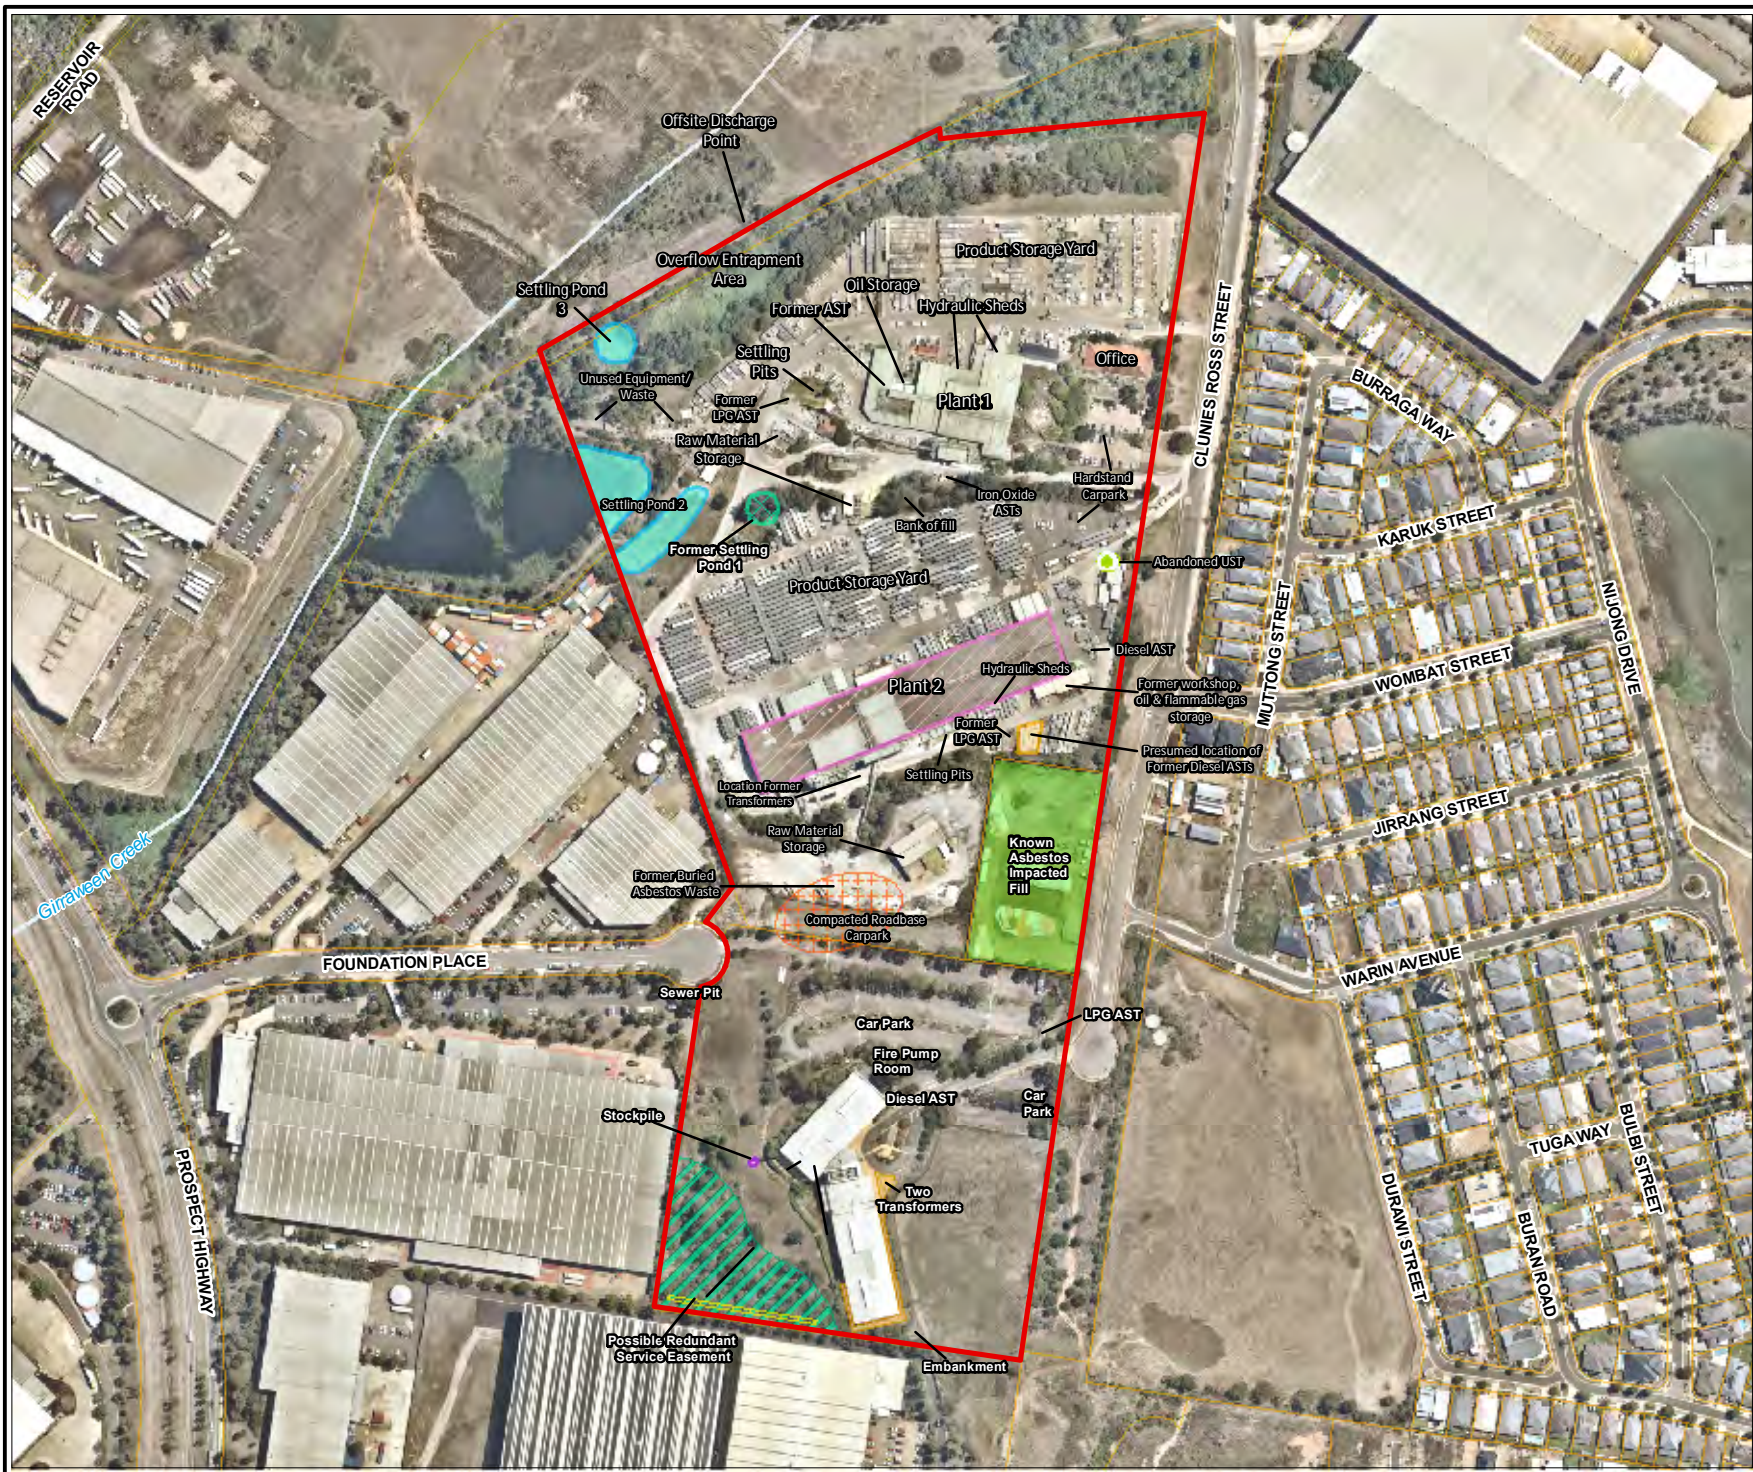
FIGURE 2B

Waste and/or raw material storage was observed within the western portion of the site and surrounding a shed in the central portion of the site (south of Plant 2, **Figure 2b**). Material storage included manufacturing by-products (slag/ash). Existing structures were noted to contain hazardous building materials (asbestos).

- Two former oil (drum) stores were identified to the northern end of the former factory building which contained various oils, grease and solvents (**Figure 2b**). An internal audit by Boral in 1996 (not cited by Woodward-Clyde or JBS&G) noted that the surface soils in the area were contaminated with oil;

A review of topographical information available on SIX Maps¹³ indicates that the site is located within a gently undulating regional topography. The south of the site is situated atop a regional high point (Prospect Hill, **Figure 2b**). Site levels were noted to fall slightly to the south and west of the crest, with the majority of the site falling towards the north/northwest, towards Girraween Creek.

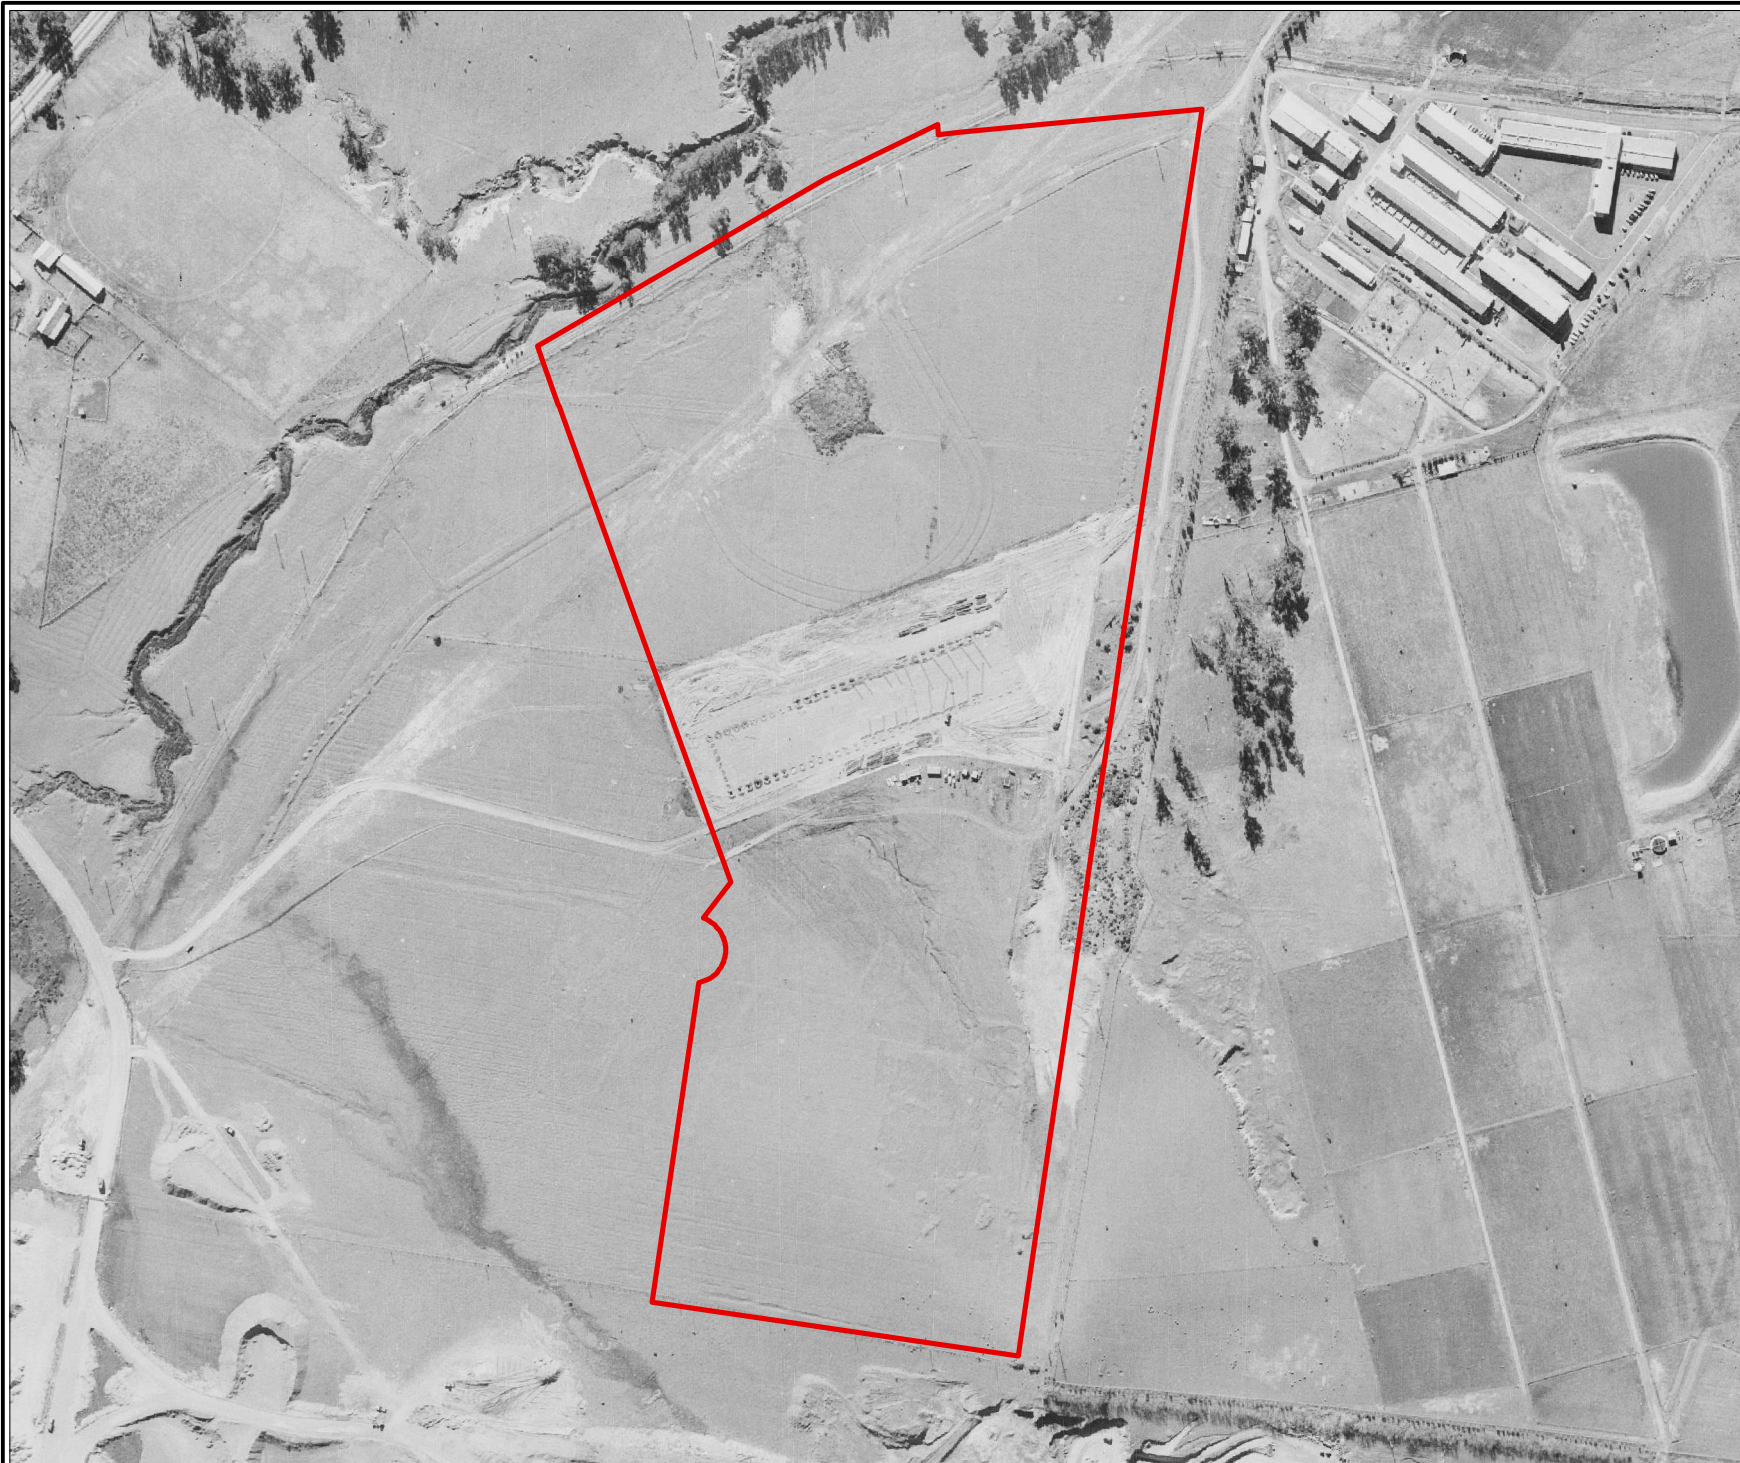
FIGURE 1961

1961	<ul style="list-style-type: none"> The accessway and small sheds had been de-established and the construction of a large warehouse (Plant 2, Figure 2b) in the central portion of the site was evident. The footprint of the warehouse area had been levelled and the importation of material was apparent to establish site levels. A large stockpile of rock/potential waste was present within the central northern portion of the site (within the “U” of the former road) and a small drainage easement was noted in the north extending beyond the site to Girraween Creek. Some minor erosional features were present in the south east. The remainder of the site remained unchanged. The surrounding area appeared generally similar to the previous aerial photograph. Demolition of the small shed structures and construction of several large warehouses to the north east of the site had occurred. Land to the east appeared to have been subdivided into rectangular lots (presumably for agriculture/livestock) and a large water retention basin established further east. Land to the south and south west contained large stockpiles of material and evident ground disturbance activities, presumably associated with regional quarrying activities further south (Prospect Quarry).

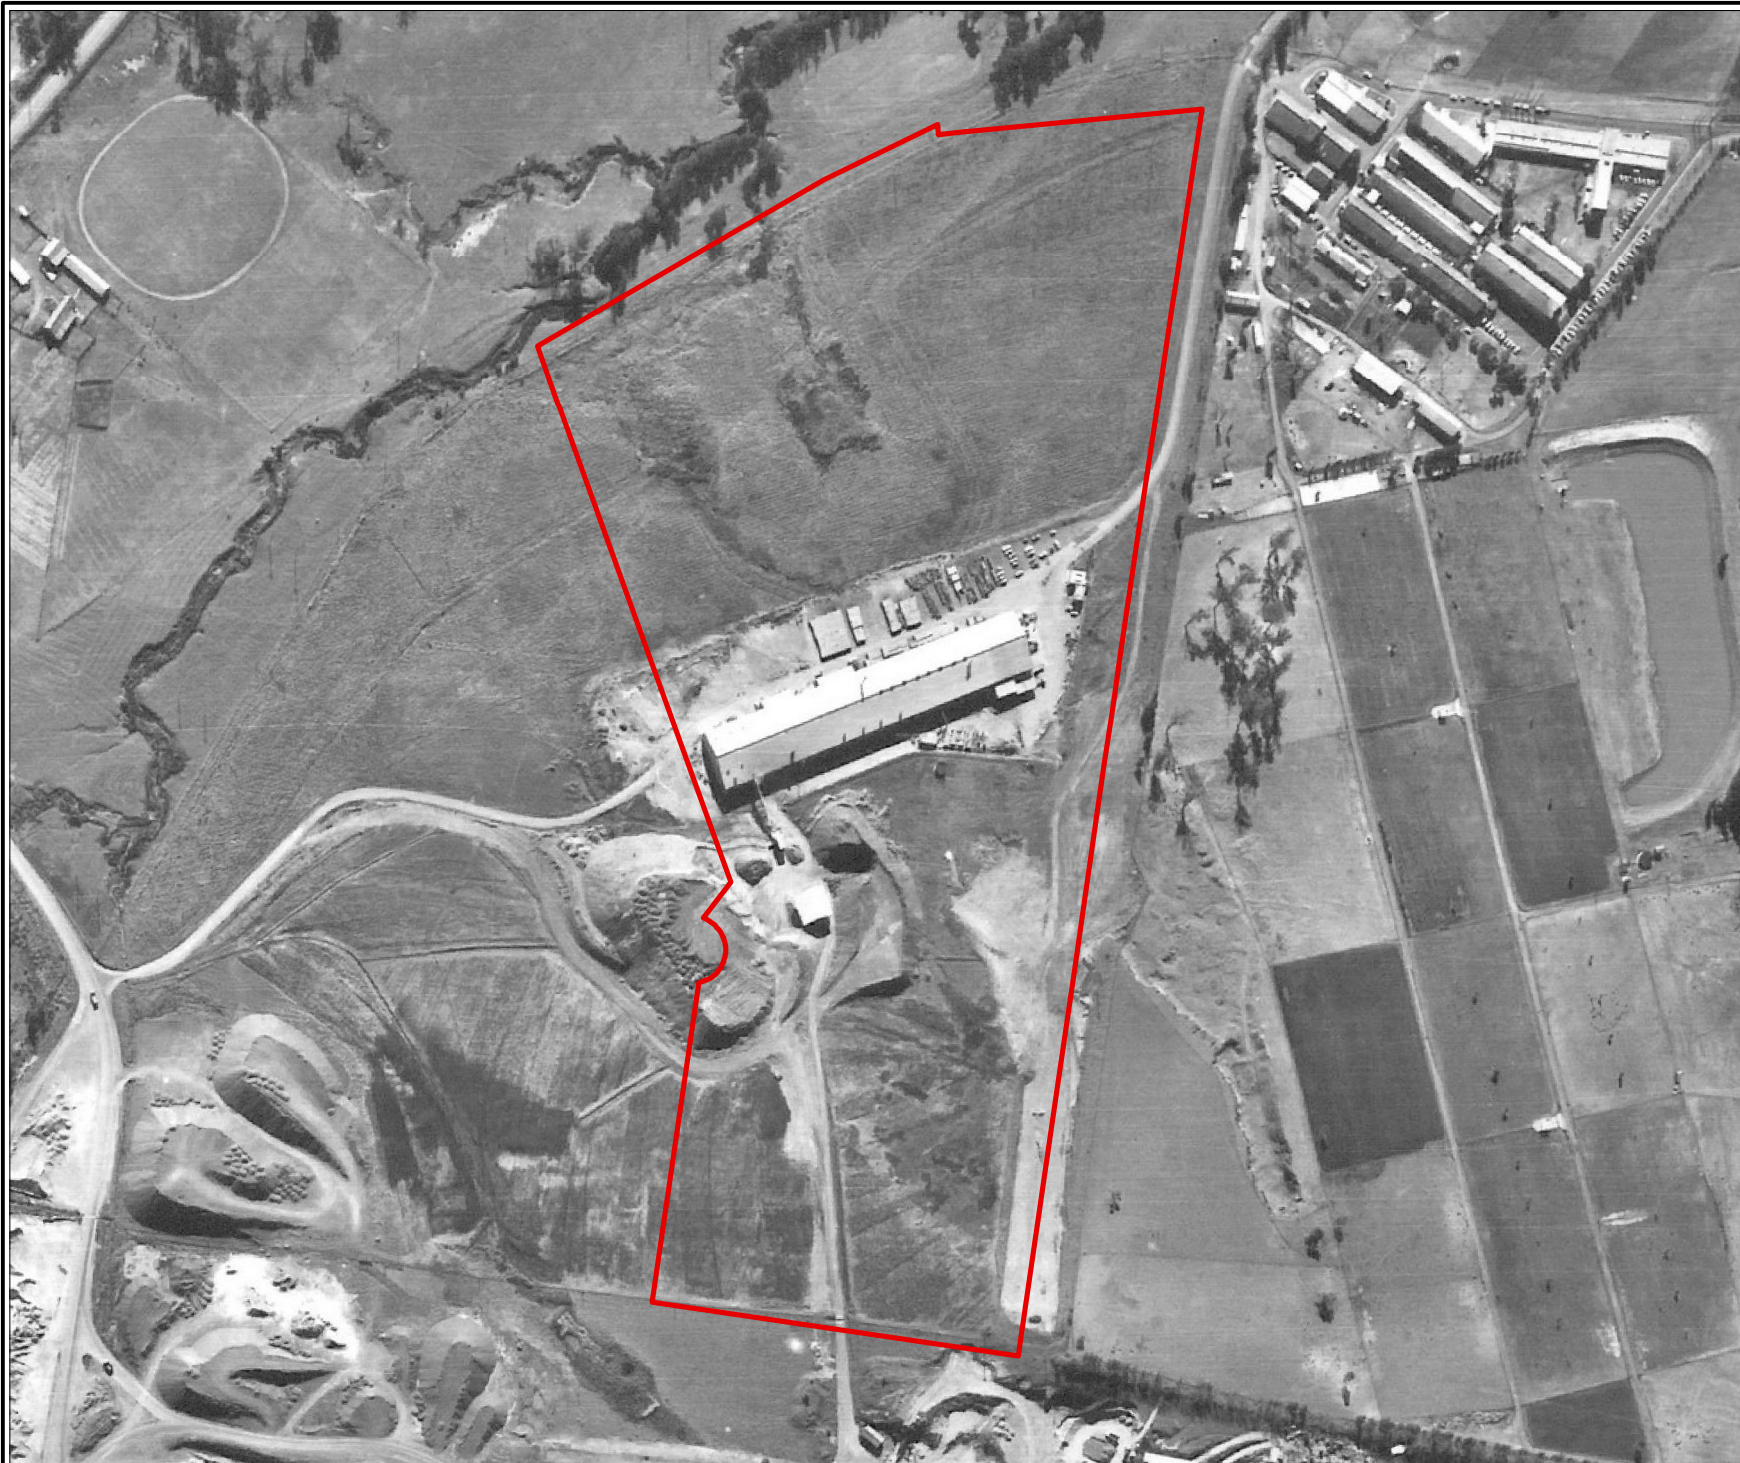
FIGURE 1970

1970	<ul style="list-style-type: none"> The construction of the large warehouse in the central portion of the site had been completed. Several small storage sheds, stored products and vehicles were identified surrounding the warehouse. Several rectangular structures noted to the immediate south of the central portion of the warehouse are possibly petroleum storage tanks which were reported to be present at the site during this time (Woodward-Clyde (2000), as discussed in Section 4.1.1). A material processing yard was evident to the south west of the warehouse and comprised several large stockpiles of material and a single small square warehouse. An access road had been established through the centre of the southern portion of the site. Ground disturbance was apparent along the south eastern boundary. Several large stockpiles of material were apparent to the west of the site and several roadways had been better established providing access to the south (toward the former Prospect Quarry).

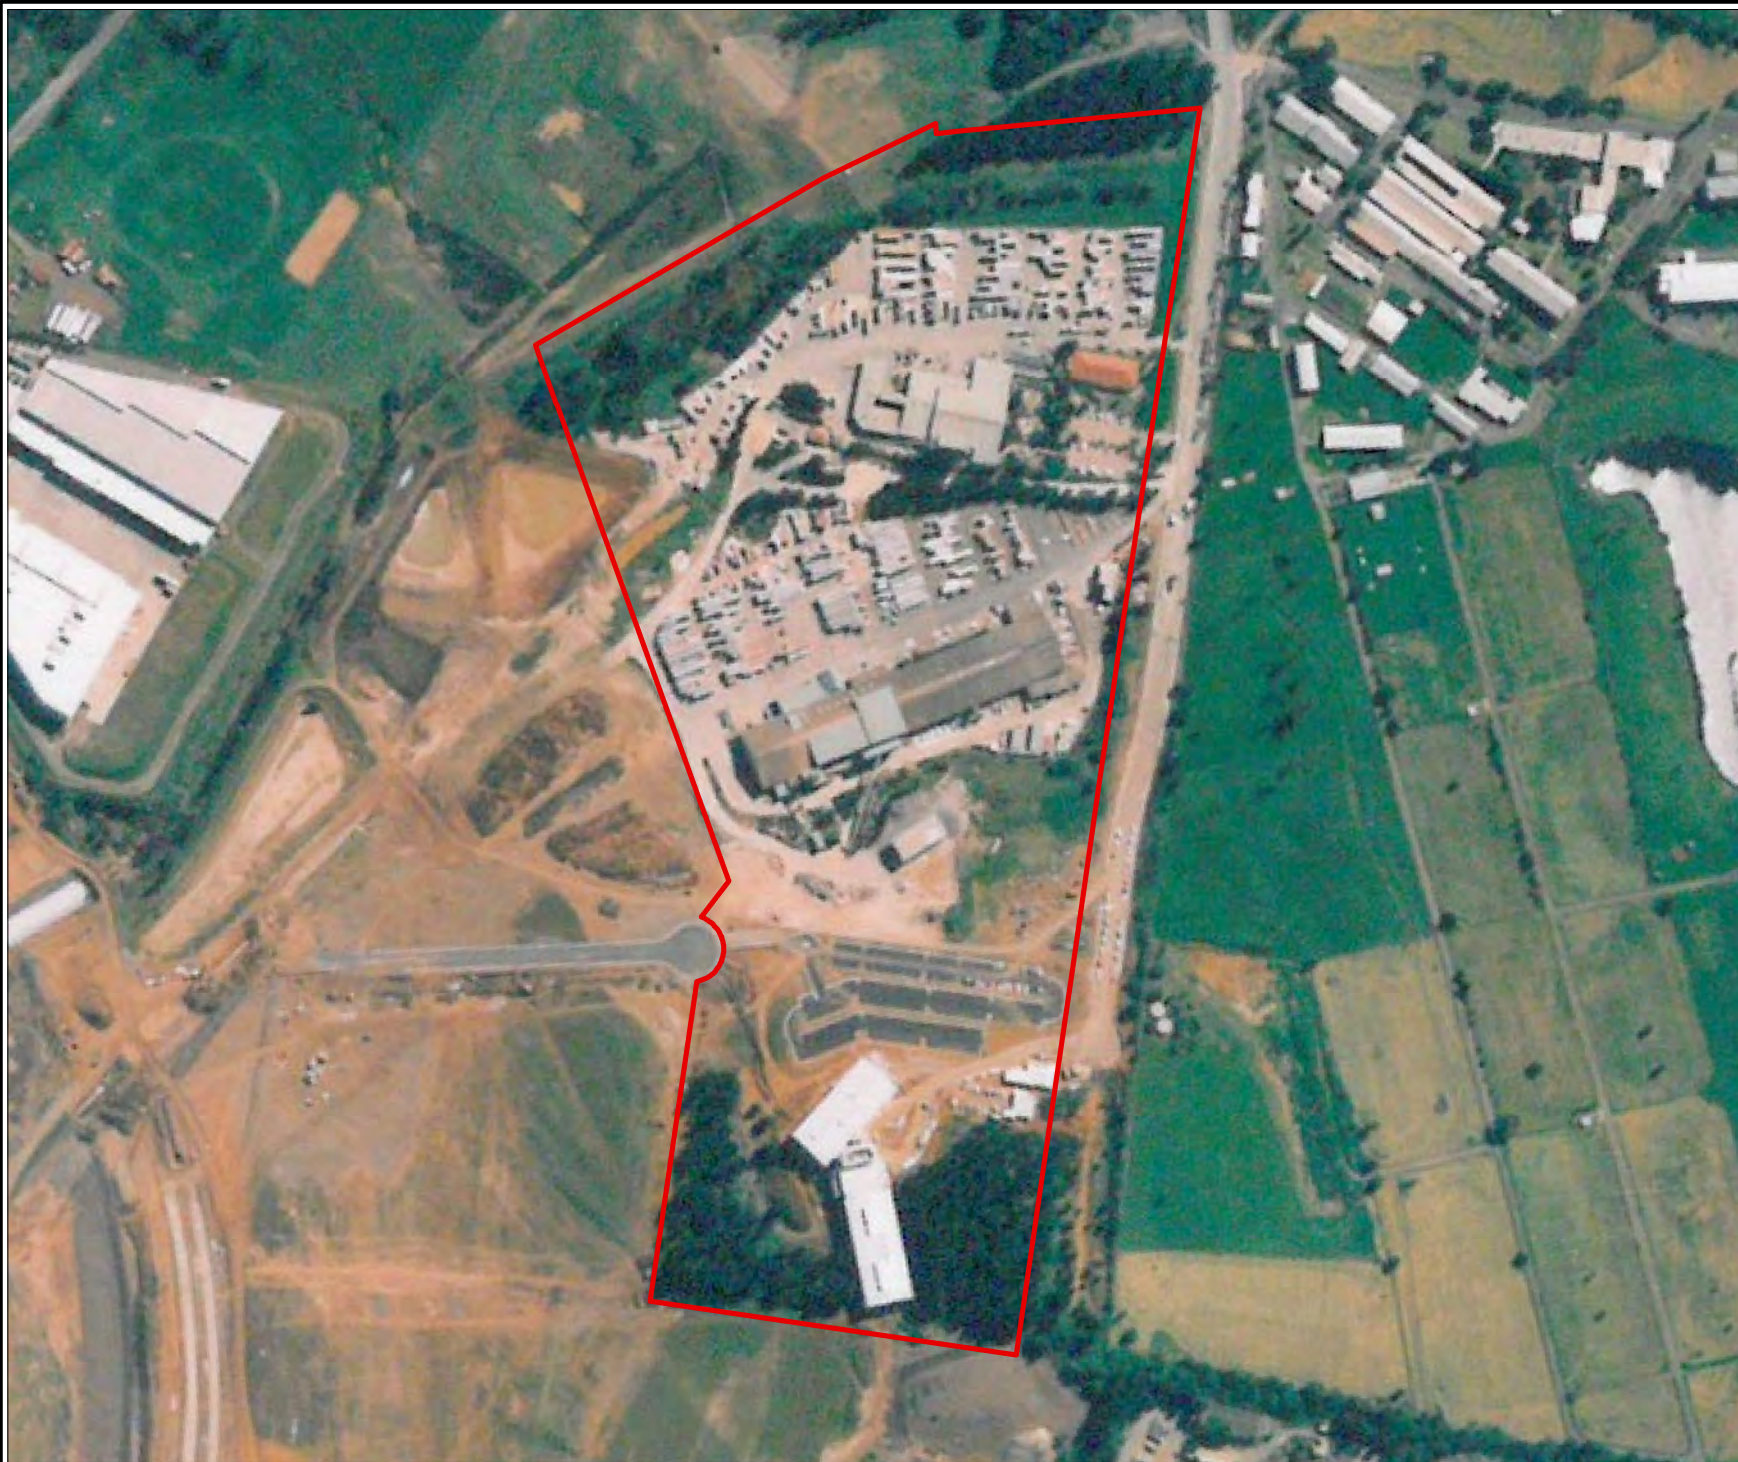
FIGURE 2002

2002	<ul style="list-style-type: none"> The northern portion of the site had undergone significant redevelopment, comprising newly constructed warehouse/office buildings, hardstand material storage yards and carparking areas in the northeast. Several minor additions to the central warehouse were noted. The southern portion of the site was undergoing redevelopment and contained two newly constructed commercial buildings where the current Boral House exists and associated bituminous car park areas which were still under construction. Two temporary structures (e.g. construction sheds) are present at the southeast boundary. Clunies Ross Street had been constructed adjacent to the east of the site. The land to the west appeared to be being redeveloped and had been stripped and levelled with two warehouses constructed further west, and Foundation Place almost completed. A retention basin associated with the adjacent redevelopment was apparent and extended to within the north western portion of the site.
