# MAROOTA SANDS PROJECT

Environmental Impact Statement  
Landscape and Visual Impact Assessment

SLR Ref: 630.30046-R01  
Version No: 2  
April 2020

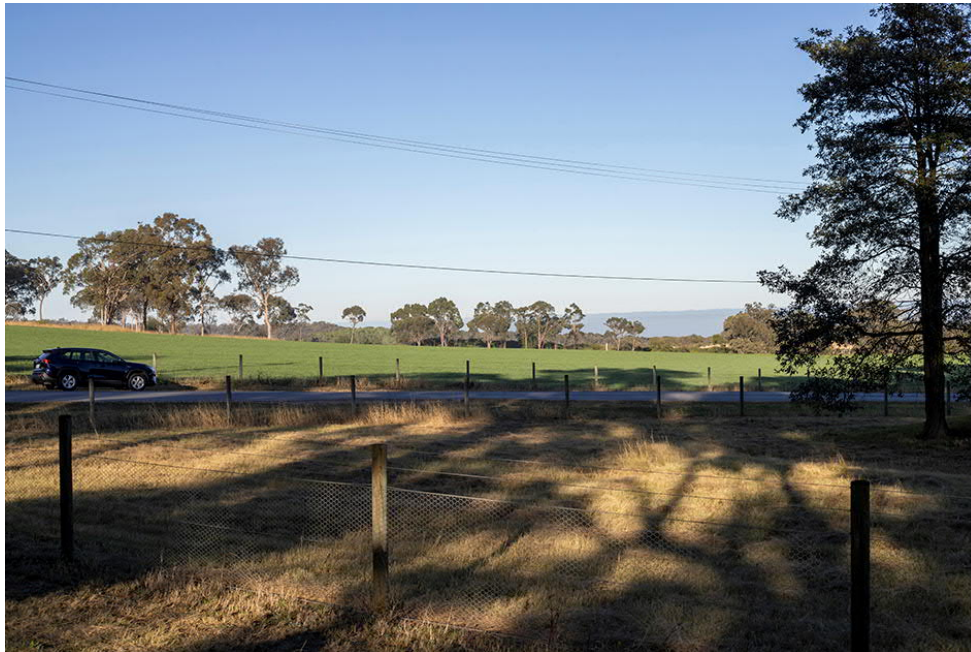
Image 2 - VP1, Proposed Rehabilitation Works as viewed from Receptor 1

| Mitigation Measures | Mitigation measures recommended would be to seed/ plant the batters of the exposed new landfill works to reduce the impact (degree of variation) on the surrounding landscape. This should occur on a staged basis as the works stage is completed. As the stage 4 and 5 works are likely to occur later in the life of the project then initial impacts from this viewpoint will be negligible. |

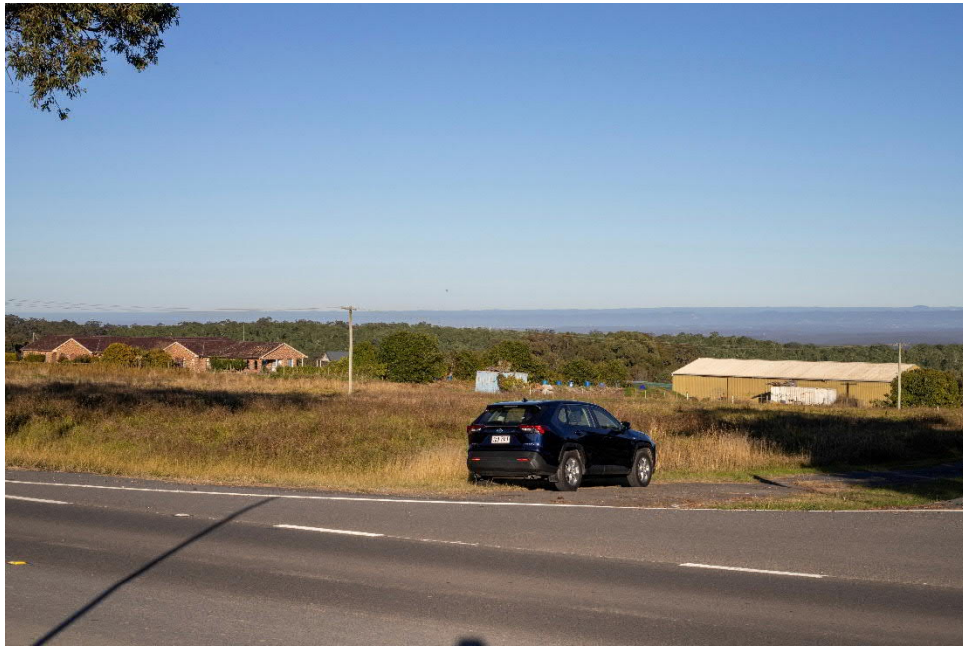
Image 4 - VP2, Proposed Rehabilitation Works as viewed from Receptor 2

| Mitigation Measures | Mitigation measures as recommended in the Rehabilitation Plans are to seed/ plant the batters of the exposed new landfill works with endemic species to reduce the impact (degree of variation) on the surrounding landscape. This should occur on a staged basis as the works stage |
