# DLALC MAROOTA SANDS PROJECT

## Rehabilitation Strategy

SLR Ref: 630.30035-R01  
Version No: -v0.2  
June 2021

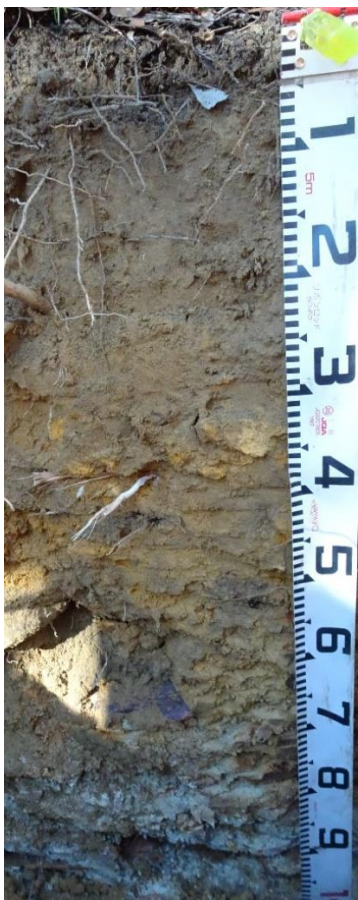
**Table 5 Dystrophic Brown Kurosol (Site 1)**

| Profile | Horizon / Depth (m) | Description |
|---|---|---|
| | A1<br>0.0 – 0.20 | Brown (7.5YR 4/2) sandy loam, weak crumb structure <10 mm peds with weak consistence and a rough fabric. Nil mottling, 10% gravel content 5-10 mm, nil segregations, abundant fine roots. Well drained with a clear and even boundary.<br>Sampled 0.0 – 0.10 |
| | B21<br>0.20 – 0.60 | Yellowish-brown (10YR 5/8) sandy clay loam, moderately structured 10-20 mm blocky peds with moderate consistence and a rough fabric. Nil mottling, 20% cobble content 40-60 mm, nil segregations, abundant fine roots. Well drained with a gradual and even boundary.<br>Sampled 0.30 – 0.40 |
| | B22<br>0.60 – 0.80 | Yellowish-brown (10YR 5/8) light-medium clay, moderately structured 15-30 mm blocky peds with strong consistence and a rough fabric. 20% distinct grey mottles, 10% gravel content 5-10 mm, nil segregations, coarse roots common. Moderately drained with a clear and even boundary.<br>Sampled 0.60 – 0.70 |

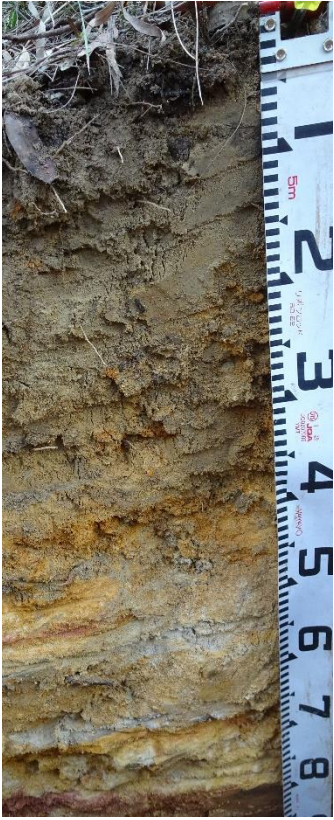
**Table 7 Profile: Mesotrophic Yellow Kandosol (Site 6)**

| Profile | Horizon / Depth (m) | Description |
|---|---|---|
| | A1<br>0.0 – 0.20 | Greyish-brown (10YR5/2) sandy loam, weak crumb structured 5-10 mm peds with weak consistence and a rough fabric. Nil mottling, nil stone content, nil segregations, abundant fine roots. Well drained with a gradual and even boundary.<br>Sampled 0.0 – 0.10 |
| | B2<br>0.20 – 0.40 | Light yellowish-brown (2.5Y 6/4) clay loam, moderately structured 10-30 mm blocky peds with moderate consistence and a rough fabric. Nil mottles, nil gravel content, nil segregations, coarse roots common. Well drained with a gradual and even boundary.<br>Sampled 0.20 – 0.30 |
| | BC<br>+0.40 | Weathered sandstone.<br>Not sampled |
