## Appendix I

Contamination database searches and historical aerial photos

## ENVIRO-SCREEN

Sheraton Road, Eulomogo NSW

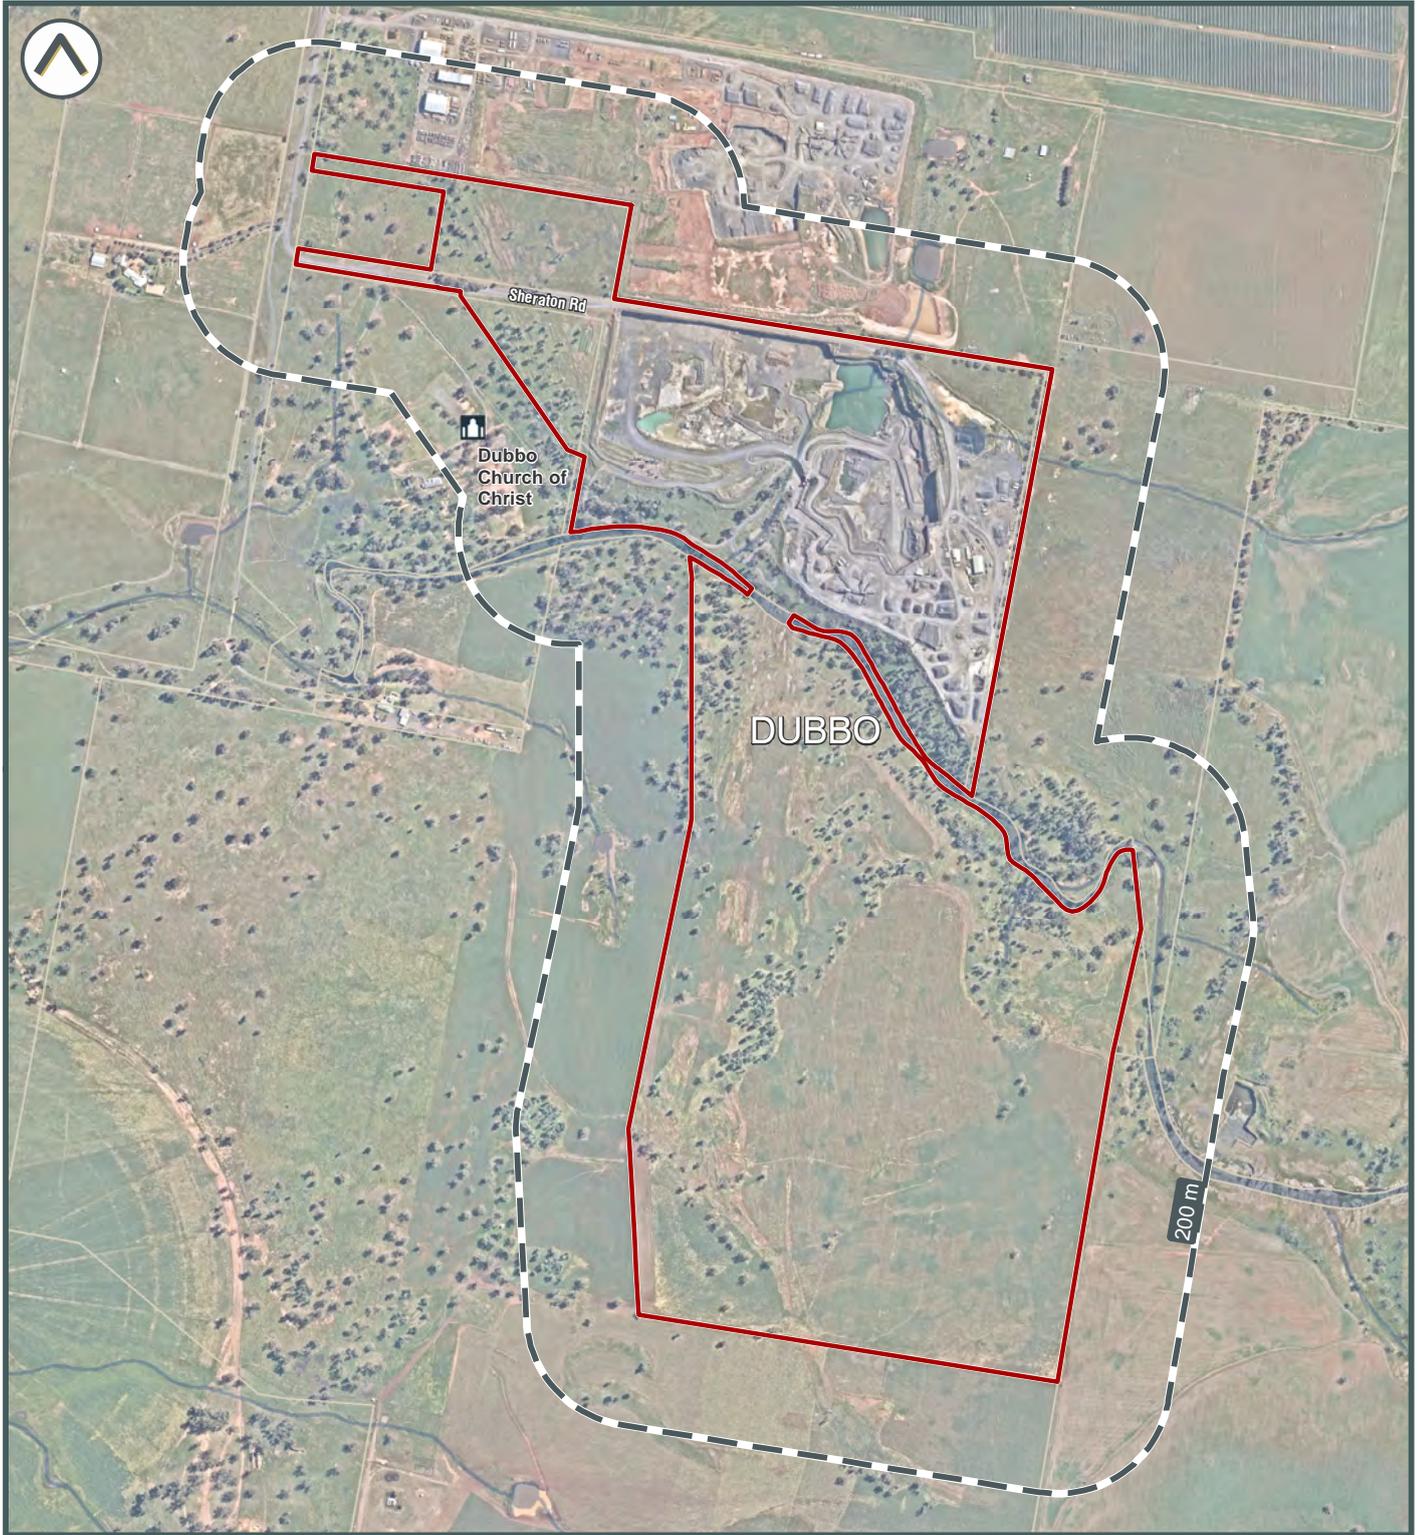
- Subject area
- Transmission Line
- Stormwater channel
- Sewer Main
- Water Main
- Pipeline

**Sensitive Receptors**  
 Places of Worship & Religious Organisations

Sensitive receptor	Category	Distance (m)*	Direction
Dubbo Church of Christ	Place of worship	116	west

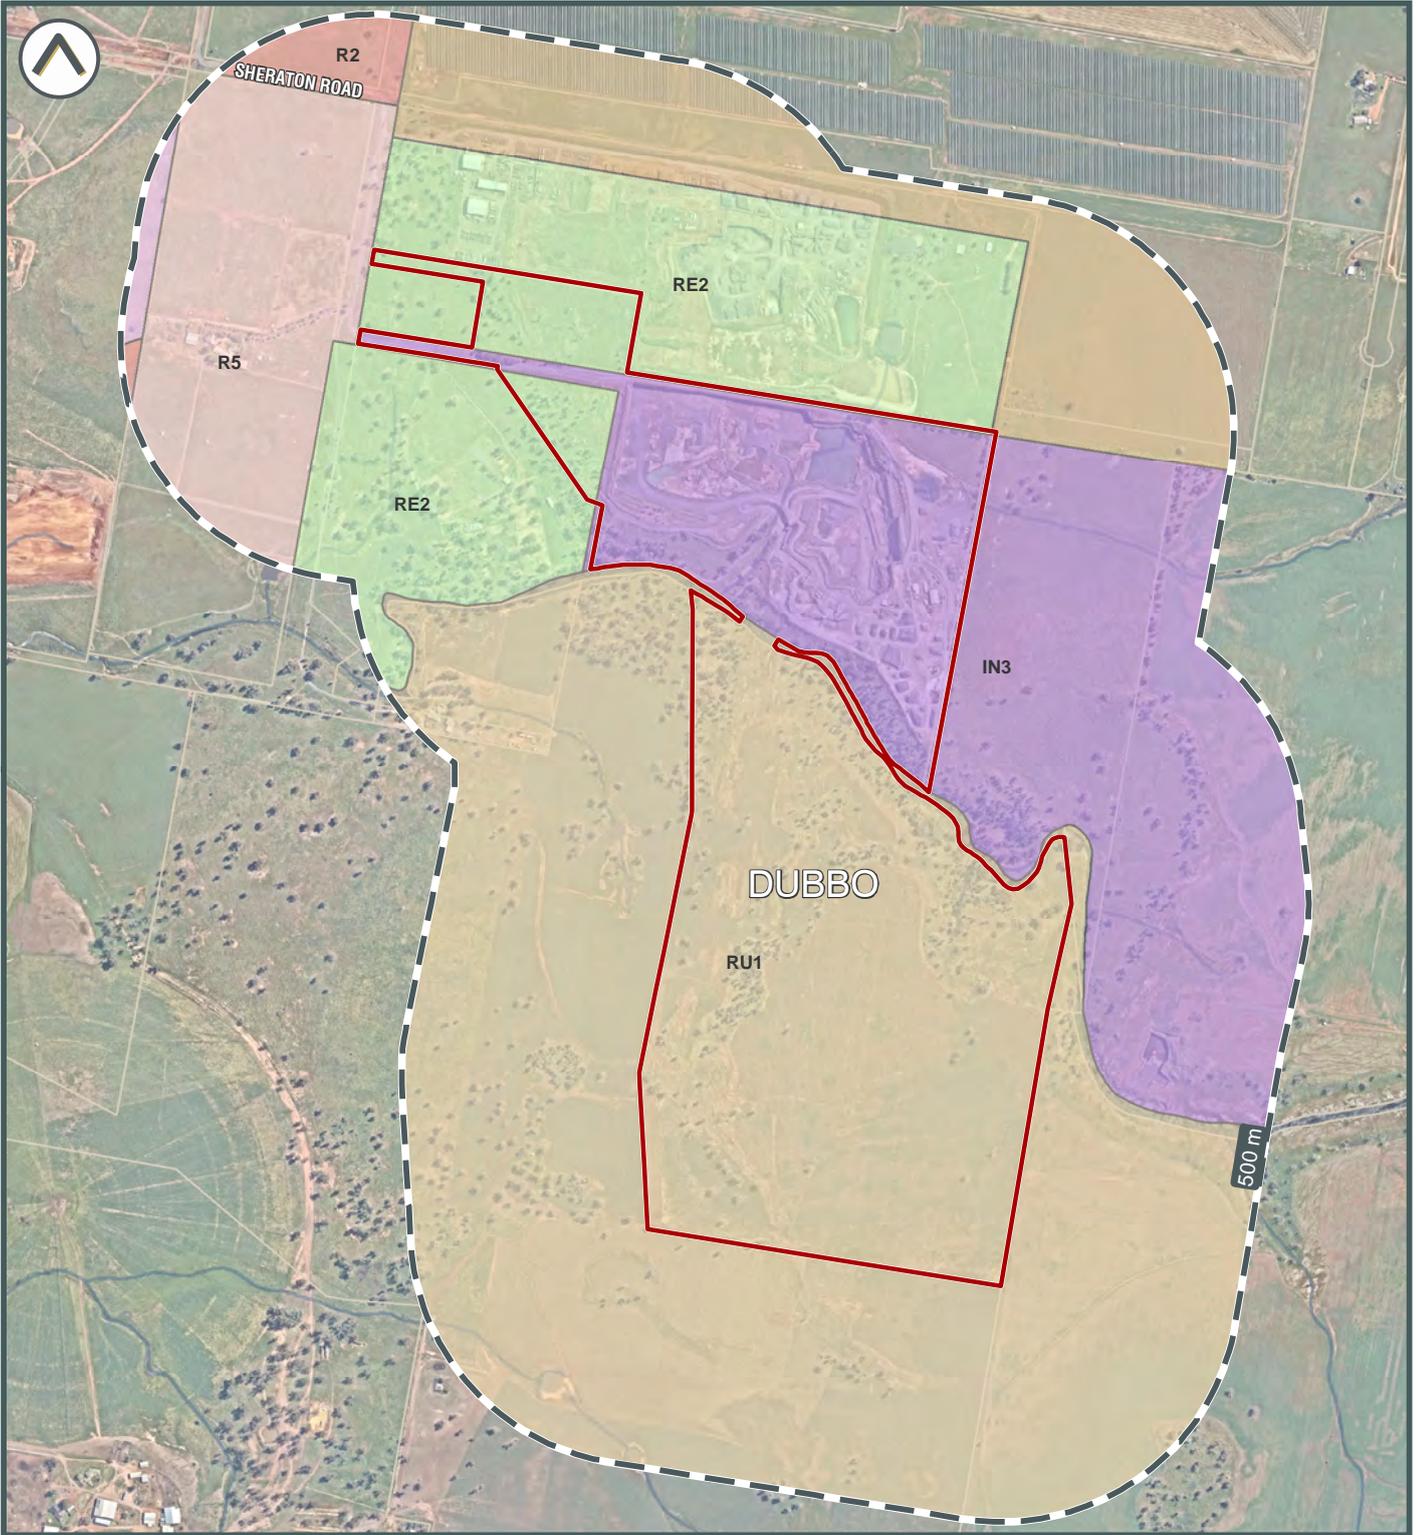
- Land Zoning**
- IN3 | Heavy Industrial
- R1 | General Residential
- R2 | Low Density Residential
- R5 | Large Lot Residential
- RE2
- RU1 | Primary Production
- RU2

Code	Classification
IN3 RE2 RU1	Heavy Industrial Private Recreation Primary Production

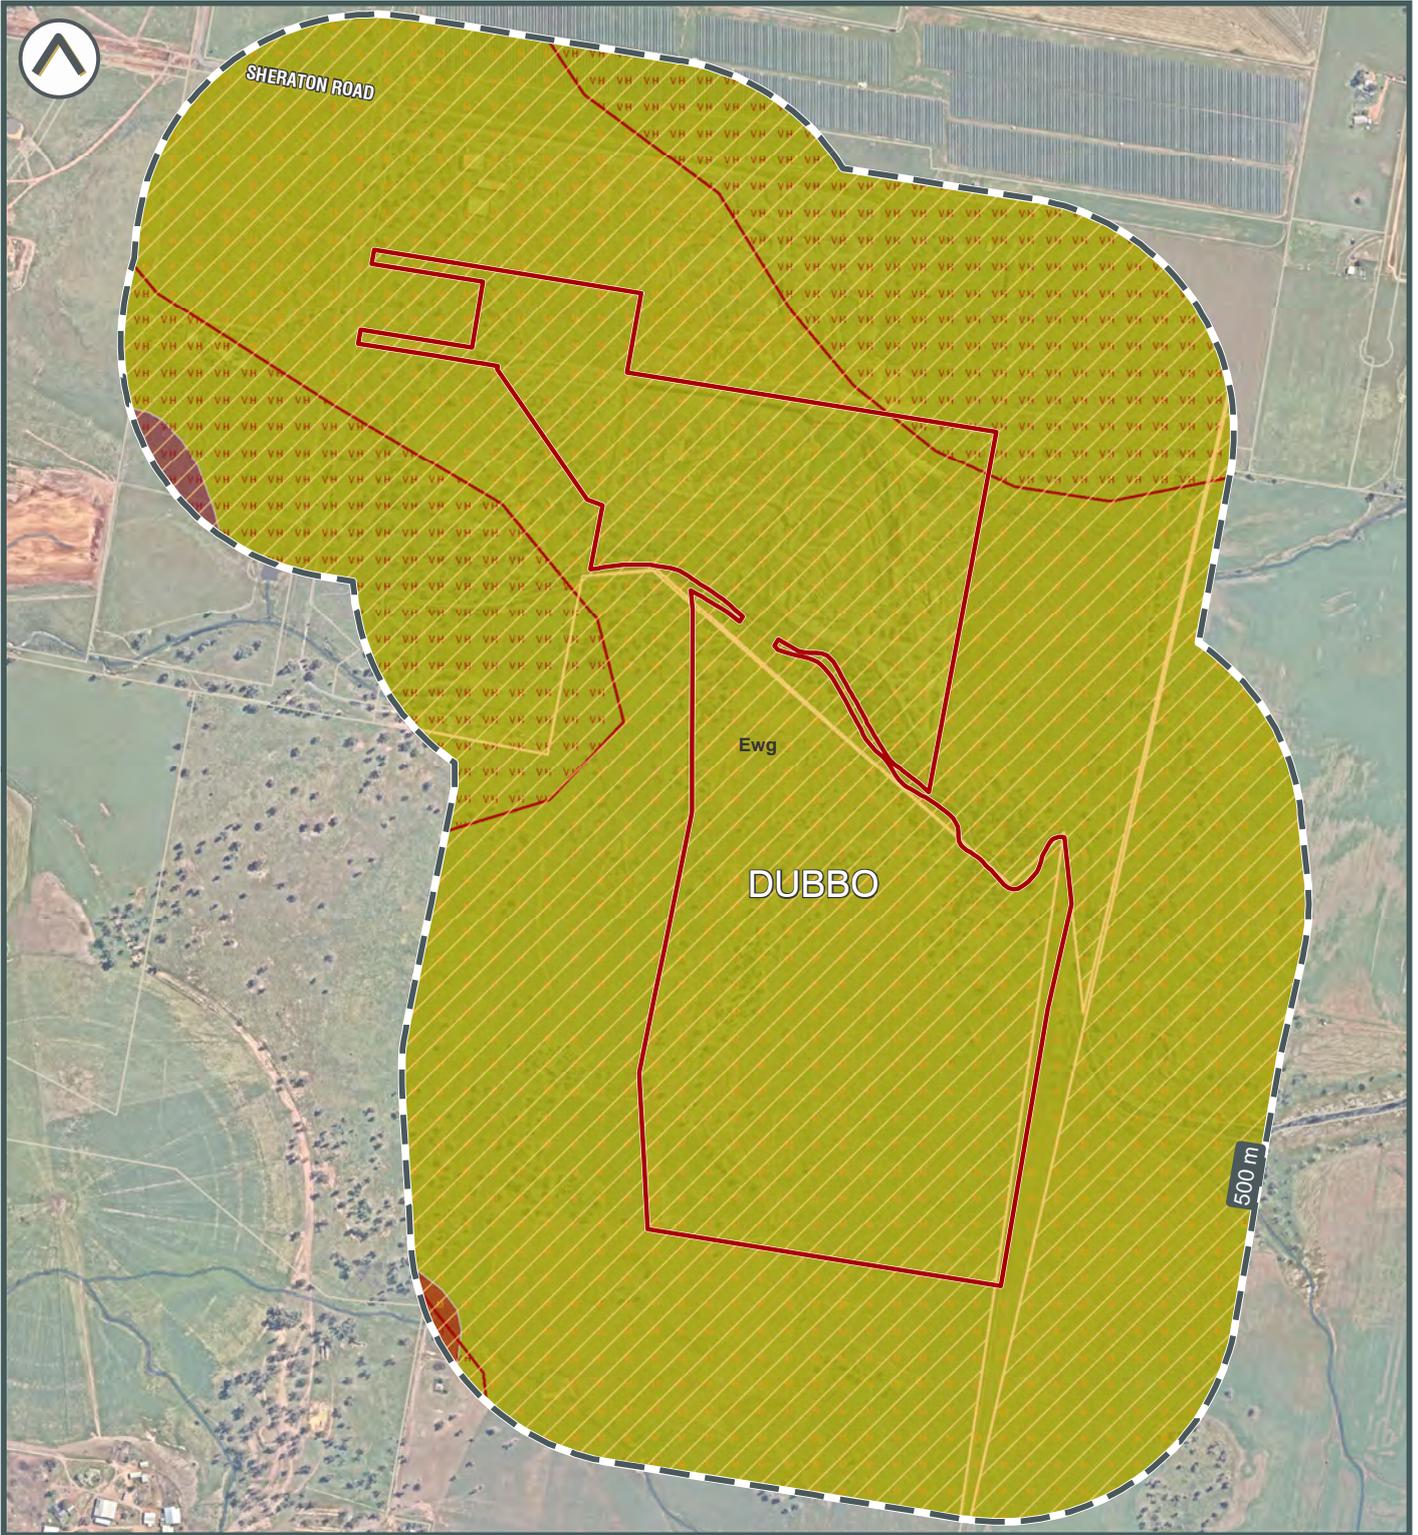
**Salinity Hazard**

- Very High
- Moderate

**Soils Landscape**

- Ewg | EUCHROZEMS

RBEbg | RED-BROWN EARTHS

REel | RED EARTHS

**Radon Level (Bq/m<sup>3</sup>)**

5-19

Soil Landscape	Ewg	WONGARBON	Soil Group	EUCHROZEMS
Description	213 km2 gently undulating rises and low hills with some stony hillocks. Basalt. Relief 20 - 60 m; slopes 3 - 8%. Soils include Euchrozems (Gn3.12; Gn3.13) and red (Ug5.37; Ug5.38) and brown (Ug5.32; Ug5.34) cracking clays often exhibiting linear gilgai on slopes. LIMITATIONS Moderate to high fertility; friable surface soils; high waterholding capacity; moderate to high erosion hazard under cultivation; moderate to high shrinkswell potential which may affect foundations.

Salinity Hazard	Very High	Western Central West Hydrogeological Landscapes
	Moderate	Western Central West Hydrogeological Landscapes

Radon Level	Bq/m3	14
-------------	-------	----

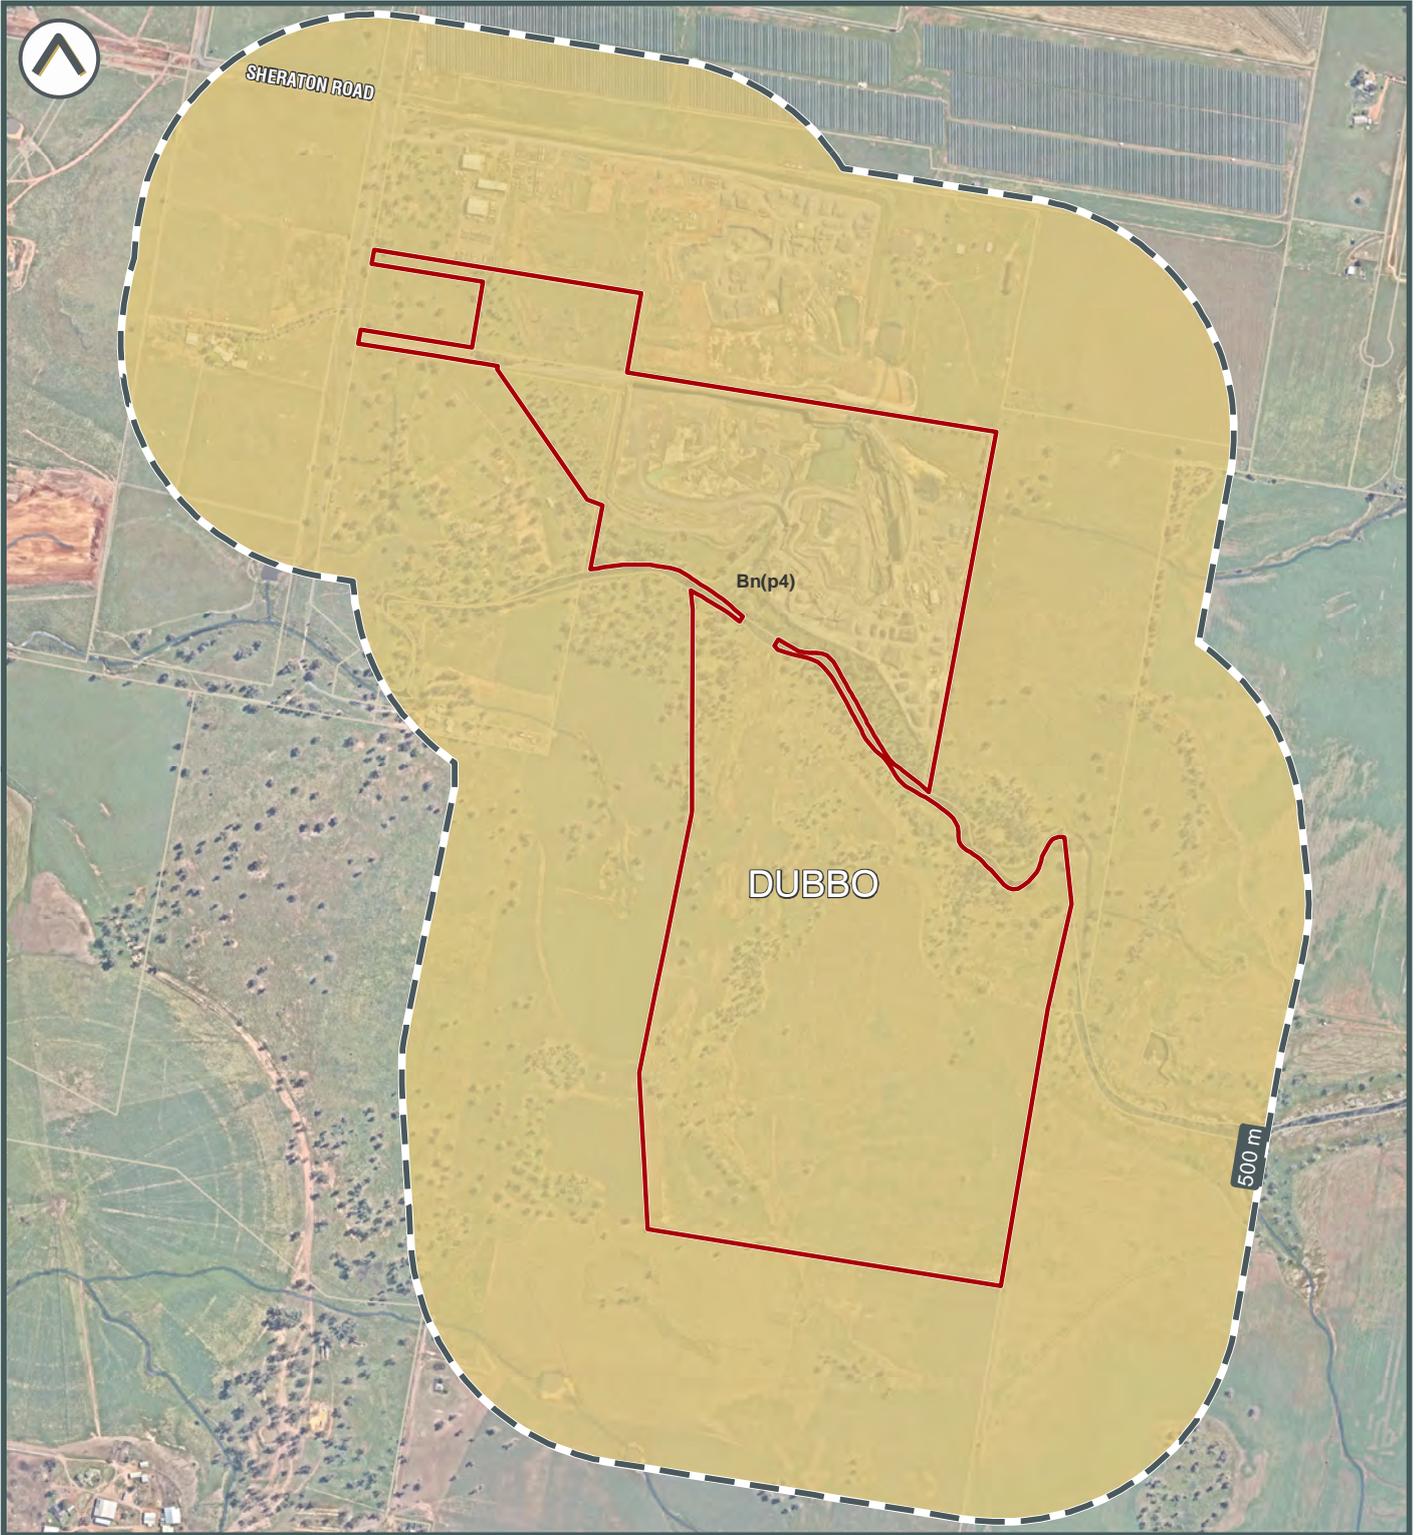
ASRIS Atlas of Australian Sulfate Soils

Bn(p4) | ASS in inland lakes, waterways, wetlands and riparian zones

ASS Risk Maps (Table 1.3.1)	On the Property?		Within Buffer?	
Class	Not identified		Not identified	
Atlas of Australian Acid Sulfate Soil (Table 1.3.2)	Bn(p4)	ASS in inland lakes, waterways, wetlands and riparian zones	Probability of Occurrence	Low Probability of occurrence

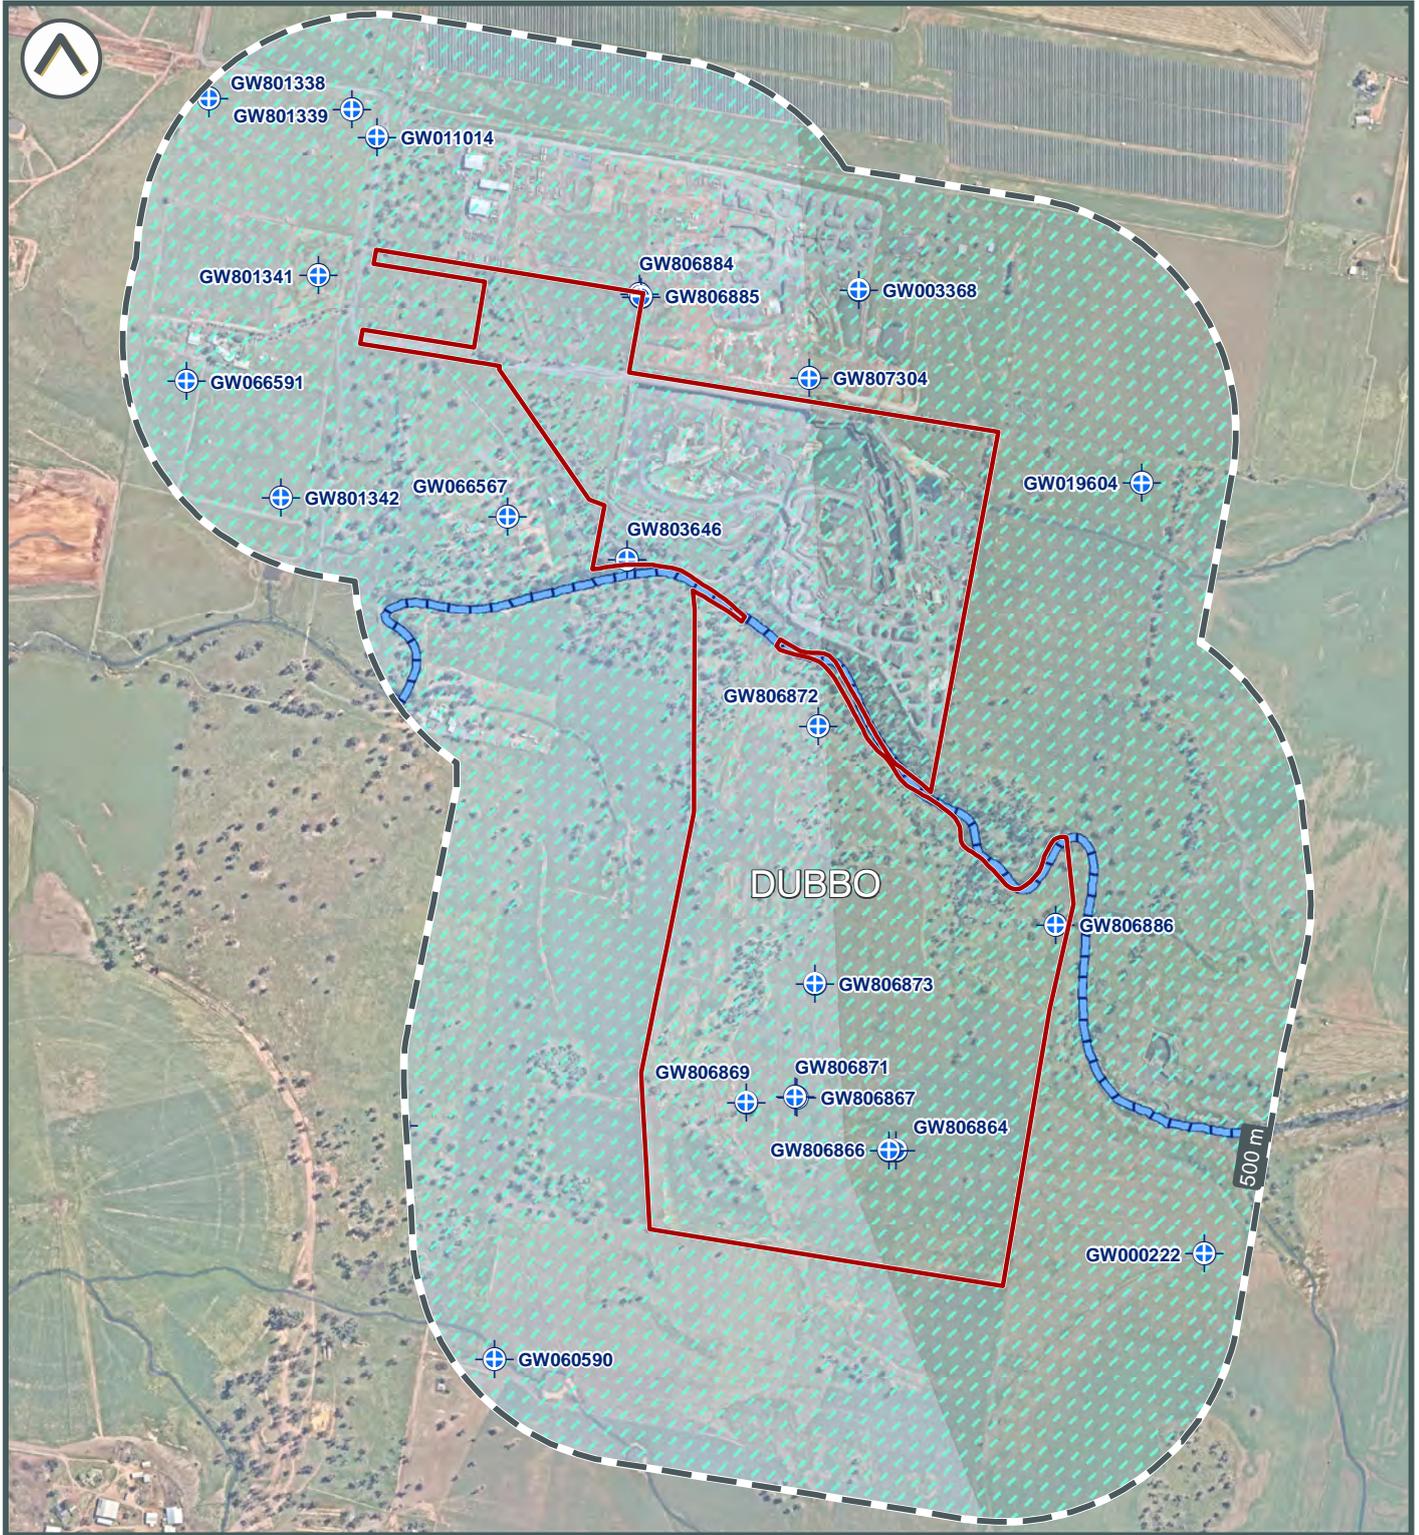
- Subject area
- Protected riparian corridor
- UPSS Environmentally Sensitive Zone

- + Groundwater bores
- Aquifer Type**
- Porous, extensive aquifers of low to moderate productivity
- Porous, extensive highly productive aquifers

GW066567	#N/A	162.20	south-west
GW011014	0m-3.05m Soil 3.05m-27.43m Clay coloured 27.43m-33.53m Coal shale 33.53m-57.91m Shale 57.91m-60.96m Sandstone white 60.96m-67.06m Shale	216.40	north-west
GW003368	0m-0.61m Boulders 0.61m-4.57m Basalt 4.57m-21.34m Clay 21.34m-27.74m Gravel 27.74m-28.35m Sand 28.35m-49.68m Sandstone water supply	226.90	north
GW801339	0m-1m Topsoil 1m-10m Basalt, weathered 10m-19m Clay, yellow 19m-25m Clay, yellow/brown 25m-29m Sand	274.60	north-west
GW019604	0m-1.52m Clay 1.52m-3.05m Basalt loose 3.05m-16.76m Pipe clay white 16.76m-23.16m Gravel clean 23.16m-26.21m Pipe clay white 26.21m-33.53m Shale 33.53m-41.15m Sandstone water supply	334.00	east
GW801342	0m-1m Topsoil 1m-8m Sandstone 8m-40m Siltstone 40m-46m Sandstone 46m-50m Siltstone 50m-55m Sandstone, fine 55m-72m Siltstone	343.00	south-west
GW066591	0m-1.5m Topsoil 1.5m-6.2m Hard siltstone with clay bands 6.2m-19m Sand & clay 19m-26m Sandstone 26m-71m Siltstone 71m-93m Basalt	394.60	west

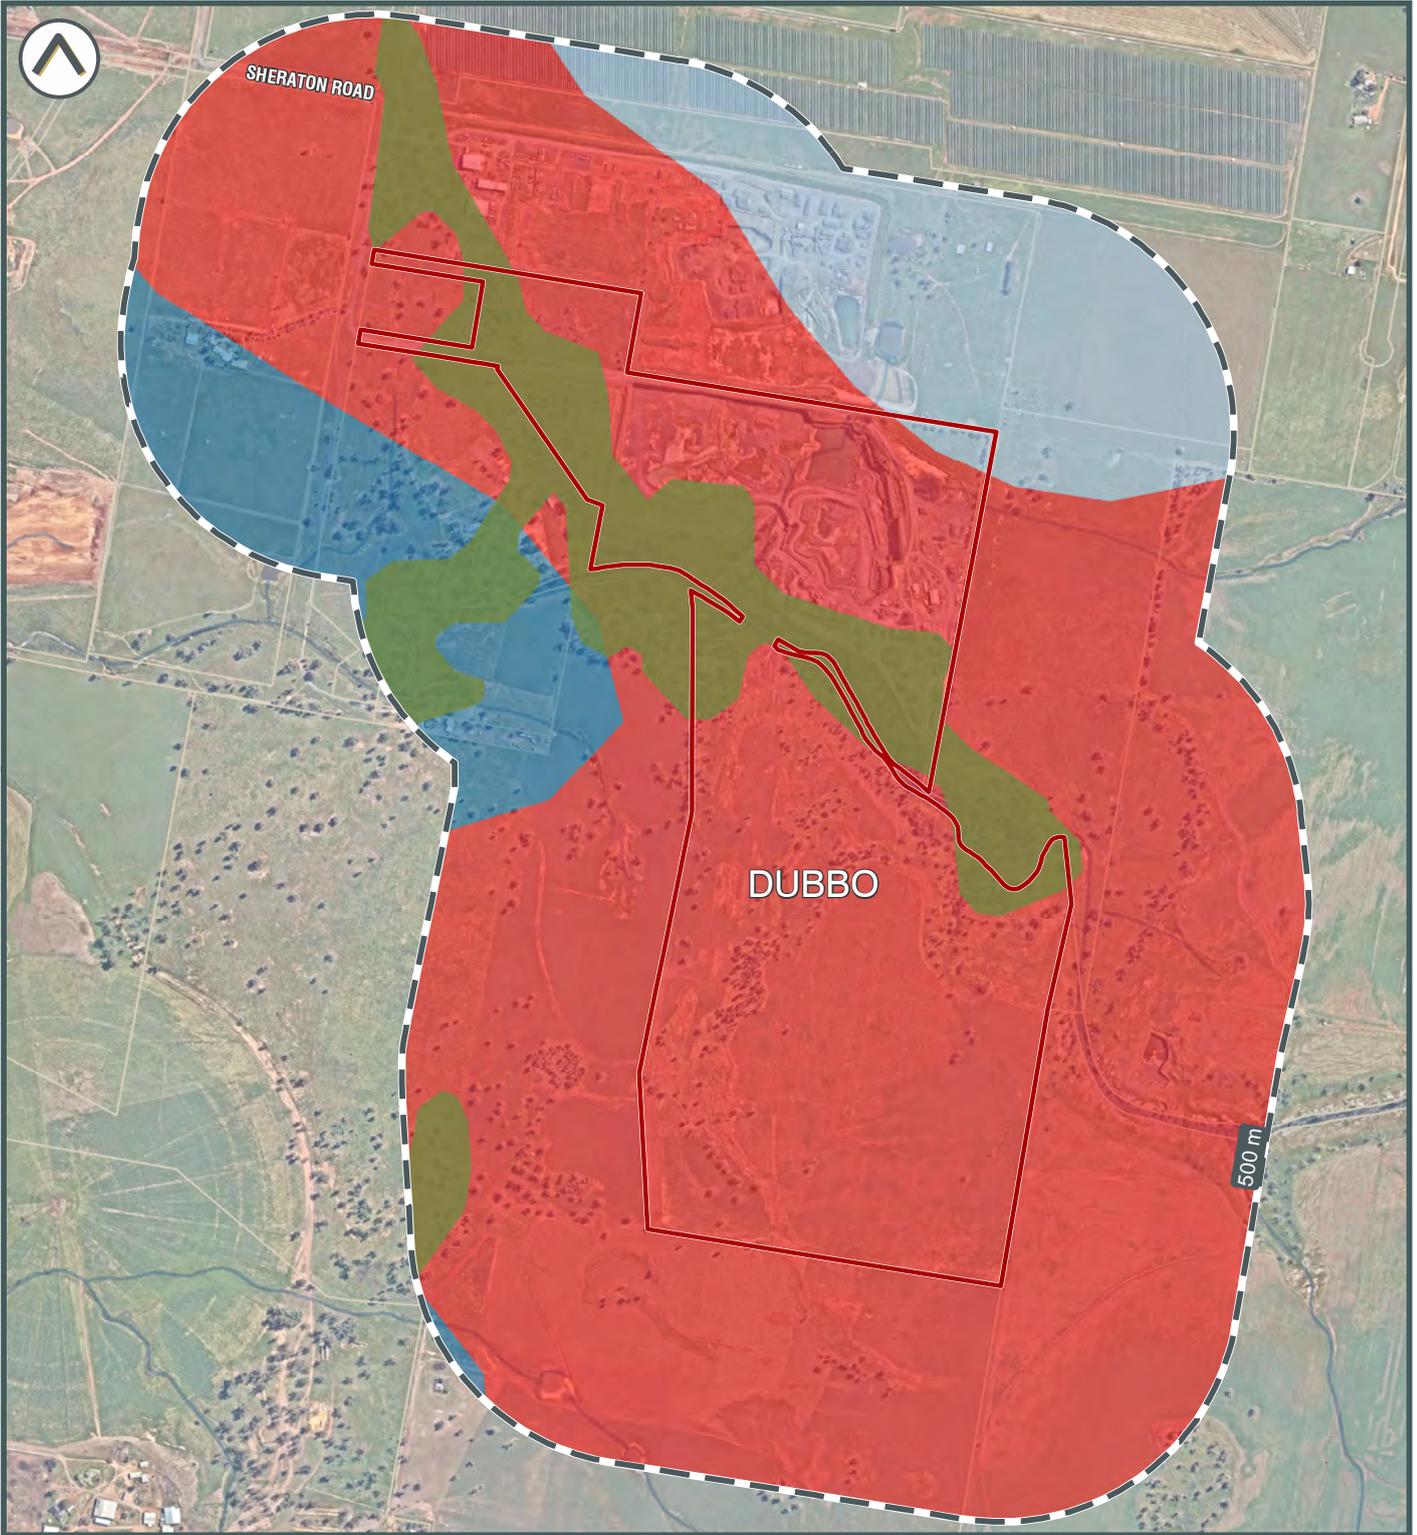
Subject area	<b>Hydrogeologic Unit</b>
Other borehole/monitoring well location	Tertiary Basalt Aquifer (fractured rock)
<b>Ecosystems that rely on Subsurface presence of Groundwater</b>	Late Permian/Triassic sediments (porous media - consolidated)
Moderate potential for GW interaction	Late Permian/Triassic intrusives and volcanics fractured rock aquifers

On the Property?	Within Buffer?
<b>Groundwater Vulnerability</b>	Not identified	Not identified
<b>Groundwater Exclusion Zones<sup>1,2</sup></b>	Not identified	Not identified
<b>Hydrogeologic Unit</b>	Tertiary Basalt Aquifer (fractured rock) Late Permian/Triassic intrusives and volcanics fractured rock aquifers	Tertiary Basalt Aquifer (fractured rock) Late Permian/Triassic sediments (porous media - consolidated) Late Permian/Triassic intrusives and volcanics fractured rock aquifers
<b>Other known borehole investigations</b>	Not identified	Not identified

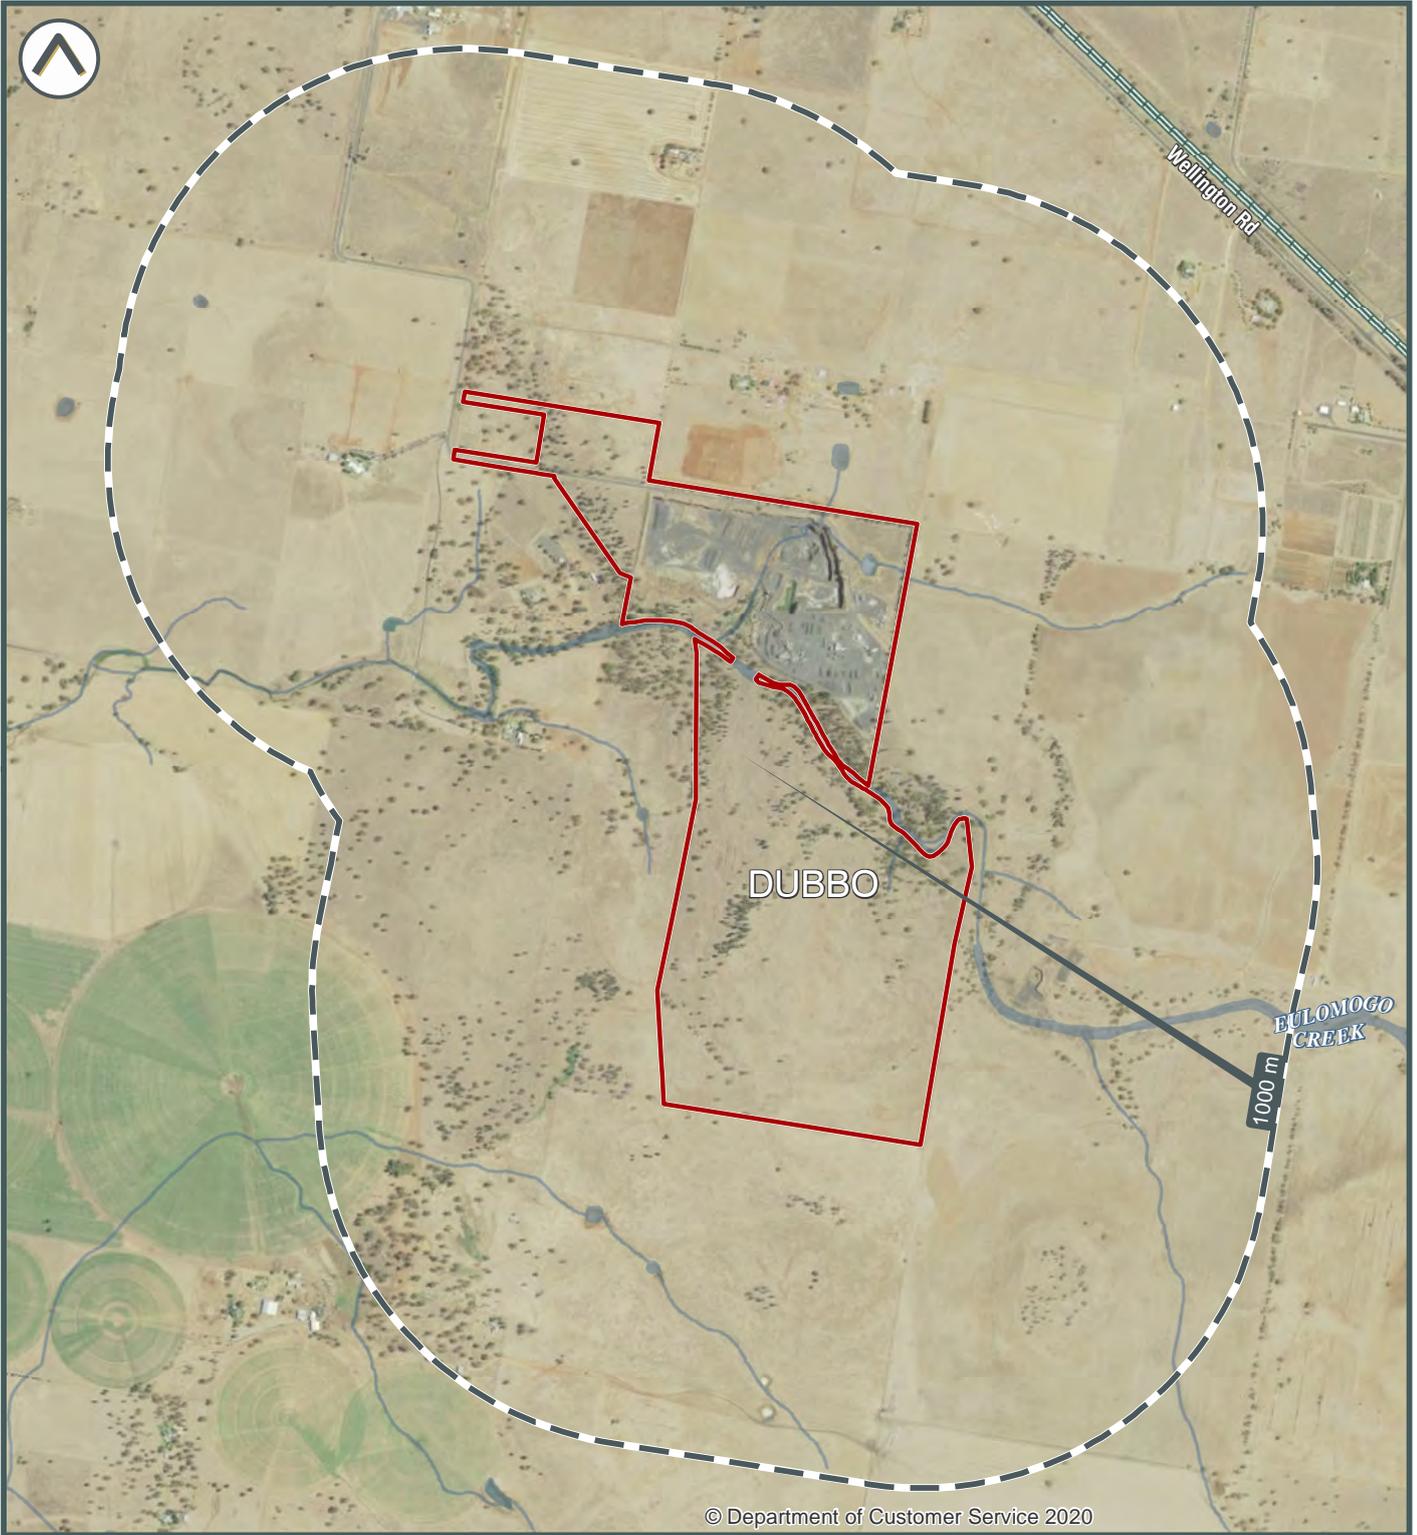
- Subject area
- Contaminated Land Register (EPA)**
- Current - Sites notified as contaminated
- Former - Sites notified as contaminated
- Contaminated Land Record of Notices
- PFAS Sites
- Potentially Contaminated Areas**
- Defence Sites
- Former Gasworks Sites

Site Name <sup>2</sup>	Address <sup>1</sup>	Activity that caused Contamination	EPA Site Management Class <sup>3</sup>	Distance (m)	Direction
Not identified	-	-	-	-	-

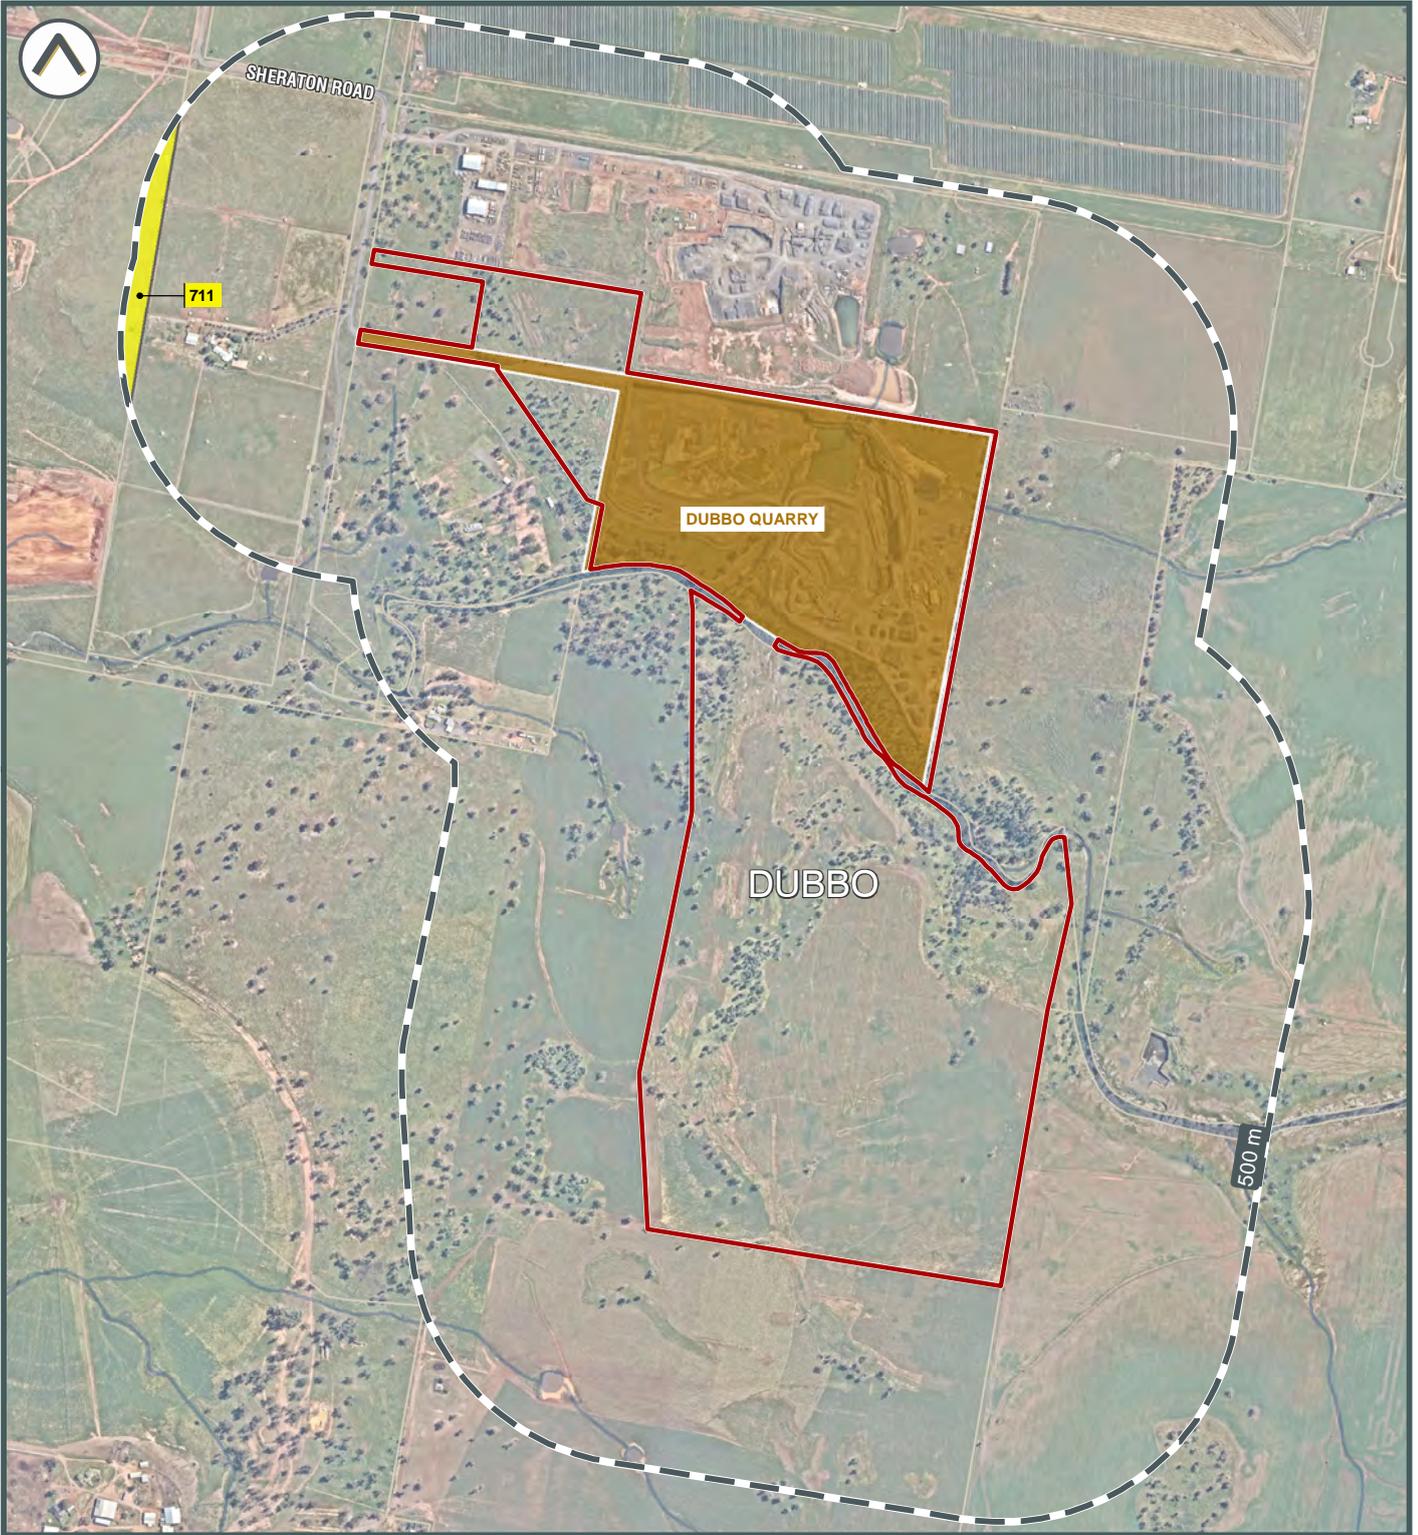
- Subject area
- NPI Facilities
- POEO Register**
- POEO licences
- Surrendered Licences still Regulated by EPA
- Clean Up and Penalty Notices

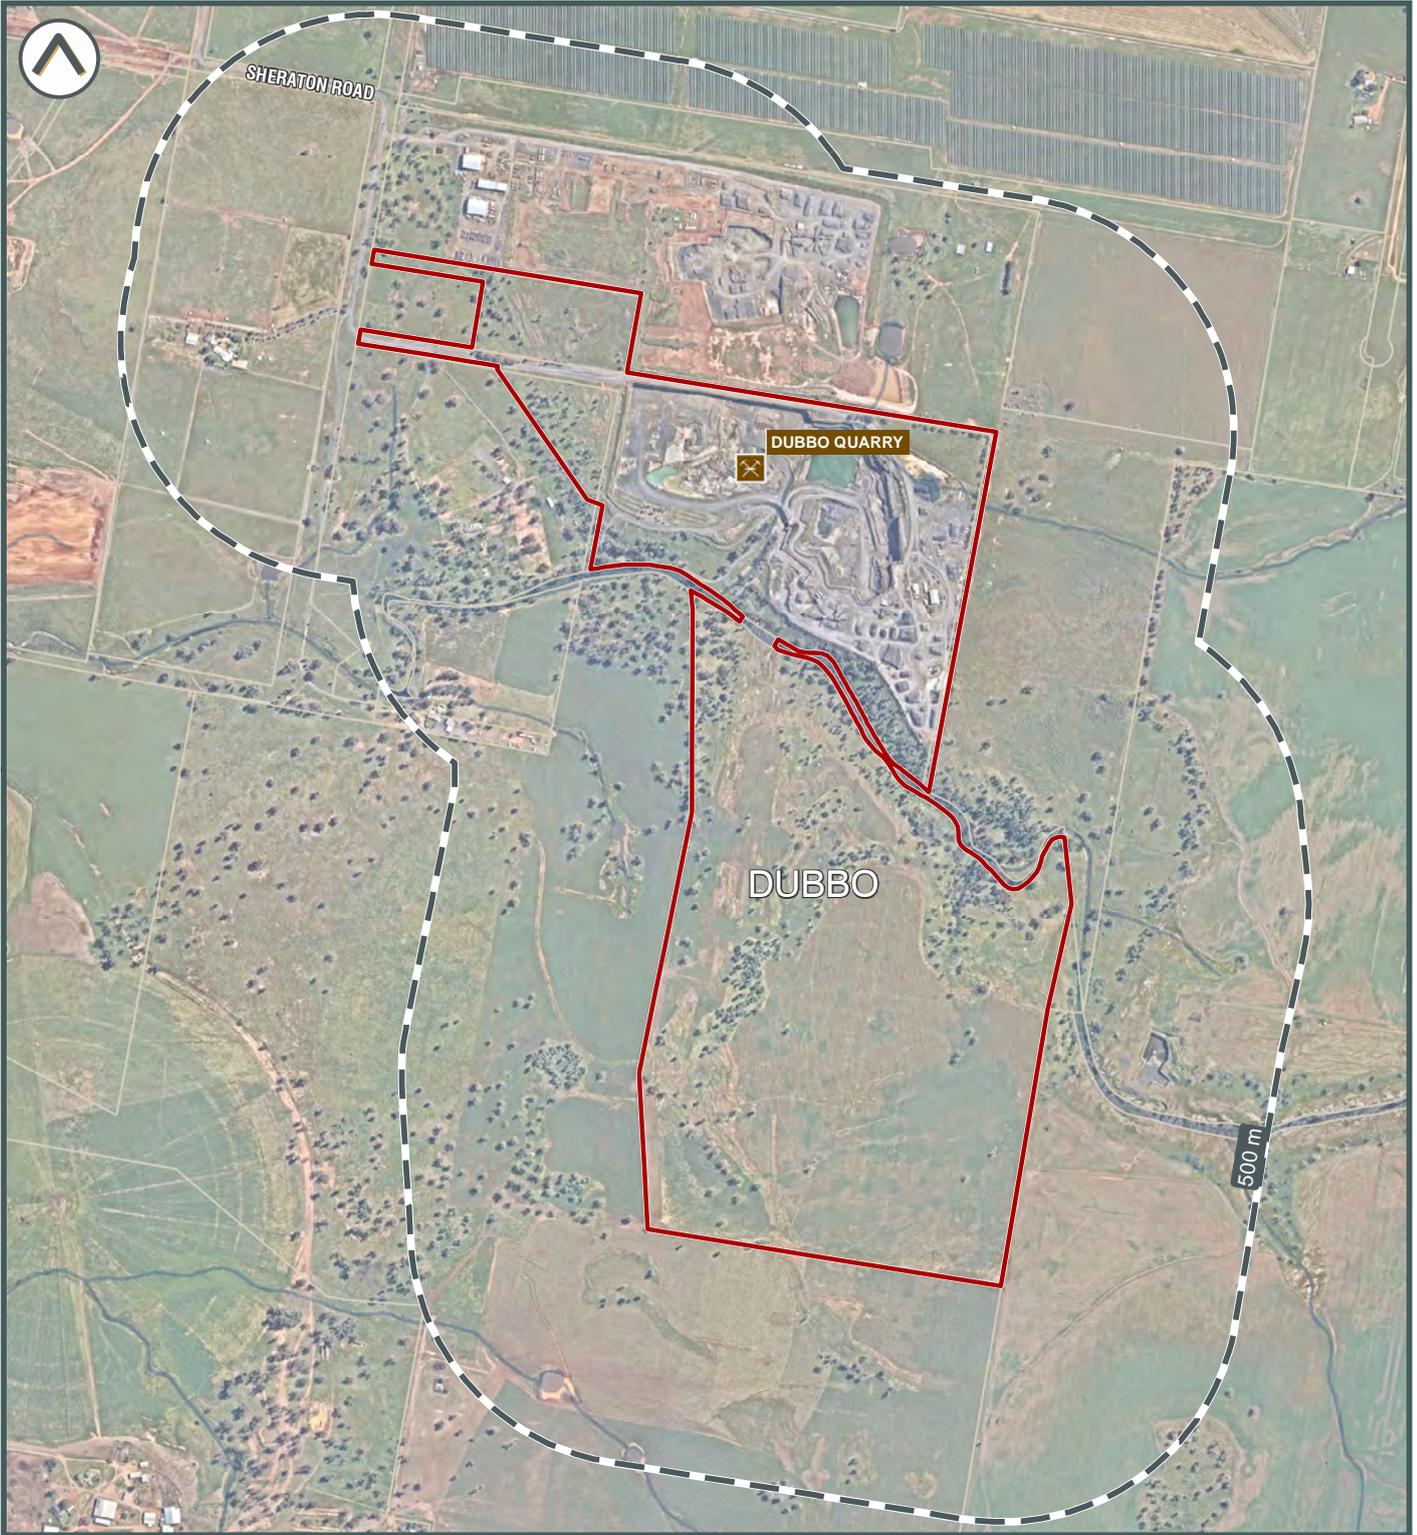
| Subject area | Gas supplier / terminals | Petrol stations | Telephone exchanges |
| Cattle dip/ saleyards | Liquid fuel depots / terminals | Power stations | Waste management facilities |
| Dry cleaners | Mine/quarry | Substation locations | Wastewater Treatment Facility |
| Fire Rescue sites | | | |

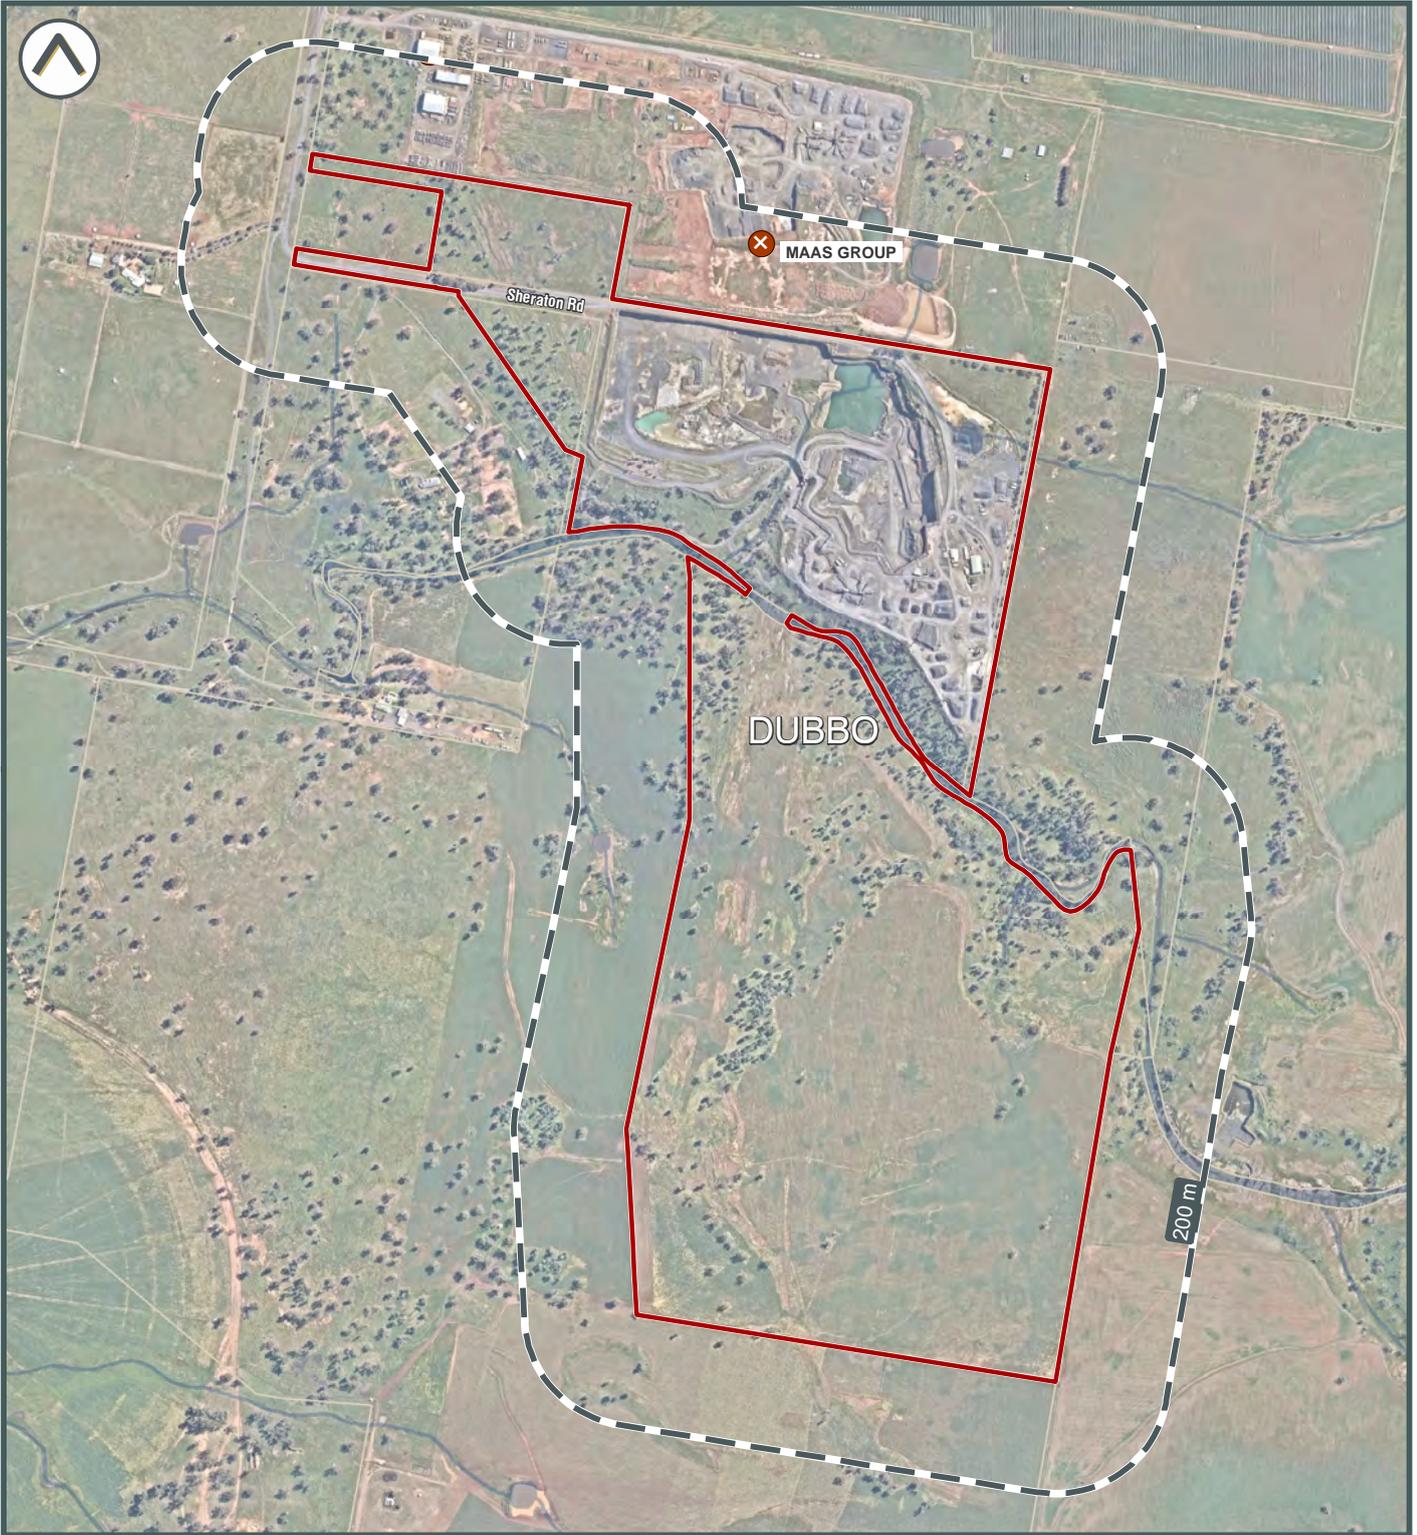
**Commercial & Trade Directory**

- Other potentially contaminating activities
- Former potentially contaminating activities

**Tanks**

- Aboveground Storage Tank - Current
- Aboveground Storage Tank - Former

- Underground Storage Tank - Current
- Underground Storage Tank - Former/Unknown
- Unknown
