## Appendix I

Contamination database searches and historical aerial photos

## ENVIRO-SCREEN

Sheraton Road, Eulomogo NSW

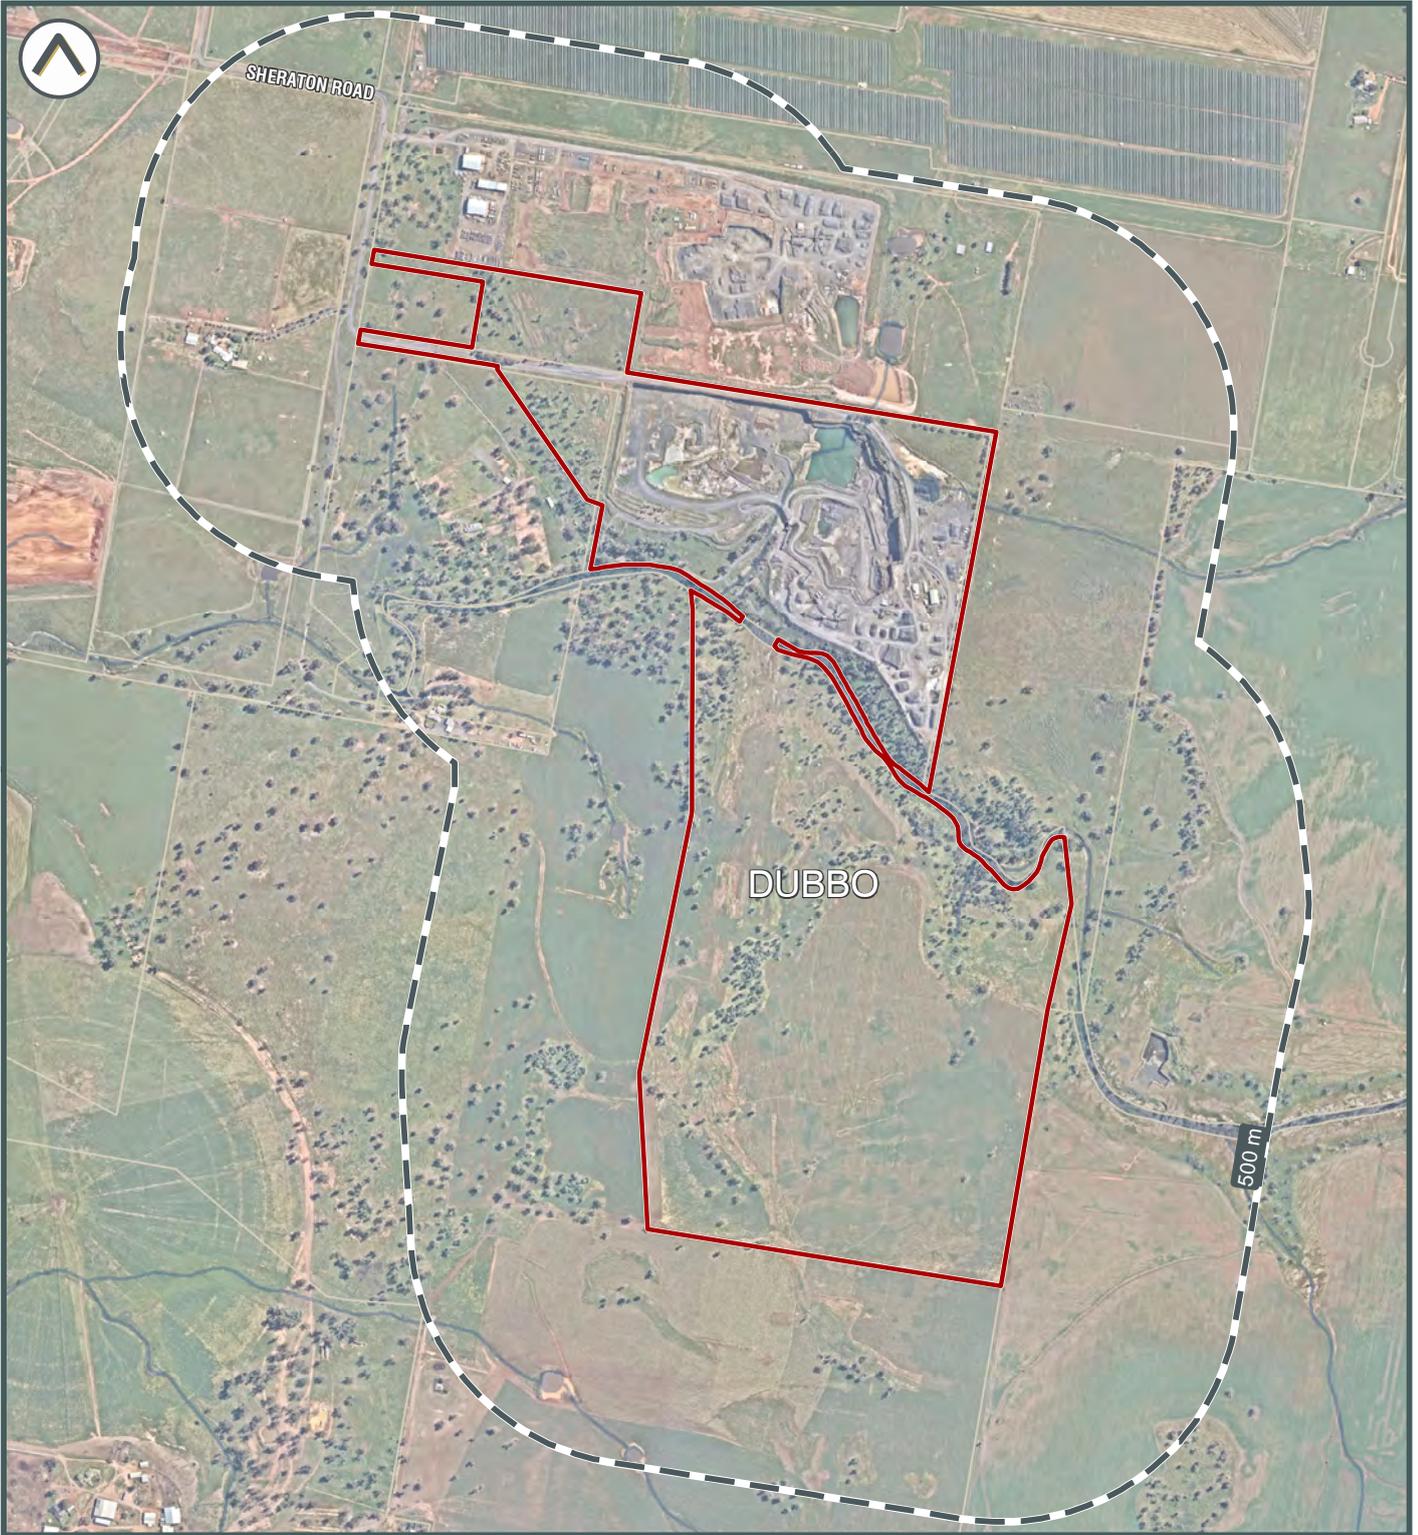
Contaminated Legacy Areas

Derelict Mines and Quarries
-

Historical (Legacy) Landfills

Unexploded Ordnance (UXO) Areas

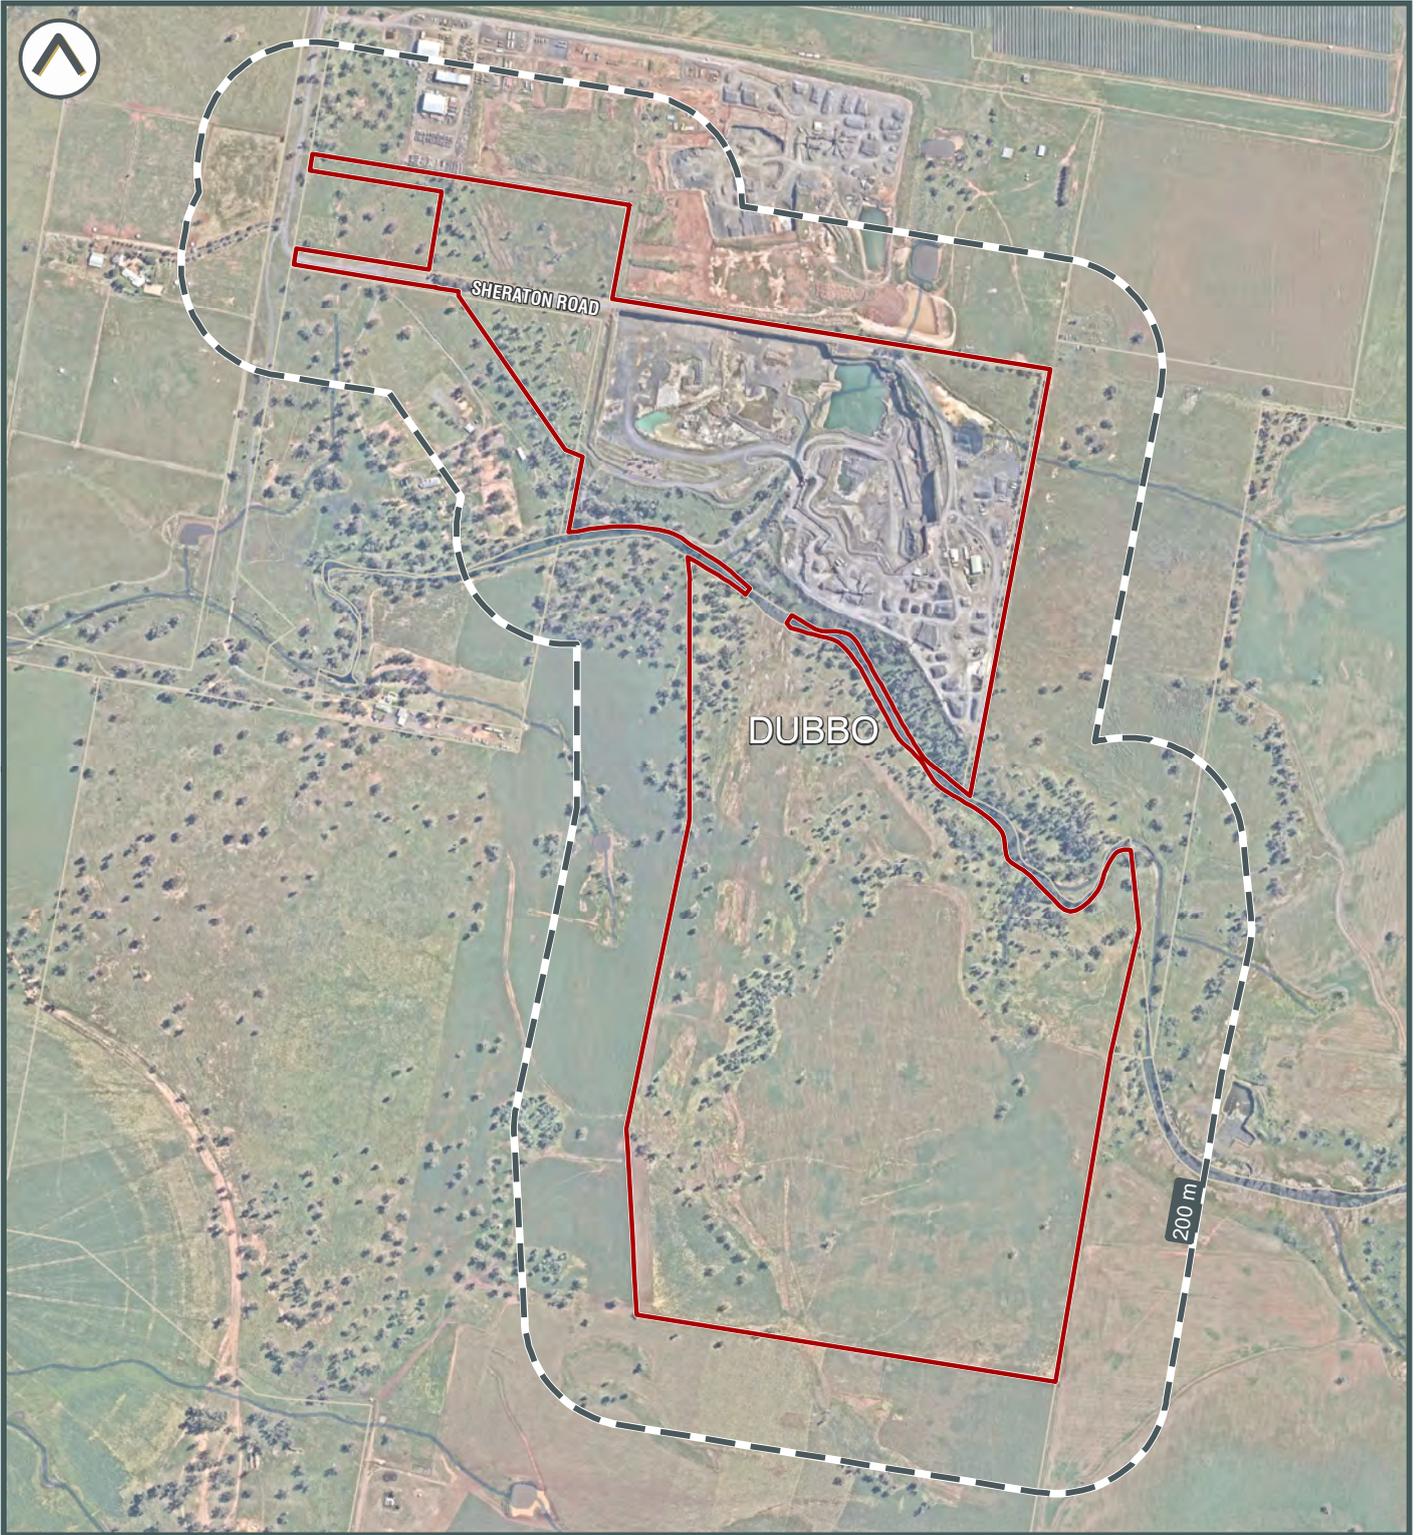
Federal, State and Local Heritage

Heritage Area (LEP)

Register of the National Estate (RNE)

National Heritage List (NHL)

Non-Aboriginal heritage item (SHR)

Commonwealth Heritage List (CHL)

World Heritage Area (WHA)

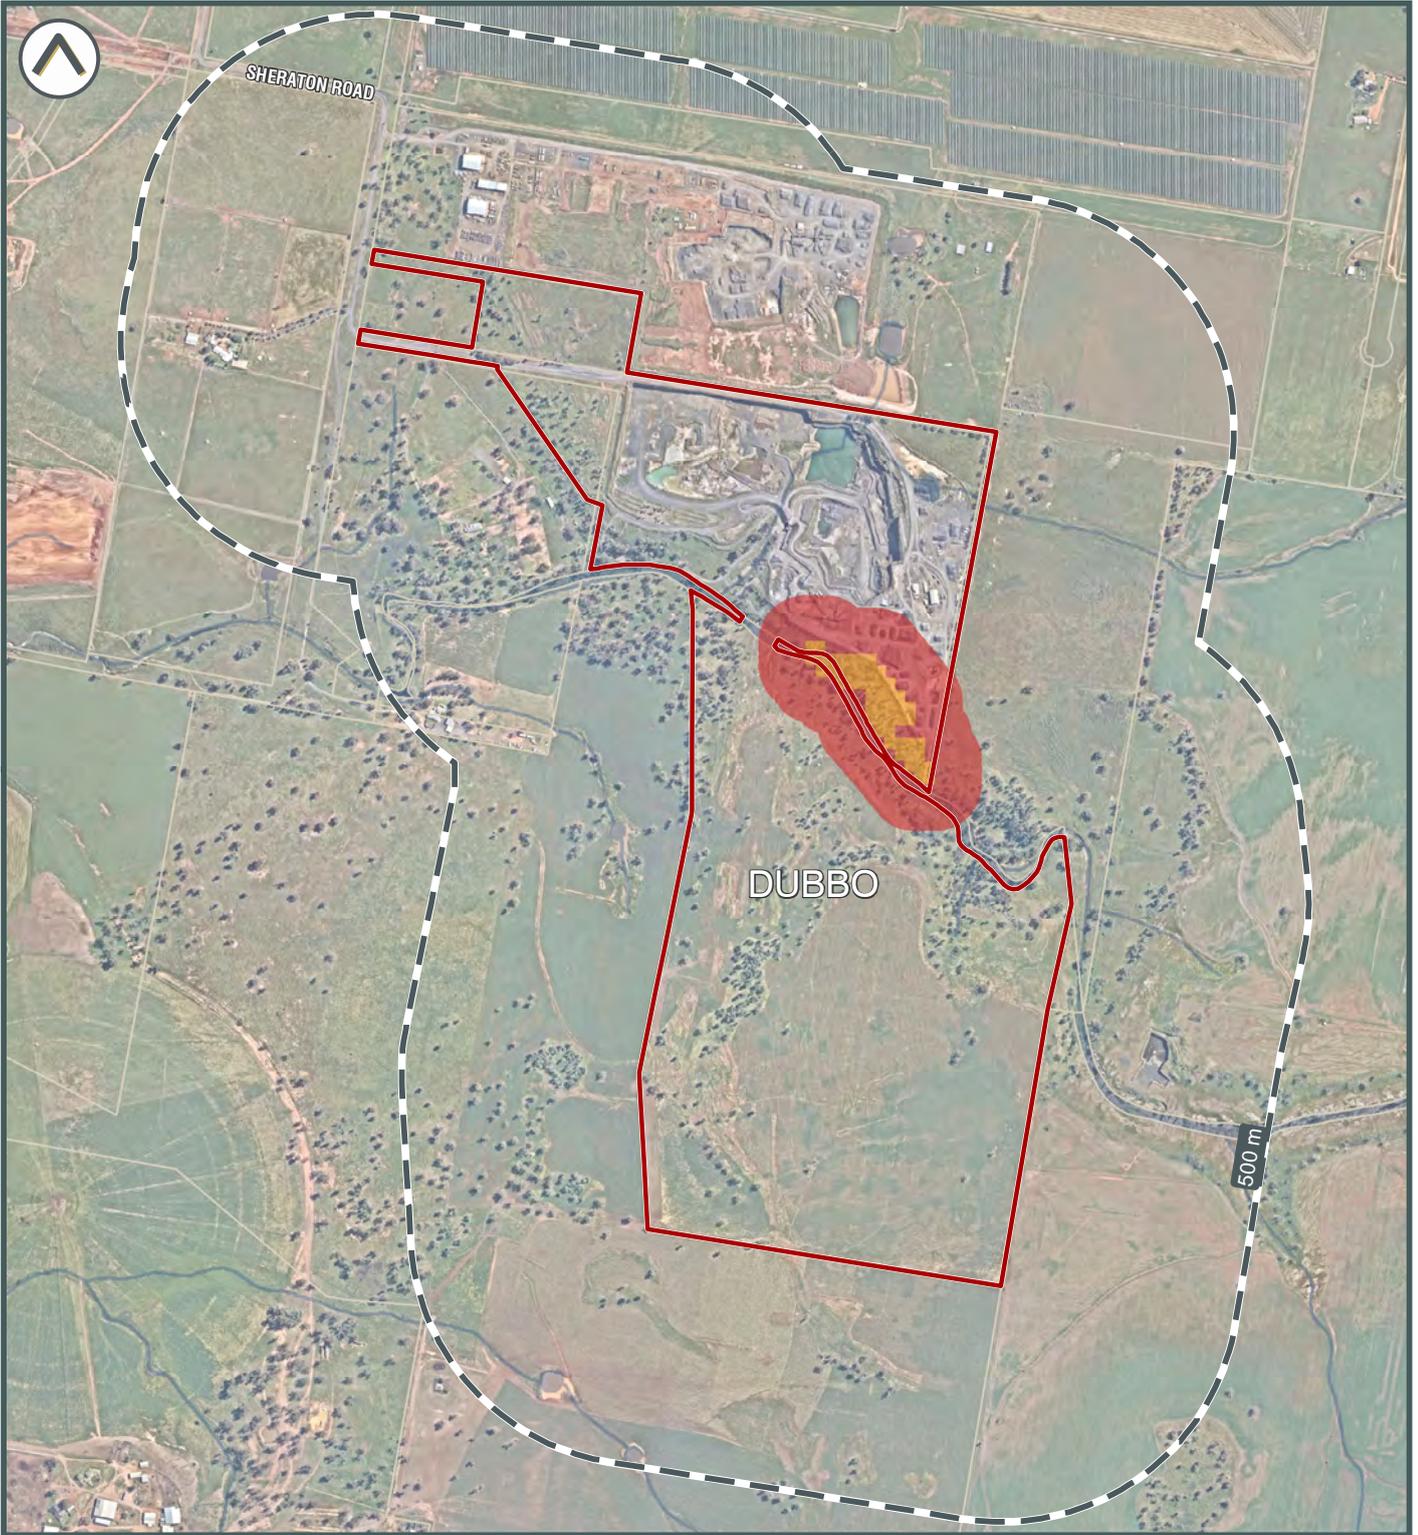
Flood Hazard

Fire

Bush Fire Prone Land

Vegetation Buffer

Vegetation Category 1

Coastal Management
