Geotechnical Investigation

Tallawong Station Precinct South, Rouse Hill, NSW

Report No: E24445.G03_Rev1

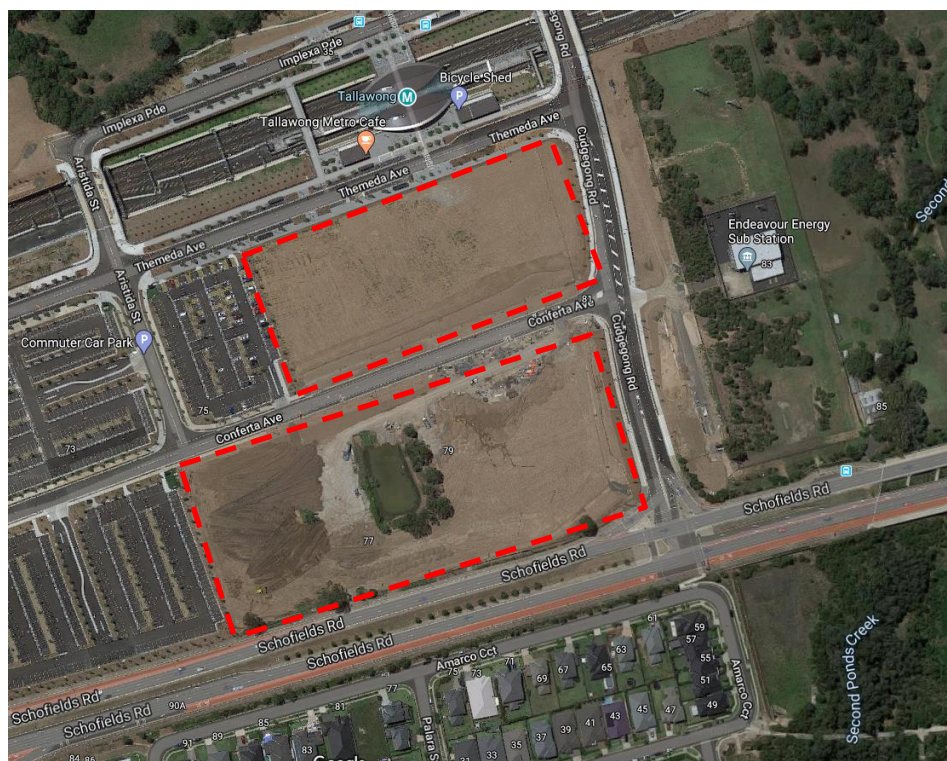
Plate 1: Aerial photograph of the site (source: Google maps, accessed 17/2/20)

The site identification details and associated information are presented in **Table 2-1** below while the site locality is shown on **Figure 1**. An aerial photograph of the site is presented in **Plate 1** below.

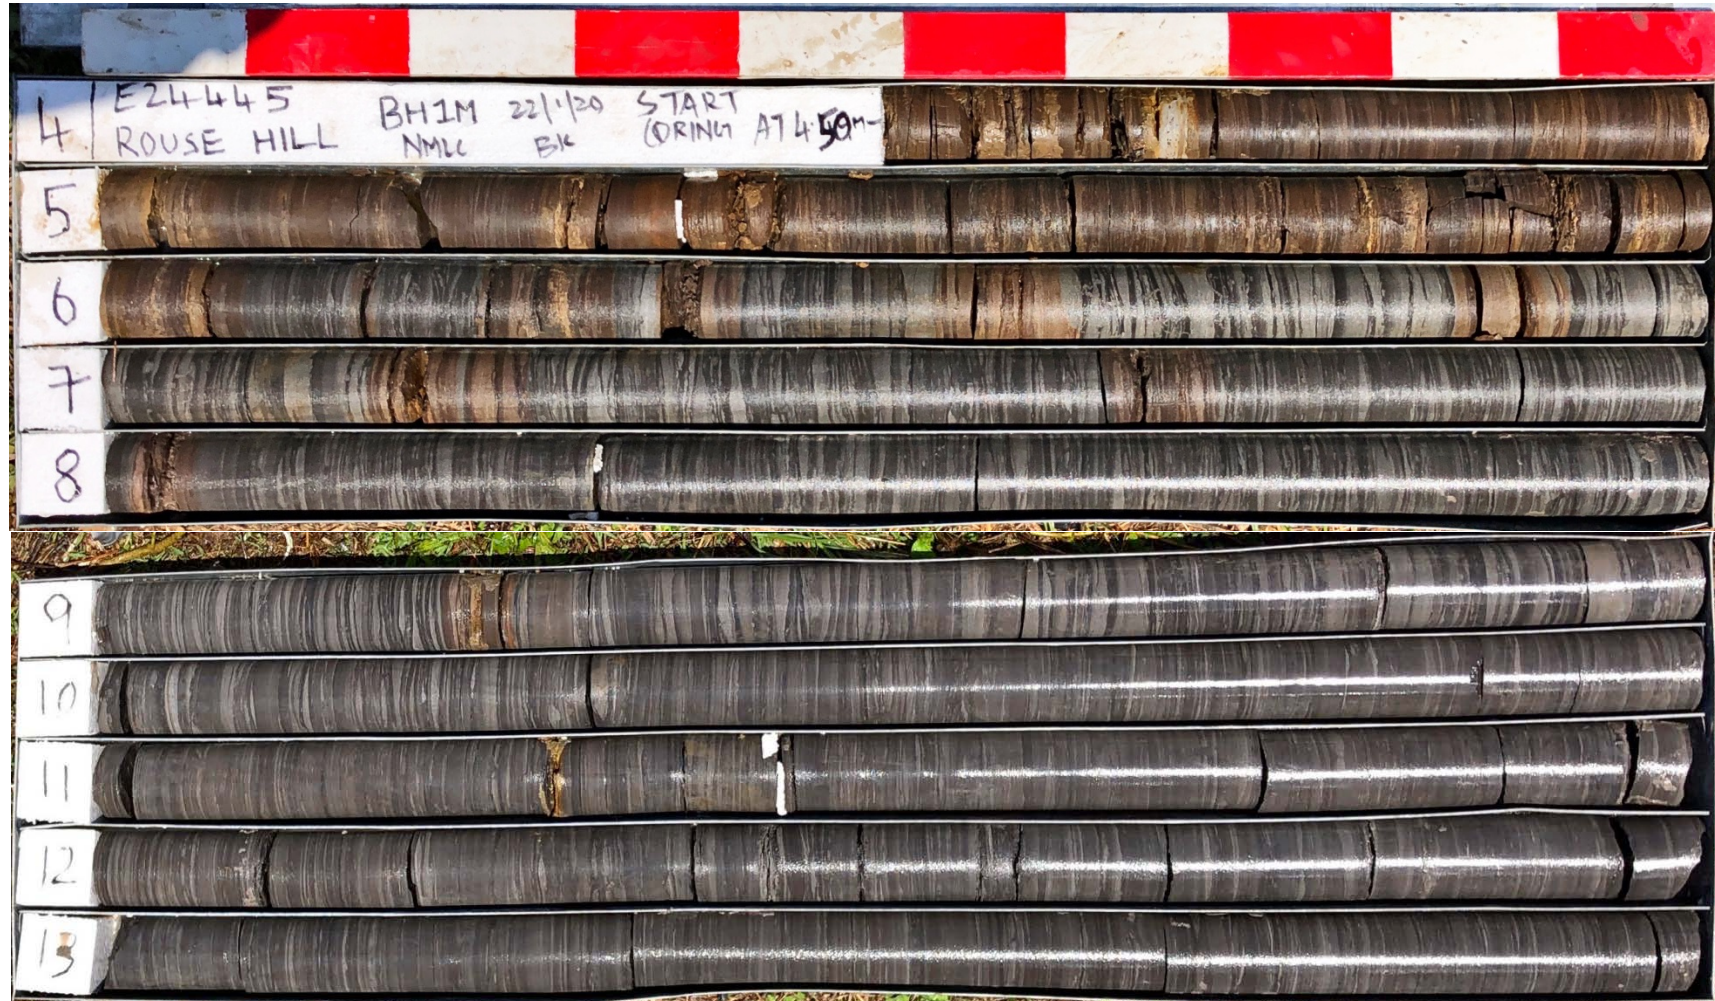
CORE PHOTOGRAPH OF BOREHOLE: BH1M

Project	Proposed Development	Depth Range	14.0m to 20.51m BEGL	
Location	Tallawong Station Precinct South, Rouse Hill NSW	Contractor	Geosense Drilling Engineers Pty Ltd	
Position	See Figure 2	Drill Rig	Hanjin D&B 8D	
Job No.	E24445.G03	Logged	BK	Date 22 / 01 / 2020
Client	Deicorp Projects (Tallawong Station) Pty Ltd	Checked	SK	Date 06 / 03 / 2020
		Surface RL	≈ 58.5m	
		Inclination	-90°	
		Box	3-4 of 4

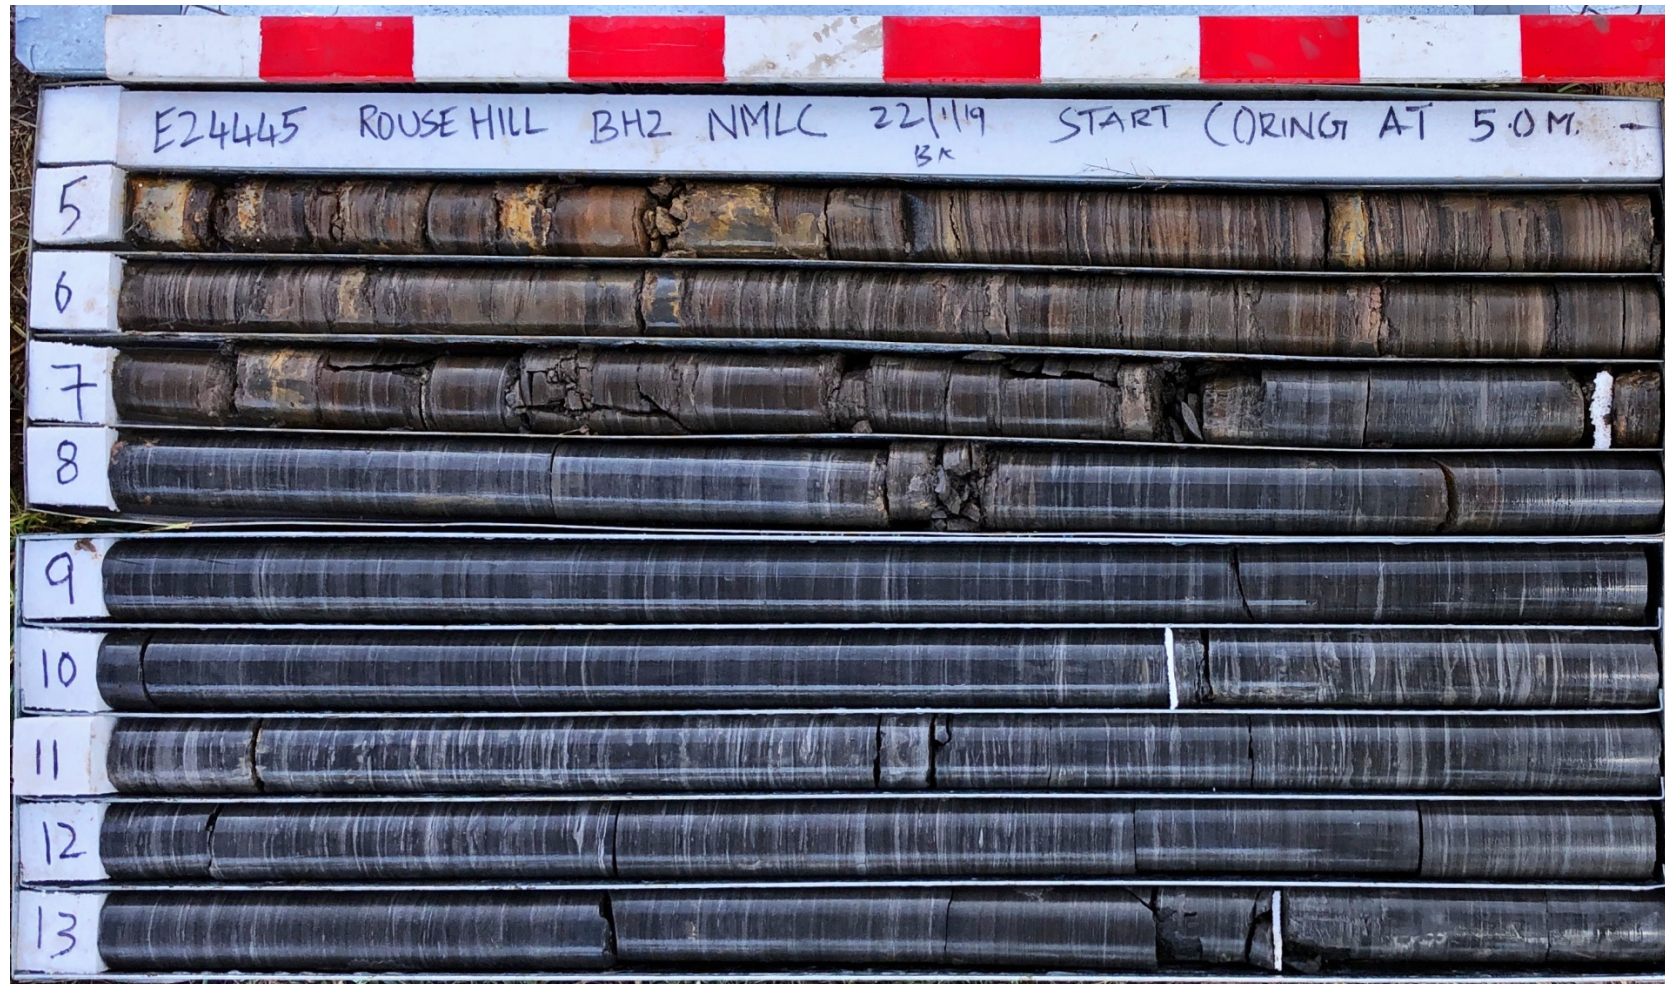
CORE PHOTOGRAPH OF BOREHOLE: BH2M

Project	Proposed Development	Depth Range	14.0m to 19.98m BEGL	
Location	Tallawong Station Precinct South, Rouse Hill NSW	Contractor	Geosense Drilling Engineers Pty Ltd	
Position	See Figure 2	Drill Rig	Hanjin D&B 8D	
Job No.	E24445.G03	Logged	BK	Date 23 / 01 / 2020
Client	Deicorp Projects (Tallawong Station) Pty Ltd	Inclination	-90°	Date 06 / 03 / 2020
		Box	3-4 of 4

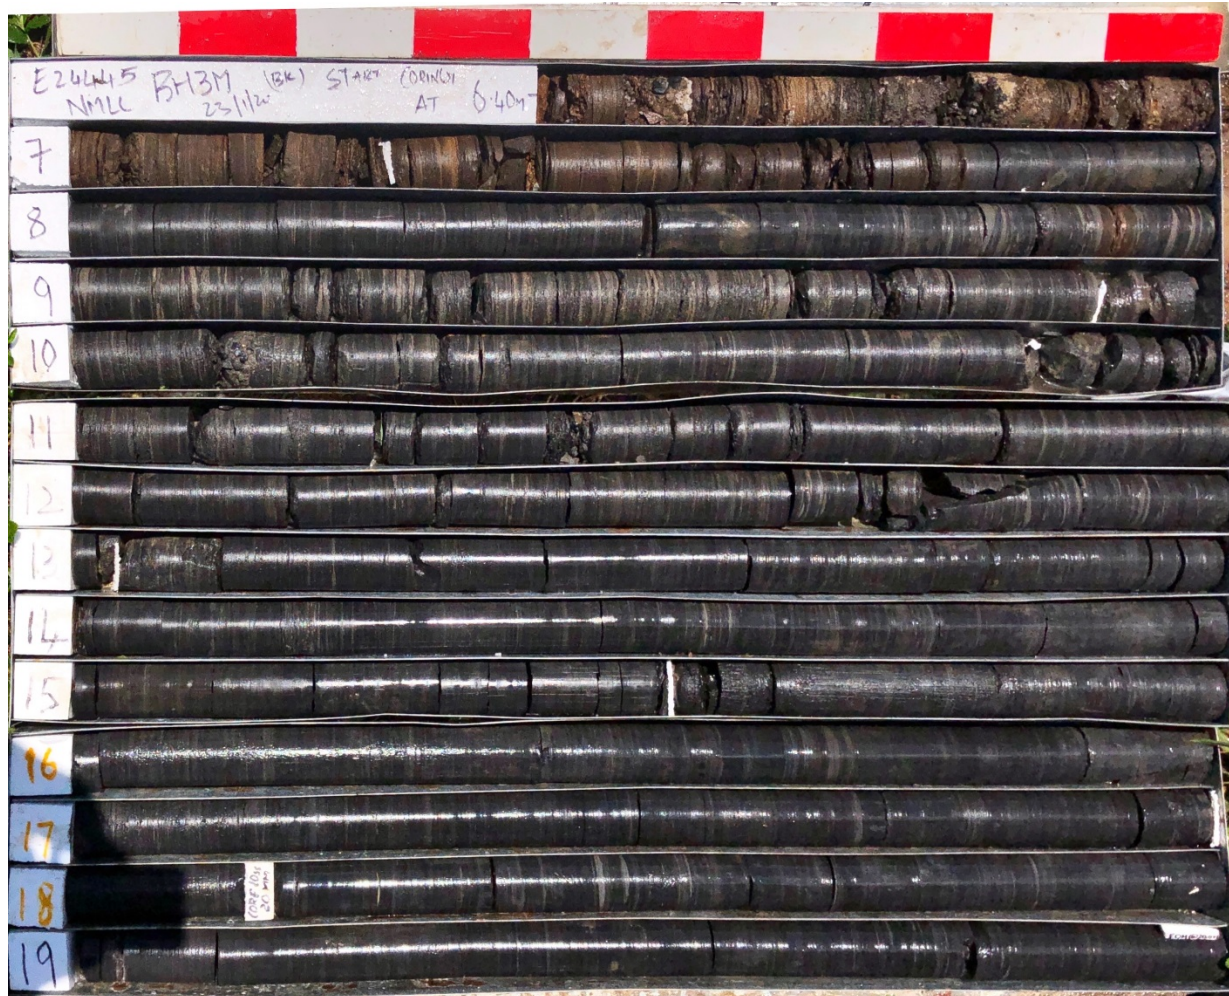
CORE PHOTOGRAPH OF BOREHOLE: BH3M

Project	Proposed Development	Depth Range	6.4m to 20.0m BEGL	
Location	Tallawong Station Precinct South, Rouse Hill NSW	Contractor	Geosense Drilling Engineers Pty Ltd	
Position	See Figure 2	Drill Rig	Hanjin D&B 8D	
Job No.	E24445.G03	Logged	BK	Date 23 / 01 / 2020
Client	Deicorp Projects (Tallawong Station) Pty Ltd	Box	1-3 of 3	Checked SK Date 06 / 03 / 2020

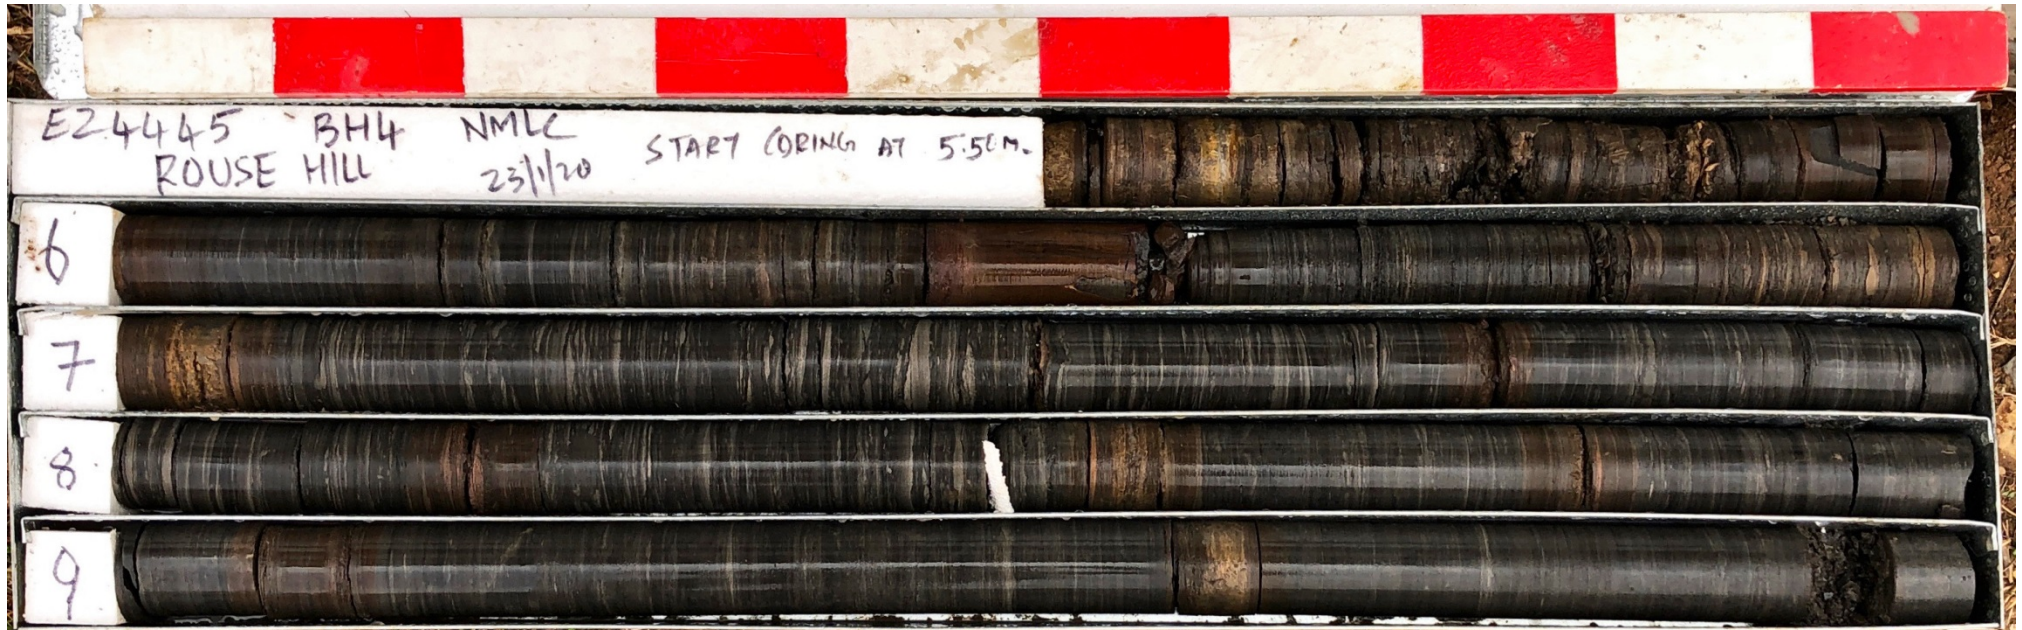
CORE PHOTOGRAPH OF BOREHOLE: BH4

Project	Proposed Development	Depth Range	10.0m to 20.0m BEGL	
Location	Tallawong Station Precinct South, Rouse Hill NSW	Contractor	Geosense Drilling Engineers Pty Ltd	
Position	See Figure 2	Drill Rig	Hanjin D&B 8D	
Job No.	E24445.G03	Logged	BK	Date 23 / 01 / 2020
Client	Deicorp Projects (Tallawong Station) Pty Ltd	Box	2-3 of 3	Checked SK Date 06 / 03 / 2020

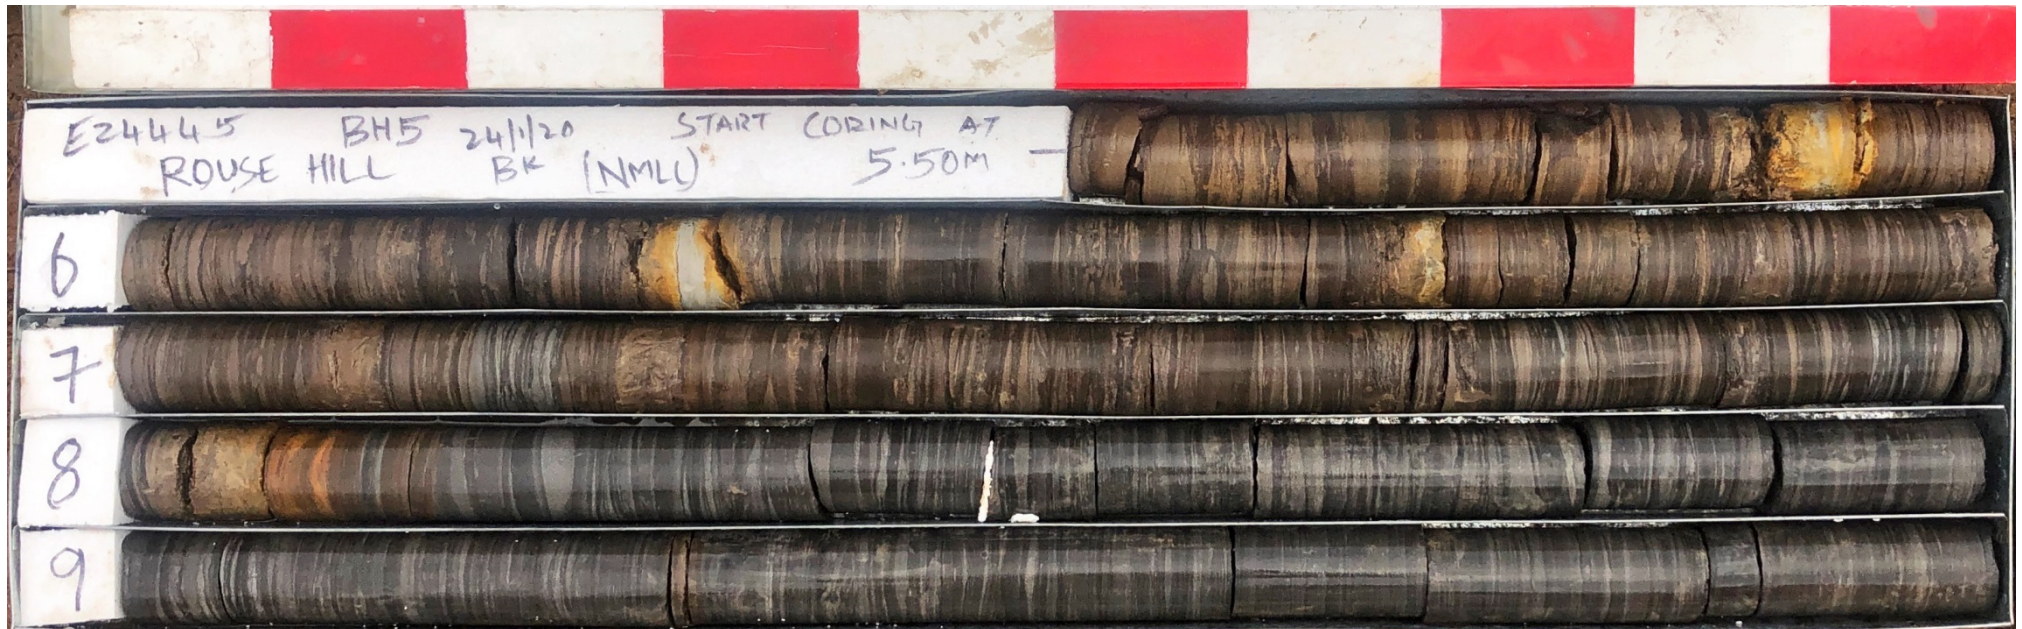
CORE PHOTOGRAPH OF BOREHOLE: BH5

Project	Proposed Development	Depth Range	10.0m to 20.0m BEGL	
Location	Tallawong Station Precinct South, Rouse Hill NSW	Contractor	Geosense Drilling Engineers Pty Ltd	
Position	See Figure 2	Drill Rig	Hanjin D&B 8D	
Job No.	E24445.G03	Logged	BK	Date 24 / 01 / 2020
Client	Deicorp Projects (Tallawong Station) Pty Ltd	Checked	SK	Date 06 / 03 / 2020
		Surface RL	≈ 56.5m	
		Inclination	-90°	
		Box	2-3 of 3

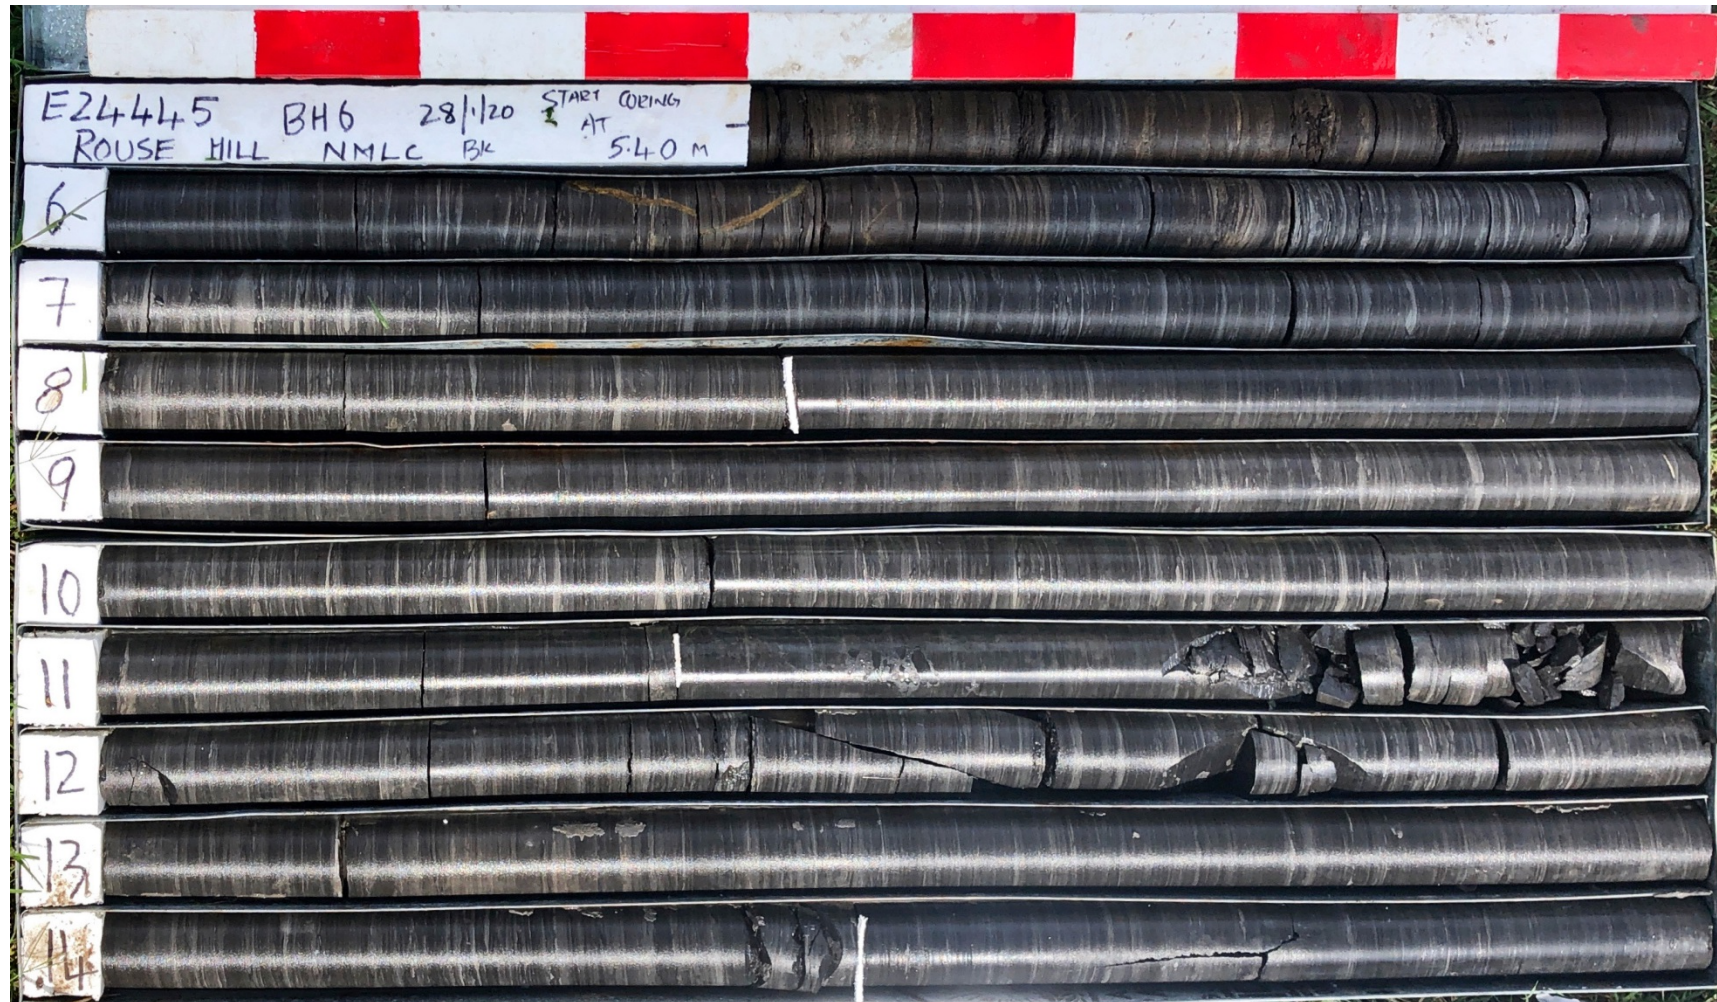
CORE PHOTOGRAPH OF BOREHOLE: BH6

Project	Proposed Development	Depth Range	15.0m to 20.0m BEGL	
Location	Tallawong Station Precinct South, Rouse Hill NSW	Contractor	Geosense Drilling Engineers Pty Ltd	
Position	See Figure 2	Drill Rig	Hanjin D&B 8D	
Job No.	E24445.G03	Logged	BK	Date 24 / 01 / 2020
Client	Deicorp Projects (Tallawong Station) Pty Ltd	Inclination	-90°	Date 06 / 03 / 2020
		Box	3 of 3

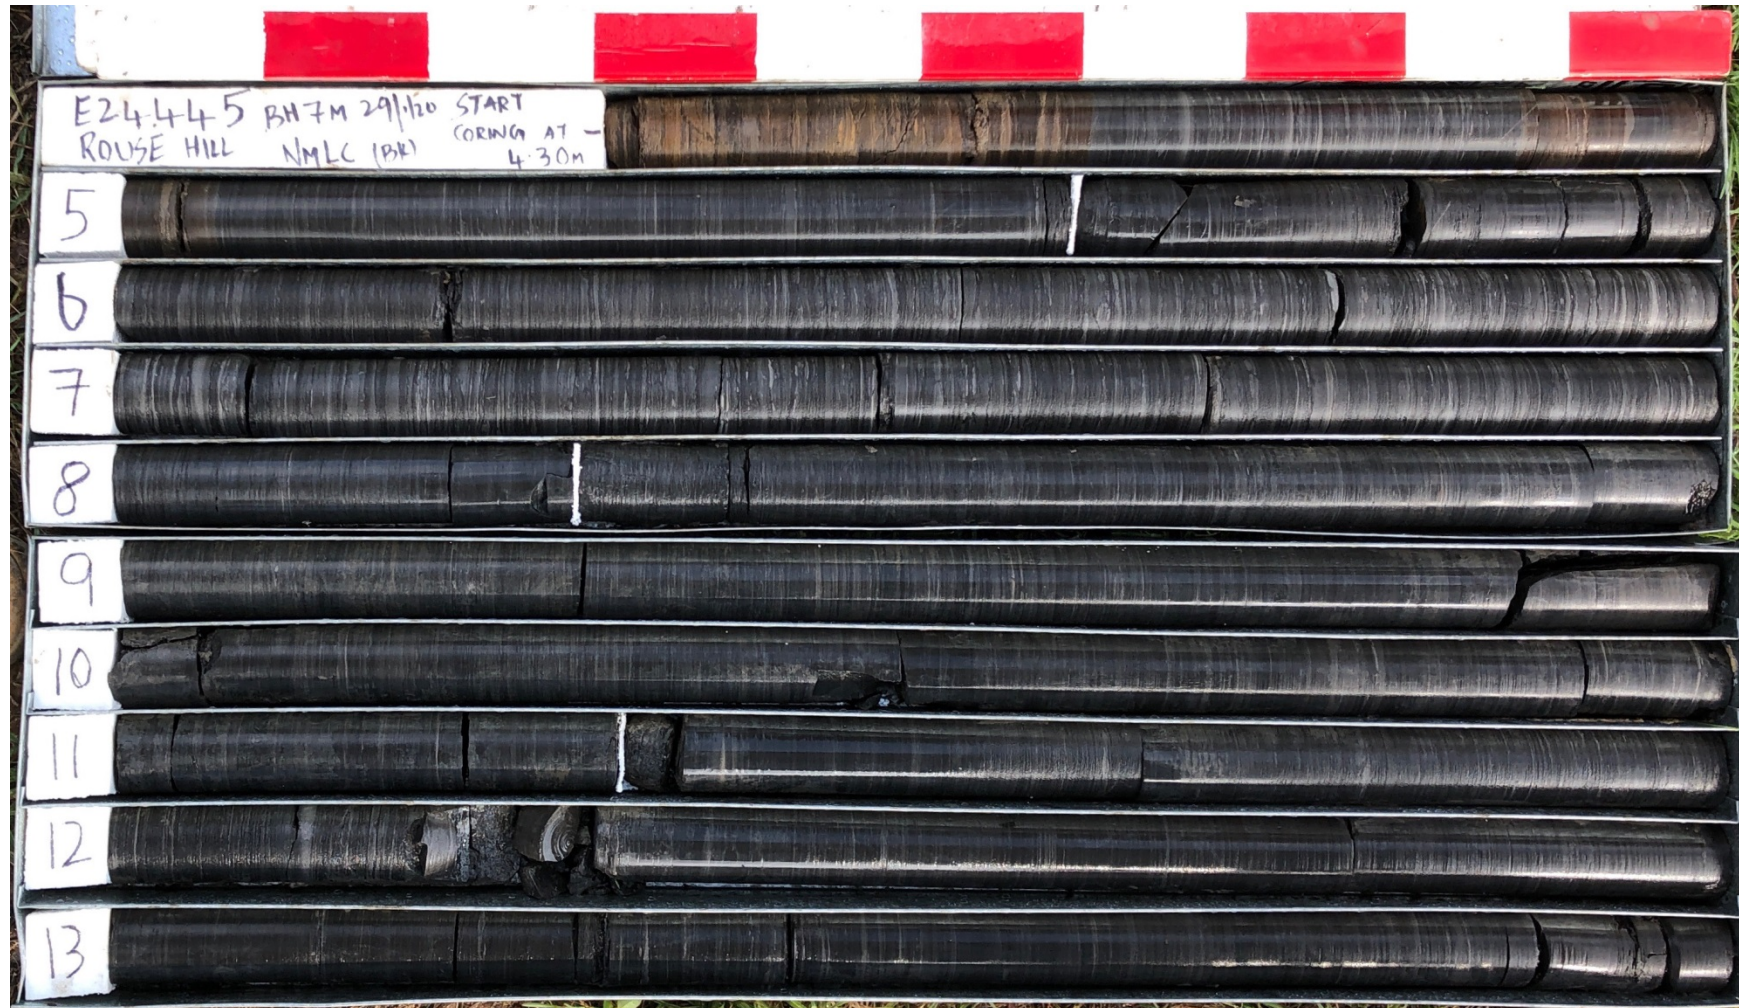
CORE PHOTOGRAPH OF BOREHOLE: BH7M

Project	Proposed Development	Depth Range	14.0m to 19.61m BEGL	
Location	Tallawong Station Precinct South, Rouse Hill NSW	Contractor	Geosense Drilling Engineers Pty Ltd	
Position	See Figure 2	Drill Rig	Hanjin D&B 8D	
Job No.	E24445.G03	Logged	BK	Date 28 / 01 / 2020
Client	Deicorp Projects (Tallawong Station) Pty Ltd	Inclination	-90°	Date 06 / 03 / 2020
		Box	3-4 of 4

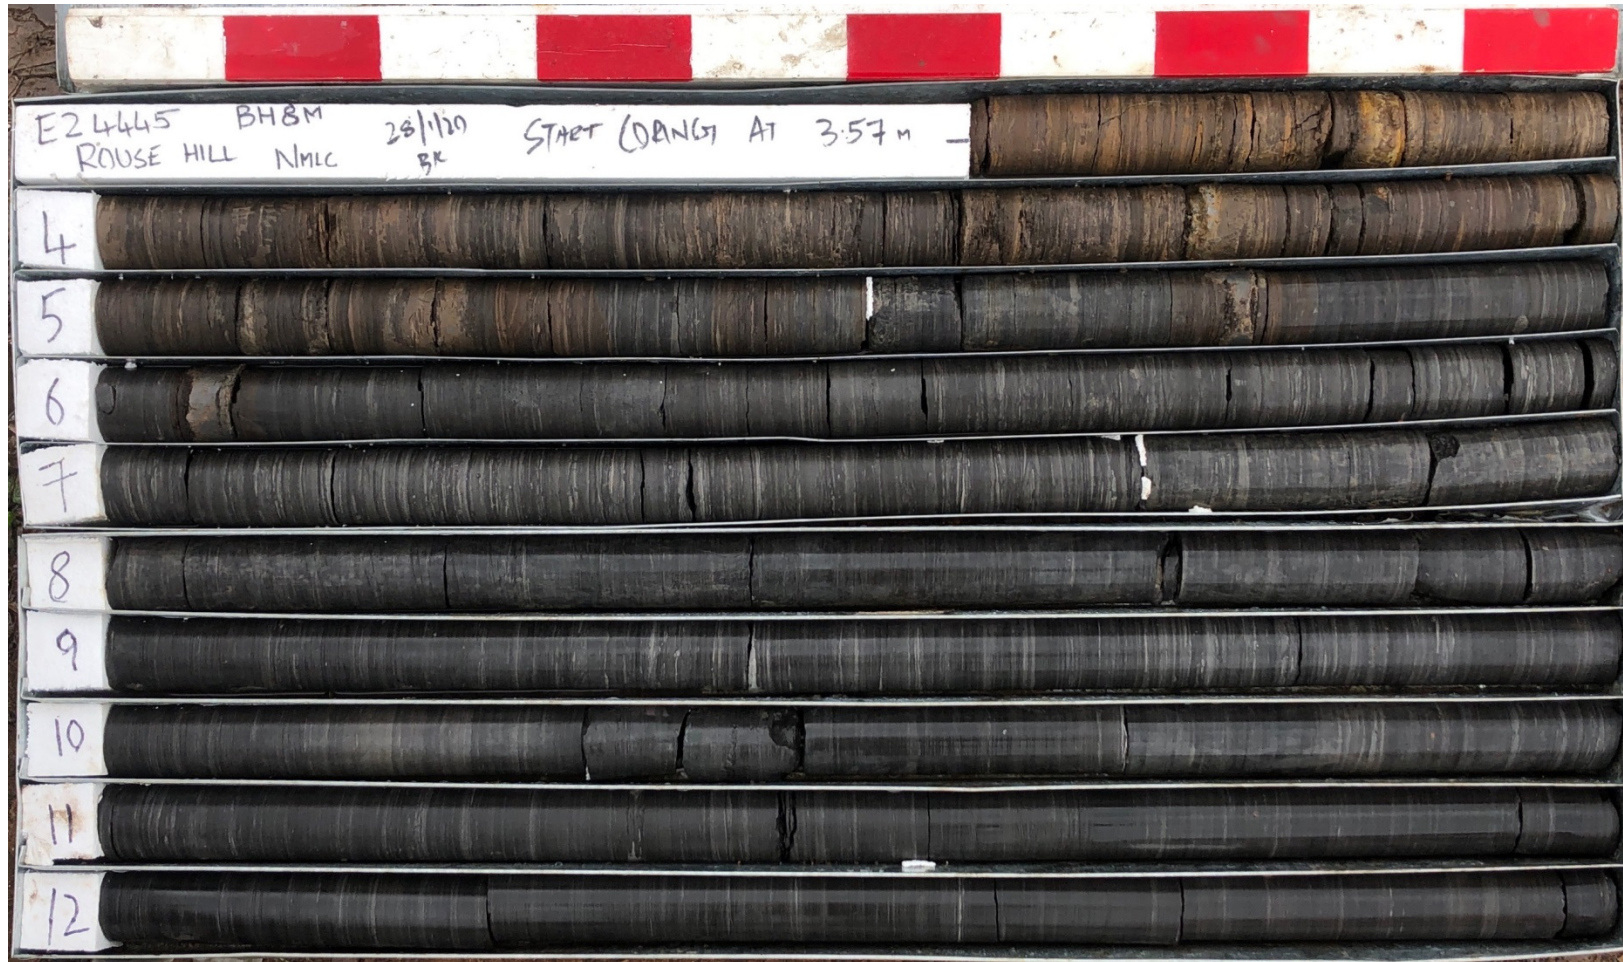
CORE PHOTOGRAPH OF BOREHOLE: BH8M

Project	Proposed Development	Depth Range	13.0m to 20.47m BEGL	
Location	Tallawong Station Precinct South, Rouse Hill NSW	Contractor	Geosense Drilling Engineers Pty Ltd	
Position	See Figure 2	Drill Rig	Hanjin D&B 8D	
Job No.	E24445.G03	Logged	BK	Date 28 / 01 / 2020
Client	Deicorp Projects (Tallawong Station) Pty Ltd	Inclination	-90°	Date 06 / 03 / 2020
		Box	3-4 of 4

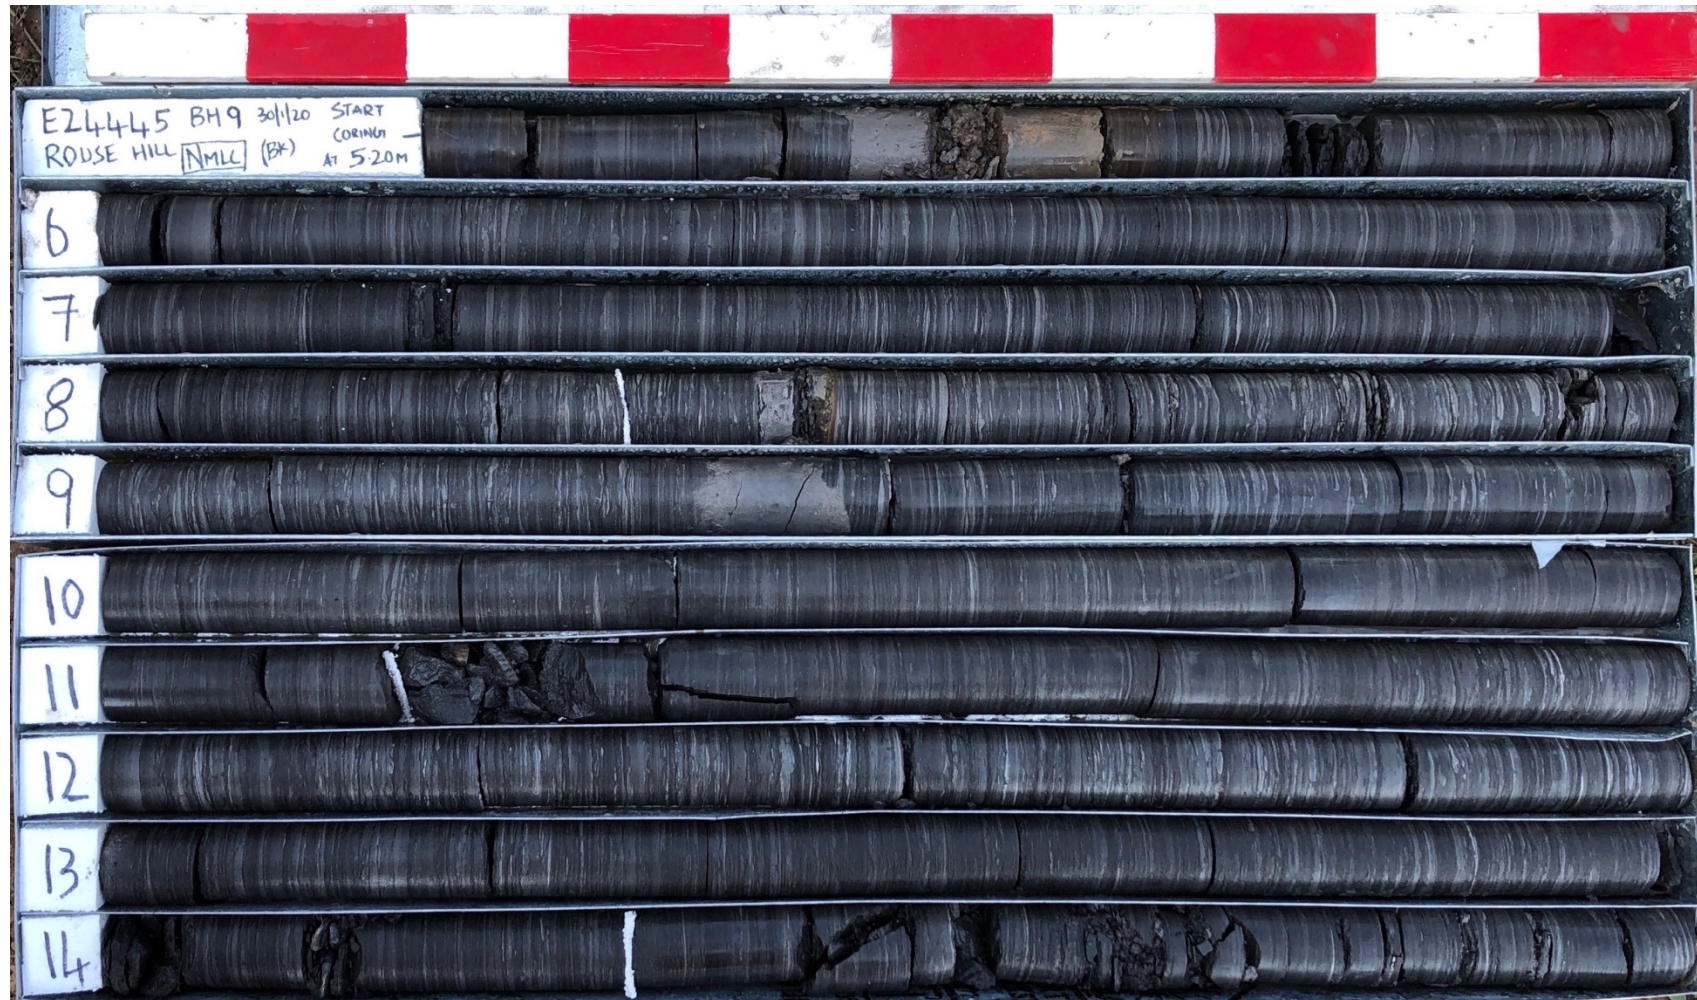
CORE PHOTOGRAPH OF BOREHOLE: BH9

Project	Proposed Development	Depth Range	15.0m to 20.47m BEGL	
Location	Tallawong Station Precinct South, Rouse Hill NSW	Contractor	Geosense Drilling Engineers Pty Ltd	
Position	See Figure 2	Drill Rig	Hanjin D&B 8D	
Job No.	E24445.G03	Logged	BK	Date 30 / 01 / 2020
Client	Deicorp Projects (Tallawong Station) Pty Ltd	Inclination	-90°	Date 06 / 03 / 2020
		Box	3-4 of 4

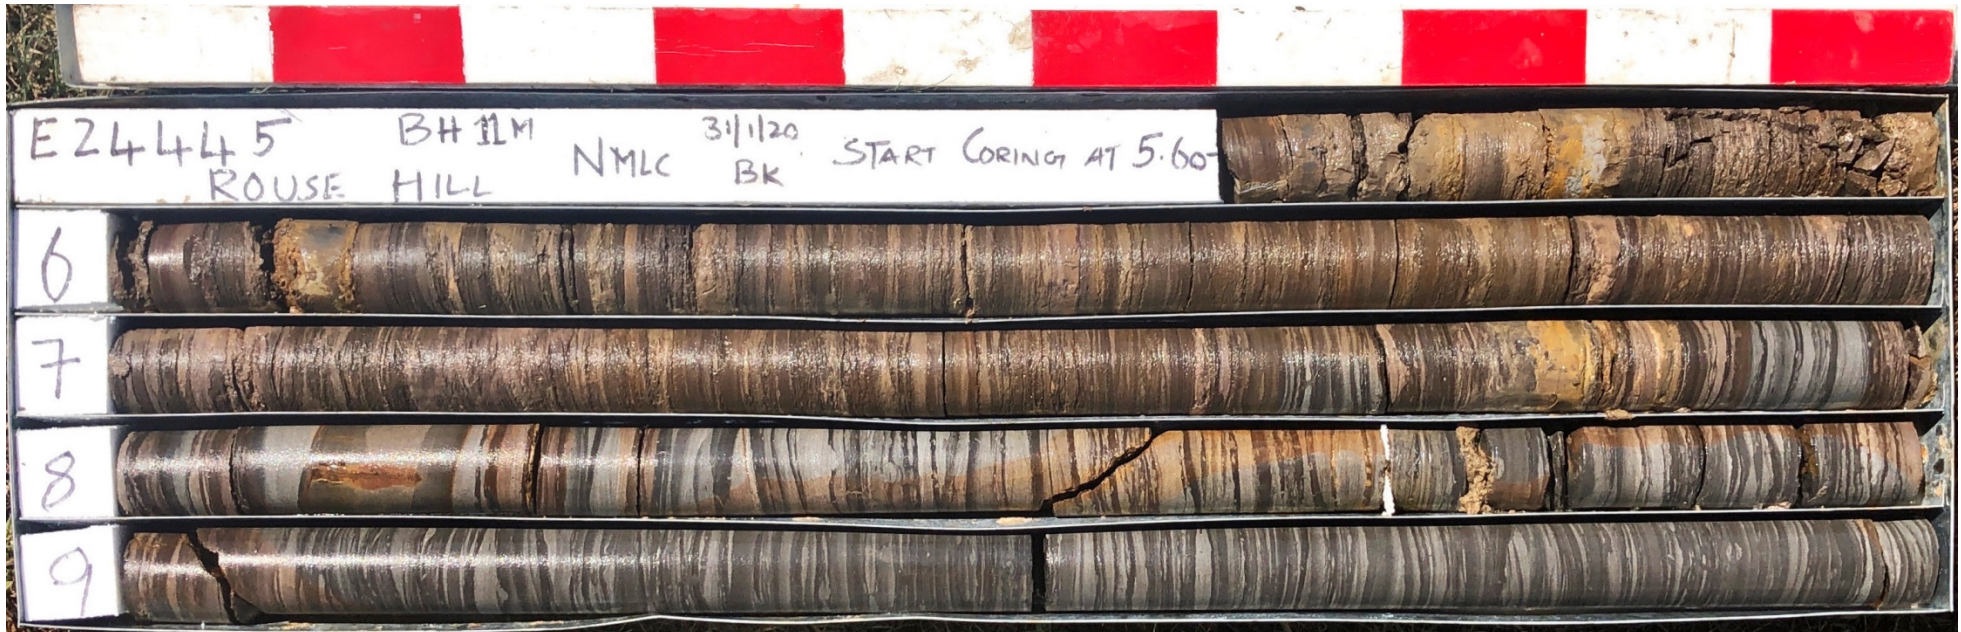
CORE PHOTOGRAPH OF BOREHOLE: BH11M

Project	Proposed Development	Depth Range	10.0m to 20.0m BEGL	
Location	Tallawong Station Precinct South, Rouse Hill NSW	Contractor	Geosense Drilling Engineers Pty Ltd	
Position	See Figure 2	Drill Rig	Hanjin D&B 8D	
Job No.	E24445.G03	Logged	BK	Date 31 / 01 / 2020
Client	Deicorp Projects (Tallawong Station) Pty Ltd	Box	2-3 of 3	Date 06 / 03 / 2020
		Inclination	-90°	
		Surface RL	≈ 57.5m

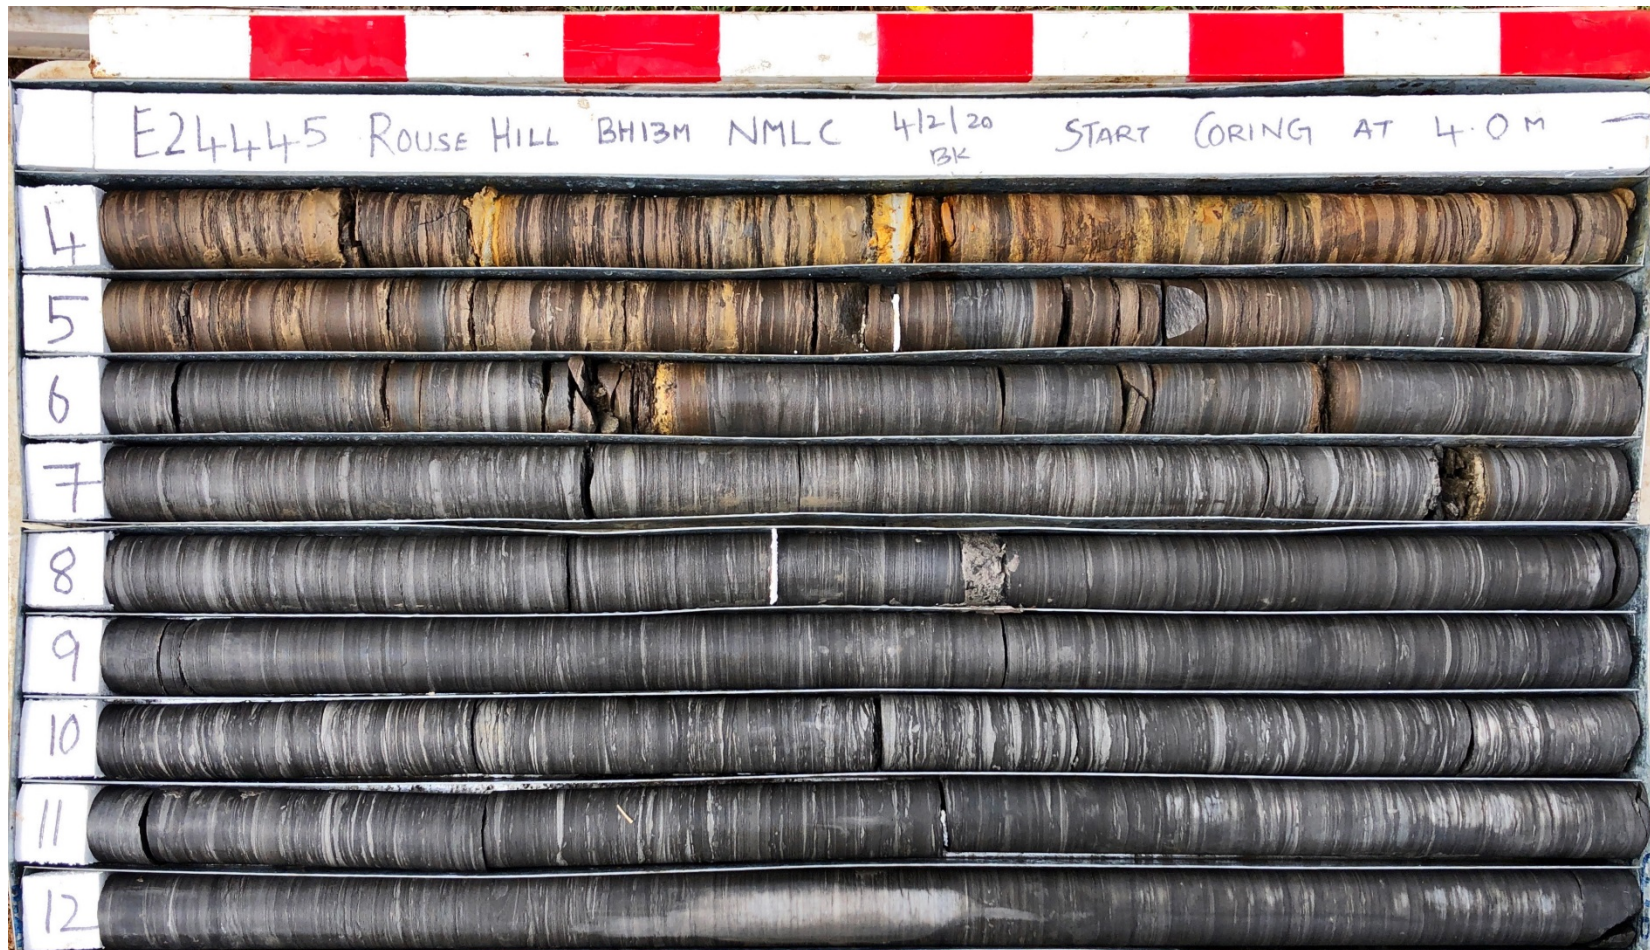
CORE PHOTOGRAPH OF BOREHOLE: BH13M

Project	Proposed Development	Depth Range	13.0m to 20.28m BEGL	
Location	Tallawong Station Precinct South, Rouse Hill NSW	Contractor	Geosense Drilling Engineers Pty Ltd	
Position	See Figure 2	Drill Rig	Hanjin D&B 8D	
Job No.	E24445.G03	Logged	BK	Date 04 / 02 / 2020
Client	Deicorp Projects (Tallawong Station) Pty Ltd	Box	3-4 of 4	Checked SK Date 06 / 03 / 2020
		Surface RL	≈ 56.5m	
		Inclination	-90°

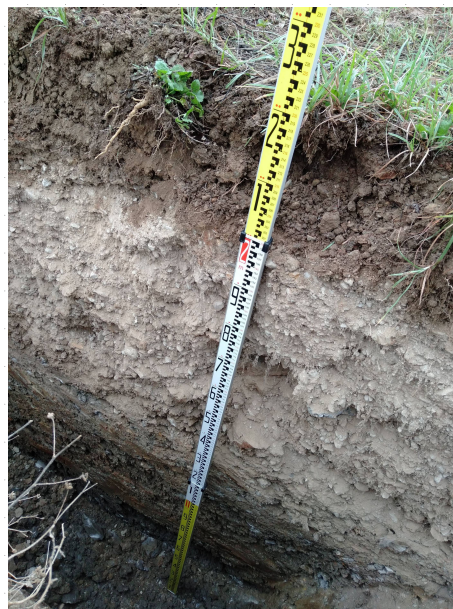
TEST PIT: TP14

Excavation				Sampling		Field Material Description					
METHOD	EXCAVATION RESISTANCE	WATER	DEPTH (metres)	DEPTH RL	SAMPLE OR FIELD TEST	RECOVERED	GRAPHIC LOG	GROUP SYMBOL	SOIL/ROCK MATERIAL DESCRIPTION	MOISTURE CONDITION	STRUCTURE AND ADDITIONAL OBSERVATIONS
E	.	GWNE	0	59.50	TP14_0.2-0.3 ES			-	FILL: Gravelly CLAY; low plasticity light brown to grey, with medium to coarse and sub-angular to angular gravel, with brick and concrete fragments.	M	FILL
			0.80	58.70				-	FILL: Gravelly CLAY; medium plasticity, dark grey and red, with sub-angular to angular gravels.	M	
			2	2.20	TP14_1.8-1.9 ES				Test Pit Refusal on SHALE at 2.20 m.		
			3

Comments
 Refusal on SHALE

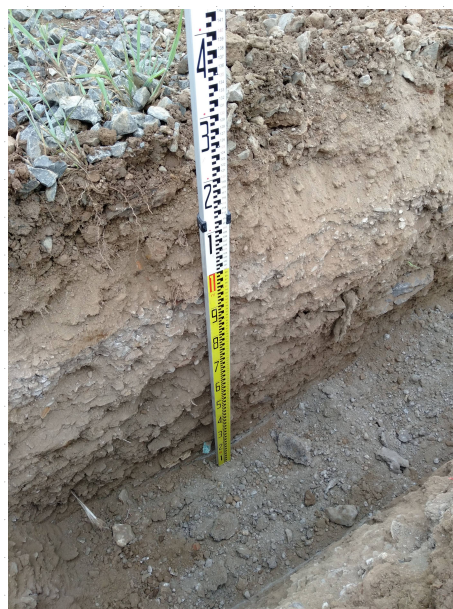
Excavation				Sampling		Field Material Description					
METHOD	EXCAVATION RESISTANCE	WATER	DEPTH (metres)	DEPTH RL	SAMPLE OR FIELD TEST	RECOVERED	GRAPHIC LOG	GROUP SYMBOL	SOIL/ROCK MATERIAL DESCRIPTION	MOISTURE CONDITION	STRUCTURE AND ADDITIONAL OBSERVATIONS
E	.	GWNE	0	56.50	TP15_0.2-0.3 ES			-	FILL: Gravelly CLAY; low plasticity light brown to grey, with medium to coarse and sub-angular to angular gravel, with brick and concrete fragments.	M	FILL
			1								
			1.20		TP15_1.1-1.2 ES				Test Pit Refusal on SHALE at 1.20 m.		
			2								
			3

Comments
 Refusal on SHALE

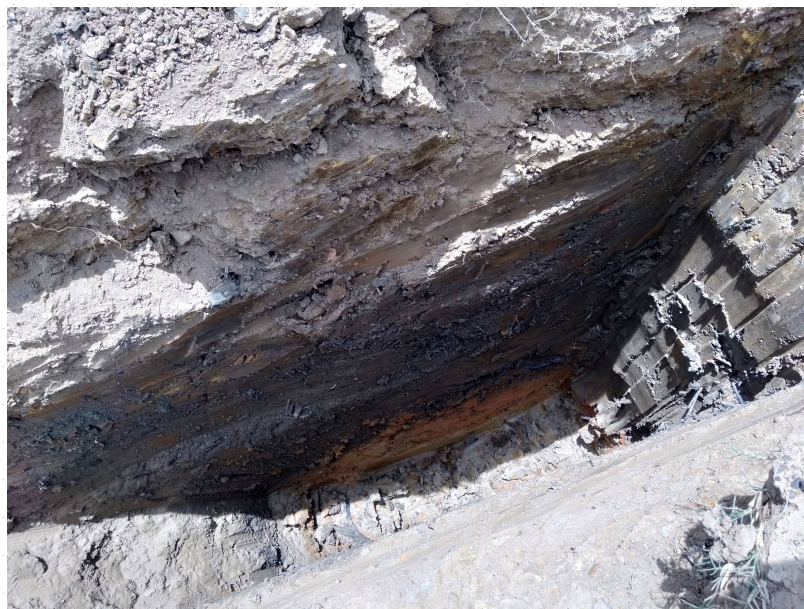
CL-CH	Silty CLAY; medium to high plasticity, red mottled brown.	M	-	RESIDUAL SOIL		
			2.10	2.20				-	Weathered SHALE.	M	-	BEDROCK		
								-	Test Pit Terminated at 2.20 m.		-

Comments
 Target depth reached

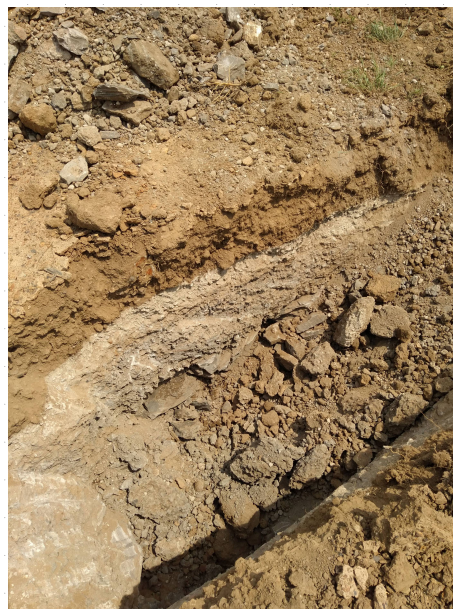
-	SHALE.	M	-	BEDROCK							
								Test Pit Refusal on SHALE at 1.00 m.											
			2

Comments
 Refusal on SHALE
