# STATEMENT OF HERITAGE IMPACT

Proposed development at

1 Rosemead Road

HORNSBY

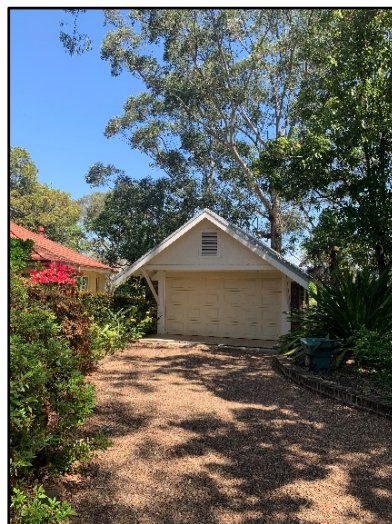
**Figure 45.** Detail of existing garage looking west.

To the rear, there is a non-original weatherboard garage on the western side of the allotment that was built in the early 1900s to replace the original one that was damaged by fire (refer to Section 2.3). The former tennis court, no longer evident due to the introduction of various plantings and grass, at the rear south western corner of the yard. It is evident that the subject dwelling is in very good condition, specifically, significant features of this dwelling include the principal façade, original siting, the chimneys, fireplaces, ceiling roses, pressed metal ceilings, gravel driveway and the view lines to and from Rosemead Road.

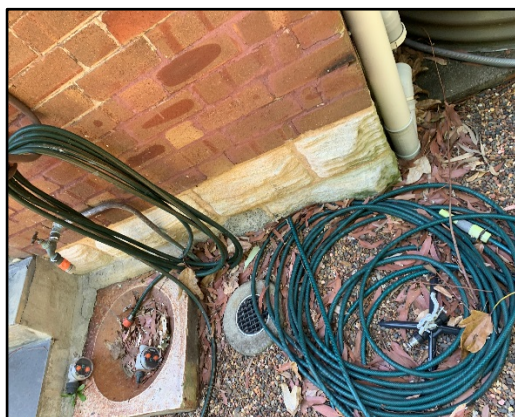
**Figure 54.** Detail of sandstone foundation.

The dwelling appears to have been constructed on a sandstone foundation that is visible at some points beneath the exterior walls. The external finishes feature dark red face brick at the ground floor in an English bond arrangement and alabaster roughcast rendering at the upper floor. The face brick shows signs of tuckpointing.

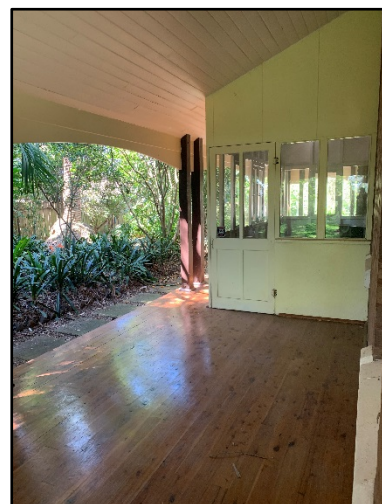
**Figure 55.** Detail of eastern façade of the subject dwelling showing the non-original sewing room.

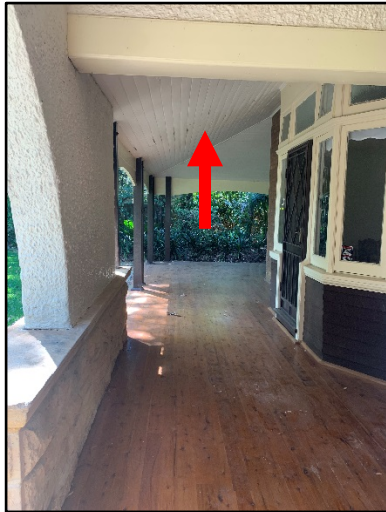
**Figure 56.** View of the verandah at the primary facade looking east. The painted timber soffit is visible above.

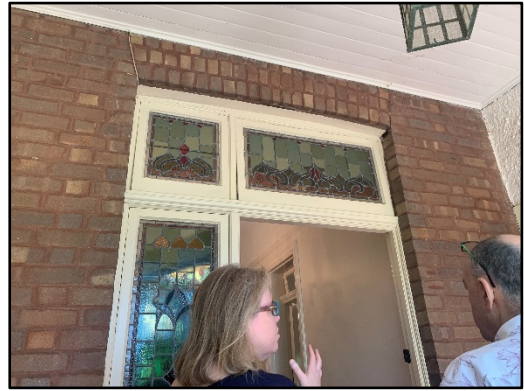
**Figure 57.** Detail on the front entrance. Also noted in the repointing work on the face brick façade.

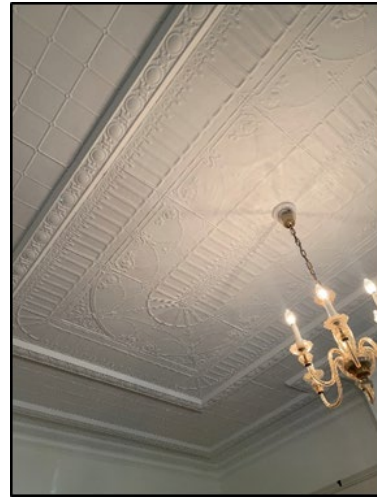
**Figure 63.** Detail of the pressed metal ceilings in drawing room.

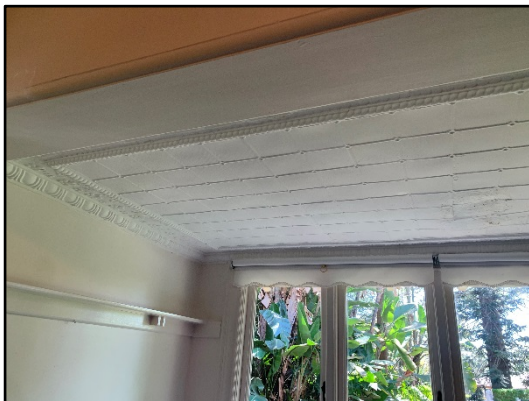
**Figure 64.** Detail of pressed metal ceiling in bay window of drawing room.
