PRELIMINARY (STAGE 1) SITE INVESTIGATION

Proposed Community School1 Rosemead Road Hornsby NSW

NG Child & Associates

30 April 2020

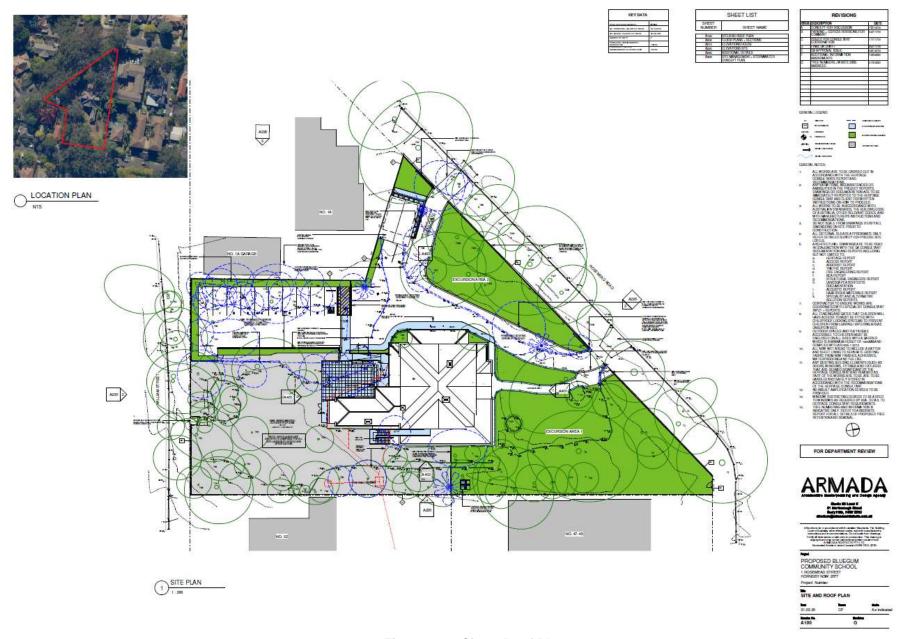
Figure 2.6 - Site & Roof Plan

The development will involve modifications to an existing building at the 1 Rosemead Road site, as indicated by the plans and drawings provided in Figures 2.6 to 2.12 on subsequent pages, as follows:

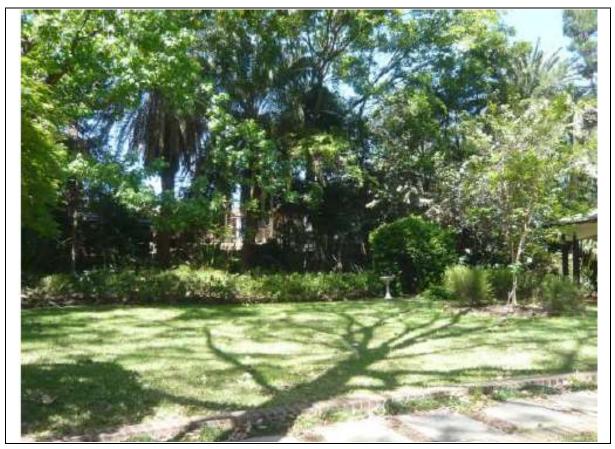
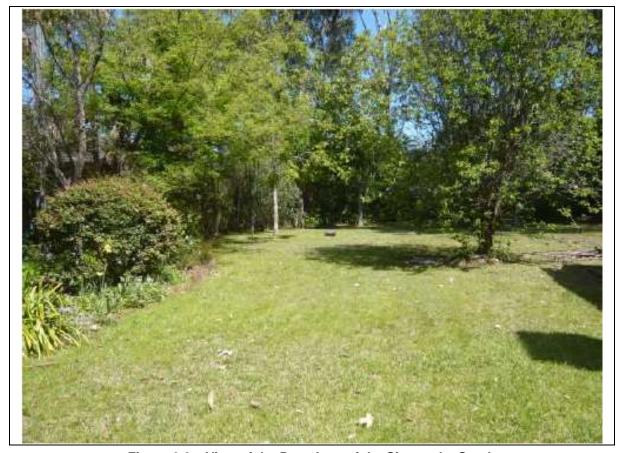
These photographs confirm the general impression formed during the site inspection, namely that the general condition of the site and immediate surroundings indicated healthy vegetation growth and provided no physical indication of any systematic underlying soil contamination issue.

Figure 6.1 - View of the Rear Area of the Site, to the West

Figure 6.2 – View of the Rear Area of the Site, to the South

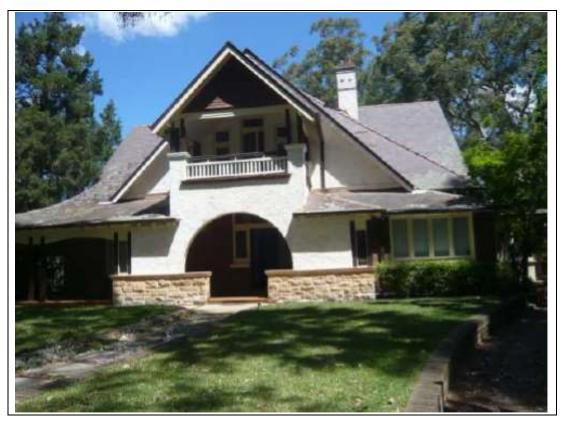
The 1 Rosemead Road site currently includes a substantial residential dwelling, as shown in Figure 6.3, below.

Figure 6.3 – Existing Dwelling at the Site (Viewed from Rosemead Road)

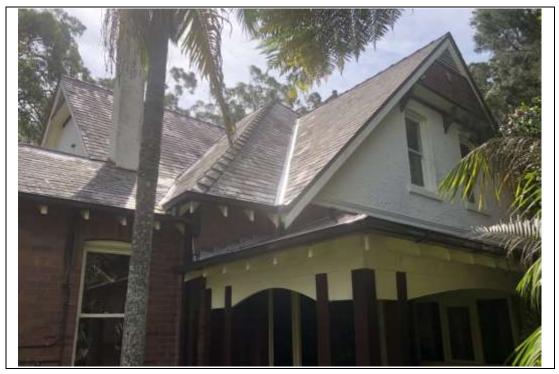
Figure 6.4 – Roof Line of Existing Dwelling

A quantity of lead based ridge capping was noted on part of the property roof. Once again, comments are provided in Section 6.8.

It was noted that the ridge capping in question was stable and was not considered to pose an environmental or health hazard.

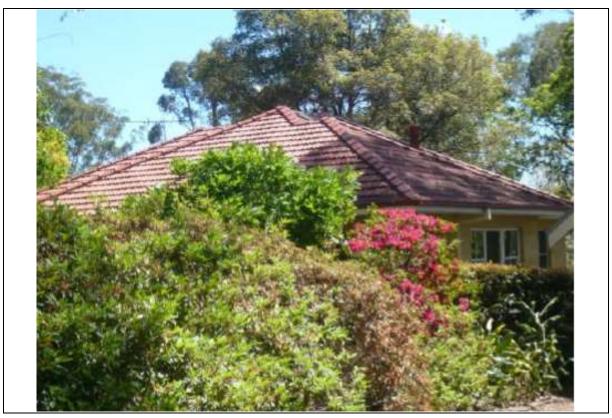
Surrounding building were noted to be residential in nature, as shown in Figure 6.5 and 6.6 below.

Figure 6.5 – Adjoining Residence to the West

No significant environmental issues, exposures or risks of a general nature were noted in relation to any nearby buildings and activities.

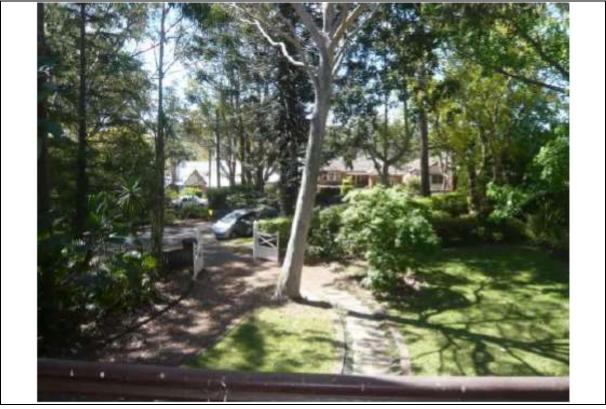
Figure 6.6 – Neighbouring Properties Opposite Rosemead Road to the North

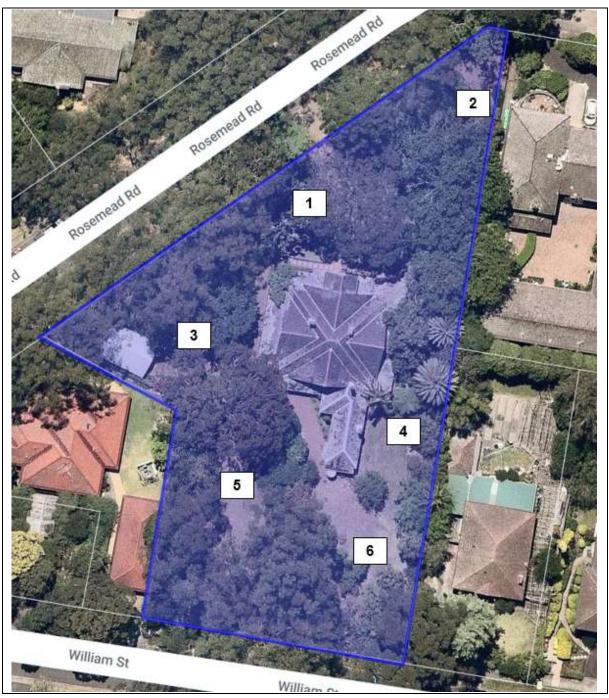
Soil samples were inspected field for any indications of discolouration, staining or odour, and by photoionisation detection for the presence of volatile hydrocarbons.

Figure 7.1 - Soil Sampling Locations

Sample Location	Sample Depth (mm)	Results
	Surface/300	No staining or odour. No indication of atypical or imported material. No photoionisation response – no indication of hydrocarbon contamination.
1	500	No staining or odour. No indication of atypical or imported material. No photoionisation response – no indication of hydrocarbon contamination.
	1000	No staining or odour. No indication of atypical or imported material. No photoionisation response – no indication of hydrocarbon contamination.
	Surface/300	No staining or odour. No indication of atypical or imported material. No photoionisation response – no indication of hydrocarbon contamination.
2	500	No staining or odour. No indication of atypical or imported material. No photoionisation response – no indication of hydrocarbon contamination.
	1000	No staining or odour. No indication of atypical or imported material. No photoionisation response – no indication of hydrocarbon contamination.
