ARBORICULTURAL IMPACT ASSESSMENT

Upper Australia Exhibit-

Taronga Zoo

Prepared for: Taronga
Conservation Society

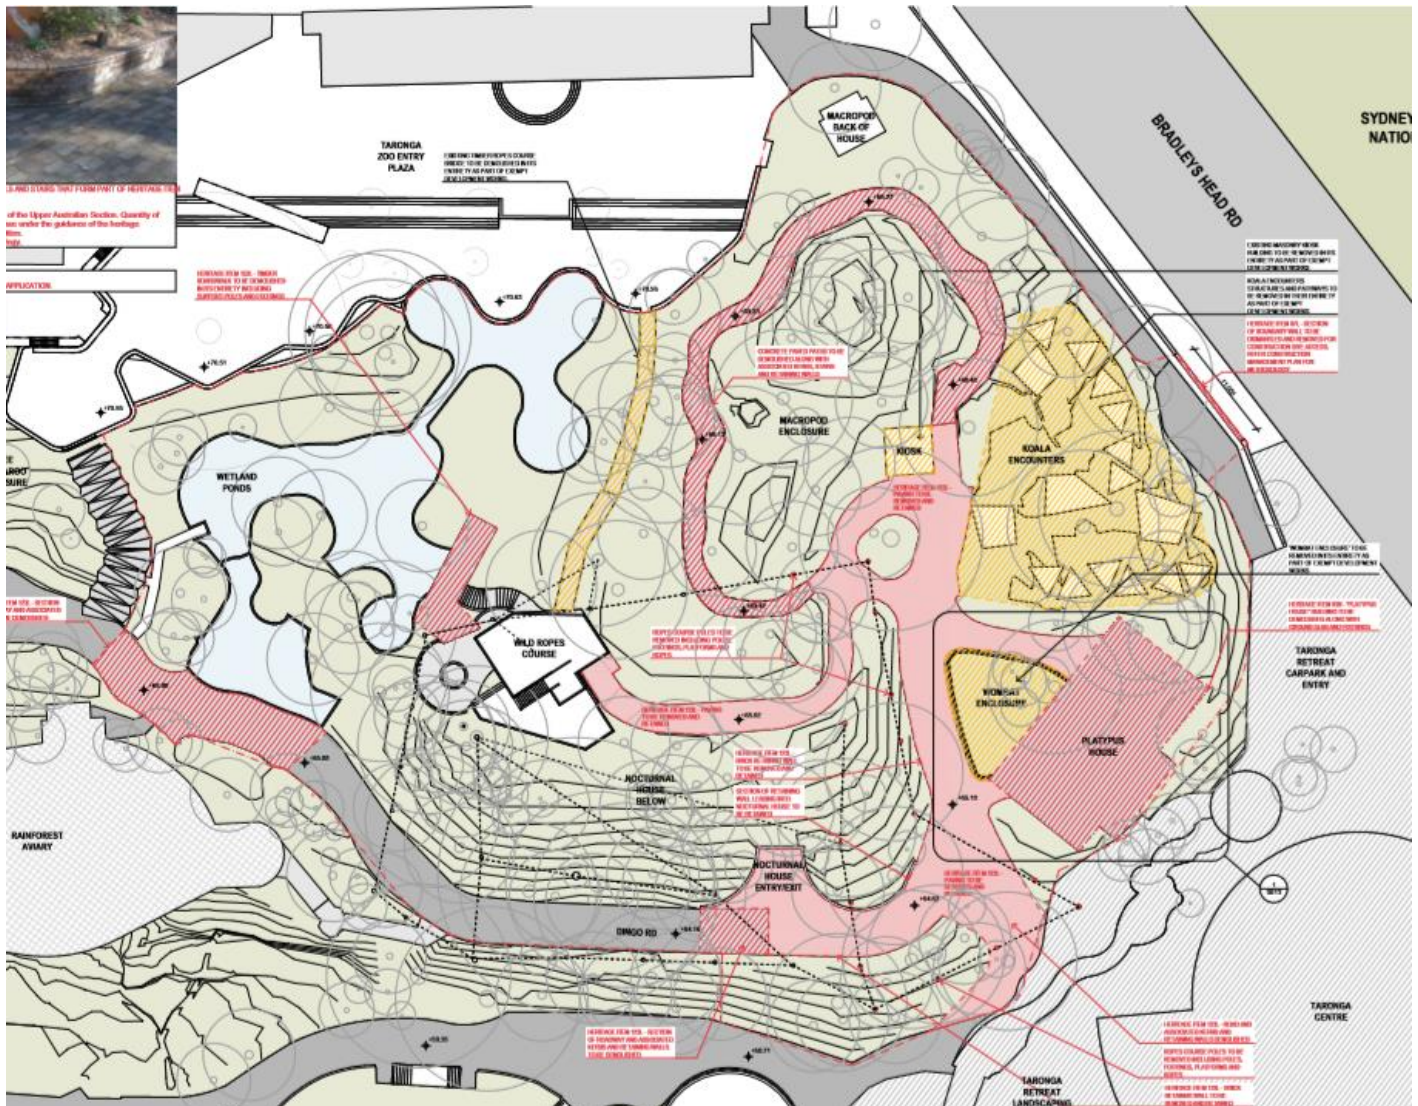
Figure 1- Demolition plan showing the structures to be demolished for stage 1 works.

The proposed development is to demolish the existing site features shown in red and orange in figure 1 below as part of the early works schedule.

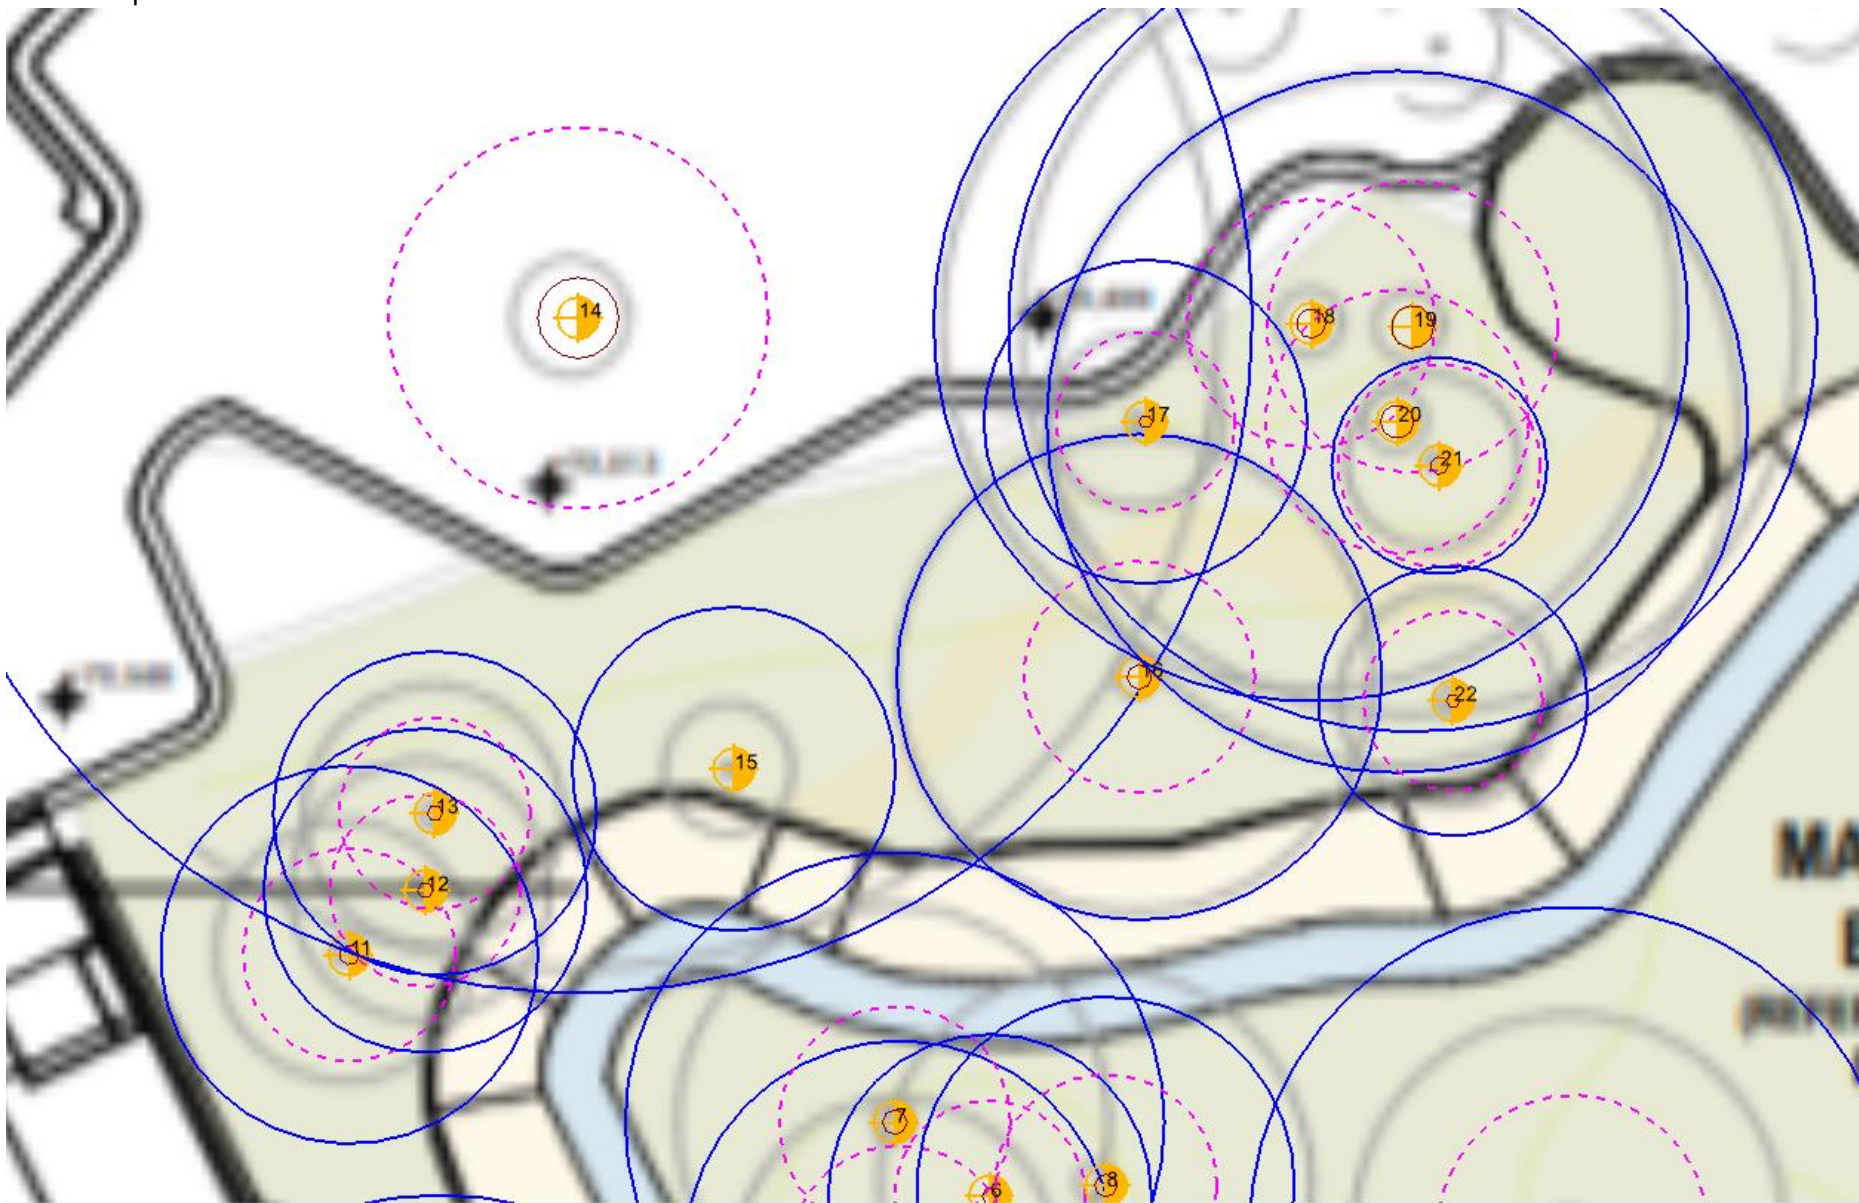
Figure 6- Trees impacted by the Macropod trail

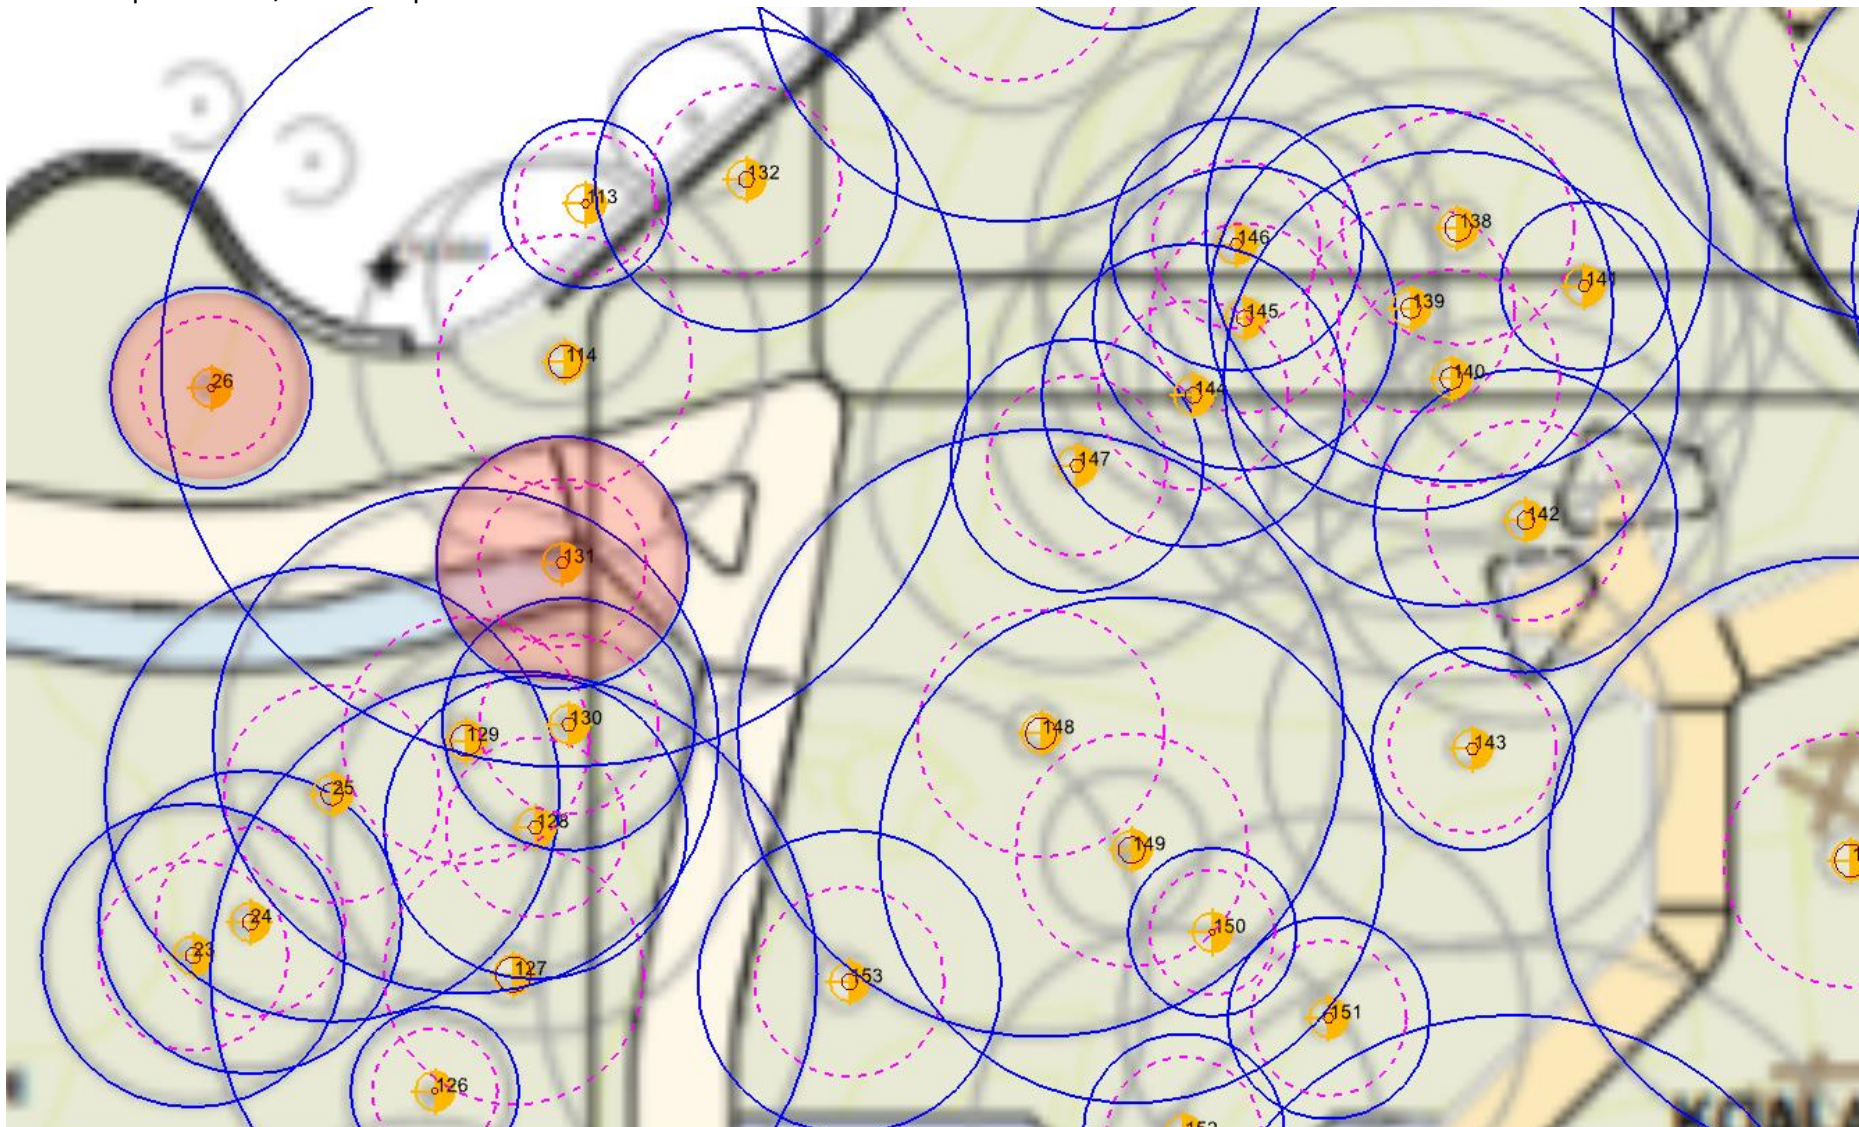
Figure 7- Macropod trail continued.

Tree number	Impacts	Mitigation	Remove/retain
11	Drainage of existing ponds/ altered micro-climate	Install irrigation and misters to maintain moisture levels	Retain & protect
12	Drainage of existing ponds/ altered micro-climate	Install irrigation and misters to maintain moisture levels	Retain & protect
13	Drainage of existing ponds/ altered micro-climate	Install irrigation and misters to maintain moisture levels	Retain & protect
14	Drainage of existing ponds/ altered micro-climate	Install irrigation and misters to maintain moisture levels	Retain & protect
15	Drainage of existing ponds/ altered micro-climate	Install irrigation and misters to maintain moisture levels	Retain & protect
16	Drainage of existing ponds/ altered micro-climate	Install irrigation and misters to maintain moisture levels	Retain & protect
17	Drainage of existing ponds/ altered micro-climate	Install irrigation and misters to maintain moisture levels	Retain & protect

18	Drainage of existing ponds/ altered micro-climate	Install irrigation and misters to maintain moisture levels	Retain & protect
19	Drainage of existing ponds/ altered micro-climate	Install irrigation and misters to maintain moisture levels	Retain & protect
20	Drainage of existing ponds/ altered micro-climate	Install irrigation and misters to maintain moisture levels	Retain & protect
21	Drainage of existing ponds/ altered micro-climate	Install irrigation and misters to maintain moisture levels	Retain & protect
22	Drainage of existing ponds/ altered micro-climate	Install irrigation and misters to maintain moisture levels	Retain & protect
23	Drainage of existing ponds/ altered micro-climate	Install irrigation and misters to maintain moisture levels	Retain & protect
24	Drainage of existing ponds/ altered micro-climate	Install irrigation and misters to maintain moisture levels	Retain & protect
25	Drainage of existing ponds/ altered micro-climate	Install irrigation and misters to maintain moisture levels	Retain & protect

26	Dead tree	N/A	Proposed for removal
113	Unaffected by proposal	Tree protection fencing	Retain & protect
114	Heavily encroached upon by Macropod trail	Section of the trail within the TPZ must be built on or above grade using tree sensitive construction methods.	Retain & protect
126	Unaffected by proposal	Tree protection fencing	Retain & protect
127	Heavily encroached upon by Macropod trail	Section of the trail within the TPZ must be built on or above grade using tree sensitive construction methods.	Retain & protect
128	Minor encroachment from the Macropod trail	Tree protection fencing	Retain & protect
129	Minor encroachment from the Macropod trail	Tree protection fencing	Retain & protect
130	Minor encroachment from the Macropod trail	Tree protection fencing	Retain & protect
131	Heavily encroached upon by Macropod trail and water feature	N/A	Proposed for removal

132	Heavily encroached upon by new containment fence	Fencing must be installed using tree sensitive construction measures with piers located outside of SRZ.	Retain & protect
138	Unaffected by proposal	Tree protection fencing	Retain & protect
139	Unaffected by proposal	Tree protection fencing	Retain & protect
140	Unaffected by proposal	Tree protection fencing	Retain & protect
141	Unaffected by proposal	Tree protection fencing	Retain & protect
142	Encroached upon by viewing platform	Raised platform footings must be installed using tree sensitive construction measures with piers located outside of SRZ.	Retain & protect
143	Unaffected by proposal	Tree protection fencing	Retain & protect
144	Unaffected by proposal	Tree protection fencing	Retain & protect
145	Unaffected by proposal	Tree protection fencing	Retain & protect
146	Unaffected by proposal	Tree protection fencing	Retain & protect
147	Unaffected by proposal	Tree protection fencing	Retain & protect

148	Minor encroachment from the Macropod trail	Tree protection fencing	Retain & protect
149	Unaffected by proposal	Tree protection fencing	Retain & protect
150	Unaffected by proposal	Tree protection fencing	Retain & protect
151	Unaffected by proposal	Tree protection fencing	Retain & protect
152	Unaffected by proposal	Tree protection fencing	Retain & protect
153	Minor encroachment from the Macropod trail	Tree protection fencing	Retain & protect
<p>Notes: Many of the trees are near the edge of the existing ponds. The removal of the ponds must consider sensitive construction methods such as hand demolition or retaining sections of the ponds in situ. The trail must be located within the footprint of the existing ponds. There is a small Melaleuca which does not meet the definition of a prescribed tree which will require removal to enable the pathway to be installed. Tree sixteen (16) is a large Tuckeroo which may require minor crown lifting for pedestrian access.</p> <p>Trees #144, #127, #132, #142 are heavily encroached upon the proposed structures and tree sensitive construction methods must be employed.</p>

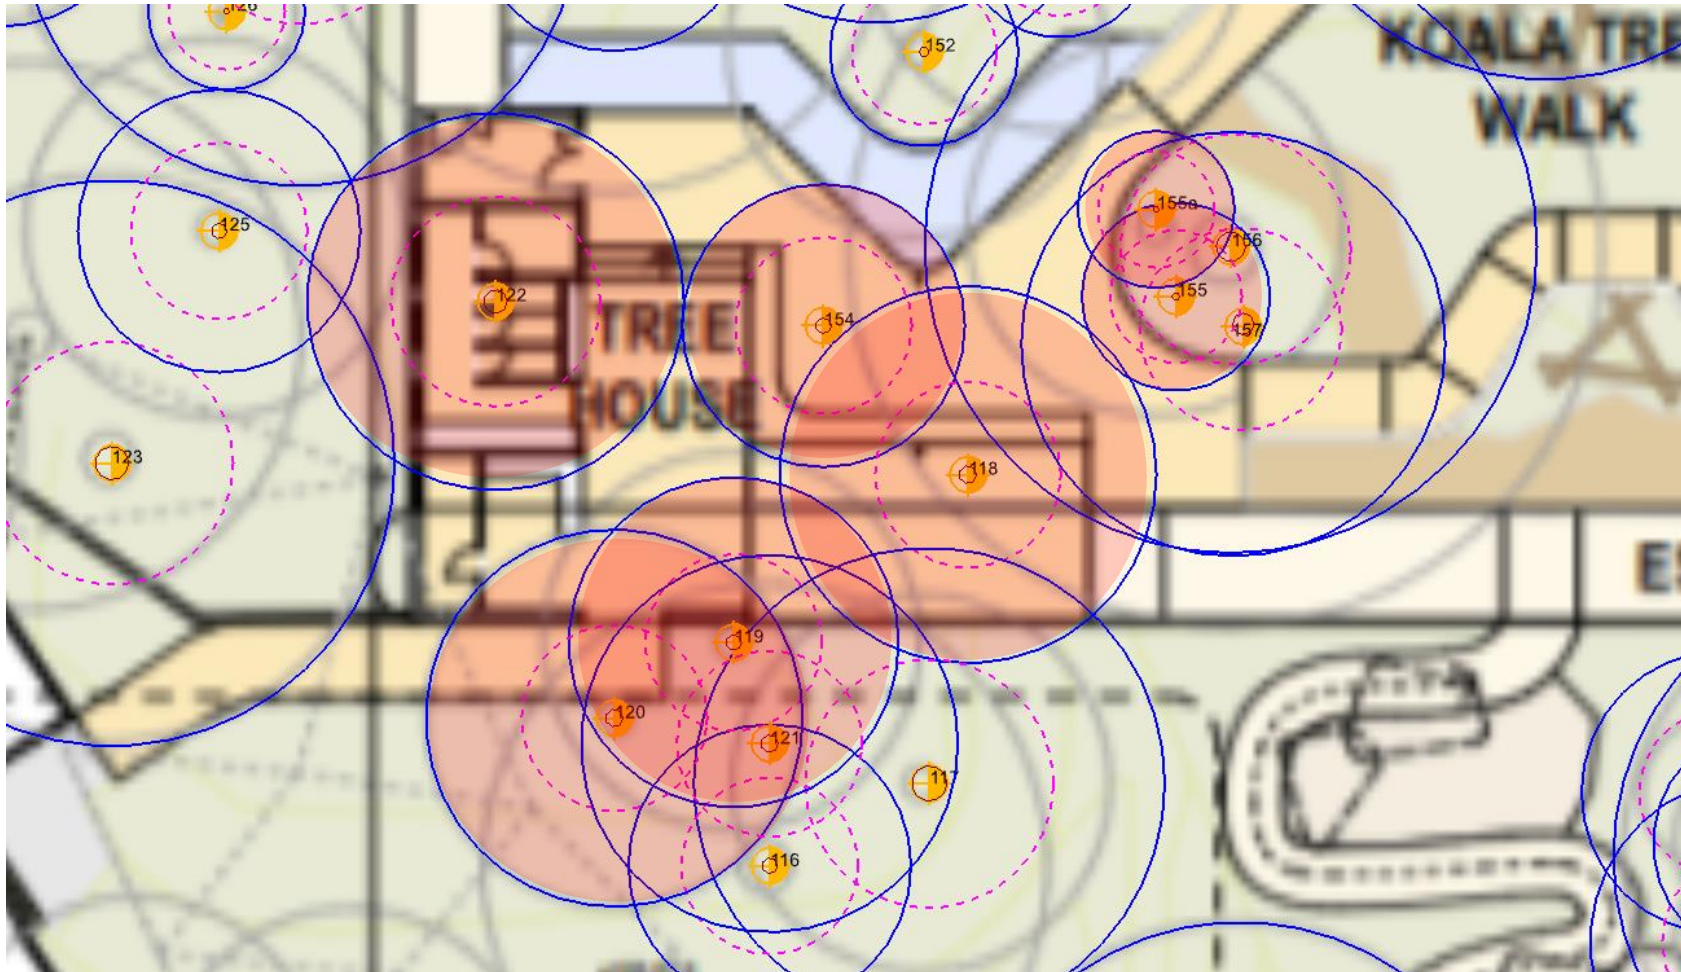
Figure 9- Trees impacted by the tree house

Tree #	Impacts	Mitigation	Remove/retain
116	Unaffected by development	N/A	Retain & protect
117	Minor encroachment from tree house structure	Tree protection fencing	Retain & protect
118	Within Tree House footprint	N/A	Proposed for removal
119	Major encroachment from tree house structure	N/A	Proposed for removal
120	Major encroachment from tree house structure	N/A	Proposed for removal
121	Minor encroachment from tree house structure	Tree protection fencing	Retain & protect
122	Within Tree House footprint	N/A	Proposed for removal
123	Minor encroachment from tree house structure	Tree protection fencing	Retain & protect
125	Unaffected by development	N/A	Retain & protect
152	Unaffected by development	N/A	Retain & protect
154	Within Tree House footprint	N/A	Proposed for removal
155	Major encroachment from tree house structure	N/A	Proposed for removal
155a	Major encroachment from tree house structure	N/A	Proposed for removal

156	Major encroachment from tree house structure	Structures must be installed using tree sensitive construction measures with piers located outside of SRZ.	Retain & protect
157	Major encroachment from tree house structure	Structures must be installed using tree sensitive construction measures with piers located outside of SRZ.	Retain & protect

Notes: The tree house structure is primarily a raised structure and few impacts are anticipated other than what arises from direct conflicts with the building line itself. Trees #118, #122, #154 are all within the building footprint and will require removal. Trees #119 and #120 are too close to the proposed structure to be sustainable in the long-term and are proposed for removal. Trees #155 and #155a are small suppressed trees that are leaning towards the proposed structures, there will be ongoing canopy conflicts between the trees and the proposed structures so they have been recommended for removal.

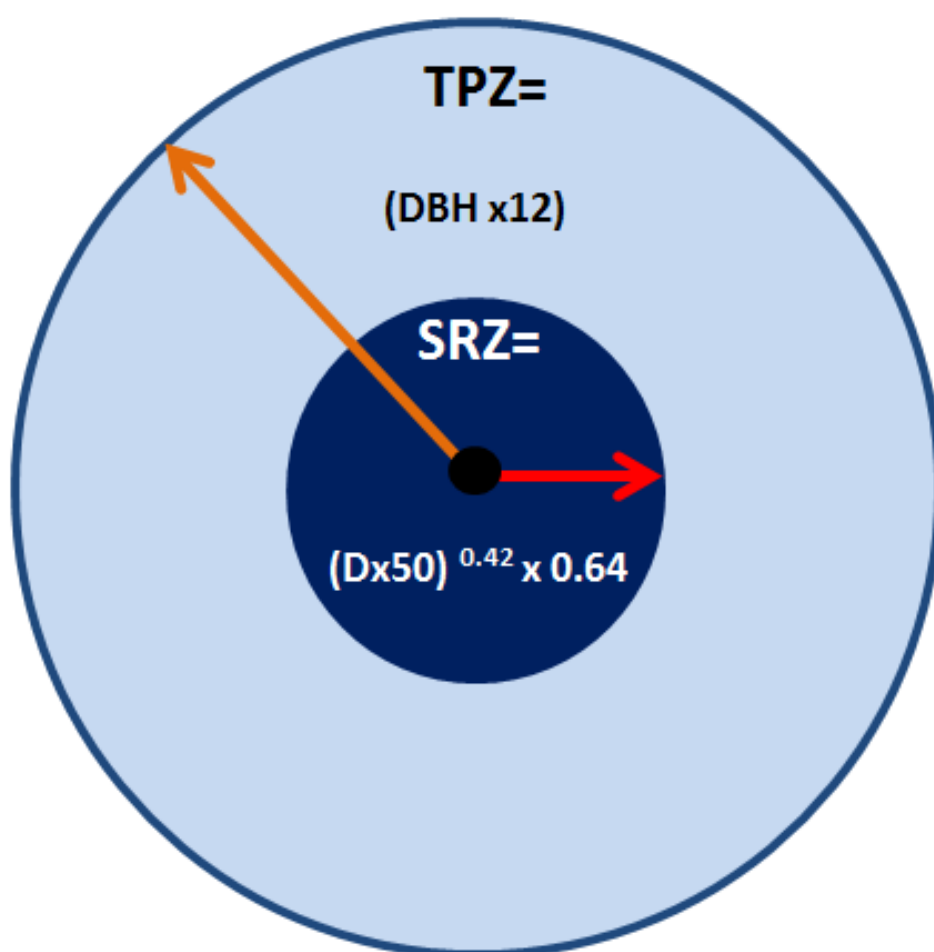
The Structural Root Zone (SRZ) radius is calculated by measuring the diameter of the stem close to ground level, just above the basal flare. This measurement is taken as D and then used in the following formula: $R_{SRZ} = (D \times 50)^{0.42} \times 0.64$ and becomes the Structural Root Zone, measured radially from the centre of the stem.

Figure 2 – A representation of TPZ & SRZ calculations.

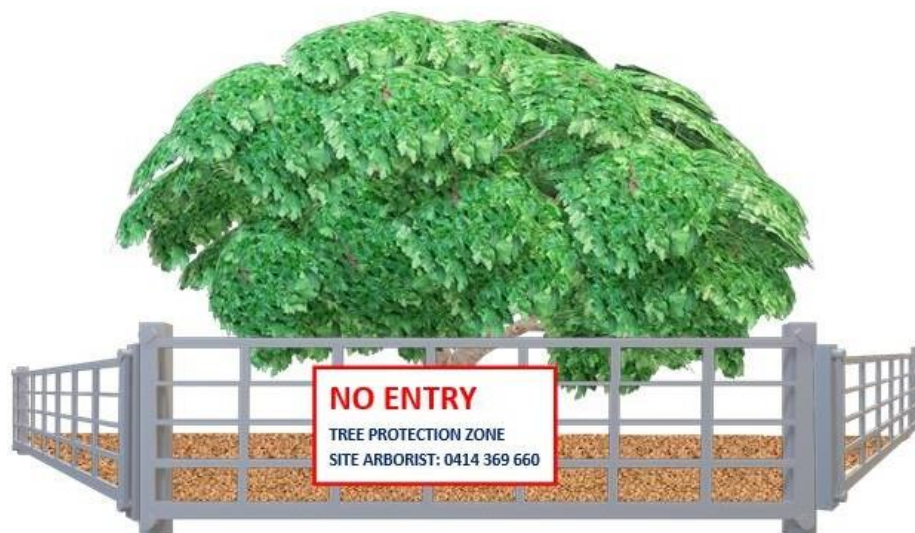
Tree root protection: TPZ Fencing- Figure 1

Tree root protection is generally achieved with the allocation and delineation of a tree protection zone (TPZ) in accordance with AS4970-2009- The Protection of Trees on Development Sites. Temporary fencing is used to isolate the area from construction activity and restrict unauthorized access. Where access into the TPZ is required and unavoidable, ground protection measures may be recommended to ensure that the tree roots which are to be protected remain undamaged during works within the TPZ. Any works within the allocated tree protection zones must be directly supervised by a project Arborist with a minimum AQF level 5 qualification. In situations where there are low lying tree branches to be protected, the TPZ may be extended beyond the calculated TPZ in order to incorporate canopy protection as shown below.

All fencing must be chainmesh fencing 1.8m in height, secured with concrete 'feet' and in accordance with AS4678-Temporary Fencing and Hoardings. Depending on the type of development, shade cloth or similar may be recommended to reduce the spread of dust, particulate matter and liquids into the protected area. Silt fencing may also be required and may be incorporated into the TPZ fencing if required. Once the TPZ fencing has been installed the site Arborist must provide a letter of certification of tree protection measures to the client which may be forwarded on to the private certifier or council. Tree protection fencing is not to be moved, realigned, dismantled or tampered with in any way and shall only be relocated under instruction of the project Arborist. (See Figure 1) If the protective fencing requires temporary removal, trunk, branch and ground protection must be installed and must comply with AS 4970-2009 - Protection of trees on development sites. Existing fencing and site hoarding may be used as tree protection fencing, providing the TPZ remains isolated from construction activities. The purpose of ground protection is to prevent root damage and soil compaction within the TPZ. Ground protection may include a permeable membrane such as geotextile fabric beneath a layer of mulch, crushed rock or rumble boards.
