**NSW Department of Education, School Infrastructure**

**Remedial Action Plan – Mosman High School**

Military Road, Mosman, NSW

SYDEN233510-R03-Rev4

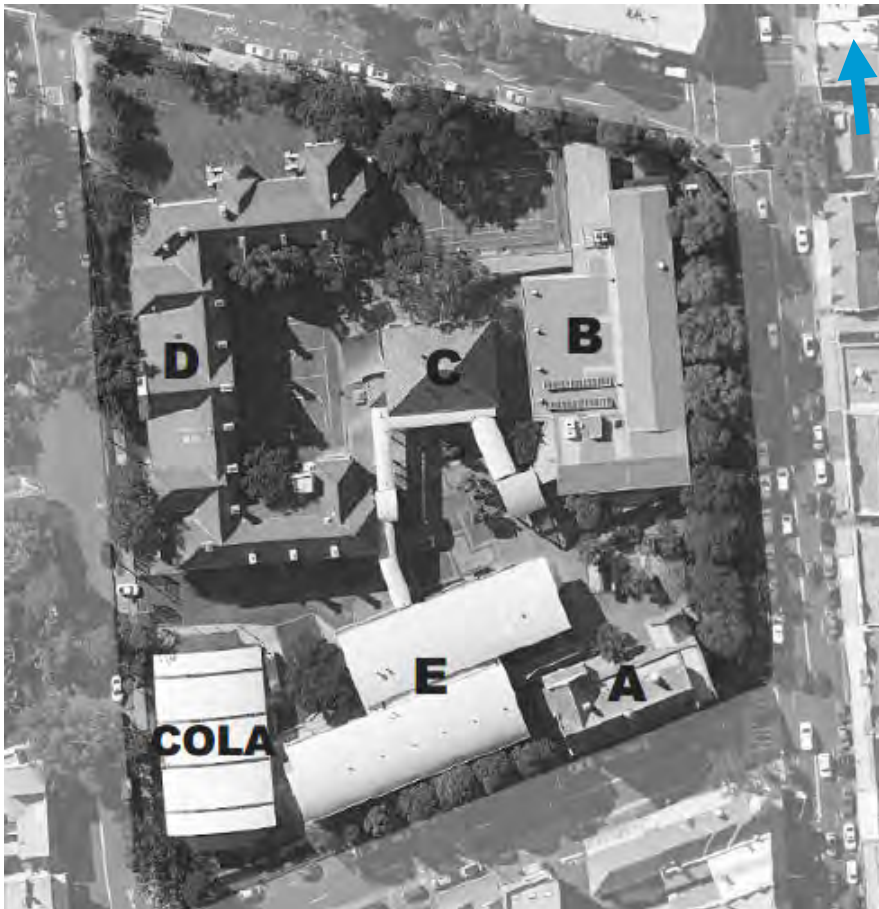
**Figure A:** Existing Building Layout (DJRD architects). Note, the blue arrow denotes north.
