Report on
Geotechnical Investigation

SCH 1 / CCCC
Corner of High Street and Hospital Road, Randwick

Prepared for
Lendlease Building Pty Ltd on behalf of Health
Infrastructure

Project 72505.20
January 2021

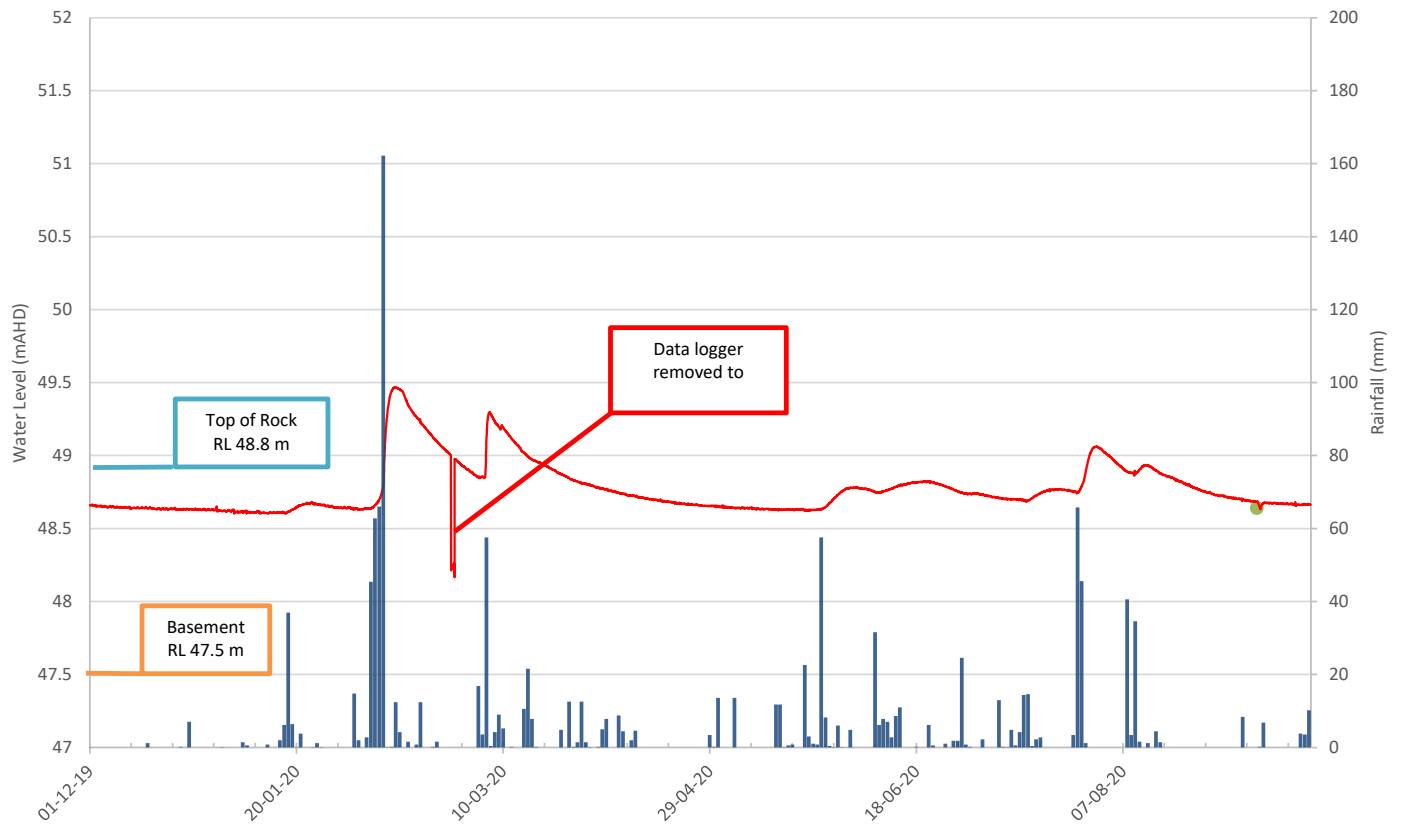
BH13

Note: Reading Interval = 1 hour

The groundwater seepage levels should be expected to fluctuate with variations in climatic conditions. For design, based on groundwater monitoring data to date and DP's experience in the area, the groundwater seepage level may periodically rise by up to 1 m (and possibly more) over the rock surface, following extended periods of rainfall. Groundwater is expected to flow downslope over the rock surface, generally towards the south and west.
