Report on
Remediation Action Plan

Sydney Children's Hospital Stage 1 and Children's
Comprehensive Cancer Centre (SCH 1 / CCCC)
High Street and Hospital Road, Randwick

Project 72505.19
April 2021

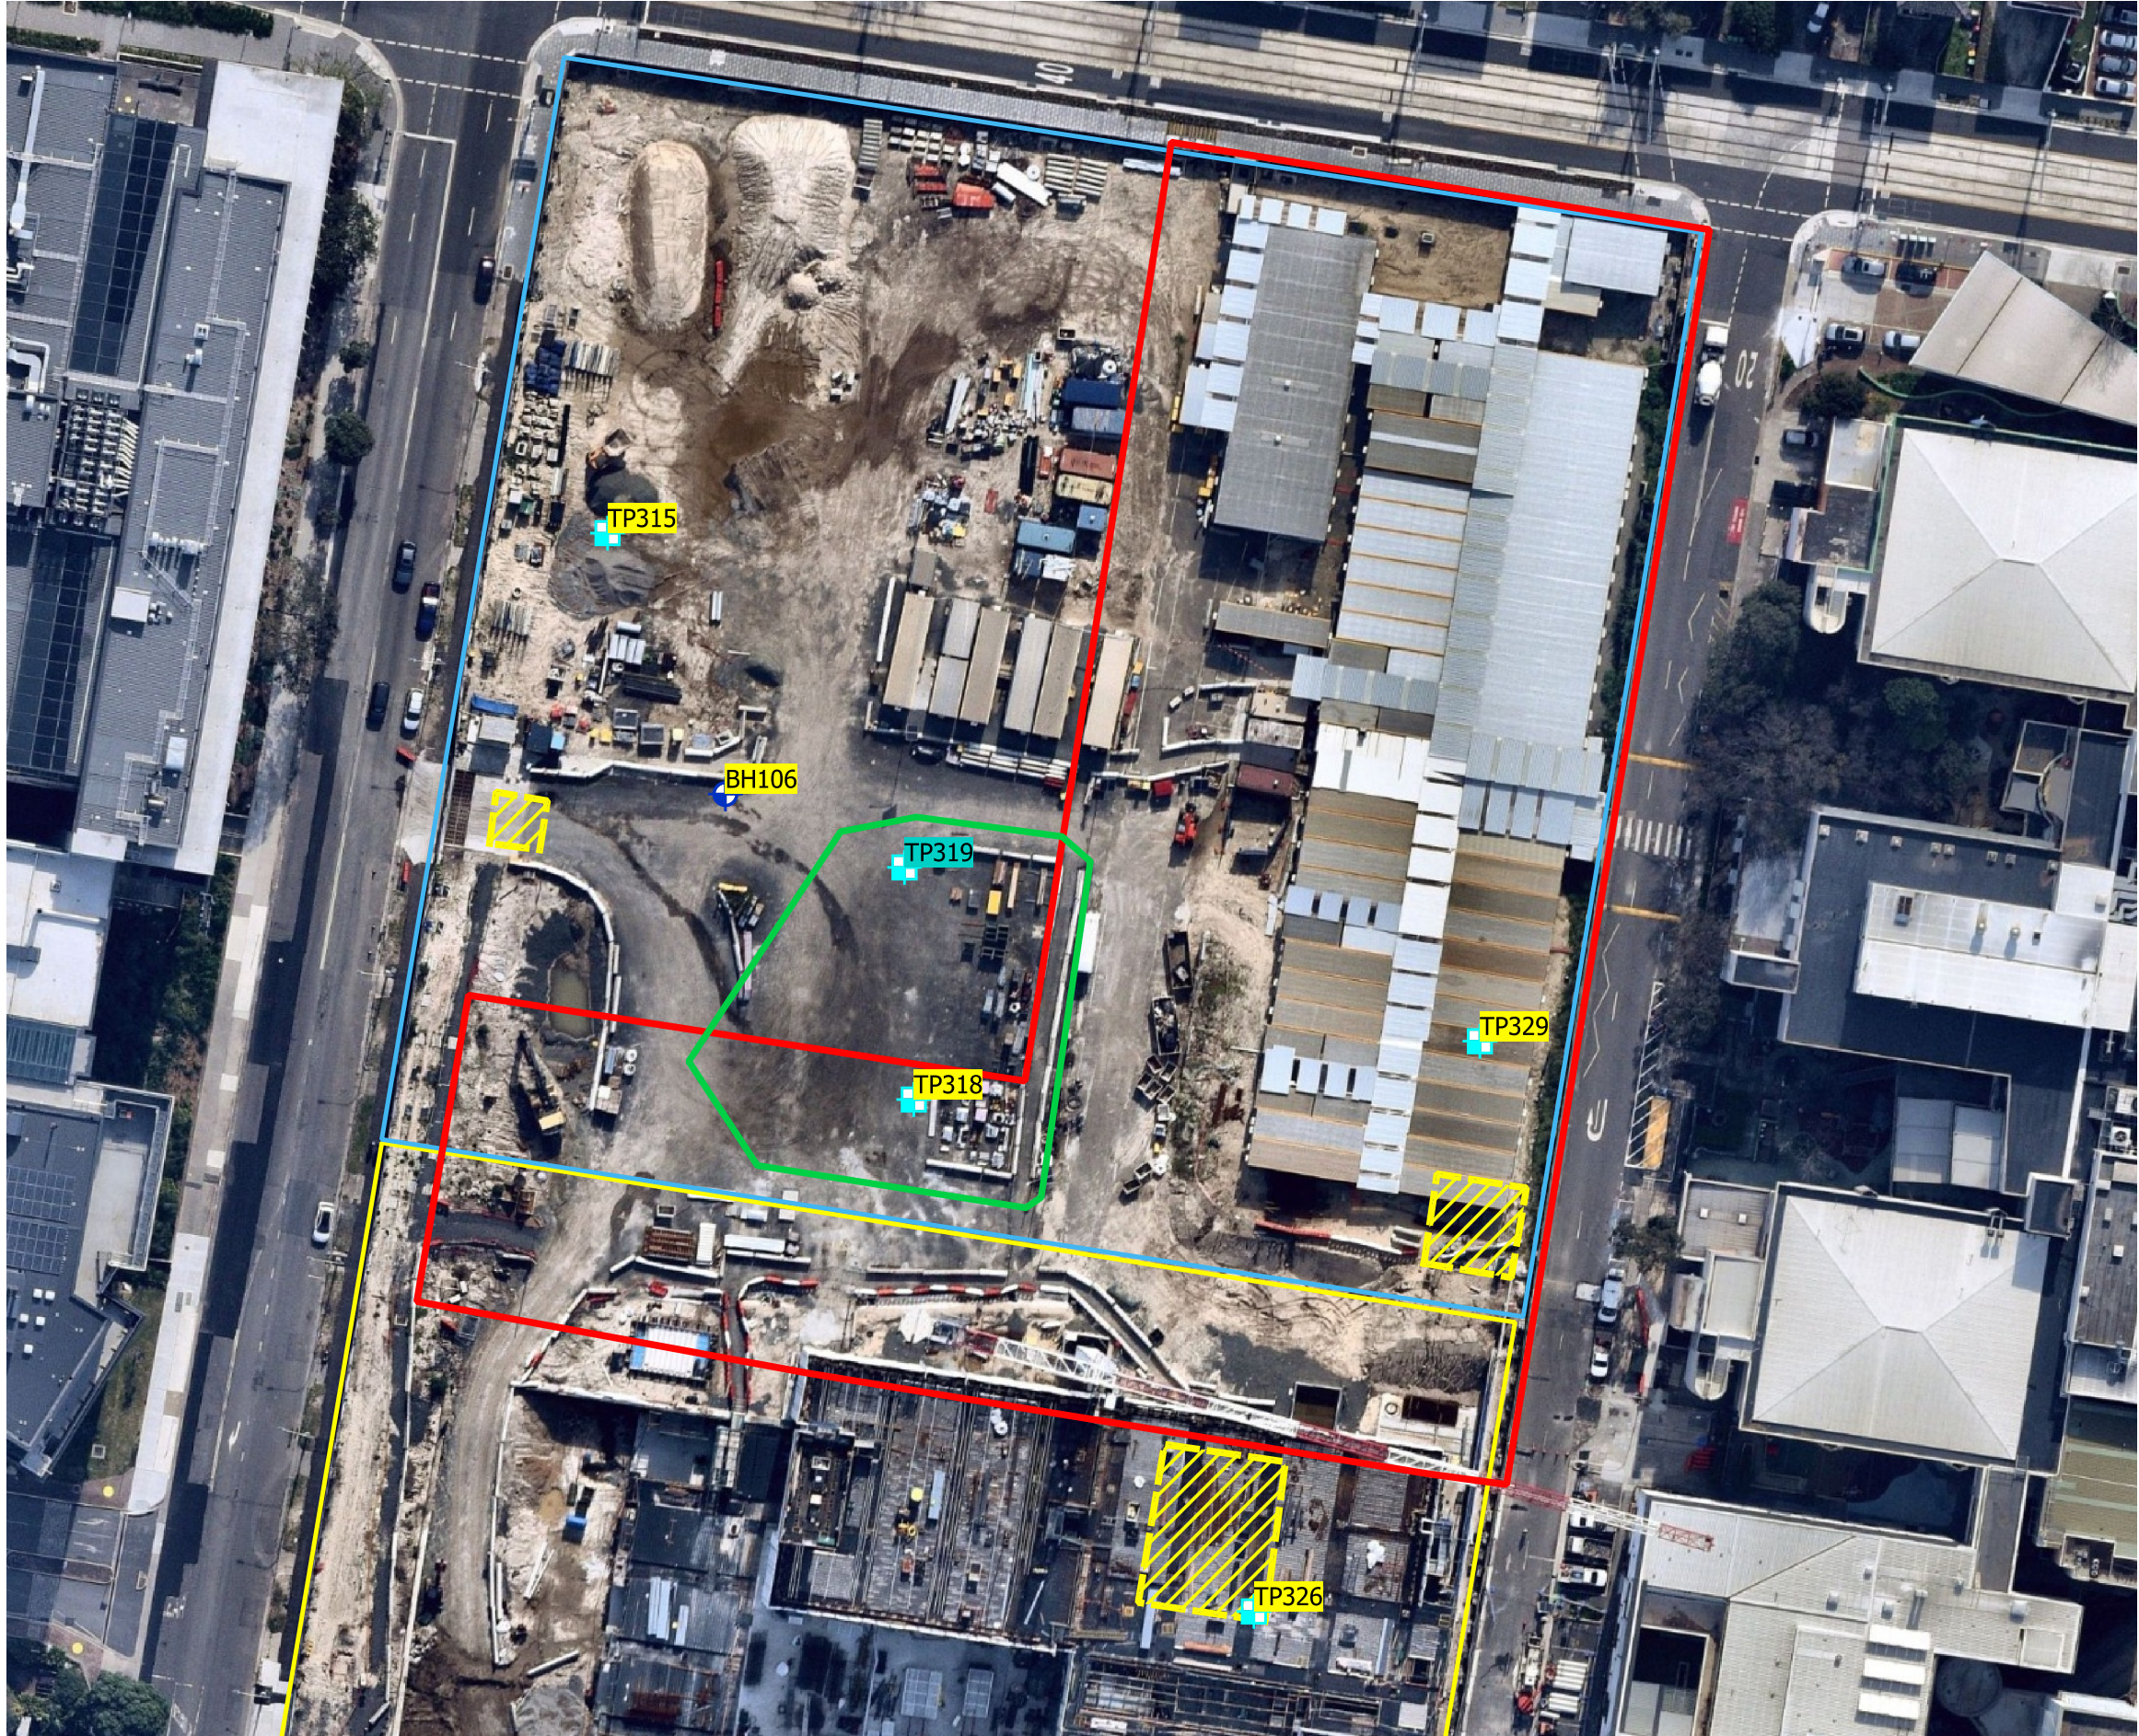
- SCH1/CCCC Boundary (the site)
- Previous Surficial ACM Finds (DP 2019a)
- "Tear drop" area (soils may contain asbestos)
- DP Environmental borehole (PSI, DP 2018)
- DP test pit location (DSI, DP 2019a)
- Post Demolition Test Pit (DSI, DP 2019a)
- ACM observed at test location/during seiving (0 - 0.2 m depth) (DP 2019a)
- ACM observed at test location/during seiving (0.4 - 0.5 m depth) (DP 2019a)

Additional surficial asbestos was noted in-between test locations, as summarised on the attached Drawing 5, Appendix A.

It is also noted that further surficial asbestos was previously identified within parts of Stage 1 and 2 of the RCR area, including the 'tear drop' shaped area. These areas are summarised in Drawing 5, Appendix A.
