**REPORT TO  
NSW DEPARTMENT OF EDUCATION**

**ON  
SALINITY ASSESSMENT AND SALINITY  
MANAGEMENT PLAN**

**FOR  
PROPOSED NEW PRIMARY SCHOOL IN MULGOA  
RISE**

**AT  
1-23 FORESTWOOD DRIVE, GLENMORE PARK,  
NSW**

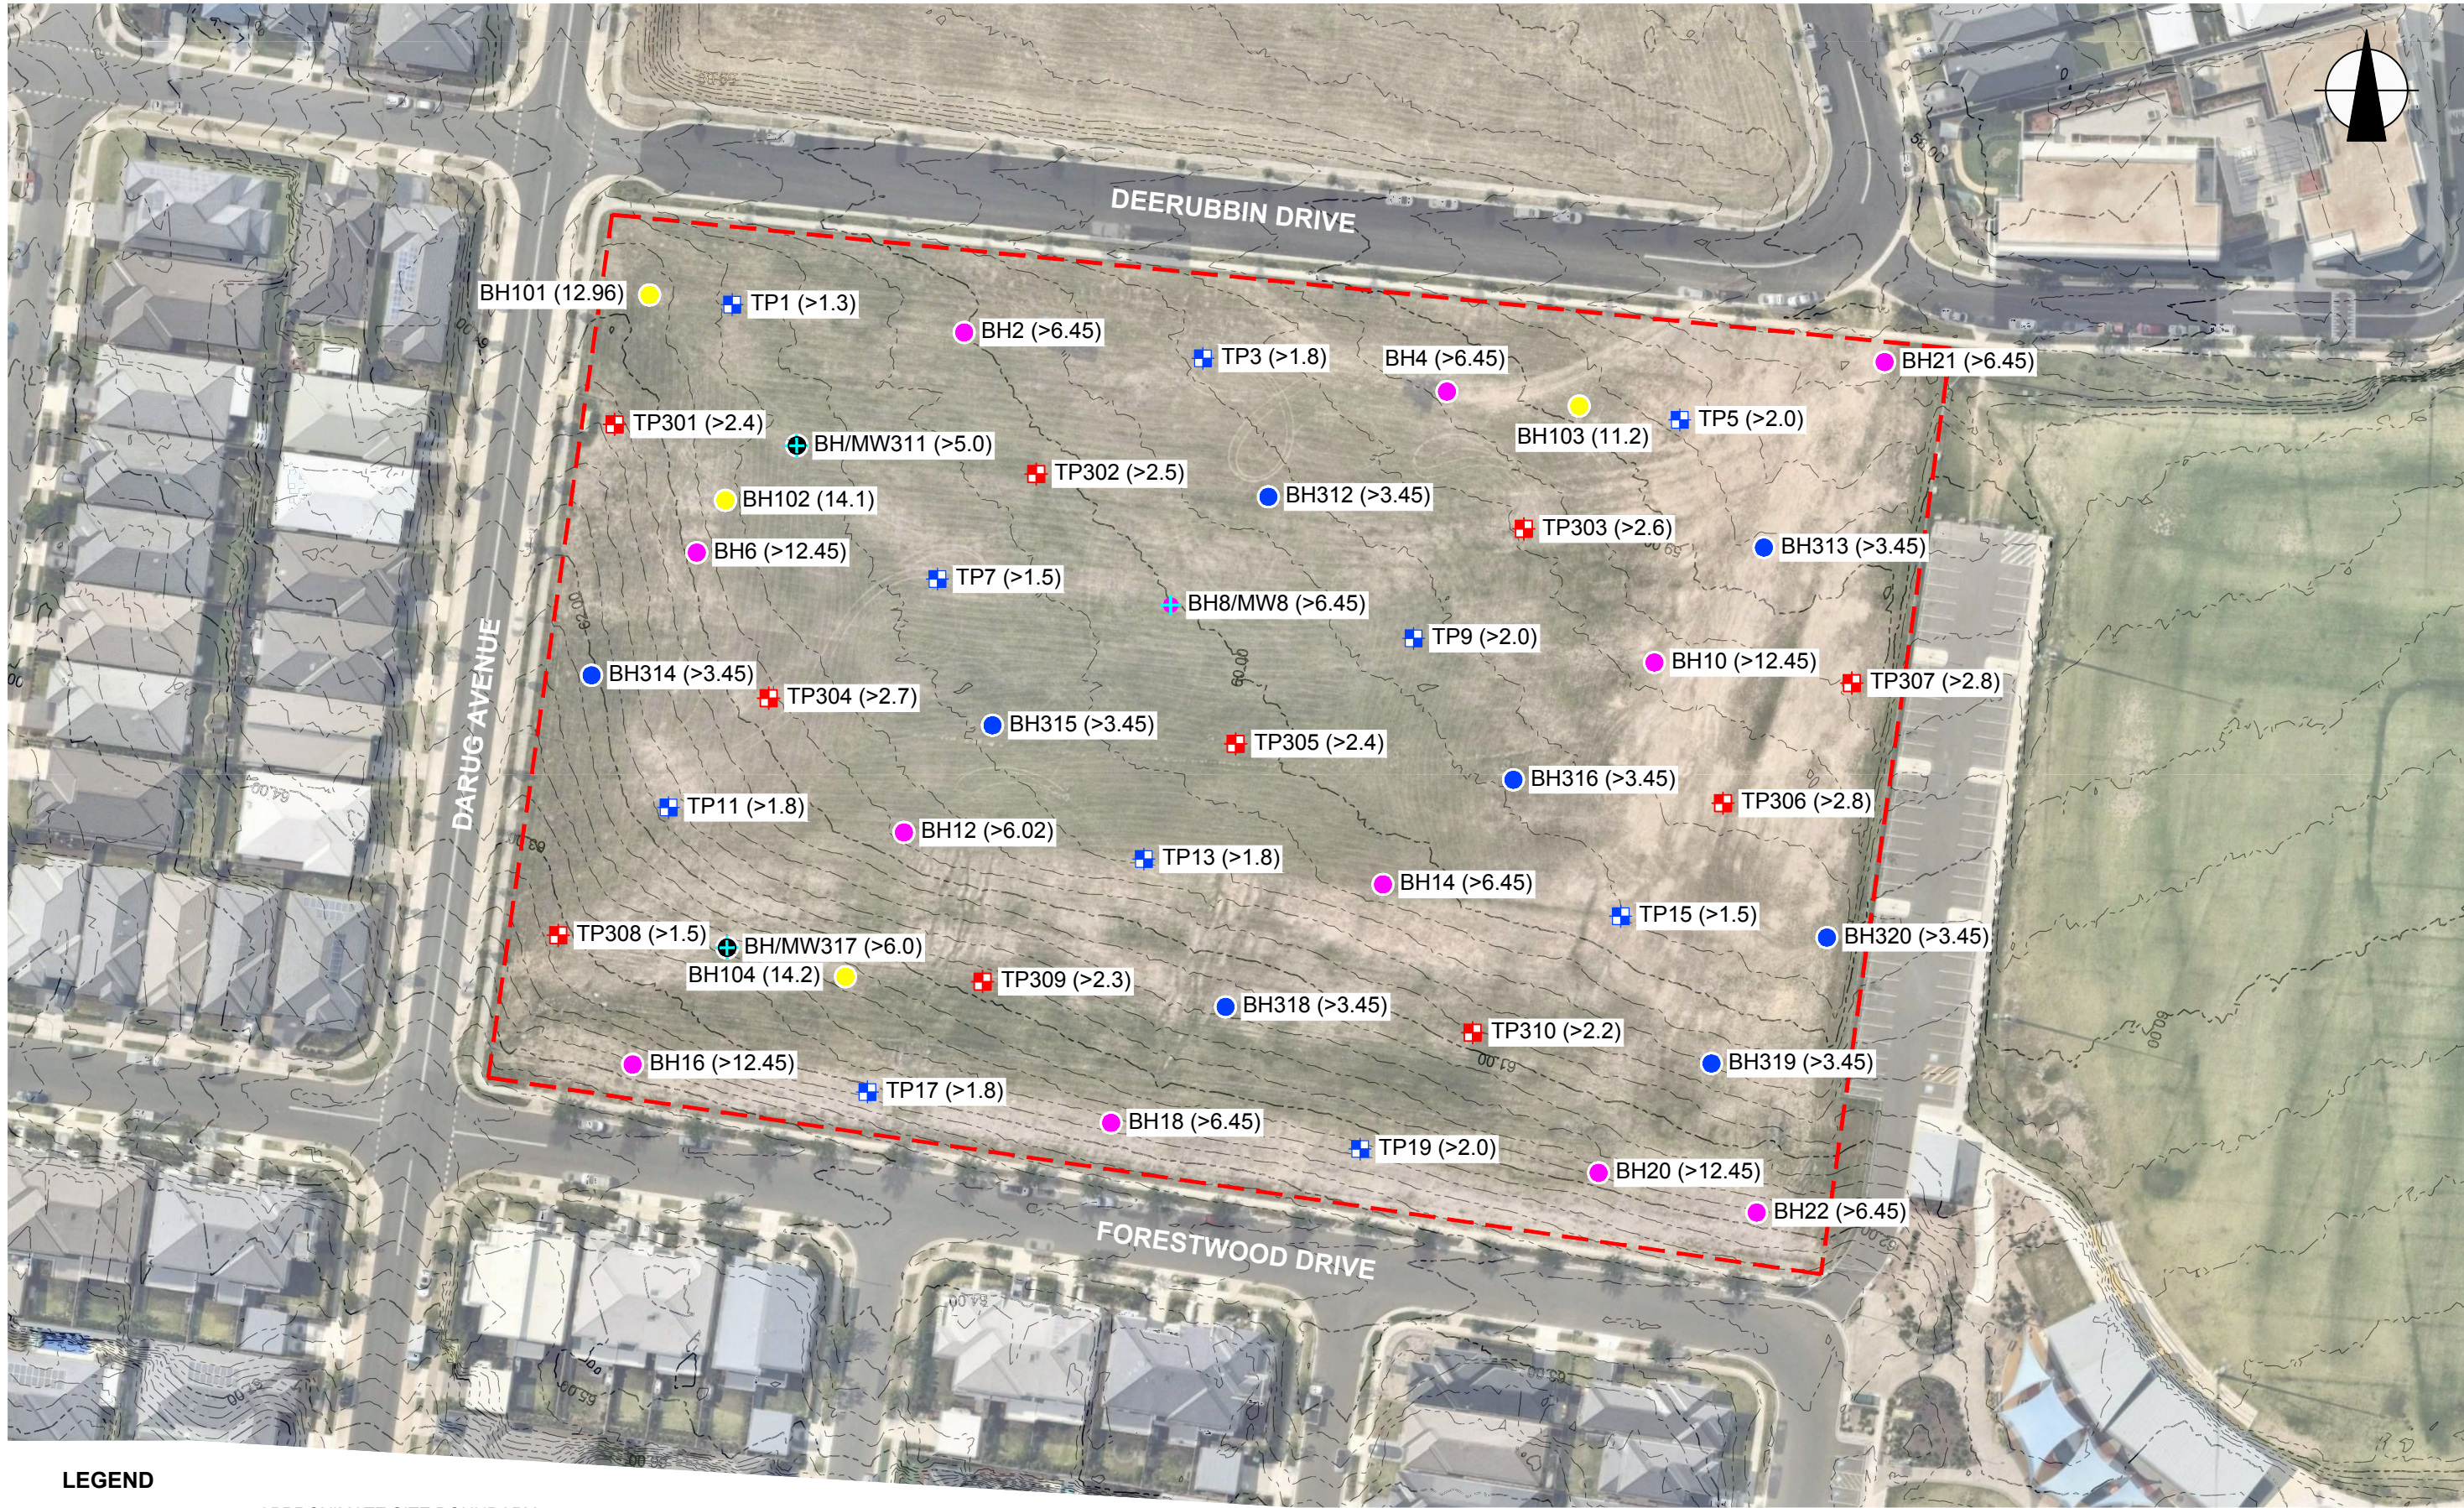
The investigation included soil sampling from eight locations (boreholes BH311, BH312, BH314 to BH317, BH319 and BH320) targeted at the proposed built structures whilst also providing spatial coverage of the site. The sampling locations are shown on Figure 2 attached in Appendix A. This density is equivalent to approximately 2.5 sampling points per hectare (the area of the site is approximately 3 hectares) and meets the requirements for an 'initial site investigation' recommended in the DLWC 2002 document for 'moderately intensive construction'. The density was considered adequate to identify large areas of salinity impacted soils at the site.
