**REPORT TO
NSW DEPARTMENT OF EDUCATION**

**ON
PRELIMINARY SITE INVESTIGATION (PSI) -
CONTAMINATION**

**FOR
PROPOSED MULGOA RISE PUBLIC SCHOOL**

**AT
1-23 FORESTWOOD DRIVE, GLENMORE PARK
NSW**

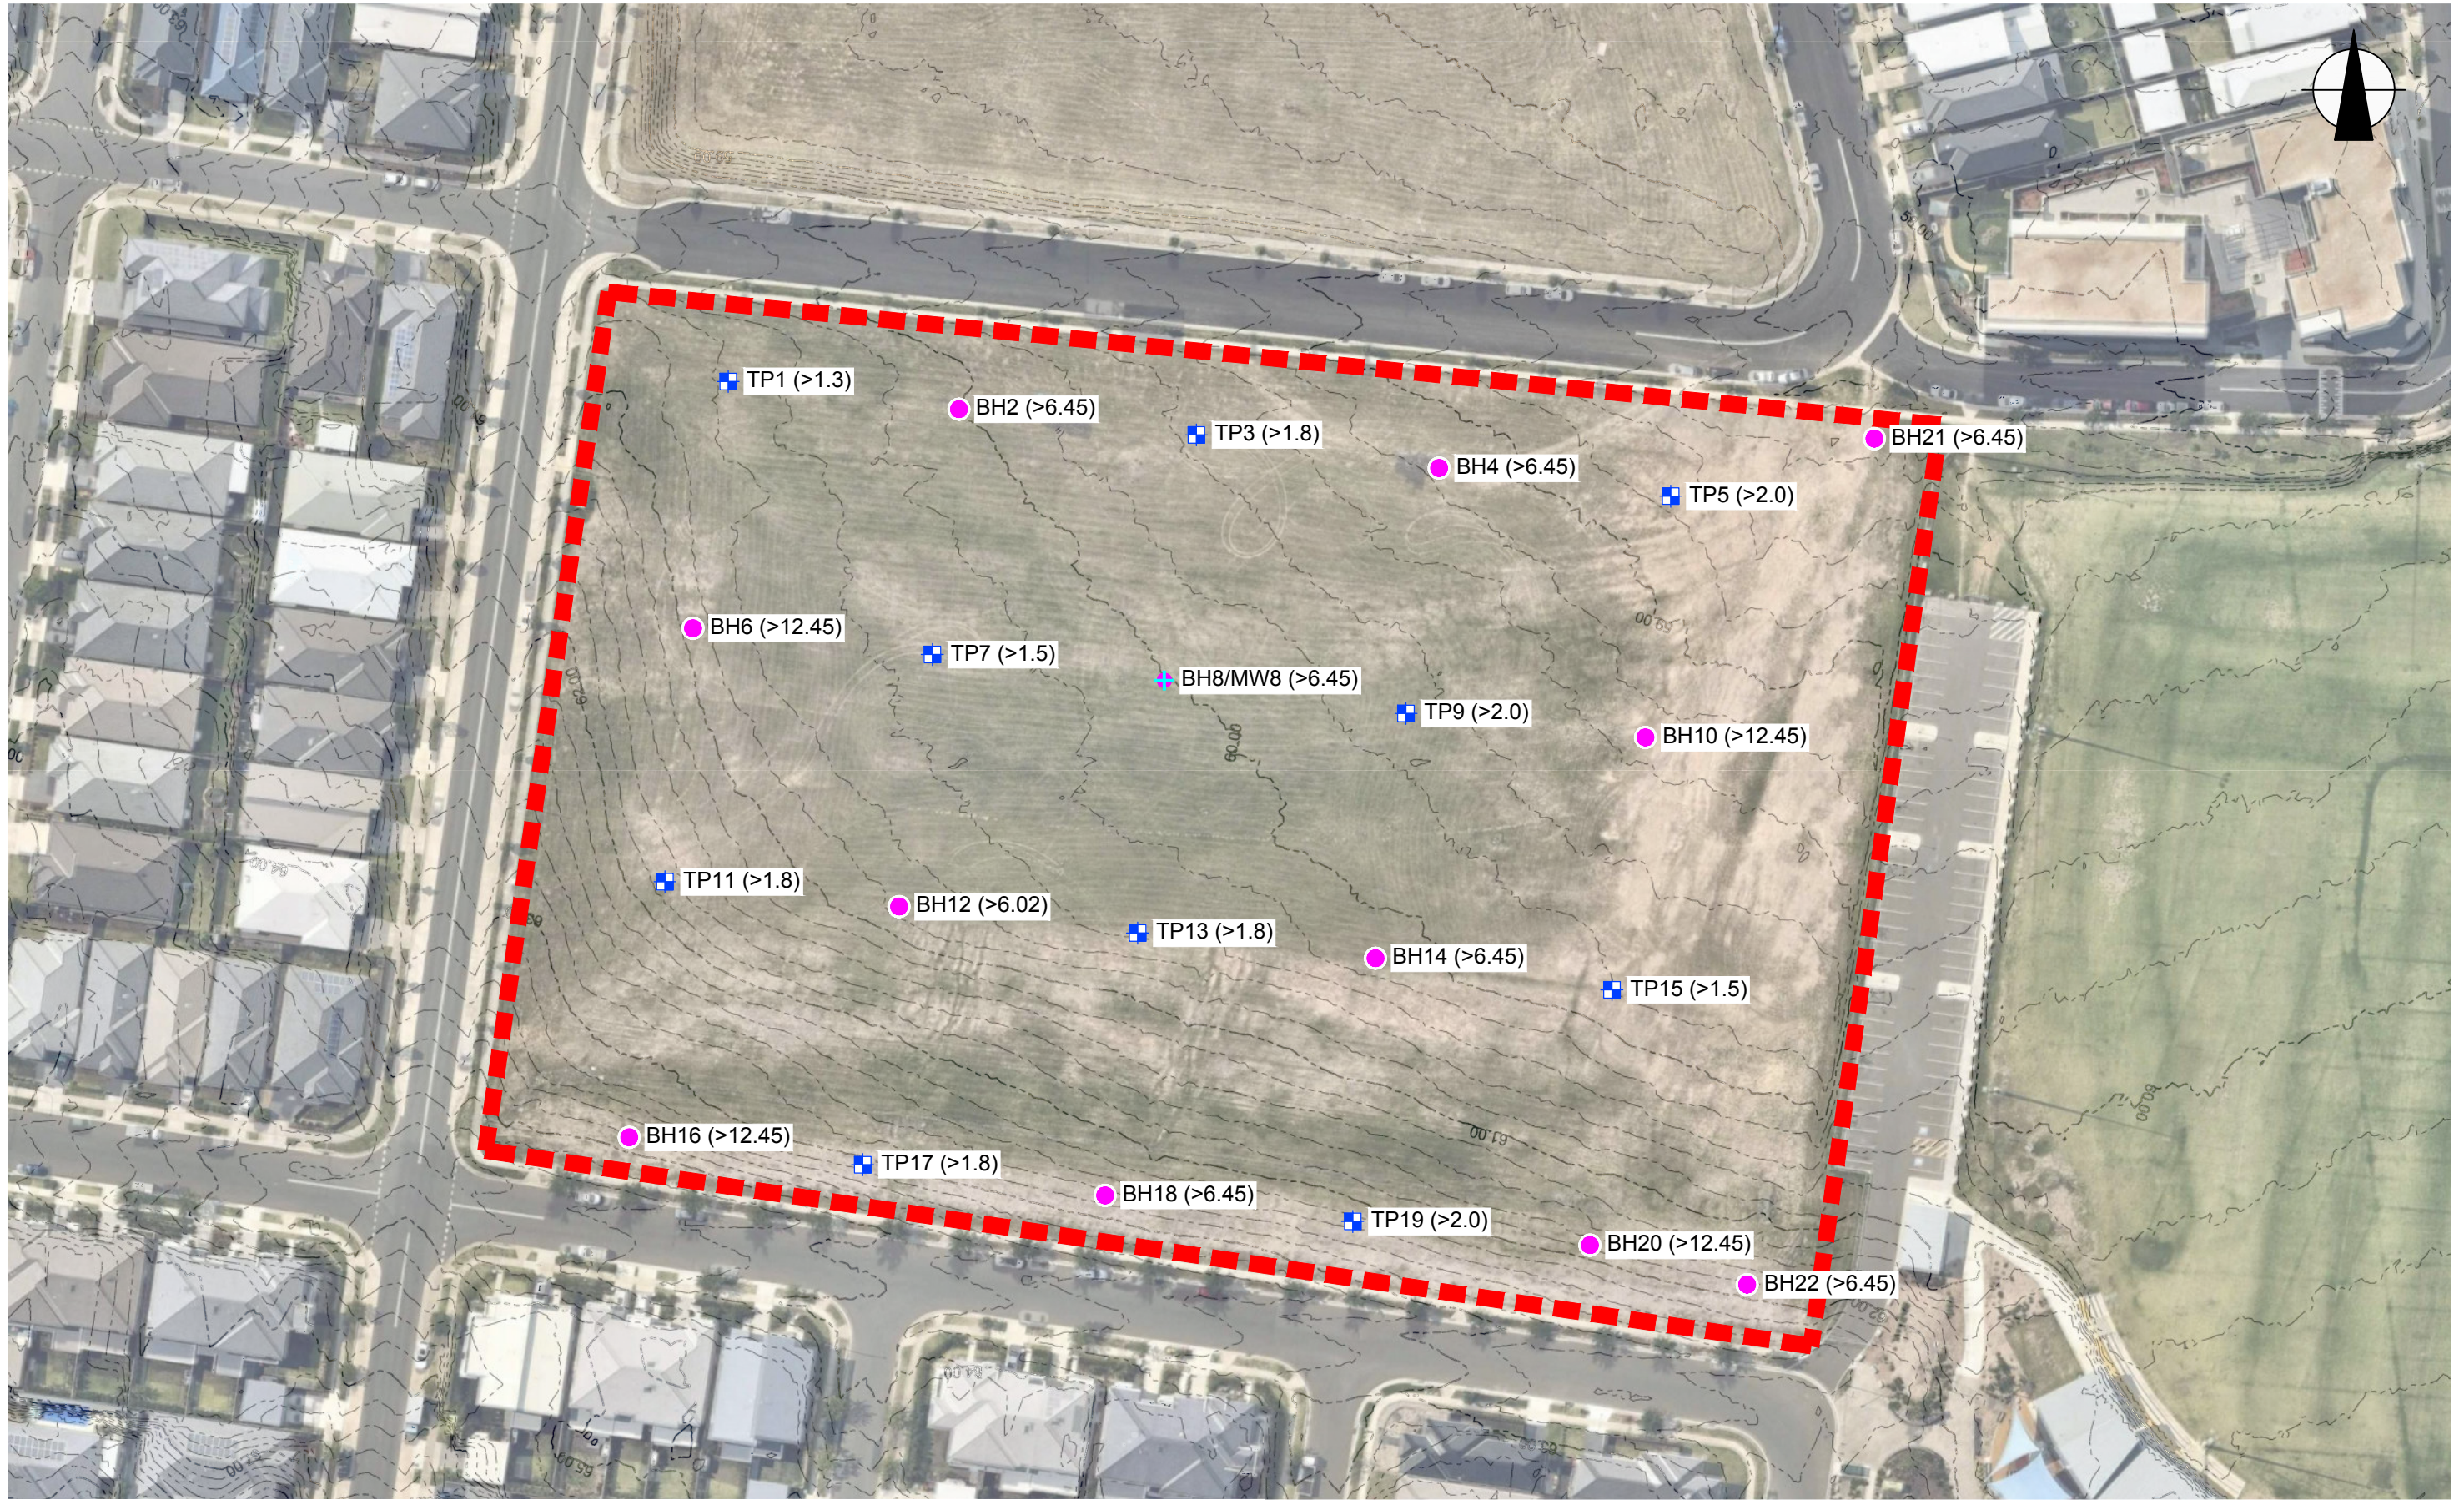
Title: SAMPLE LOCATION PLAN	
Location: 1-23 FORESTWOOD DRIVE, GLENMORE PARK, NSW	
Project No: E33177PA	Figure No: 2
JKEnvironments

- APPROXIMATE SITE BOUNDARY
- BH(Fill Depth) BOREHOLE LOCATION, NUMBER AND DEPTH OF FILL (m)
- ⛶ BH/MW(Fill Depth) BOREHOLE AND GROUNDWATER MONITORING WELL LOCATION, NUMBER AND DEPTH OF FILL (m)
- ⛶ TP TEST PIT LOCATION, NUMBER AND DEPTH OF FILL (m)

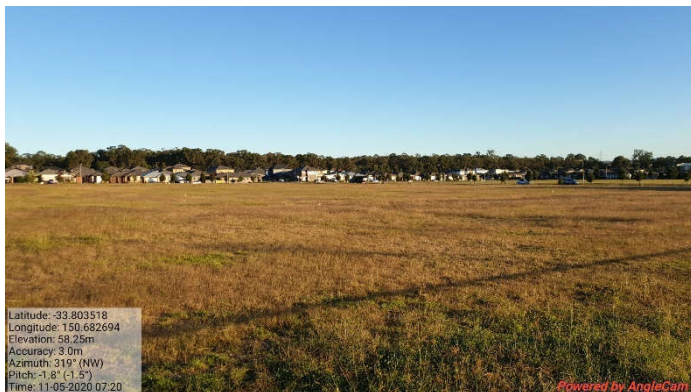
Photograph 1: Looking west/north-west at the site area.

The site was overgrown with grasses and weeds with larger tree plantings along the footpaths next to the northern, western and southern site boundaries. No obvious signs of vegetation stress or grass dieback were observed anywhere on site.

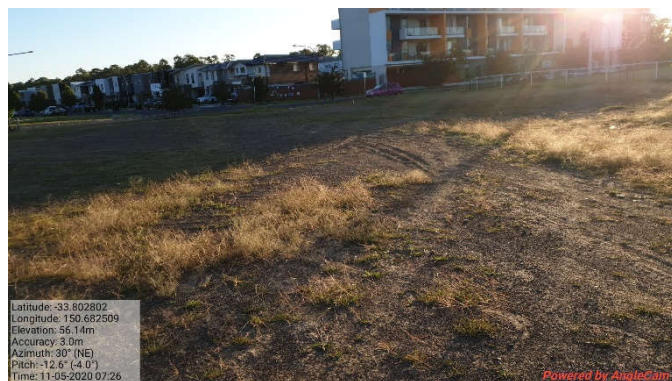
Photographs 3: Looking at the north-eastern corner of the site area.

A stormwater drain appeared to run along the eastern site boundary, with stormwater collection pit situated in the north-eastern corner of the site. A sewer main was also noted to be present in the north-eastern corner of the site.

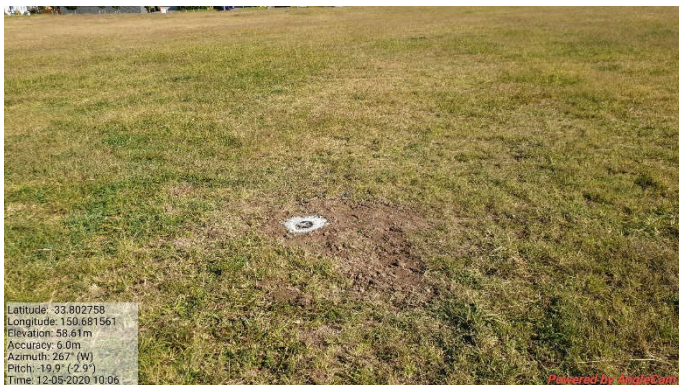
Photograph 5: Groundwater monitoring well (BH8/MW8) installed at the site.

Aspect	Input
Sampling Plan	<p>Groundwater monitoring well was installed in BH8 (MW8). The well was positioned to gain a snapshot of the groundwater conditions. Considering the topography and the location of the nearest down-gradient water body, MW8 was considered to be in the intermediate area of the site and would be expected to provide an indication of groundwater flowing across (beneath) the site.</p>
Monitoring Well Installation Procedure	<p>The monitoring well construction details are documented on the appropriate borehole log attached in the appendices. The monitoring well was installed down to approximately 6mBGL. The well was generally constructed as follows:</p> <ul style="list-style-type: none"> 50mm diameter Class 18 PVC (machine slotted screen) was installed in the lower section of the well to intersect groundwater; 50mm diameter Class 18 PVC casing was installed in the upper section of the well (screw fixed); A 2mm sand filter pack was used around the screen section for groundwater infiltration; A hydrated bentonite seal/plug was used on top of the sand pack to seal the well; and A gatic cover was installed at the surface with a concrete plug to limit the inflow of surface water. <p>The well construction was considered to be appropriate for screening purposes to assess general aquifer conditions with regards to the recommended monitoring well installation requirements in Schedule B2 of NEPM 2013.</p>

Monitoring Well Development	<p>The monitoring well was developed on 11 May 2020 using a submersible electrical pump in accordance with the SSP. The monitoring well was developed until steady state conditions were achieved. The field monitoring records and calibration data are attached in the appendices.</p>
Groundwater Sampling	<p>The monitoring well was allowed to recharge for seven days after development. Groundwater samples were obtained on 18 May 2020.</p>

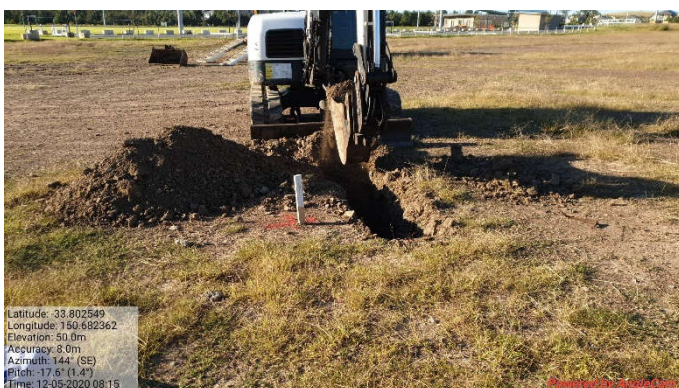
Photograph 6: Test pit excavation.

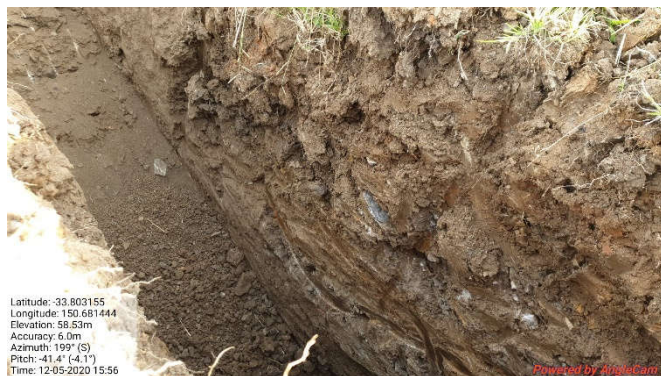
Photographs 7: Fill material profile observed within test pits.

Filling was not obvious during the inspection. However, it is noted that substantial filling was identified in all boreholes drilled across the site.

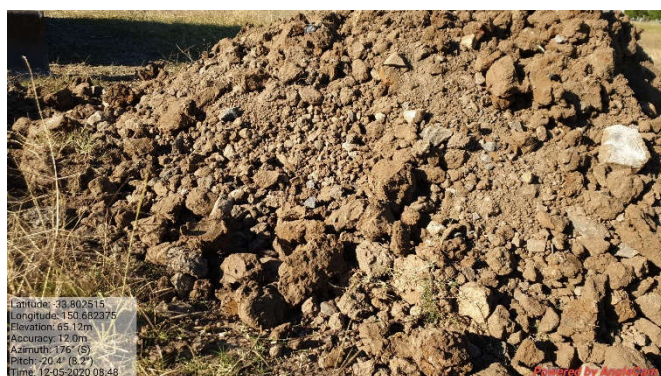
Photograph 8: Example of extracted fill material from test pits.

Although the analytical schedule for the PSI was limited and analysis was generally targeted at the surficial soils, the fill appeared to be sourced from natural material and there were negligible anthropogenic inclusions. Our boreholes and test pits identified no visual or olfactory indicators of contamination (i.e. asbestos material, staining, odours etc). On this basis, and considering the apparent controlled nature of the historical backfilling of the quarry, in our opinion it is unlikely that significant, widespread contamination impacts would occur in the fill. Additional sampling and analysis are required to support this opinion.

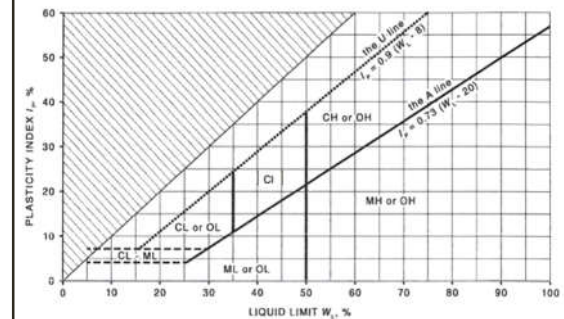
Modified Casagrande Chart for Classifying Silts and Clays according to their Behaviour
