Report on
Geotechnical Investigation

Proposed New Public School
Fairley Street, Murrumbateman

Prepared for
Hansen Yuncken Pty Ltd

Project 203624.00
May 2021

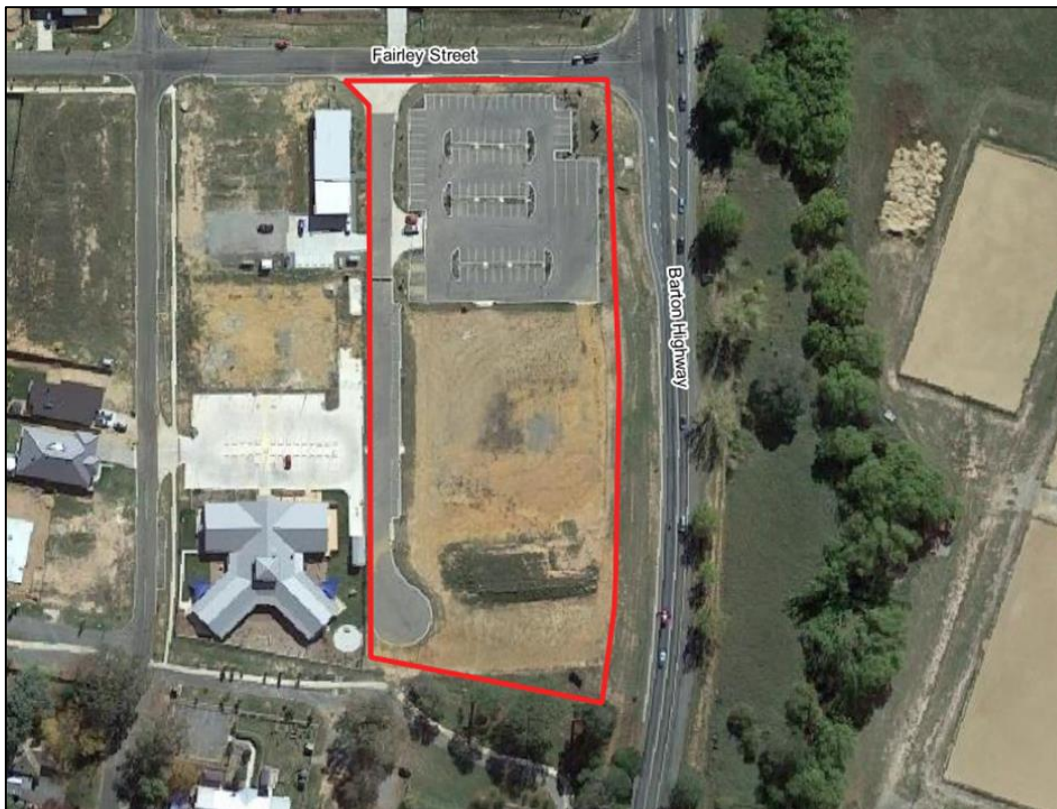
Figure 1: Site Location

The site is in a RU5 (village) zoning and is bounded by a hotel to the north, Barton highway to the east, a childcare centre to the west and an early childhood service centre to the south. At the time of investigation, the site had a moderately grassed stockpile about 2 - 4 m high, 40 m wide and 20 m deep to the south. The site is relatively flat, gently sloping from northwest to southeast with surface levels ranging approximately 566 m to 569 m Australian Height Datum (AHD). An approximate 1 m high fill batter was observed running along the eastern boundary.

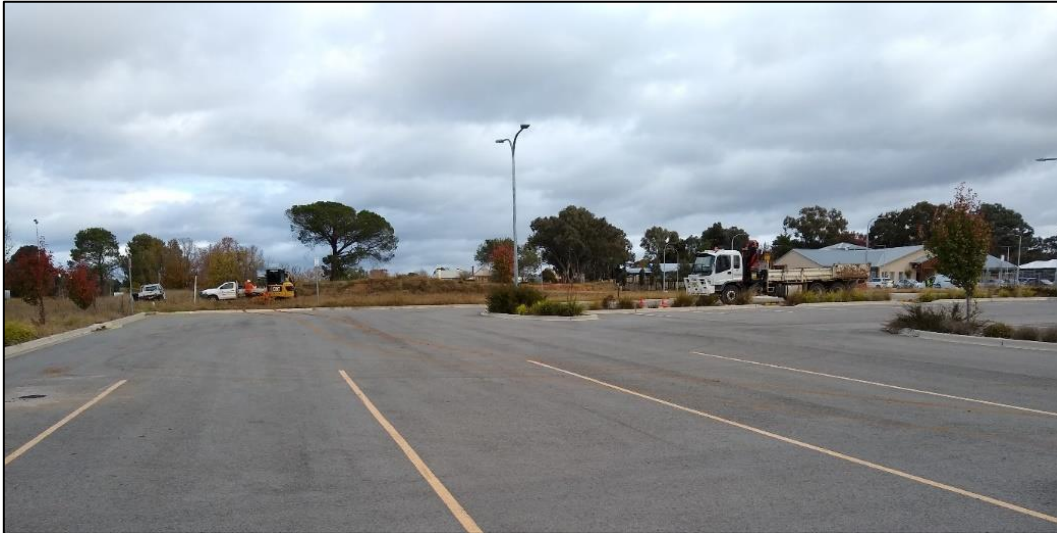
Figure 2: General conditions of the existing carpark, looking south/southwest.

The site contains an existing parking lot in its northern end and a driveway along its western boundary. There is also a mound of soil at the southern end of the site. The site is otherwise cleared and vacant.

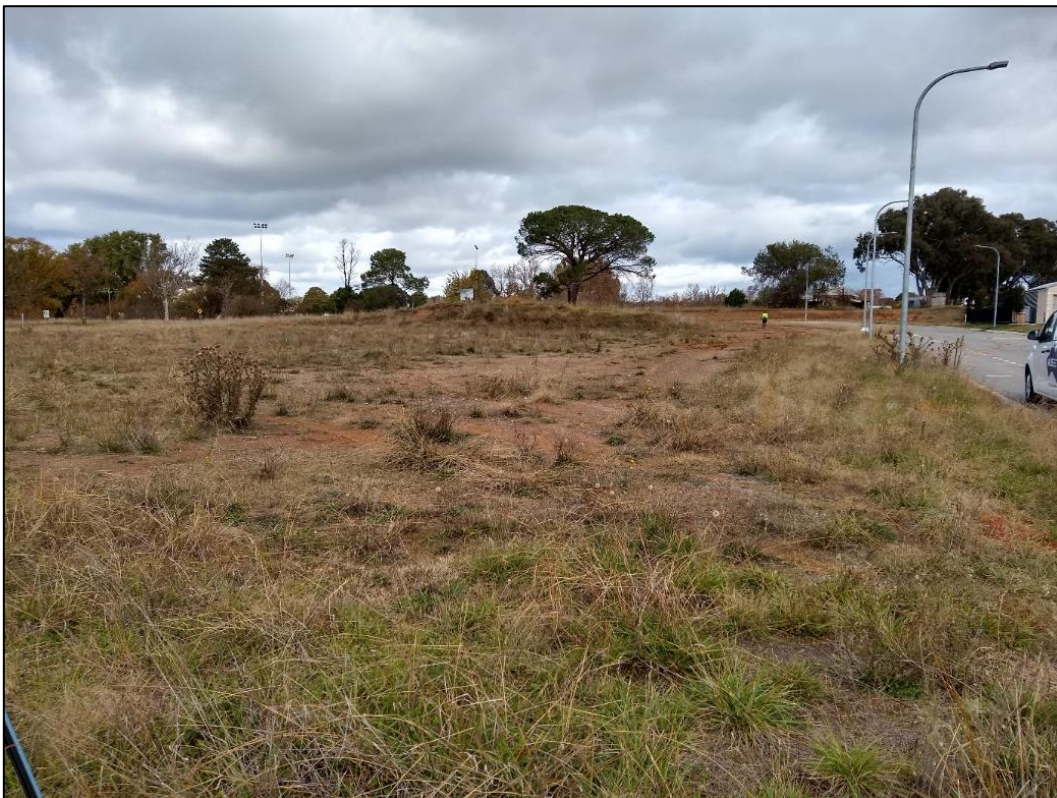
Figure 3: General conditions of the site, looking south/southeast.

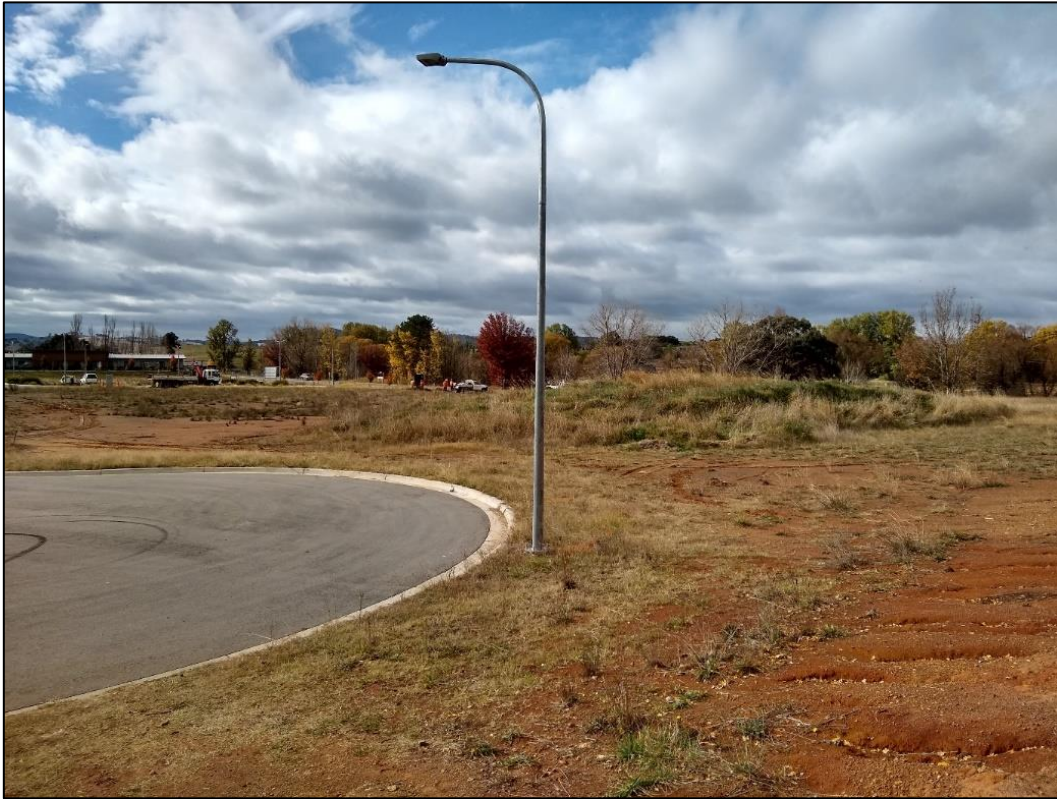
Figure 4: General conditions of the site, looking northeast.

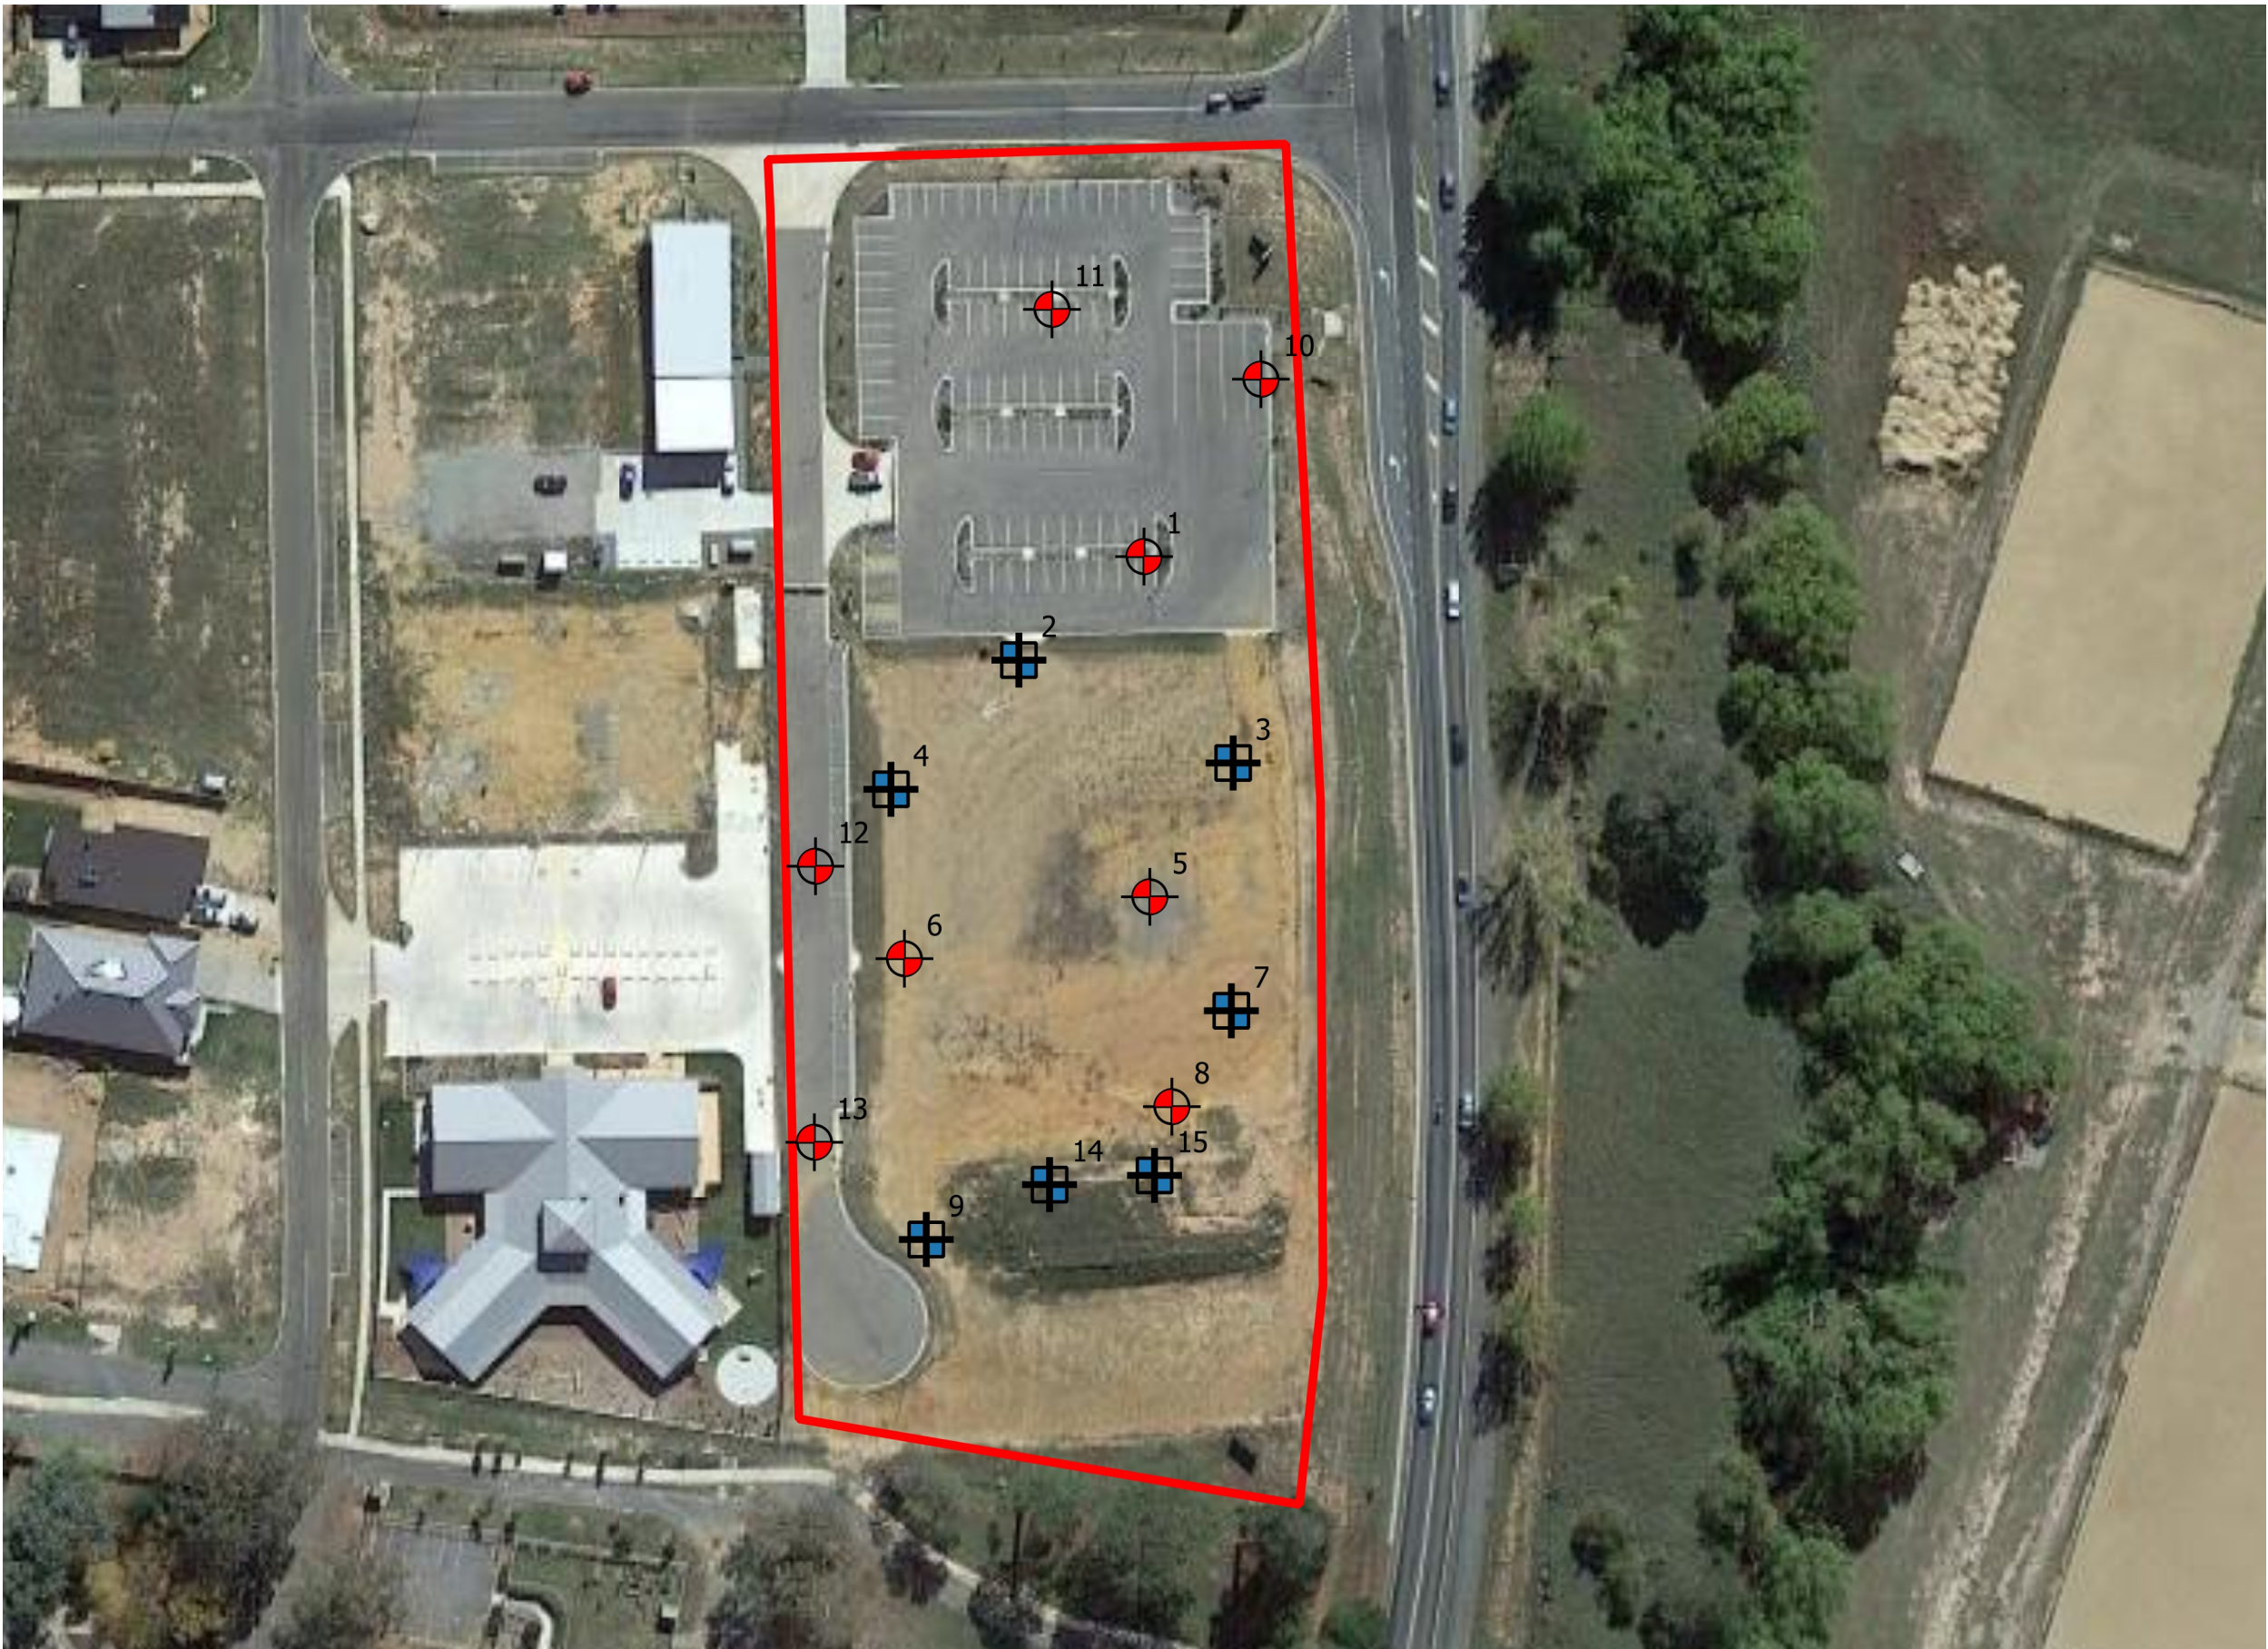
Drawing 1 – Test Location Plan

The investigation included the drilling of 8 boreholes and excavation of 7 test pits and laboratory testing of selected samples. The details of the field work and laboratory testing are presented in this report, together with comments and recommendations on the items listed above.

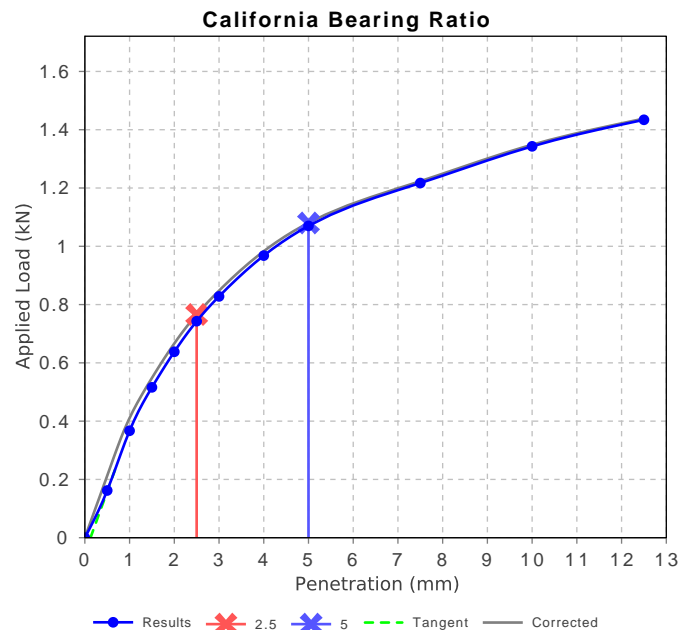
Material Test Report

California Bearing Ratio (AS 1289 6.1.1 & 2.1.1)		Min	Max
CBR taken at	2.5 mm		
CBR %	6.0		
Method of Compactive Effort	Standard		
Method used to Determine MDD	AS 1289 5.1.1 & 2.1.1		
Method used to Determine Plasticity	Visual Assessment		
Maximum Dry Density (t/m ³)	1.81		
Optimum Moisture Content (%)	15.5		
Laboratory Density Ratio (%)	100.0		
Laboratory Moisture Ratio (%)	98.5		
Dry Density after Soaking (t/m ³)	1.80		
Field Moisture Content (%)	12.5		
Moisture Content at Placement (%)	15.4		
Moisture Content Top 30mm (%)	17.3		
Moisture Content Rest of Sample (%)	17.0		
Mass Surcharge (kg)	4.5		
Soaking Period (days)	4		
Curing Hours	71.2		
Swell (%)	0.5		
Oversize Material (mm)	19		
Oversize Material Included	Excluded		
Oversize Material (%)	0		
Moisture Content (AS 1289 2.1.1)			
Moisture Content (%)		12.5

Report Number: 203624.00-1
Issue Number: 2 - This version supersedes all previous issues
Reissue Reason: CBR Results Added.
Date Issued: 20/05/2021
Client: Hansen Yuncken Pty Ltd
 Building 1, Alexandria NSW 2015
Contact: Paul Todhunter
Project Number: 203624.00
Project Name: Proposed New Public School
Project Location: Fairley Street, Murrumbateman NSW
Work Request: 5907
Sample Number: GU-5907B
Date Sampled: 07/05/2021
Dates Tested: 11/05/2021 - 18/05/2021
Sampling Method: Sampled by Engineering Department
 The results apply to the sample as received
Sample Location: Pit 9 , Depth: 0.5-0.7
Material: Clay

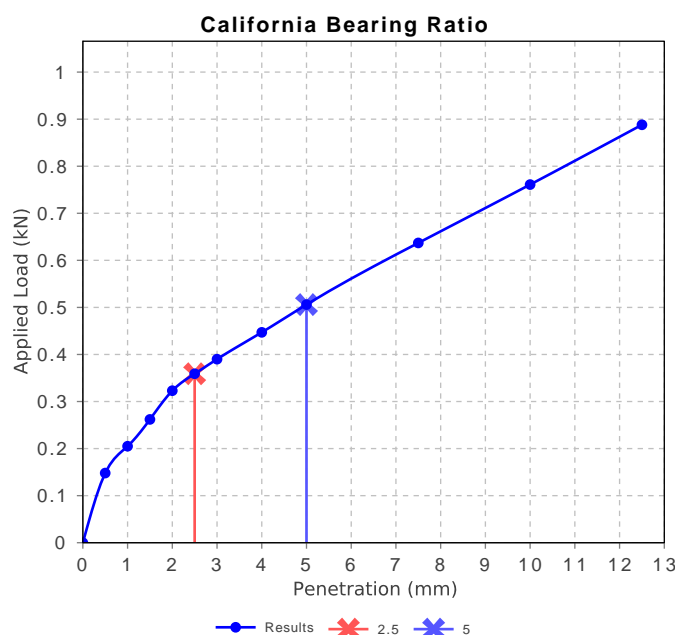
Material Test Report

California Bearing Ratio (AS 1289 6.1.1 & 2.1.1)		Min	Max
CBR taken at	2.5 mm		
CBR %	2.5		
Method of Compactive Effort	Standard		
Method used to Determine MDD	AS 1289 5.1.1 & 2.1.1		
Method used to Determine Plasticity	Visual Assessment		
Maximum Dry Density (t/m ³)	1.54		
Optimum Moisture Content (%)	23.5		
Laboratory Density Ratio (%)	100.0		
Laboratory Moisture Ratio (%)	99.5		
Dry Density after Soaking (t/m ³)	1.50		
Field Moisture Content (%)	20.8		
Moisture Content at Placement (%)	23.6		
Moisture Content Top 30mm (%)	30.9		
Moisture Content Rest of Sample (%)	27.1		
Mass Surcharge (kg)	4.5		
Soaking Period (days)	4		
Curing Hours	70.5		
Swell (%)	2.5		
Oversize Material (mm)	19		
Oversize Material Included	Excluded		
Oversize Material (%)	0		
Moisture Content (AS 1289 2.1.1)			
Moisture Content (%)		20.8

Report Number: 203624.00-1
Issue Number: 2 - This version supersedes all previous issues
Reissue Reason: CBR Results Added.
Date Issued: 20/05/2021
Client: Hansen Yuncken Pty Ltd
Building 1, Alexandria NSW 2015
Contact: Paul Todhunter
Project Number: 203624.00
Project Name: Proposed New Public School
Project Location: Fairley Street, Murrumbateman NSW
Work Request: 5907
Sample Number: GU-5907C
Date Sampled: 07/05/2021
Dates Tested: 11/05/2021 - 17/05/2021
Sampling Method: Sampled by Engineering Department
The results apply to the sample as received
Sample Location: Pit 9 , Depth: 0.5
Material: Clay
