**ARBORICULTURAL IMPACT ASSESSMENT - DEVELOPMENT OF
NEW PRIMARY SCHOOL MURRUMBATEMAN NSW - 2021.**

This Arboricultural Impact Assessment accompanies an Environmental Impact Statement (EIS) pursuant to Part 4 of the Environmental Planning and Assessment Act 1979 (EP&A Act) in support of an application for a State Significant Development (SSD-11233241). The development is for a new primary school located at 2 Fairley Street, Murrumbateman. This report addresses the relevant Secretary's Environmental Assessment Requirements (SEARs), namely:

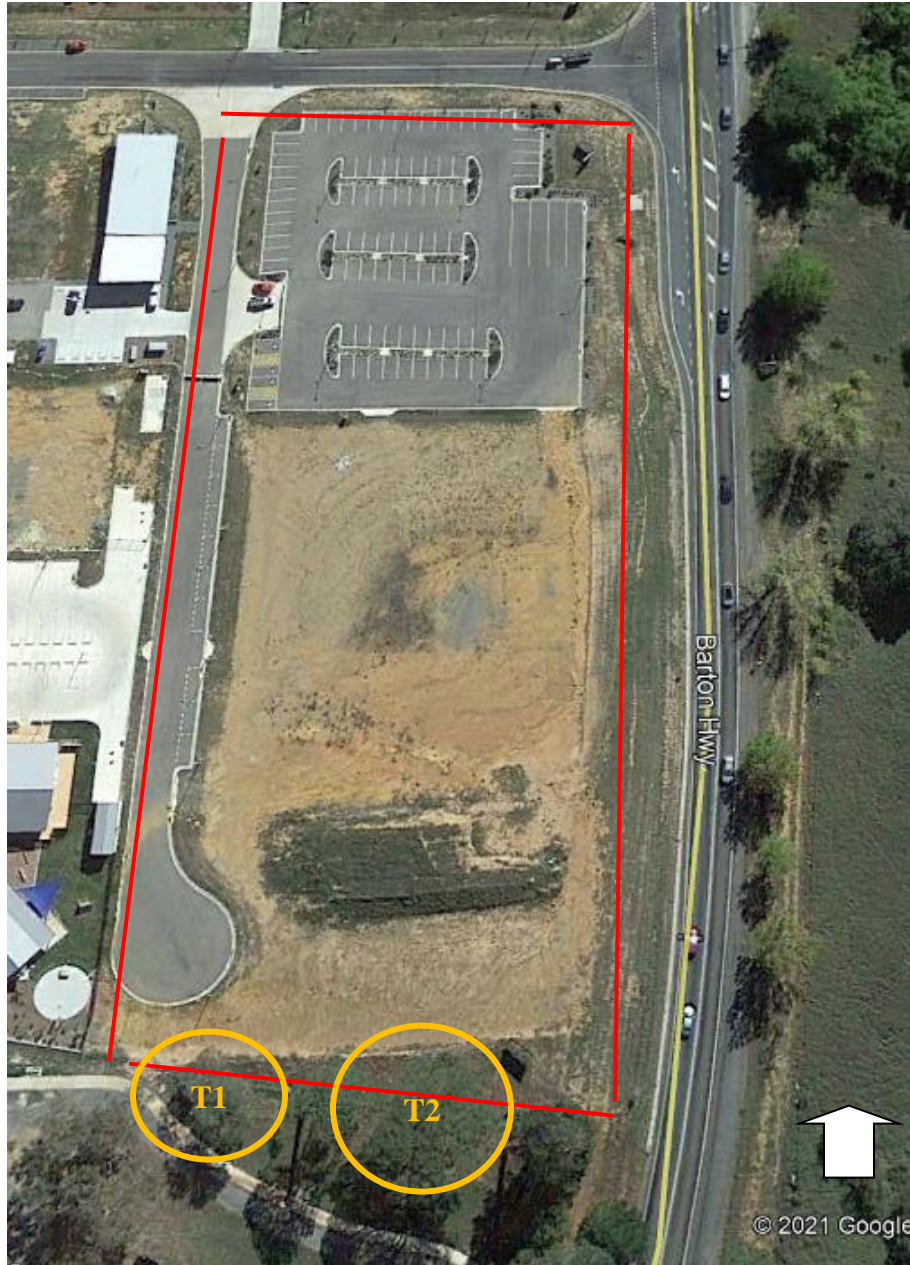
Diagram 2 – Location of site with approximate boundary indicated by red lines. Two trees are identified on the Old Murrumbateman School Site that may be impacted by the development. Note – Image date is April 2019 and only two trees remain current. Source – Google Earth 2021.

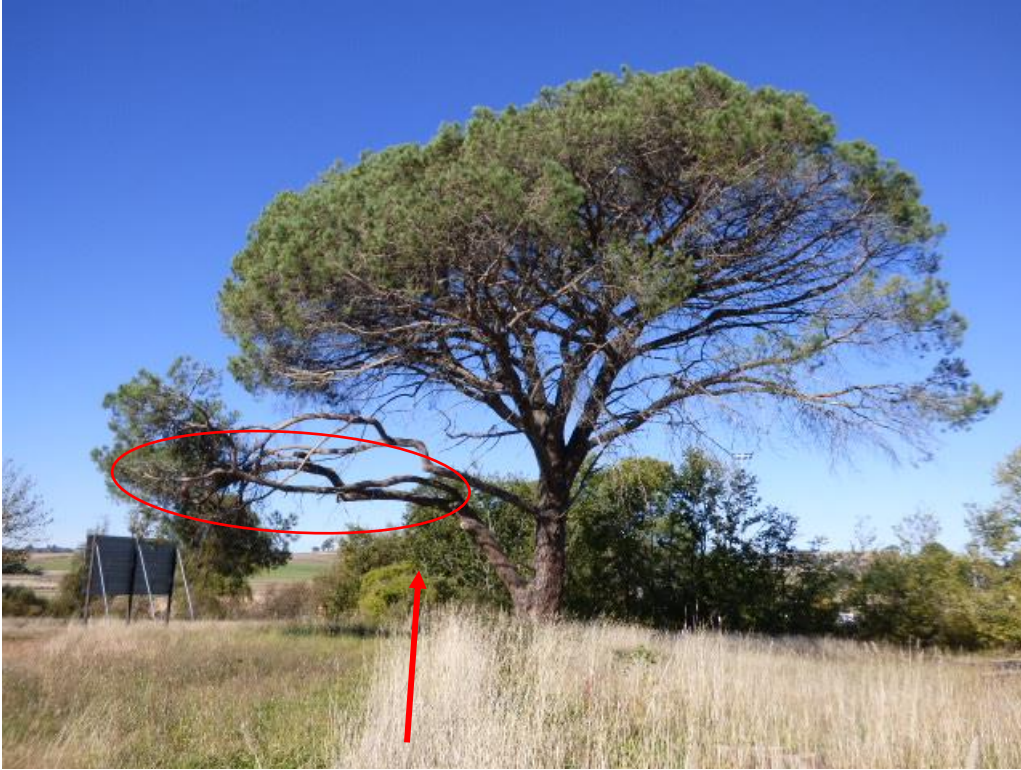
Photo 2 – Tree two in location.

Large Imposing tree with extended canopy over development site. Red line indicates approximate location of boundary. The TPZ reduction to 10 m on the development side may require the large limb of the tree to be removed. If machinery will impact the tree then it must be pruned first.

<ol style="list-style-type: none">7. Post hole boring within the TPZ for the boundary fence is an acceptable impact as per general recommendation F below.8. Landscape design could consider amelioration of the TPZ impacts if feasible.
--	--

- F. Boring of post holes in the order of 150 to 200 mm diameter for the erection of the boundary fence posts are identified as an acceptable impact within the TPZ, but not excavation of soil for the laying of strip footings.
- G. I do not see the requirement of a formal tree protection plan, but I would suggest it is in the interests of the construction organisation to have the trees inspected at site establishment, mid construction and completion to verify the condition of the trees; particularly if Yass Valley Council indicate heritage values attached to the trees.
- H. The landscaping plan for the project needs to consider the TPZ of the two trees and look to maximise the opportunity for root retention and future root development – which will be important for the longevity of the trees.
