Report on Geotechnical Investigation

Proposed Sydney Olympic Park New High School Burroway Road, Wentworth Point

Prepared for School Infrastructure New South Wales (SINSW)

> Project 202029.00 August 2021

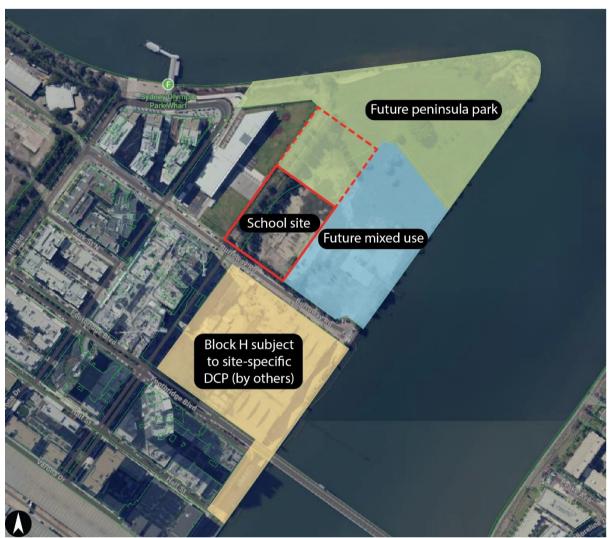
Figure 1: Site Aerial Map. Source: Mecone

The surrounding area is generally characterised by high rise residential and mixed-use developments. The site is directly adjacent to the Wentworth Point Peninsula Park and immediately east of Wentworth Point Public School.

An embankment for the previously proposed 'Ridge Road' runs through the site and was constructed in 2019. With the exception of the area covered by the embankment, there is typically remnant concrete slabs present in the southern portion of the site, with grass and scattered trees elsewhere.

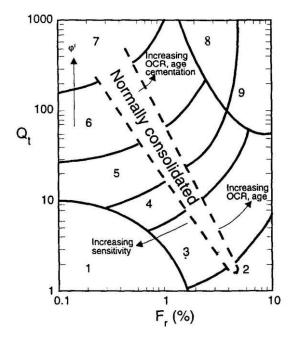
The CPT parameters can be used to infer the Soil Behaviour Type (SBT), based on normalised values of cone resistance (Qt) and friction ratio (Fr). These are used in conjunction with soil classification charts, such as the one below (after Robertson 1990)

Figure 3: Soil Classification Chart

DP's in-house CPT software provides computer aided interpretation of soil strata, generating soil descriptions and strengths for each layer. The software can also produce plots of estimated soil parameters, including modulus, friction angle, relative density, shear strength and over consolidation ratio.
