# State Significant Development Road Safety Assessment Report

ARRB Project No.: 017134

Prepared for: Gunlake Quarries

15 September 2021  
Final Report

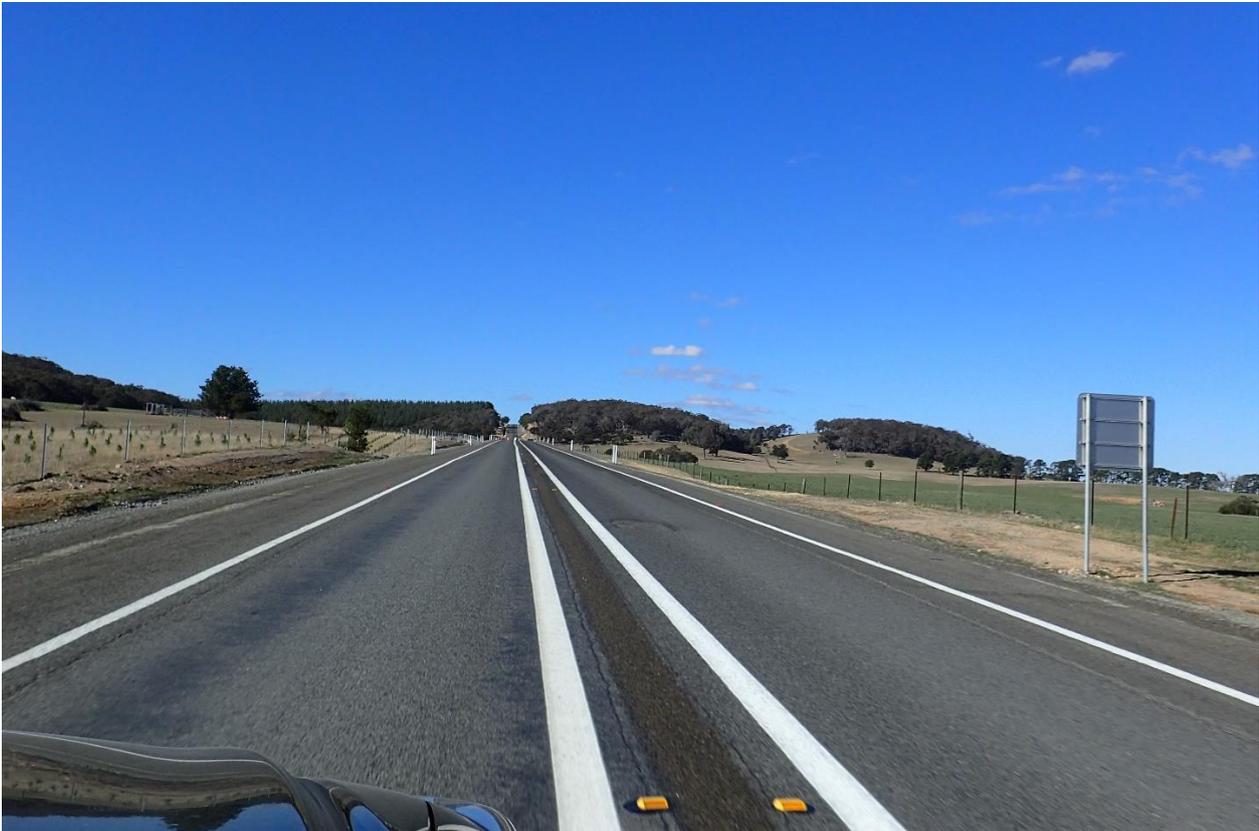
Figure 2-2: Typical view of a wide centreline treated section of the Primary Transport Route

A schematic diagram of a typical cross-section of the route is provided in Appendix A for information; a typical view of a wide centreline treatment section is shown in Figure 2-2.

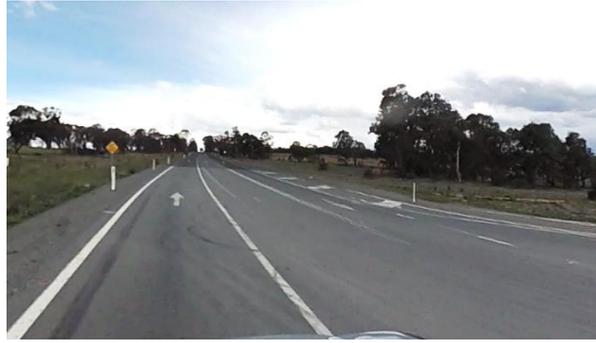
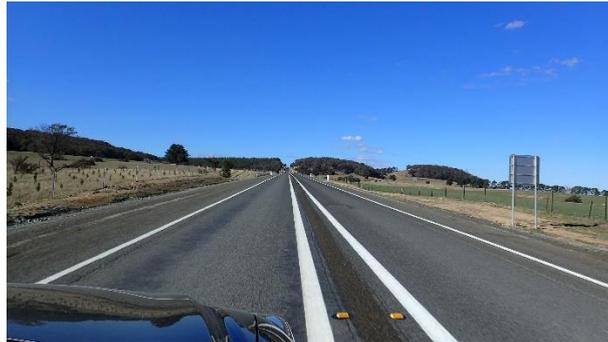
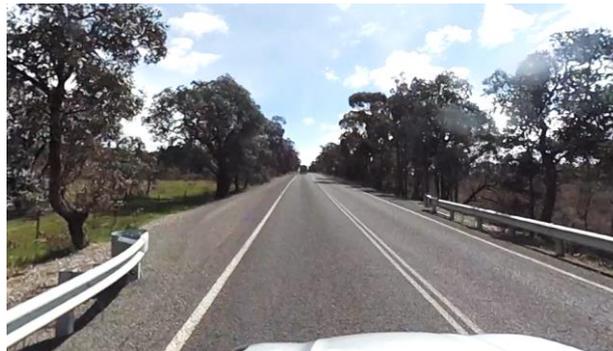
Figure 2-3 Photographs of the Primary Transport Route after implementation of works

T-intersection Treatment – Quarry Access Road intersection with Brayton Road

Typical wide centreline treatment

Typical existing treatment near culvert sections

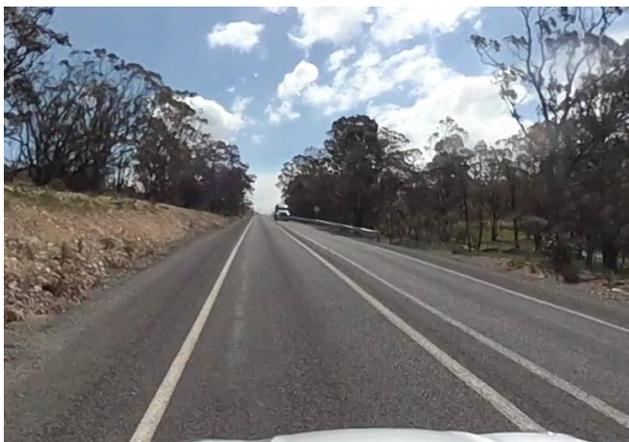
Figure 4-1 Typical WCLT formation

Key elements of the upgrade of the Primary Transport Route included the application of a WCLT to increase separation of opposing traffic streams, new and extended steel w-beam guardrail to prevent vehicles impacting roadside hazards and/or traversing steep embankments and culvert headwall drop-offs, clearing of roadside vegetation to provide a minimum 3.0 metre clear zone, provision of wide sealed and unsealed shoulders that provide drivers the opportunity to recover a drifting or errant vehicle, enhanced delineation with guideposts, line marking, and retro-reflective pavement markers, upgrade of the Quarry Entrance intersection on Brayton Road to improve vehicle separation and downstream merge arrangements, constructed roadside bus bays to permit public transport services (particularly school services) to move off the traffic lanes.

A review of these key elements, under increased traffic loading indicate they are expected to continue to mitigate foreseeable road safety risks. The typical WCLT and standard centreline formations along the Primary Transport Route are illustrated in Figure 4-1 and Figure 4-2, respectively.

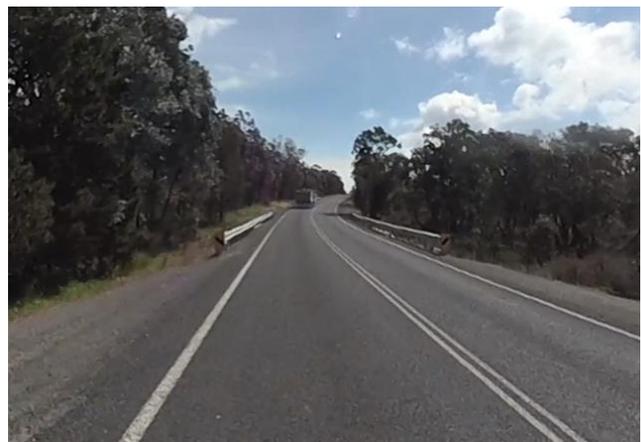
Figure 4-2 Typical normal centreline formation

Currently, WCLTs have not been implemented in locations where major culverts are present along the Primary Transport Route, for example as shown in Figure 4-2. It is recommended these major culverts be extended and the road is widened and protected with guardrail to accommodate an extension of the wide centreline as per the typical cross section shown in Appendix A.

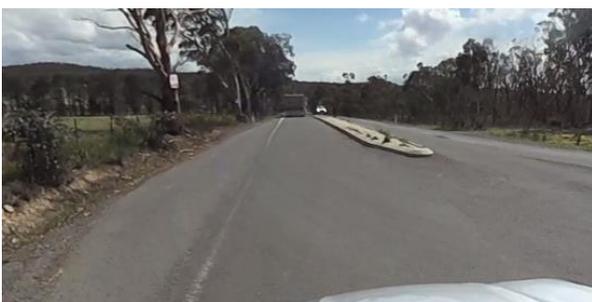
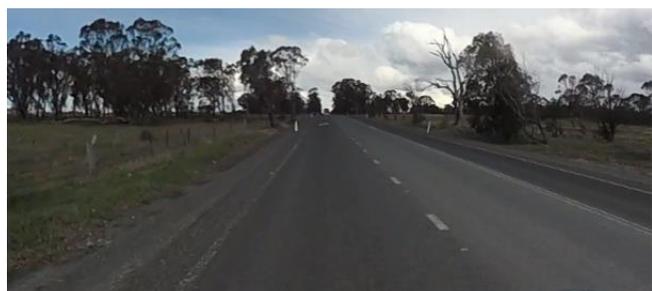
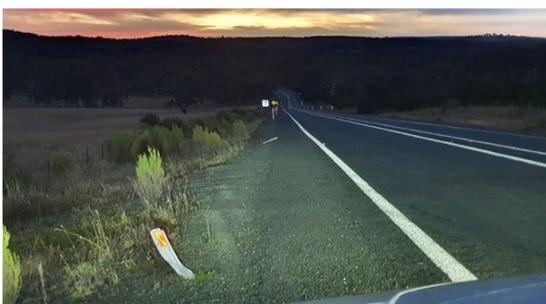
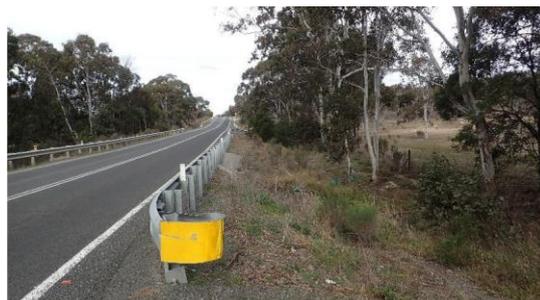
Figure 4-3 Examples of deteriorated assets

Line marking and guideposts along the route are generally in a good condition, however gaps exist due to a degradation in condition at some locations, thus requiring routine maintenance to improve were noted. This leads to an inconsistency in guiding drivers along the route, sometimes at critical locations such as barrier terminals and on curves, especially in night-time and poor visibility conditions such as fog.

Deteriorating and faded line marking was identified during the site inspection and represents a road safety issue.

One factor in line marking durability is the effect of traffic, particularly at intersections where the 'scrubbing' action from the tyres of turning vehicles directly impacts line marking. Increased traffic volumes may increase the rate of deterioration of lines along the route, thus requiring more frequent inspection and renewal of the line marking to maintain effectiveness. Examples of faded line marking and degraded delineation along the Primary Transport Route are shown in Figure 4-3.

**Conclusion:** Increased surveillance and maintenance of the along the Primary Transport Route is a key element to mitigating road safety risk. This includes improved maintenance of guideposts, line marking, and hazard marker signs (on barrier terminals), including cleaning, repair, and replacement as necessary to ensure drivers are provided the appropriate level of guidance along the route.

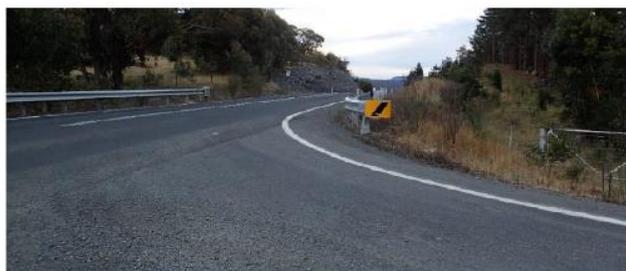
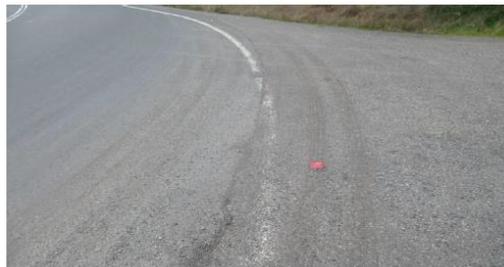
Figure 4-4 Examples of build-up of gravel

A build-up of gravel was noted along sections of road as shown in Figure 4-4; this is typical especially in rural areas with aggregate generally coming from the road surface seal and roadside shoulders and requires sweeping maintenance to avoid obscuring line marking and creating a road safety hazard, especially for motorcyclists and cyclists.

In both instances, increased traffic volumes can exacerbate these adverse road surface conditions. Potentially increased monitoring and scheduled maintenance is considered sufficient to retain acceptable road safety performance.

**Conclusion:** The road pavement surface condition will likely be impacted by an increase in heavy vehicle volume. The routine inspection schedule should be reviewed by the responsible road authority to ensure an appropriate scheduled maintenance program is applied to address deterioration in a timely manner.

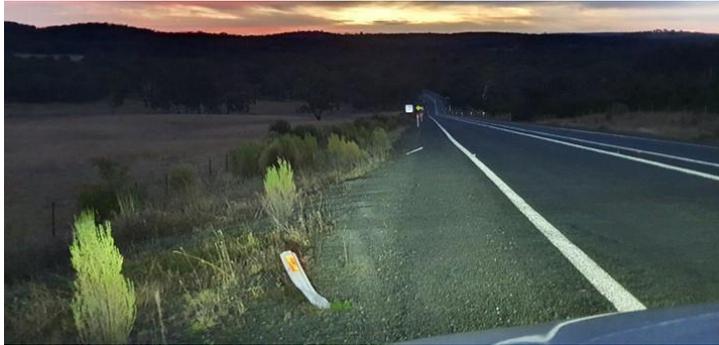
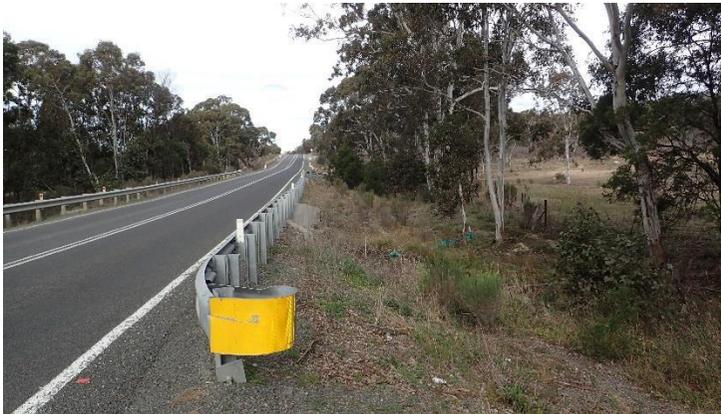
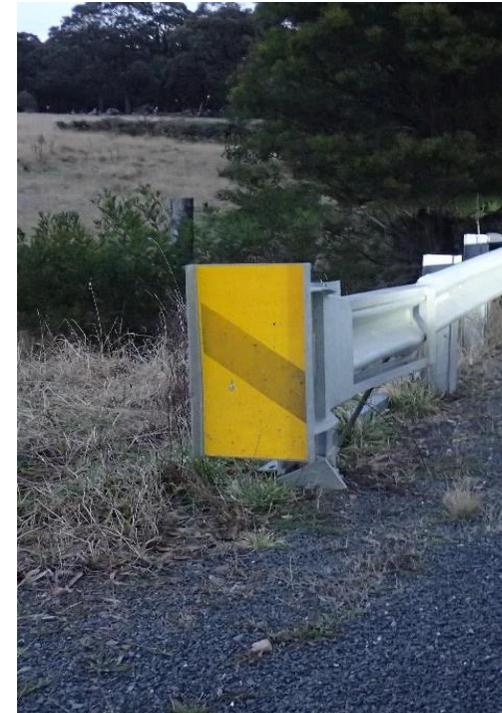
NO.	FINDING	EXISTING RISK	SUGGESTED CORRECTIVE ACTION	RESIDUAL RISK	CLIENT REPOSE AND PROPOSED ACTION
<b>GENERAL FINDINGS APPLICABLE ALONG THE LENGTH OF THE AUDIT ROUTE</b>					
1	<p>Delineation – guideposts, linemarking, signage, and supplementary markers</p> <p>Linemarking and guideposts along the route are generally in a good condition, however gaps due to a degradation in condition were noted that lead to inconsistency guiding drivers along the route, sometimes at semi-critical locations such as barrier terminals and on curves, especially in night-time and poor visibility conditions such as fog.</p> <p>Poorly maintained delineation can cause inconsistency in guidance resulting in driver incorrectly interpreting or adapting to changing road conditions and alignment, leading to loss of control and run-off road type crashes.</p>	High	Implement increased surveillance of the route and provide more timely maintenance of guideposts, linemarking, and hazard marker signs (on barrier terminals), including cleaning, repair, and replacement as necessary to ensure drivers are provided the appropriate level of guidance along the route.	Low	<b>Notify Council of this risk and suggest it is included in the road inspection and maintenance program.</b>

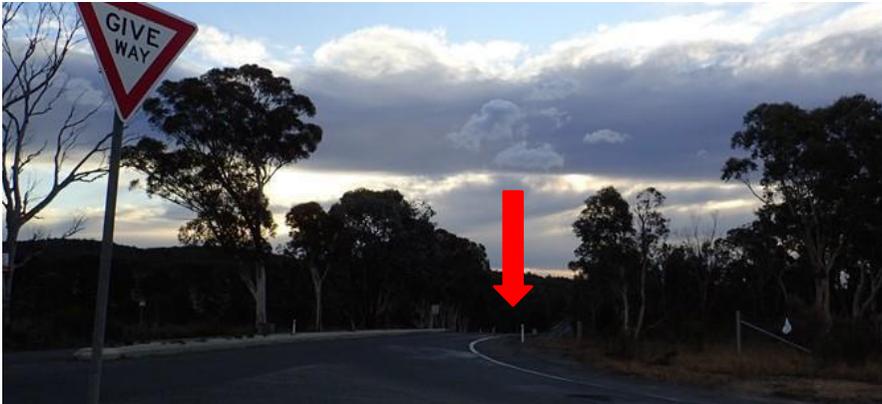
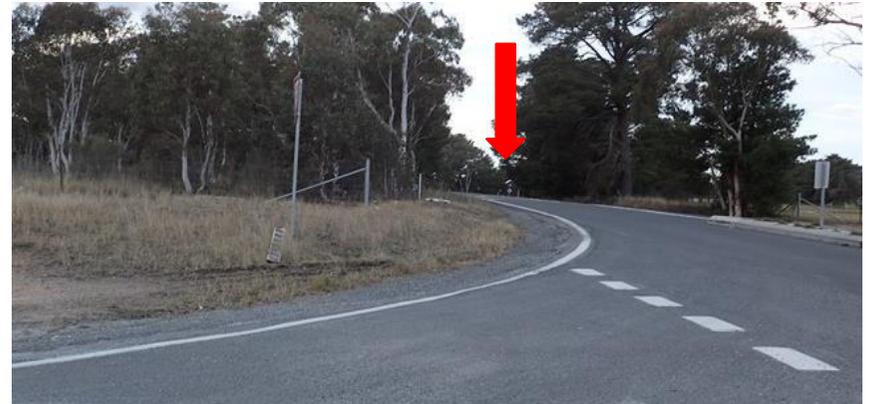
10	<p>Light vehicle drivers seeking to turn from Ambrose Road into Brayton Road have limited sight distance into Brayton Road due to the horizontal and vertical alignment of each Brayton Road leg.</p> <p>Noting the road approaches are high-speed (100 km/h), there is the potential for severe right-angle and turning type crashes.</p>	High	<p>A. Replace the current GIVE WAY yield arrangement with STOP.</p> <p>B. Provide W2-4 side road intersection signs on both approaches in Brayton Road, paint the median islands with retroreflective white paint and renew the linemarking approaching the intersection.</p> <p>C. Reduce the speed limit along Brayton Road.</p>	Low	<p><b>Notify Council of this risk and suggest it is included in the road inspection and maintenance program.</b></p> <p><b>Council and Gunlake to continue to lobby Transport for NSW to reduce the speed limit.</b></p>
11	<p>Lines of sight for light vehicle drivers waiting to turn out of Red Hill Road (side road leg) are restricted to sub-optimal distances.</p> <p>The line of sight into Ambrose Road to the right is partially impeded by the guardrail; the line of sight into Red Hill Road (left) is impeded by the new growth of sapling trees.</p> <p>The restricted lines of sight may lead drivers to misjudge approaching traffic, particularly during poor weather (rain and fog) conditions, leading to potential right angle, rear-end and side swipe type crashes at high speed.</p>	High	<p>A. Reduce the speed limit along Ambrose and Red Hill Road.</p> <p>B. Relocate the existing guardrail to improve the line of sight.</p> <p>C. Trim/remove the vegetation and monitor to ensure adequate line of sight is maintained.</p> <p>D. Consider alternate measures to warn/inform motorists of the hazard to improve safety, particularly during adverse weather conditions.</p>	Low	<p><b>Notify Council of this risk and suggest it is included in the road inspection and maintenance program.</b></p> <p><b>Council and Gunlake to continue to lobby Transport for NSW to reduce the speed limit.</b></p>

Ambrose Road (looking north into Brayton Road)

Ambrose Road (looking south into Brayton Road)
