# Remediation Action Plan (RAP) Newcastle Grammar School - Park Campus: 127 Union Street, Cooks Hill NSW

754-NTLGE282007-AK

13 October 2021

Tetra Tech Coffey 16 Callistemon Close Warabrook NSW 2304 Australia p: +61 2 4028 9700

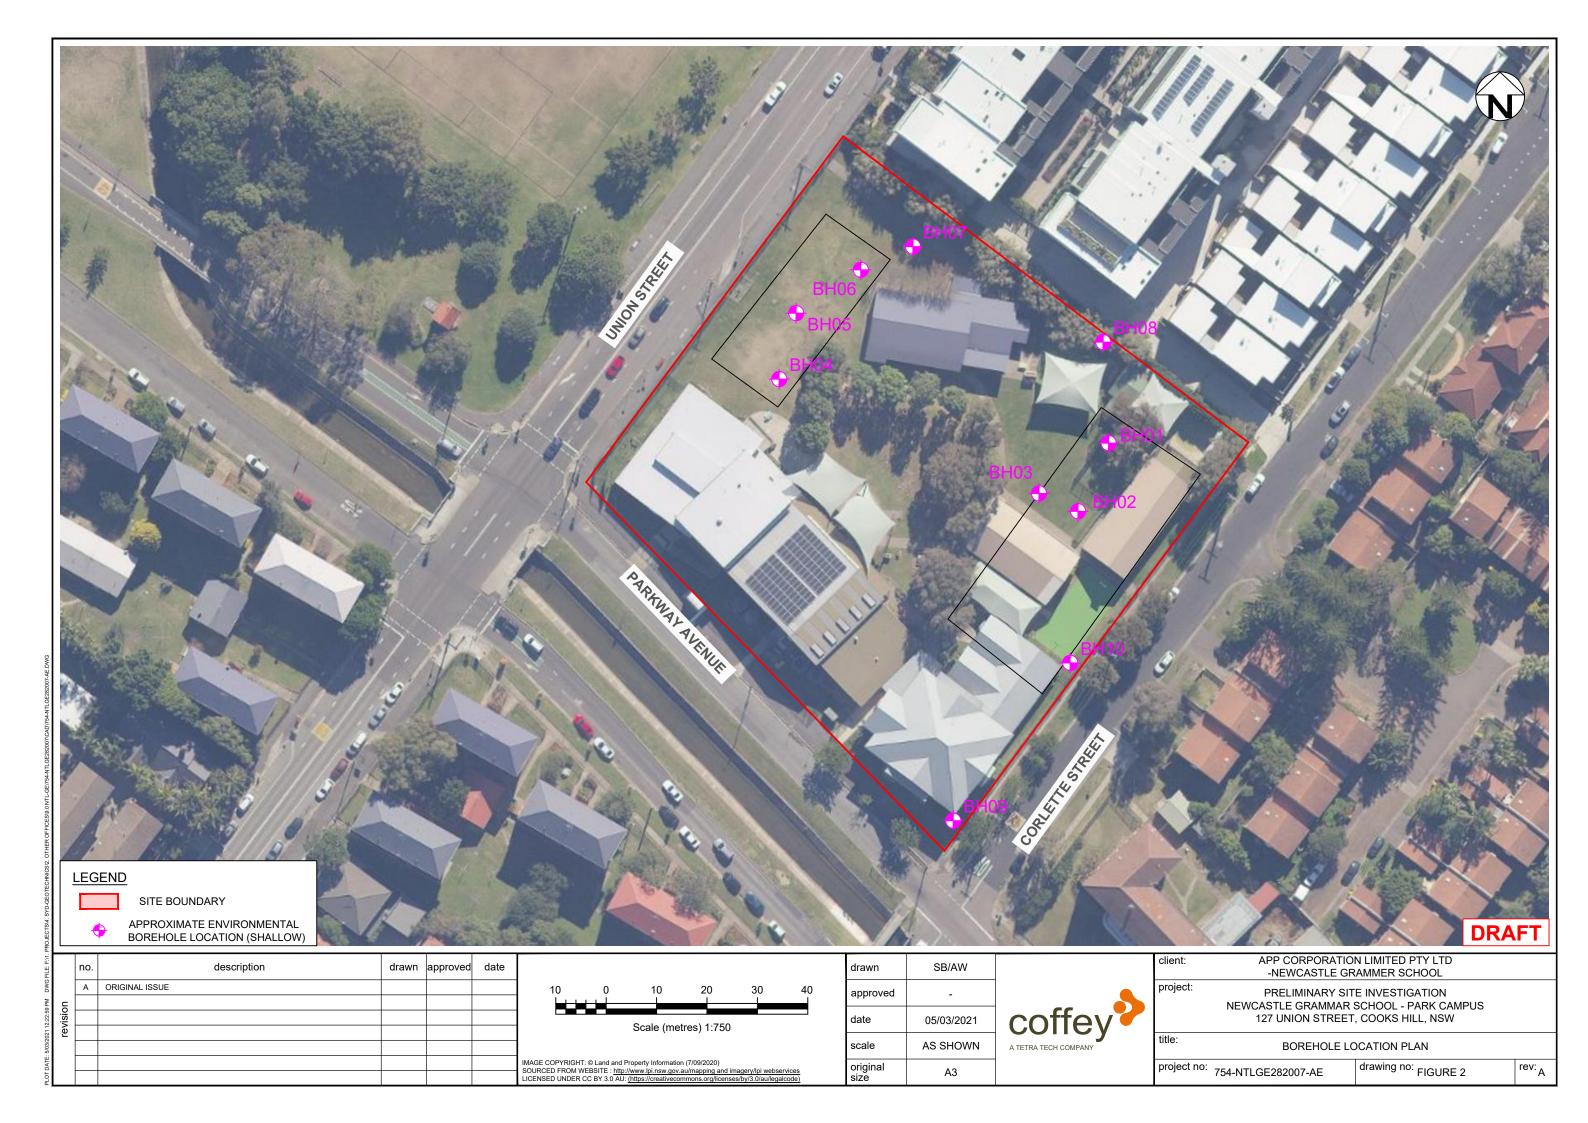
Soil will be removed from the impacted investigation area outlined in Figure 2, Appendix A:, by the earthworks/remediation contractor under the guidance of a suitably qualified Environmental Scientist. The excavated soils will be stockpiled within the excavated footprint atop HDPE liner to avoid contaminated soils impacted underlying residual soils. The stockpiled soils will be covered to lower the risk of infiltration of rainwater.

Soil will be removed from the impacted investigation area outlined in Figure 2, Appendix A:, by the earthworks/remediation contractor under the guidance of a suitably qualified Environmental Scientist. The excavated soils will be stockpiled within the excavated footprint atop HDPE liner to avoid contaminated soils impacted underlying residual soils. The stockpiled soils will be covered to lower the risk of infiltration of rainwater.

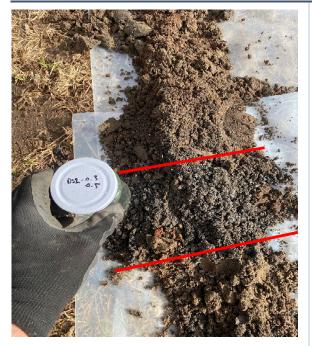
Photo 1: PAH impacted soil layer - DS2

During the initial delineation sampling event (21.06.2021), a medium to coarse grained gravelly sand material, black/grey in colour, was observed consistently across the investigation area at an approximate depth range of 0.25-0.5m bgs. The layer was confirmed to contain the most elevated concentrations of BaP<sub>TEQ</sub> and Total PAH

- 5. Fill will be observed by the Environmental Scientist to confirm the impacted soil layer (coarse grained gravelly sand black in colour) consisting of boiler ash, coal wash fines and coal chitter in order to target the contaminated fill soils.

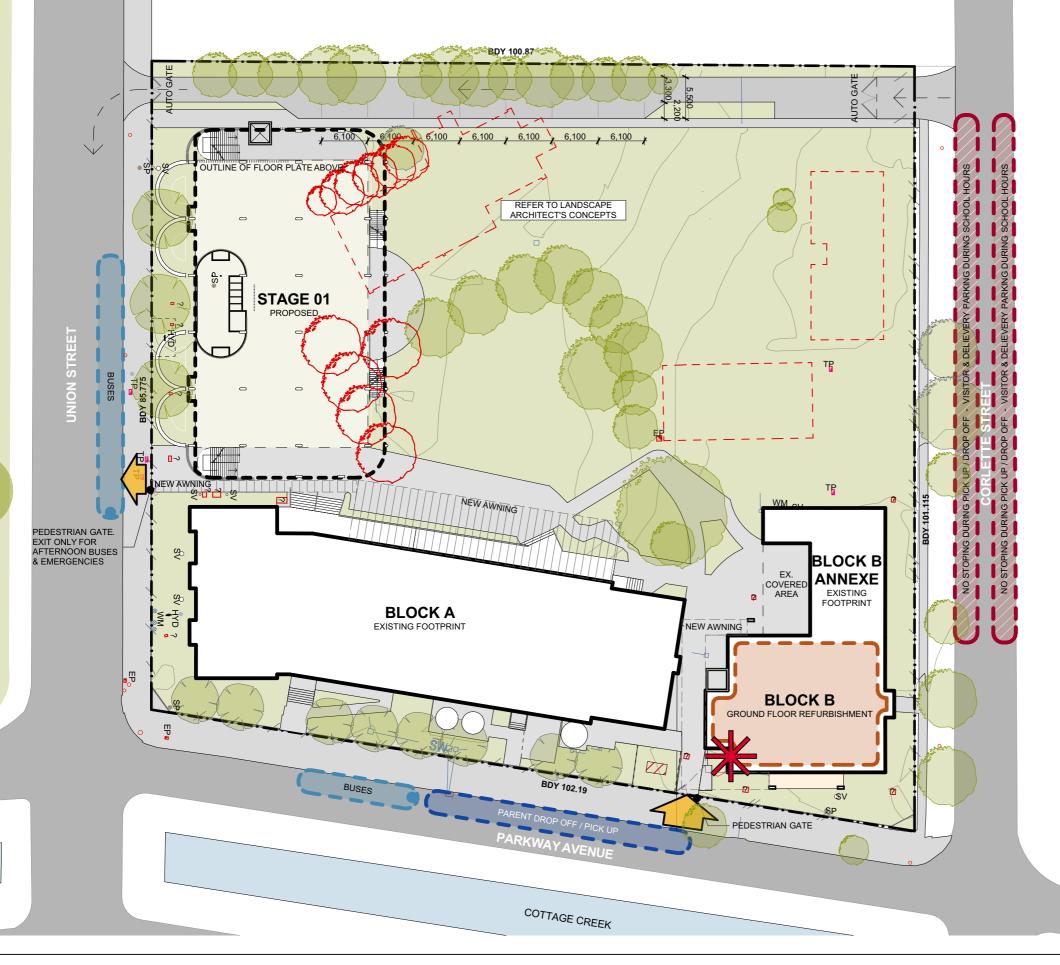
4293 4.01 RevF 07.06.21

Site Plan

The partial redevelopment will require the demolition of existing buildings occupying the northern portion of the Site, which will be replaced with a new 3-storey building along the Union St boundary and a 2-storey building along Corlette Street. The new 3 storey building will consist of an under-croft play area, 2 levels of learning space and rooftop sports court. The new 2 storey building will consist of a semi-basement level car park and 2 storeys of learning spaces, New kiss and drop internal roadway along the northern boundary. Other work will include refurbishment of the existing Block B and refurbishment of the western side of the existing Sandy Warren Centre. The proposed works will require major earthworks and spoil management activities during the construction phase of the redevelopment. A concept plan displaying the proposed site layout is presented in Appendix E:.

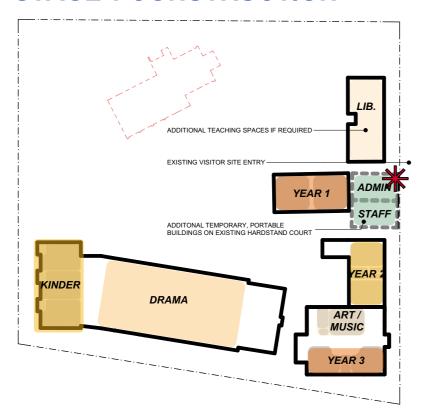
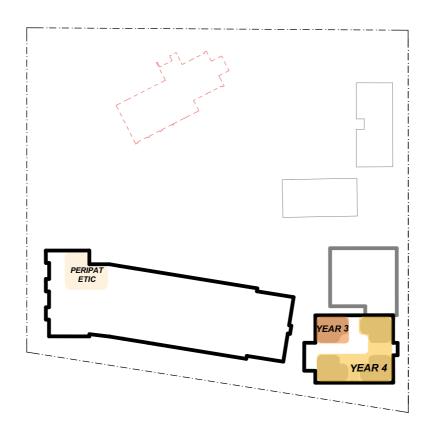
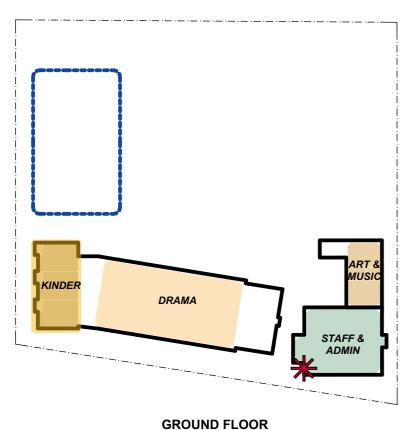
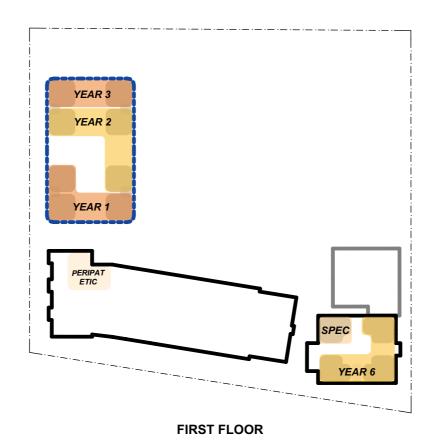
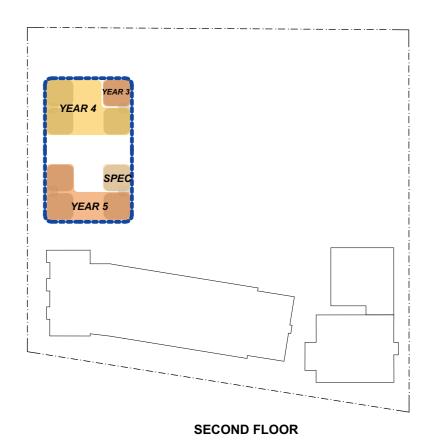
4293 4.02 RevB 07.06.21

**Staging Diagram**

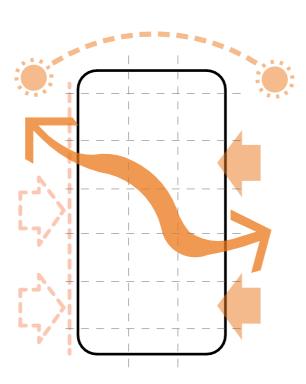
• The regular grid allows for flexibility & future adaptation of the floor plate

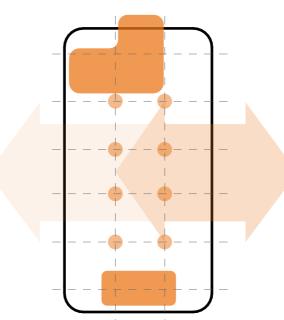
• Form allows good light & air penetration

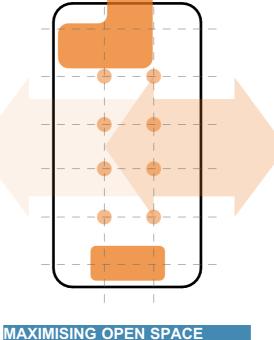
• The undercroft playspace maximises the onsite play area & maintains its connection with National Park
