#### Newcastle Grammar School Proposed Stage 1 Additions - Newcastle Grammar School- Park Campus

#### **Geotechnical Assessment**

# Proposed Stage 1 Additions - Newcastle Grammar School - Park Campus - Geotechnical Assessment

Prepared for Newcastle Grammar School

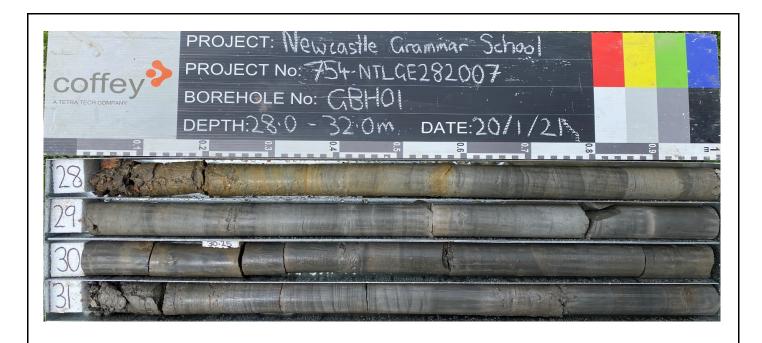
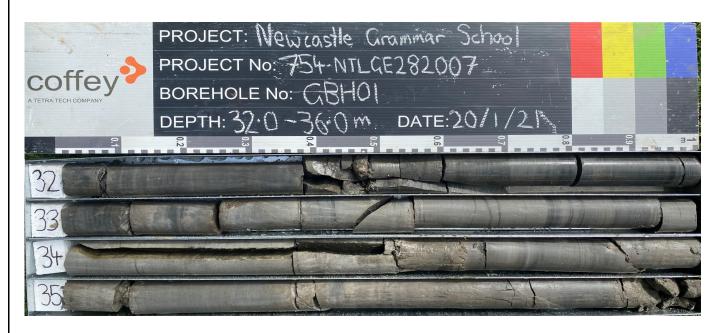
drawn	SJB		client:	NEWCASTLE GRAMI	MAR SCHOOL LTD
approved	JD	a off a v	project:	NEWCASTEL GRAMMAR S STAG	
date	19/02/2021	coffey		127 UNON STREE	T COOKS HILL
scale	N/A	A TETRA TECH COMPANY	title:	CORE PHOT	OGRAPH
original size	A4		project no:	754-NTLGE282007	borehole no: GBH01
\\ -4700f-1\C70	0/CEOTECHNICC/4 I			ITI CE000007 Nameda Carana Cal	and Dark Compus Ctage 1\Correspondent

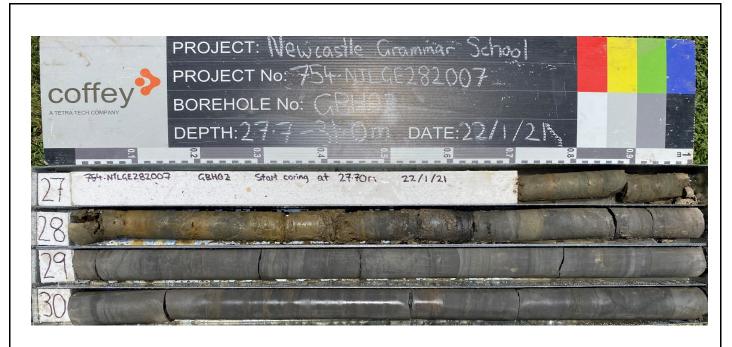
SJB		client:	NEWCASTLE GRAM	MAR SCHOOL LTD					
JD	a off a v	project:	NEWCASTEL GRAMMAR SO STAG						
19/02/2021			127 UNON STREET COOKS HILL						
N/A	A TETRA TECH COMPANY	title:	CORE PHOT	OGRAPH					
A4		project no:	754-NTLGE282007	borehole no: GBH02 PT1					
	JD 19/02/2021 N/A A4	JD 19/02/2021 N/A A4	JD 19/02/2021 N/A A4  Project:  title: project no:	JD  19/02/2021  N/A  A4  NEWCASTEL GRAMMAR SO STAG  127 UNON STREE  title: CORE PHOTO  project no: 754-NTLGE282007

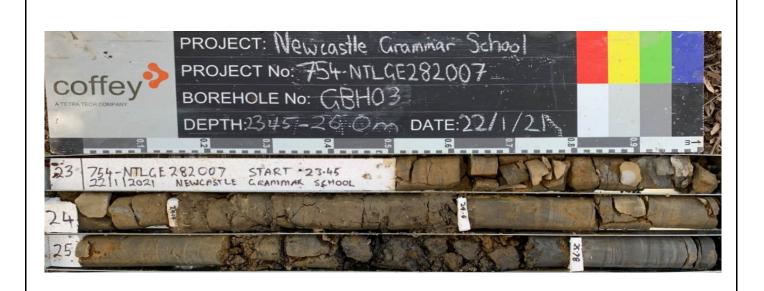
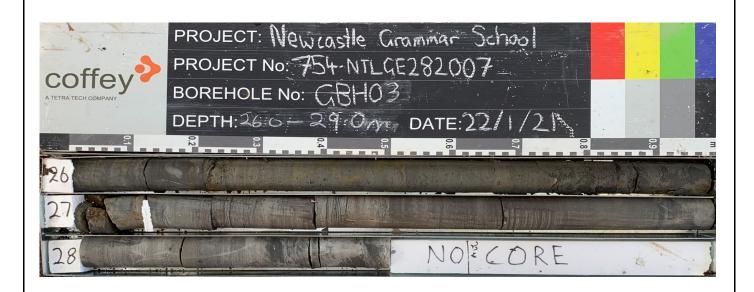
drawn	SJB		client:	NEWCASTLE GRAMI	MAR SCHOOL LTD					
approved	JD	a off a v	project:	NEWCASTEL GRAMMAR SO STAG						
date	19/02/2021	coffey		127 UNON STREET COOKS HILL  CORE PHOTOGRAPH						
scale	N/A	A TETRA TECH COMPANY	title:							
original size	A4		project no:	754-NTLGE282007	borehole no: GBH03 PT1

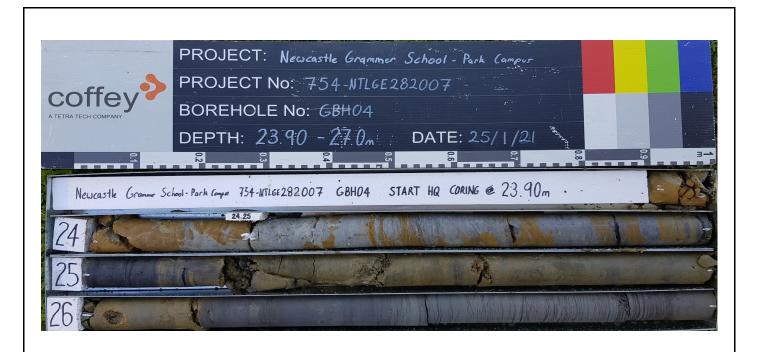
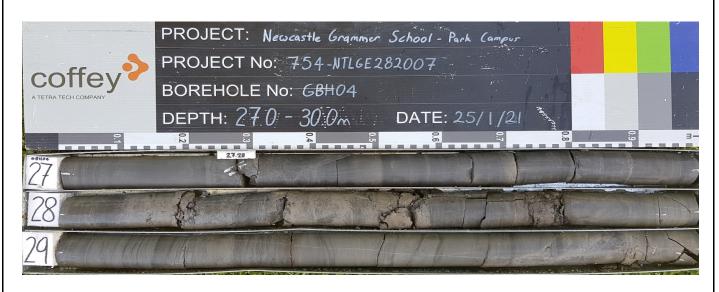
drawn	SJB		client:	NEWCASTLE GRAM	MAR SCHOOL LTD	
approved	JD	ooffor §	project:	NEWCASTEL GRAMMAR SCHOOL PARK CAMPUS - STAGE 1		
date	19/02/2021	coffey		127 UNON STREET COOKS HILL		
scale	N/A	A TETRA TECH COMPANY	title:	CORE PHO	rograph .	
original size	A4		project no:	754-NTLGE282007	borehole no: GBH04 PT1	
	8/CEOTECHNICS/1 I	OD EII ES/NEWOASTI E DDO IECTS/NI	TI CE280000\754 N	NTI GE282007 - Newcastle Grammar Sch	ool Park Campus Stago 1\Correspondent

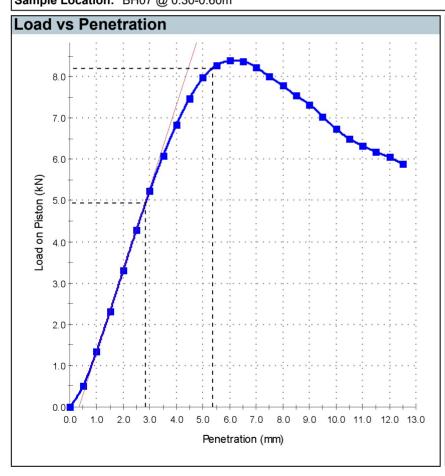
#### CBR at 5.0mm (%): 40 Dry Density before Soaking (t/m³): 1.72 Density Ratio before Soaking (%): 100.0 14.0 Moisture Content before Soaking (%): Moisture Ratio before Soaking (%): 99 5 Dry Density after Soaking (t/m³): 1.72 Density Ratio after Soaking (%): 100.0 Swell (%): 0.0 Moisture Content of Top 30mm (%): 14.8 Moisture Content of Remaining Depth (%): 14.6 Compaction Hammer Used: Standard AS 1289.5.1.1

Hole ID	Depth (m)	Field Moisture Content (%)	Optimum Moisture Content (%)	SMDD (t/m³)	CBR <sup>(1)</sup>	Swell (%)
BH07	0.3 - 0.6	10.3	14	1.72	40	0.0
GBH03	0.5 - 1.0	21.7	13.0	1.76	7	0.5
