Report on
Additional Geotechnical Investigation

Centre of Excellence in Agricultural Education (CoE)
Londonderry Road
Richmond

Prepared for
Conrad Gargett Pty Ltd

Project 85644.02
April 2021

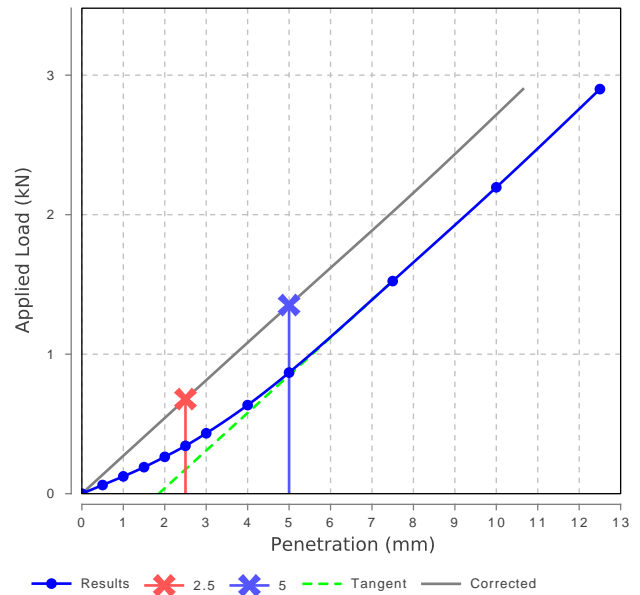
California Bearing Ratio (AS 1289 6.1.1 & 2.1.1)		Min	Max
CBR taken at	5 mm		
CBR %	7		
Method of Compactive Effort	Standard		
Method used to Determine MDD	AS 1289 5.1.1 & 2.1.1		
Maximum Dry Density (t/m^3)	1.98		
Optimum Moisture Content (%)	11.0		
Laboratory Density Ratio (%)	100.0		
Laboratory Moisture Ratio (%)	101.0		
Dry Density after Soaking (t/m^3)	1.98		
Field Moisture Content (%)	11.5		
Moisture Content at Placement (%)	11.1		
Moisture Content Top 30mm (%)	12.3		
Moisture Content Rest of Sample (%)	11.7		
Mass Surcharge (kg)	4.5		
Soaking Period (days)	4		
Swell (%)	-0.5		
Oversize Material (mm)	19		
Oversize Material Included	Excluded		
Oversize Material (%)	0
