Remediation Action Plan

Centre of Excellence in Agricultural Education (CoE) Londonderry Road, Richmond, NSW

Prepared for NSW Department of Education

Project 85644.05 May 2021

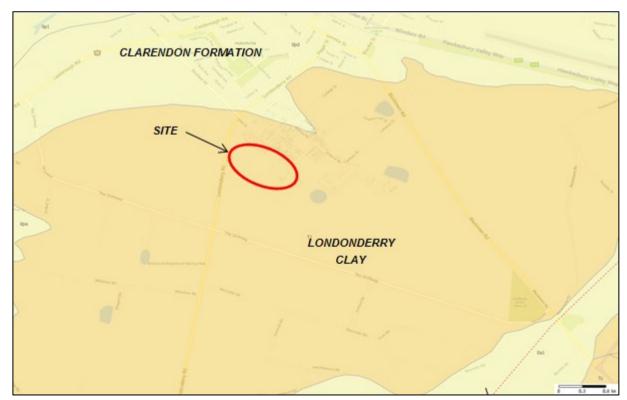
Figure 1: Extract from Penrith 1:100,000 Soils Landscape Sheet (Soil Conservation Service of NSW, 1990)

As presented in the DSI, reference to the Penrith 1:100 000 Soils Landscape Sheet (Soil Conservation Service of NSW, 1990) indicates that the site is underlain by the Tertiary-aged Londonderry Clay which comprises clay with patches of cemented, consolidated sand. The area to the north is shown as being underlain by the Quaternary-aged Clarendon Formation which comprises clay, clayey sand and silt. An extract from the soil landscape map is shown in Figure 1 below.

The field work undertaken for the DSI confirmed the mapping.

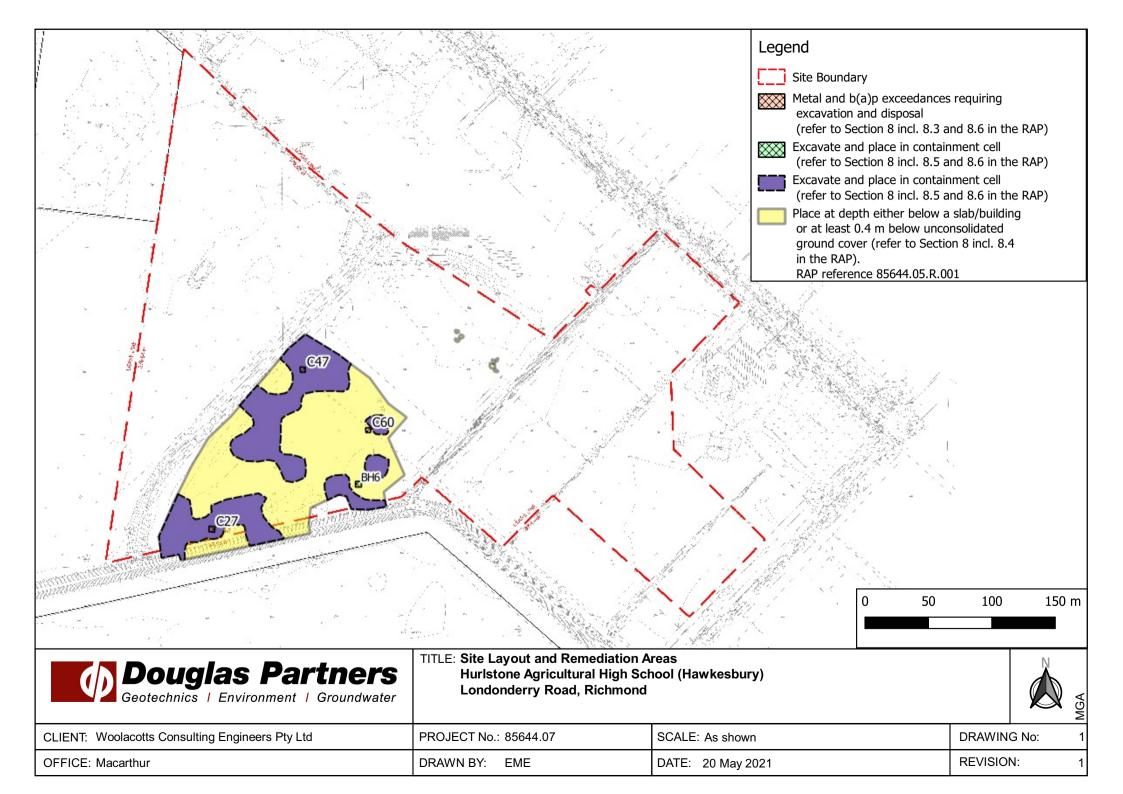
- Filling with anthropogenic material including porcelain, bricks, glass, terracotta, sheet metal, concrete, plastic, scrap metal and bonded asbestos containing materials (ACM) in places was observed in the central-southern portion of the site (refer Drawing 1, Appendix A);

- Filling within the purple areas (see Drawing 1, Appendix A) exceed adopted criteria including bonded and friable asbestos. As such, filling in the purple areas will require remediation (i.e. placed in a on-site containment cell) in accordance with Section 8.5 of this RAP.

Douglas Partners Pty Ltd (DP) was commissioned by the NSW Department of Education to prepare a Remediation Action Plan (RAP – this report) for identified contamination at a proposed school development located on Londonderry Road, Richmond, NSW ('the site'). The site locality is presented on Drawing 1, Appendix A.

At the time of the DSI, the site comprised paddocks with very few improvements and drainage swales are understood to be located at the site. The surface was generally well-grassed and some trees were present on the site as well as along the southern boundary of the original investigation area. The location of the site is shown on Drawing 1 in Appendix A.

- Filling at DSI locations C27, C60 and C47 is required to be remediated (disposed to landfill) in accordance with Section 8.3 of this RAP;
- Filling within yellow shaded areas excluding fill in the vicinity of BH6 (see Drawing 1, Appendix A)
 is generally suitable for reuse at the site and should be managed in accordance with Section 8.4 of
 this RAP;

- Asbestos impact in filling in the central southern portion of the site as follows;
 - o Filling within yellow shaded areas excluding fill in the vicinity of BH6 (see Drawing 1, Appendix A) is generally suitable for reuse at the site and should be managed in accordance with Section 8.4 of this RAP;

- Filling within the purple areas (see Drawing 1, Appendix A) exceed adopted criteria including bonded and friable asbestos. As such, filling in the purple areas will require remediation (i.e. placed in an on-site containment cell) in accordance with Section 8.5 of this RAP.

Filling at location BH6 and within yellow areas (see Drawing 1, Appendix A) is suitable for retention on site at depth. Therefore, it is recommended that all filling material that passes the RAC is placed at depth at the site as follows:
