Factual Report on  
Geotechnical Investigation

Centre of Excellence in Agricultural Education  
Vines Drive, Richmond

Prepared for  
NSW Department of Education

Project 202196.00  
May 2021

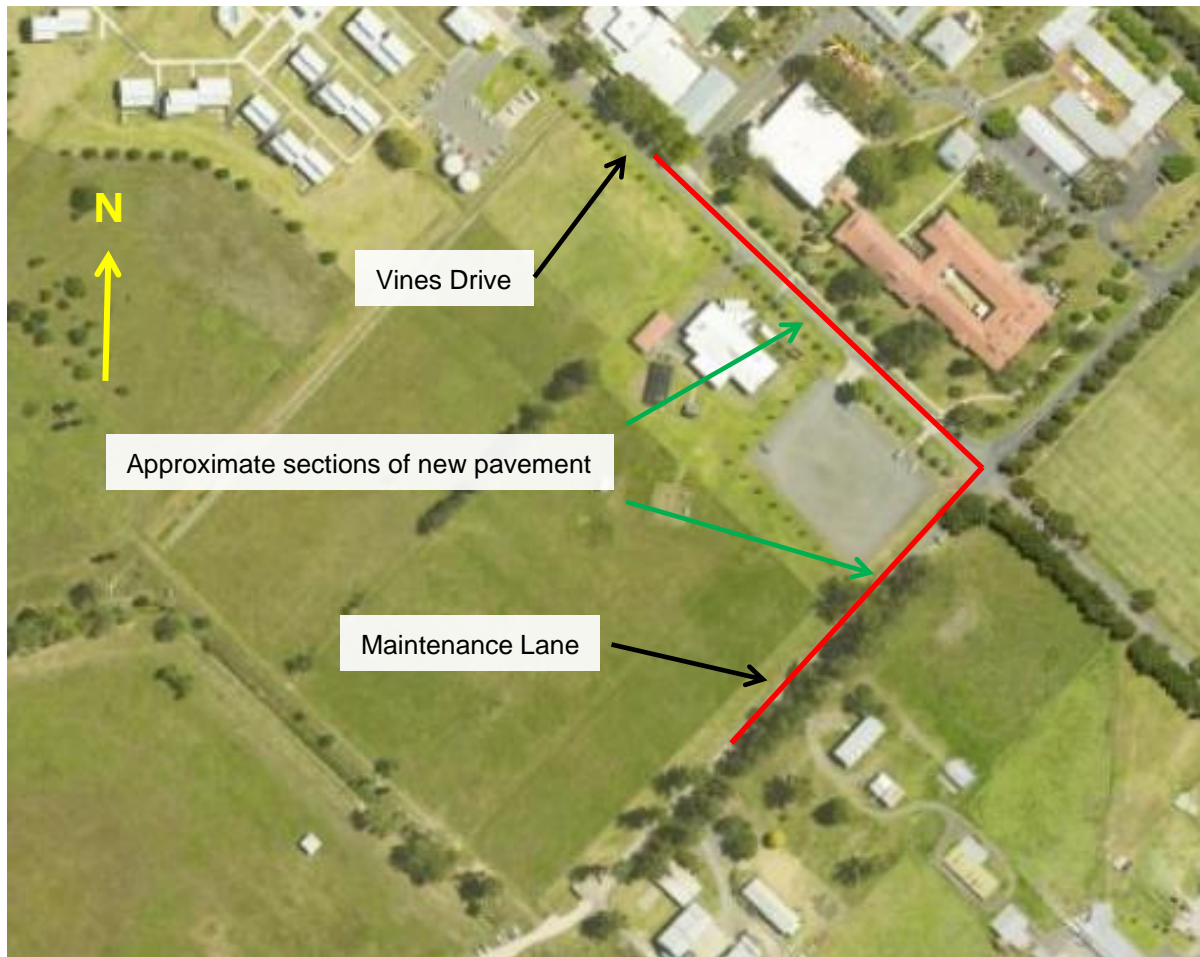
**Figure 1: Site location plan showing approximate sections of new pavement (Source: MetroMap)**

The pavements are at Vines Drive and Maintenance Lane, Richmond. The section along Vines Drive is approximately 200 m long and extends from the intersection with Maintenance Lane to the north-west. The section of Maintenance Lane extends for about 150 m to the south-east of the intersection with Vines Drive.

A location plan showing the approximate sections of new pavement is presented in Figure 1.

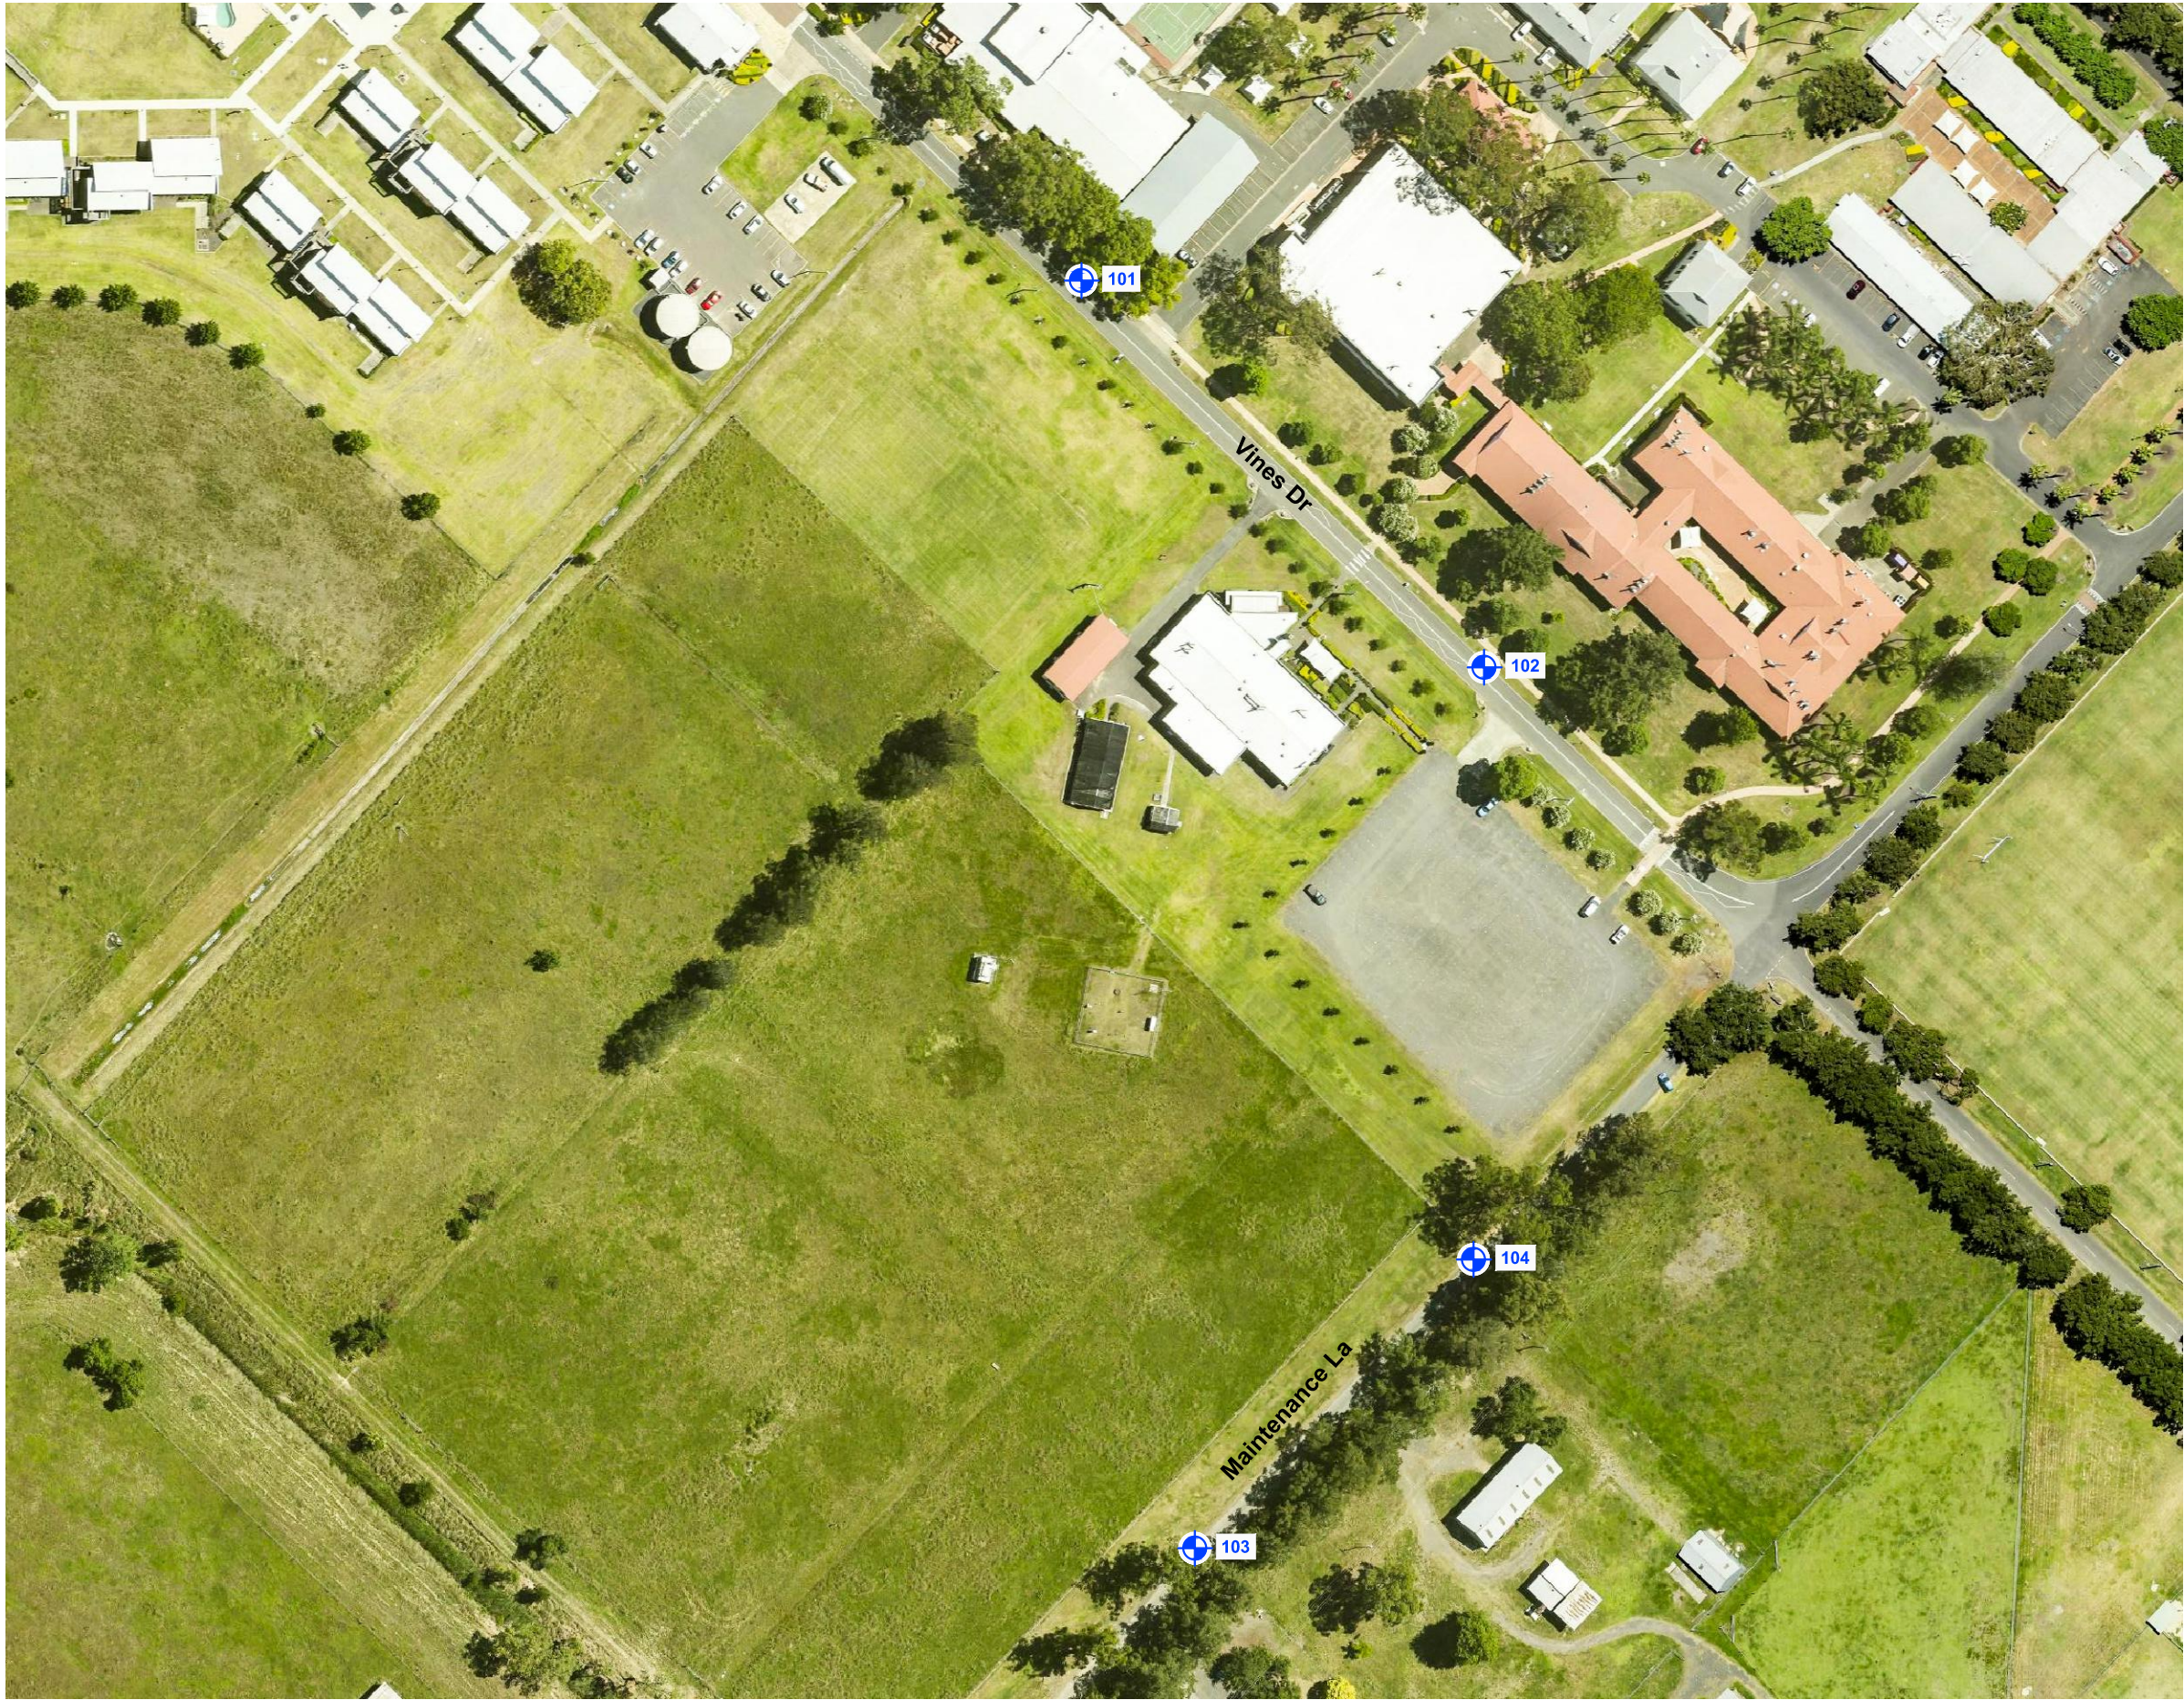
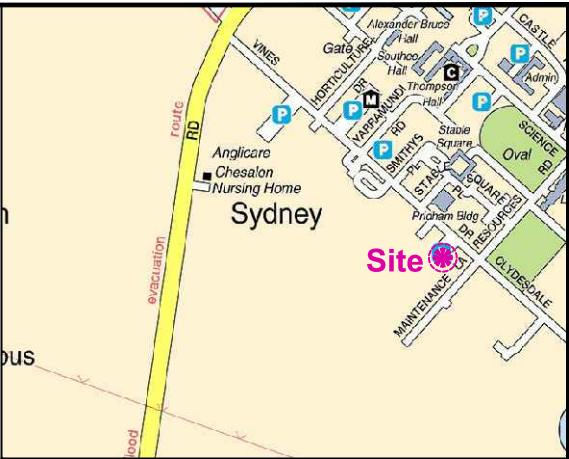
Drawing No 1

Disturbed samples were collected from the boreholes to assist with logging and for laboratory testing. The ground surface levels (measured in 'metres above Australian Height Datum AHD') together with the Eastings and Northings (measured to MGA94) at the borehole locations were determined by using a high precision Differential GPS which is accurate to approximately 0.1 m. The locations of the boreholes are shown on Drawing 1 in Appendix B.

Location Plan

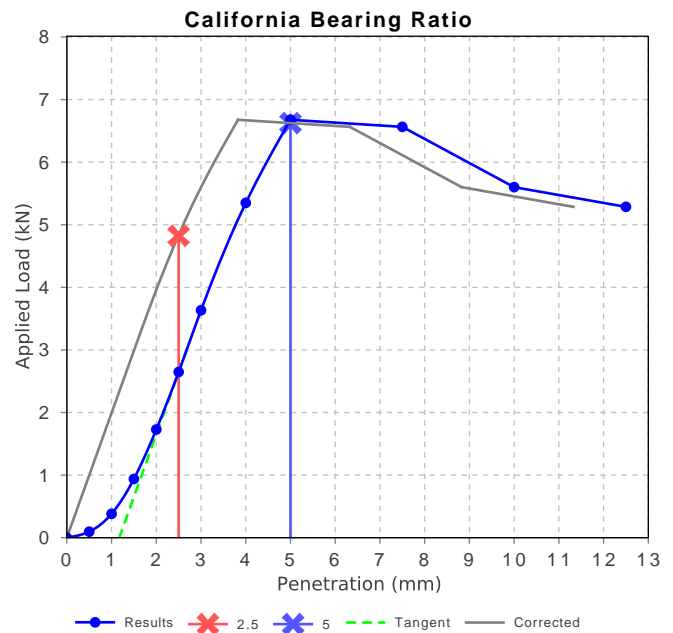
**Report Number:** 202196.00-1  
**Issue Number:** 1  
**Date Issued:** 07/05/2021  
**Client:** NSW Department of Education  
Level 5 NSW, 2000, Sydney NSW 2000  
**Contact:** Alex Phillips  
**Project Number:** 202196.00  
**Project Name:** Centre of Excellence in Agricultural Education  
**Project Location:** Vines Drive, Richmond  
**Work Request:** 7699  
**Sample Number:** SY-7699A  
**Date Sampled:** 19/04/2021  
**Dates Tested:** 20/04/2021 - 04/05/2021  
**Sampling Method:** Sampled by Engineering Department  
*The results apply to the sample as received*  
**Sample Location:** BH101 , Depth: 0.2-1.0m  
**Material:** SAND: brown grey

California Bearing Ratio (AS 1289 6.1.1 & 2.1.1)		Min	Max
CBR taken at	2.5 mm		
CBR %	35.0		
Method of Compactive Effort	Standard		
Method used to Determine MDD	AS 1289 5.1.1 & 2.1.1		
Method used to Determine Plasticity	Visual Assessment		
Maximum Dry Density (t/m <sup>3</sup> )	1.97		
Optimum Moisture Content (%)	9.5		
Laboratory Density Ratio (%)	99.5		
Laboratory Moisture Ratio (%)	104.0		
Dry Density after Soaking (t/m <sup>3</sup> )	1.96		
Field Moisture Content (%)	9.7		
Moisture Content at Placement (%)	9.9		
Moisture Content Top 30mm (%)	11.2		
Moisture Content Rest of Sample (%)	10.1		
Mass Surcharge (kg)	4.5		
Soaking Period (days)	4		
Curing Hours	2		
Swell (%)	0.0		
Oversize Material (mm)	19		
Oversize Material Included	Excluded		
Oversize Material (%)	0

The CBR samples were compacted to approximately 100 % of standard maximum dry density at near optimum moisture content then soaked for four days under a 4.5 kg surcharge until tested. The CBR values were 35 % and 30 % for the sand samples tested, respectively. The samples were between 0.2 % and 2.3 % wet of Standard Optimum Moisture Content.

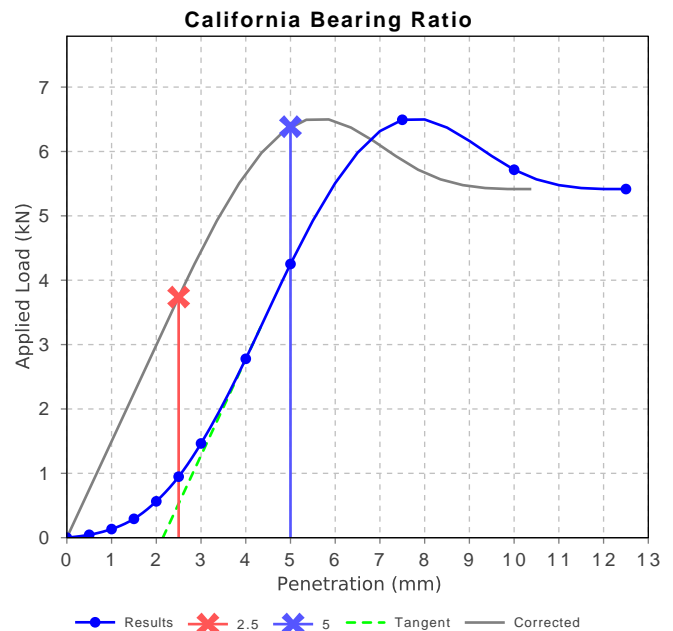
**Report Number:** 202196.00-1  
**Issue Number:** 1  
**Date Issued:** 07/05/2021  
**Client:** NSW Department of Education  
Level 5 NSW, 2000, Sydney NSW 2000  
**Contact:** Alex Phillips  
**Project Number:** 202196.00  
**Project Name:** Centre of Excellence in Agricultural Education  
**Project Location:** Vines Drive, Richmond  
**Work Request:** 7699  
**Sample Number:** SY-7699B  
**Date Sampled:** 19/04/2021  
**Dates Tested:** 20/04/2021 - 04/05/2021  
**Sampling Method:** Sampled by Engineering Department  
*The results apply to the sample as received*  
**Sample Location:** BH104 , Depth: 0.3-1.3m  
**Material:** SAND: brown grey

California Bearing Ratio (AS 1289 6.1.1 & 2.1.1)		Min	Max
CBR taken at	5 mm		
CBR %	30.0		
Method of Compactive Effort	Standard		
Method used to Determine MDD	AS 1289 5.1.1 & 2.1.1		
Method used to Determine Plasticity	Visual Assessment		
Maximum Dry Density (t/m <sup>3</sup> )	1.94		
Optimum Moisture Content (%)	10.5		
Laboratory Density Ratio (%)	100.0		
Laboratory Moisture Ratio (%)	102.0		
Dry Density after Soaking (t/m <sup>3</sup> )	1.95		
Field Moisture Content (%)	12.8		
Moisture Content at Placement (%)	10.5		
Moisture Content Top 30mm (%)	12.9		
Moisture Content Rest of Sample (%)	11.1		
Mass Surcharge (kg)	4.5		
Soaking Period (days)	4		
Curing Hours	0.1		
Swell (%)	-0.5		
Oversize Material (mm)	19		
Oversize Material Included	Excluded		
Oversize Material (%)	0
