Report on  
Geotechnical Investigation of C4 Site

Stage 2 - Midtown  
Herring Road, Macquarie Park

Prepared for  
Frasers Property Ivanhoe Pty Ltd

Project 86043.06  
August 2021

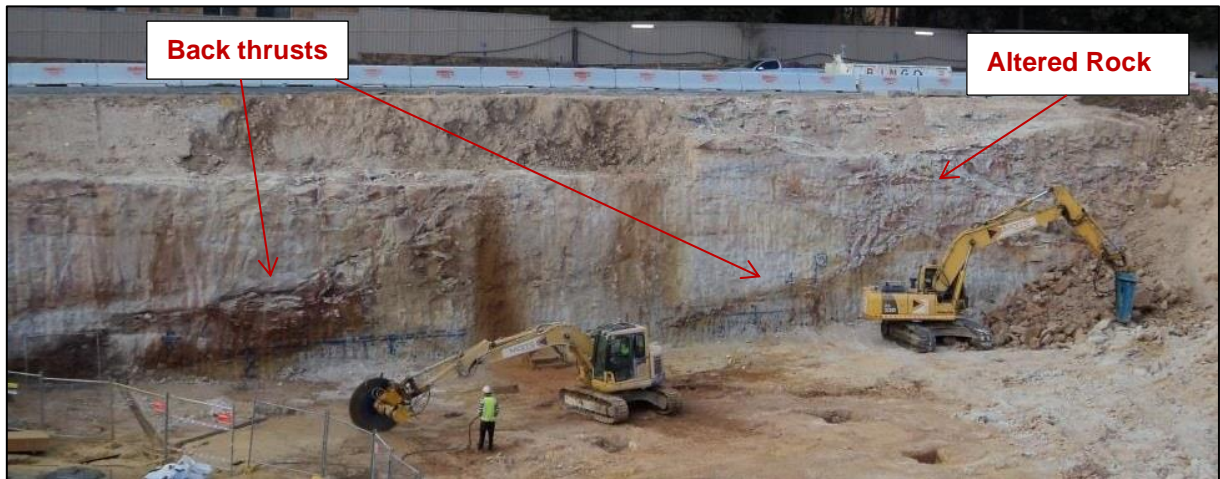
- **Thrust Faults** – Thrust faulting, often associated with dykes, have been previously identified on nearby sites. A photograph showing the subsurface profile exposed by bulk excavation at a recently developed site to the north-west of the greater Midtown site, is included in Figure 2.

**Figure 2: Back thrusts in an excavation wall at a nearby site**

These features are of limited lateral extent and may be present but remain undetected by even significant geotechnical investigation. If encountered, the precise influence and treatment (if required) of dykes and thrust faults are often only determined at construction stage, when their presence, extent and orientation with respect to the works can be more reliably assessed.

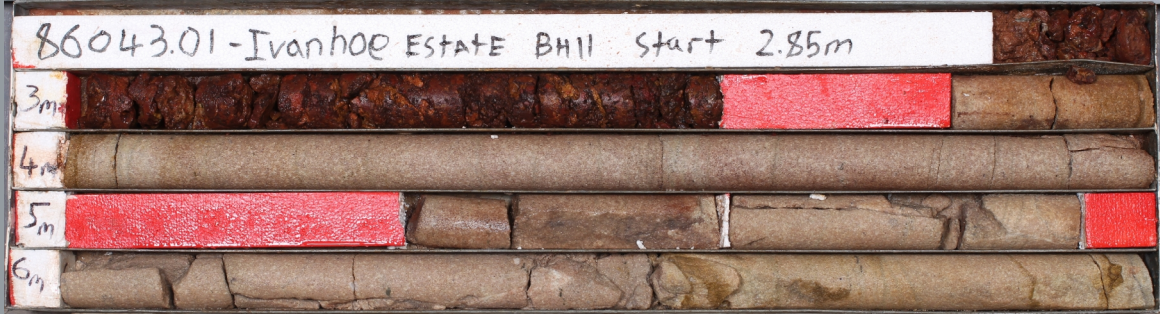
2.85 – 7.0m

Project No: 86043.01  
BH ID: BH11  
Depth: 2.85- 7.0m  
Core Box No.: 1 of 2

While not included in the above interpreted Cross-Sections, Bore 11 drilled east of (beyond) the proposed basement, encountered a significant band of lateritic sandstone in the upper 3.8 m (to RL 40.4), and some significant bands of core loss to 6 m depth (RL 37.2). These materials would generally be associated with high permeability. While these conditions have not been indicated by the other bores within the proposed C4 basement and may not affect the proposed excavation, such ground conditions would be significant to the works, if encountered. Accordingly, the logs and photographs for Bore 11 are included in Appendix E, for information.

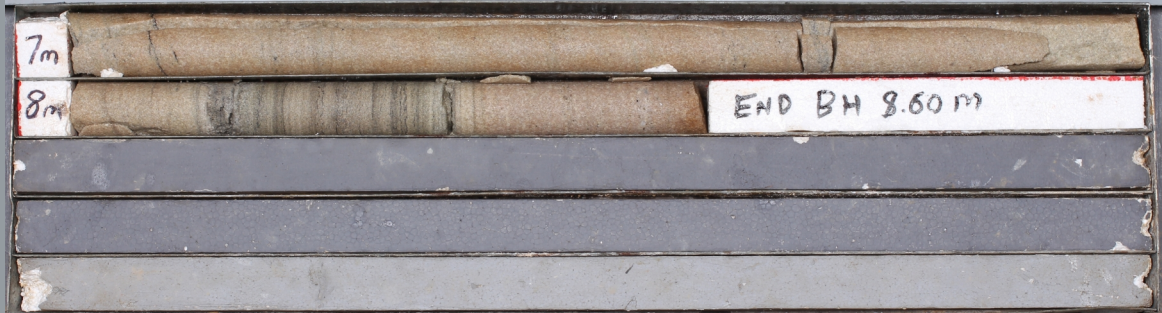
7.0 – 8.60m

Project No: 86043.01  
BH ID: BH11  
Depth: 7.0- 8.60m  
Core Box No.: 2 of 2
