Report on Preliminary Geotechnical Investigation

Proposed Medical Research Centre Campbelltown Hospital, Therry Road, Campbelltown

Prepared for Western Sydney University
- Office of Estate and Commercial

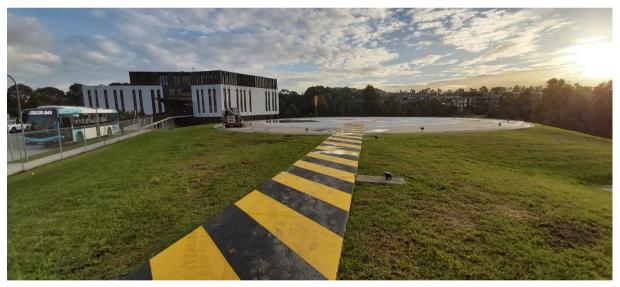
Figure 1: Looking south across the helipad toward WSU Clinical School

The site is currently occupied by the hospital helipad which comprises an on-grade concrete slab at RL83 m AHD. The helipad has been constructed on a fill platform which is approximately level with the carpark to the east. Surface levels fall away from the helipad to the north, south and west at grades in the range 5H:1V to 3H:1V. The battered slopes are then supported by gabion walls up to 4 m in height which are founded at RL74 – 75 m AHD along Parkside Crescent and the access driveways for the adjacent buildings.

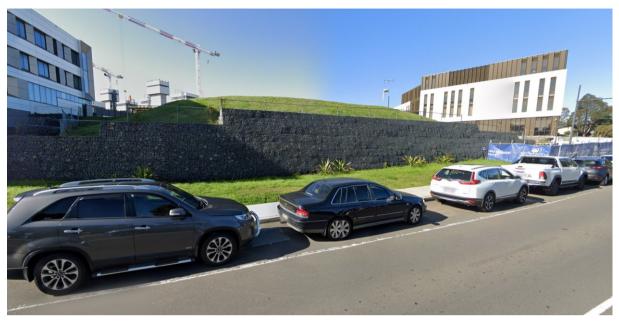
Figure 2: Looking west from Parkside Crescent (helipad is above gabion retaining wall and batter)
