Appendix to Due Diligence Report issued for Glenwood High School proposed development on the 16th of October 2020.

ABORIGINAL AND HISTORICAL HERITAGE DUE DILIGENCE ASSESSMENT

Proposed Development at Glenwood High School

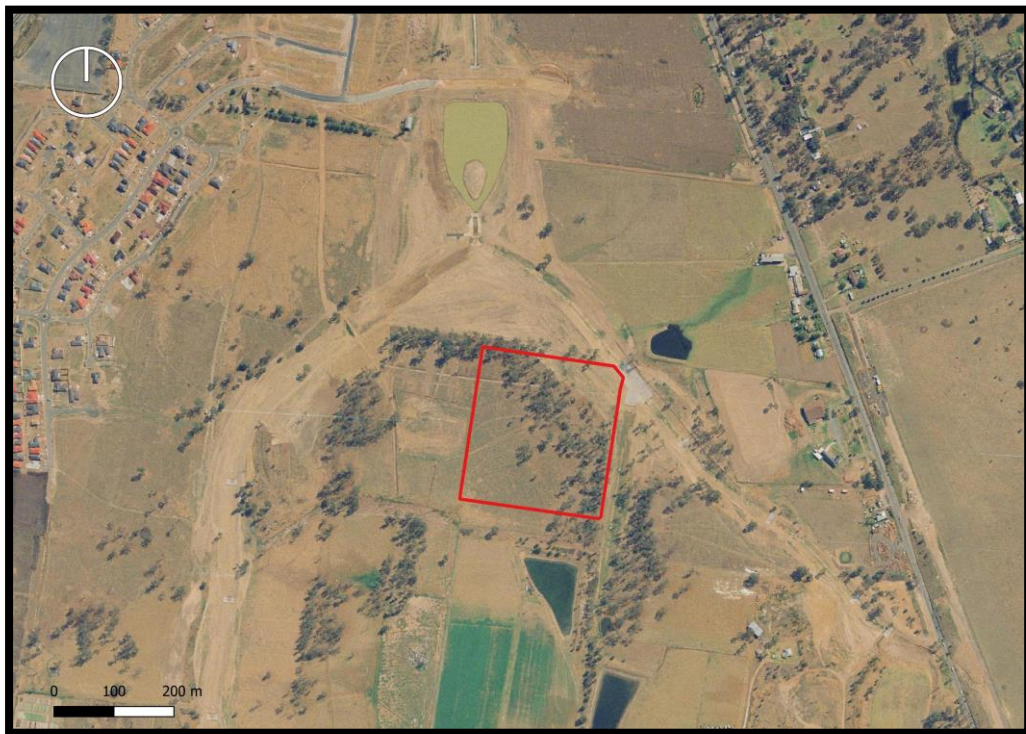
Figure 12: Aerial Image from 1994 showing that civil works associated with the remodelling of the stream have intruded into the study area (Source: Spatial Services NSW).

A visual inspection of the Glenwood High School was carried out on the 12th of August 2020. All of the locations within the proposed development footprint were inspected by archaeologists William Moon and Danielle Mitchell. There is evidence that the study area and development foot print have been subjected to land clearing and some degree of modification associated with the installation of the temporary buildings and the associated services to these buildings. There is also evidence in the aerial imagery sourced for the assessment that shows the civil works associated with the remodelling and changes to the nearby stream have impacted upon the northeast corner of the study area (refer to Figure 12). Figure 13 shows a photograph of the northeast corner of the study area.

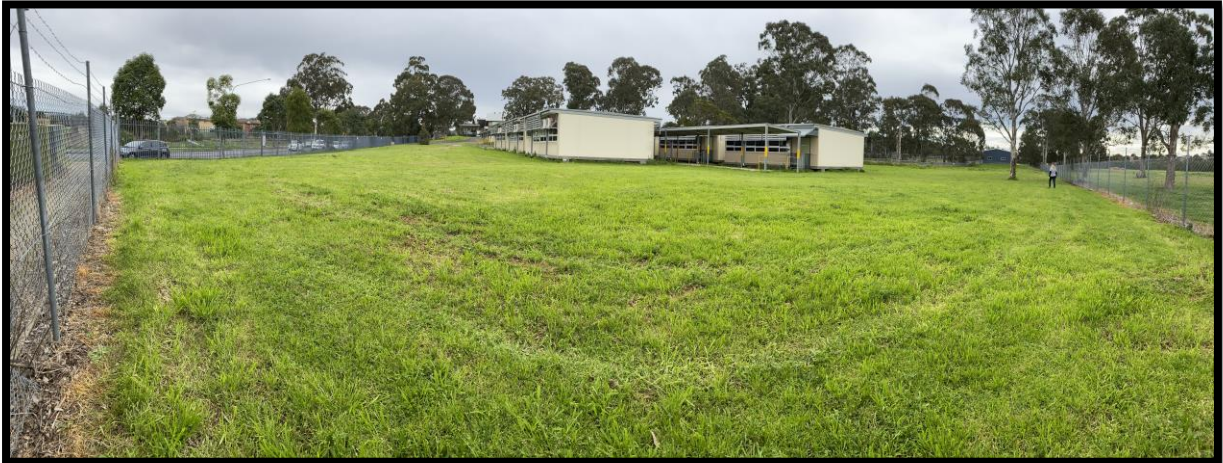
Figure 13: Looking south-west across the proposed development footprint.

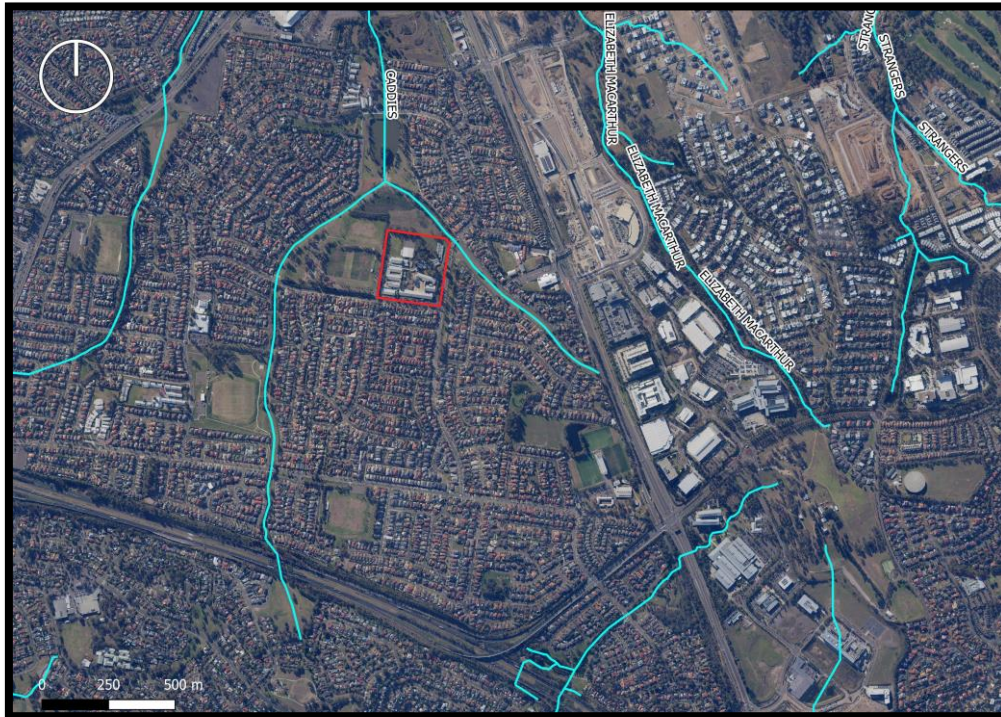
Figure 16: Image showing first order streams to the northwest and northeast of the study area converging just to the north. Streams data accessed from Spatial Services NSW. Aerial image from SixMaps © Department Finance, Services and Innovation.

Research of the results of systematic test excavations undertaken in the Rouse Hill area of the Cumberland Plain by White and MacDonald (2010) found that the highest density of artefact concentrations correlated with higher order streams. Highest densities were found associated with terraces and lower slope zones within 50 to 100 metres of 2nd and 4th order streams. They also found that landscapes associated with first order streams had very low artefact counts with test squares predominantly yielding zero artefacts. A review of the archaeological studies undertaken in the surrounding area within a 2km radius of the study area suggests that low density artefact distribution is likely within the development footprint for the study area.

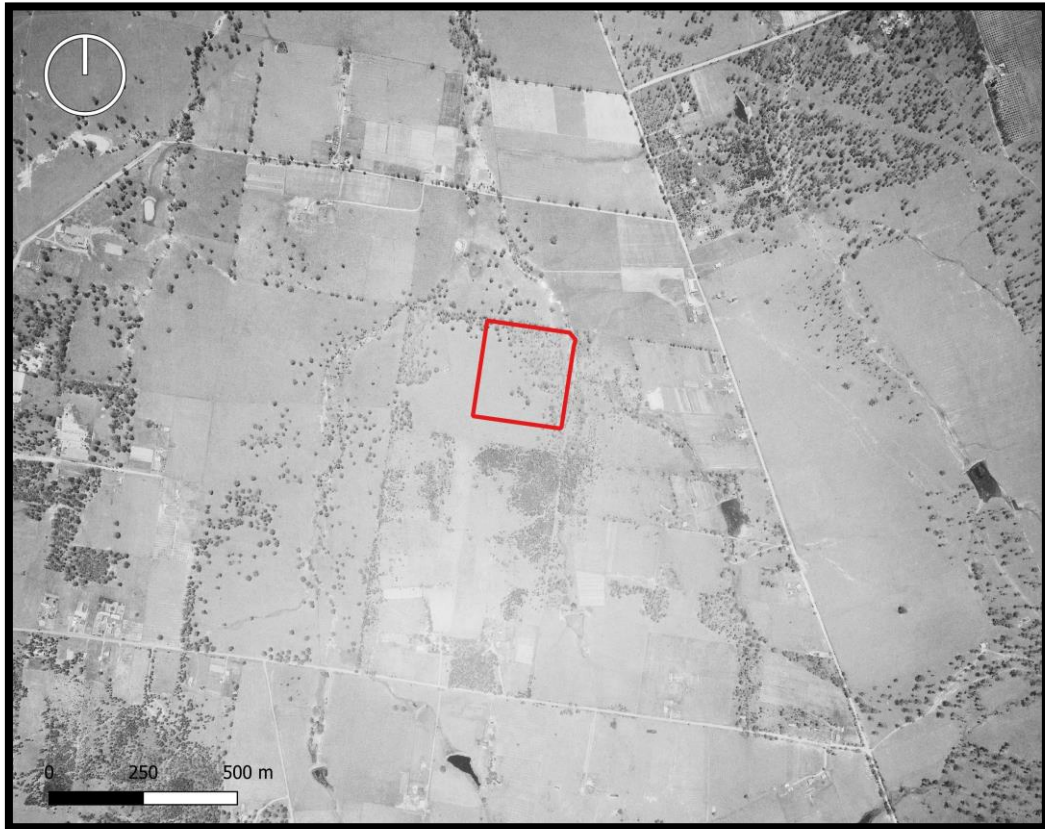
Figure 19: 1955 Aerial Photo of the Glenwood High School site (Source: Spatial Services NSW Government).

Research of the study area does not indicate that there were any early buildings, dwellings or other structures on the site of the Glenwood High School. Early aerial images of the site from 1955 show the study area as being partially cleared on the west side and partially vegetated to the east. There is no evidence of furrows or cultivation in this image suggesting that the study area was probably initially used for grazing. Aerial imagery from the 1970s show the presence of furrows from cultivation on the western half of the study area indicating that this part of the study area was used for crop production around this time. Images from 1986 show that there was no further changes in the use of the land. In 1994, whilst the land use remains unchanged there is evidence of the impacts upon the north-eastern corner of the study area from the shaping of the drainage channels associated with the modifications of the stream.
