Report on  
Geotechnical Investigation

New High School in Jerrabomberra  
Part Lot 1 DP 1263364, Jerrabomberra

Prepared for  
NSW Department of Education - School Infrastructure  
NSW

Project 94188.02  
September 2021

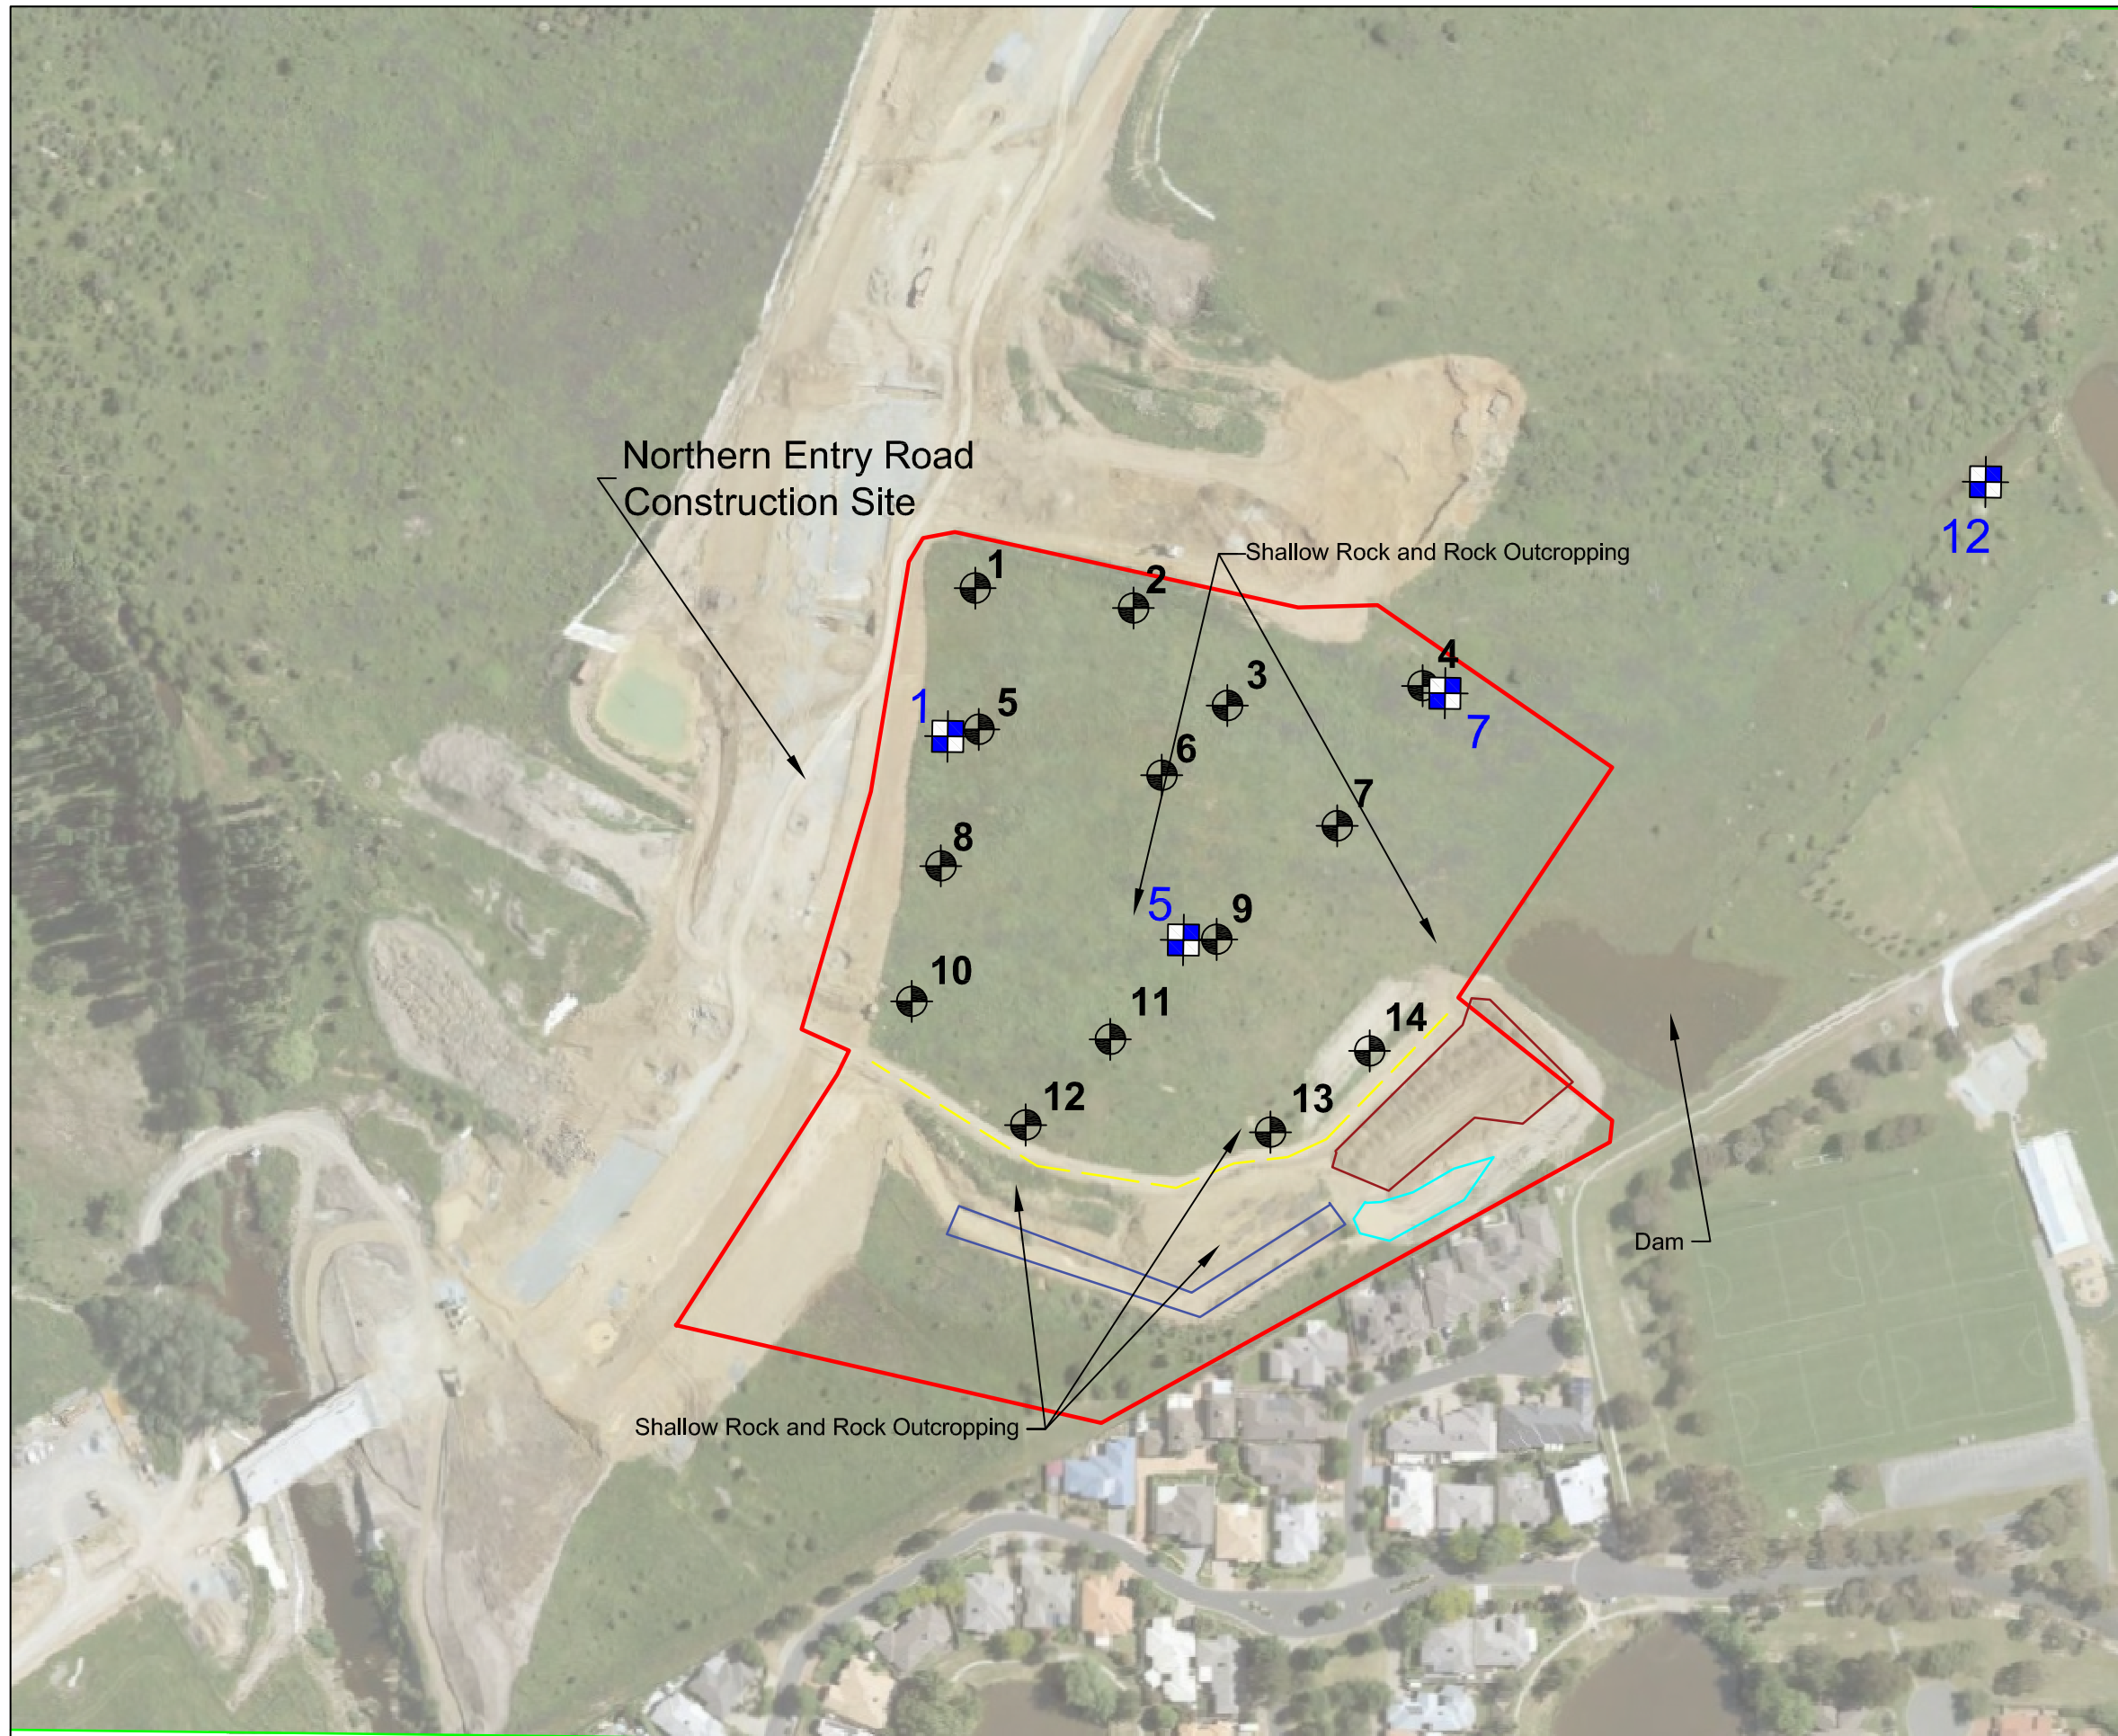
Locality Plan

The California Bearing Ratio (CBR) testing was carried out during previous investigation (DP, 2019) on samples compacted to about 100% standard maximum dry density at close to optimum moisture content. The samples were soaked for four days under surcharge loading of 4.5 kg. The test locations are shown on Drawing 1 and the results are summarised in Table 5 below.

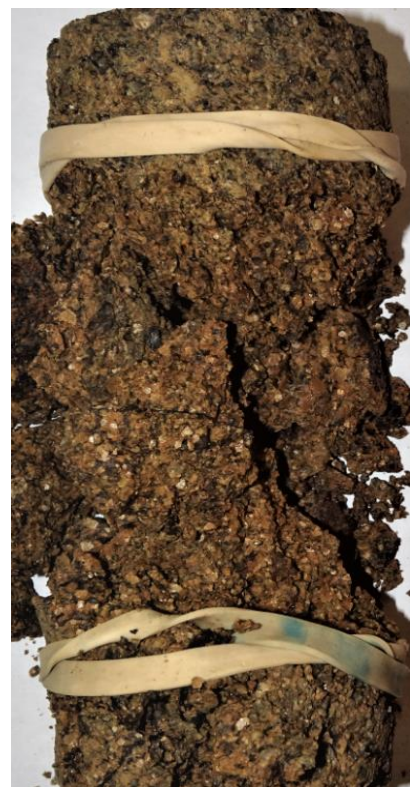
Sample Number	NC-6582B
Sample Location	Bore 7
Depth (m)	4.72 - 5.0
Rock Description	Rhyodacitic Ignimbrite
Storage History and Environment	Tested as Received
Orientation to Bedding	-
Compression Machine	Automax Multitest
Date of Testing	29.03.2021
Duration of Test (seconds)	38
Average Diameter (mm)	51.3
Average Height (mm)	119
Height to Diameter Ratio	2.3 : 1
Moisture Content (%)	5.5
Wet Mass / Unit Volume (t/m <sup>3</sup> )	2.34
Dry Mass / Unit Volume (t/m <sup>3</sup> )	2.21
<b>Uniaxial Compressive Strength (MPa)</b>	<b>2.7</b>
Comments

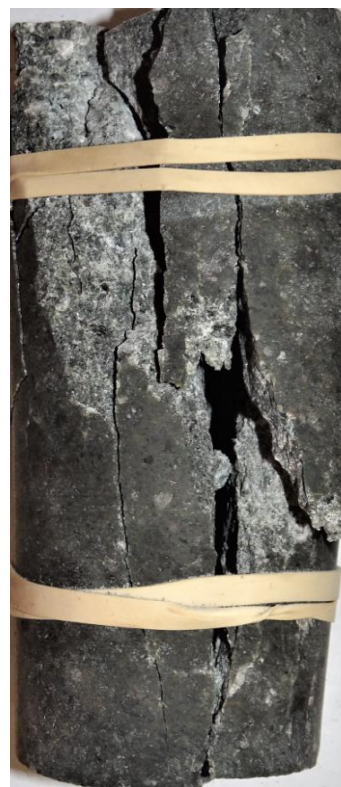
Sample Number	NC-6582C
Sample Location	Bore 13
Depth (m)	5.47 - 6.0
Rock Description	Rhyodacitic Ignimbrite
Storage History and Environment	Tested as Received
Orientation to Bedding	-
Compression Machine	Automax Multitest
Date of Testing	29.03.2021
Duration of Test (seconds)	1315
Average Diameter (mm)	51.7
Average Height (mm)	140
Height to Diameter Ratio	2.7 : 1
Moisture Content (%)	0.2
Wet Mass / Unit Volume (t/m <sup>3</sup> )	2.70
Dry Mass / Unit Volume (t/m <sup>3</sup> )	2.69
<b>Uniaxial Compressive Strength (MPa)</b>	<b>131.4</b>
Comments

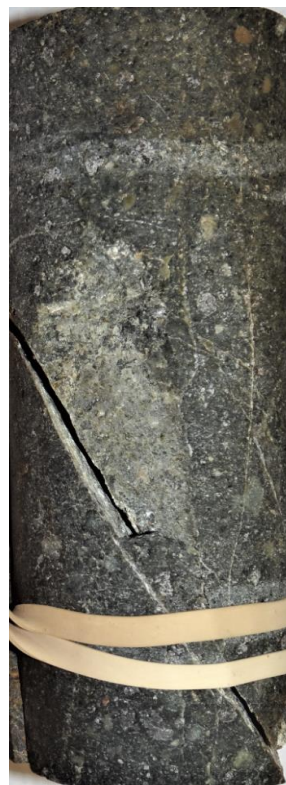
Sample Number	NC-6582D
Sample Location	Bore 3
Depth (m)	6.65 - 7.0
Rock Description	Rhyodacitic Ignimbrite
Storage History and Environment	Tested as Received
Orientation to Bedding	-
Compression Machine	Automax Multitest
Date of Testing	29.03.2021
Duration of Test (seconds)	315
Average Diameter (mm)	51.7
Average Height (mm)	129
Height to Diameter Ratio	2.5 : 1
Moisture Content (%)	0.6
Wet Mass / Unit Volume (t/m <sup>3</sup> )	2.72
Dry Mass / Unit Volume (t/m <sup>3</sup> )	2.70
<b>Uniaxial Compressive Strength (MPa)</b>	<b>34.0</b>
Comments

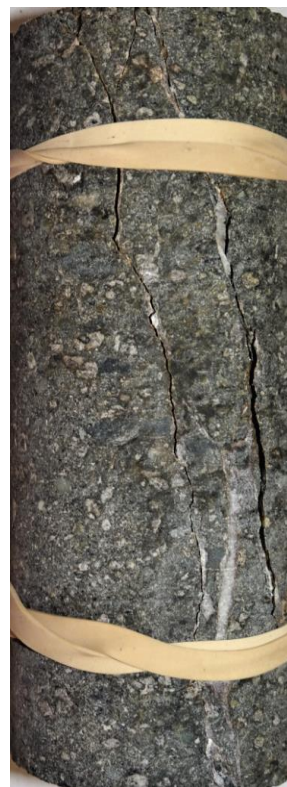
Sample Number	NC-6582G
Sample Location	Bore 4
Depth (m)	5.7 - 6.0
Rock Description	Rhyodacitic Ignimbrite
Storage History and Environment	Tested as Received
Orientation to Bedding	-
Compression Machine	Automax Multitest
Date of Testing	29.03.2021
Duration of Test (seconds)	292
Average Diameter (mm)	51.7
Average Height (mm)	137
Height to Diameter Ratio	2.7 : 1
Moisture Content (%)	0.8
Wet Mass / Unit Volume (t/m <sup>3</sup> )	2.72
Dry Mass / Unit Volume (t/m <sup>3</sup> )	2.69
<b>Uniaxial Compressive Strength (MPa)</b>	<b>31.4</b>
Comments

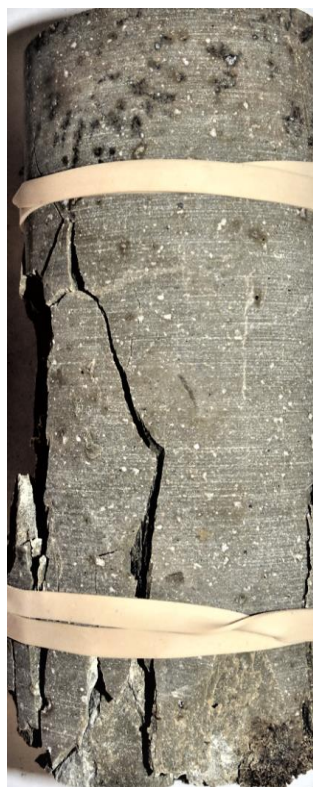
Sample Number	NC-6582H
Sample Location	Bore 8
Depth (m)	5.29 - 5.54
Rock Description	Rhyodacitic Ignimbrite
Storage History and Environment	Tested as Received
Orientation to Bedding	-
Compression Machine	Automax Multitest
Date of Testing	29.03.2021
Duration of Test (seconds)	1164
Average Diameter (mm)	51.7
Average Height (mm)	133
Height to Diameter Ratio	2.6 : 1
Moisture Content (%)	1.0
Wet Mass / Unit Volume (t/m <sup>3</sup> )	2.69
Dry Mass / Unit Volume (t/m <sup>3</sup> )	2.66
<b>Uniaxial Compressive Strength (MPa)</b>	<b>116.3</b>
Comments

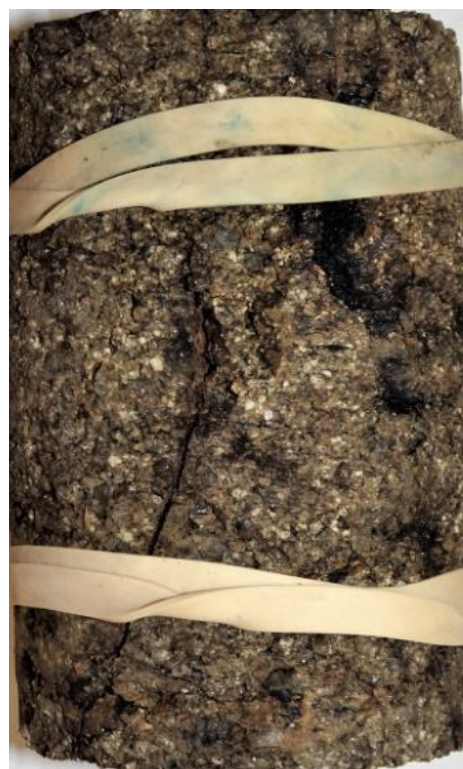
Sample Number	NC-6582I
Sample Location	Bore 9
Depth (m)	6.13 - 6.3
Rock Description	Rhyodacitic Ignimbrite
Storage History and Environment	Tested as Received
Orientation to Bedding	-
Compression Machine	Automax Multitest
Date of Testing	29.03.2021
Duration of Test (seconds)	13
Average Diameter (mm)	51.6
Average Height (mm)	87
Height to Diameter Ratio	1.7 : 1
Moisture Content (%)	4.2
Wet Mass / Unit Volume (t/m <sup>3</sup> )	2.41
Dry Mass / Unit Volume (t/m <sup>3</sup> )	2.31
<b>Uniaxial Compressive Strength (MPa)</b>	<b>2.8</b>
Comments
