Realty Realizations Pty Ltd
c/o Allen Price and Associates Pty Ltd

Geotechnical Constraints Assessment
Lot 61 DP 755971 and Part of Lot 6
DP1065111, Culburra Road, West
Culburra, NSW.

P1002842JR02V01
November 2012

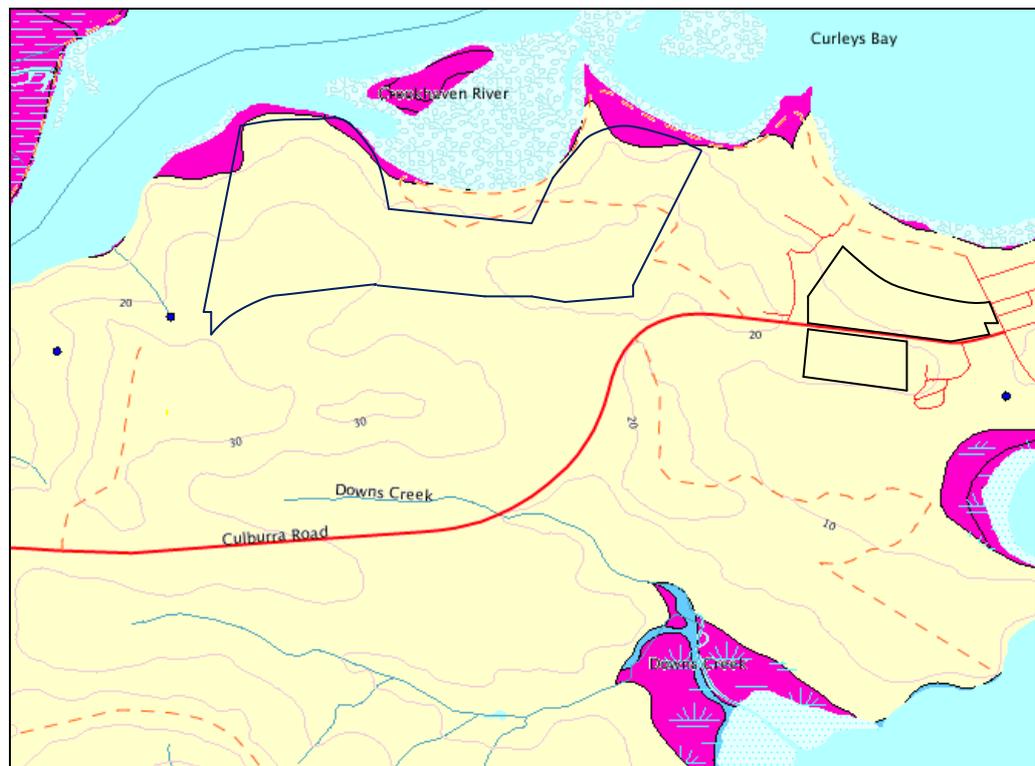
Figure 2: Acid Sulfate Soils Risk Map (NSW Natural Resource Atlas).

Review of the NSW Natural Resource Atlas acid sulphate soils risk map (see Figure 2) indicates that perimeter areas of the site, most notably adjacent to Crookhaven River Estuary are classified as Class 2 (works below the ground surface). In consideration of ASS risk to the development, it is noted that a 100 m foreshore set-back distance is required for the proposed development.

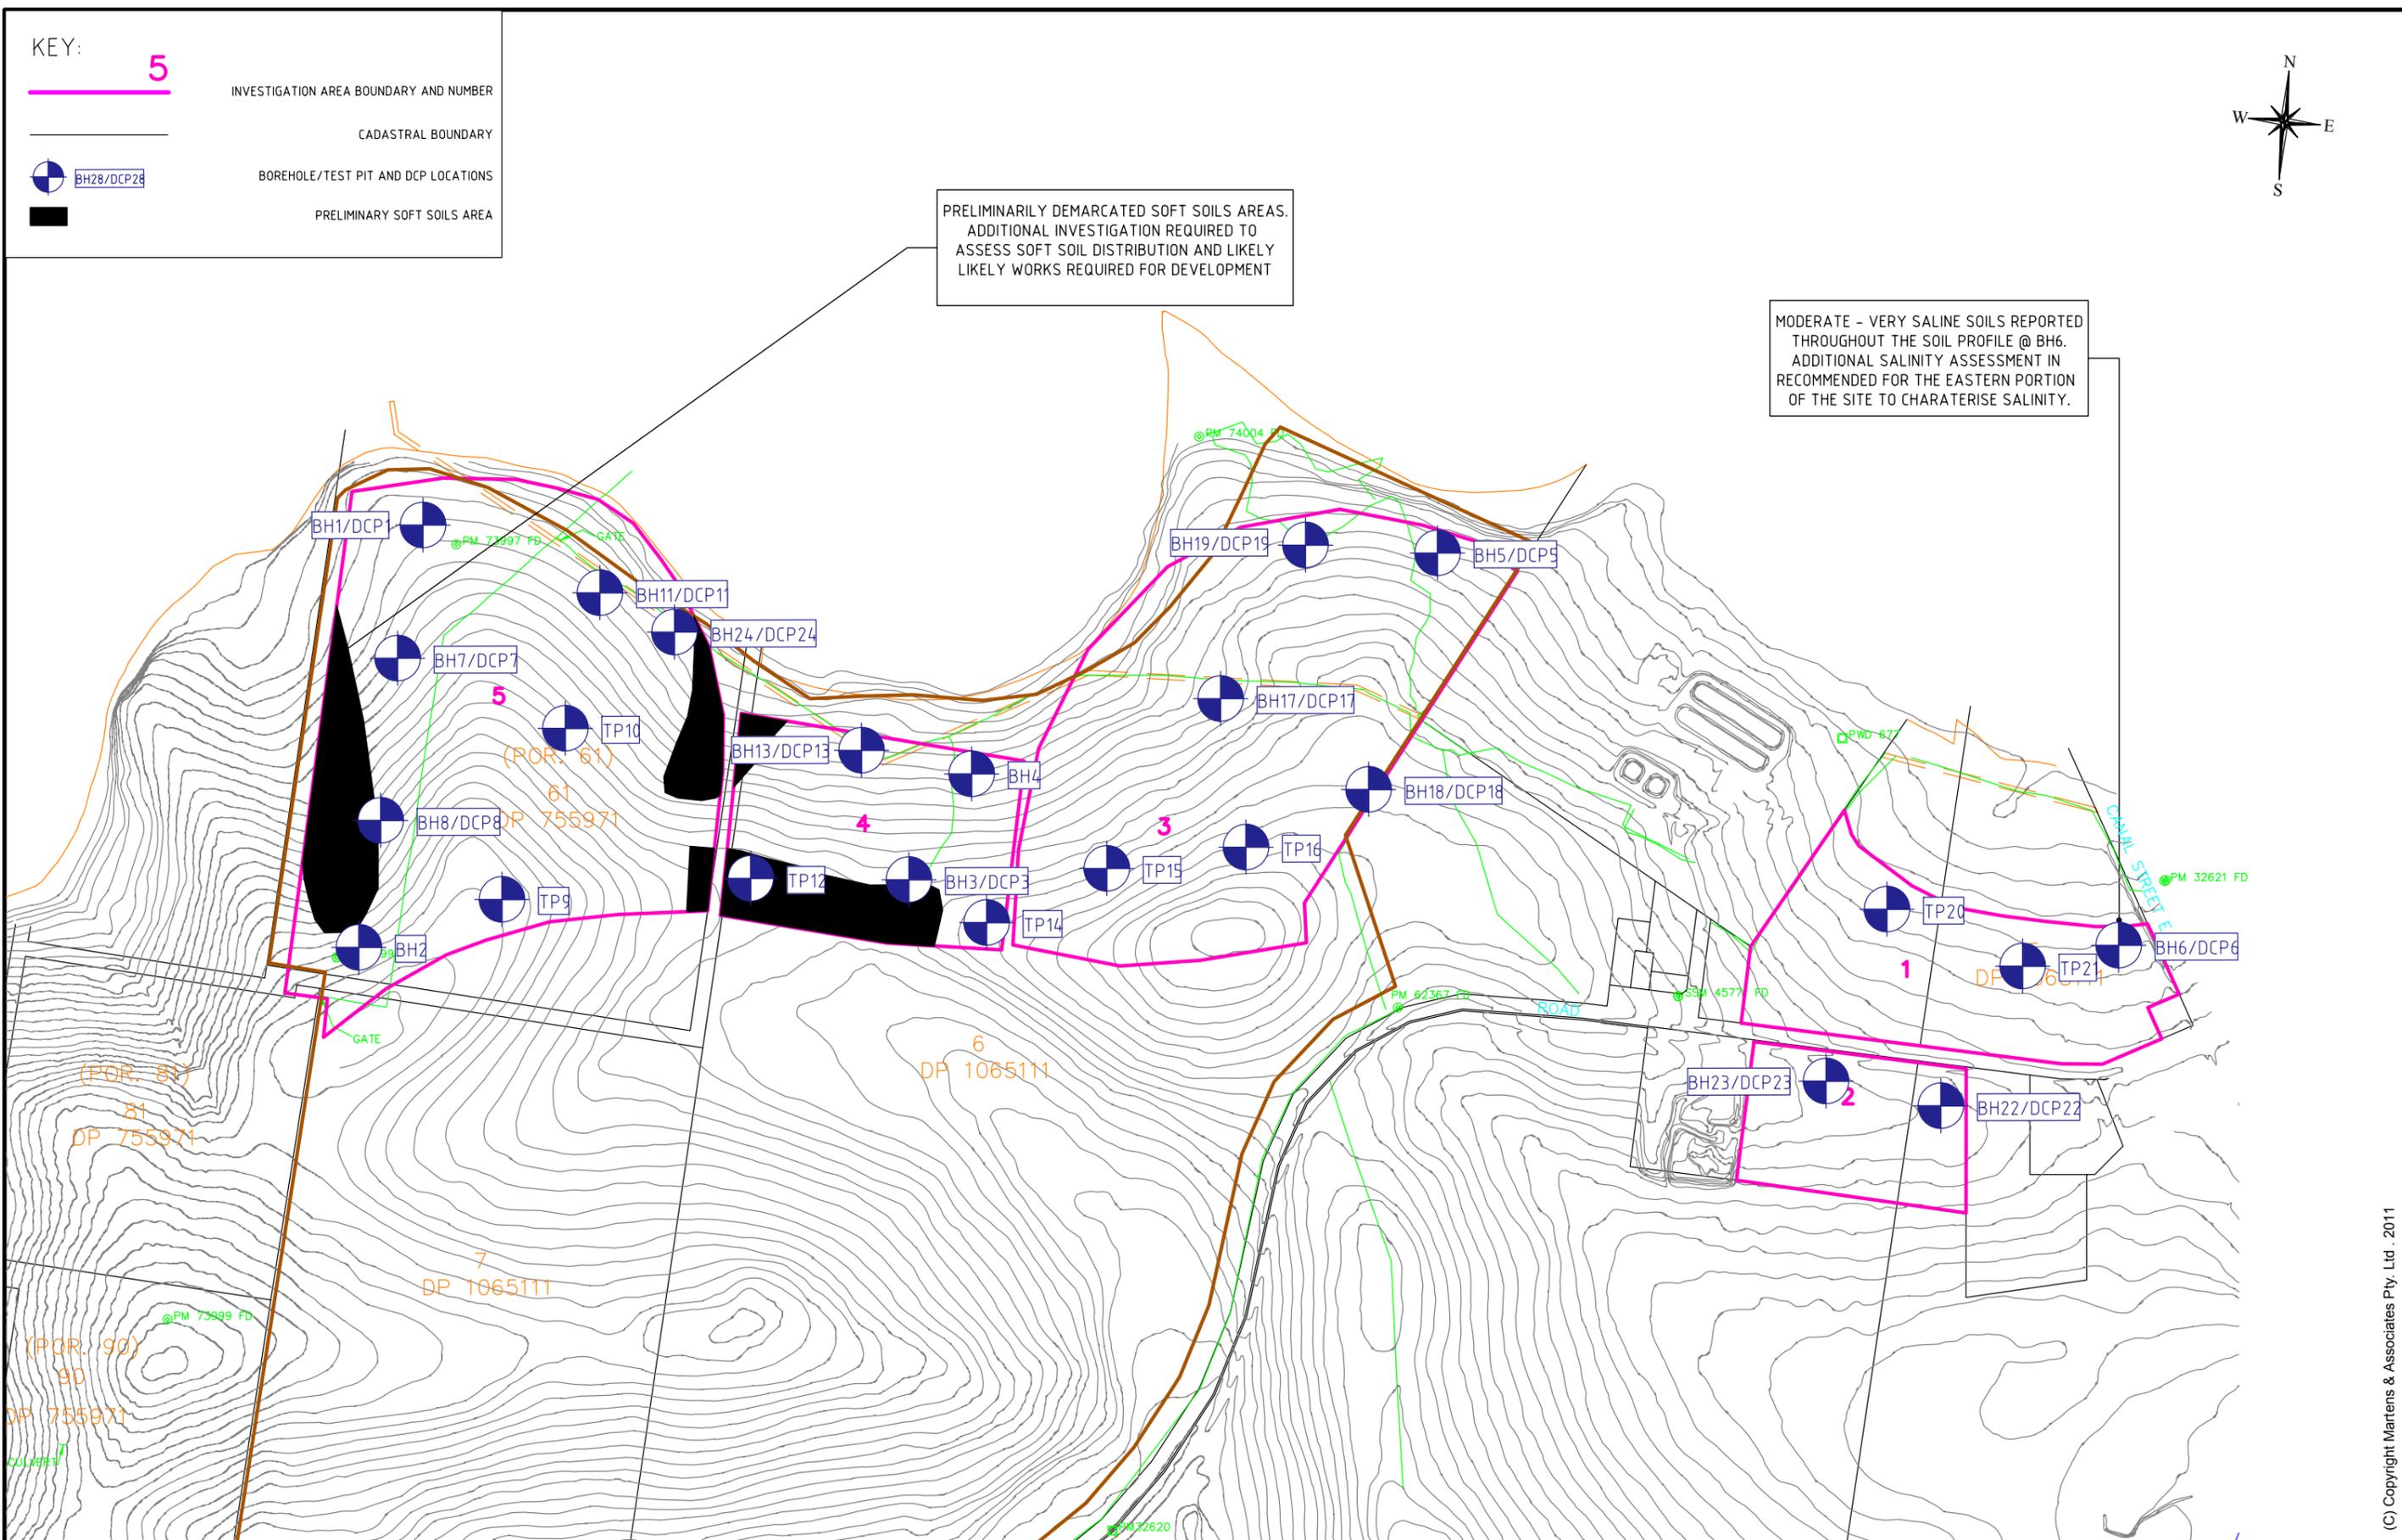
PRELIMINARILY DEMARCATED SOFT SOILS AREAS.
ADDITIONAL INVESTIGATION REQUIRED TO
ASSESS SOFT SOIL DISTRIBUTION AND LIKELY
LIKELY WORKS REQUIRED FOR DEVELOPMENT

MODERATE - VERY SALINE SOILS REPORTED
THROUGHOUT THE SOIL PROFILE @ BH6.
ADDITIONAL SALINITY ASSESSMENT IN
RECOMMENDED FOR THE EASTERN PORTION
OF THE SITE TO CHARACTERISE SALINITY.

Localised soft soils were identified during site works, and approximate locations are presented in Attachment A. These areas were observed in drainage depressions or areas of extreme low relief associate with

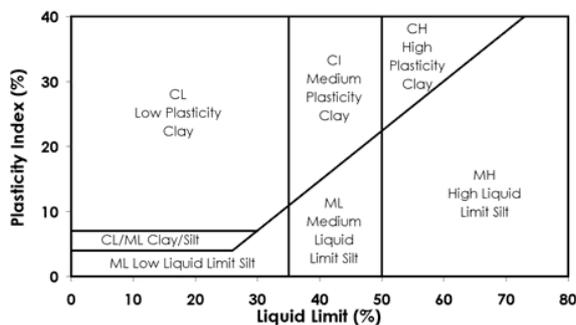
Plasticity properties can be assessed either in the field by tactile properties, or by laboratory procedures.
