GEOTECHNICAL INVESTIGATION REPORT:

161 SUSSEX STREET REDEVELOPMENT, SYDNEY, NSW
PREPARED FOR GL INVESTMENT CO PTY LTD ATF GL NO1 TRUST
c/o CADENCE AUSTRALIA PTY LTD
CES DOCUMENT REFERENCE: CES111206-CA-AD

Revision 2

Date: 29 May 2012

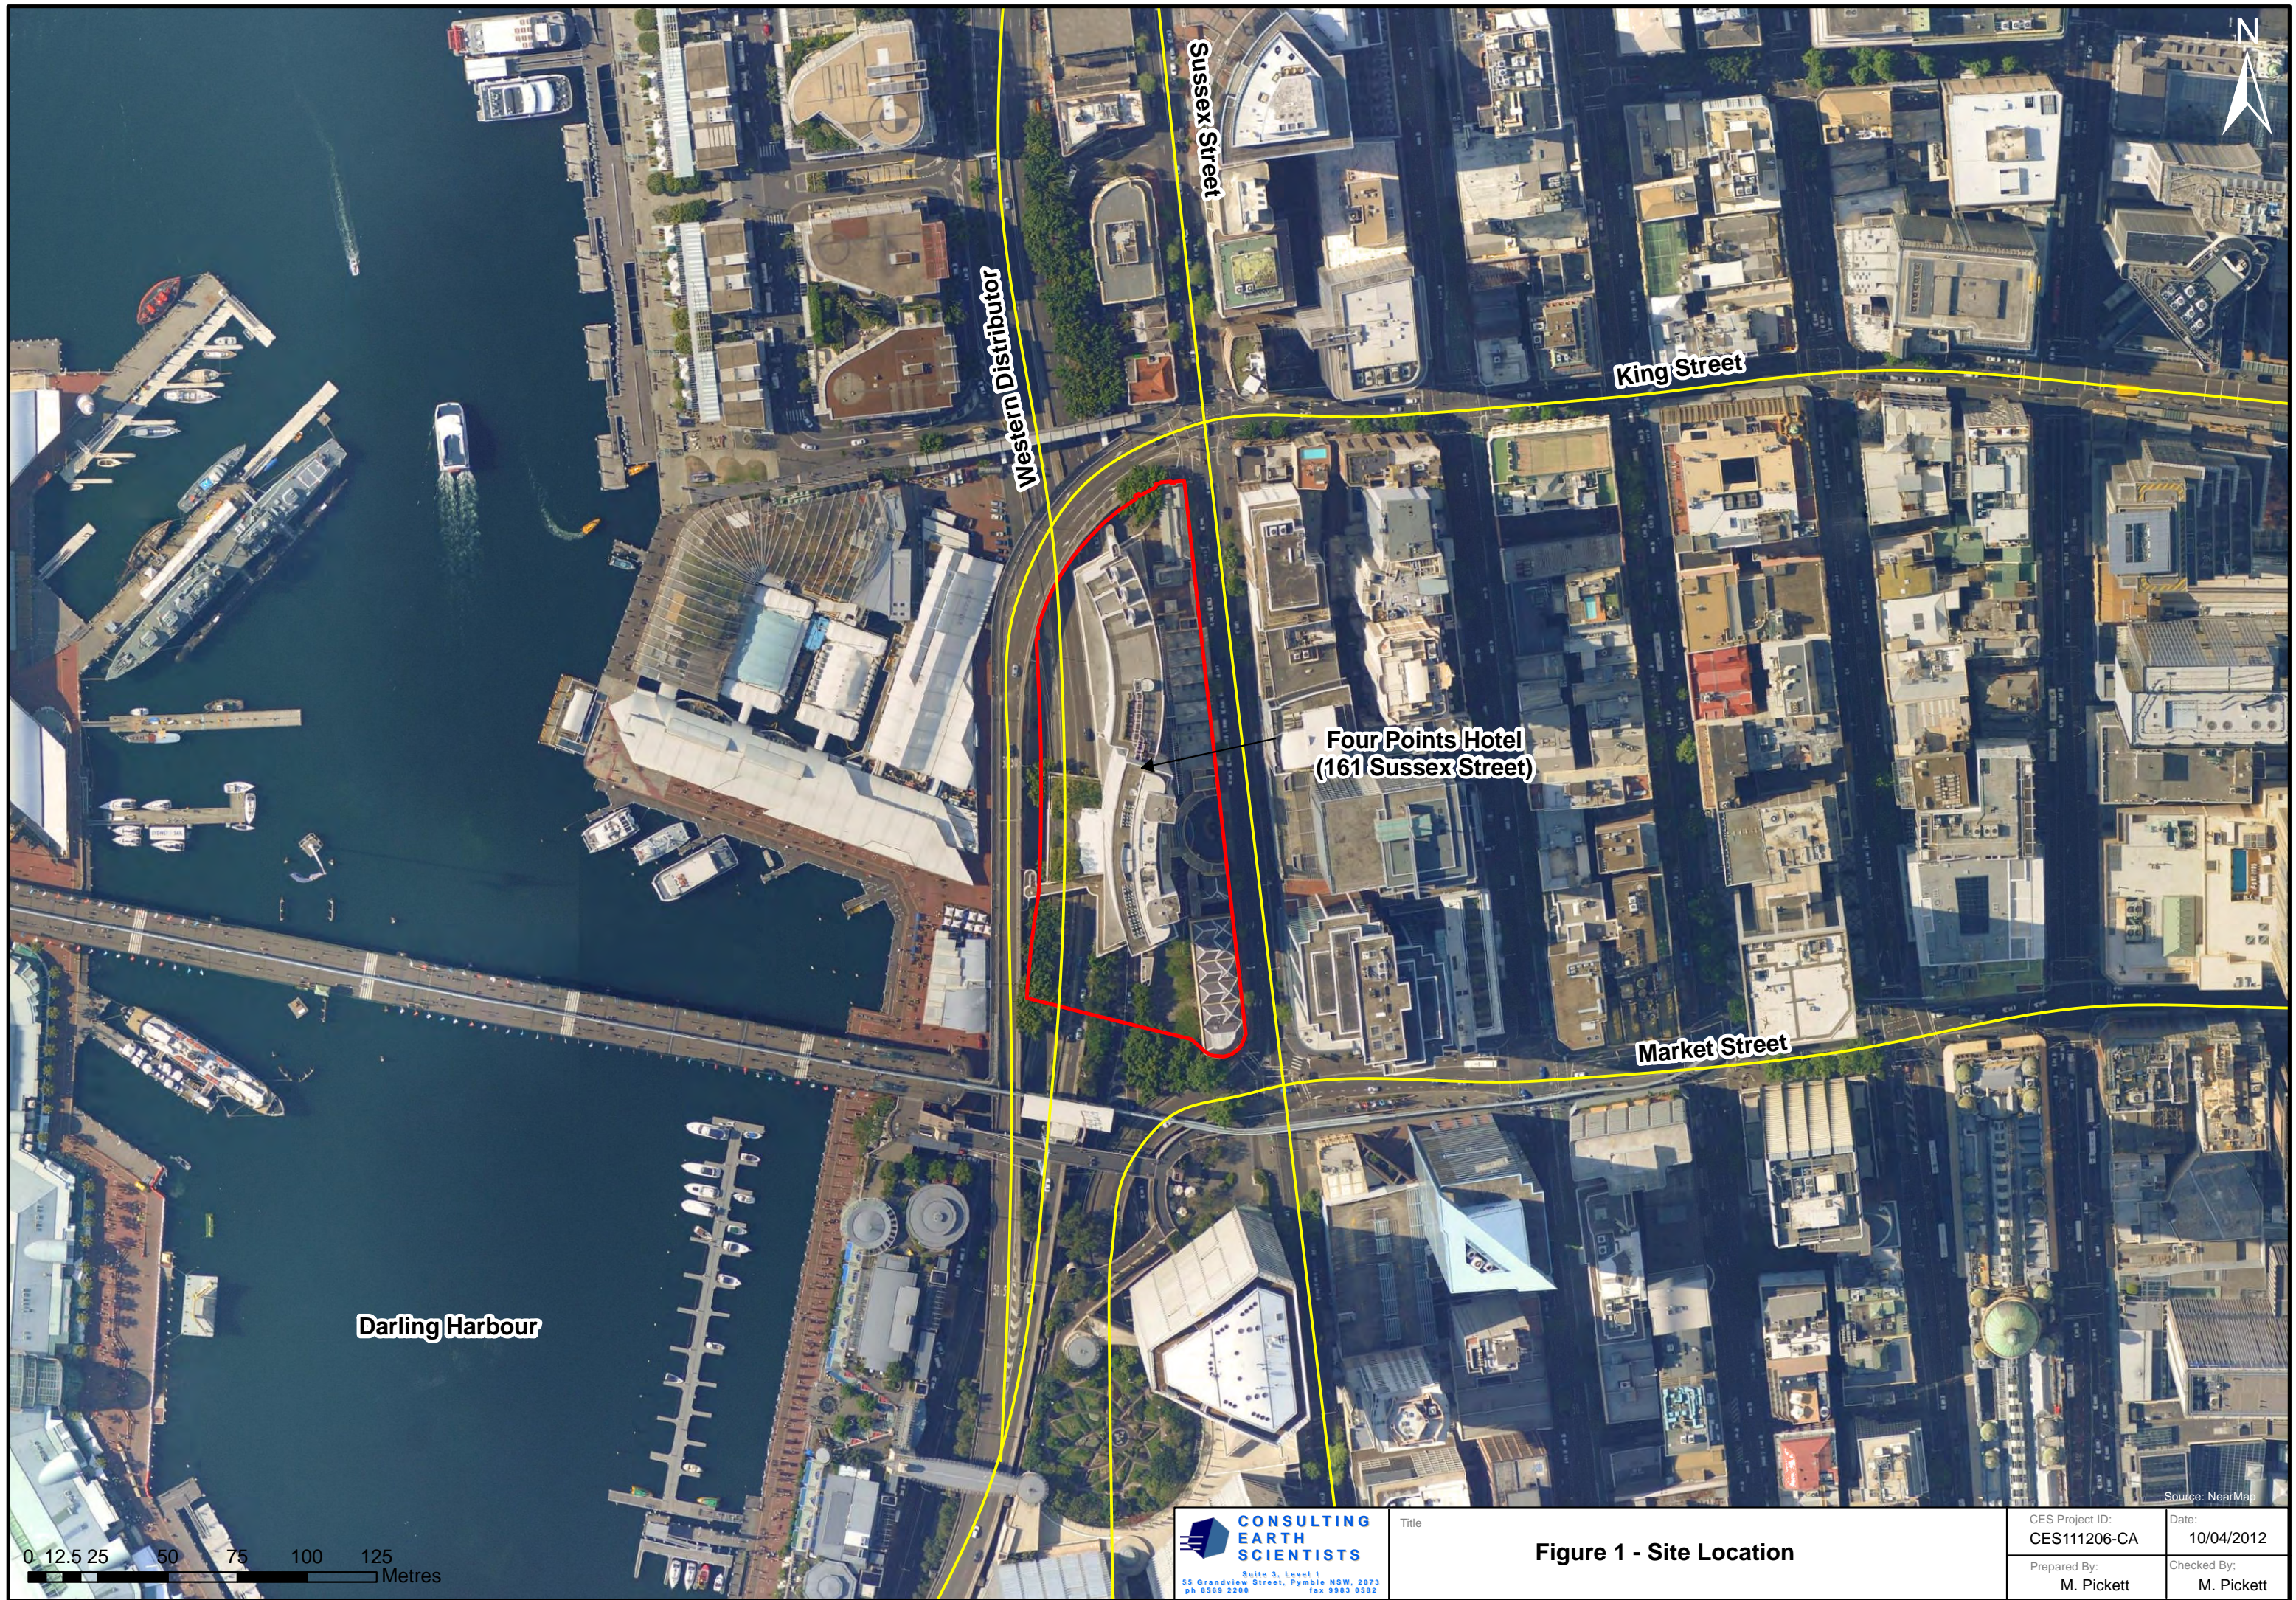
Figure 1 - Site Location

The site is located at 161 Sussex Street, Sydney NSW which is approximately 50m east of the Sydney Aquarium, 500m north west of the Sydney CBD and 500m south west of Wynyard Railway Station. The site location is shown in Figure 1.

Consulting Earth Scientists Pty Ltd (CES) has been commissioned by Cadence Australia Pty Ltd (Cadence) on behalf of GL Investment Co Pty Ltd ATF GL No1 Trust (the Client), to undertake a geotechnical investigation for the 161 Sussex Street Redevelopment, Sydney, NSW (herein referred to as the Site). This geotechnical report was undertaken in general accordance with our proposal dated 15 December 2011 (CES document referenced: CES111206-CA-AA). The site location is shown on Figure 1.

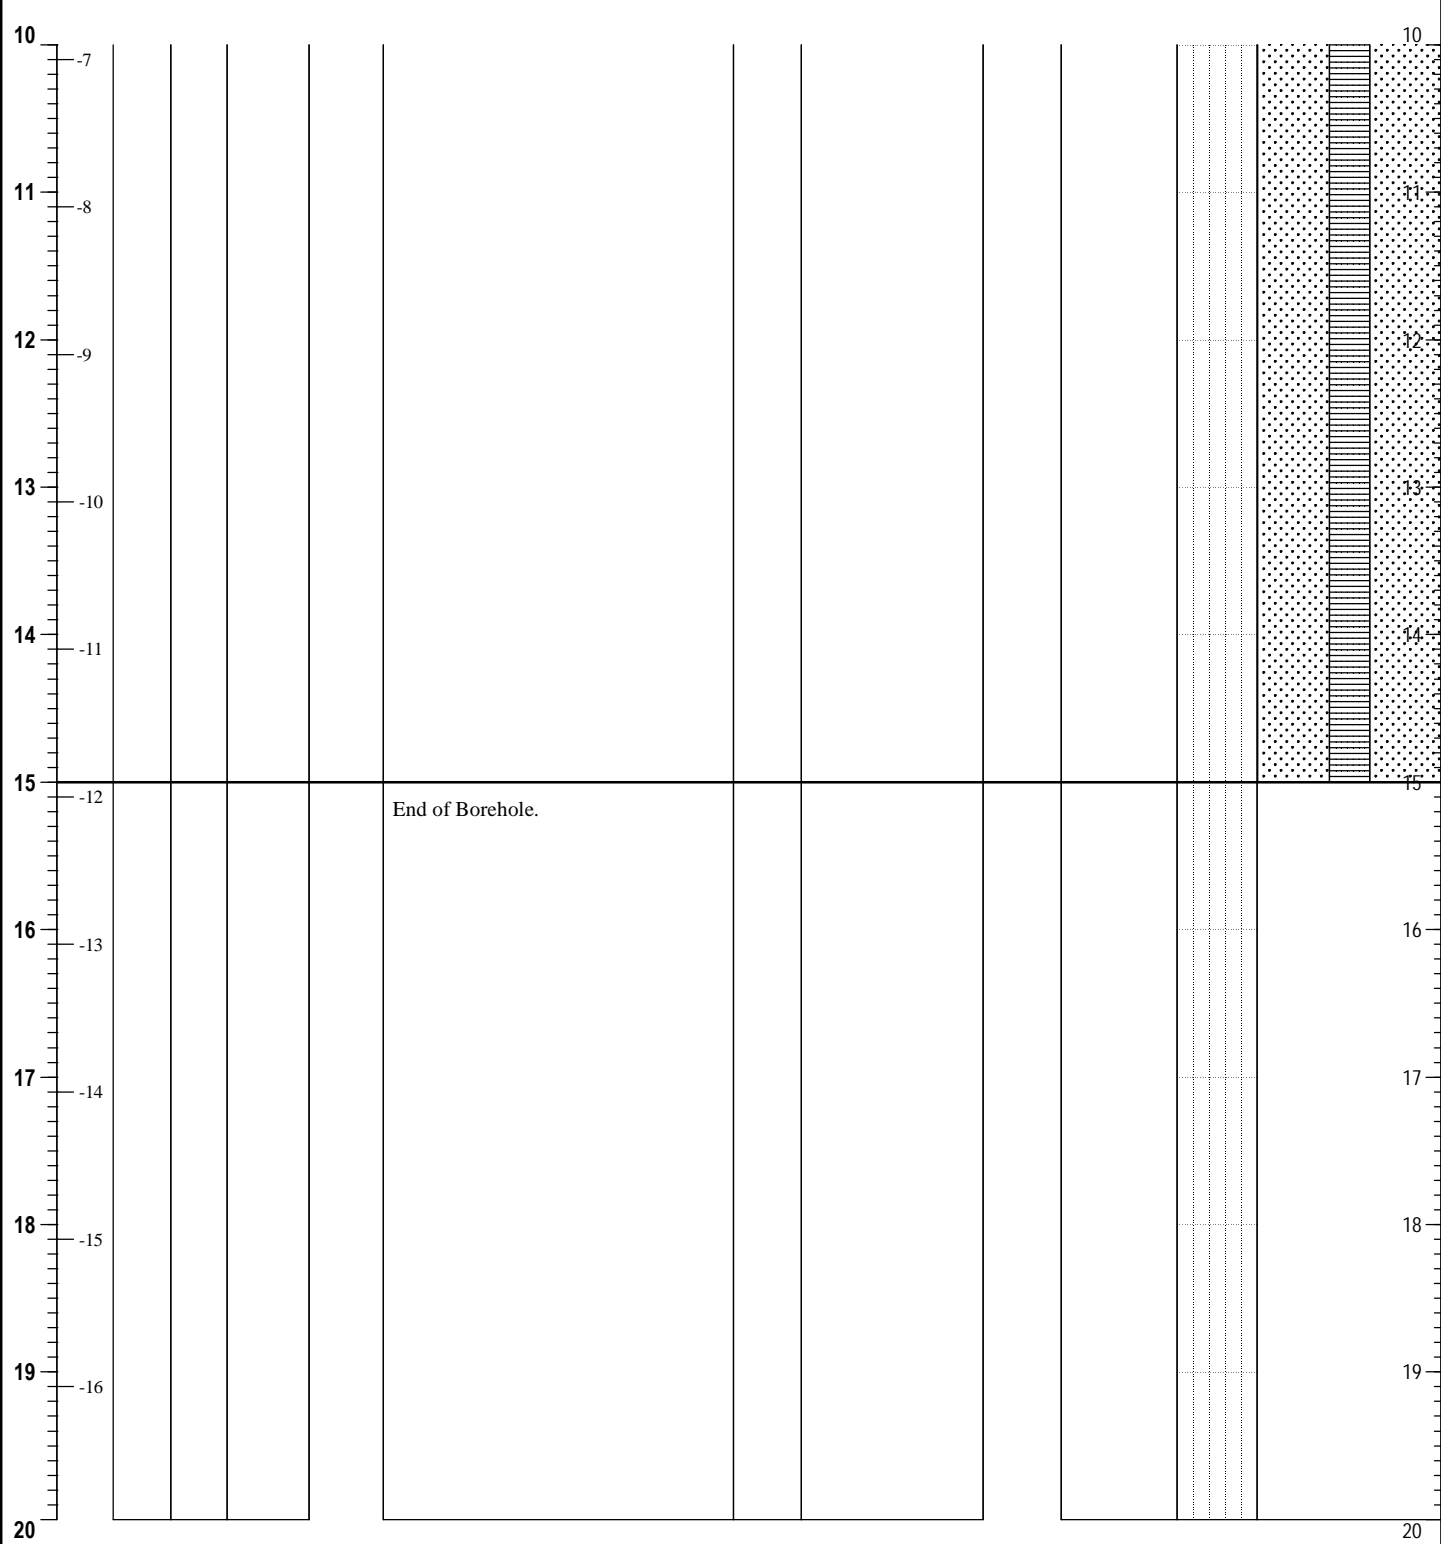
X-Coord: 333824	GDA 94 MGA 56	Date Commenced: 26/04/2012	Logged by: MTP
Y-Coord: 6250726		Date Completed: 26/04/2012	Checked by: MTP
Surface Elevation (R.L.) : 3.10 m AHD		Hole Diameter (mm): 100mm

Drilling Information				LITHOLOGY			Samples		Tests		Well Installation Detail
Depth (mBGL)	R.L. (m)	Method (Support)	Water	Symbol	USCS Symbol	Description <small>SOIL TYPE: plasticity or particle characteristics colour, moisture, secondary and minor components</small>	Consistency / Density	Sample ID	Type	SPT	Pocket Penetrometer (kPa) <small>100 200 300 400</small>

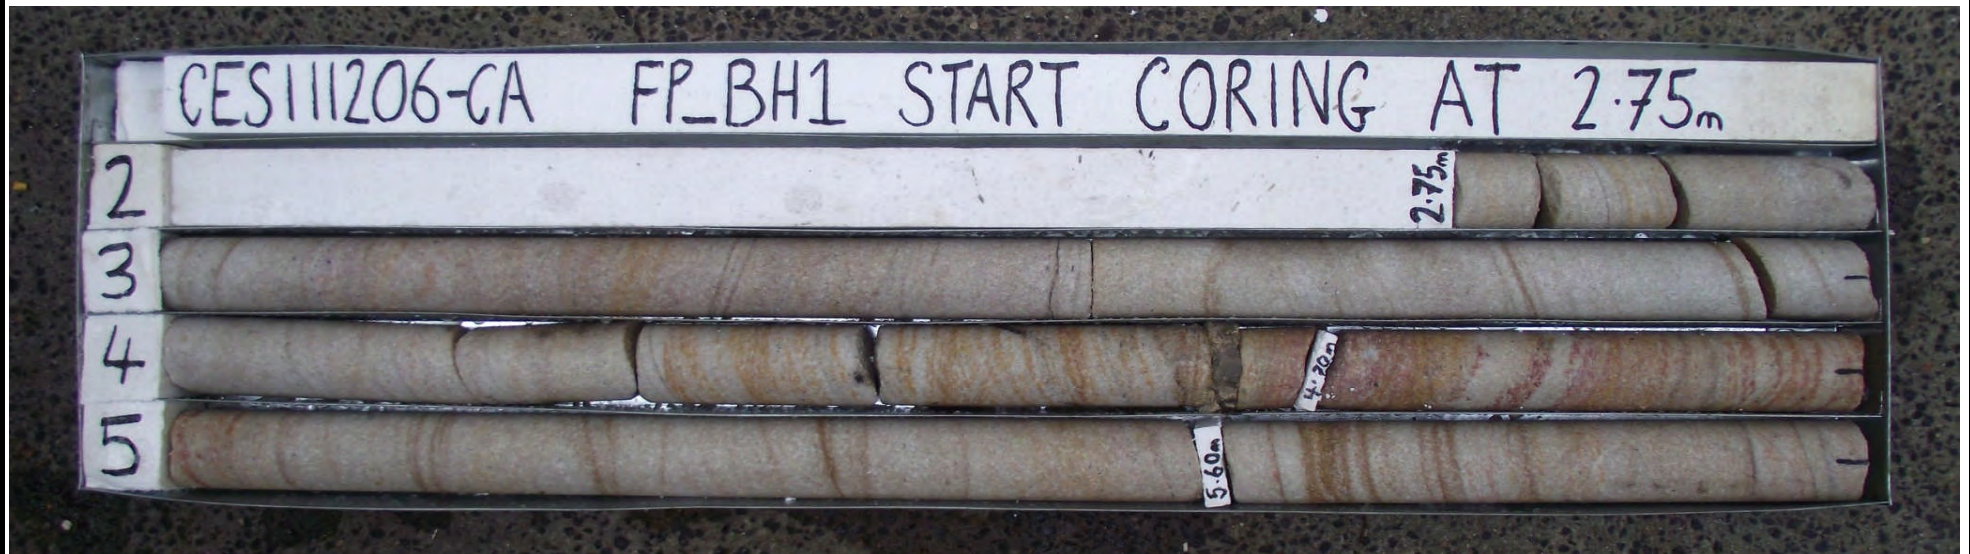
Date:	26/04/2012	Title:	FP_BH1 Four Points 2.75m to 6.00m
Prepared by:	M. Pickett		
Checked by:	D. Lowe	CES Project ID:	CES111206-CA
Scale:	NTS		
Size:	A4	Client:	Cadence Australia

Rotary coring techniques were implemented to advance boreholes in rock. Recovered rock core was boxed onsite, photographed and taken to a core storage facility. Groundwater levels and inflows observed during fieldwork were also recorded. Groundwater monitoring wells were installed in boreholes FP_BH1, FP_BH4 and FP_BH5. These were installed as part of the environmental investigation and to facilitate assessment of fluctuations in groundwater levels. Where monitoring instrumentation was not installed, the boreholes were backfilled with soil cuttings and sand and capped with concrete.
