Wallarrah 2 Coal Project

Environmental Impact Statement

Aquatic Ecology
Impact Assessment

AQUATIC ECOLOGY IMPACT ASSESSMENT

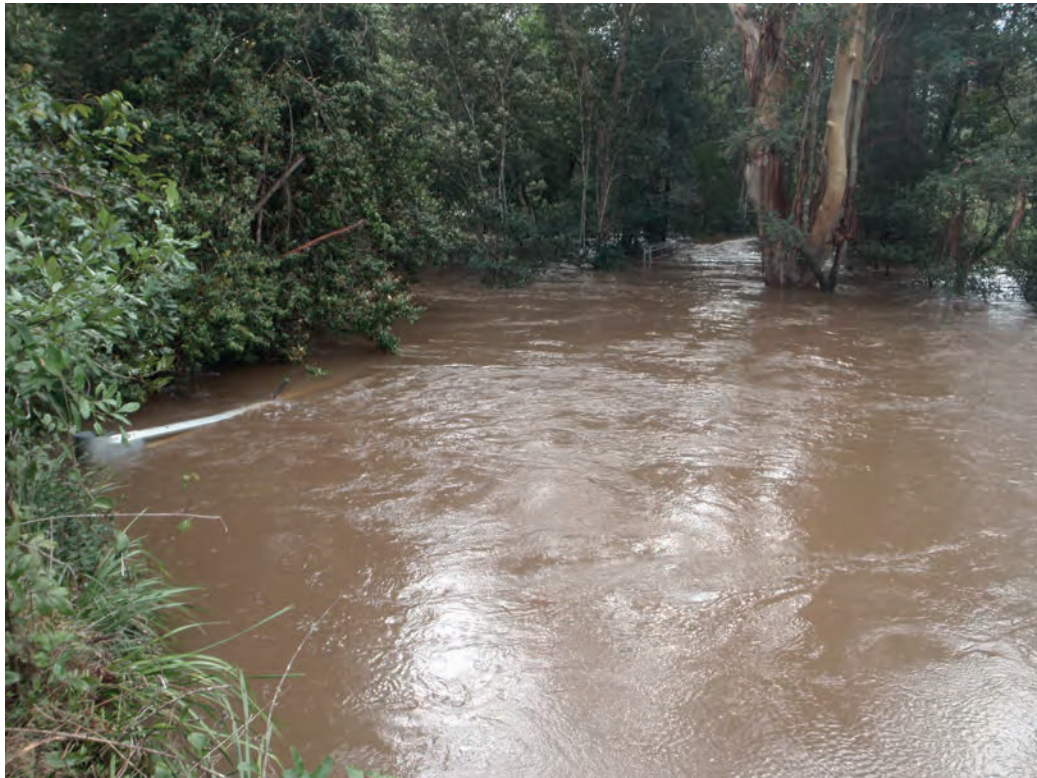
Figure 10 Wyong River flood 14 June 11 showing inundated road bridge at site WR2
As **Table 7** shows, the flow volumes in the Wyong River were considerably higher than

In the month prior to the commencement of sampling there were two flood events associated with the aforementioned heavy rainfall periods. The first extended rainfall occurred in late May to early June in which 158mm fell over two weeks and caused the creek and river levels to rise to 2.1m in Jilliby Jilliby Creek and 2.3m in Wyong River. The larger rainfall event during mid June in which 234mm of rain fell over six days resulted in water levels rises to 4.4m in Jilliby Jilliby Creek and 5.8m in Wyong River. At all sites there was evidence of recent high flows, with debris lines in trees and fences, fallen trees, eroded and slumping banks and scouring of bank vegetation (**Figure 10**).

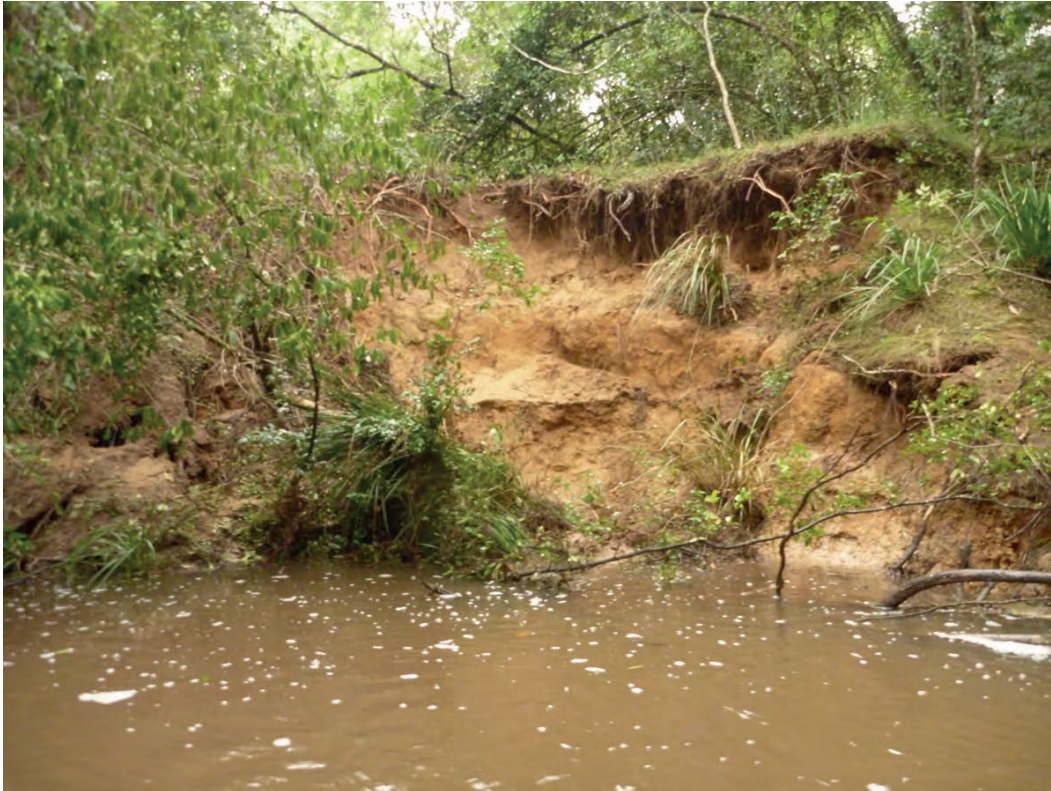
Figure 11 Bank erosion from flood-induced tree slumping in Jilliby Jilliby Creek.

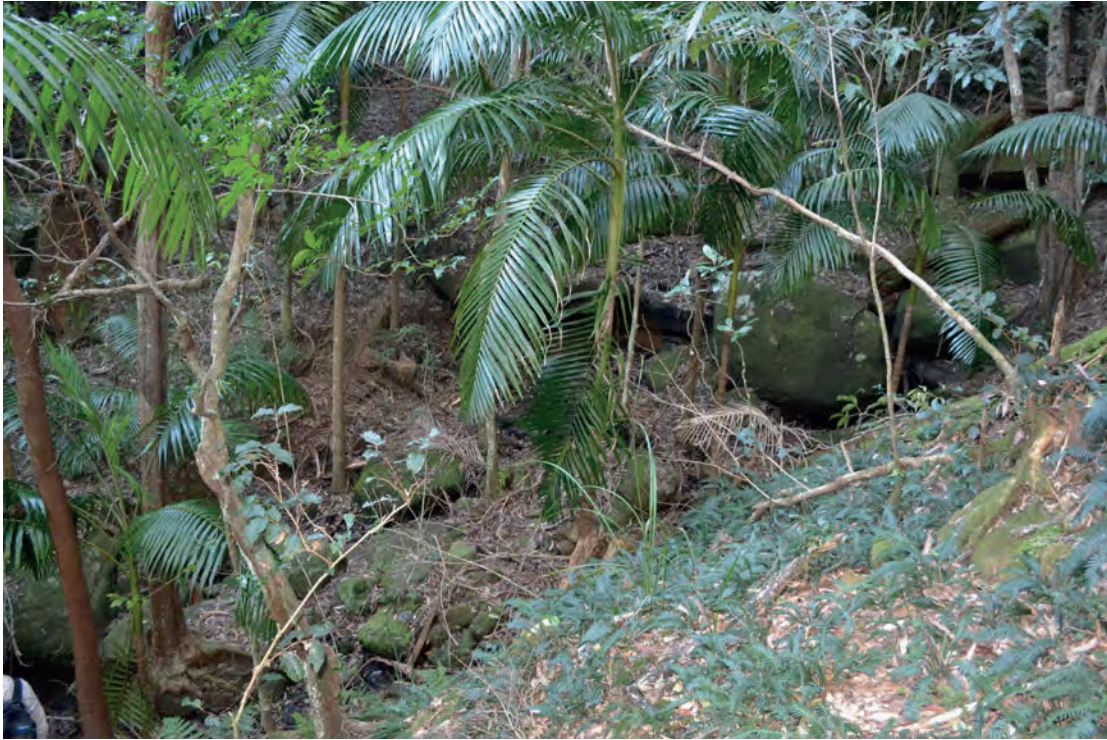
Figure 12 View of Little Jilliby Jilliby Creek (East Arm) headwaters showing broad V shaped gully with exposed broken rock in the gully (looking upstream 250 m down slope of headwaters)

In the main, the upper first-order drainage sections comprised broad V shaped gullies with exposed broken rock and no aquatic habitats. As these first order drainages come together the drainage lines become cascade rock lined with no exposed basement rock, and pockets of sediment or vegetation/litter infill. These upper second-order drainages show evidence of ephemeral flows but there are no indications of any semi-permanent aquatic habitats of long-tail seepages. These features are illustrated in **Figures 12 and 13** that show the first-order and upper second-order sections of Little Jilliby Jilliby Creek (east) to around 400 m downstream.

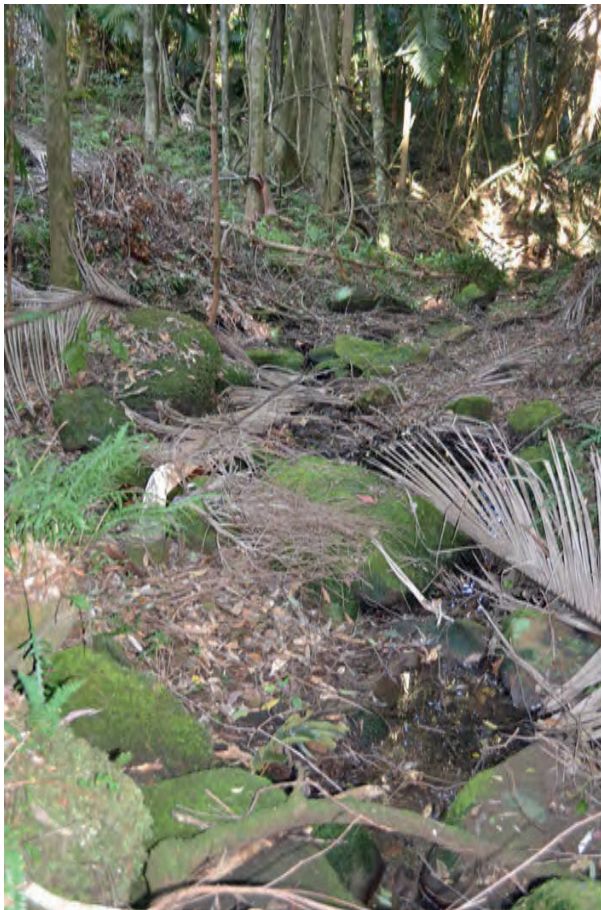
Figure 13 Little Jilliby Jilliby Creek (East Arm) 400m down slope from headwaters. The creek has a cascade rock lined form with no exposed basement rock, sediment infill and occasional sediment and litter confined pools

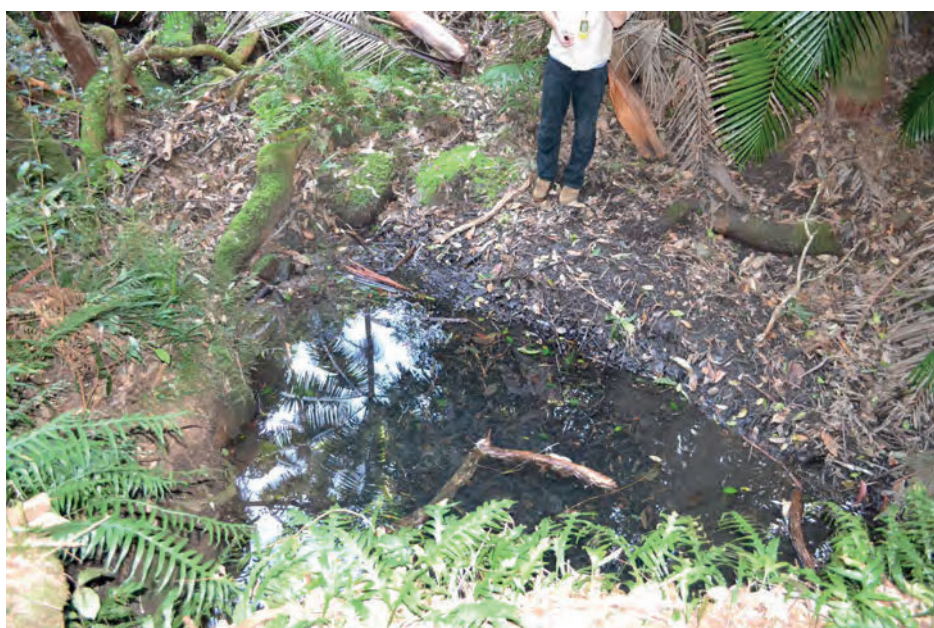
Figure 15 Little Jilliby Jilliby Creek (East Arm) 620m down slope from headwaters showing cascade rock plus sediment confined ephemeral pool. Note that there is no iron staining at this elevation (some 120m AHD).

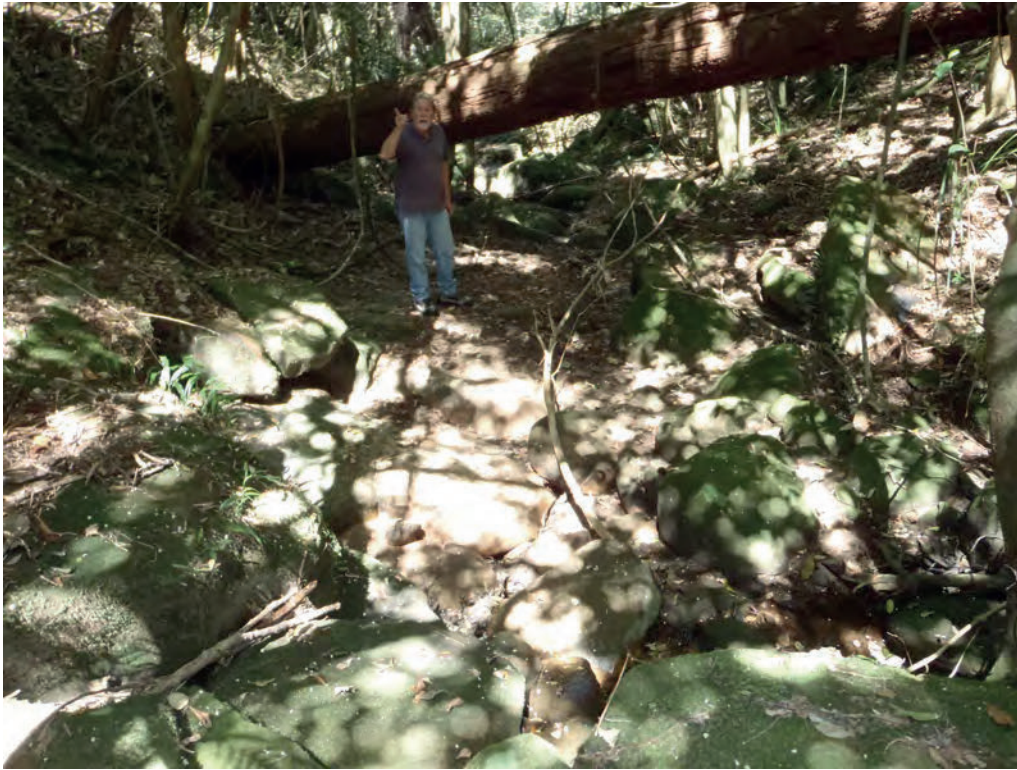
Figure 16 Upper Myrtle Creek showing wide cascade rock bed

The second-order section of Myrtle Creek shows a similar form to Little Jilliby Jilliby Creek East but the slope is less and the cascade gullies are wider and flatter with more exposed basement rock (see **Figures 16 and 17**).

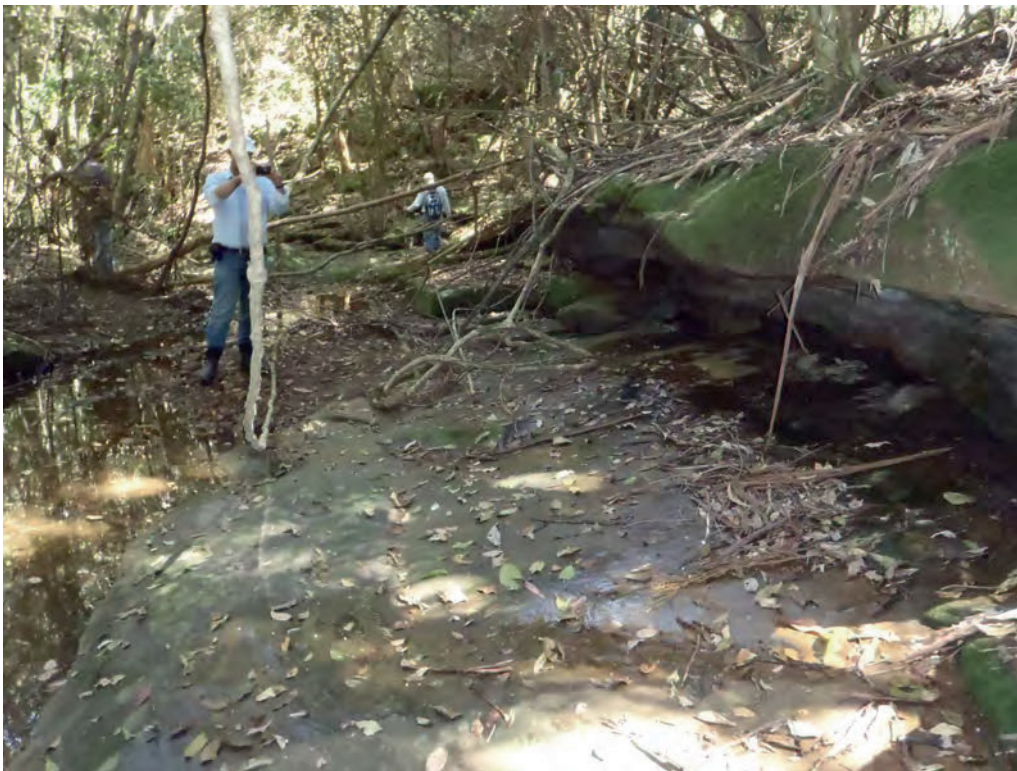
Figure 17 Upper Myrtle Creek showing exposed basement rock with seepage along the side of the creek line and a sediment constrained pool in the creek bed.

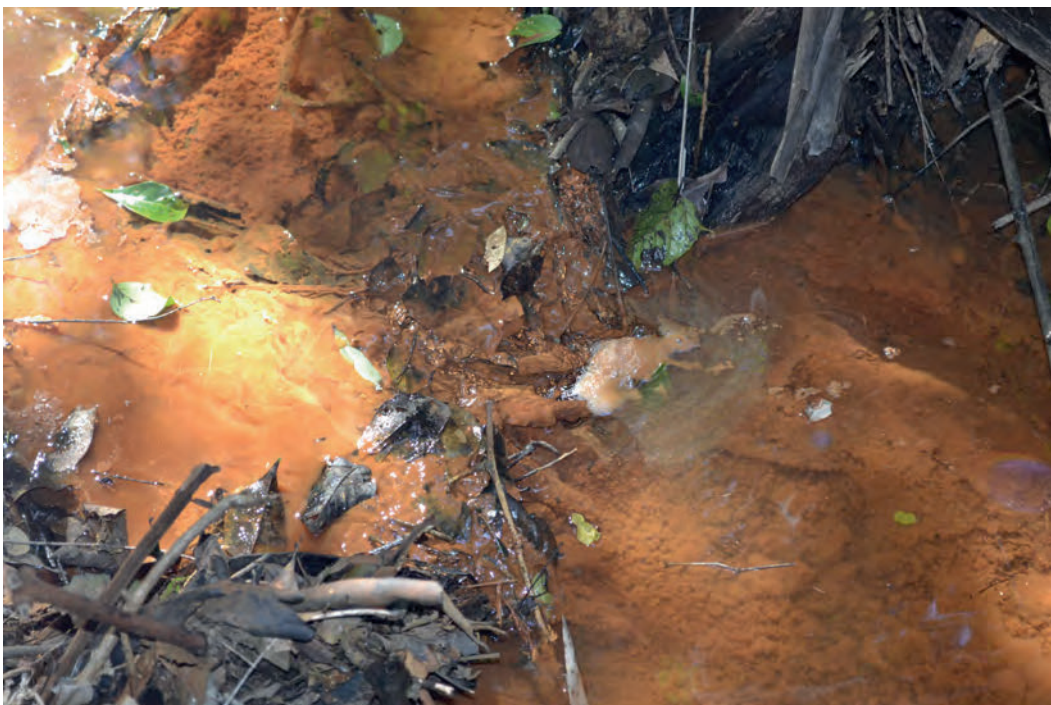
Figure 21 Creek C east of Harris Point Road Detail of iron staining and iron bacteria in the braided creek.

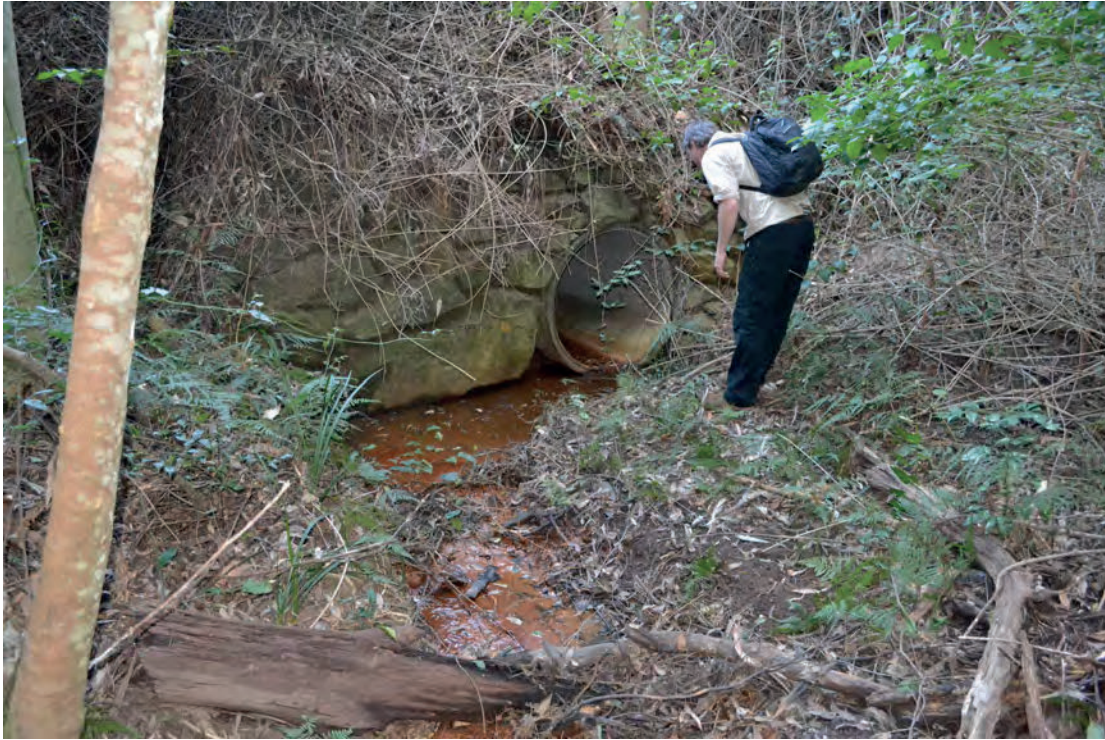
Figure 24 Armstrong Creek (north arm) showing shallow pooled iron stained water upstream of road crossing.

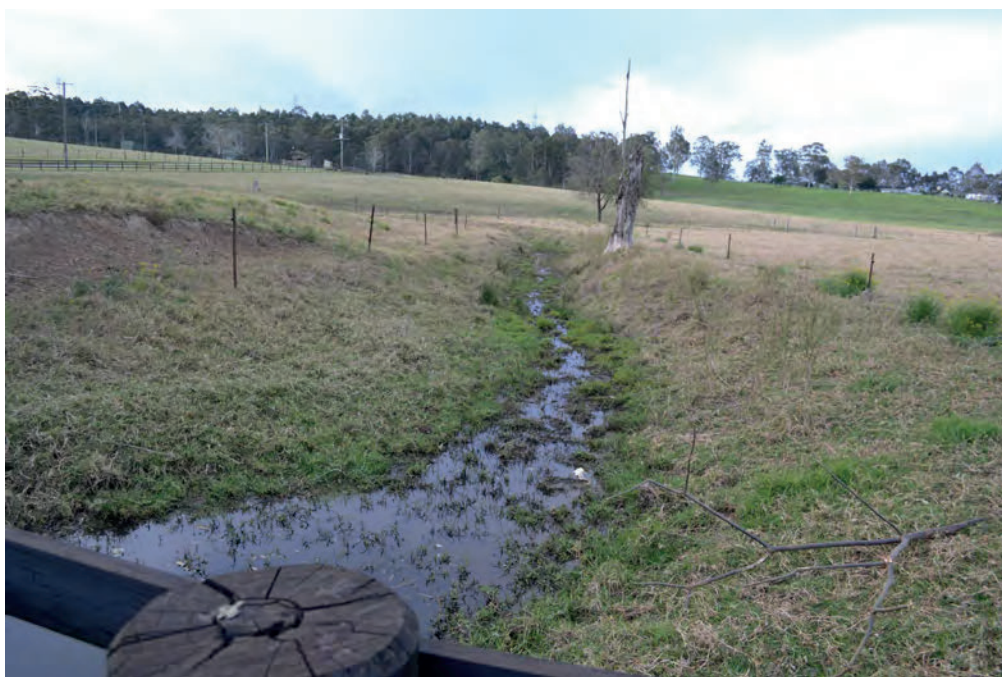
Figure 31 Baileys Road Creek Lower Crossing downstream connection to Jilliby Jilliby Creek

Whilst fish passage from lower Little Jilliby Jilliby Creek to the middle reaches of the creek is possible it is by no means guaranteed for similar creeks that flow through private lands. There are obstructions to fish passage for Armstrong Creek, Boyds Lane Creek and possibly for the lower Myrtle Creek. A number of the drainages flowing north-east to Jilliby Creek also have barriers to fish passage (see e.g., **Figure 31**).

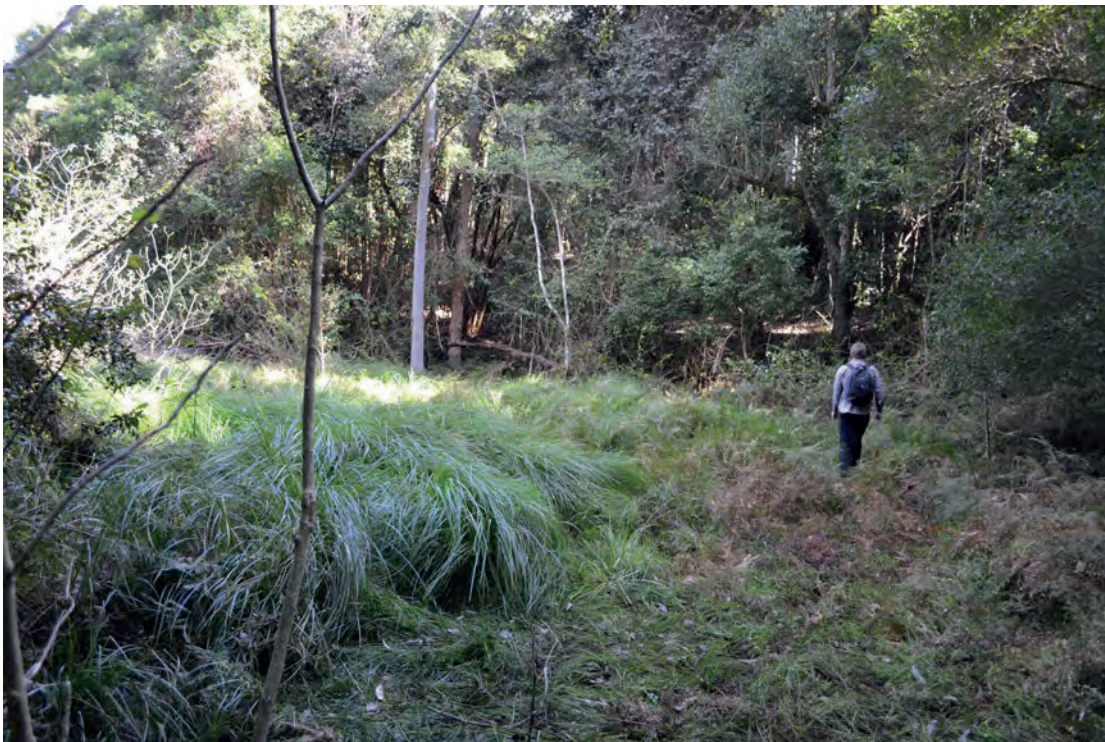
Figure 32 Creek C Overflow Sedge Swamp

In regard to the possibility of aquatic groundwater dependent ecosystems occurring in the western forested drainages, only one boggy area was observed during the survey, at the base of the braided creek system in Creek C east of Harris Point Road (**Figure 32**). This boggy area did not have any surface water expression and no indication of ponded water. It is concluded that the 'base flow' responsible for the iron staining in the upper creeks is a short-duration shallow rock flow that occurs for a little time after rainfall and after surface runoff ceases. These flows are not sufficient to sustain pools and therefore there are no significant surface water aquatic GDEs.

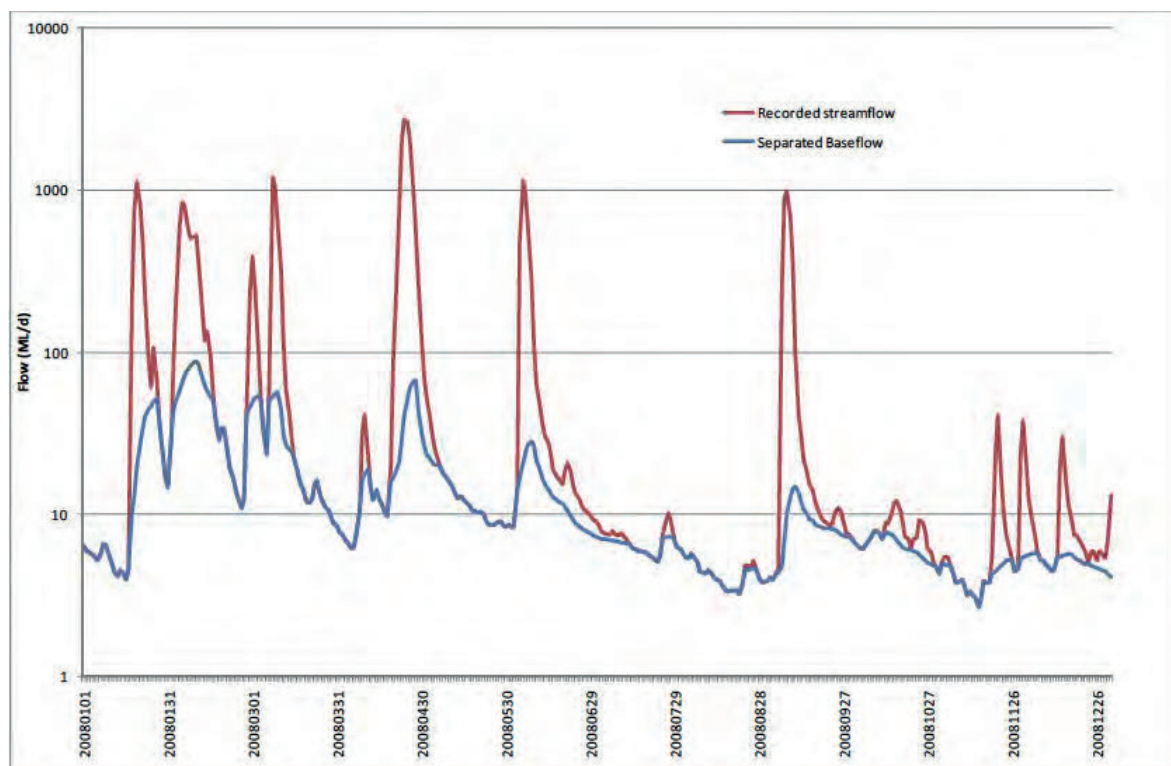
Figure 33 Modelled baseflow estimates for Jilliby Jilliby Creek at Stream Gauge 211010 for 2008 (from SKM 2010).

The alluvial unconsolidated deposits form heterogeneous aquifers with variable storage and transmissivity ranging from 0.1 to 5 m/day (MER 2013). Groundwater levels within the alluvial aquifers indicate that the typical saturated thickness of the Quaternary sediments ranges from 2 m to greater than 30 m. Some of the wetlands in the valleys may have windows to the alluvial groundwater and some dams are most probably constructed to intercept the alluvial groundwater.

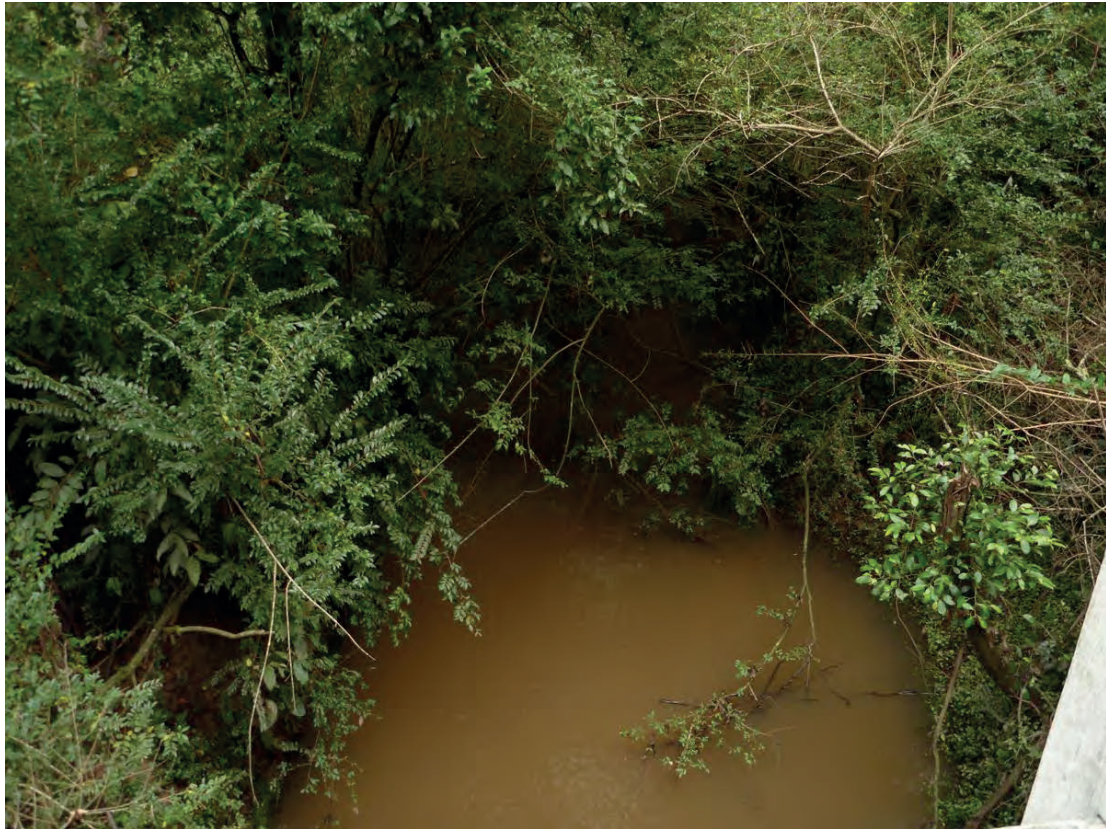
Plate 8: Looking upstream along edge banks in WR3. Note the undercut banks.

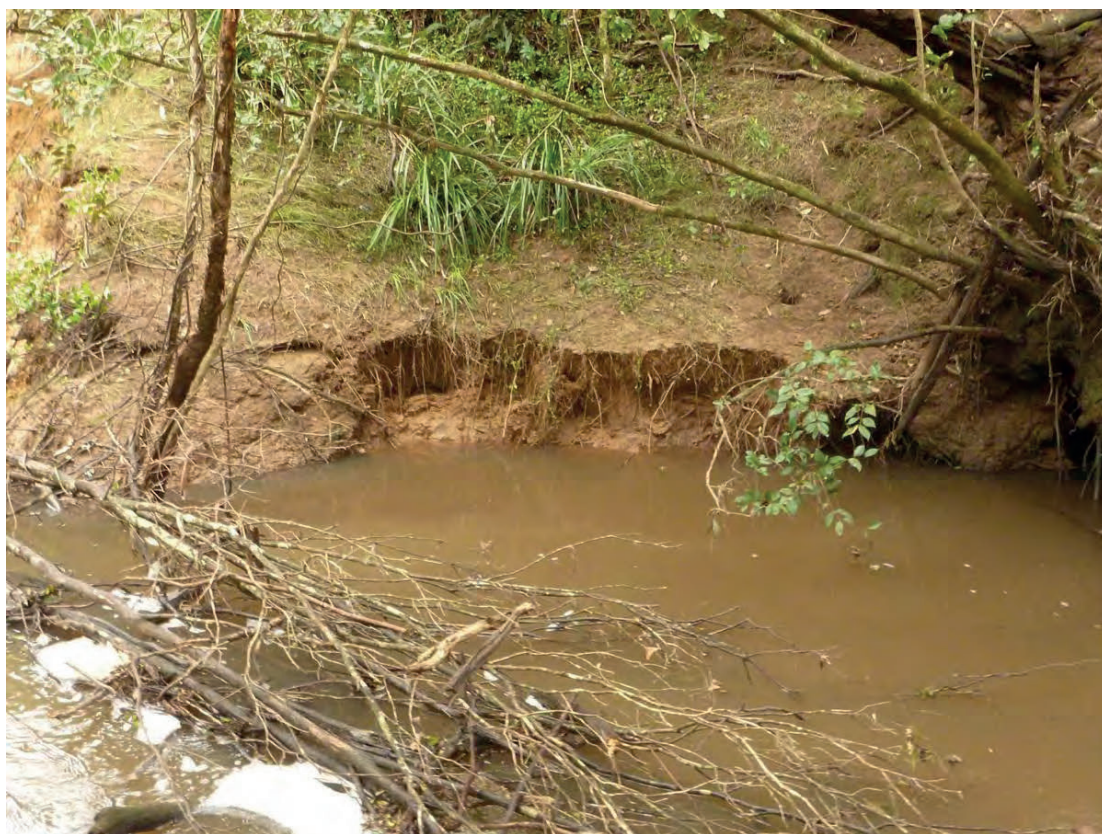
Plate 20: Edge bank erosion at JC3.

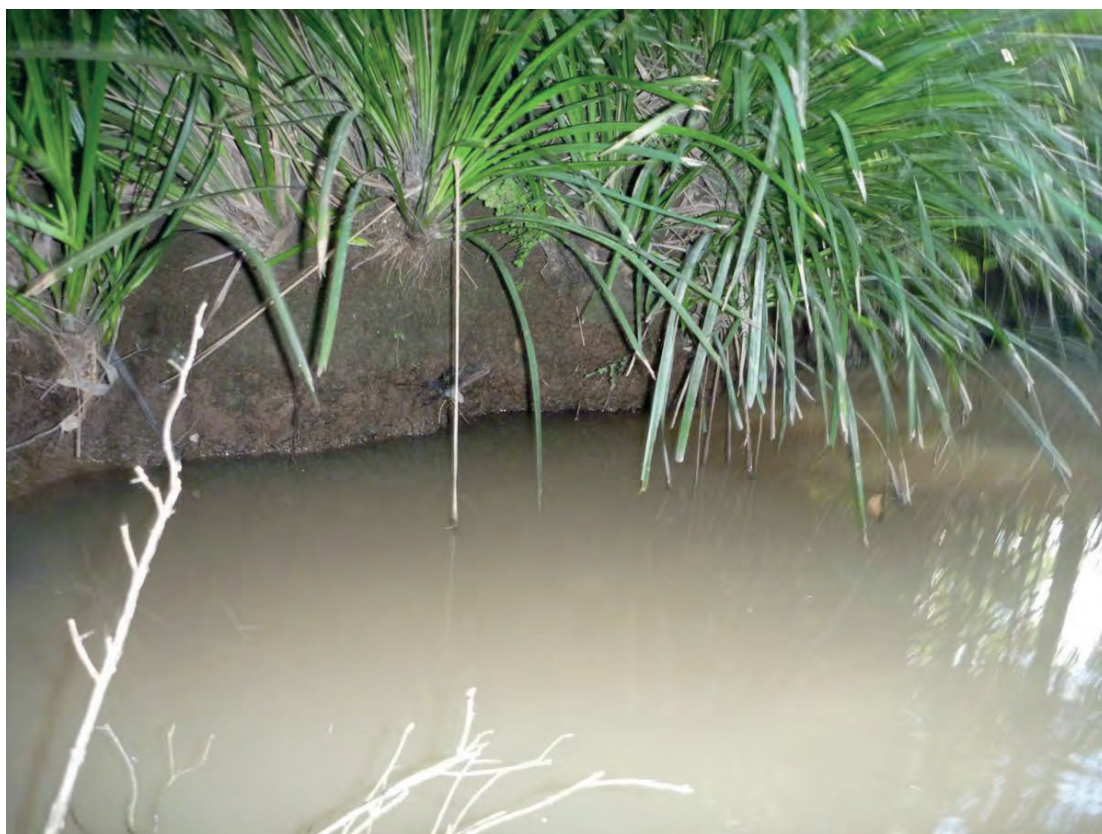
Plate 43: Undercut earth banks at BC1. Most of the edge bank vegetation at this site was above the waterline.

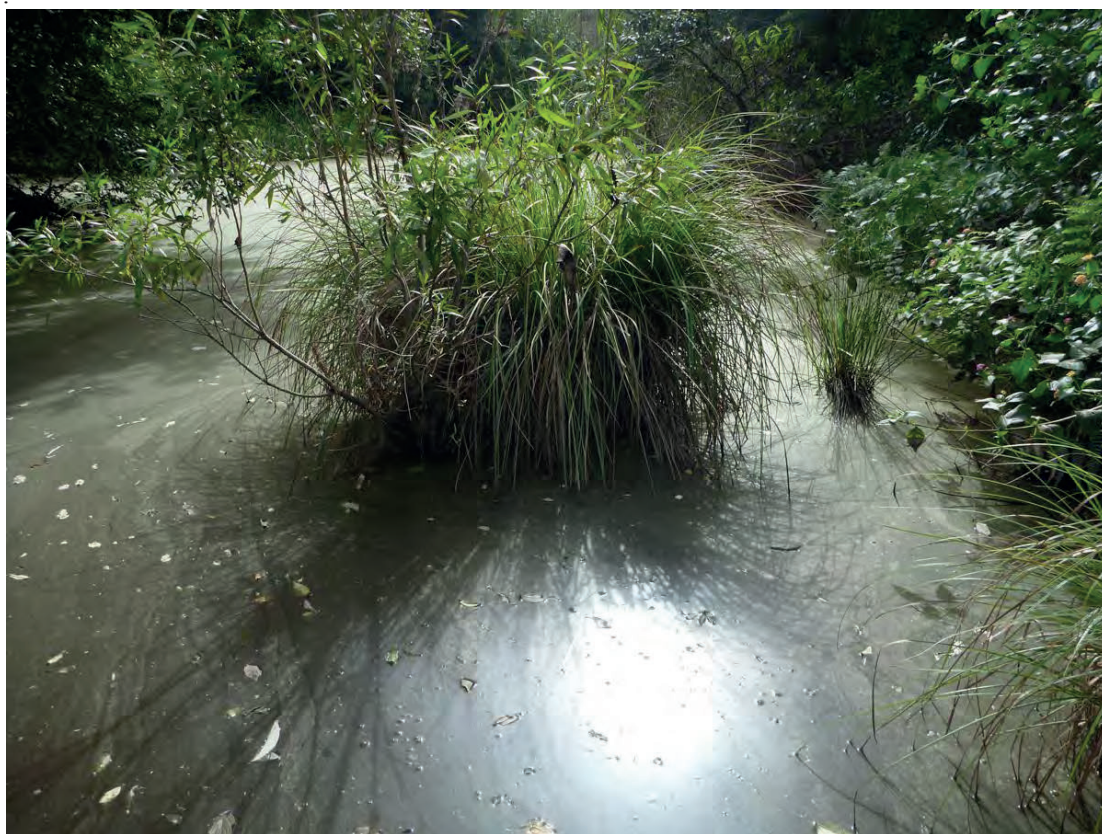
Plate 15: Looking upstream at JC2E. Note the layer of particulate matter smothering the water surface.

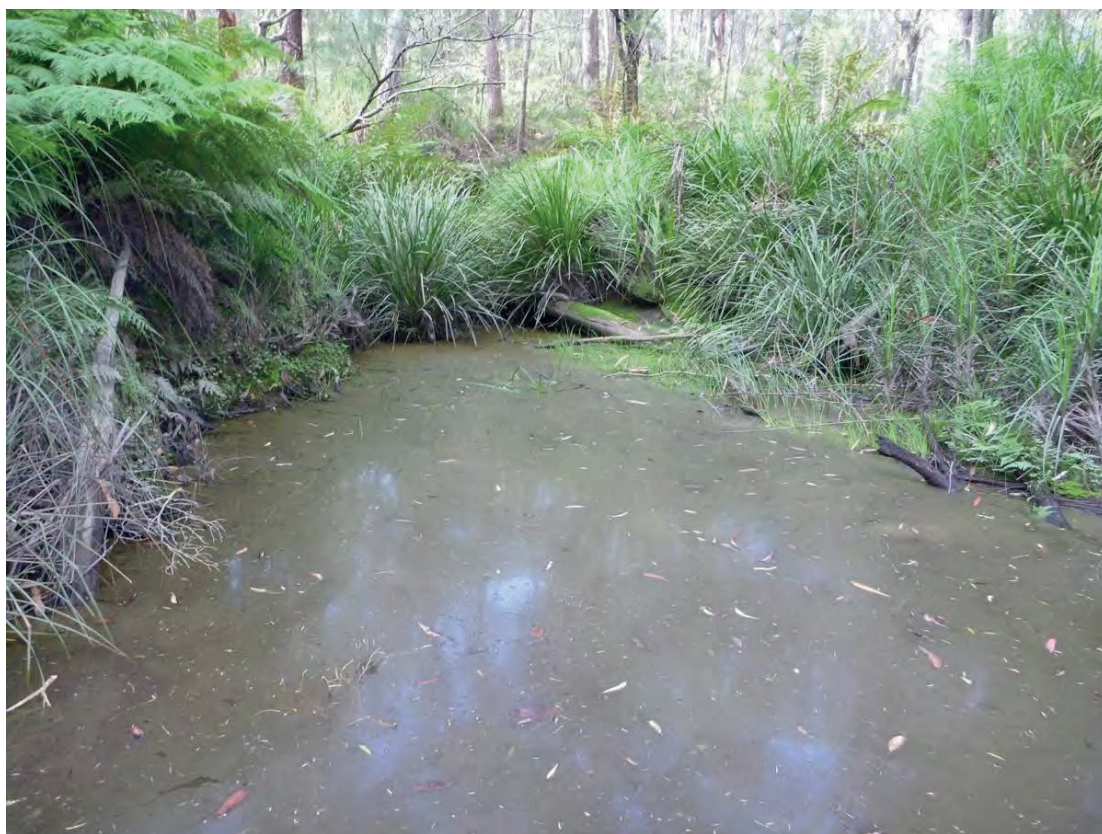
Plate 36: Pool at lower end of WC1. Note the floating particulate matter on the pool surface.
