Vickery Coal Project

LAND CONTAMINATION  
ASSESSMENT

**Stage 1 & 2 Land  
Contamination  
Assessment - Vickery  
Coal Project**

12-773-R-001

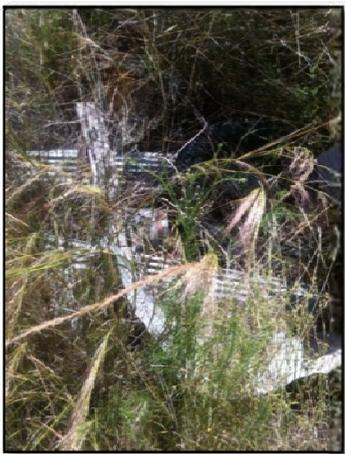
Photo 4-1 Abandoned well at MLA1-1

**MLA1-1:** The site was mostly cleared with remnants of a farmhouse present. There were no signs of a sheep dip present; however there were remnants of a holding yard. There was an abandoned well towards the rear of the site containing refuse. The refuse included some chemical containers. Samples were collected at depth adjacent to the well (**Photos 4-1 to 4-4**).

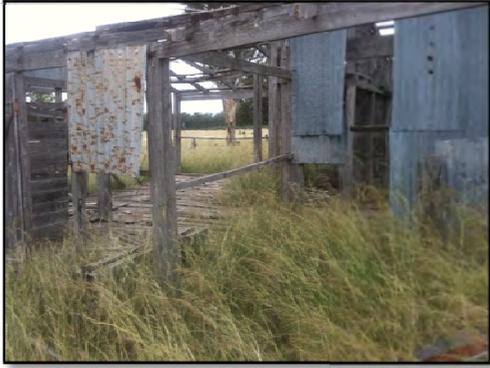
Photo 4-5 Abandoned shearing shed at MLA2-1

**MLA2-1:** The site was mostly cleared with a decommissioned sheep dip present as well as the ruins of a sheep shearing shed. A water storage dam was located to the north-east of the site. Samples were collected surrounding the dip to depth and surface samples collected within the floors of the shed (**Photos 4-5 to 4-10**).

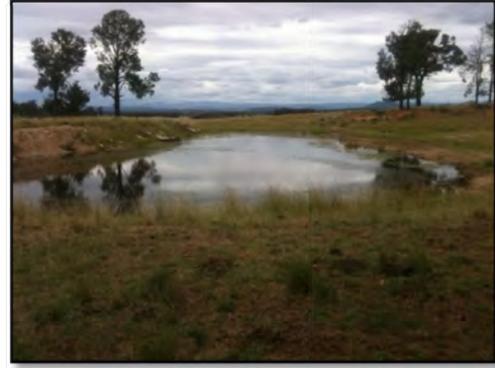
Photo 4-8 Surface water dam adjacent to MLA2-1

During the Stage 2 Detailed Investigation a surface water sample was collected from the water storage dam and was analysed for total metals and OCs and Organophosphorous Pesticides (OC/OPs). Field measurements of Dissolved Oxygen, Electrical Conductivity, Total Suspended Solids, and pH were taken using a water quality meter. The laboratory analysis showed that the water sample marginally exceeded the site assessment criteria for total copper and total zinc. The water from the storage dam is suitable for use as a dust suppressant.

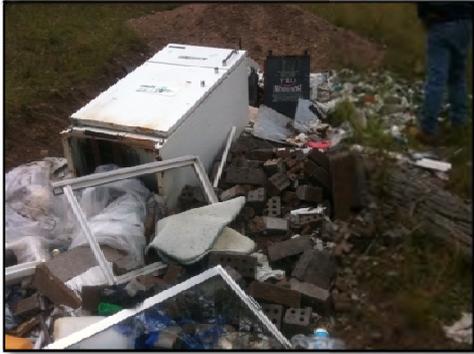
Photo 4-11 General refuse dump area at MLA3-1

**MLA3-1:** The site bordered Vickery State Forest, with areas that were densely populated by trees. The area to the south and south-west had been cleared. A general refuse dump area was identified in an area that was relatively thick with trees and was sloping towards the south (**Photo 4-11**). The refuse contained what appeared to be fuel storage containers (**Photo 4-12**). Samples were collected directly south of the refuse.

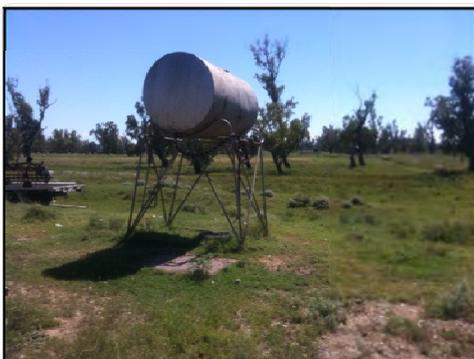
Photo 4-13 Above ground fuel storage tank

**Private haul road and Kamilaroi Highway overpass:** The presence of an Above Ground Storage Tank (AST) and large generator were identified on-site (**Photo 4-13** and **4-14** respectively), however access to the site was not available so a limited inspection was conducted from the road.

Following the site history review and a site inspection of the private haul road and Kamilaroi Highway overpass construction area, and consideration of the distance from the proposed construction works to the AST and generator identified during the site inspection, no further works are recommended for this area.

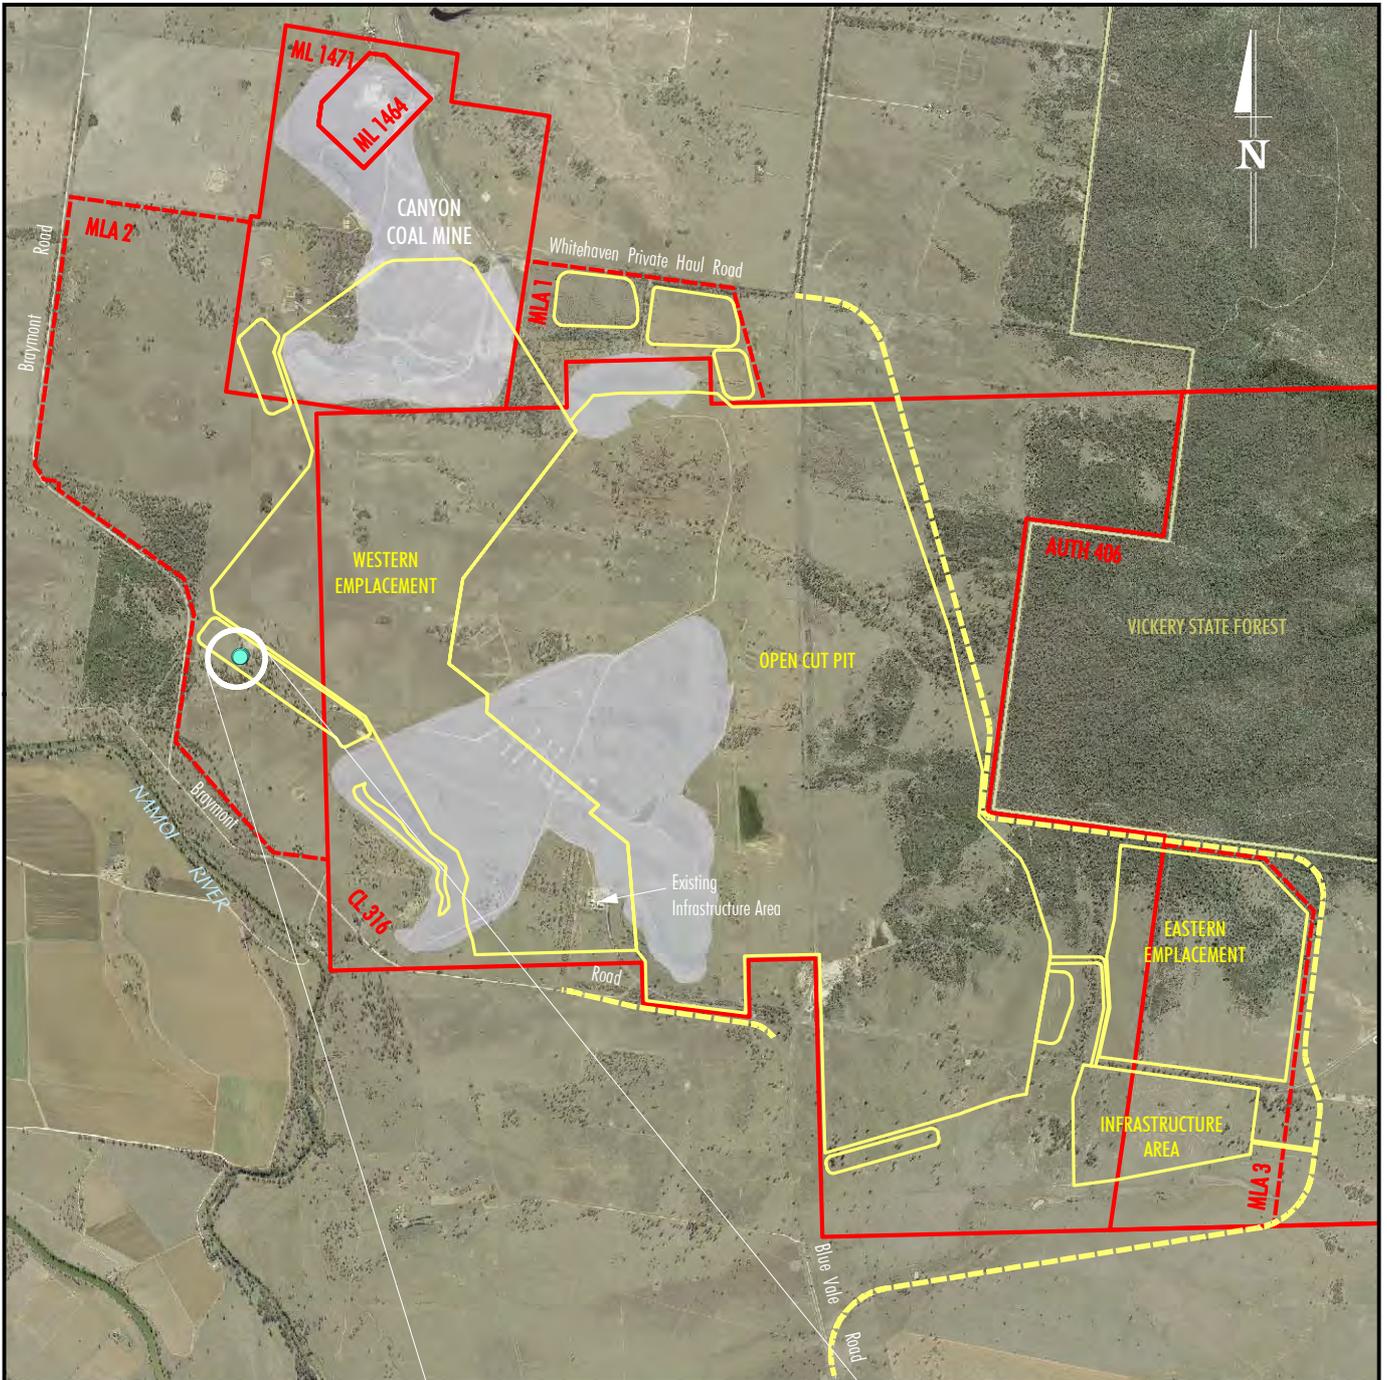
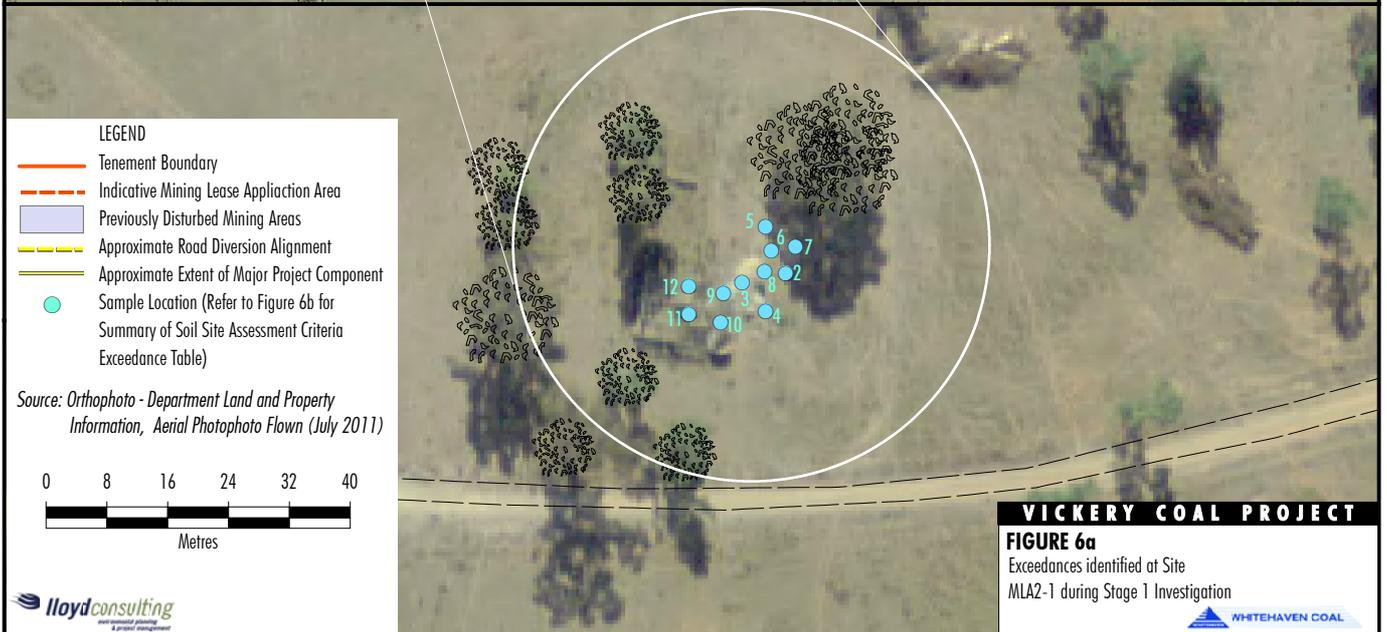
The majority of the exceedances were identified in the surface layer of soils surrounding the sheep dip and within the shed at MLA2-1. There were five exceedances of the site assessment criteria at depth (0.5 m to 1.5 m) located in the sheep dip area.

**Figure 6a** shows the locations of the samples that exceeded the site assessment criteria at MLA2-1, and **Figure 6b** identifies the exceedances. Laboratory analysis results are provided in full in **Appendix E**, with Laboratory Certificates provided in **Appendix F**.

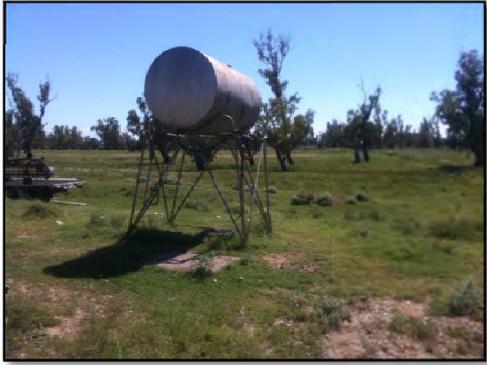
Photo 6-1 AST on fill material

As part of the Stage 2 Detailed Investigation a site inspection of the private haul road and Kamilaroi Highway overpass construction area was undertaken on 24 February 2012. From the site history review and site inspection for the private haul road and Kamilaroi Highway overpass construction area there were no potentially contaminating activities identified within the construction area. The adjacent allotment contained an AST (**Photo 6-1**), a large generator and two storage drums (possibly used for fuel or pesticides) placed on wood (**Photos 6-2 and 6-3**). There was also a disused shed and an abandoned vehicle present (**Photos 6-4 and 6-5**). The type of fuel stored within the AST and drums were not able to be identified and the AST was not placed within a bund, however soils surrounding the AST and generator did not appear to show any signs of staining. The AST and generator were constructed on what appeared to be a filled area. The type of fill appeared to be alluvial material sourced from the nearby creek (**Photo 6-6**).

The private haul road and Kamilaroi Highway overpass would be located approximately 100 m away from the AST and generator.

Following the site history review and a site inspection of the private haul road and Kamilaroi Highway overpass construction area, no further works are recommended for this area.

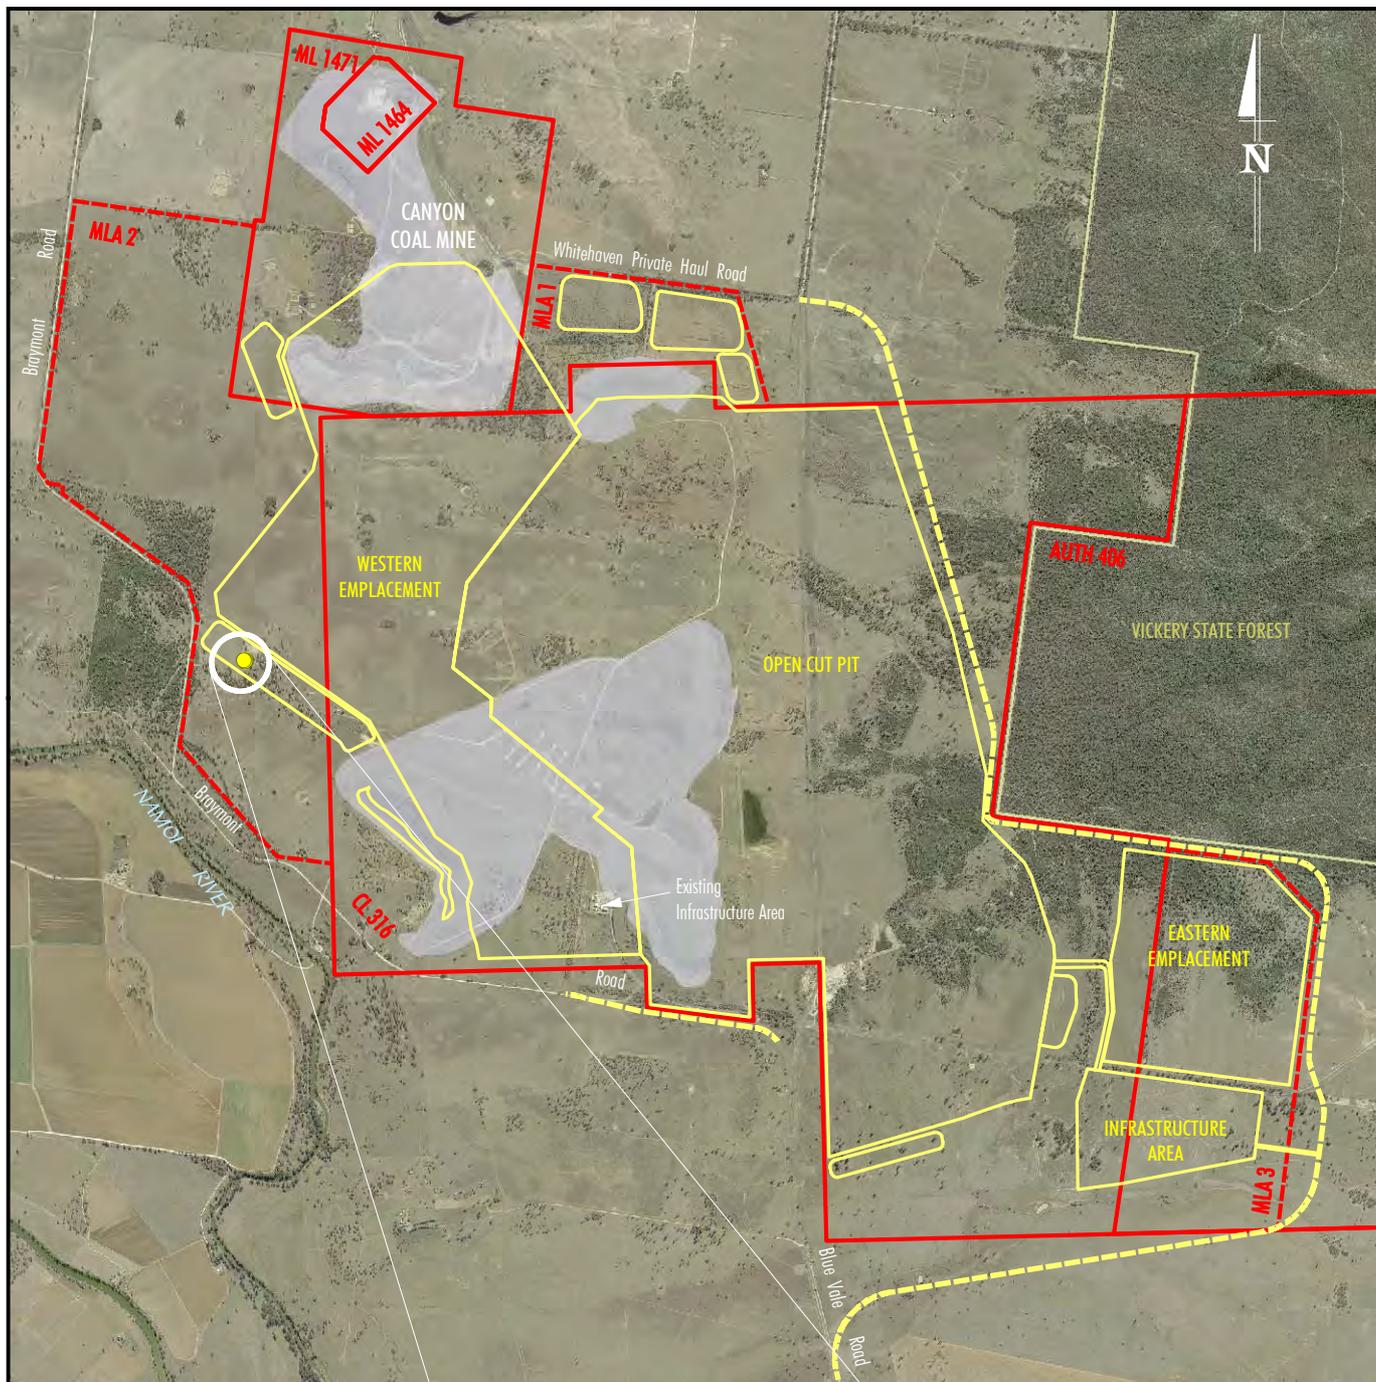
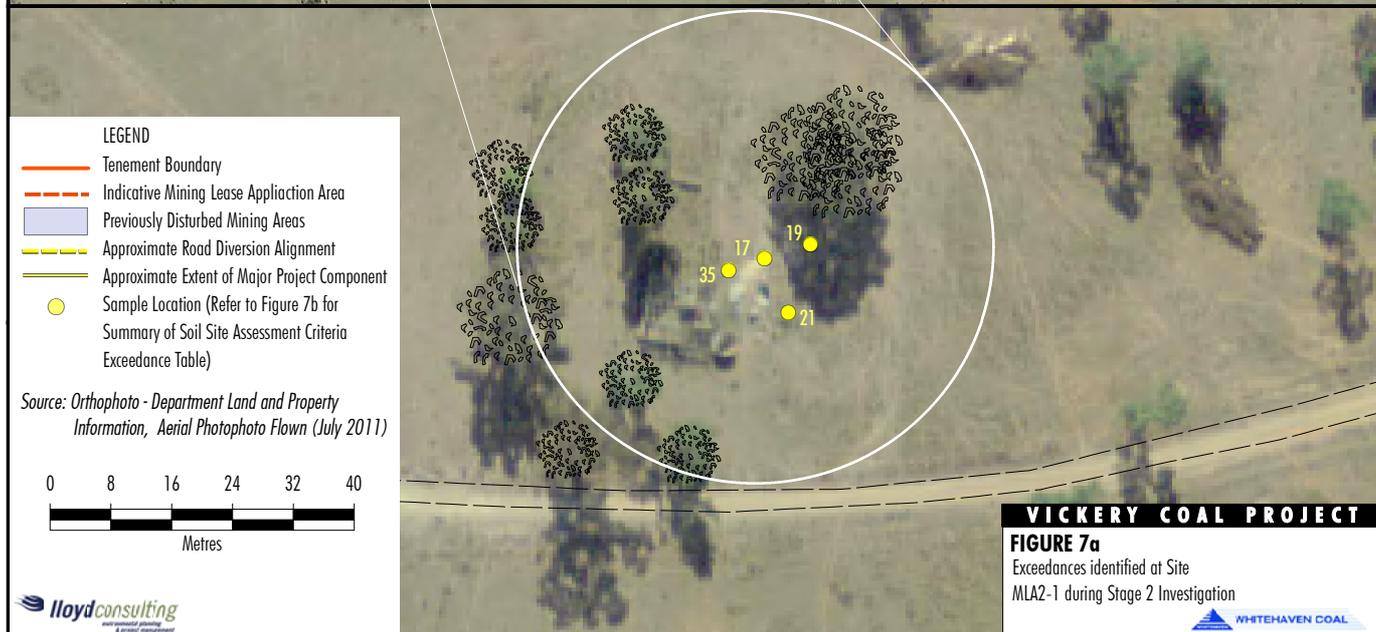
**FIGURE 7b**  
Summary of Stage 2  
Soil Site Assessment Criteria  
Exceedances

The Stage 2 Detailed Investigation identified exceedances of the site assessment criteria over a range from surface samples (0.2 m) to a depth of 1.0 m. Areas that were previously sampled during the Stage 1 Preliminary Investigation were not re-sampled during the Stage 2 Detailed Investigation. **Figure 7a** shows the locations of the samples that exceeded the site assessment criteria at MLA2-1, and **Figure 7b** identifies the exceedances.

Sampling within the area as part of the Stage 2 Detailed Investigation delineated the arsenic contamination laterally and vertically, with the contamination being observed to be present within the surface material in most areas.
