BUSHFIRE PROTECTION ASSESSMENT

Special Fire Protection Purpose Development
Campbelltown Hospital Stage 1 Redevelopment

Prepared for
Health Infrastructure NSW

25 January 2012

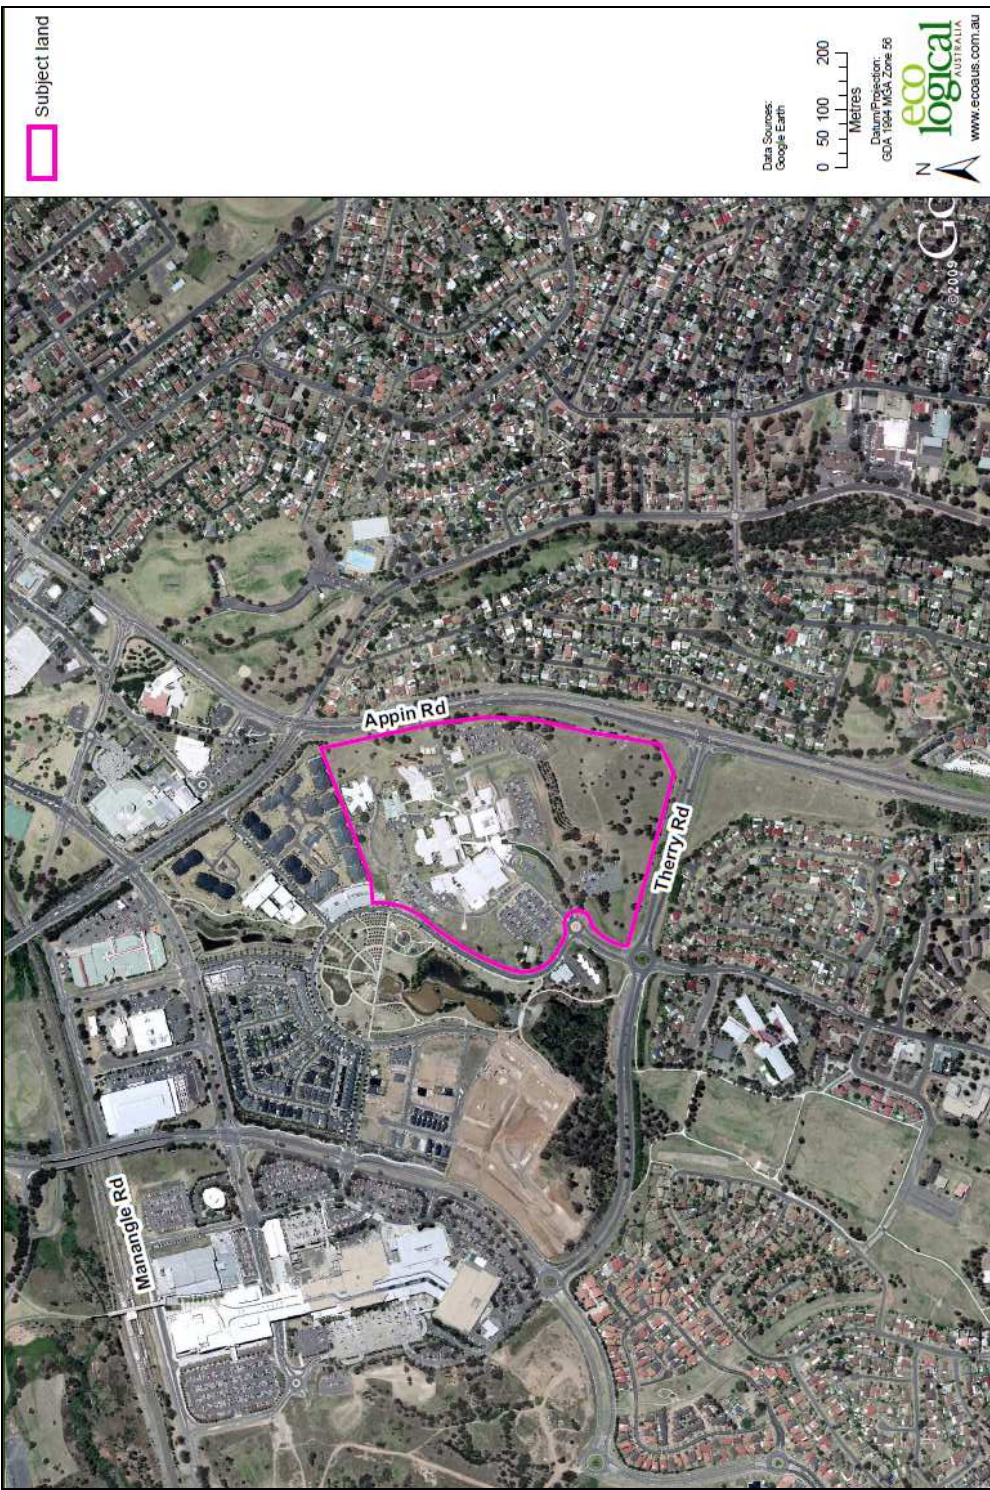
Figure 1: Aerial photograph locating subject land

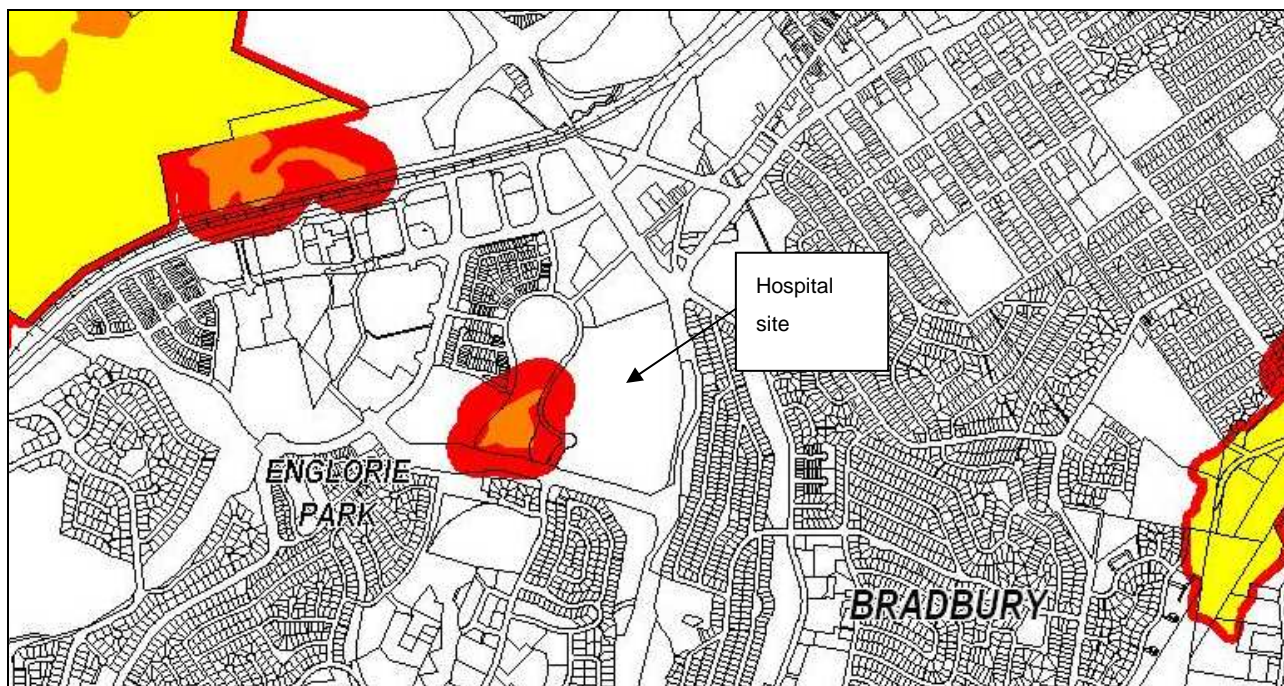
Figure 2: Campbelltown Council Bush Fire Prone Land Map

The nearest bush fire prone vegetation is an artificial landscaped corridor on the edge of a water storage basin to the west of the existing hospital site. Site investigation shows that this vegetation is unlikely to be bushfire prone as it is <1 ha in area, however the report uses a low risk approach, treating it as bushfire prone. The Bush Fire Prone Land map is shown in Figure 2 and photographs of the vegetation as shown in Section 14.

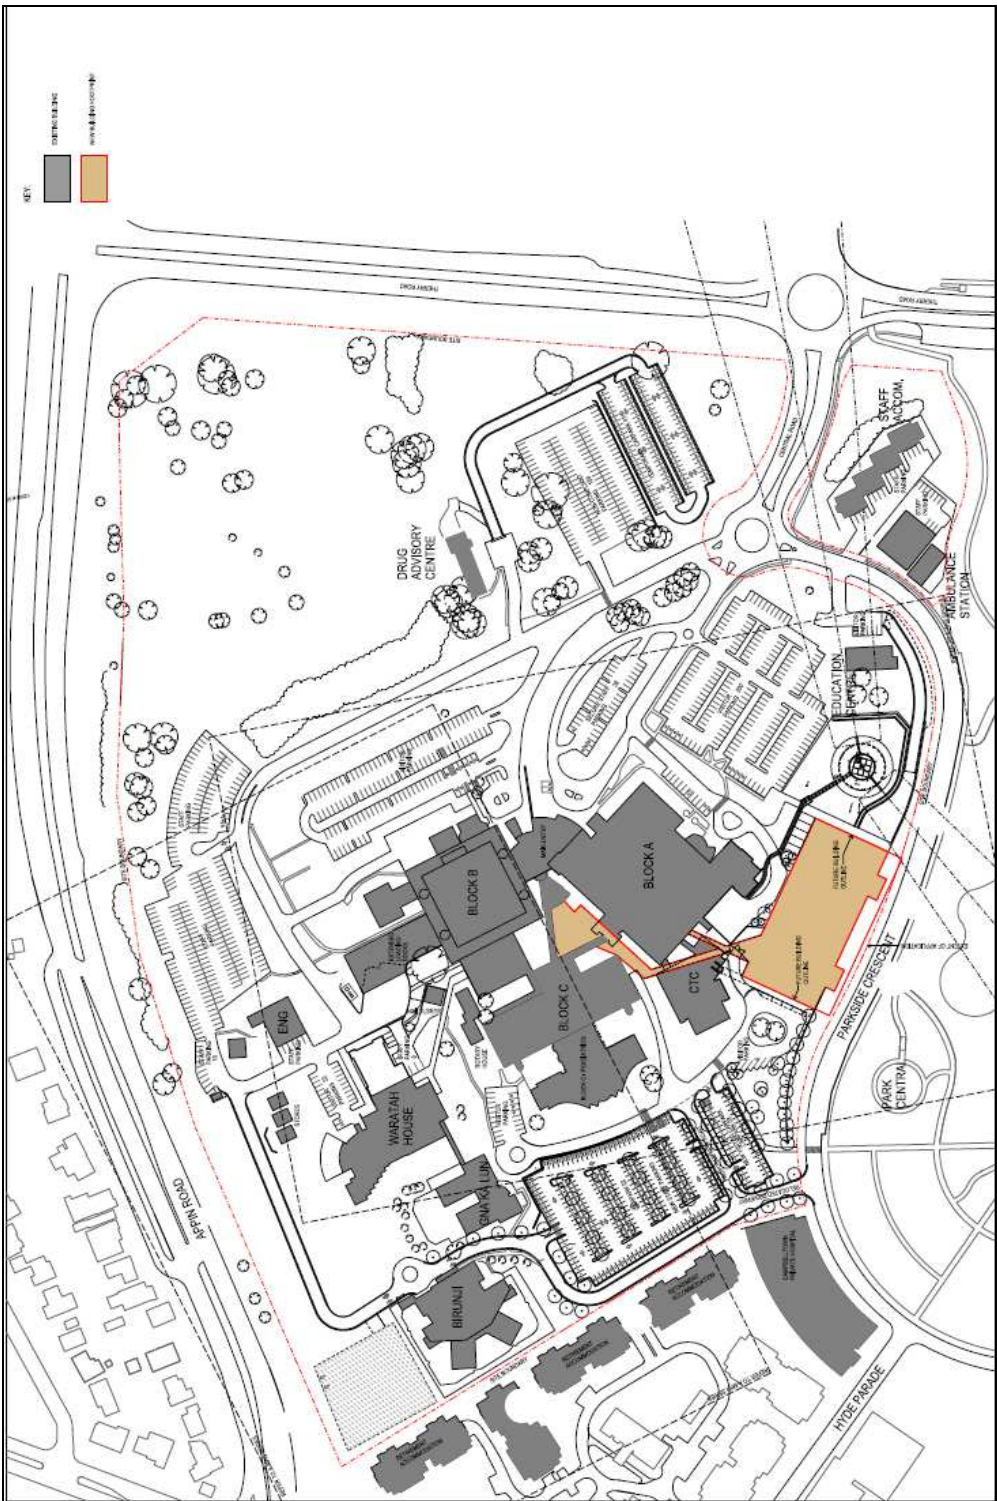
Figure 3: Development proposal (new buildings shown in brown)

Health Infrastructure NSW commissioned Eco Logical Australia Pty Ltd (ELA) to prepare a bushfire protection assessment (BPA) for the redevelopment of a portion of the Campbelltown Hospital site, (hereafter referred to as the subject land). The proposal includes the construction of a new 6 storey AHS building on the western extent of the site, along with refurbishment of existing buildings and associated site works.

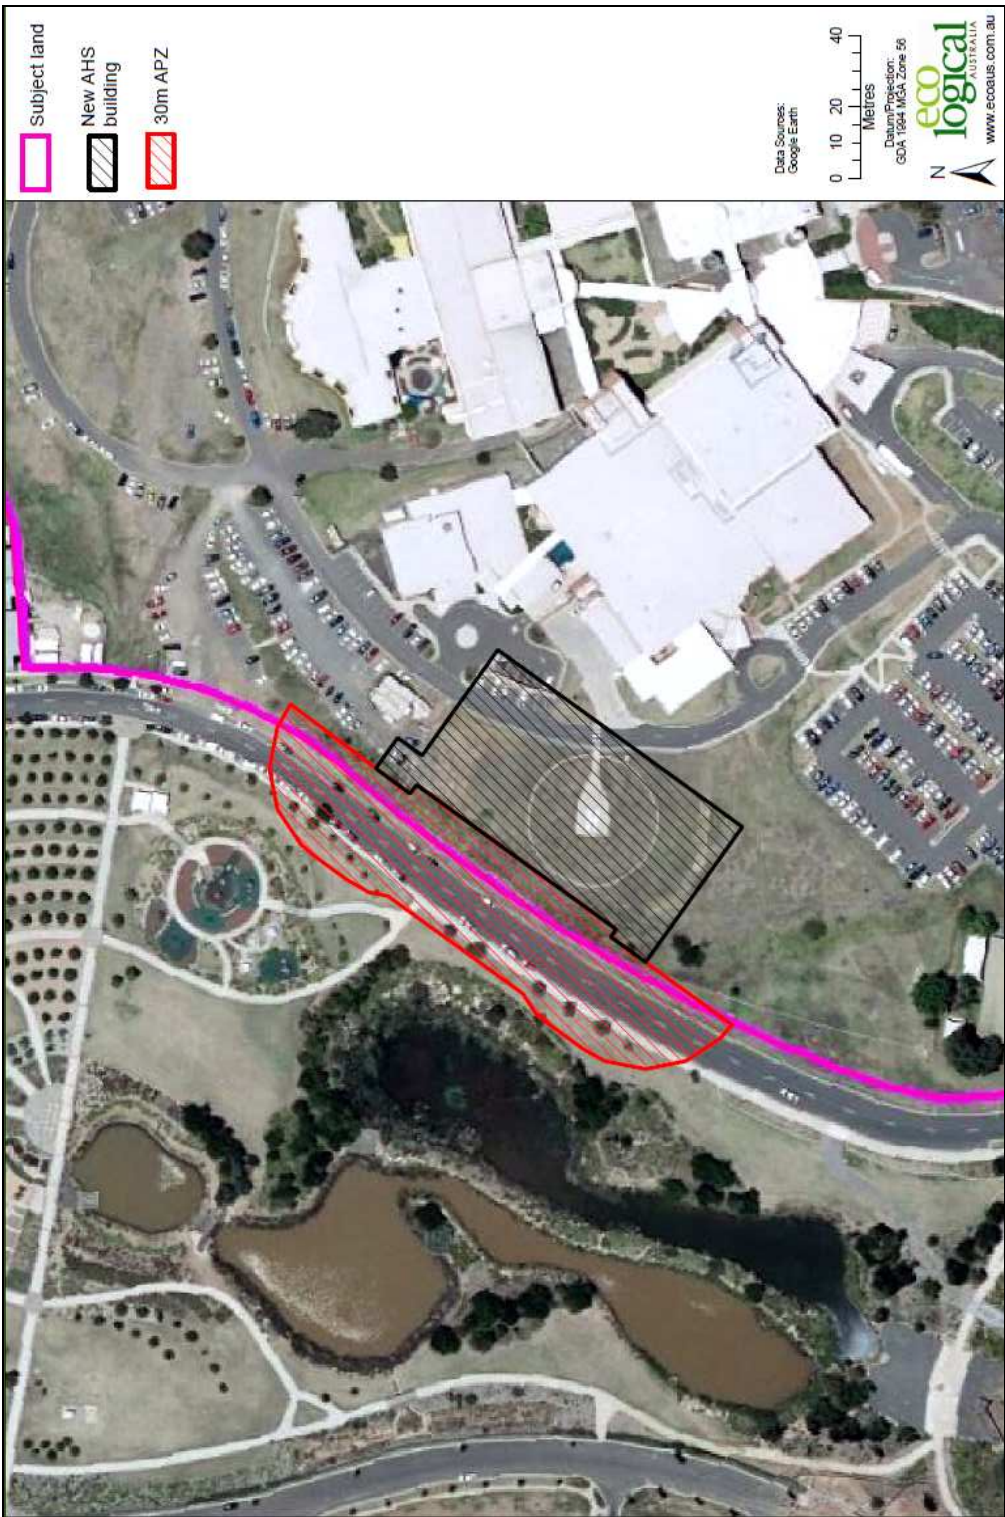
Figure 4: Proposal showing APZ

Direction from envelope	Slope ¹	Vegetation ²	PBP required APZ ³	Proposed APZ	AS3959 Construction Standard ⁴	Comment
South-east	Upslope/flat	Managed lands (carpark)	n/a	n/a	BAL12.5	
North-East	Upslope/flat	Managed lands (hospital buildings)				
South-west	Upslope/flat	Managed lands (helipad)				
North-west	Upslope/flat	Rainforest (Remnant)	30 m	>30 m	BAL12.5	APZ in place and includes existing dual lane Parkside Crescent roadway.

The required APZ is in place and no further vegetation clearance or tree removal is required to support the proposed development. Fuel management within the APZ is to be as follows:

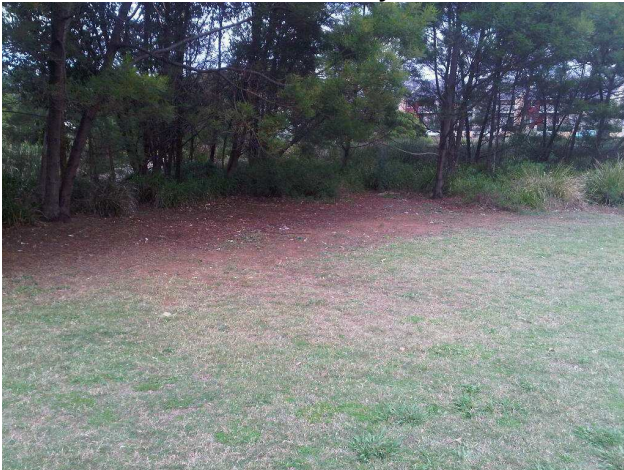
Photo 1: Narrow band of trees adjoining the northern side of the waterbody

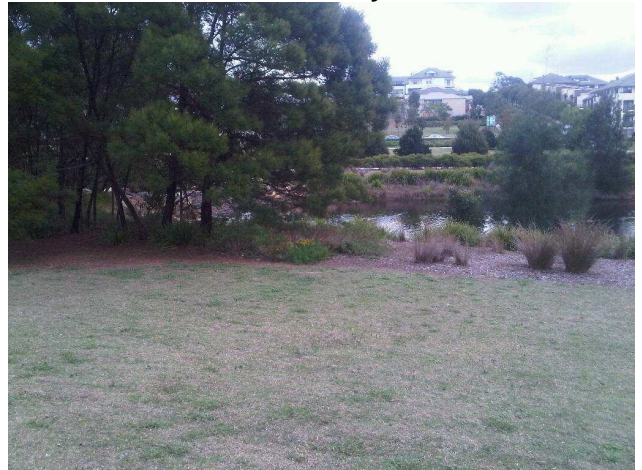
Photo 2: Narrow band of trees adjoining the eastern side of the waterbody

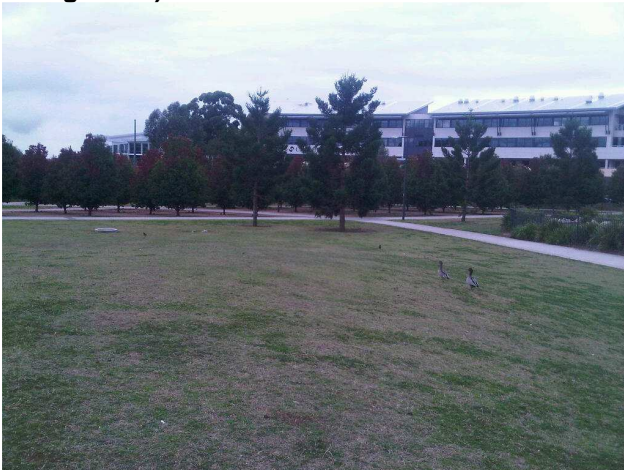
This adjoining vegetation is either mown grass or managed as amenity landscaping as shown in the photographs of the site in section 14 of this report.

Photo 3: Grassed areas north-east of the proposed building (existing hospital buildings in background)

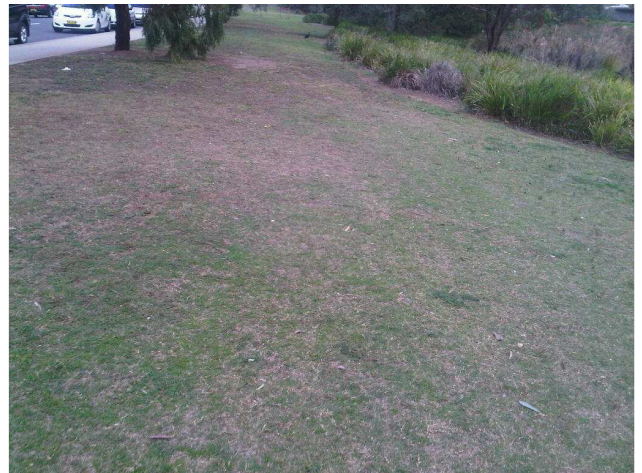
Photo 4: Existing APZ west of Parkside Crescent
