# **Balranald – Ivanhoe Road**

## **Pavement Condition Assessment**

**Cristal Mining Australia Limited**

December 2013

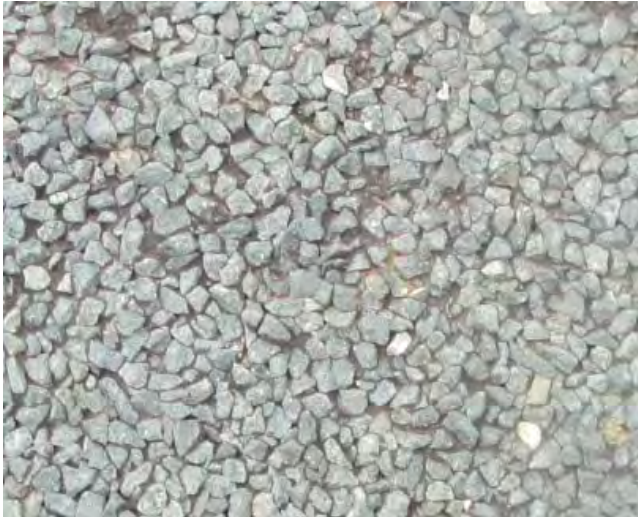
**Photograph 1**     *Typical seal condition*

- The sealed surface is in good condition with most sections having a lively binder which indicates the regular resealing program on the road is in place. Some older sections are showing signs of stripping, however only isolated sections have broken through to the pavement, which can be managed with reseals and maintenance.

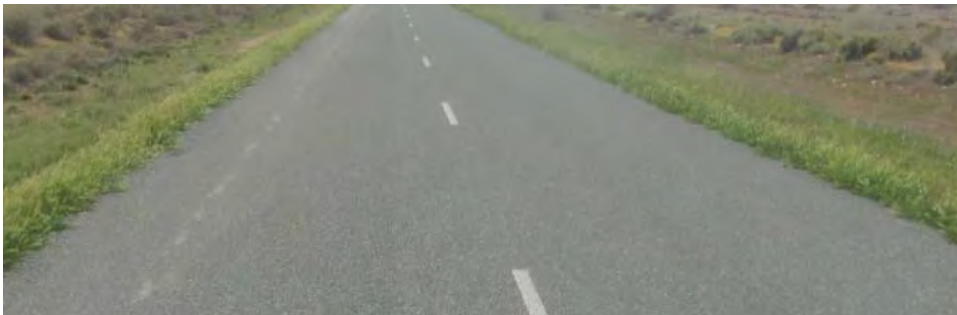
**Photograph 2**     *Sections where vegetation in the shoulder restricts drainage*

- The shoulders in places are heavily vegetated in sections which restrict stormwater draining from the edge of the road surface.

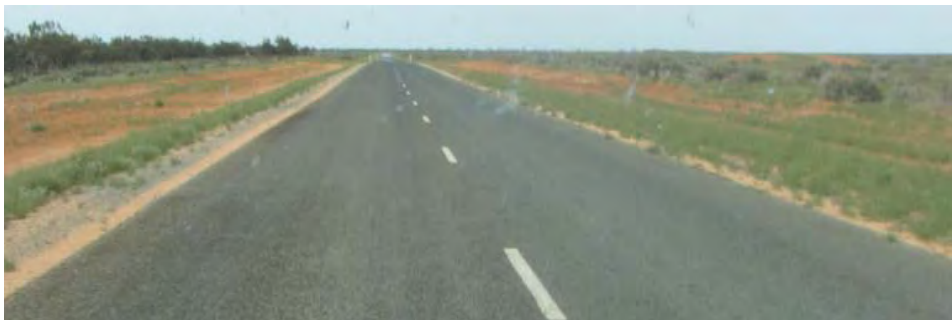
**Photograph 3**     *Typical formation cross section*

- The table drains, elevation and shape of the road cross section provide a sound platform for drainage, provided maintenance occurs, to ensure a free draining surface.

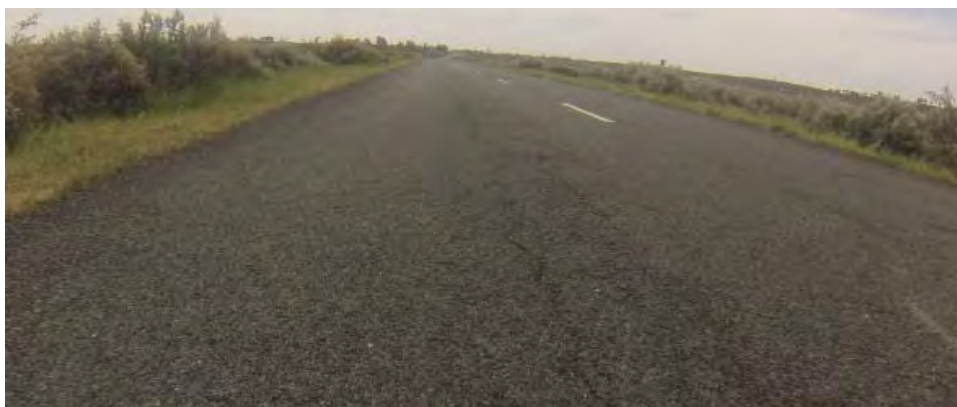
**Photograph 4**

- There are sections of the road that provide a rough ride, however the majority of the road provides a smooth ride.

***Section of road surface with poor rideability due to deformation and cracking***

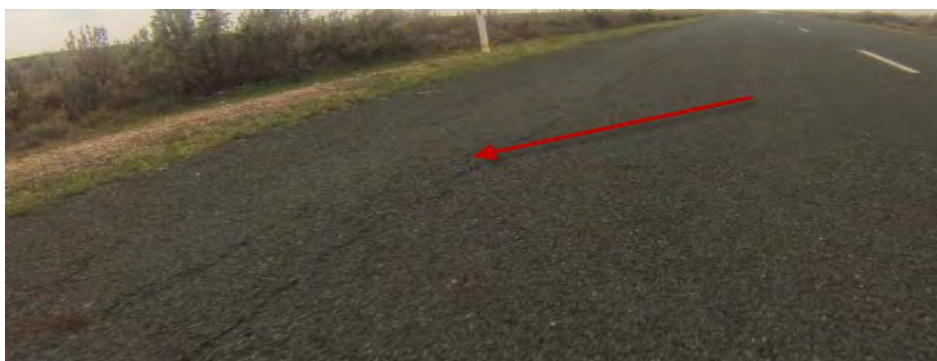
**Photograph 5      Outer wheel path cracking**

- There is evidence of cracking in sections of the road, typically longitudinal cracking in the outer wheel path. This is generally isolated to sections rather than an extensive defect along the entire length of the road.

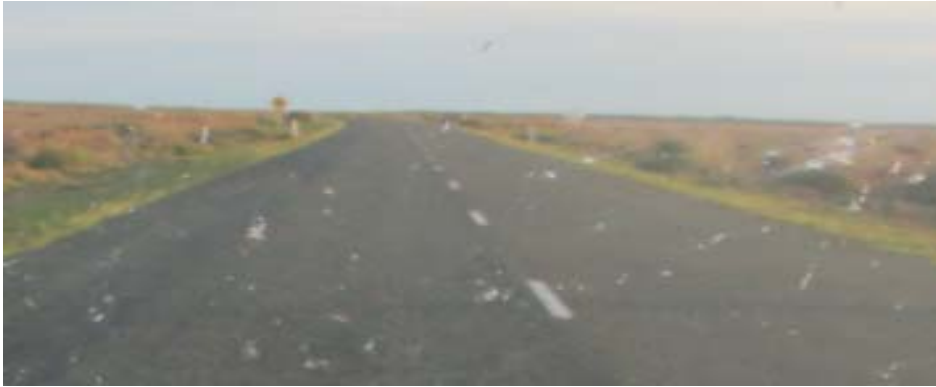
**Photograph 6**     *Shadowing indicating some rutting in outer wheel path in sections*

- There was little observable rutting, however when driving in the evening, there was some shadowing suggesting minor rutting in sections.

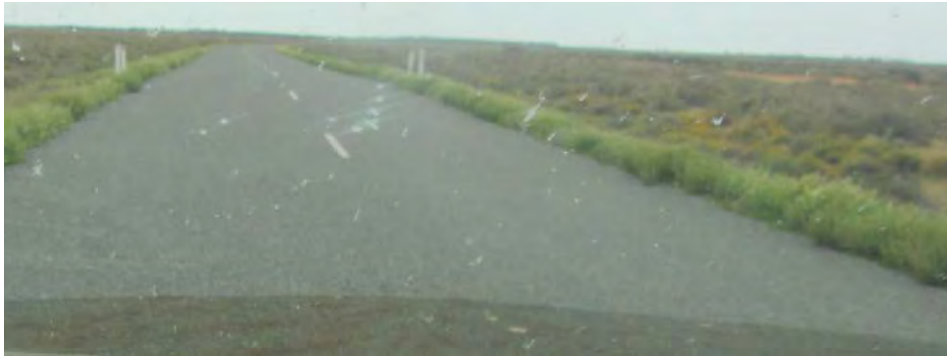
**Photograph 7**     *Typical change of seal*

- The seal changes are typically 5–8km sections providing some indication of the history and the staging of construction.

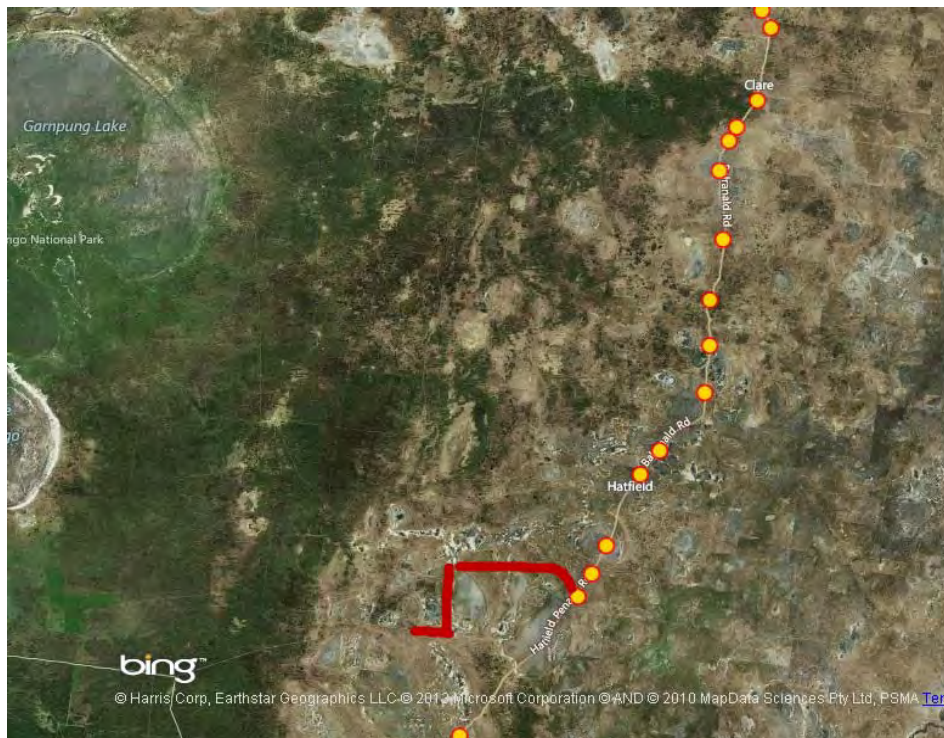
**Figure 2** *Map of the Balranald-Ivanhoe Road from Haul Road Access point (73.3km North of Balranald to Clare)*

Figure 2 below shows the haul road access point in red which is 73.3km north of Balranald and the yellow dots highlight a segment length which is evident by a change in seal. The full section of the road in this section is sealed and was subjected to additional testing in the form of Falling Weight Deflectometer (FWD) testing in order to understand the pavement and subgrade conditions. No testing was undertaken in this area for pavement depth or condition.

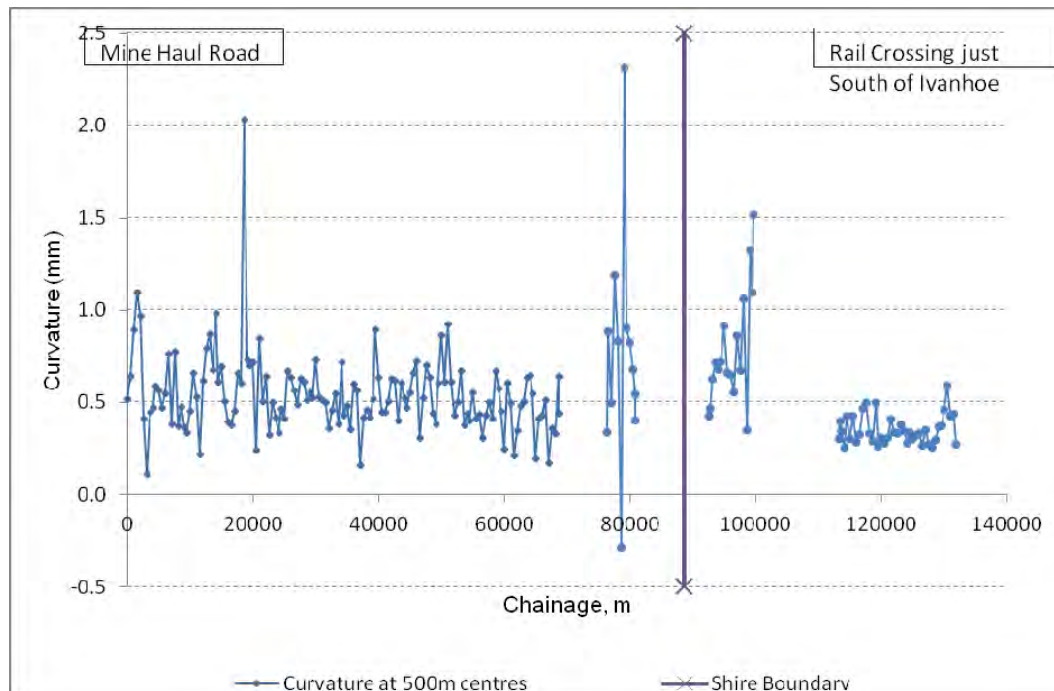
**Figure 5** Curvature Results

In terms of curvature the results are generally well above the tolerable limits for both the existing and the future traffic conditions. Refer to Figure 5 for curvature results. It is noted that the curvatures are a function of the overall pavement stiffness. The curvature results are relatively uniform, which suggests that the quality of the base course material is poor, or due to the relatively thin pavement layers (assumed to be nominally 150mm), the pavement performance is heavily influenced by the subgrade properties and therefore poor subgrade conditions will contribute to higher curvature results.

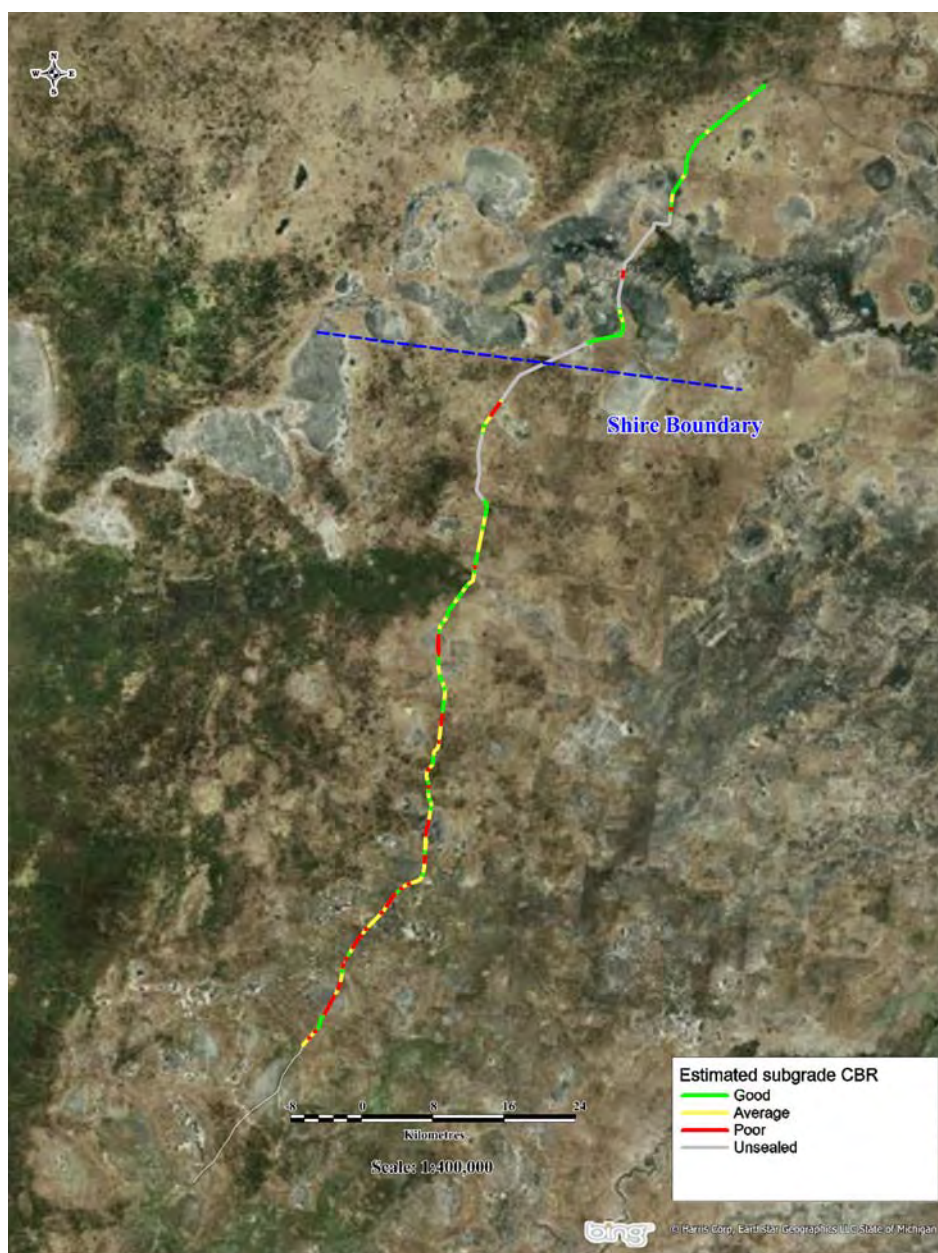
**Figure 6** CBR results along Balranald – Ivanhoe Road

- Poor Subgrade – CBR values <7% (design subgrade of 5% assumed for treatment cost estimates), shown in red.
- Average Subgrade – CBR values between 7% and 13% (design subgrade of 10% assumed for treatment cost estimates), shown in yellow.
- Good Subgrade – CBR Values >13% (design subgrade of 15% assumed for treatment cost estimates), shown in green.

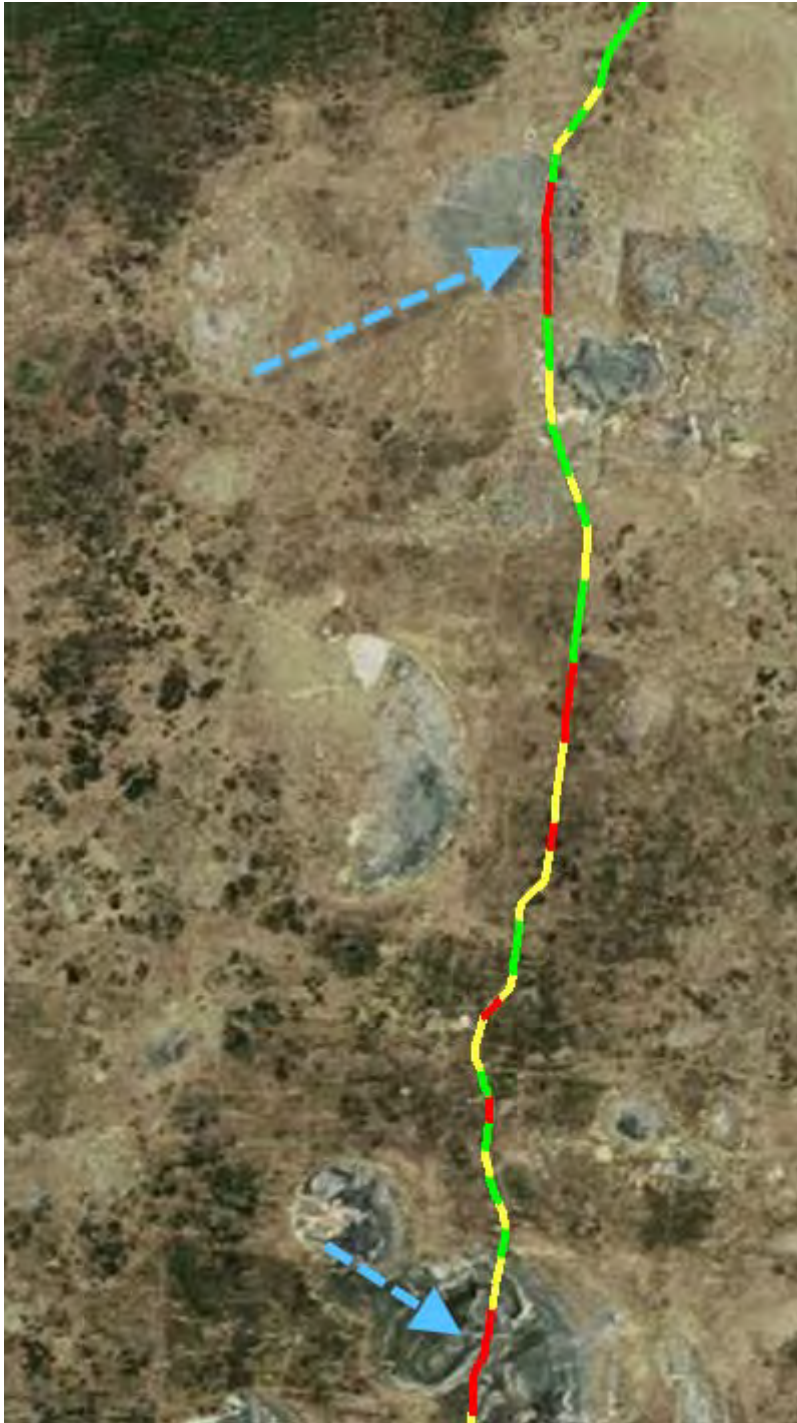
**Figure 7** *Poor CBR values within areas in lake crossings*

The areas of poor CBR appear to generally occur with low lying areas, watercourses etc. Figure 7 below shows an example.

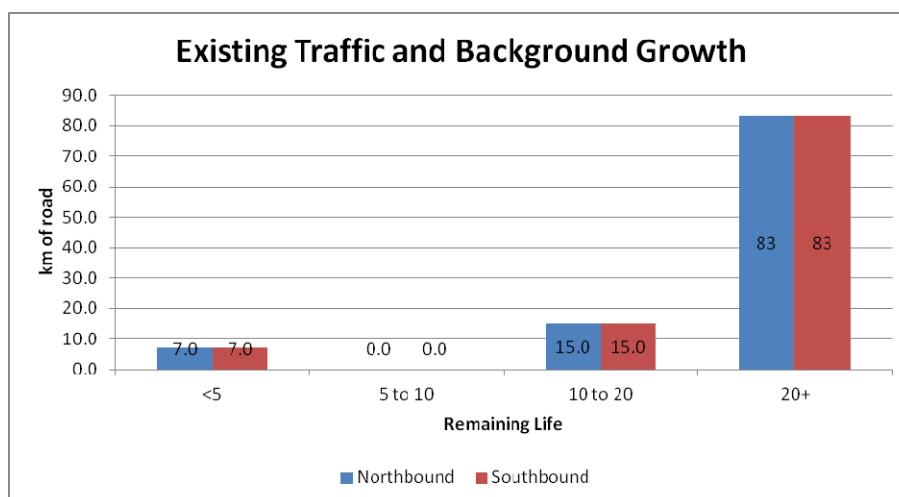
**Figure 8** Remaining life of pavement expressed in kilometres for existing traffic condition

Based on this traffic loading condition the remaining life for each segment of road can be determined and has been expressed in terms of total length in Figure 8.

As the traffic is currently assumed to be equal in both directions both the North and South bound lanes are expected to begin to fail at the same time.

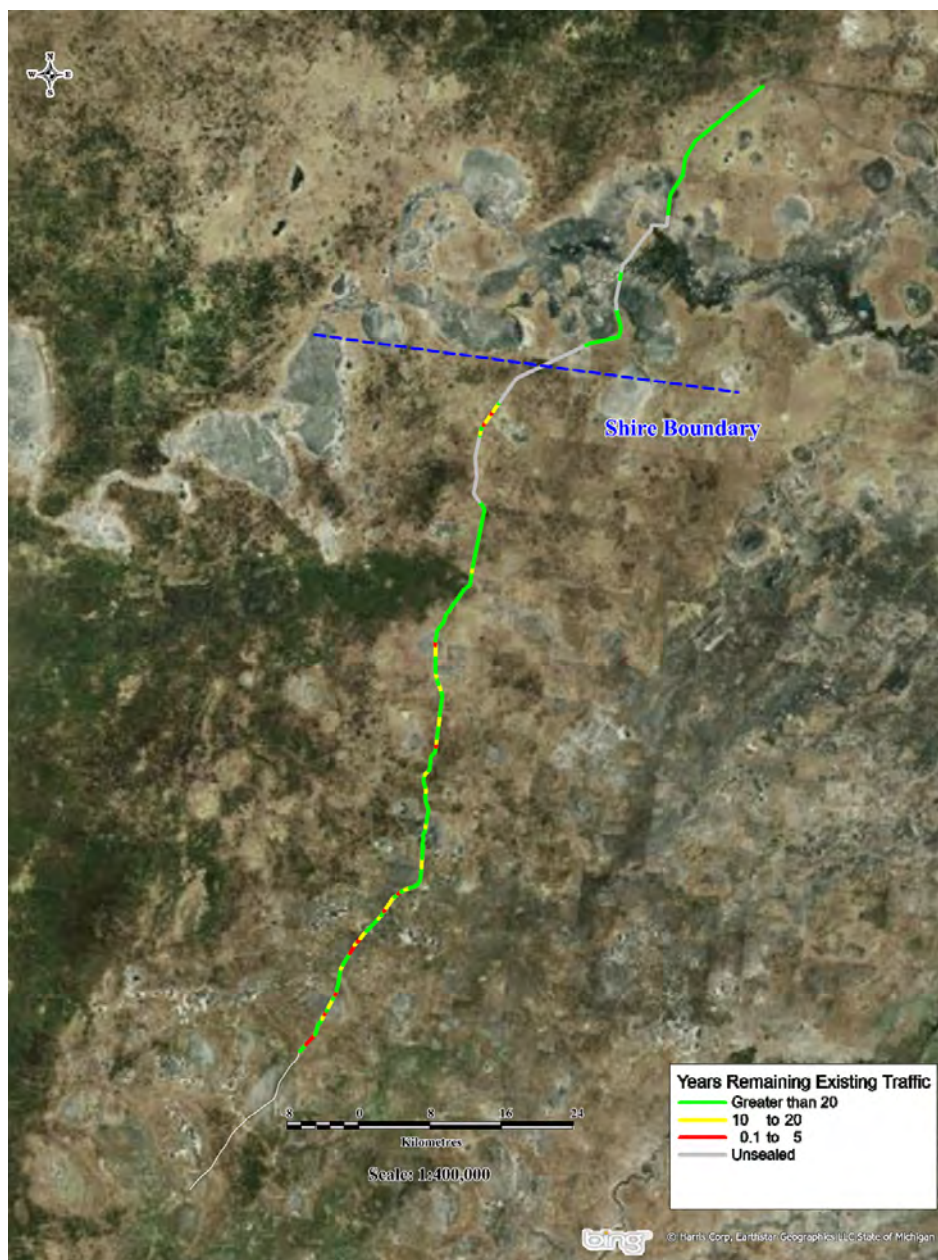
**Figure 9** Remaining Pavement Life existing traffic with growth

Figure 9 displays this information graphically, with the sections in red requiring treatment in the first five years, yellow representing 10 to to years and green 20+ years.

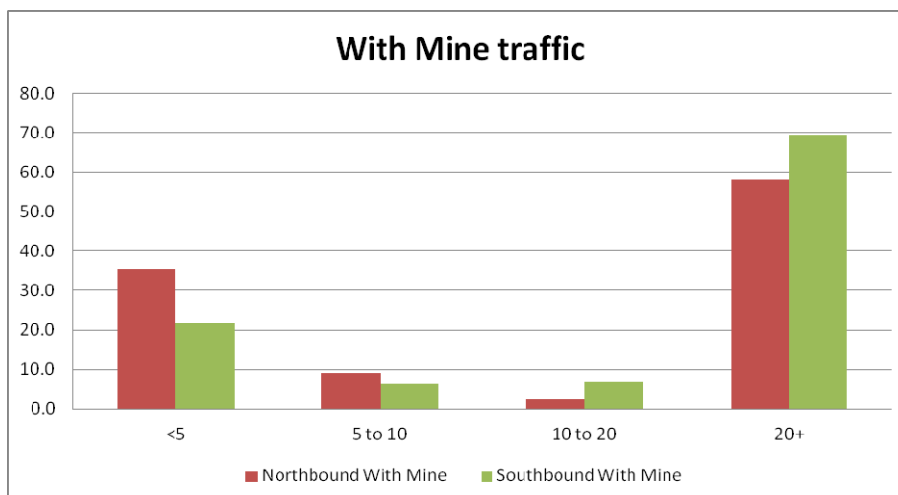
**Figure 10** *Remaining life of pavement expressed in kilometres for mine traffic condition*

As the North bound lane is more heavily loaded segments on this side of the road reach their allowable ESAs before the South bound lane. This is displayed in Figure 10 below.

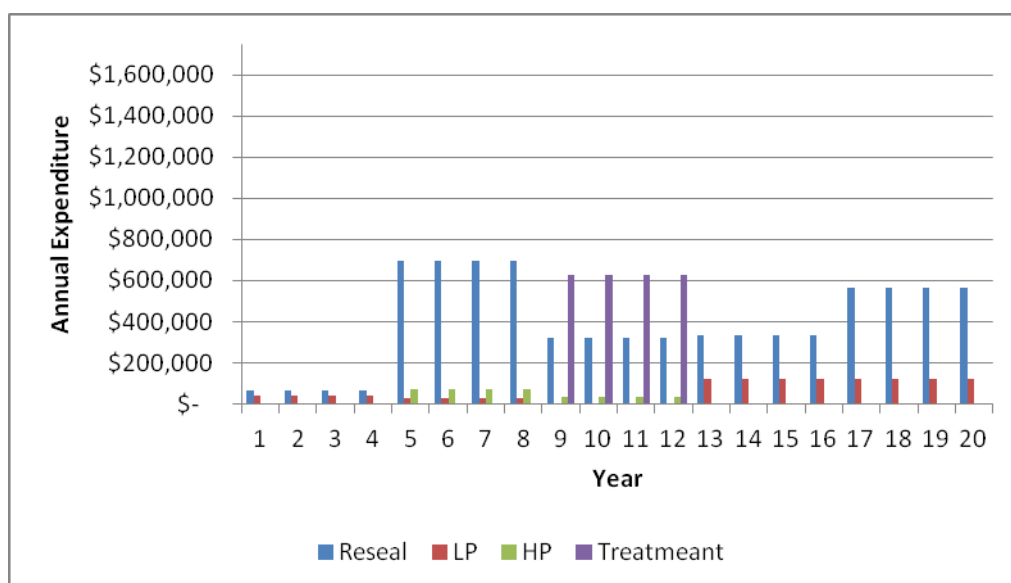
**Figure 13** *Average cost of pavement rehabilitation per year for existing traffic condition*

It is likely that this work will be staged over multiple years and as such the total expenditure has been averaged and allocated over the 4 year blocks (i.e. costs for the first four years is total required over that period divided by 4). This is displayed graphically below in Figure 13.

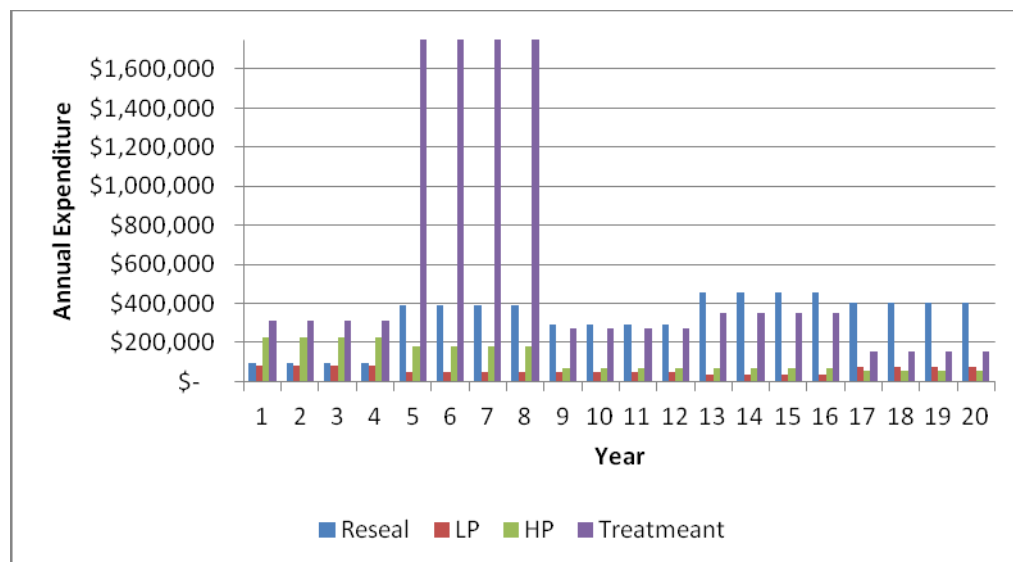
**Figure 14** *Average cost of pavement rehabilitation per year for mine traffic condition*

Again this is displayed graphically below in Figure 14:

It can be seen that under the mine scenario that the cost on period reseals decreases. This is as a result to more pavement segments requiring full reconstruction. The segments that are reconstructed will no longer need their periodic reseal.

All the other costs increase as the pavement deteriorates more rapidly due to the increased loading.

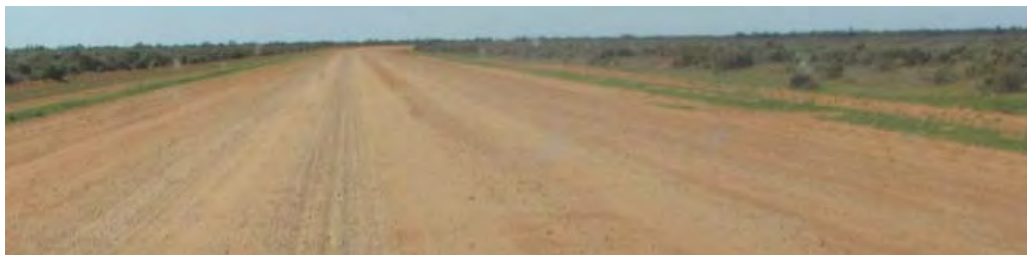
## TP1

The surface at TP1 appeared to be reworked subgrade with a minor gravel component observed. The DCP results indicate a dense to very dense pavement surface overlying a dense subgrade. The laboratory analysis results indicate a subgrade CBR of between 8% and 10%, with soaking making only a minor impact on its performance.

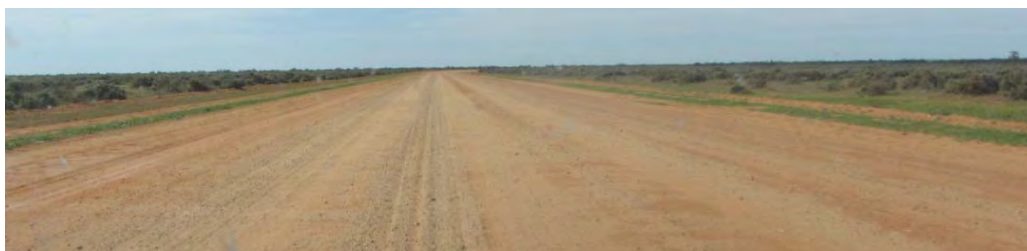
## TP2

TP2 observed a 300 mm thick pavement layer of likely imported material, which measured a relatively high soaked and unsoaked CBR value exceeding 40%. DCP results indicated the pavement materials were in a very dense state. The underlying clay subgrade of medium plasticity indicated a CBR of 3% to 6%, and was observed to be of very stiff consistency with a field moisture greater than plastic limit.

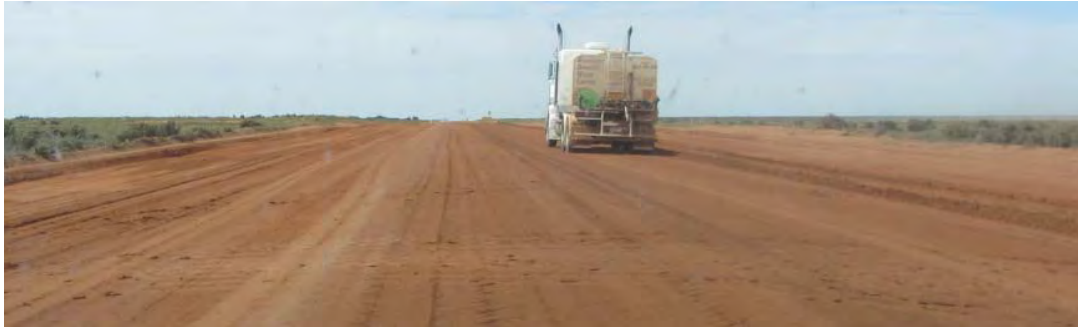
### TP3

The surface materials at TP3 were assumed to be reworked subgrade materials which have had some addition of granular materials sourced from off site. The pavement materials appeared to be very dense based on DCP results with a CBR value exceeding 14%. The subgrade materials observed are considered consistent with those observed in TP2, with a slightly higher sand content.

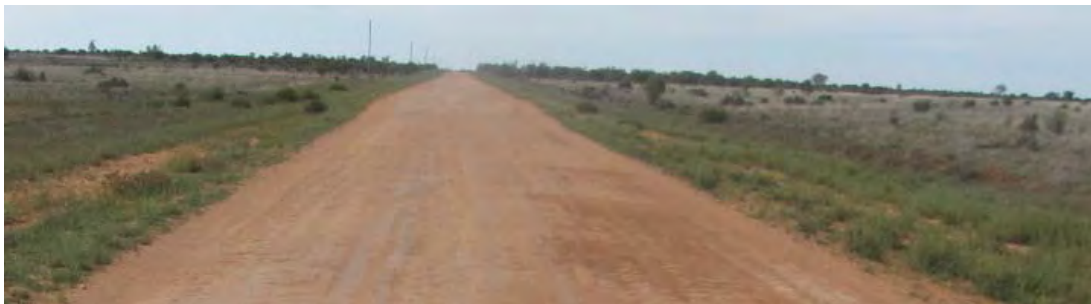
### TP4

At TP4 there was no distinguishable difference between the pavement and subgrade materials. DCP results indicated that the materials were of very dense state. Laboratory analysis indicate the materials achieved a CBR in the order of 10% to 16%, with some variation observed due to soaking.

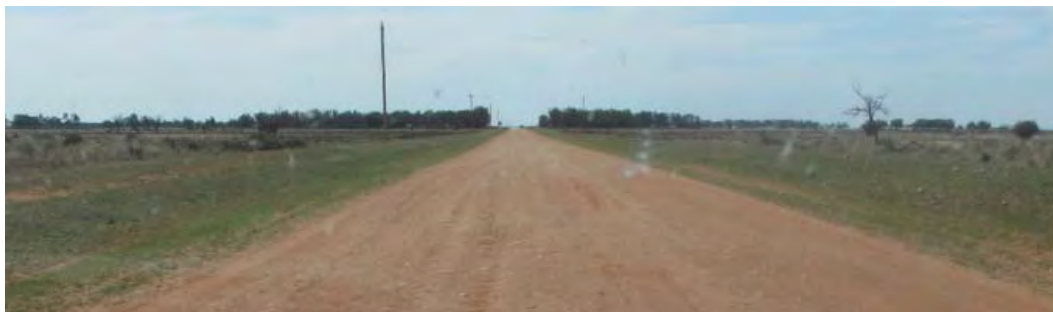
## TP5

The surface materials at TP5 are assumed to be reworked subgrade materials with some inclusion of granular materials sourced from off site. DCP results indicated a very dense surface until the DCP equipment failed. Soaked and unsoaked CBR results of the surface materials indicate a reasonable material with a CBR greater than 35%. The subgrade observed is similar to the subgrade observed in TP4 with a CBR expected to be greater than 10%.

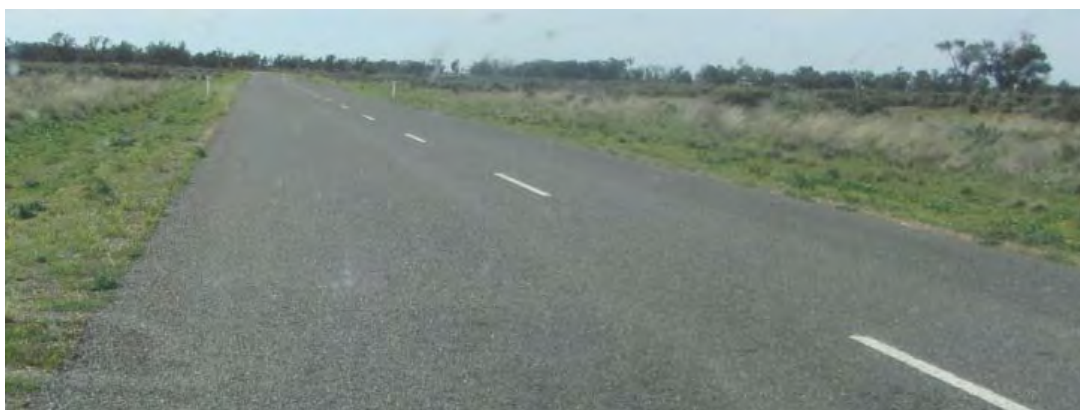
## TP6

TP6 was excavated adjacent to the failed seal due to edge break. A pavement thickness of 160 mm was observed. The pavement material is considered to be of good quality with a CBR exceeding 40%. The subgrade materials encountered appear similar to subgrade materials observed in TP2 and TP3 consisting of a medium plasticity clay, at a moisture content greater than its plastic limit.

The measured soaked CBR of 3.5% is much lower than the unsoaked value of 12% indicating its potential poor performance under wet conditions.
