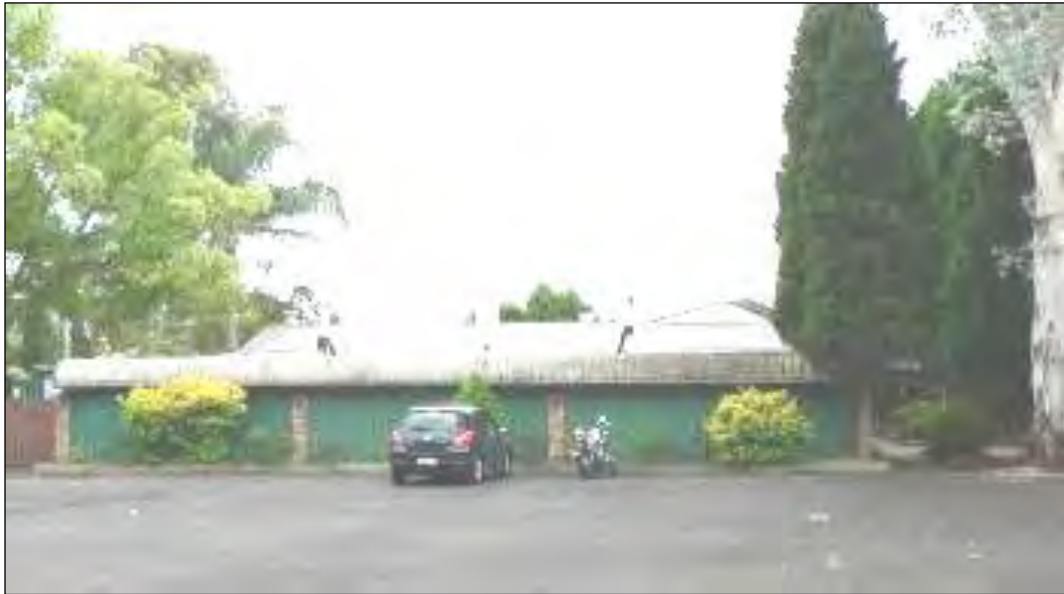
**Figure 5.17** Building B21 - Mess and courtyard from south

The Sergeant’s Mess appeared to have originally been constructed using a group of P1 style buildings as the original sections displayed similar construction techniques to the P1 Style. The building had been extended in several locations. A verandah and pergolas had been constructed on the southern side of the building in an enclosed garden/terrace area. The gardens were enclosed by timber paling fences (refer Figure 5.17).

Part of the external wall had been rendered and painted to approximately 1.5 m above the ground. This treatment detracted from the original character of the building.

The interior of the building comprised large open spaces which had a modern (non-original) feature. The building appeared to be in fair condition throughout.

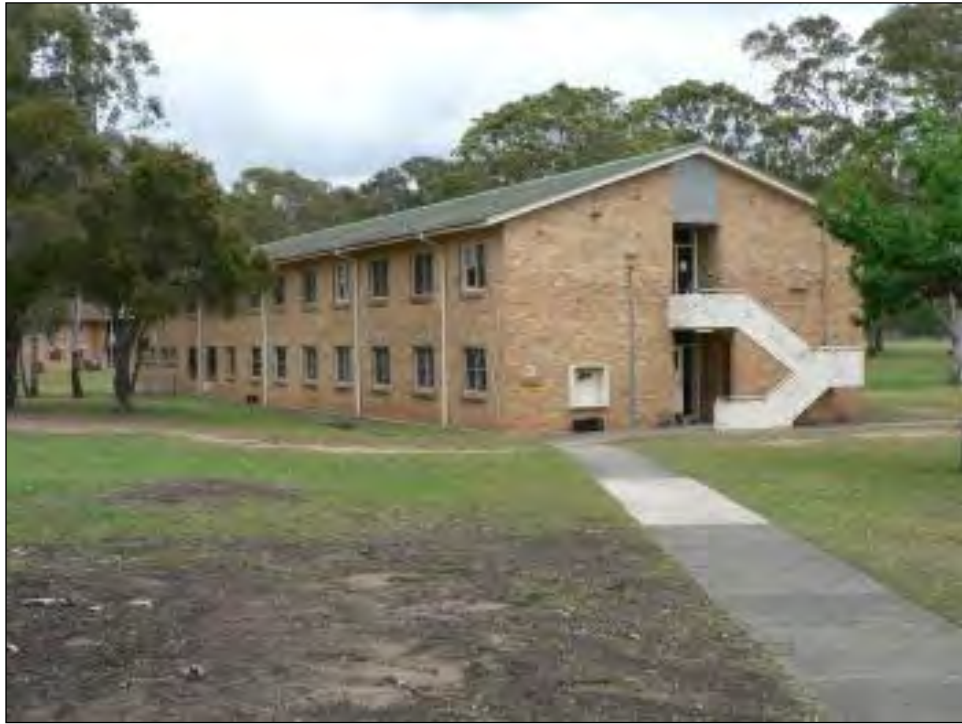
**Figure 5.18** Building B33 – representative of 1960s LIAs

These buildings were located on the western side of the main north/south road through the precinct. The group included 5 two-storey live-in accommodation blocks (LIAs). The buildings were cream double face brick construction with concrete floors. Gabled reforms were clad in brown glazed concrete tiles. The group included a single storey mess/dining room building of similar construction. Based on limited visual inspection the buildings appeared to be generally in good condition (refer Figure 5.18).

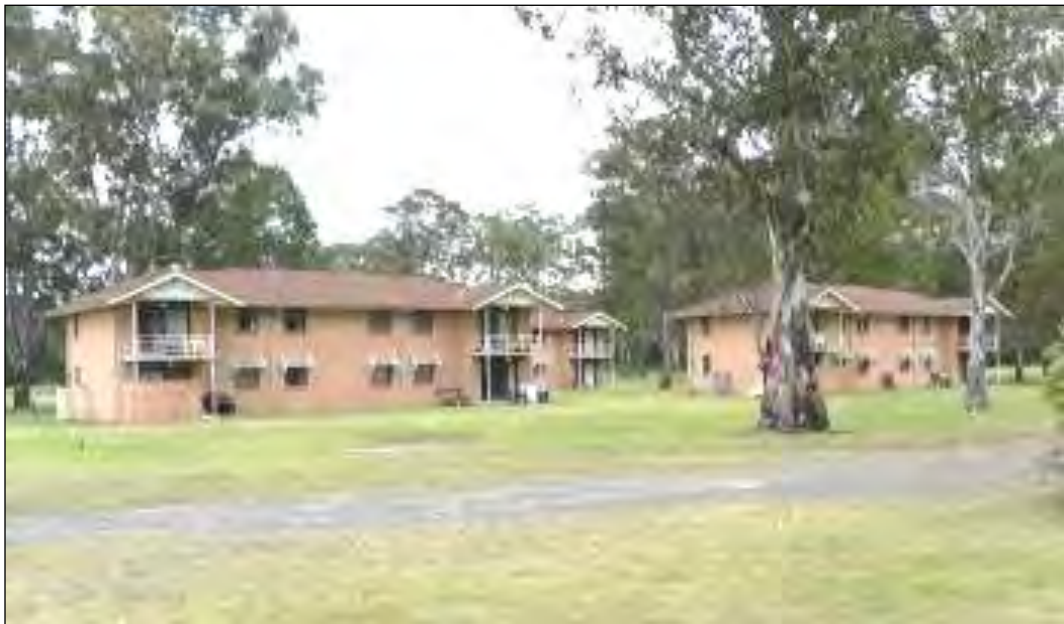
**Figure 5.19** 1990's LIAs from north – Buildings 25, 26 and 27

Four two-storey face brick live-in accommodation buildings (LIAs) at the southern end of the precinct appeared to have been constructed in the 1990s. The buildings had pitched corrugated Colorbond roofs and aluminium framed windows. They were representative of this period but had no outstanding characteristics. At the time of the inspection the buildings were occupied and generally in good condition (refer Figure 5.19).

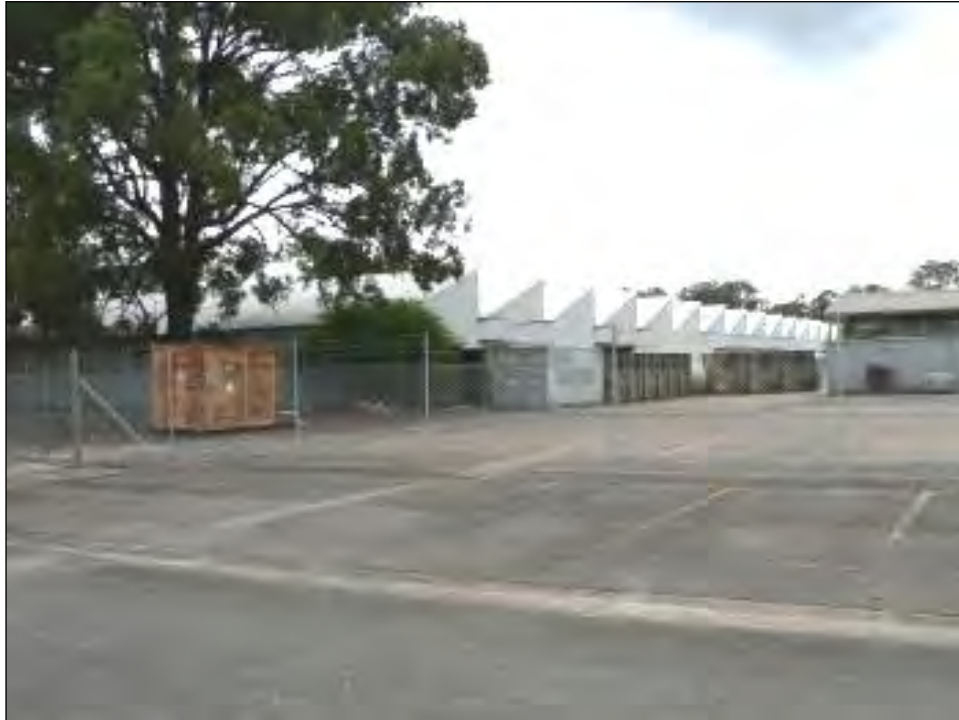
**Figure 5.20** Building 99 from northwest

Building 99 in the Transport Compound was constructed pre-1943 (Australian War Memorial photographic evidence). It is a large saw-toothed roofed workshop building (2-3 storeys in height). The structure is a steel frame; walls and roof are clad in Colorbond steel sheeting. The building has been re-clad since its construction circa 1940s (refer Figure 5.20). Originally the walls were clad in flat sheet. The re-cladding was undertaken during the mid-1990's redevelopment of the SME. The building is occupied as a transport workshop and is in good condition.

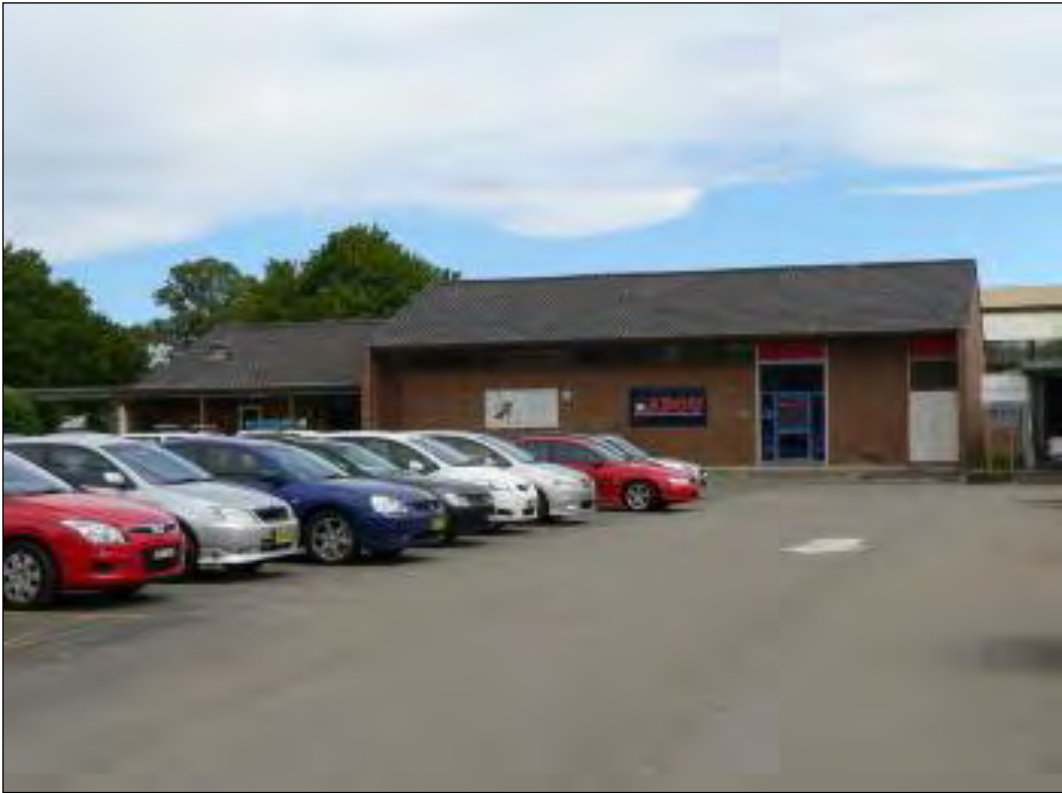
**Figure 5.22** Building B2 from north

The buildings in this precinct include face brick single-storey offices (Buildings B1 and B2) from the 1980s. Building B1 has been extended in the past five years in a style similar to the original buildings. Conference rooms, amenities and some offices are located in prefabricated transportable buildings through the precinct which appear to have been installed in the 1980s or early 1990s as there are no buildings in this location on aerial photos until 1994 (refer Figure 5.22).

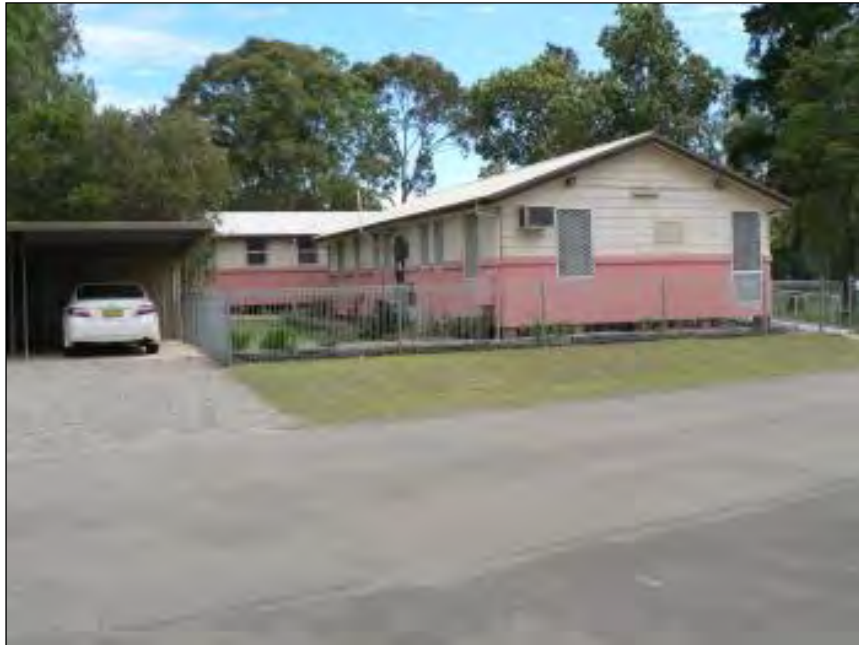
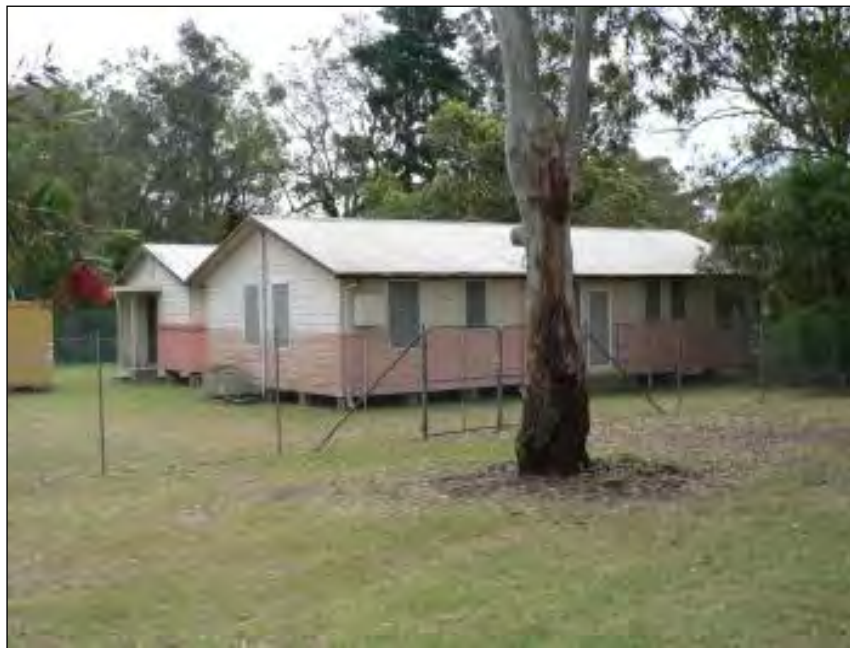
Four weatherboard clad buildings of the P1 style World War II building are located in the western edge of the built area of the precinct. These are connected by more recently constructed covered ways (Building B7–B9 and B103). The buildings have an irregular placement. Three are aligned north south and one at right angles. There are slight variances of window, door and wall construction across the group indicating different periods of construction. The buildings appear to have been relocated here from another site (as there is no record of WWII development in this part of the Project area). The variance in details and irregular site placement also indicate a non-original grouping. The walls of B9, part of B7 and B8 have been rendered and painted externally to 1.5 m above the ground (in a similar manner to B21 at Moorebank BASC). The rest of the walls are painted weatherboard. The roofs of all of the buildings have been re-clad in corrugated Colorbond steel with new gutters and down pipes installed. The buildings are actively used and generally are in good condition externally (refer Figures 5.23 and 5.24).

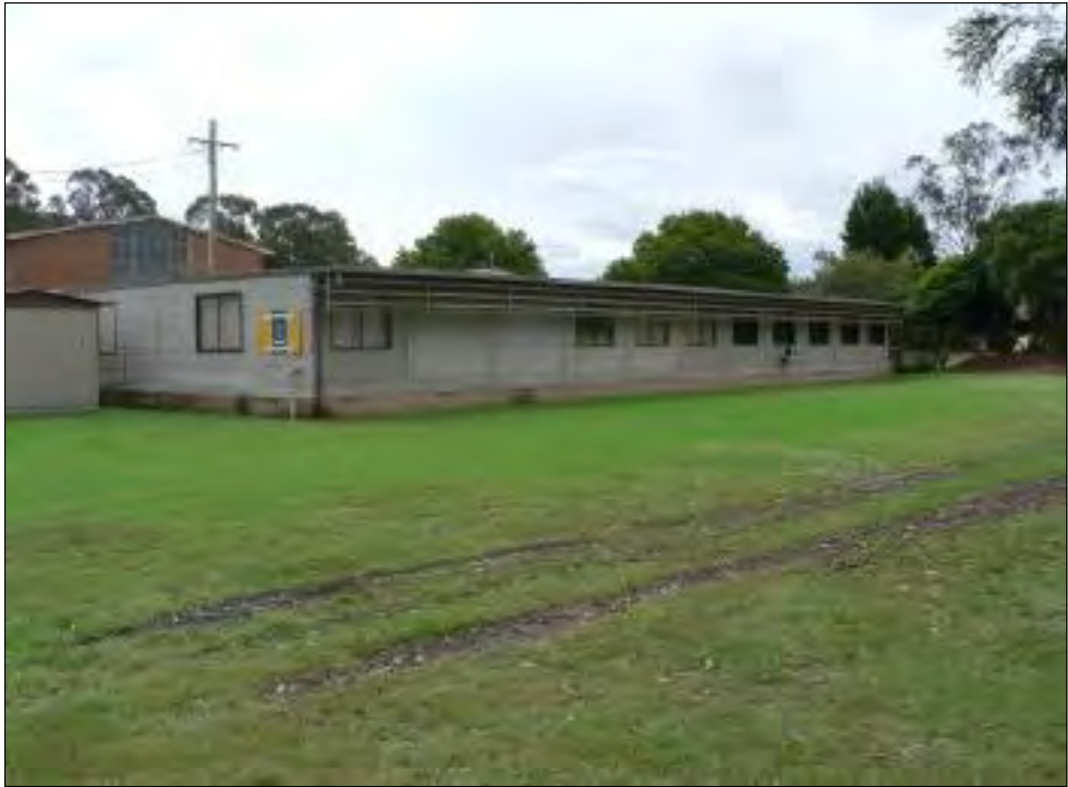
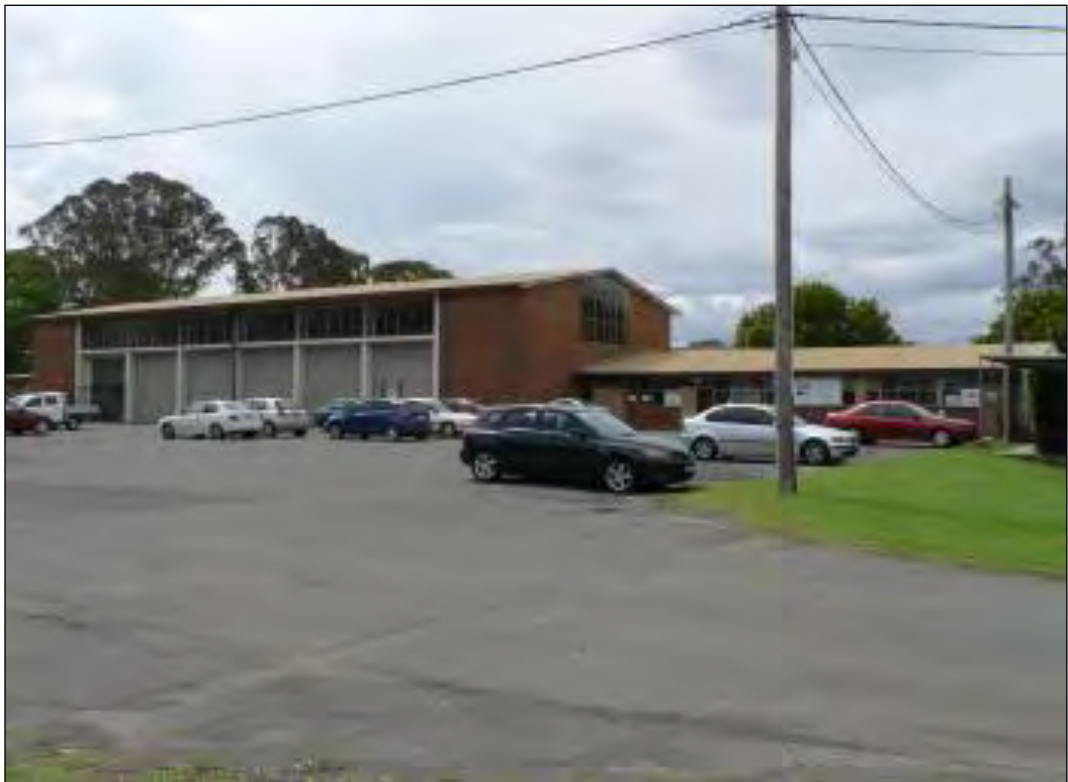
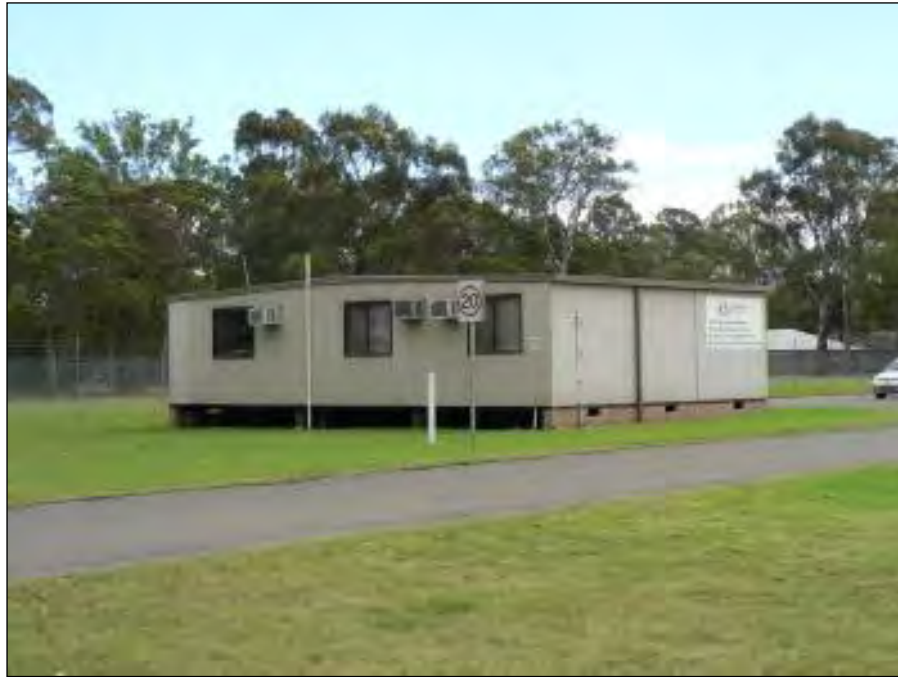
The southern half of Precinct 3 contains the stores areas. This area is enclosed by a perimeter chain wire fence. The buildings are located around a large bitumen car park. The buildings include a prefabricated office (B12 and B13), a single-storey weatherboard P1 office building and a large steel and concrete framed Q-Store building. Walls of this building are brickwork. All of the buildings are occupied and condition varies from fair to good (refer Figures 5.25, 5.26 and 5.27).

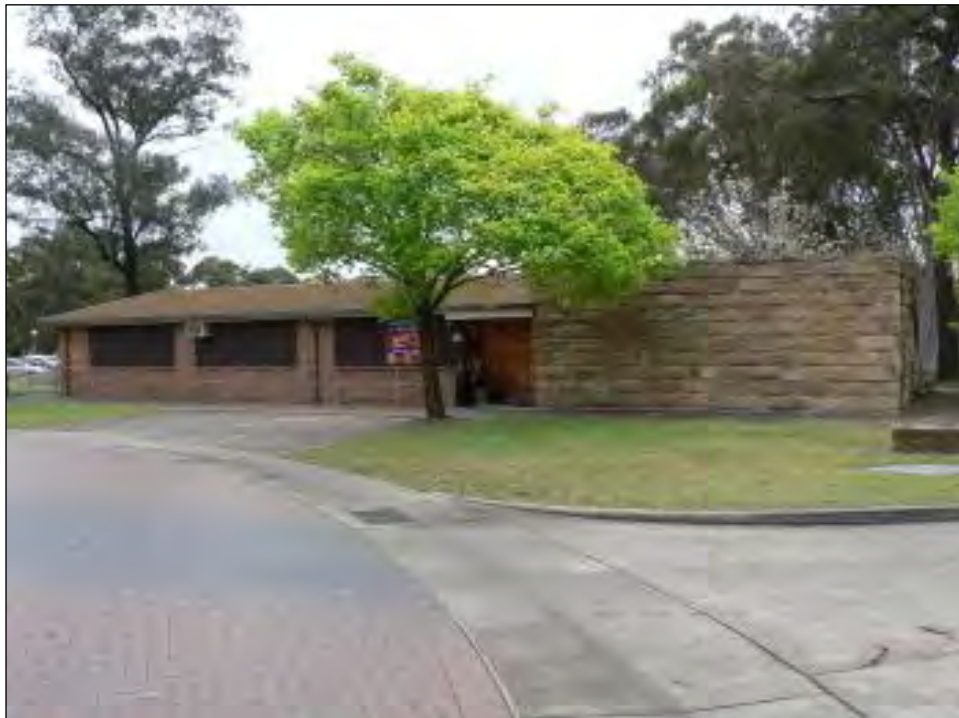
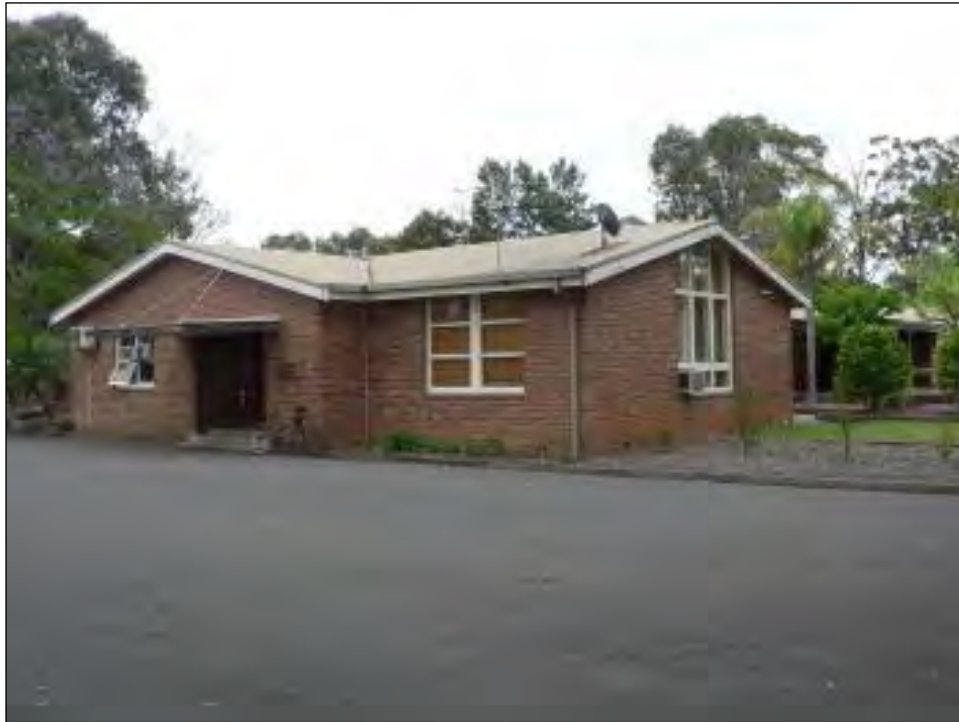
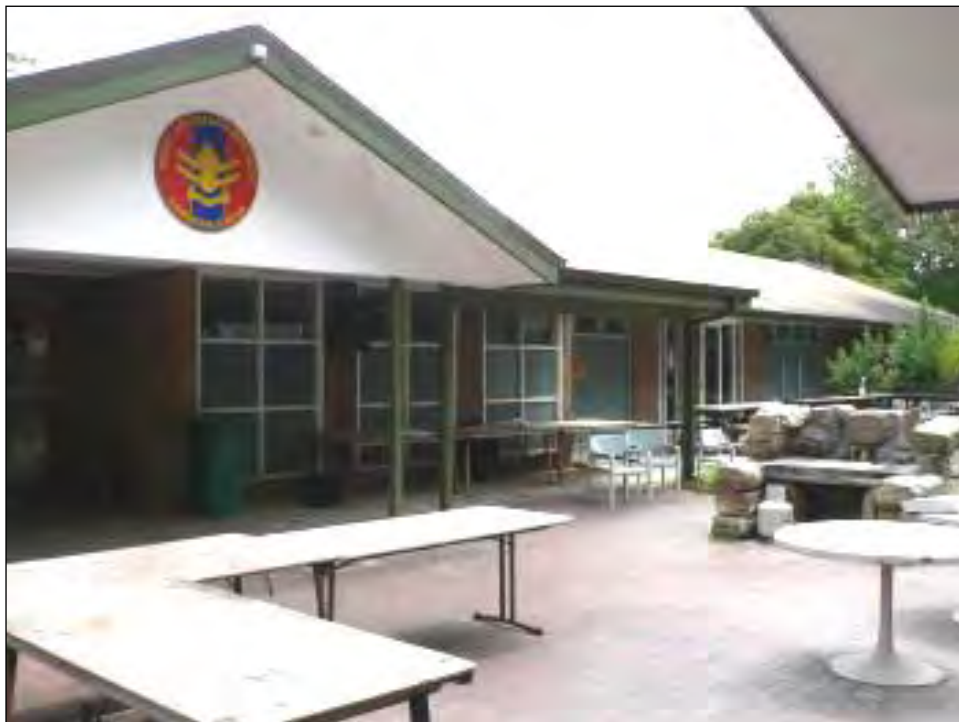
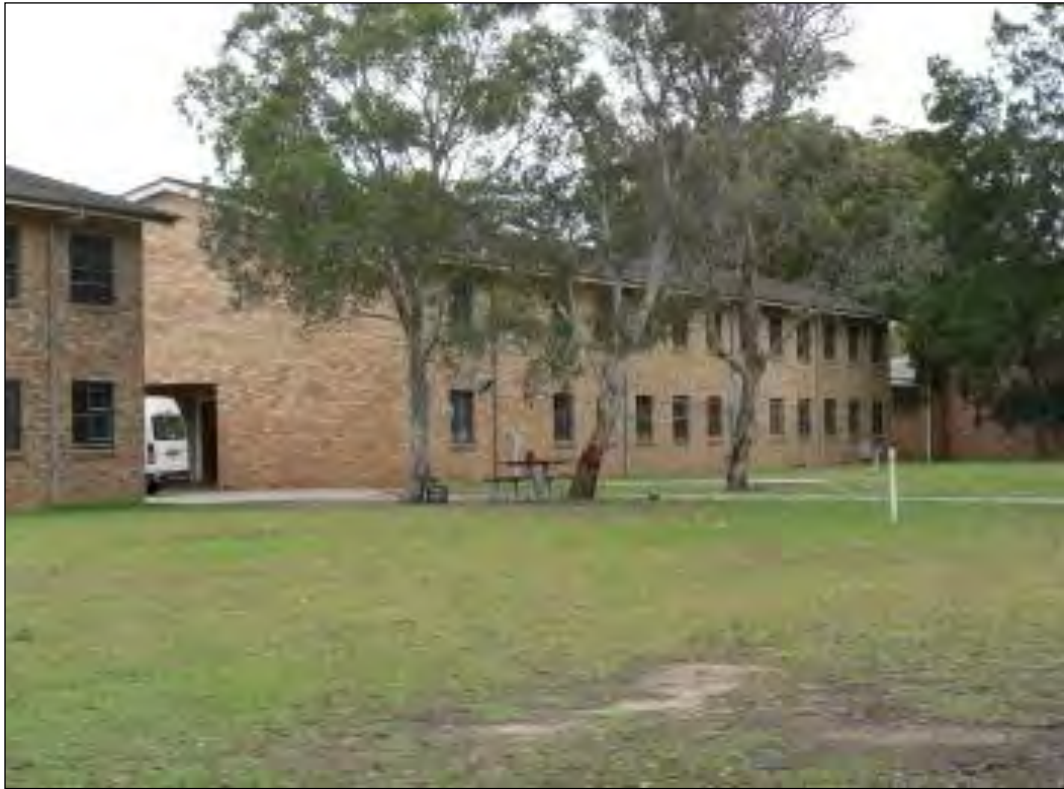
The Peeler Club and Officer's Mess have been extended in a sympathetic manner. The buildings are designed in a simple and economical style. The RAE Museum building southern facade includes a section of wall constructed of stone blocks salvaged from a railway bridge constructed by internees of Holsworthy Internment Camp during World War I. All are being used and externally are generally in good condition (refer Figures 5.31 to 5.34).

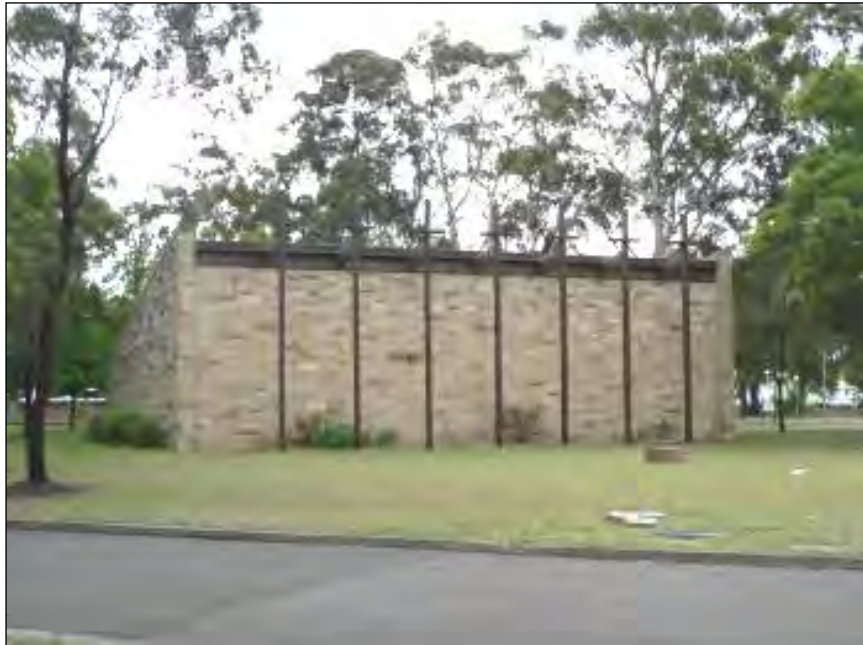
**Figure 5.35** Northern elevation of Chapel (S03)

The roof is a low pitched skillion constructed of a stramit deck supported on large exposed timber beams. On the northern façade the beams extend through past the eaves and are supported on cross timber columns of which there are seven. The columns extend past the roof beams and have a horizontal beam installed approximately one metre above which gives the columns a cross form in the elevation. This design detail provides a strong ecclesiastical reference for the building when viewed from Chatham Avenue. The lower end of the roof is supported on a structural timber window wall, which extends the full height of the southern wall. There is high level timber framed windows in the northern wall between the beam (refer Figure 5.35 and 5.36).

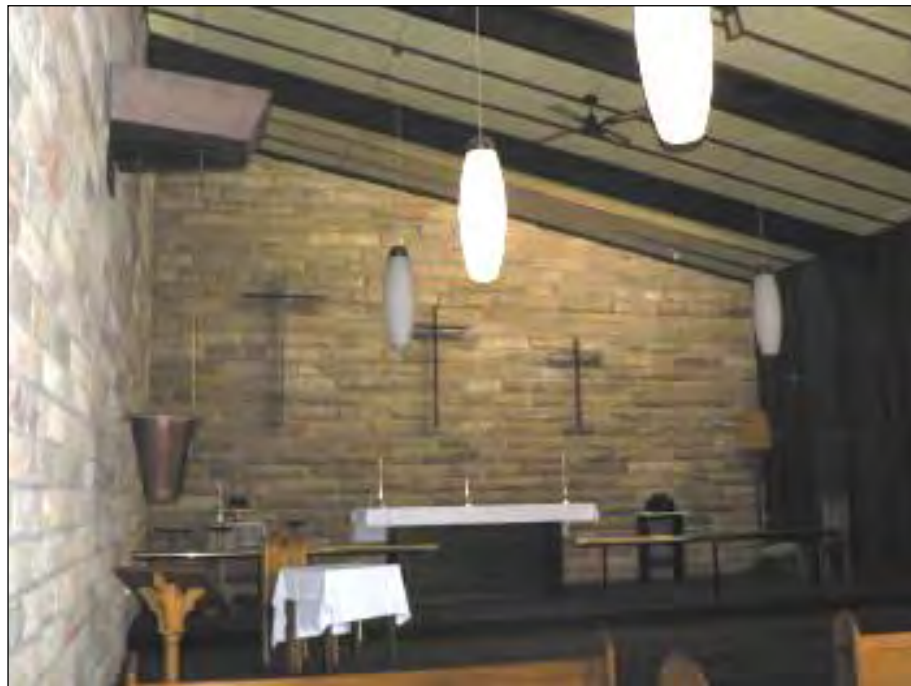
**Figure 5.37** Chapel (S03) interior

The interior of the Chapel has hand hewn face stonework walls on three facades. The southern wall and part of the eastern wall are clad in vertical timber boards which have a dark stained finish. The floor is concrete finished with vinyl tiles and a carpet runner on the central aisle. The ceiling is vermiculite stramit board (refer Figure 5.37).

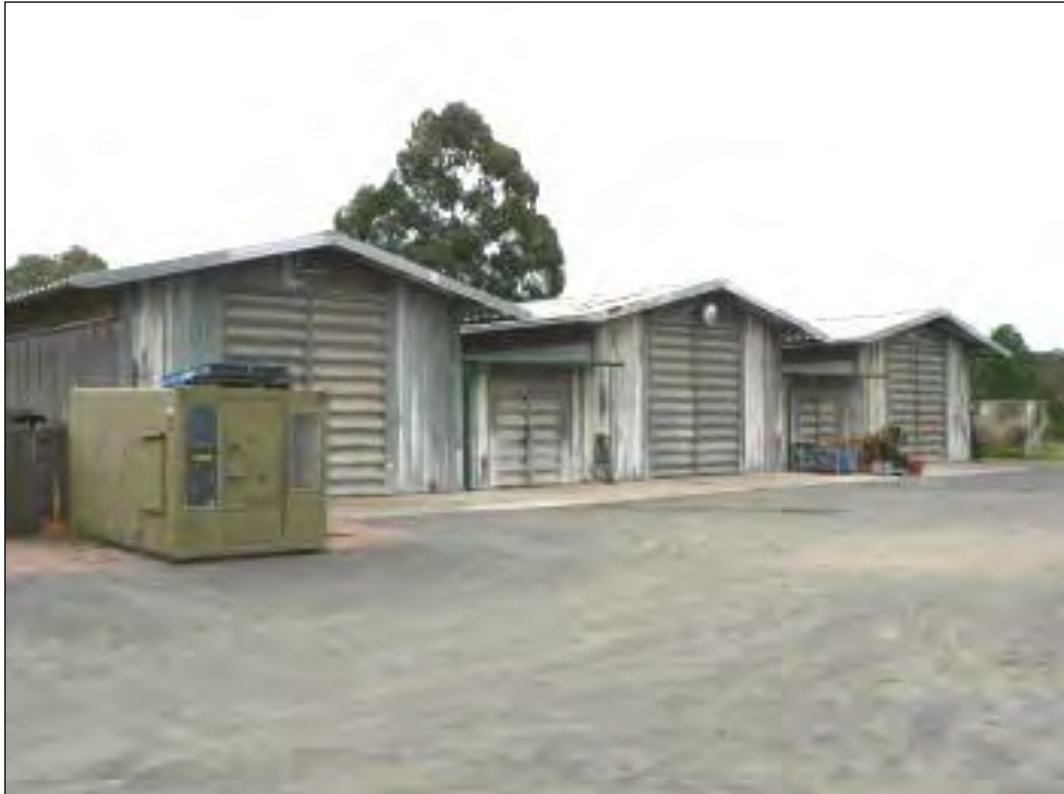
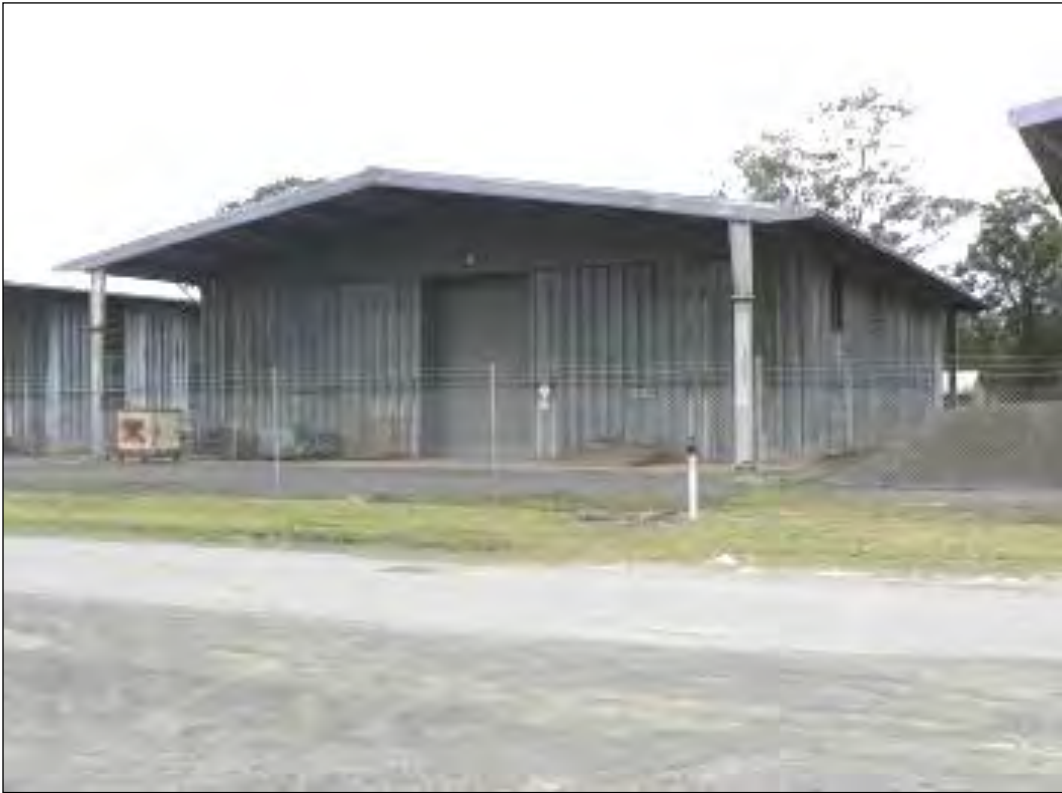
The sheds at SME are a range of sizes and include multiple units banked side-by-side. The sheds are being used as workshops and storage facilities. There does not appear to have been many changes to the exterior of the sheds. Generally they appear to be in fair to good condition. There is extensive surface rust evident on building S131. It is presently used as workshops for the RAE Museum. Buildings included in this description are S113, S114, S116, S131 and S358 (refer Figure 5.41 and 5.42).

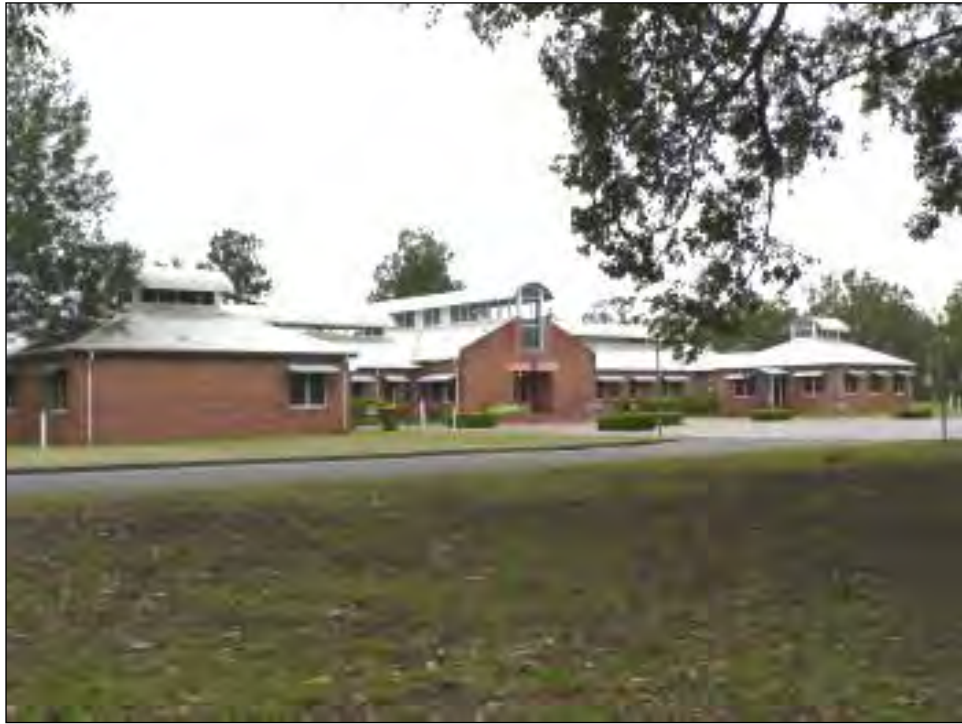
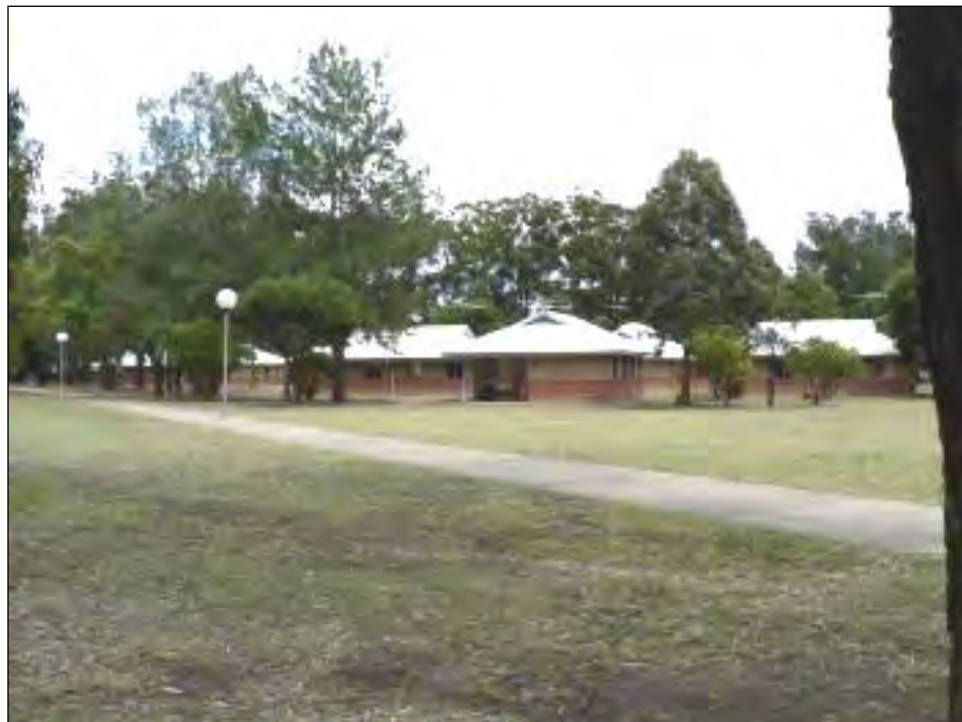
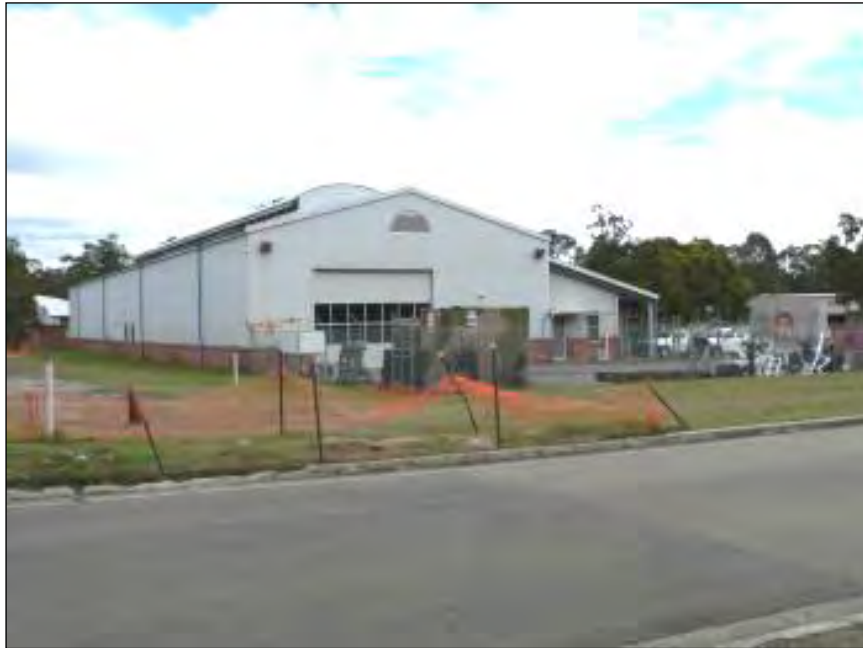
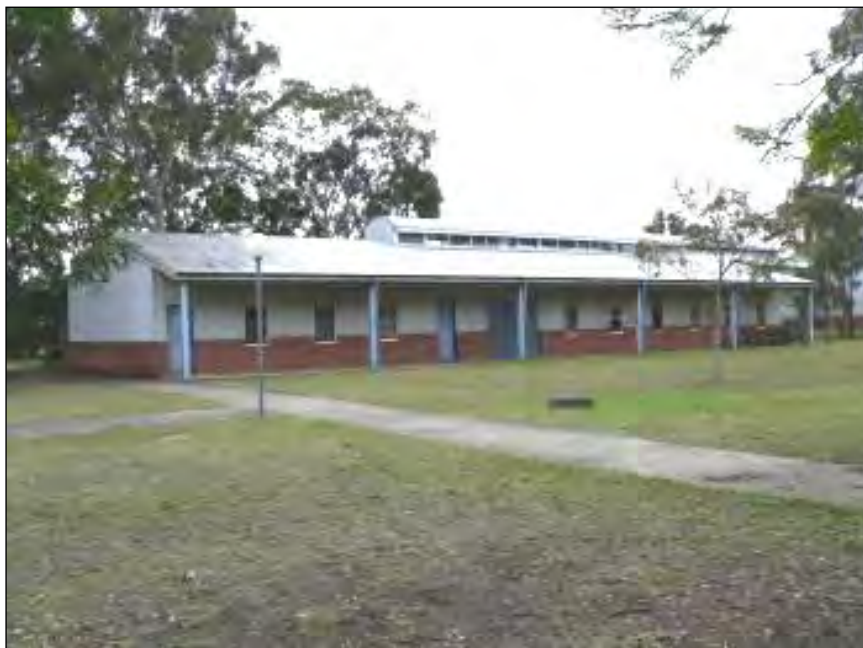
- Hipped or gabled roof forms with roof pitch 18° to 22°.
- Roof clad in white Colorbond custom orb.
- Walls part-height face cream brick with painted flat sheet above.
- Powder coated aluminium framed windows, predominantly vertical in proportion double hung sash operation, except where a high level.
- Flush panel external doors in steel frame. Often doors and frame are painted blue.
- Barrel vaulted clerestory window vents are located on the ridge line of large office buildings, mess or warehouse buildings (refer Figures 5.43 to 5.46).

All of the 1992 to 1994 period buildings are occupied and externally they are in good condition.

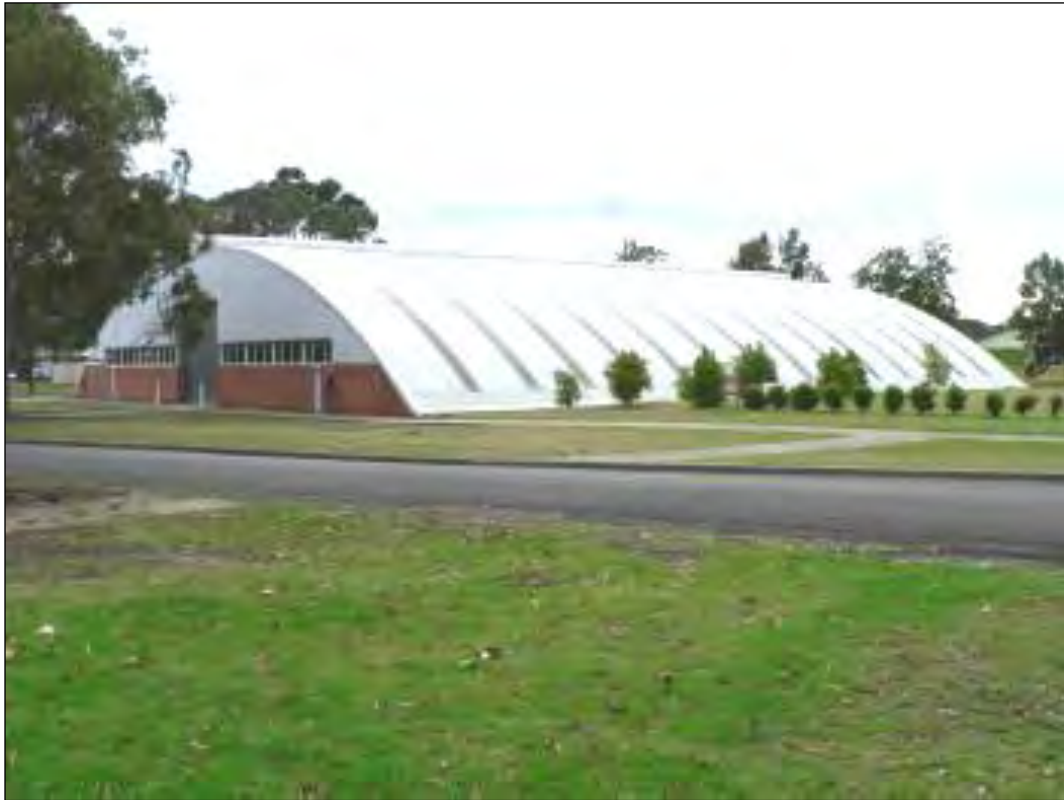
**Figure 5.47** CUST Hut (S135) viewed from southwest

The finishes in the end walls and roof are consistent with the 1990s period. As the building was erected pre-1949, this indicates that the building was refurbished during the 1990s redevelopment. The replacement of roofing is confirmed in the presence of safety mesh under the roof sheeting. This practice was only introduced in the past two decades.

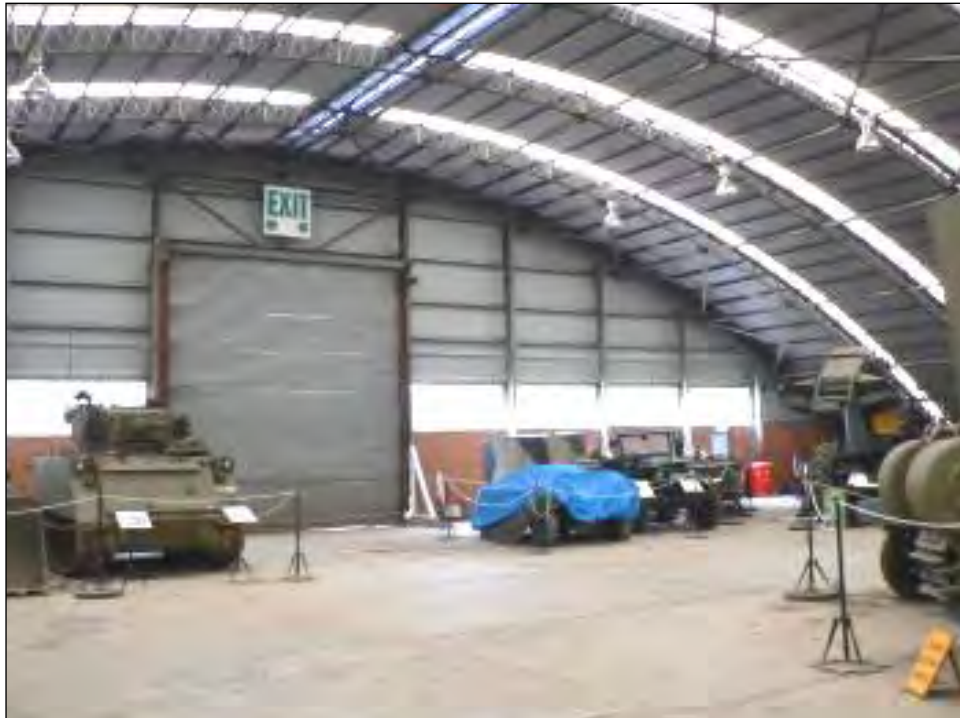
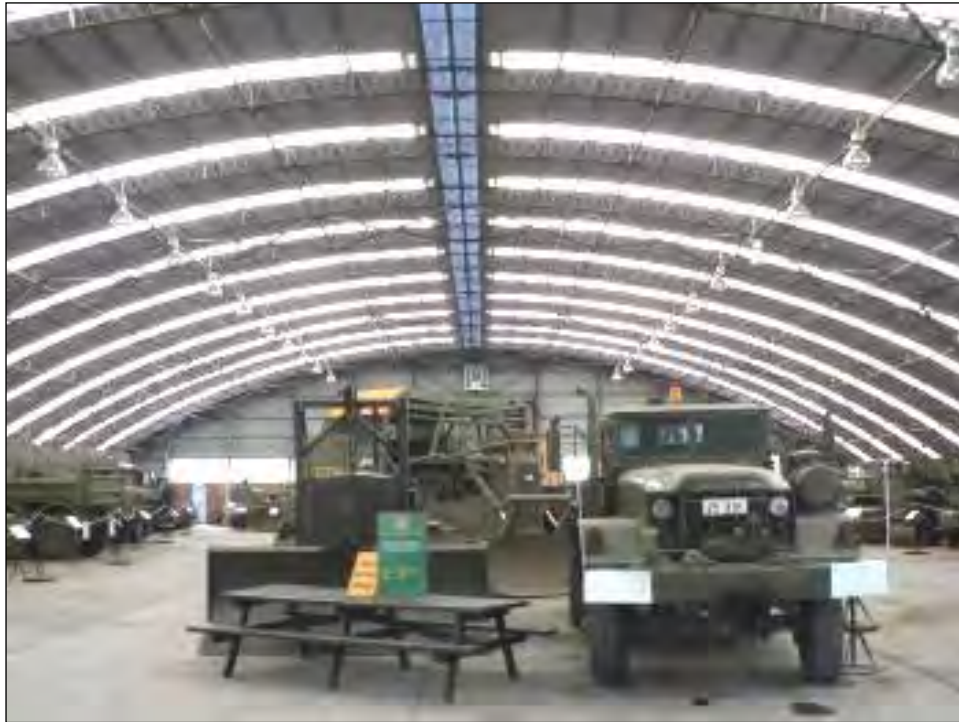
The interior of the building is a very large, column free space with unlined vaulted roof over. The solid roof sheeting is interspersed with bands of translucent sheeting. The truss frame of the roof and all roof and wall framing is exposed. The building has a concrete floor slab throughout. Large modern Hi-bay type lights are suspended from the roof. The building is presently used to store large vehicles and equipment from the RAE Museum Collection (refer Figures 5.48 and 5.49).

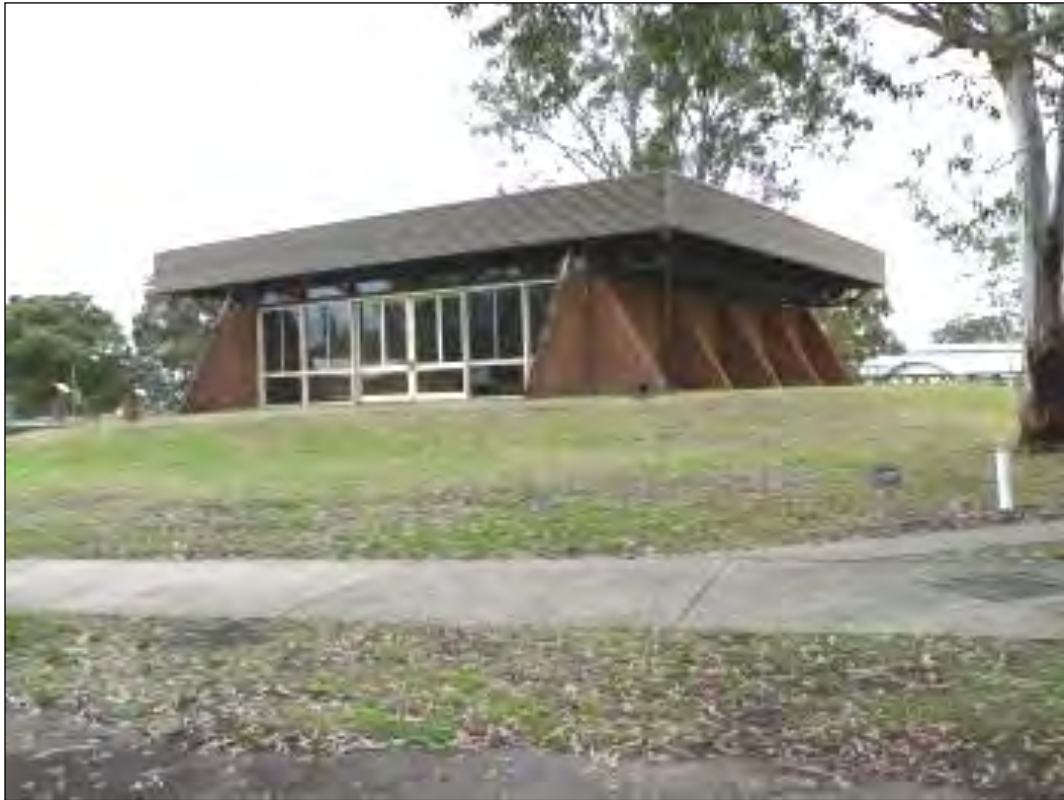
**Figure 5.50** Bicentenary building (S111) from southeast

The building has a space frame trussed roof which is exposed internally. A metal panel fascia encloses the perimeter of the roof.

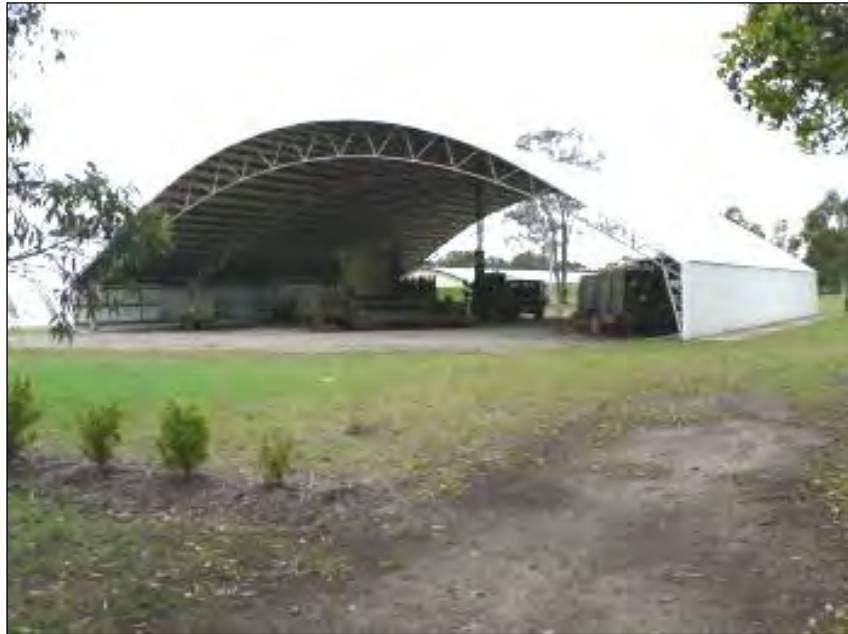
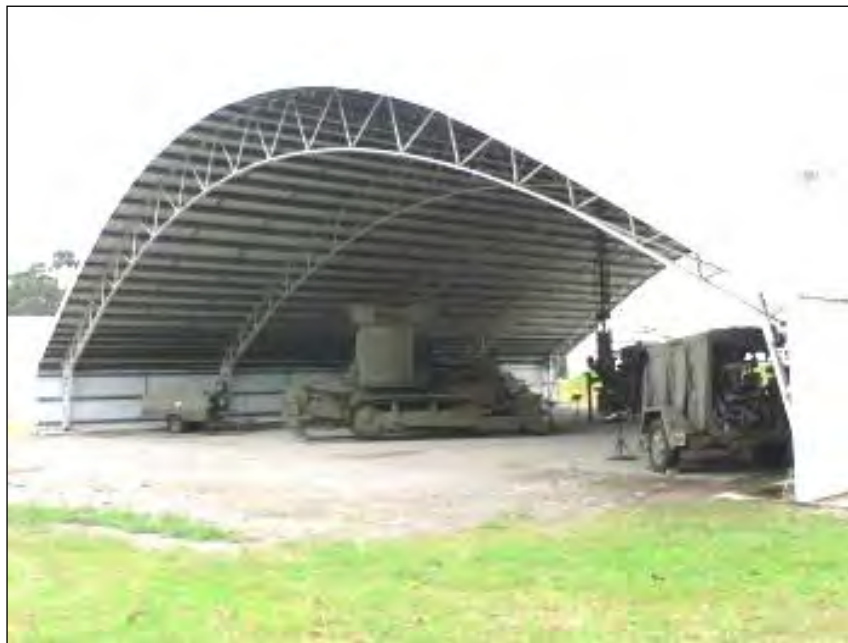
The building is a recent addition to the Park and houses large machinery and equipment from the RAE Museum collection. The hangar is in very good condition (refer Figures 5.51 and 5.52).

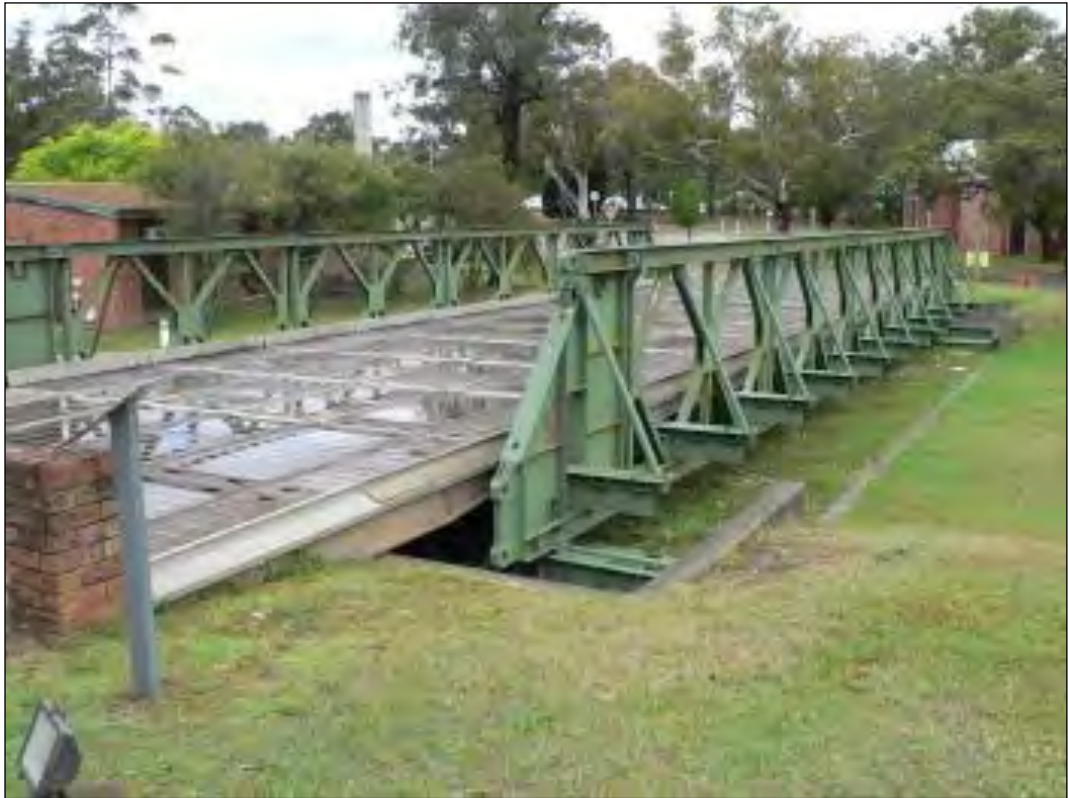
**Figure 5.53** Heavy Girder Bridge

- Steele Bridge, an example of the relocatable bridge type designed by Major-General Sir Clive Steele
- Bofor Gun and Anchor
- Australian Panel Bridge
- Bailey Bridge
- Heavy Girder Bridge (refer Figure 5.53).
