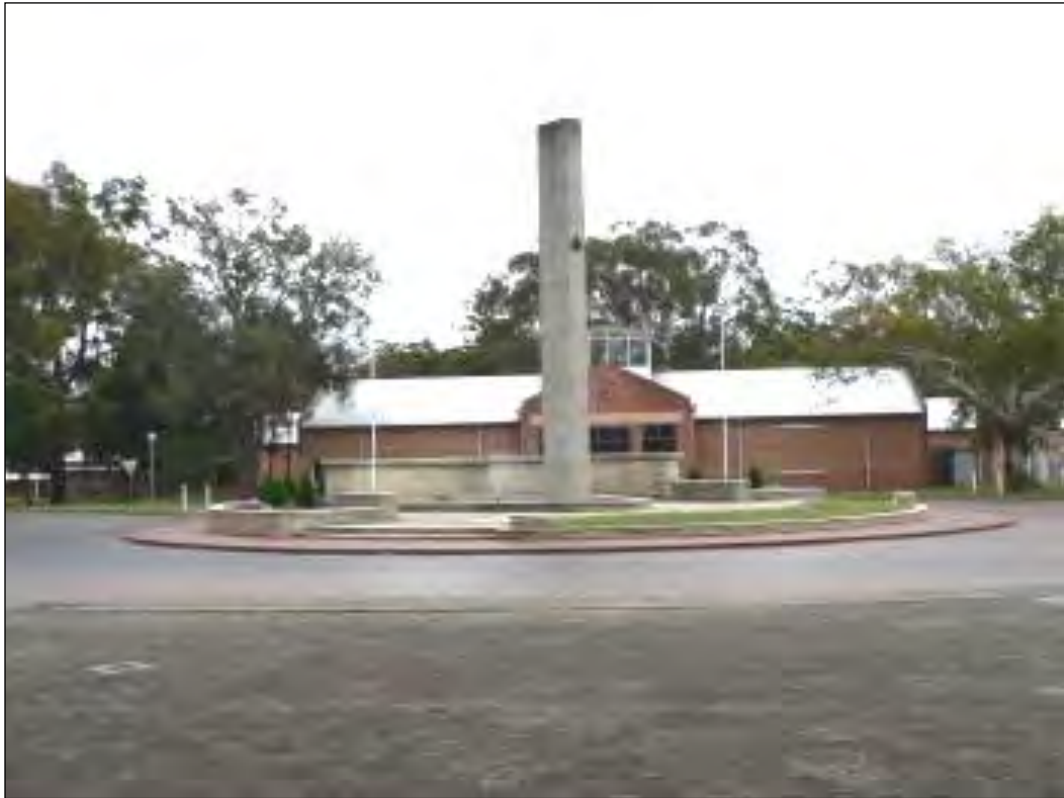
**Figure 5.56** RAE Memorial viewed from Chapel

The central column is approximately eight metres high and 600 x 600 mm in plan. It is constructed of off-form concrete. The finish when poured was considered unacceptable so Sappers used angle grinders to produce the rough cast finish which exists today (refer Figure 5.56).

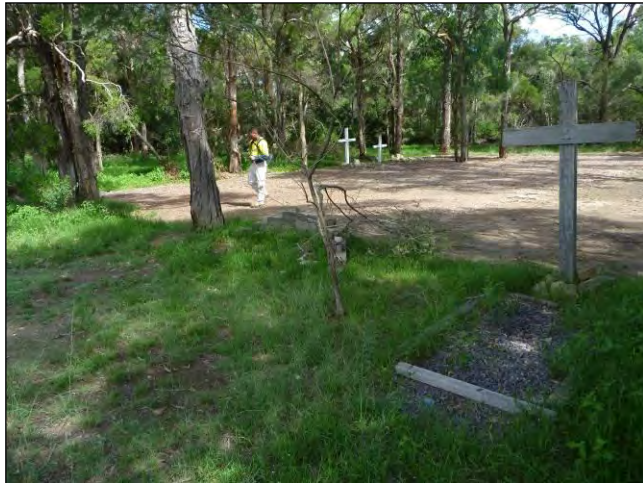
The cemetery grounds are defined by a gravelled rectangular earth platform, approximately 20 x 20m, around and within which, at least seven graves can be distinguished (Figures 5.57 and 5.58). Each evident grave has variously defined borders, using stone cobbles, brick, and wooden elements. Rope and plastic dog toys have been placed on some graves. Three graves contain standing wooden crosses, the names 'Jasmine DM403' and 'Nugget' are each evident on two of the crosses (Figure 5.58). It is considered possible that there may be other graves which are not identified by surface features.

**Figure 5.57** General view of Dog Cemetery, MH1, looking SE. Graves occur within a gravelled rectangle and around its perimeter (photo Dec. 2010).

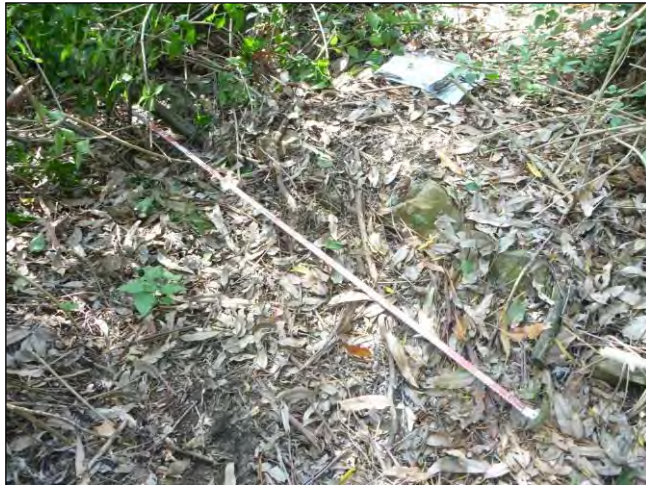
The recording consists of two parallel excavated ditches or gutters, 2m apart, and aligned in an east to west direction across the slope contours (Figure 5.59). Both are roughly bordered with sandstone cobbles and show evidence of surface hardening with the placement of hardened sediments within the channels. The gutters were possibly installed to drain water from the playing fields that are situated upslope and some distance to the east. The ditches are approximately 1m wide, and average approximately 40cm in depth. One of the end stones on the western end of the most northerly gutter seems to be partially dressed.

Based on the location, form and construction of these features, this recording is interpreted as a Defence related feature. And probably dates from the establishment of the nearby playing fields.

**Figure 5.59** MH2 – Detail of ditch showing edging of aligned sandstone cobbles. Scale rod parallels the ditch and is 2 m long. Aligned stones are situated to the right of the rod (photo Dec. 2010).

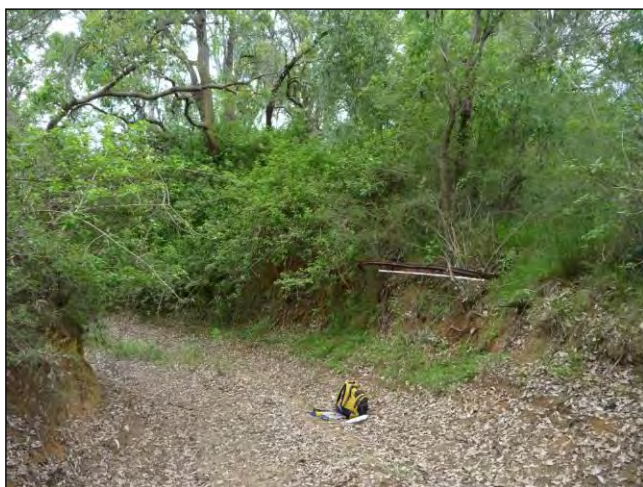
This recording comprises a section of light rail exposed in the bank of deeply entrenched vehicle track (Figures 5.60 and 5.61). The site is situated on the embankment of the tertiary terrace, at the southern end of the “dirt pans”. Two rails are evident, attached by a connecting plate to form a continuous section. The connection plate has been bent close to a right angle, with the second rail evident only by its end protruding from the bank (Figure 5.62). The rail is 57mm wide at the base, and 65mm in height, with the top edge of the rail measuring 32 x 13mm. Pins in the connecting plate are 105mm apart.

The rail is situated within a landscape which has been highly disturbed by earth works associated with Defence training installations and infrastructure. Based on this context, and the isolated nature of this find, it can be concluded that the rail portion is neither *in situ* nor likely to be close to its original location. The rail may have originally formed part of the light rail line which serviced a sand mining operation in the Project area between 1917 and 1930. Alternatively it may have formed part of former Defence infrastructure or a piece of training equipment.

**Figure 5.60** General view of a section of light rail (MH3) protruding from a road side bank, looking NW. Scale rod is 2 m (photo Dec. 2010).

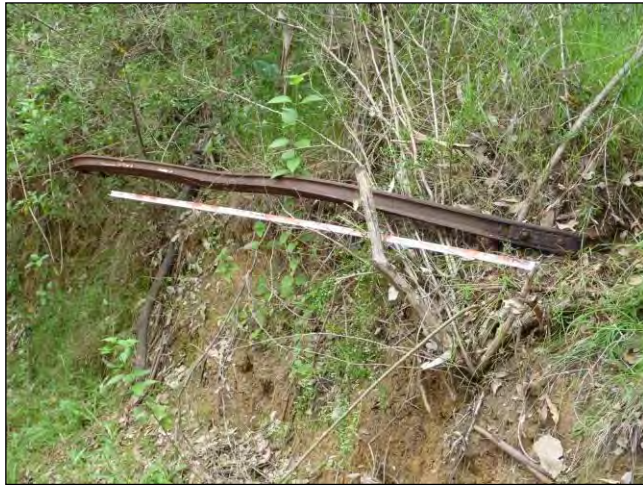
**Figure 5.61** View of light rail portion (MH3), note connecting plate at right hand end. Scale rod is 2 m (photo Dec. 2010).

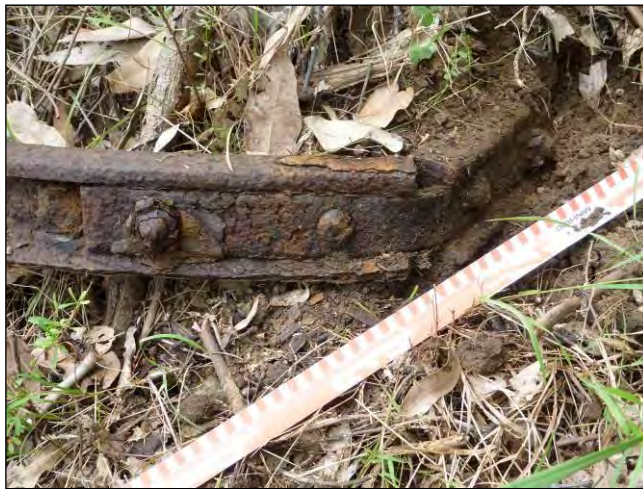
**Figure 5.62** Detail of connection plate joining two light rail portions at MH3 (photo Dec. 2010).

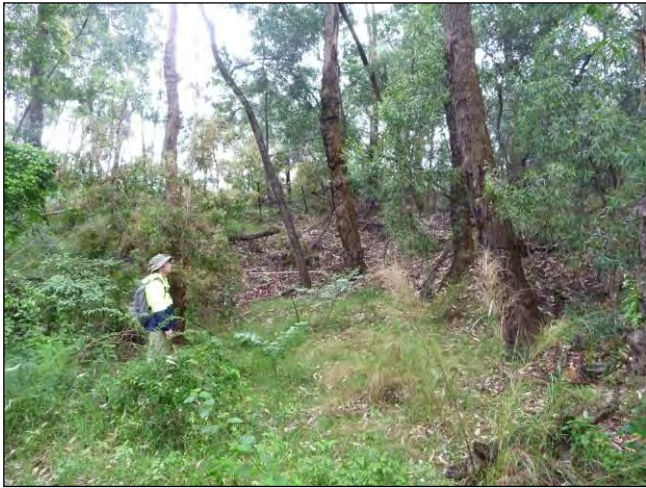
This recording comprises a section of light rail and a bent linear metal plate exposed in spoil associated with the disturbed embankment of the tertiary terrace bank (Figures 5.63 and 5.65). This portion of the terrace embankment, like the majority of the slope within the Project area, has been substantially disturbed by the construction of training course earthworks and obstacles.

**Figure 5.63** General view, looking E, at location of metal plate and rail finds at MH4 (picture centre). Note disturbance to ground from former Defence use a field training course (photo Dec. 2010).

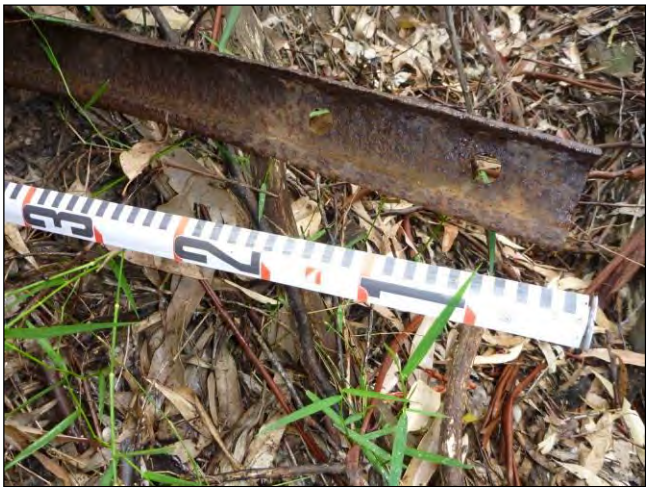
The portion of light rail extends from a low bank (Figure 5.64). Nearby is a long linear metal plate/rim which protrudes up to 1.5 m above ground level (Figure 5.65). The dimensions of the exposed section of plate/rim are 3m x 10cm x 12mm. It has a bracket on one side with a hole possibly for a connecting hinge pin. The dimensions of the light rail are 50mm wide at the base, and 55mm in height, with the top edge of the rail measuring 27 x 10mm. Pin holes on the light rail are 16mm in diameter and are placed at 105mm intervals.

**Figure 5.64** Detail of light rail protruding from spoil at MH4 (photo Dec. 2010).

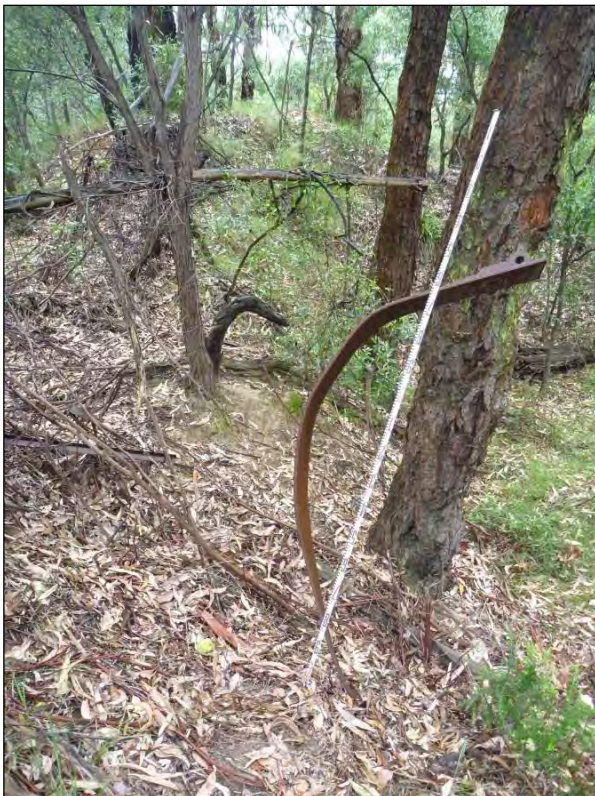
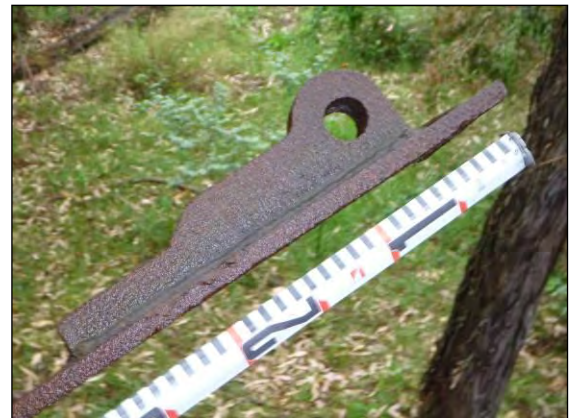
Based on the context, and the isolated nature of this find, it can be concluded that the rail portion is not *in situ* and may not be close to its original location. The rail may have originally formed part of the light rail line which serviced a sand mining operation in the Project area between 1917 and 1930. Alternatively it may have formed part of former Defence infrastructure or a piece of training equipment.

**Figures 5.65 and 5.66** General and detail views of metal plate component at MH4, looking S. Scale rod is 2 m long. Detail is of bracket positioned at the free end of the plate component (photos Dec. 2010).

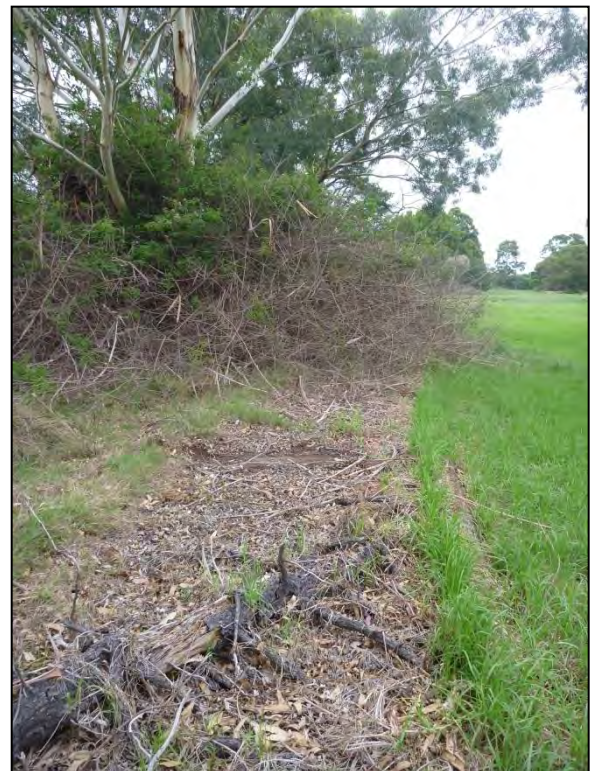
includes posts marking the location of the fifth and twelfth tees, and remnants of concrete paving associated with the twelfth tee (Figures 5.74 and 5.75).

**Figure 5.75** Overgrown concrete paving adjacent the 12<sup>th</sup> Tee (photo Feb. 2013)

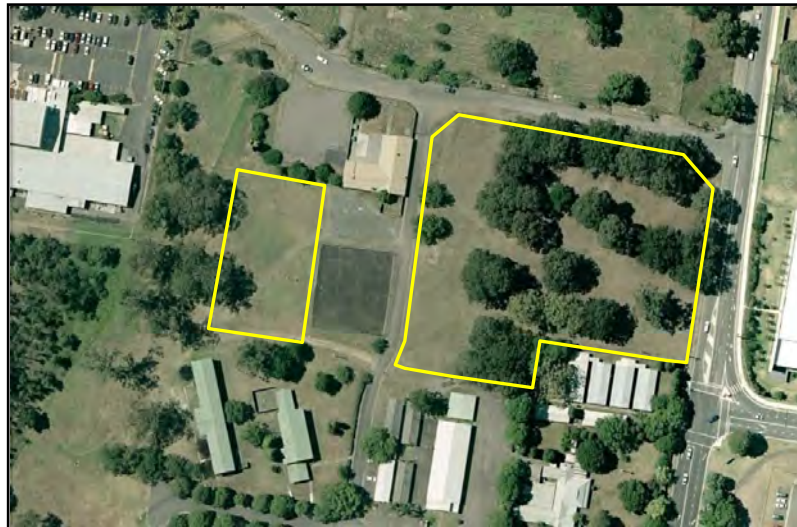
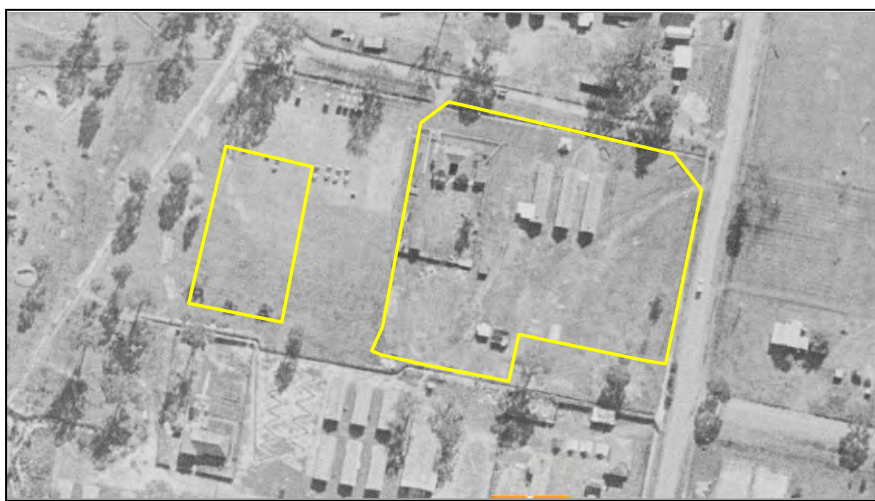
2012 aerial photo from Google Earth Pro showing boundary of MHPAD1 (yellow outline)

1943 aerial photo from [www.six.nsw.gov.au](http://www.six.nsw.gov.au) showing boundary of MHPAD1 (yellow outline) relative to World War II infrastructure

**Figure 5.78** Comparison of contemporary and 1943 aerial photography of the Titalka Park region and the area of MHPAD1 (yellow boundary).

A 1943 aerial photograph, towards the end of World War II, shows the presence of Defence related infrastructure in the area of MHPAD1 (Figure 5.79). Three P1 type hut buildings are shown on the south side of, and perpendicular to Bapaume Rd (the northern boundary of Titalka Park), and a U shaped building with enclosed rear yard and outbuildings is shown in the north western portion of the future park. A number of smaller buildings and structures are associated with the P1 huts or situated near the southern park perimeter.

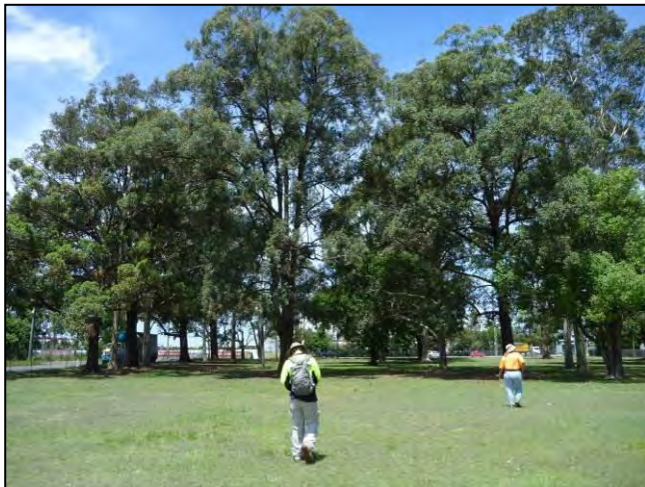
**Figure 5.82** Looking E across the northern portion of Titalka Park (photo Dec. 2010).

At the time of survey (2011), Titalka Park consisted of an open area park with broadly spaced and aligned planted shade trees (Eucalyptus) and continuous grass turf (Figures 5.81 – 5.83). The area is fully fenced along its eastern (Moorebank Avenue) and northern (Bapaume Road) perimeter, and appears to be used for low impact recreation by Defence personnel. No standing structures remain within the MHPAD1 area although a number of buildings, including variously modified P1 type hut buildings dating from the 1940s, were present adjacent to the southern boundary of the park and PAD area. Apart from a remnant concrete floor near the southern boundary of the park (Figure 5.83), no clear surface remains of former structures are evident.

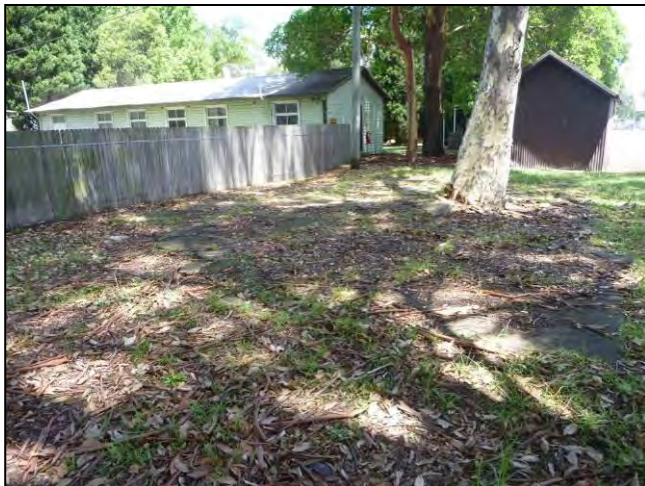
**Figure 5.83** Looking S across a remnant concrete floor on the southern margin of Titalka Park. These remains were removed during demolition works in 2012 (photo Dec. 2010).

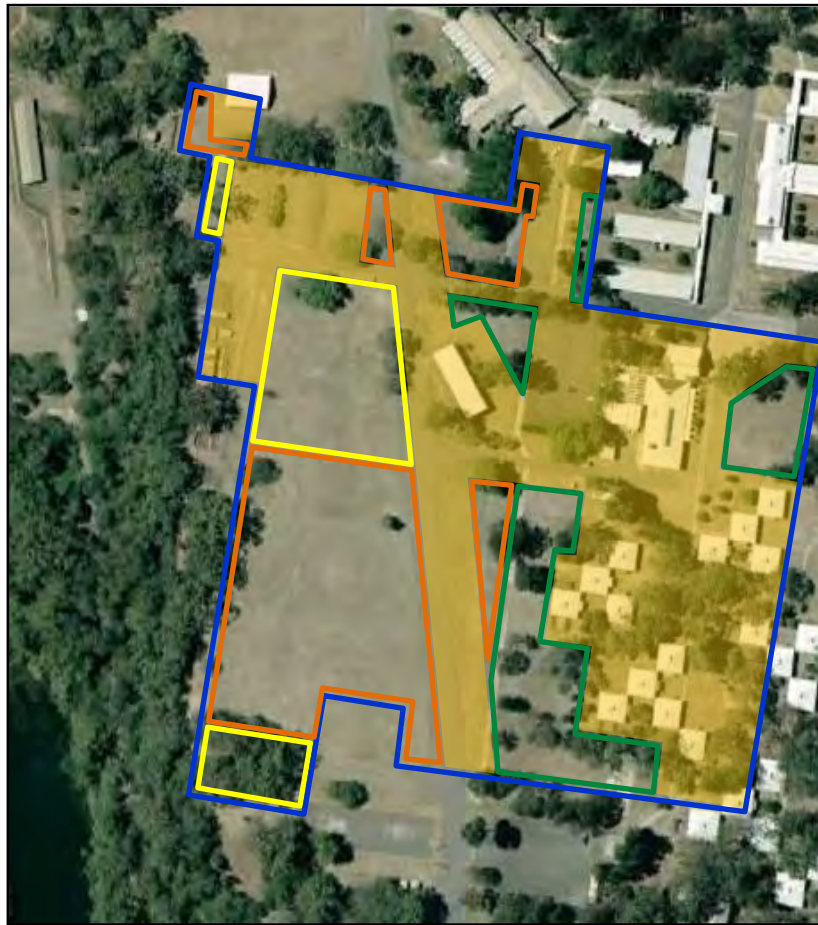
**Figure 5.86** Interpretation of archaeological potential across MH PAD2

A 1943 aerial photograph, dating towards the end of World War II, shows the presence of Defence related infrastructure in the area of MHPAD2 (Figure 5.85). The deposit is situated at the eastern end of Chatham Avenue within the SME (Figure 5.86). The deposit is situated within a former locus of WWII buildings, most of which appear to have been P1 type buildings. These were situated within an area of approximately 270 x 250m. Subsequent development has impacted a large proportion of this original area (Figure 5.82). The remaining portions of archaeological potential occur in open space areas which appear to have been variously used by Defence for field training and sporting activities.

Greatest potential occurs within areas that are distant from areas of post WWII construction and high impact training grounds. The largest area of least impact (defined as 'high potential') is a central northern remnant (refer Figure 5.86) where some masonry remains (probably footings) are evident on the ground surface. To the south of this area, field training impacts include excavation and surface erosion which will have impacted potentially occurring archaeological deposits. Areas in proximity of post WWII construction areas, depending on distance and likely impact, have been variously assessed as having moderate or low potential.

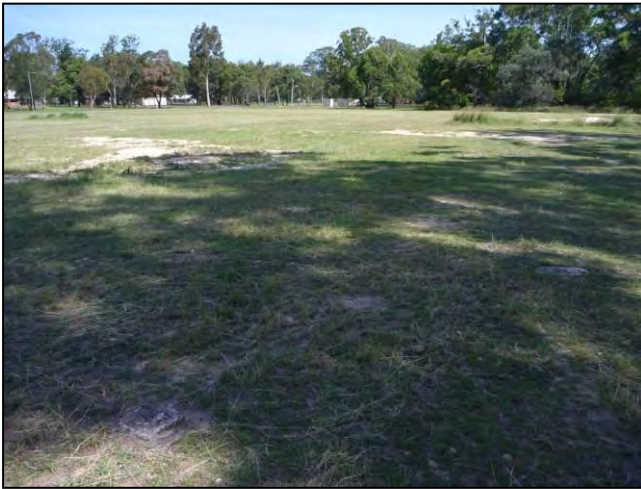
**Figure 5.87** Looking SE across the south western portion of MHPAD2. Note footing remains aligned in foreground (photo Dec 2010).

At the time of survey (Dec 2010), the MH PAD2 area consisted of an open grassed area, with some excavation and erosion scalds evident in the Southern western portion (Figures 5.87-5.89). No standing structures remain within the high potential portions of the PAD.

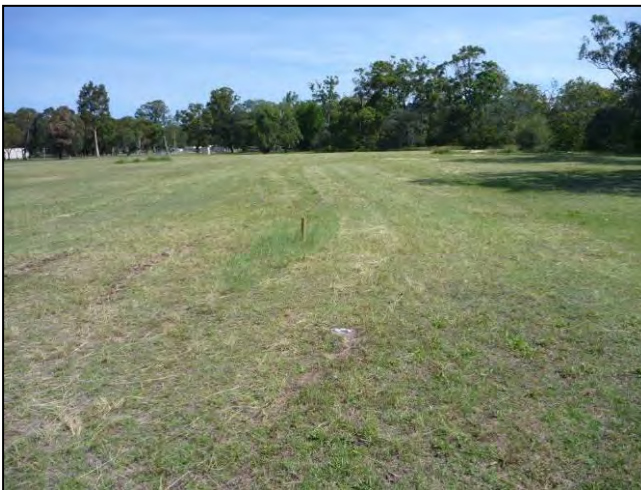
**Figure 5.88** Looking S across western portion of MHPAD2, note footing remains in foreground (photo Dec 2010).

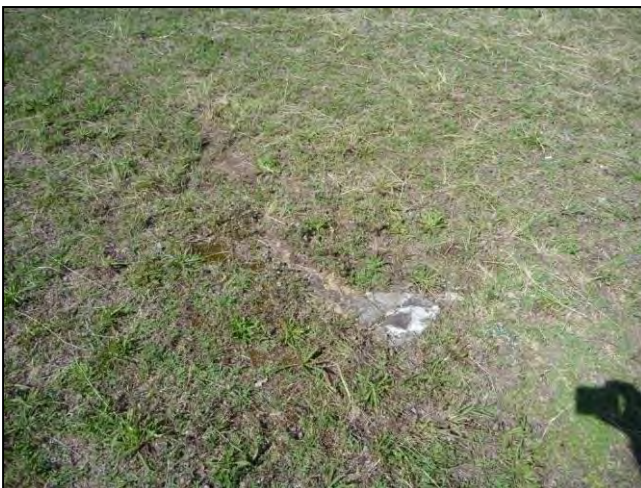
**Figure 5.89** Detail of surface evidence of footings at MHPAD2, also shown in Figure above (photo Dec 2010).

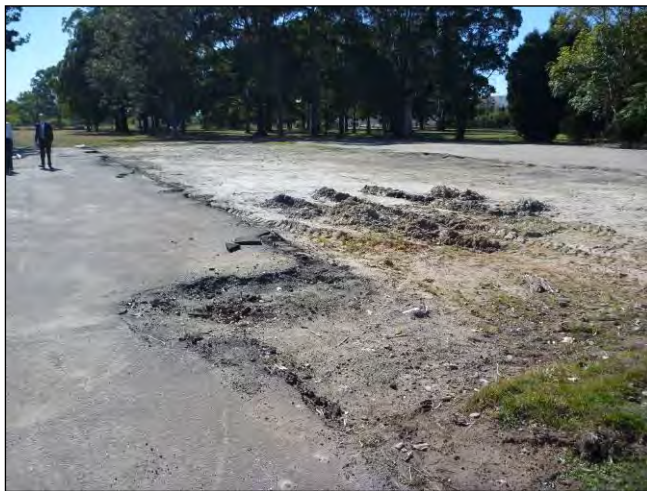
**Figure 5.92** Looking N across the footprint of the former Drill Hall (Building B40), showing surrounding MHPAD3 deposits under bitumen (photo Aug 2012).

- The footprint of the former Drill Hall Building (B40) (Figure 5.92);
- A margin of deposit (extending between 18 and 8m from the footprint), situated around the former building. Most of this margin is situated below a surviving bitumen surface (Figure 5.92). There are two unsealed areas to the north and south of the footprint (being remnant garden beds and entrance paths at the southern end, Figure 5.89, and grassed open ground to the northwest, Figure 5.90); and
- A remnant garden area, formerly situated at the southern end of building 39 (Figure 5.93).

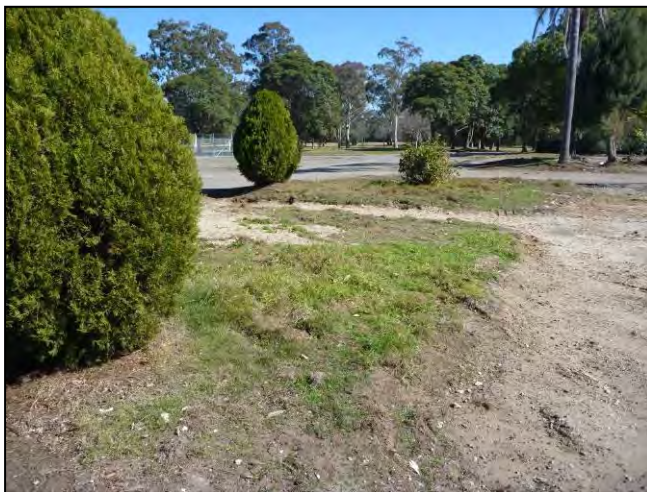
**Figure 5.93** Looking W across the southern portion of MHPAD3, showing the two garden beds and former entrances to former buildings B39 and B40 (photo Aug 2012).

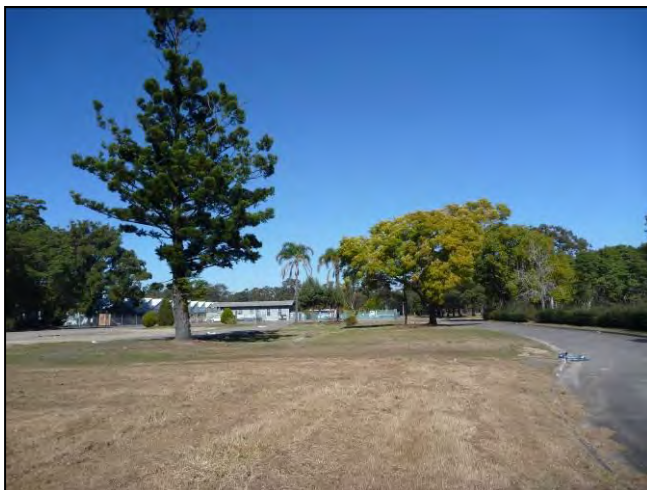
**Figure 5.94** Looking S towards the western boundary of MHPAD3 and the adjacent former location of buildings B36-39. Note the lack of archaeological potential due to disturbance from the removal of footings, and subsequent grading and seeding.

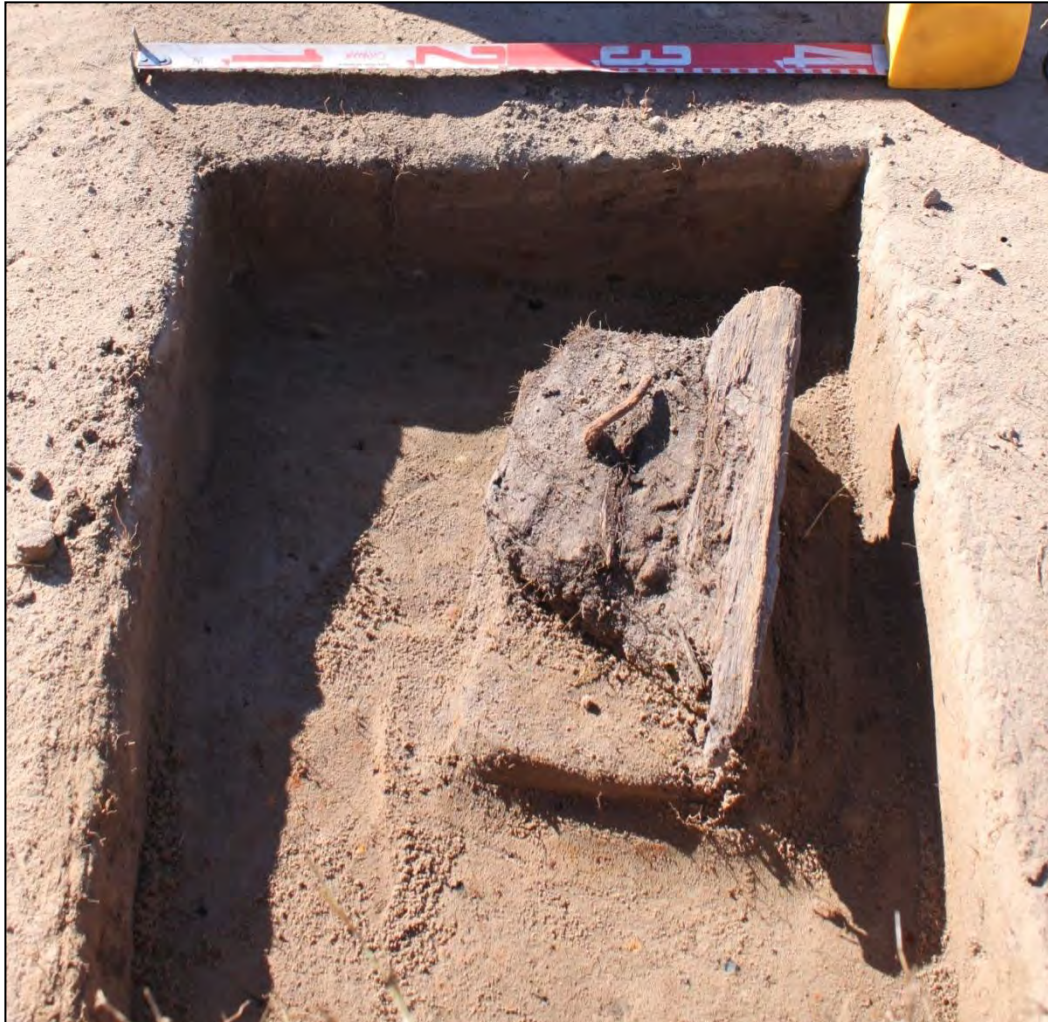
**Figure 8.2** Piece of wood excavated within Transect 2, Square 4

- at the western end of the transect, a rectangular, grey-brown silty sandy feature was revealed extending into the sand at the base of Cut 3 with what appeared to be *in situ* wood associated (Figure 8.2);

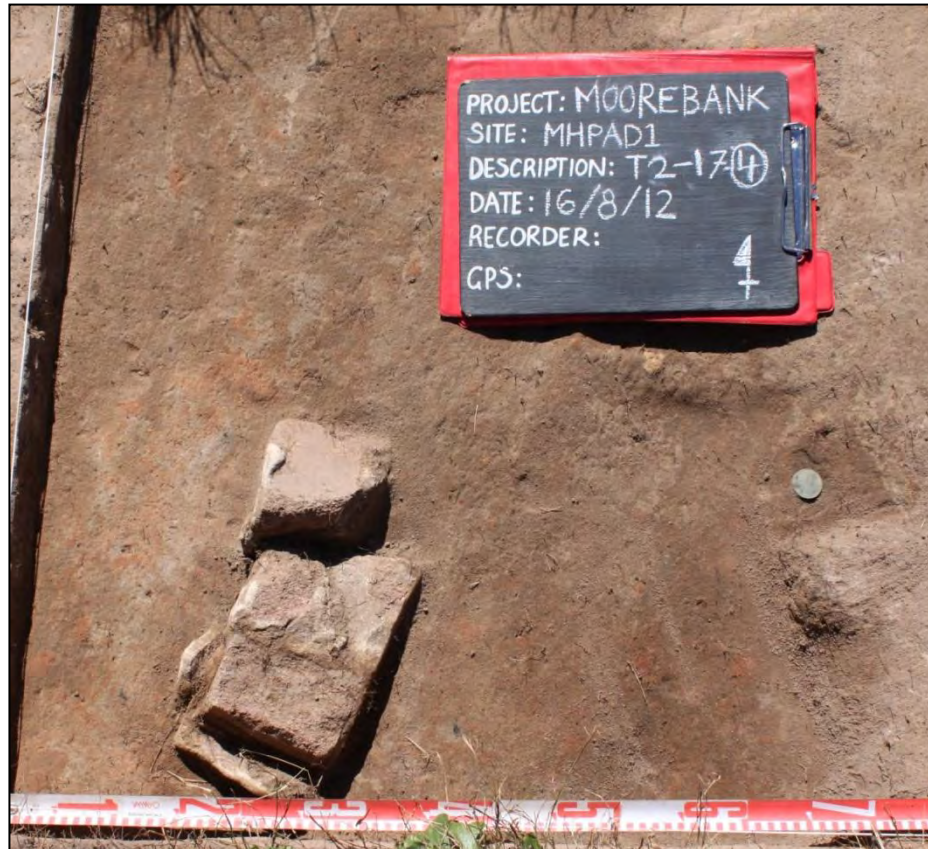
**Figure 8.3** Bricks and 1919 coin revealed by excavation at Transect 2 Square 17

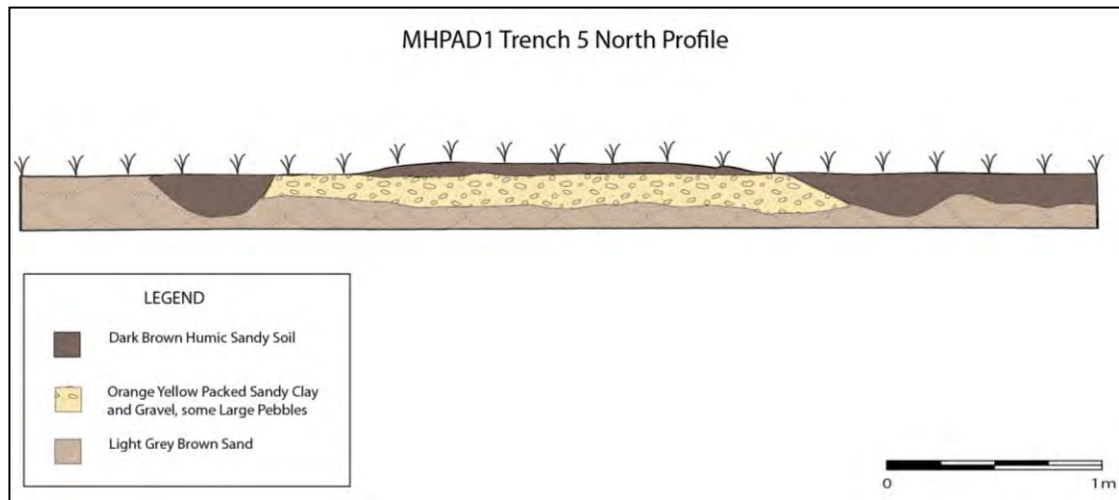
Cut 3 concentrated on the central portion of the transect, extending from Square 58 through to 108 - the area between the diagonal path features (B2 and B4) and either side of the apparent road (B3). This cut exposed more of the detail around B3, revealing that this feature was flanked on each side by a 30-40 cm band of dark brown humic loam, similar to that observed adjacent B5.

**Figure 8.5** Cross section of the road feature (B3) present in Transect 5

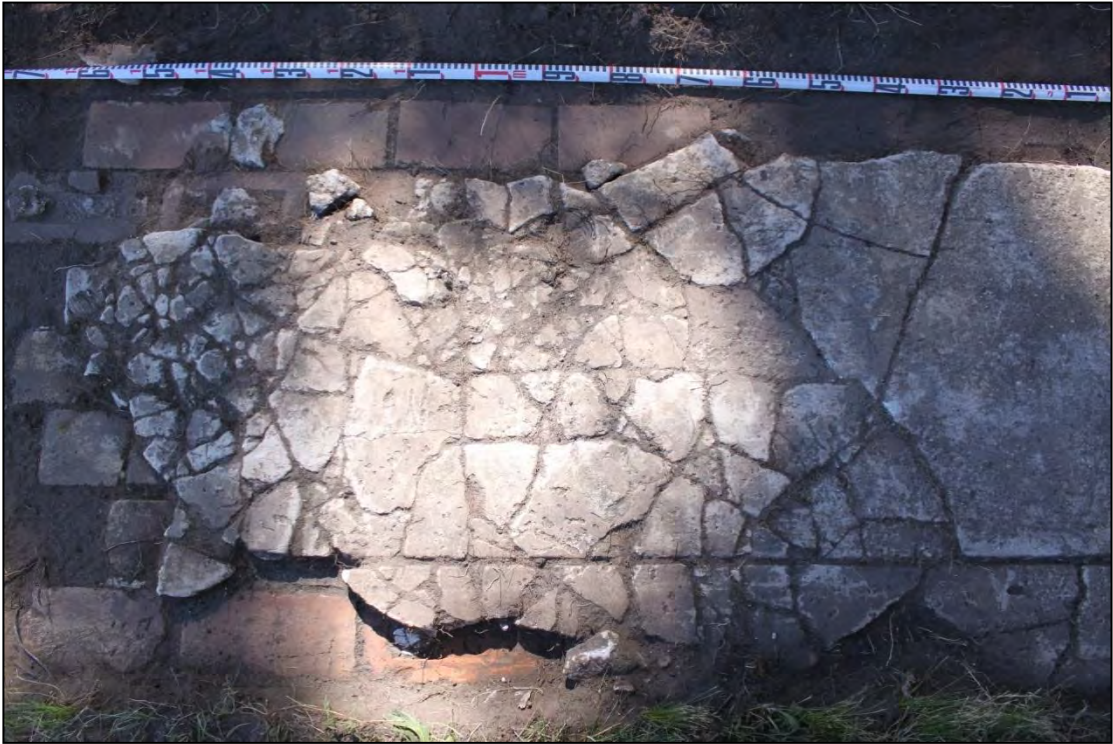
**Figure 8.6** Brick and cement flooring uncovered at eastern end of Transect 7

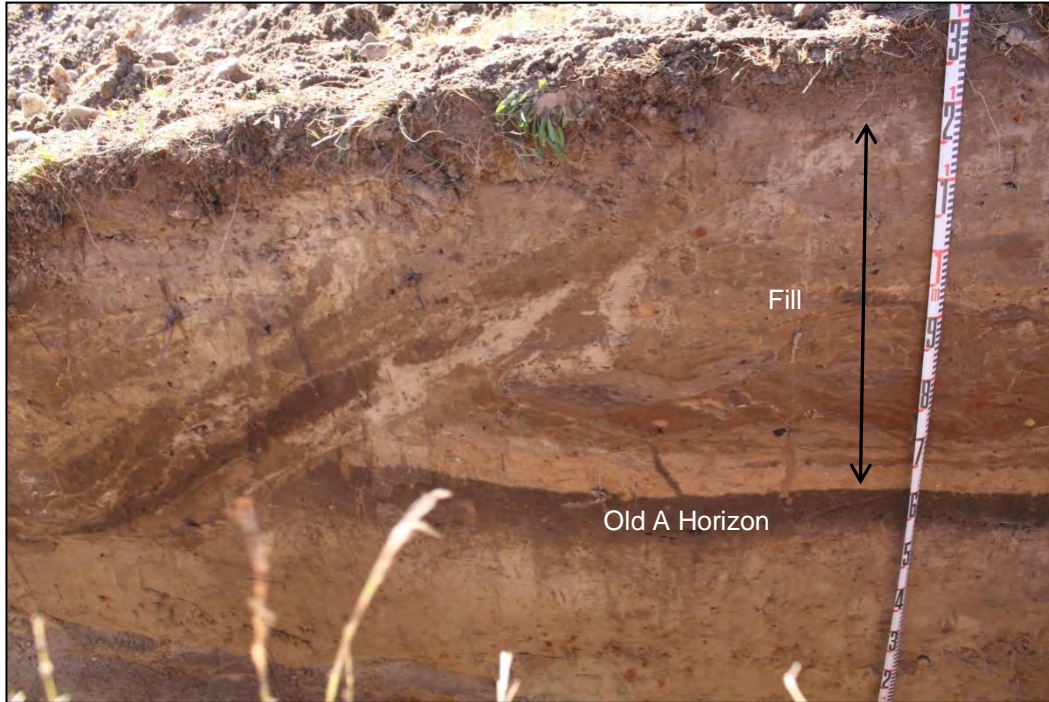
As a result of this discovery there was a need to reassess the nature of the deposits encountered across Transects 1 and 2. The *sondage* was subsequently extended a further 6 m to the east in order to follow the A horizon through the western portion of Transect 8. It was found that the A horizon continued eastwards at a depth of around 500-600 mm. Furthermore, a series of cross shaped dark silty features were found extending into the B-horizon sands below; these features appeared to be following an east-west alignment at a regular interval of about 2 m. Items of bottle glass were also recovered from within the old A-horizon soils in the trench wall.

**Figure 8.7** Northern profile of the western end of Transect 8 showing the layers of fill above an old A-Horizon soil

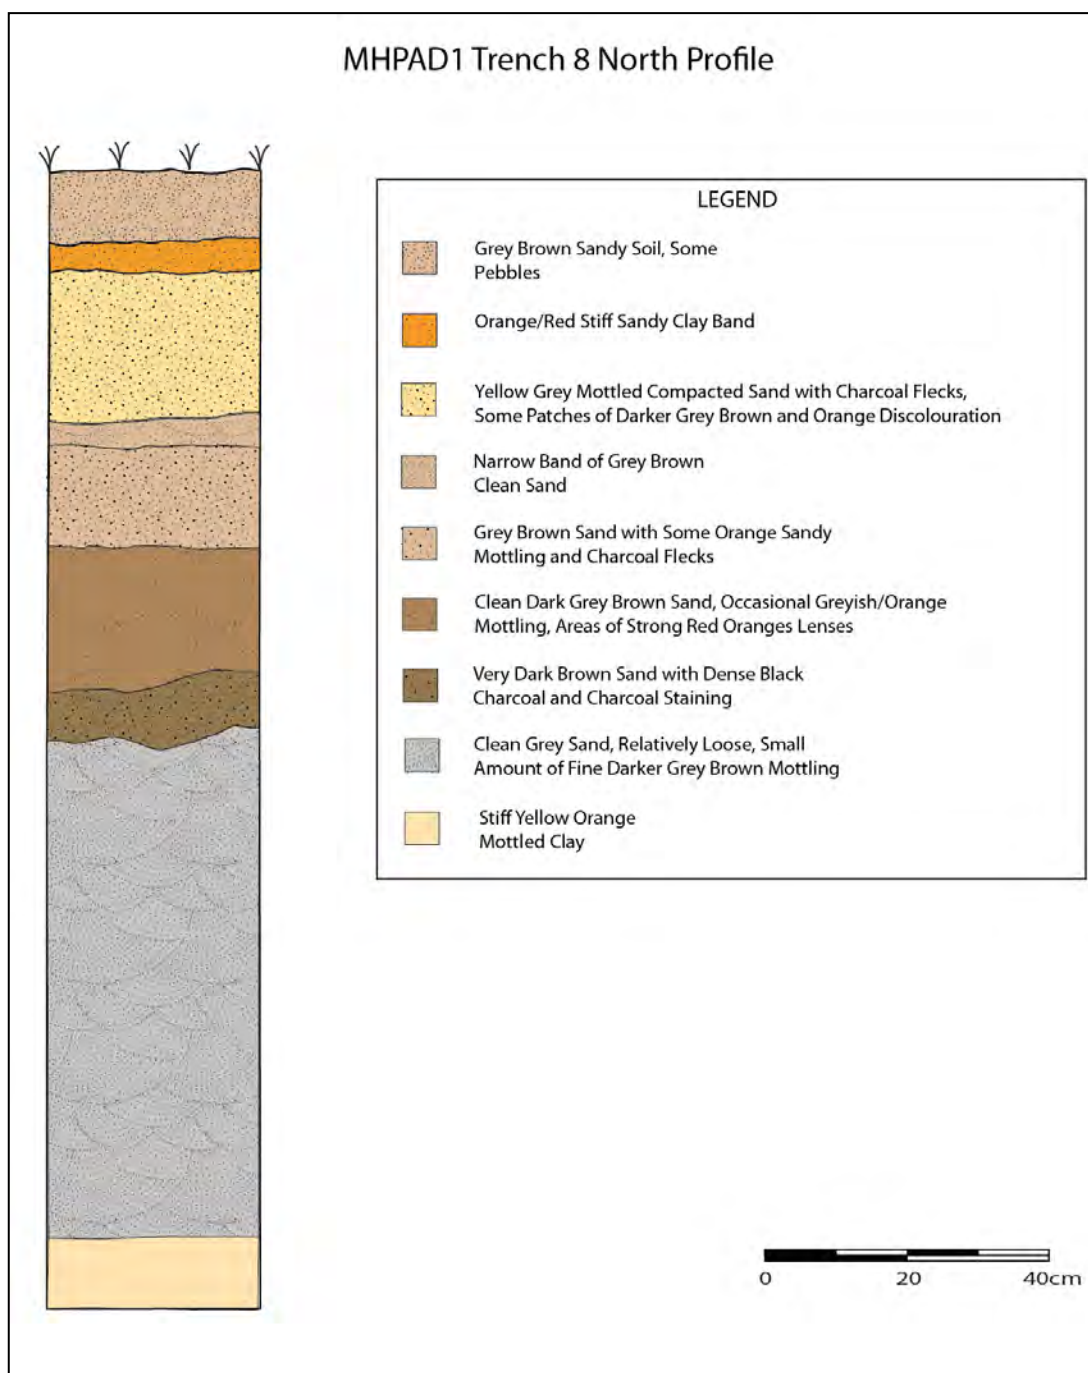
The evidence for this change in the land surface was most clearly evidenced in the soil profiles at the western end of Transect 8 (Figures 8.11 and 8.12), however the remnant topsoil layer evidenced by a very dark brown sand with charcoal staining was also observed in some portions of the soil profile in Transect 9.

**Figure 8.12** Full profile of deposits at western end of Transect 8.

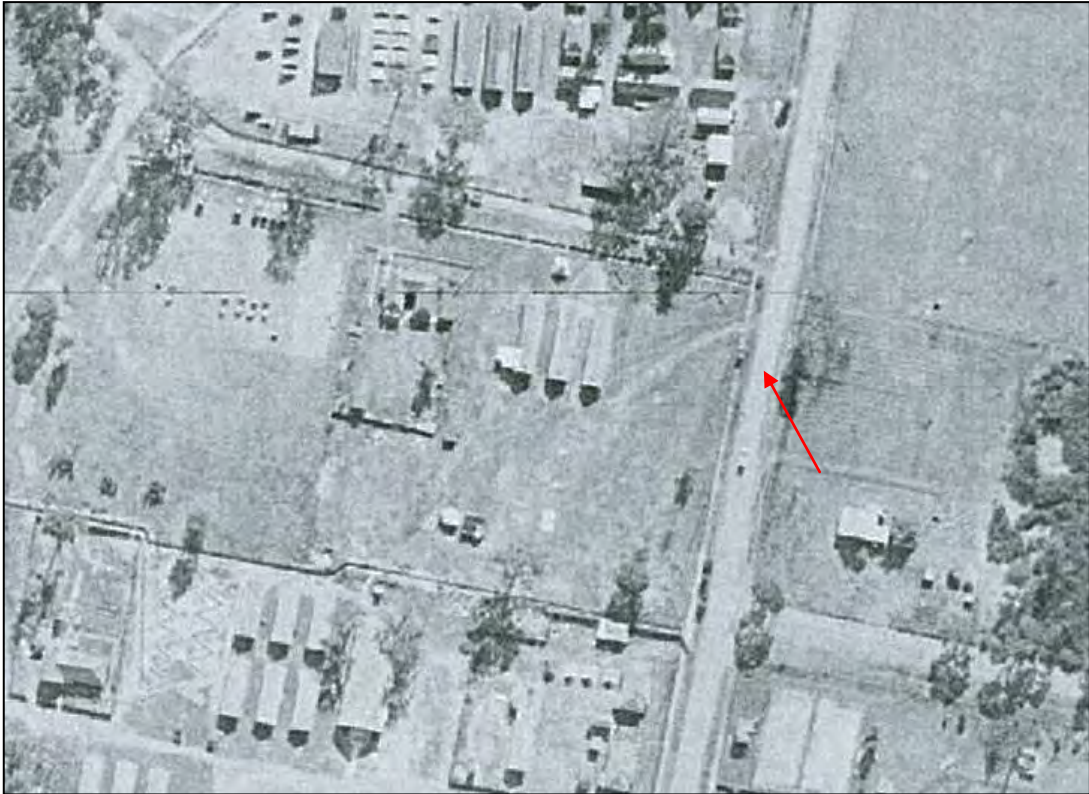
**Figure 8.13** 1943 aerial image of structure at MHPAD1, arrow indicates presence of a feature that appears to relate to the pathway evidenced within Transect 5 and 6  
(Six Viewer [www.six.nsw.gov.au](http://www.six.nsw.gov.au))

Across the eastern portion of MHPAD1, Transects 5, 6 and 7 revealed evidence of a linear network of paths and a road that appear to predate the WWII structures. They include a 3 m wide packed gravel road extending north-south, and various narrower paths (approximately 1.5 m wide) running both parallel with and diagonally flanking the road. The two diagonal paths extend from Transect 6 in the north, southwest and southeast to intersect with the road in the vicinity of Transect 5 (Figure 8.4). Traces of the easternmost path also appear to be evident in the 1943 aerial photography (Figure 8.13). Given that these features are generally not evident in 1943, it is possible that they fell into disuse some years prior; they may relate to activities during WWI or the interwar period.

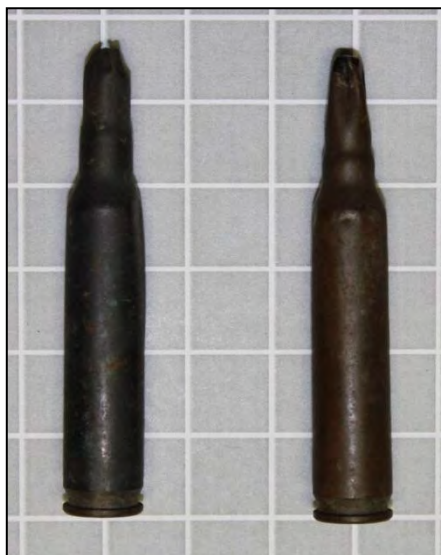
**Figure 8.17** 5.56x45mm ADI rounds (Catalogue #3146 & 3164)

Three bullet casings were found within the upper contexts. All three were the same type: 5.56x45 mm Australian Defence Industries (ADI) blank rounds (Figure 8.17) used for training purposes (Pearson, D 2012, Pers. Comm., 20 Aug). This ammunition is used by the Steyr assault rifle used by the Australian Defence Force since 1989 (Anon 2008).

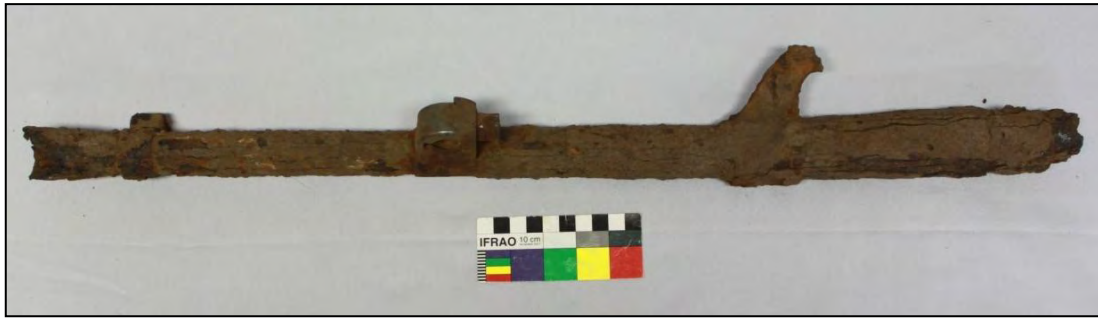
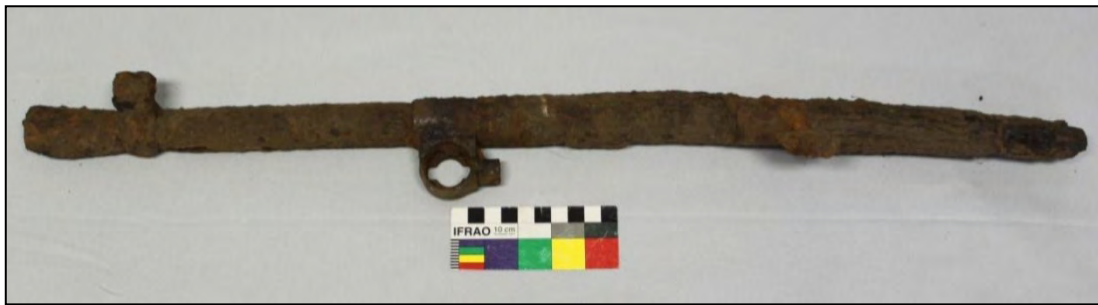
**Figures 8.18 and 8.19** Bren Light Machine Gun Barrel Group (Catalogue #3201)

The barrel group of a Bren Light Machine Gun (Figures 8.18- 8.20) was also recovered from Transect 6. This weapon was used during WWII by the Allies and adopted by many Commonwealth countries after the war. It was used by the Australian Defence Force in WWII (1939-1946) and the Korean War (1950-1953) (Pearson, D 2012, Pers. Comm., 11 Oct).

The barrel group itself was an interchangeable part that was swapped out during use when it heated up too much. The presence of this item as part of the archaeological record is intriguing in so much as it represents an item that would be signed out from the Quartermaster, therefore, someone would have been accountable for the loss of this particular artefact (Pearson, D 2012, Pers. Comm., 11 Oct).

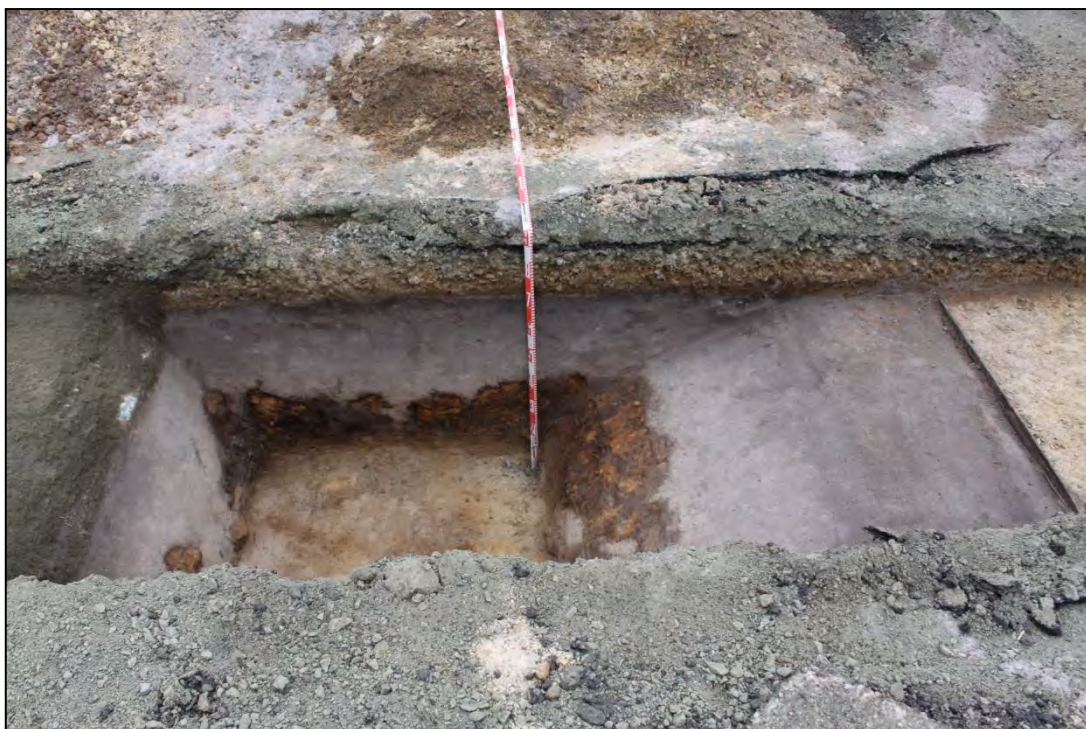
**Figure 8.22** Trench excavated across MHPAD3 showing different phases of road formation and maintenance

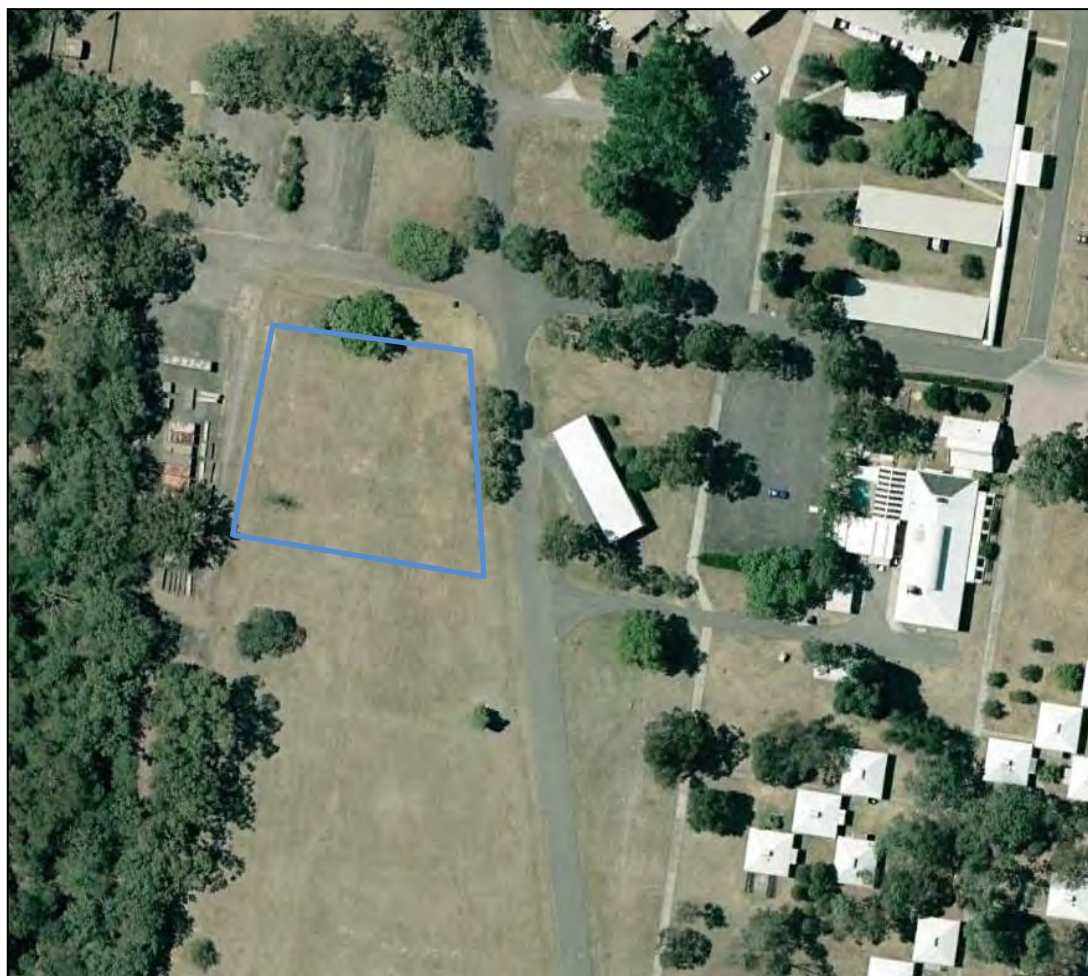
**Figure 8.24** Revised MHPAD2 boundary following subsurface testing program  
(Google Earth Pro 2012)

Test excavations at MHPAD2 indicated that archaeological deposits at this site are relatively intact. On the basis of the test excavations and the surface mapping undertaken at this site it is predicted that archaeological deposits extend across virtually the entire grassed area north of the mines training compound (Figure 8.24). Archaeological deposits at MHPAD2 are likely to be concentrated within the upper 20-30 cm and preservation is predicted to generally be greatest across the central portion of the grassed area. Disturbance is likely to be greatest around the margins of the site, particularly in the south where it borders the mines training compound and in the north and east where service trenches and road construction has impacted the site.
