# LACHLAN'S LINE, PEDESTRIAN BRIDGE, DELHI ROAD, NORTH RYDE ARBORICULTURAL IMPACT ASSESSMENT

PREPARED FOR:

**LANDCOM**

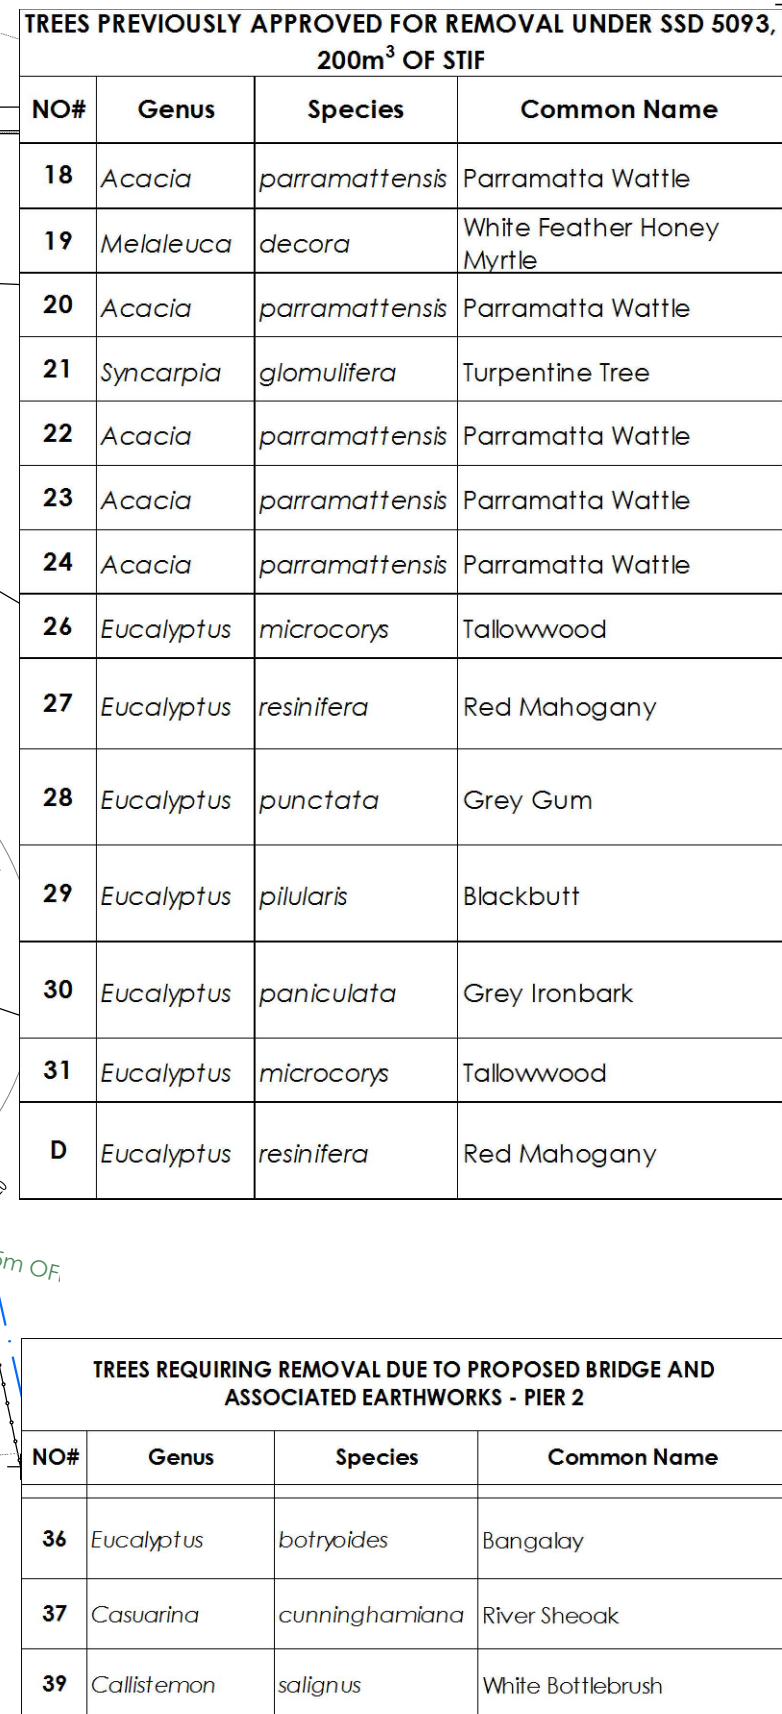
DRAWING TREE LOCATION PLAN - PIER 1			
SCALE N.T.S. @ A3	ISSUE REF	SHEET T - 02	
DRAWN LD+AM	CHECK AM	DATE 22-05-18	REVISION J

FOR FURTHER DETAIL REFER TO SHEETS T06,  
T07 & T08

- The removal of Tree No.'s 18, 19, 20, 21, 22, 23, 24, 26, 27, 28, 29, 30(L-M), 31 & D has previously been approved under SSD 5093.
- The removal of Tree No.'s 1, 2, 3, 4, 5, 6, 7, 8, 9 & 12 if the development is approved, as they are within the development footprint of the pedestrian bridge or within the earthworks associated with Pier 1 of the proposed bridge.

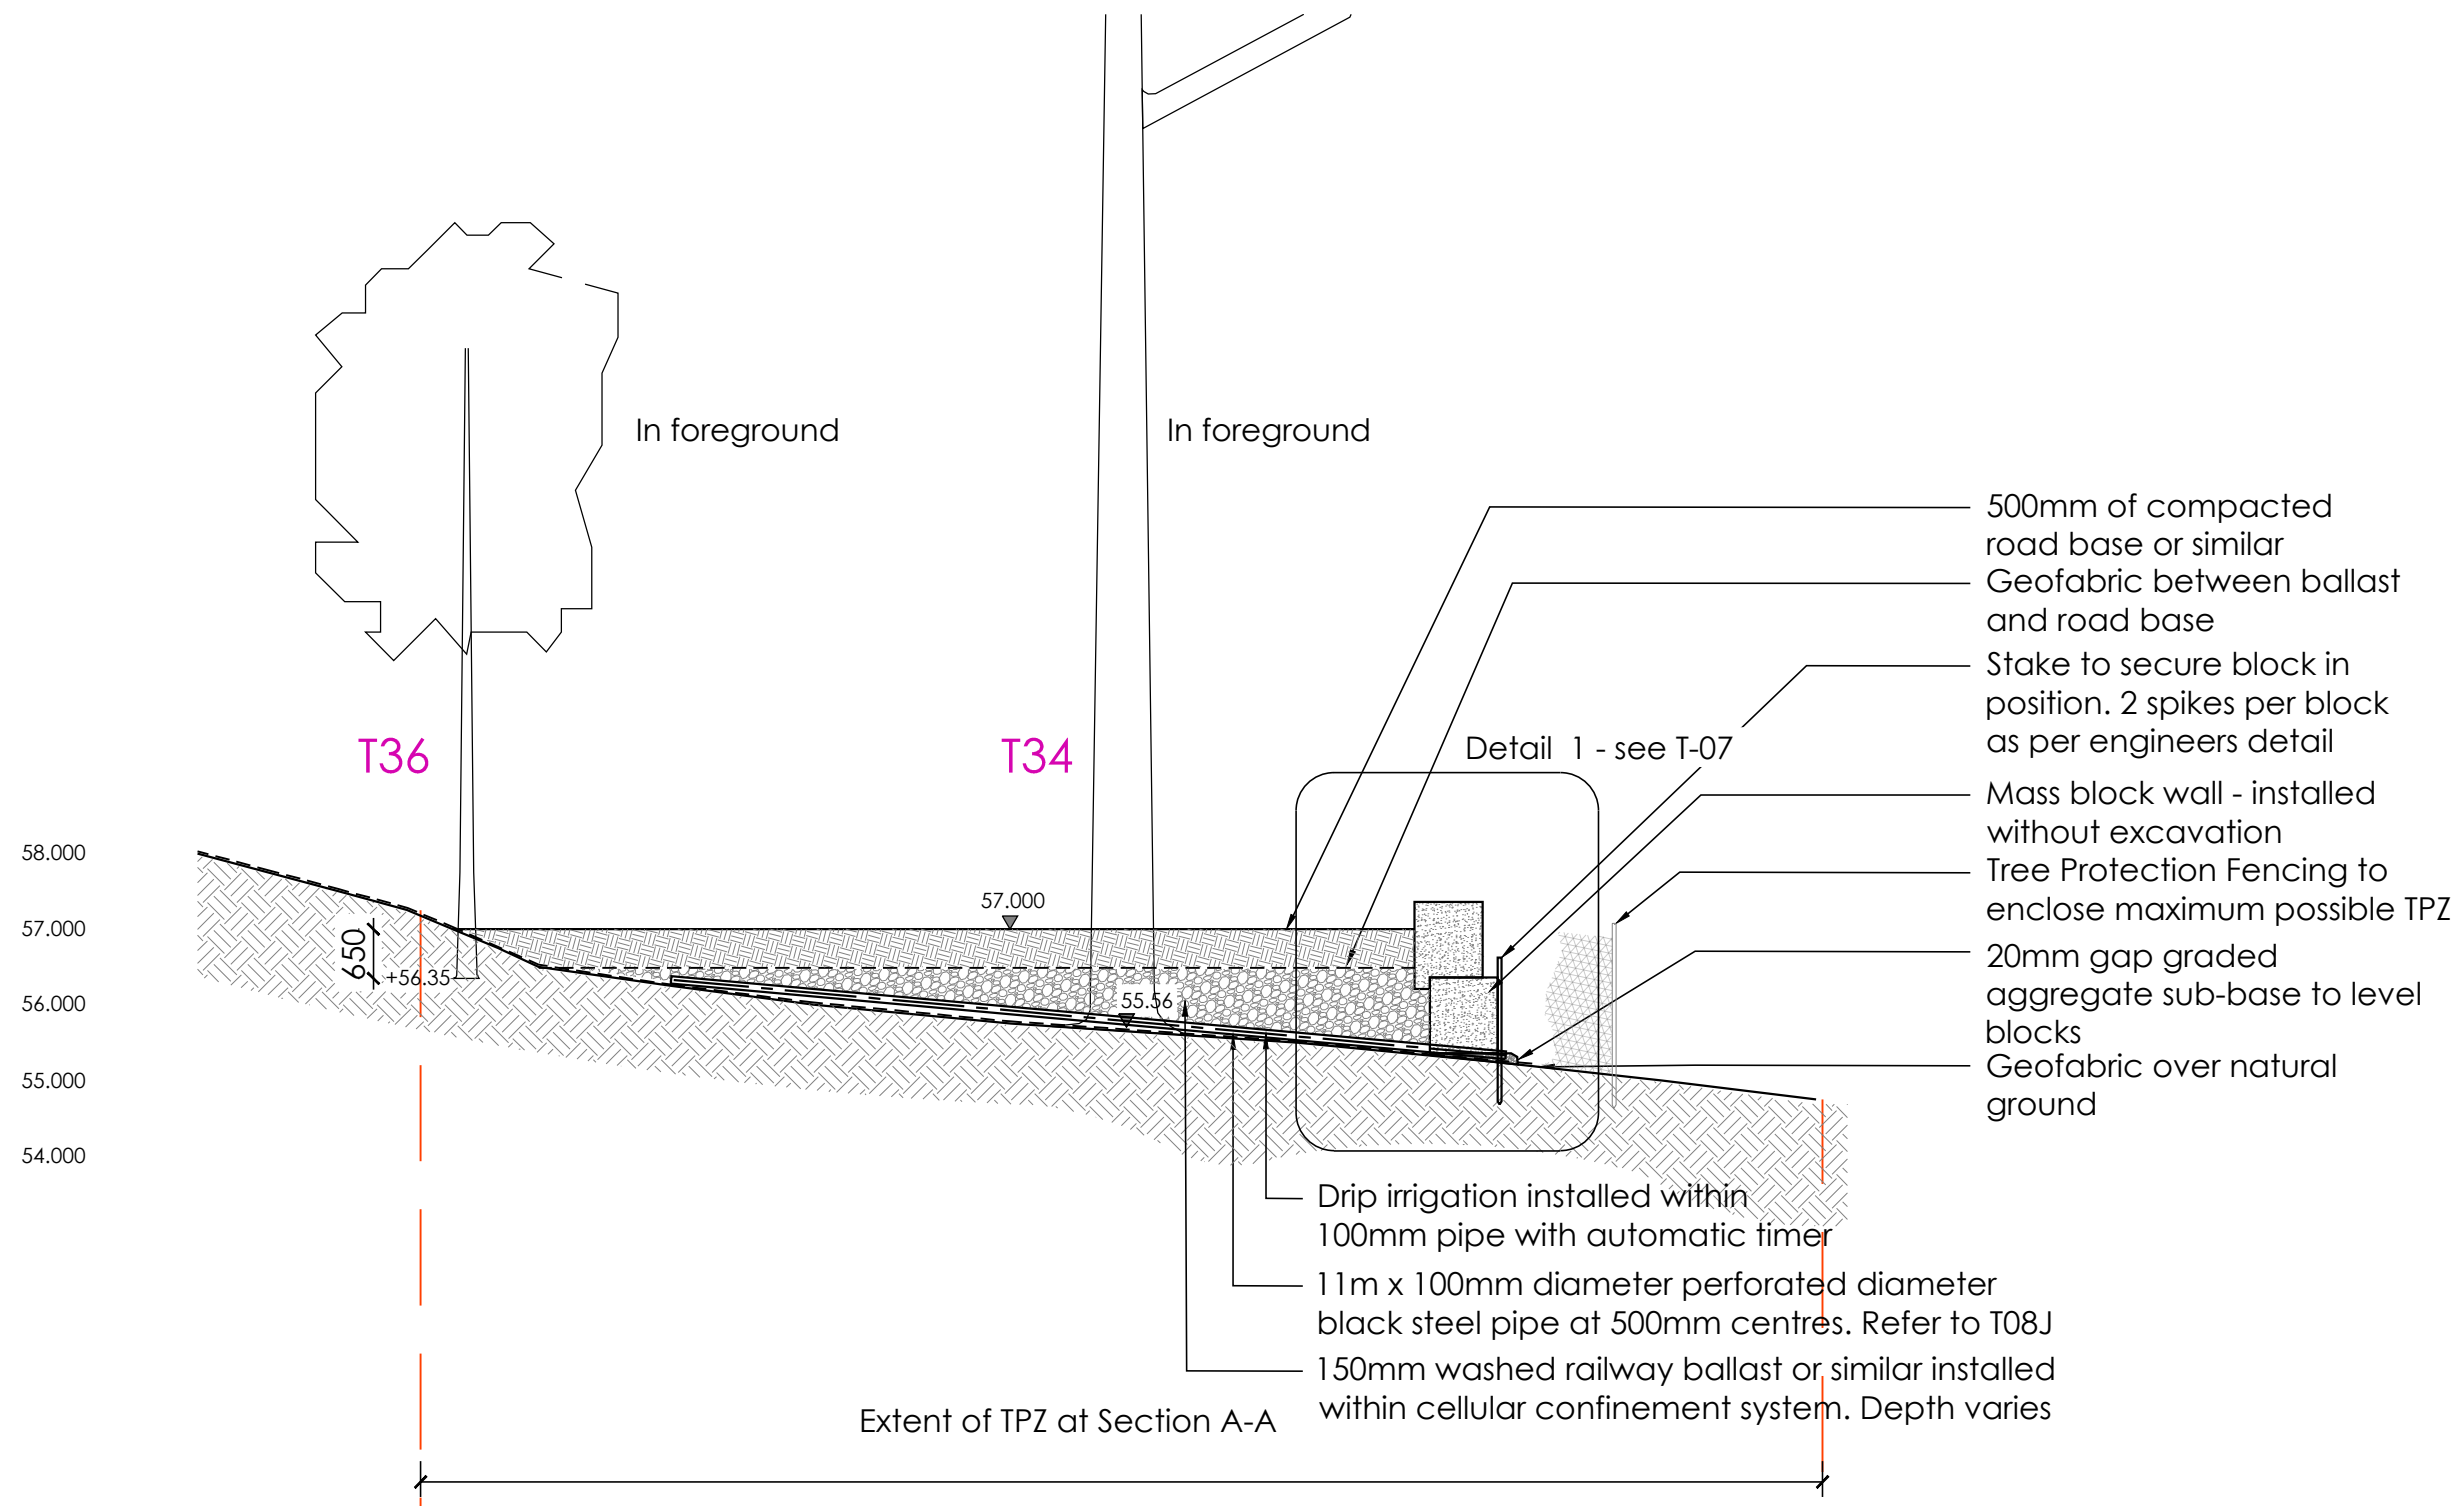
**A**  
**1:100**  
**TYPICAL SECTION**  
TEMPORARY WORK PLATFORM  
All structures and grades to engineers details

- 1.5.2 Allow gaseous exchange and water permeability.
  - 1.5.3 Provide barrier between fill materials and existing soil.
- 1.6 14 x 100mm perforated black steel pipes laid at 500-600mm centres over geofabric to allow maximum possible air movement and water infiltration near existing ground level within TPZ. Pipes to be secured with 300mm S12 pegs at 2.5m centres Refer to T08 for pipe lengths.

- 2.1 Monthly site inspections by arborist to monitor tree health, inspect tree damage and determine irrigation scheduling.
- 2.2 Use of a rigger/dogman to guide the rig operator to avoid tree stems and crowns.
- 2.3 Contact project arborist if any spills or accidental injury to retained trees on site.
- 2.4 Contact project arborist if any pruning of branches or roots is required.
- 2.5 Contractor to put in place Hydrocarbon, Chemical and other liquids Spill Response plan and a Bulk Materials Spill Response Plan which are compliant with the relevant authority.

- 3.3 Measurement of degree of compaction at the conclusion of construction using penetrometer to depth of 300mm or similar at the same 8 locations as above in point 1.3.
- 3.4 Replace stockpiled original mulch/soil as to achieve as close to original coverage as possible.
